# MONA OFFSHORE WIND PROJECT

## Geomorphology Clarification Note

Document Reference: S\_D4\_7

Document Number: MOCNS-J3303-RPS-10313

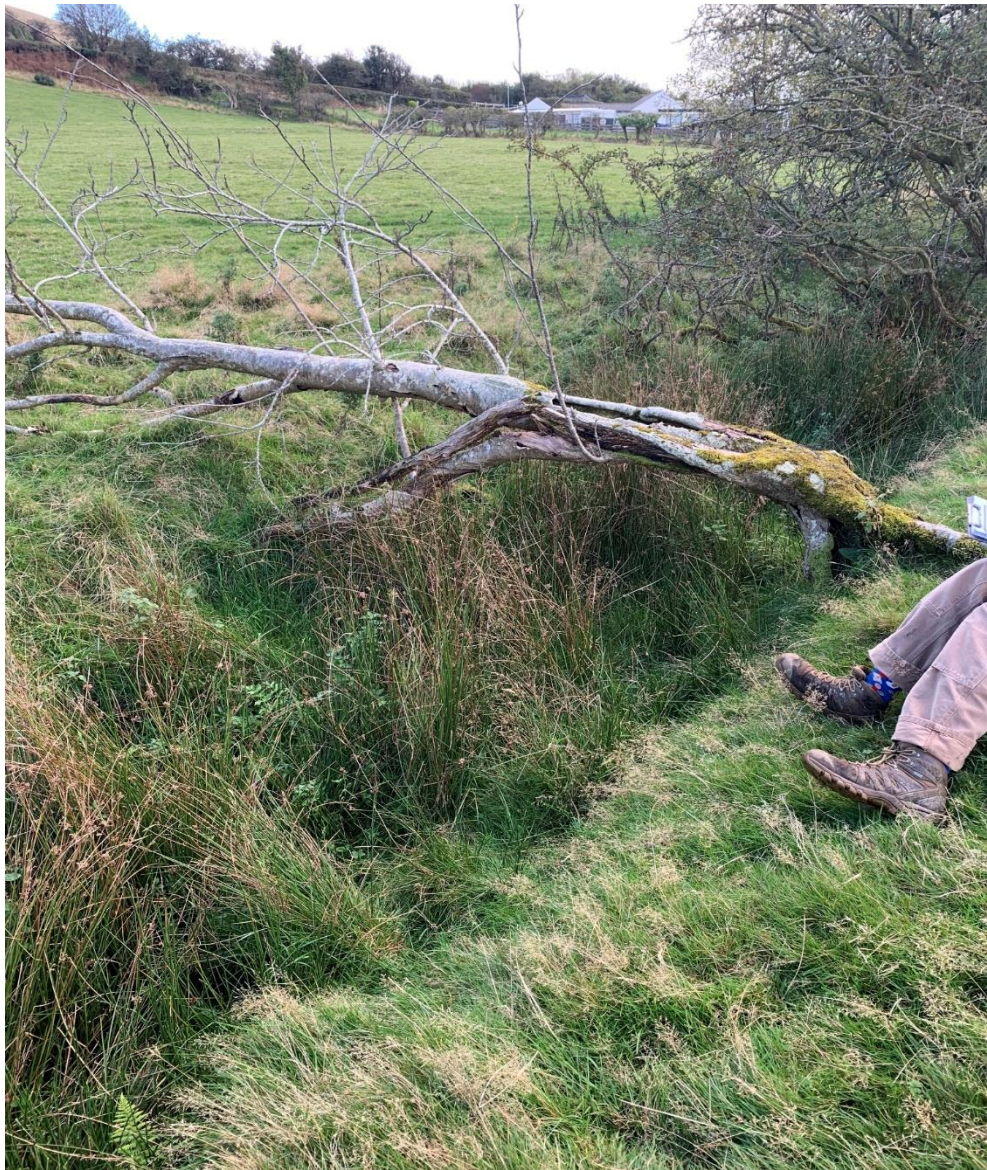
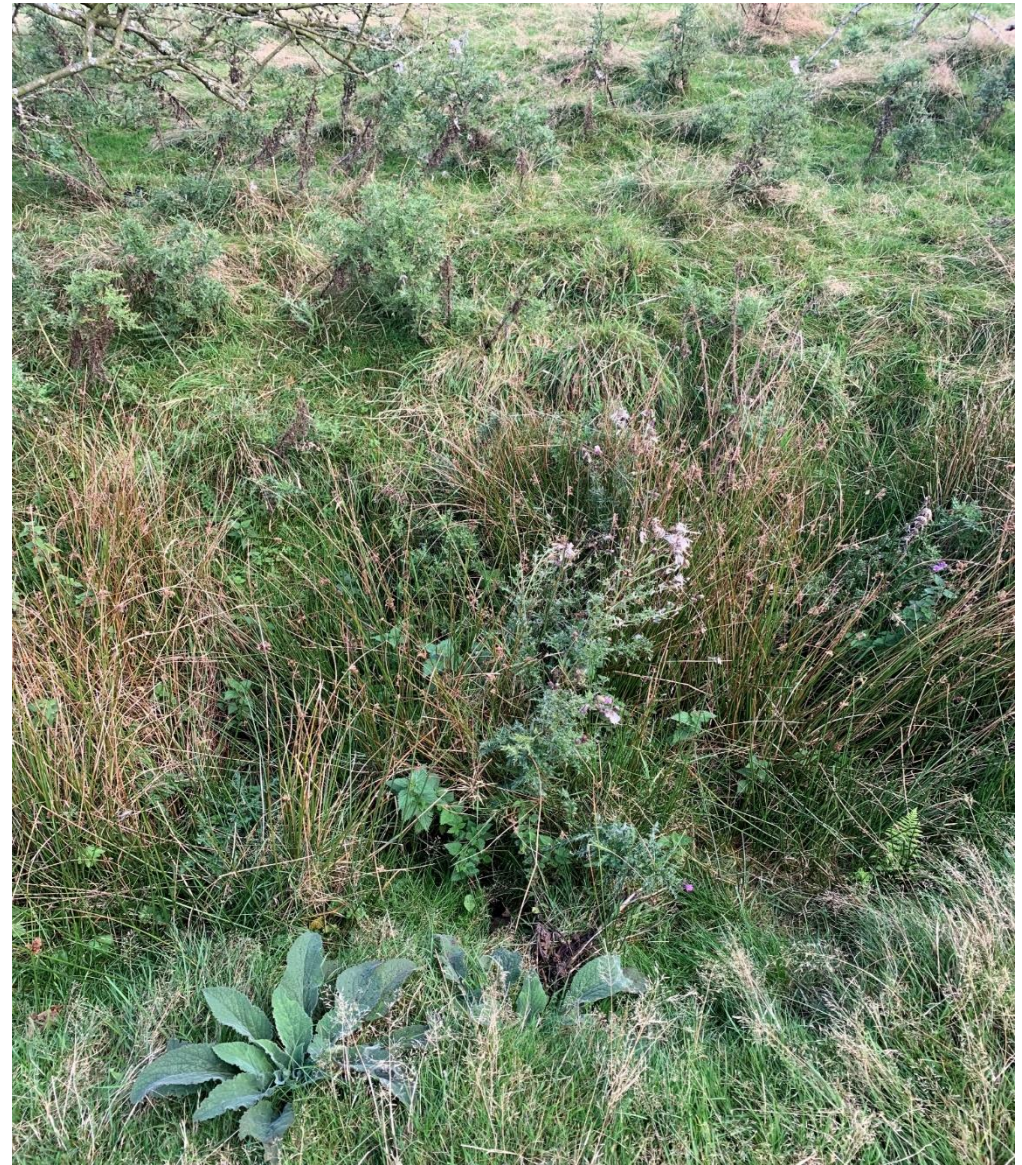
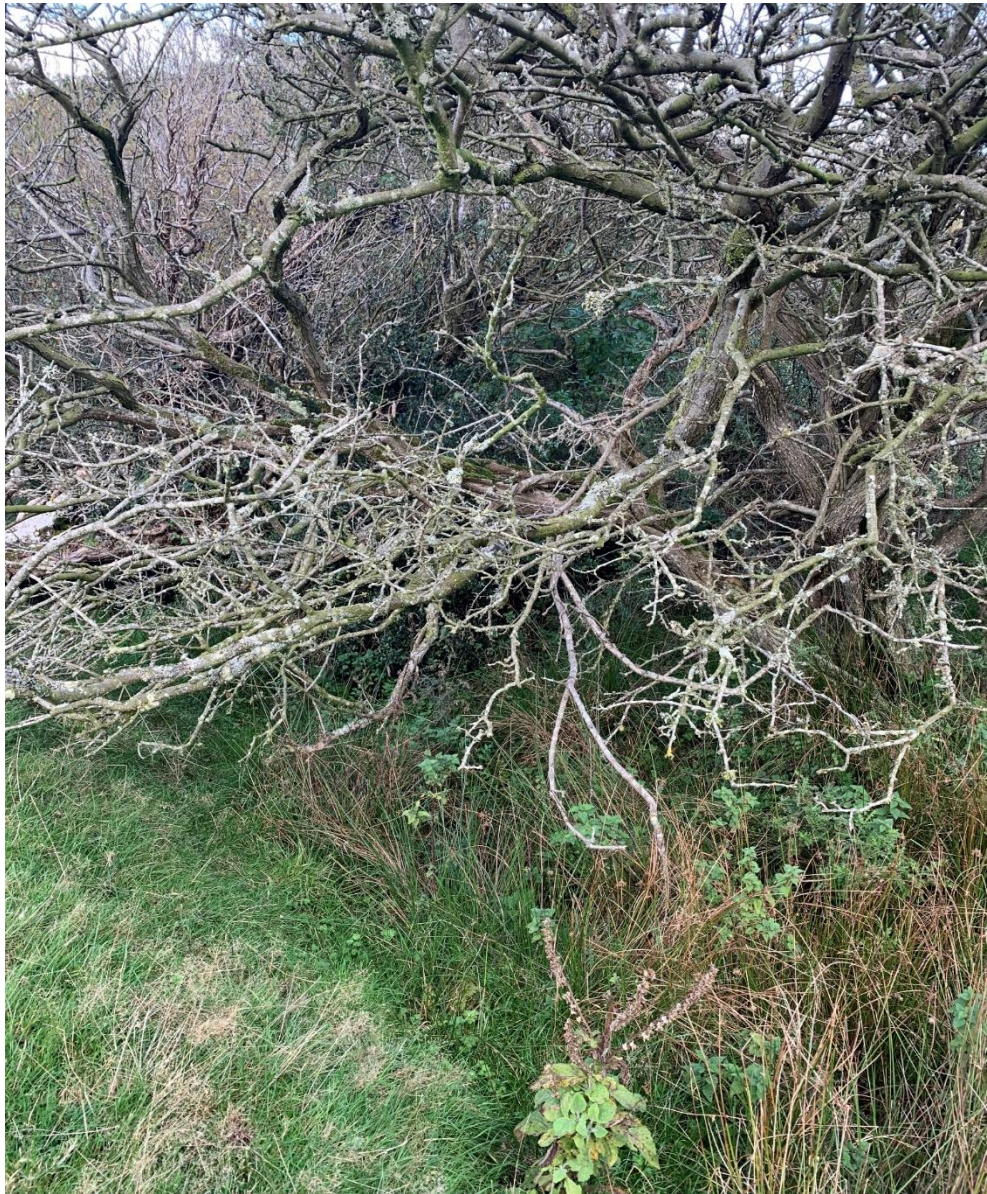
A.4.6 Location F

- 1.2.5.23 Location F comprises unnamed seepage located 520m to the west of Afon Gele and appeared to drain to the adjacent catchment. The watercourse is not suitable for a MoRPh survey as there is insufficient flow to support morphological activity; it is also not suitable for a ditch condition assessment.
- 1.2.5.24 The seepage appeared to be generally in good condition with no noticeable turbidity or signs of pollution. There were also no signs of stress from agricultural activity such as grazing. No NNIPS were observed at the time of walkover.
- 1.2.5.25 At this location the watercourse will be crossed using trenchless techniques and the haul road will require a new temporary crossing to be constructed.

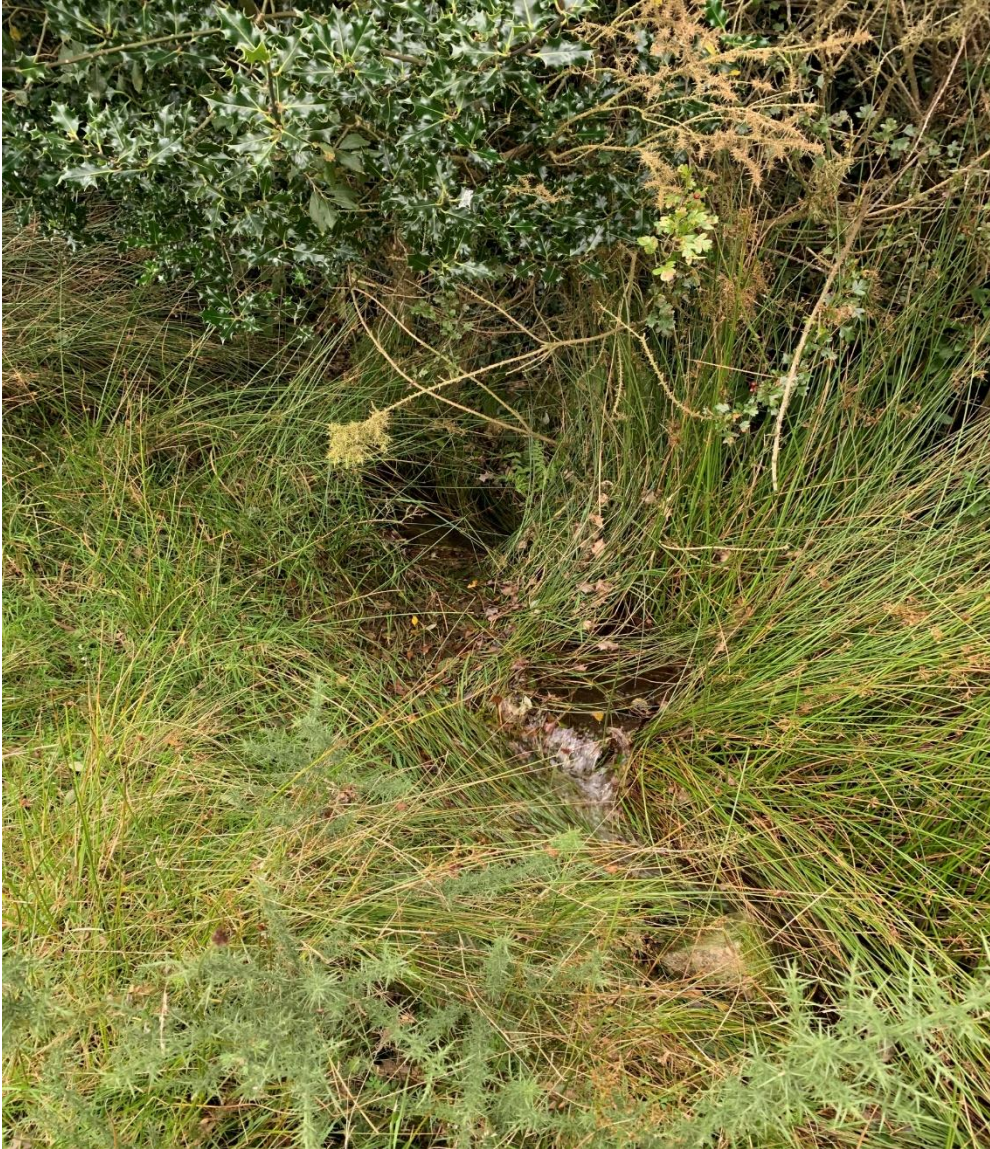
## A.4.7 Location G

- 1.2.5.26 Observations of Location G were undertaken from the right bank, the left bank top was not accessible nor visible through vegetation and foliage. Location G comprises a very small upland watercourse which feeds into Nant y Greigiau downstream. It has a catchment area of 0.2km<sup>2</sup>. The classification of this watercourse is River Type K – straight/sinuuous, coarsest SA, average SI.
- 1.2.5.27 The right bank top was extensively covered by short grasses and tall grasses. There was a dense tree and shrubbery line on the left bank top and left channel margin. This constituted some large wood on the channel margins and extensive branches trailing into the channel. There was heavy vegetation within the channel with emergent linear leaved plants and tall herbs/grasses choking the channel.

- 1.2.5.28 There was almost no morphological richness of the channel bed and marginal features due to the small size of the watercourse, however there was some variety in terms of flow types. The watercourse had good connectivity to the floodplain (particularly given the size of the watercourse) and there is little evidence of stress from the surrounding pasture.
- 1.2.5.29 No artificial reinforcements were evident. No NNIPS were observed at the time of survey.
- 1.2.5.30 At this location the watercourse will be crossed using trenchless techniques and the haul road will require a new temporary crossing to be constructed.

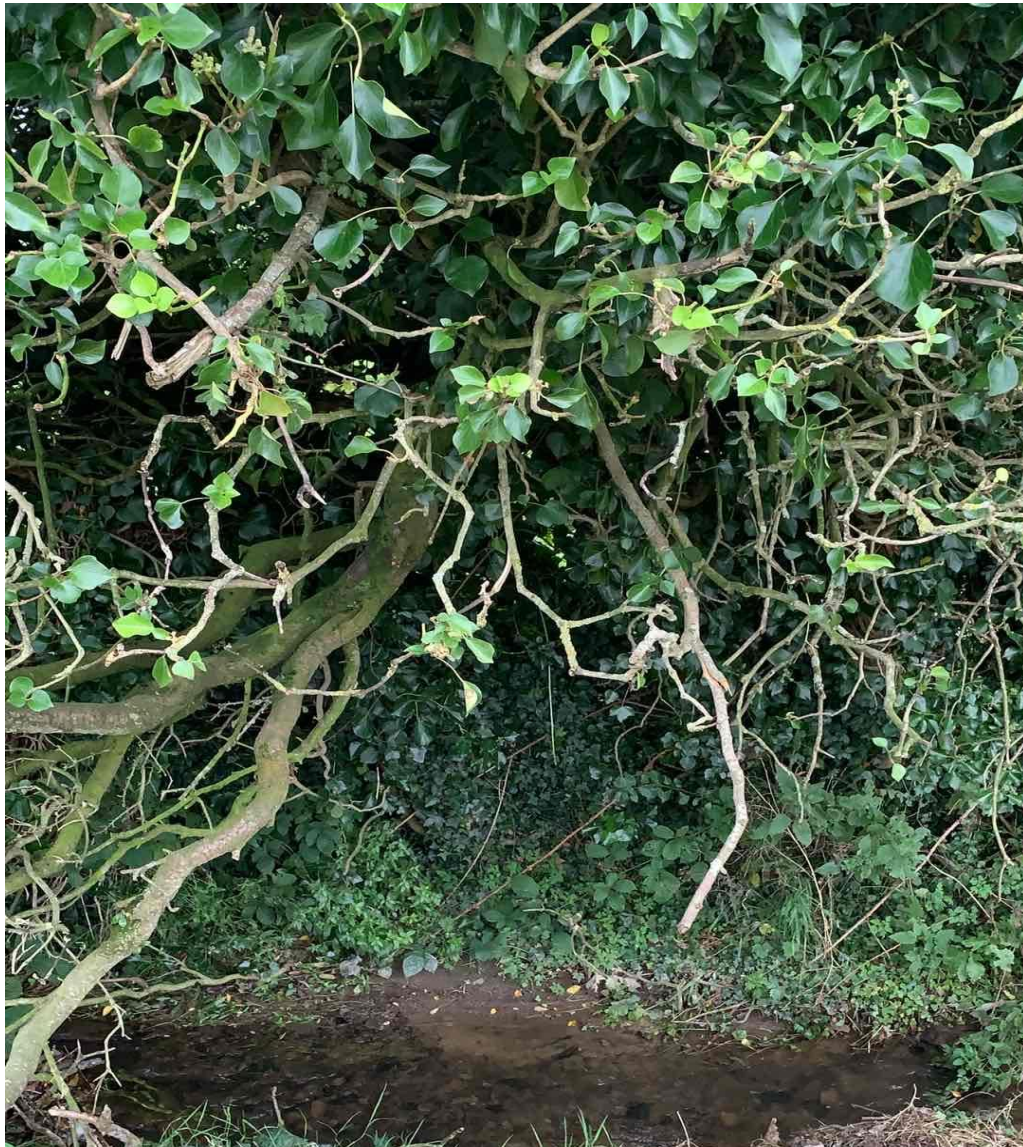
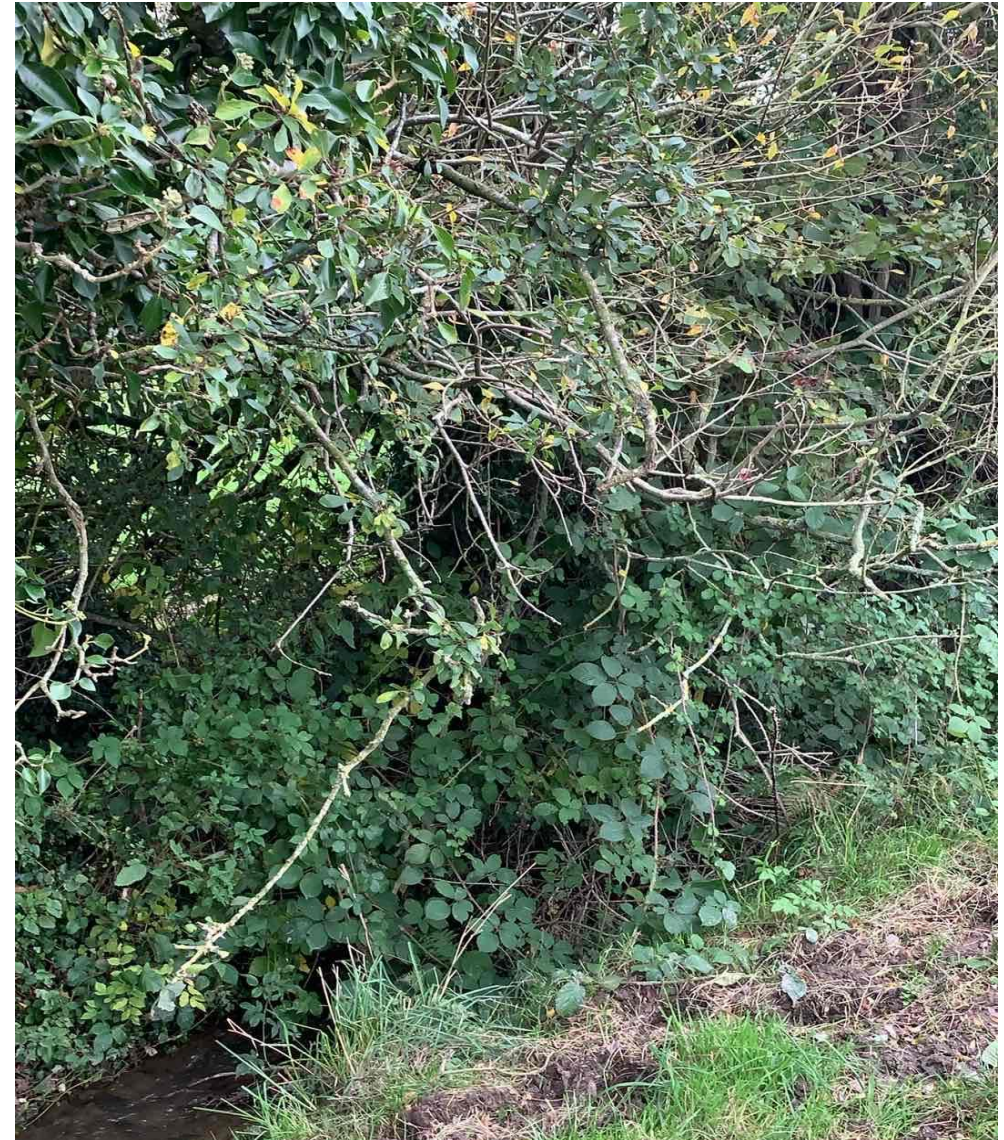
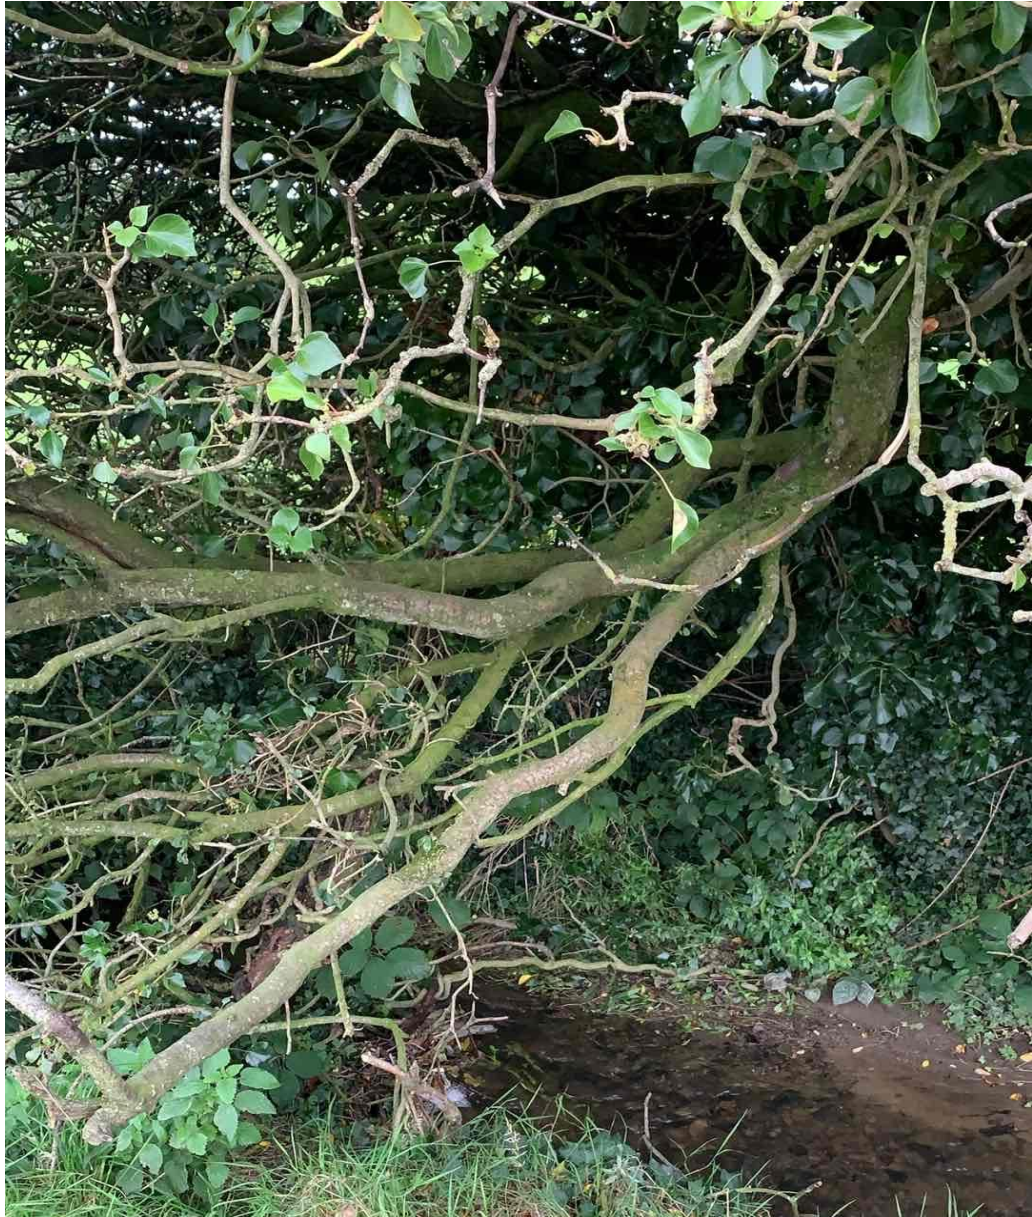
A.4.8 Location H

- 1.2.5.31 The Location H survey was undertaken from both banks. Location H comprises a small watercourse which drains into Nant Luke and has a catchment area of 0.3km<sup>2</sup>. The classification of this watercourse is River Type F – straight/sinuuous, coarsest CO (cobble), average GP.

- 1.2.5.32 Both bank tops had a dominant ground cover of permanently vegetated agriculture, but the left bank also had an unvegetated mud path/road present. Saplings and trees were present extensively on both bank faces, with a leaning trees and branches trailing into the channel on the right bank only. Other vegetation on the bank face included short grasses and tall grasses, with shrubs/scrub noted on the right bank face only. Emergent linear leaved plants were also present at the right channel bank face.

- 1.2.5.33 Channel vegetation included trace amounts of emergent broad leaved and emergent linear leaves, but the channel was not considered to be choked with aquatic vegetation. There was significant channel shading from trees.

- 1.2.5.34 The channel displayed some richness of bed and marginal morphological features and more than one flow type. Its condition is generally moderate. There is little evidence of stress from agricultural land use. The channel appeared slightly over-deepened and confined on both sides meaning that floodplain connectivity is poor.

- 1.2.5.35 No artificial reinforcements were evident. No NNIPS were observed at the time of survey.
- 1.2.5.36 At this location the watercourse will be crossed using trenchless techniques and the haul road will use an existing crossing location.
