MONA OFFSHORE WIND PROJECT

Hydrogeological risk assessment for Tan-y-Mynydd Trout Fishery

Document Reference: S_D6_8

Document Number: MOCNS-J3303-RPS-10482

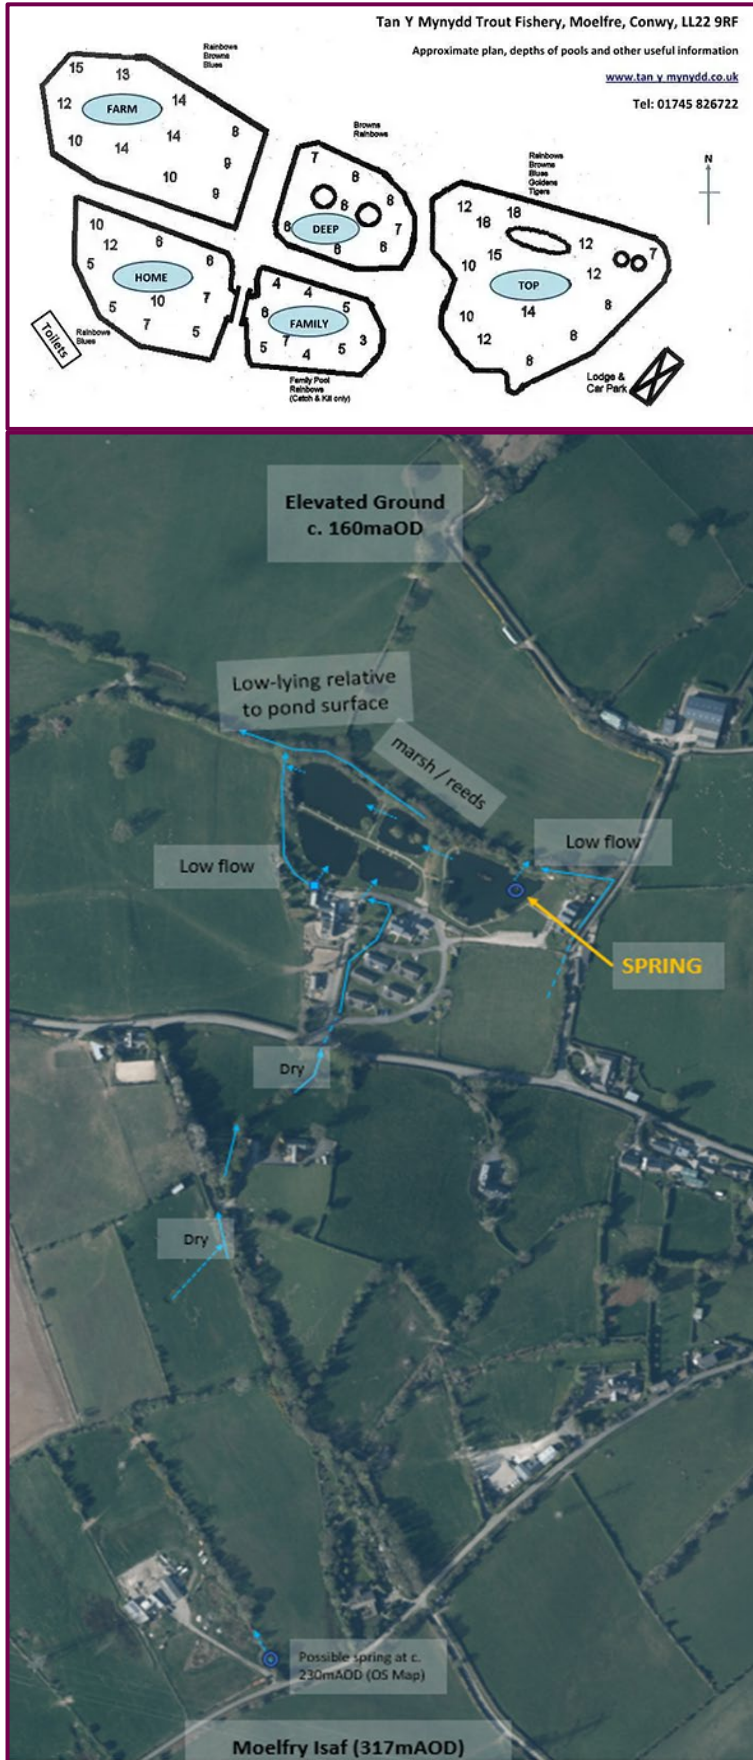
Figure 2: Water features at the time of the site walkover in May 2024

- High elevation springs – Springs 1, 2 and 3 are located on Moelfre Isaf at above 200 mAOD, typically more than 50m above the elevation of the Tan-y-Mynydd Trout Fishery spring. These are likely to represent groundwater discharge points from the shallow fractured bedrock.
- Low elevation springs - Spring 4 and the Tan-y-Mynydd Trout Fishery spring are located at low elevation (160 to 174 mAOD).

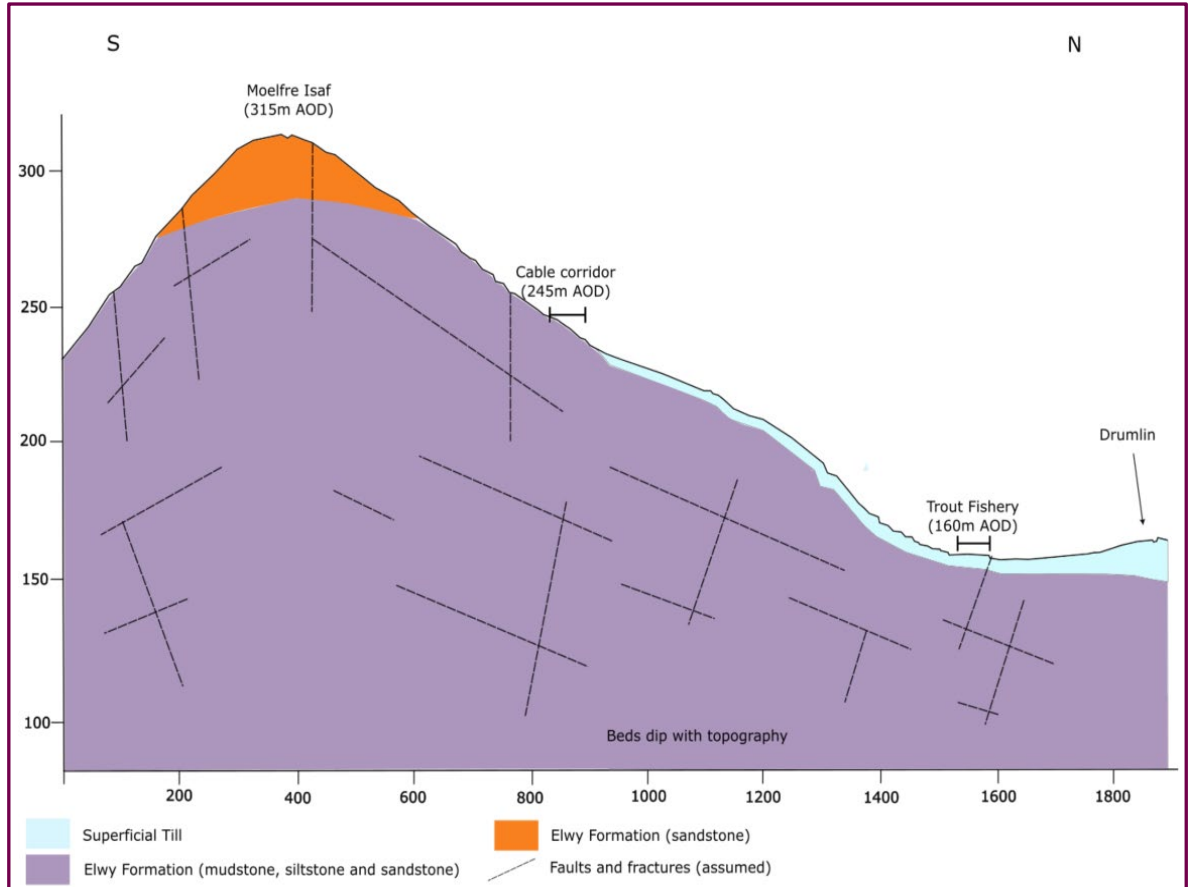
Figure 6: Geological cross section

- Large horizontal (lateral) and vertical separation between the Tan-y-Mynydd Trout Fishery and the Onshore Cable Corridor
- The bedrock geology of area is dominated by mudstones of the Elwy Formation.
- The localised presence of sandstone units in the Elwy Formation, as mapped at the summit of Moelfre Isaf
- The folded nature of the Elwy Formation, which dips to the north in the direction of the Tan-y-Mynydd Trout Fishery on the northern side of Moelfre Isaf.
- Variety of low angle (bedding parallel) fractures and high angle fracture sets albeit limited fracture sets.

3.2.1.10 The cross section does not give any impression of large-scale regional faulting seen on the BGS mapping, because those faults / fault zones extend south-southeast to north-northwest and therefore occur outside of the cross section.

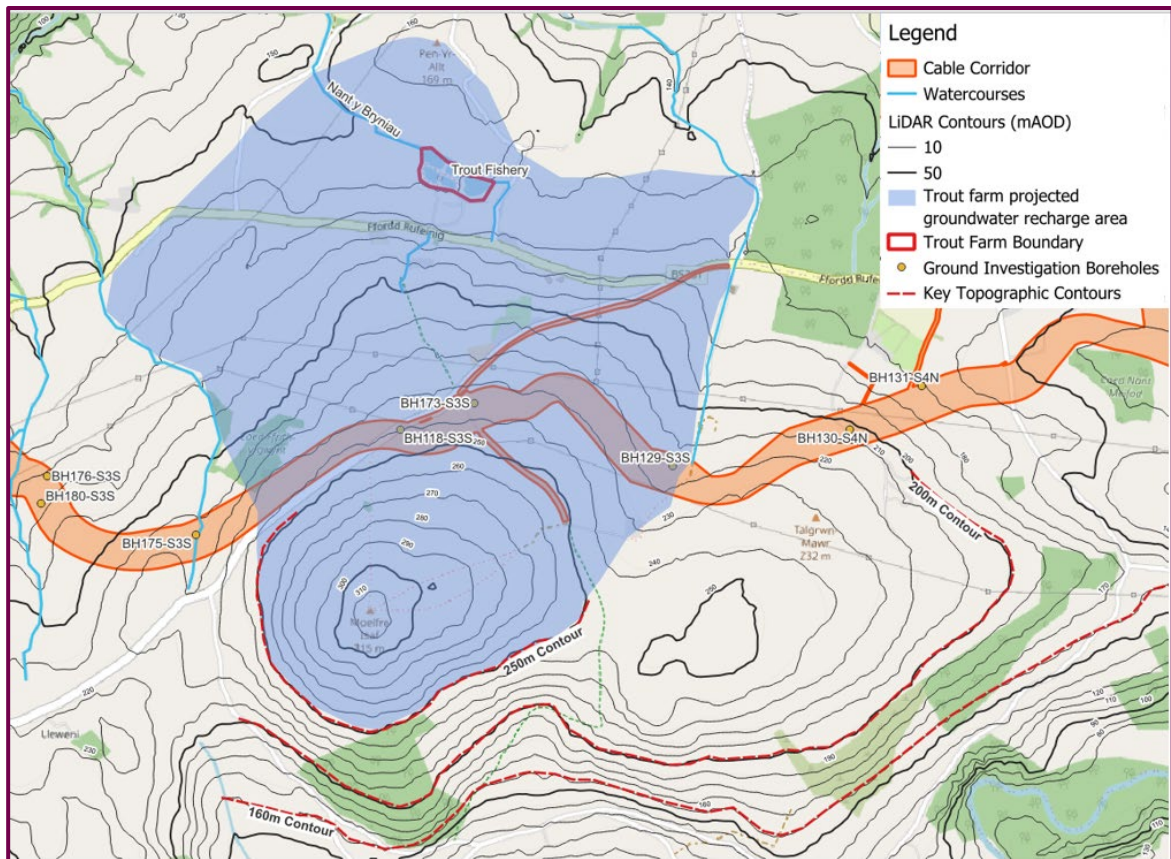
Figure 8: Schematic groundwater recharge catchment area, showing the Onshore Cable Corridor and the Tan-y-Mynydd Trout Fishery

- 3.4.3.2 A schematic groundwater catchment area that includes the Tan-y-Mynydd Trout Fishery and Onshore Cable Corridor as shown in **Figure 8**. The catchment area also extends to the north, given the locally elevated topography relative to the fishery in that direction. The total potential catchment area shown in **Figure 8** exceeds 1.4 km² and includes exposed bedrock and bedrock shown to be concealed beneath glacial till. However, it is likely that the actual catchment area supporting spring flow at the Tan-y-Mynydd Trout Fishery, will be a smaller subset of this total catchment area, possibly of the order of 1km².

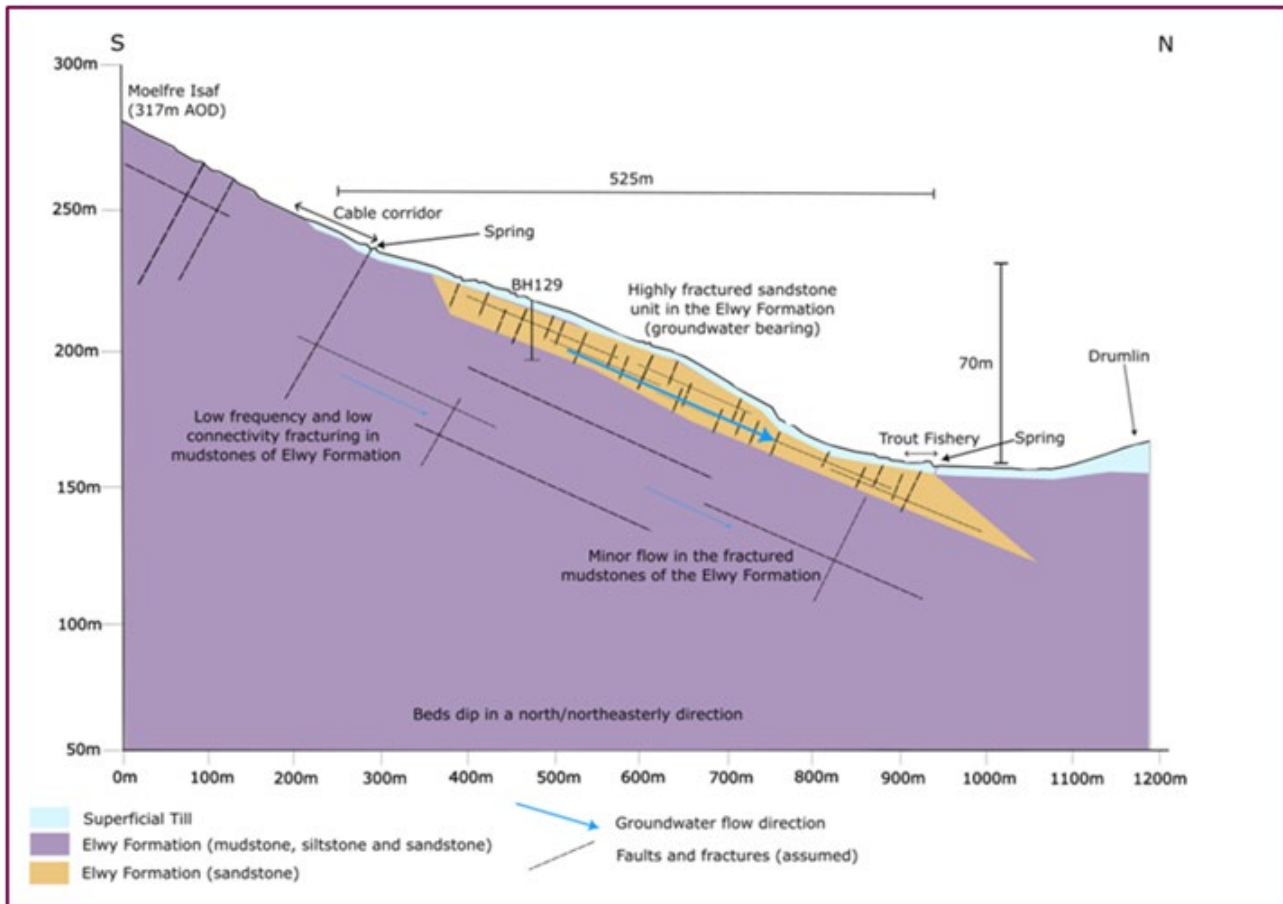
Figure 10: Conceptual Hydrogeological Model 2 – highly fractured sandstone or mudstone units in the Elwy Formation

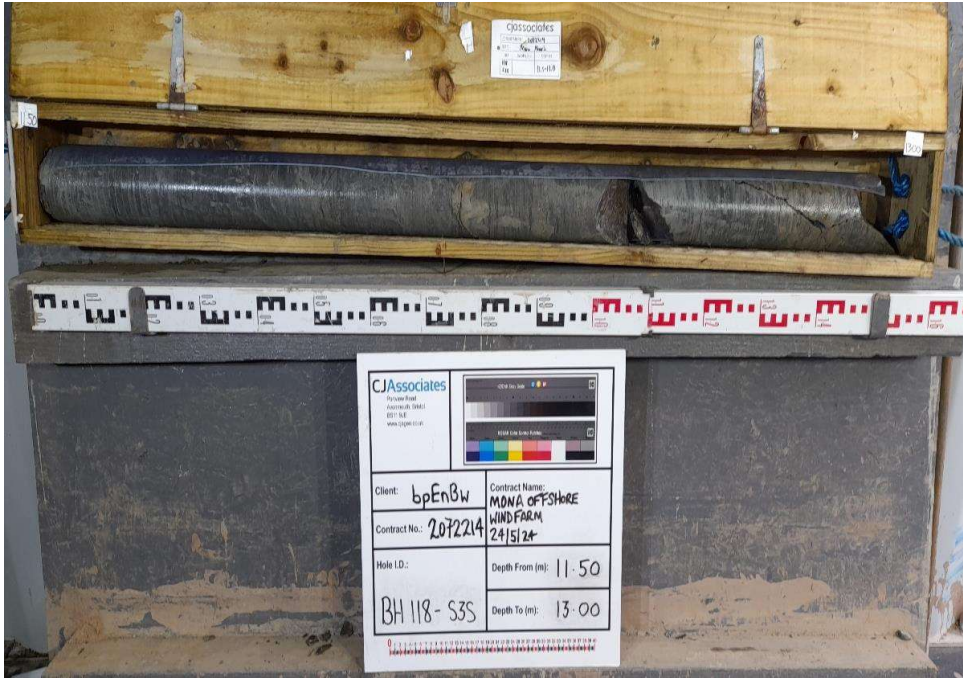
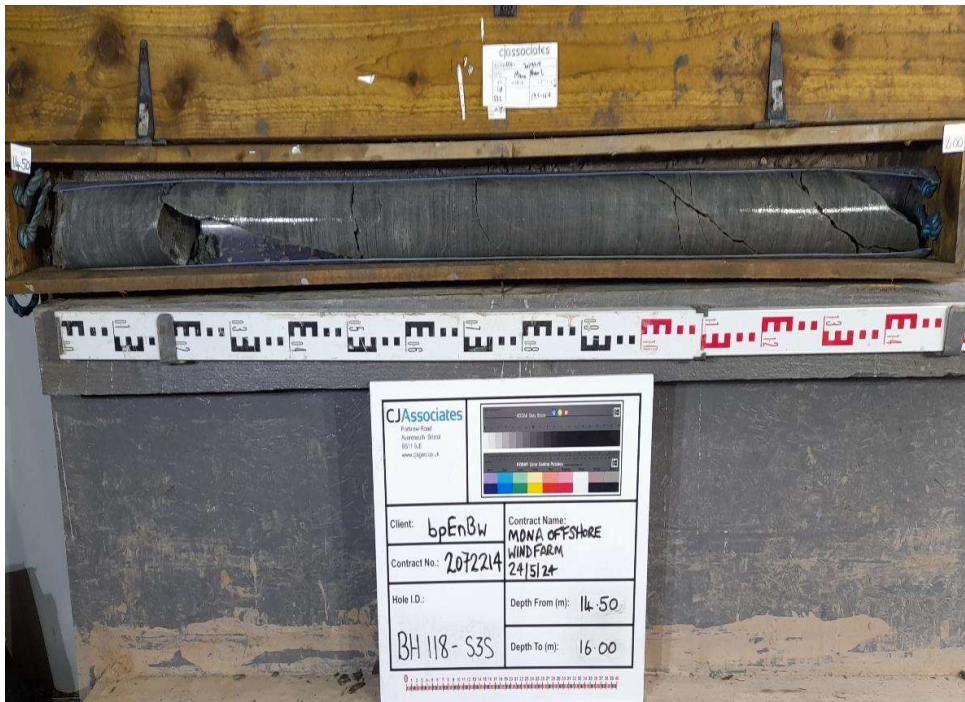
| Unit 3, Block 6 Newlands Avenue Brackla Industrial Estate Bridgend, CF31 2DA | Project Mona Offshore Wind Project Ground Investigation | Drawing Title BH118-S3S |

| Direction from Fishery | Borehole reference | Ground Elevation (m AOD) | Distance from Fishery (m) | Depth to base (m) | Logged rock/soil type | Average depth to groundwater (m bgl) | Hydrogeological Observations | Presumed Unit | Groundwater Data in R1, R2, R3 Depth to GW (m bgl) GW Level (mAOD) Height of GW column (m) |
|---|---|---|---|---|---|---|---|--|---|
| South of Fishery | BH118 | 242.72 | 660 to S | 16 Slotted 1m – 16m | Gravel to 0.5m bgl, then mudstone and siltstone | 2.89 | Thin surface weathered horizon overlying a consolidated mudstone, with only limited fracturing. Fractures are mostly in the shallow depths and become less common with depth. Some fractures are high angle relative to bedding. Limited fracturing indicates limited pathways for groundwater. | Elwy Fm mudstone (limited fracturing) | Not sampled, 2.88, 2.90 N/A, 239.84, 239.82 N/A, 13.12, 13.10 |

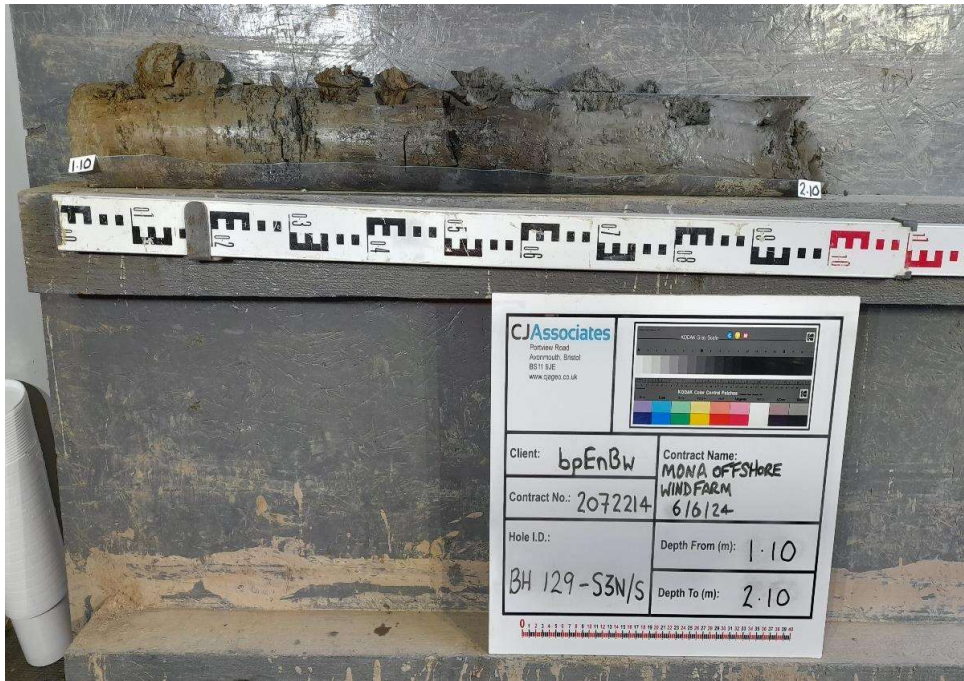
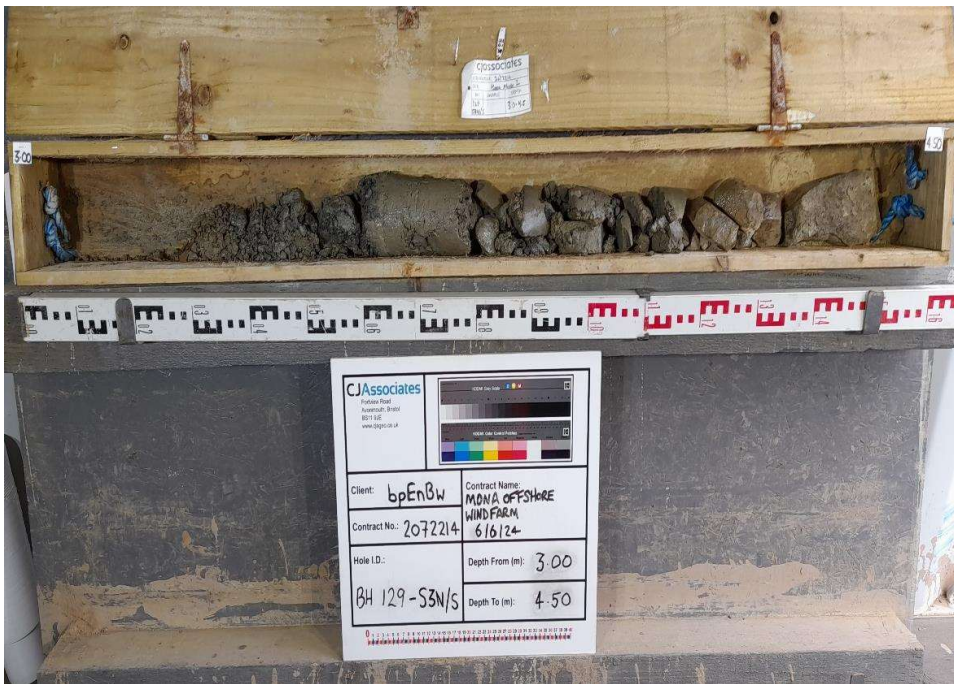
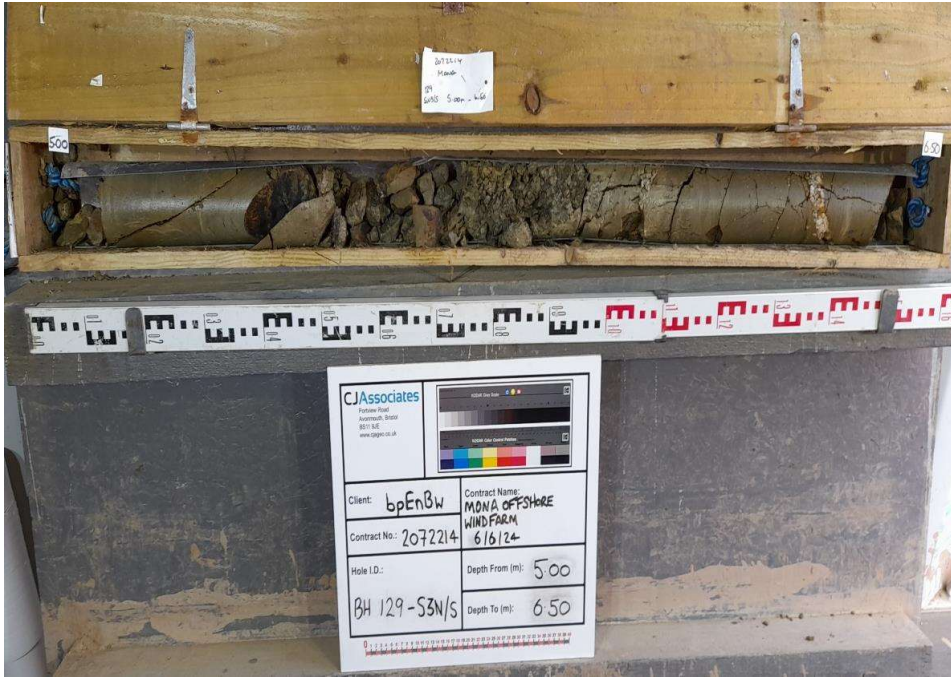
| <p>Unit 3, Block 6 Newlands Avenue Brackla Industrial Estate Bridgend, CF31 2DA</p> | Project Mona Offshore Wind Project Ground Investigation | Drawing Title BH129-S3N/S |

| Direction from Fishery | Borehole reference | Ground Elevation (m AOD) | Distance from Fishery (m) | Depth to base (m) | Logged rock/soil type | Average depth to groundwater (m bgl) | Hydrogeological Observations | Presumed Unit | Groundwater Data in R1, R2, R3 Depth to GW (m bgl) GW Level (mAOD) Height of GW column (m) |
|---|---|---|---|---|--|---|---|---|---|
| Southeast / East of Fishery | BH129 | 216.94 | 875 to SE | 10 Slotted 4m – 10m | Clay and gravel to 5m bgl, then sandstone and siltstone | 0.44 | <p>Generally grey, clay rich surface deposits.</p> <p>Overlies silty sandstone which is heavily fractured, with both shallow and high angle fractures. The slotted section covers the sandstone. Transitional into highly fractured mudstone (often at high angle)</p> <p>Potential groundwater pathways given groundwater levels and fracturing.</p> | Fractured Elwy Fm sandstone and mudstone. | 0.50, 0.42, 0.40 216.44, 216.52, 216.54 9.5, 9.58, 9.6 |

- Shallow geology with the CRC on the eastern flank of Moelfre Isaf (BH129 to BH131 inclusive) is dominated by highly fractured sandstones and mudstones of the Elwy Formation, often including high angle fracture sets and bedding parallel fractures. These boreholes are located a greater lateral distance from the Trout Fishery (greater than 875 m) but generally located lower elevation, between 13 m and 57 m above the Fishery. The vertical height difference declining with greater distance from the Fishery. This section of the Onshore Cable Corridor is termed the Eastern section.

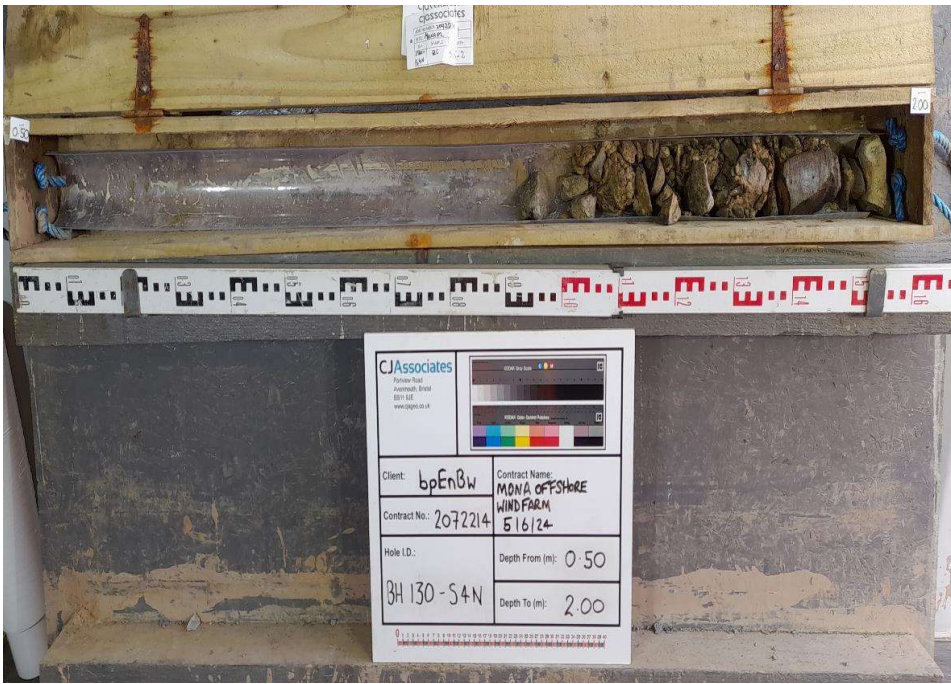
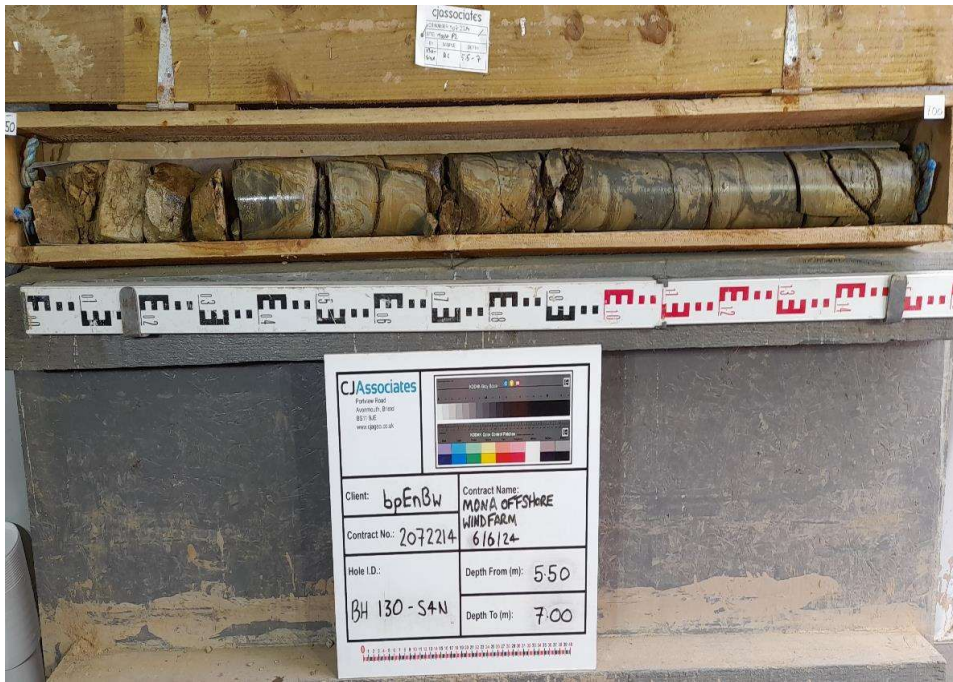
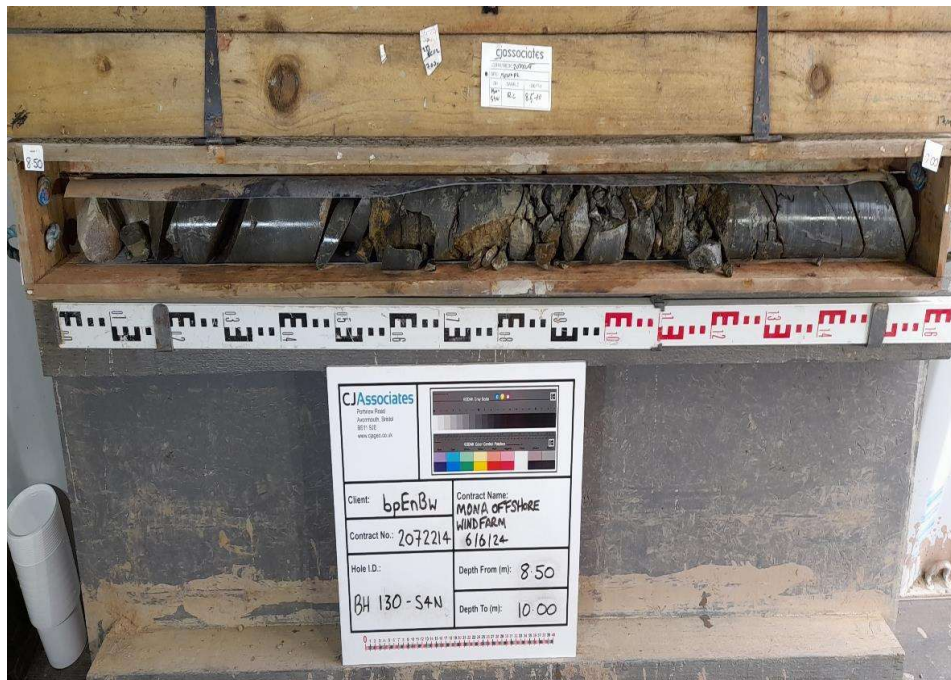
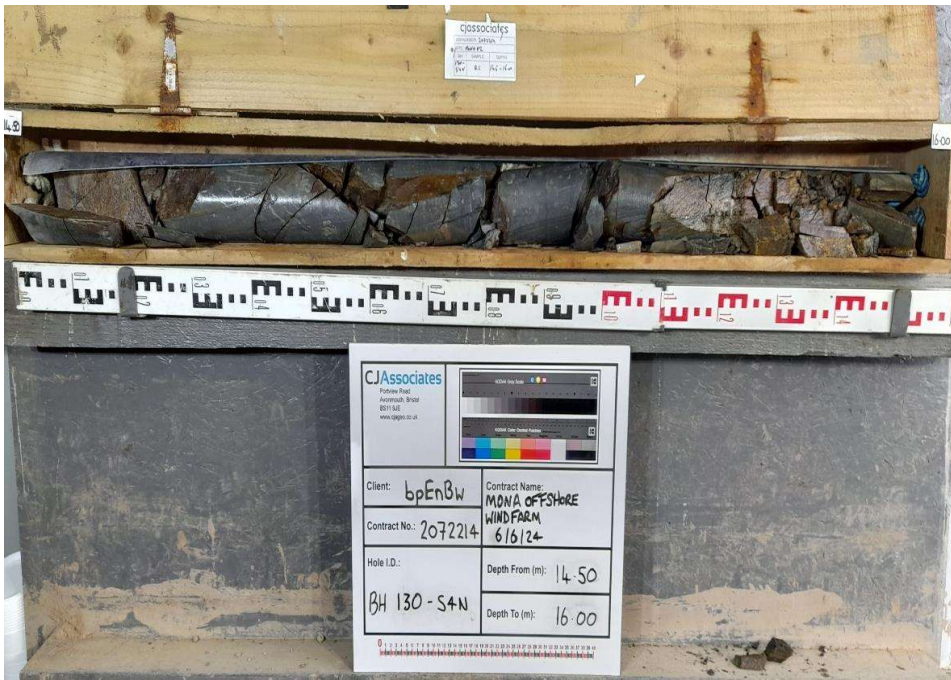
| Unit 3, Block 6 Newlands Avenue Brackla Industrial Estate Bridgend, CF31 2DA | Project Mona Offshore Wind Project Ground Investigation | Drawing Title BH130-S4N |

| Direction from Fishery | Borehole reference | Ground Elevation (m AOD) | Distance from Fishery (m) | Depth to base (m) | Logged rock/soil type | Average depth to groundwater (m bgl) | Hydrogeological Observations | Presumed Unit | Groundwater Data in R1, R2, R3 Depth to GW (m bgl) GW Level (mAOD) Height of GW column (m) |
|---|---|---|---|---|--|---|---|---|---|
| | BH130 | 207.21 | 1145 to SE | 20 Slotted 1.9m – 20m | Siltstone, mudstone and sandstone to 8.2m bgl, then mudstone | 13.75 | <p>Fractured sandstone which transitions into highly fractured mudstone at 8.2m bgl. The sandstone is heavily fractured, with shallow and high angle fractures.</p> <p>Assumed fractured sandstones and mudstones of the Elwy Formation. Potential groundwater pathways given groundwater levels and fracturing.</p> | Elwy Fm mudstone and sandstone | 12.80, 14.26, 14.20 194.41, 192.95, 193.01 7.2, 5.74, 5.8 |

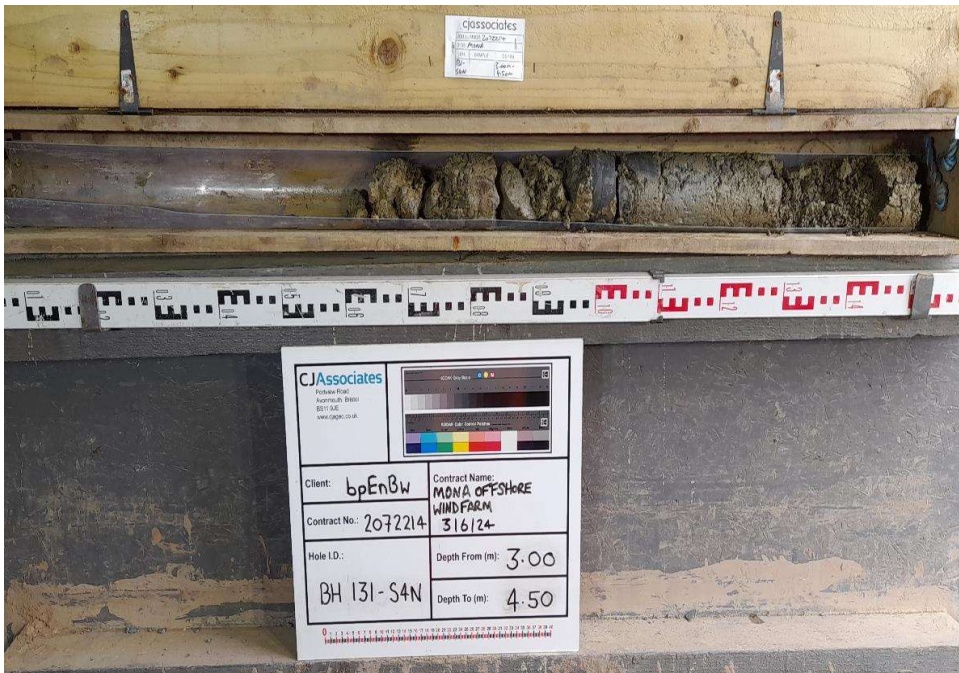
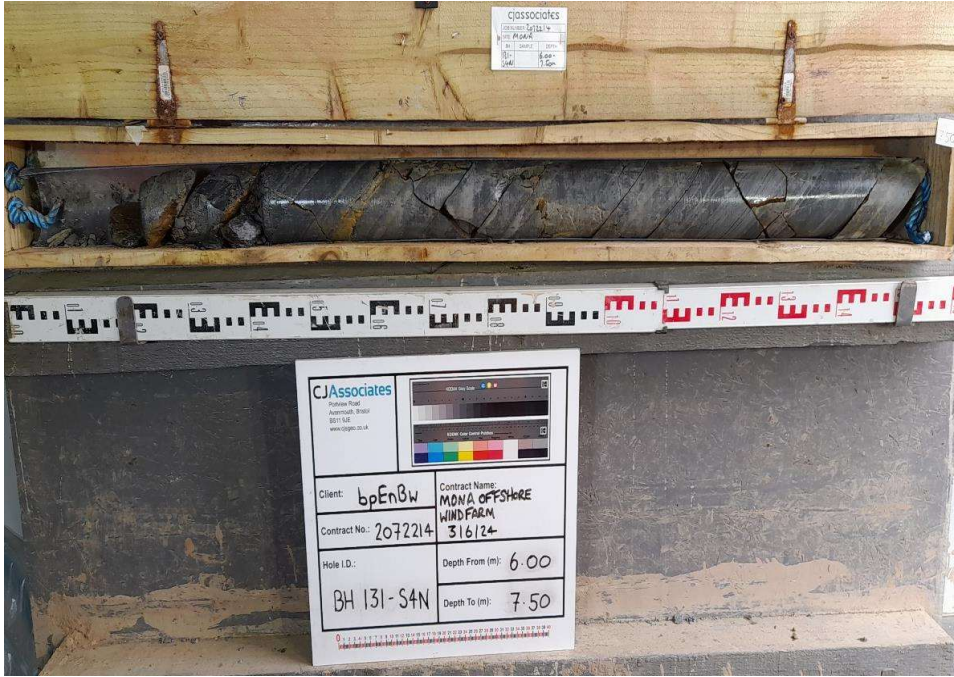
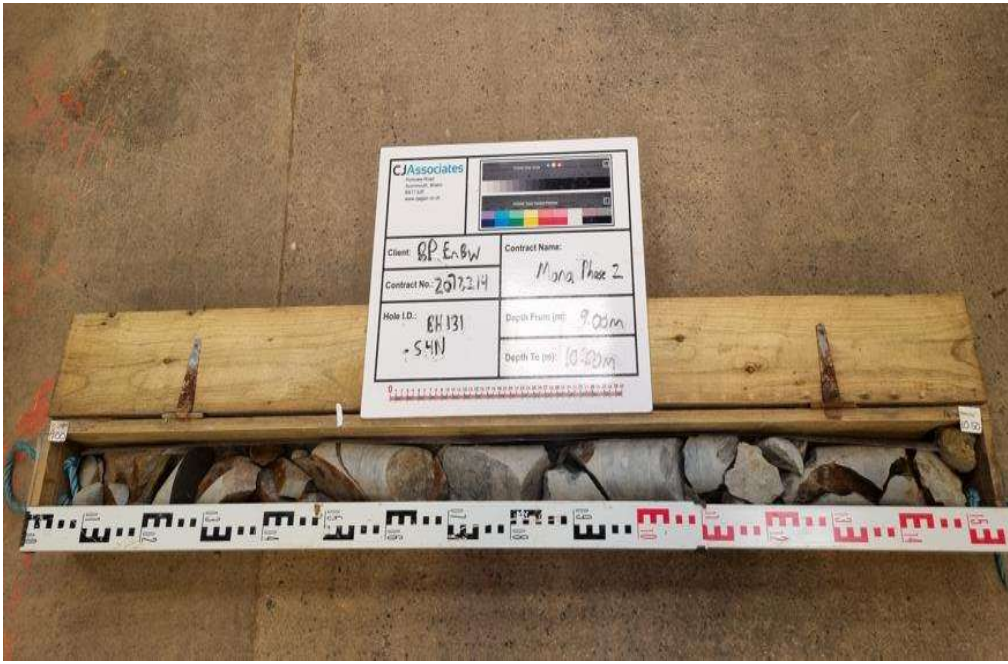
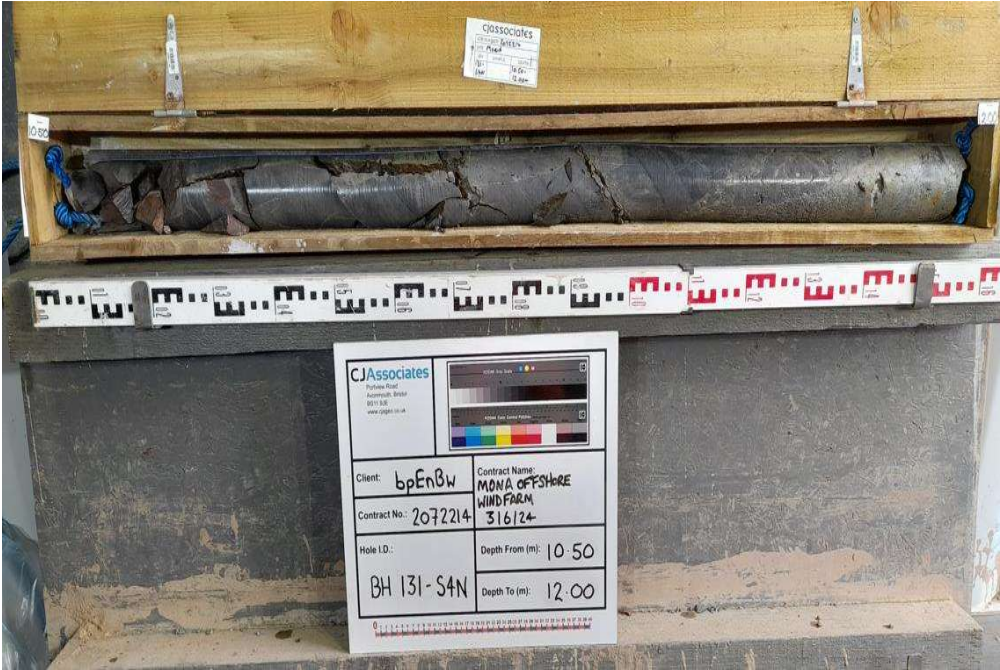
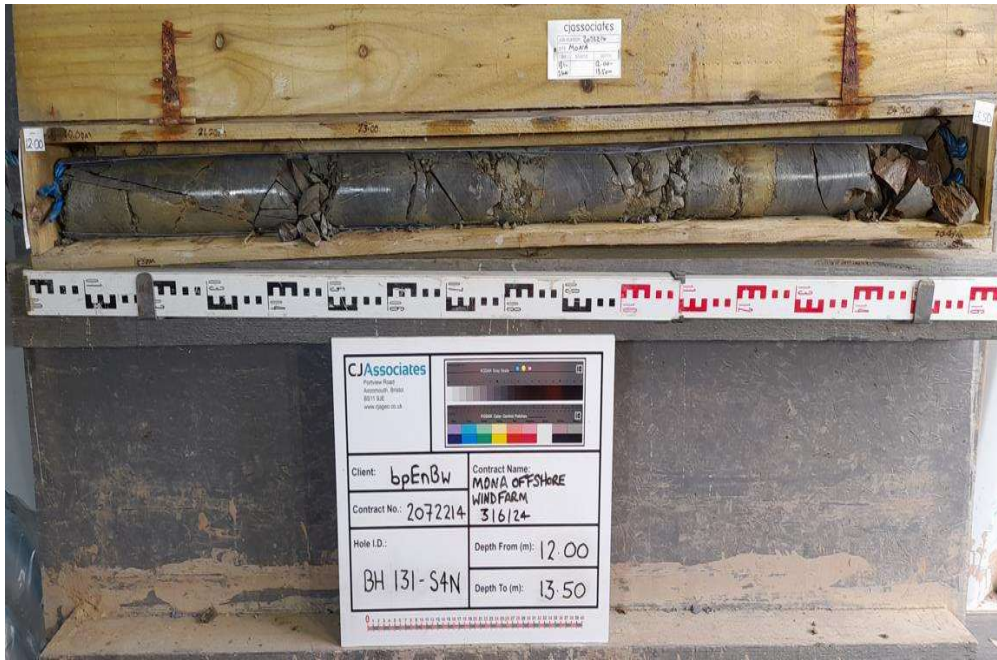
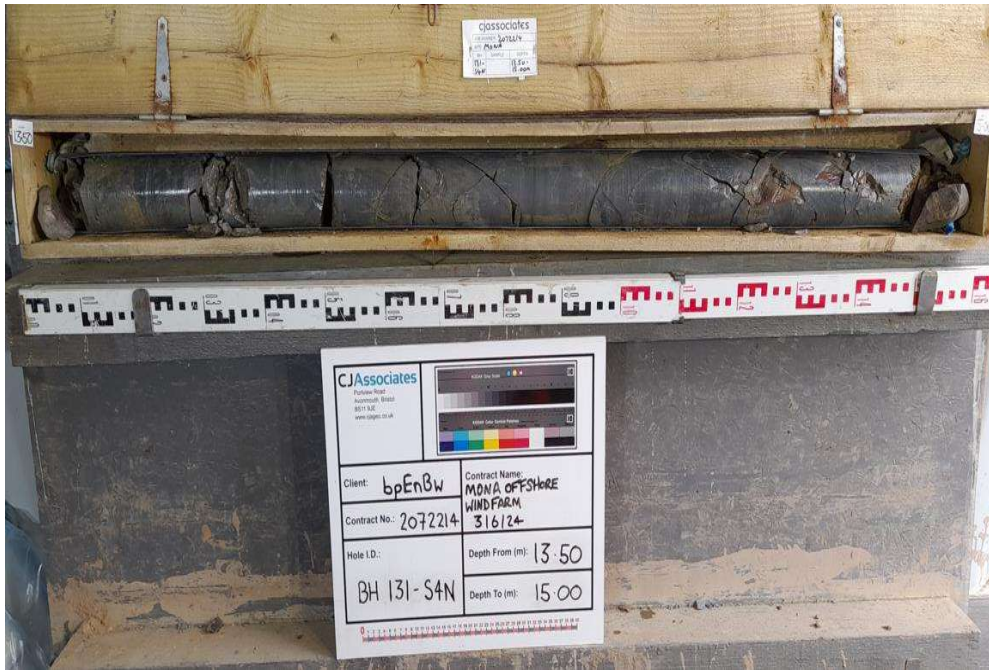
| Unit 3, Block 6 Newlands Avenue Brackla Industrial Estate Bridgend, CF31 2DA | Project Mona Offshore Wind Project Ground Investigation | Drawing Title BH131-S4N |

| Direction from Fishery | Borehole reference | Ground Elevation (m AOD) | Distance from Fishery (m) | Depth to base (m) | Logged rock/soil type | Average depth to groundwater (m bgl) | Hydrogeological Observations | Presumed Unit | Groundwater Data in R1, R2, R3 Depth to GW (m bgl) GW Level (mAOD) Height of GW column (m) |
|---|---|---|---|---|--|---|---|---|---|
| | BH131 | 172.60 | 1255 to SE | 16 Slotted 1m – 16m | Clay and silt to 6.4mbgl, then mudstone | 6.00 | Mudstone bedrock with high angle laminations and open fractures. | Elwy Fm mudstone | 6.41, 5.61, 5.97 166.19, 166.99, 166.63 9.59, 10.39, 10.03 |

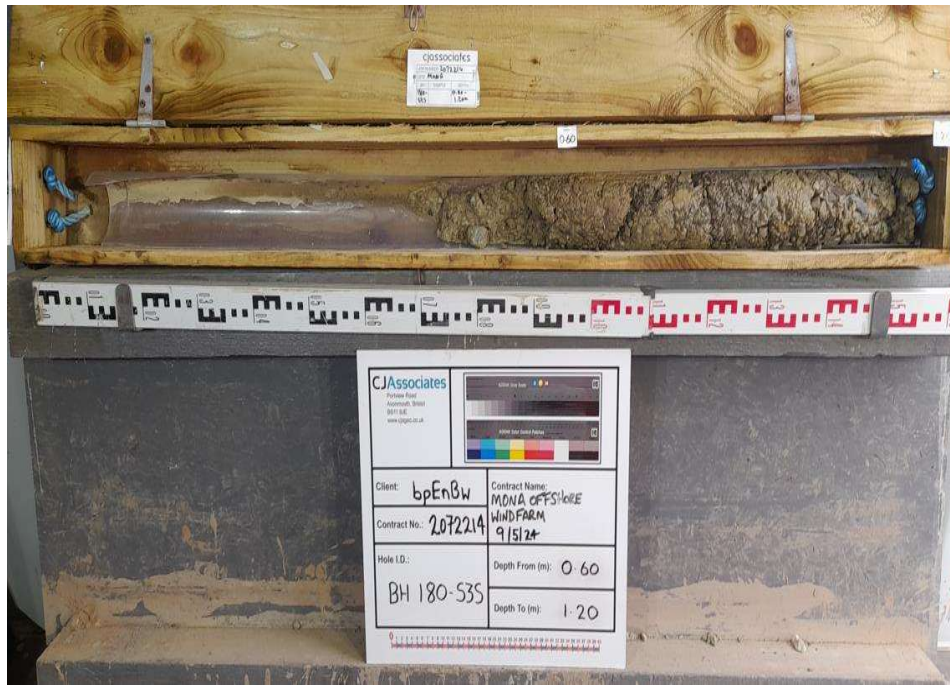
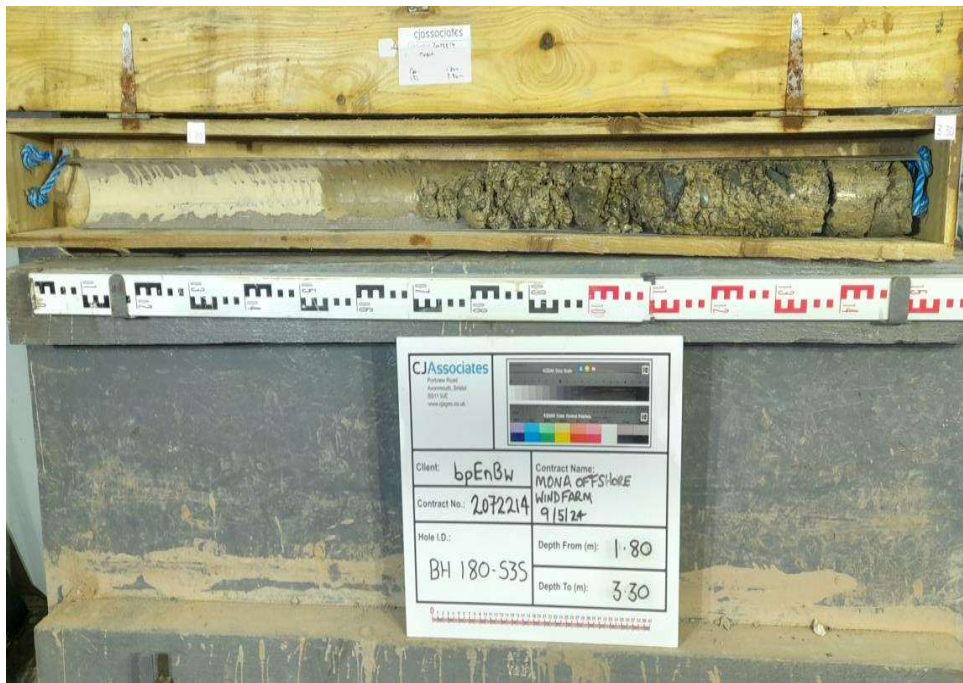
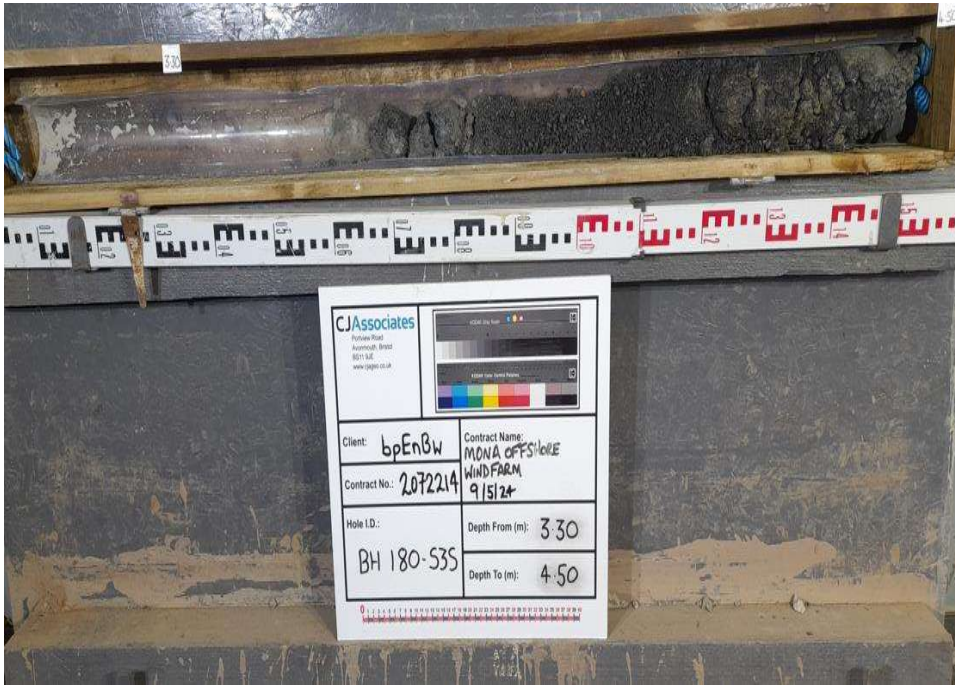
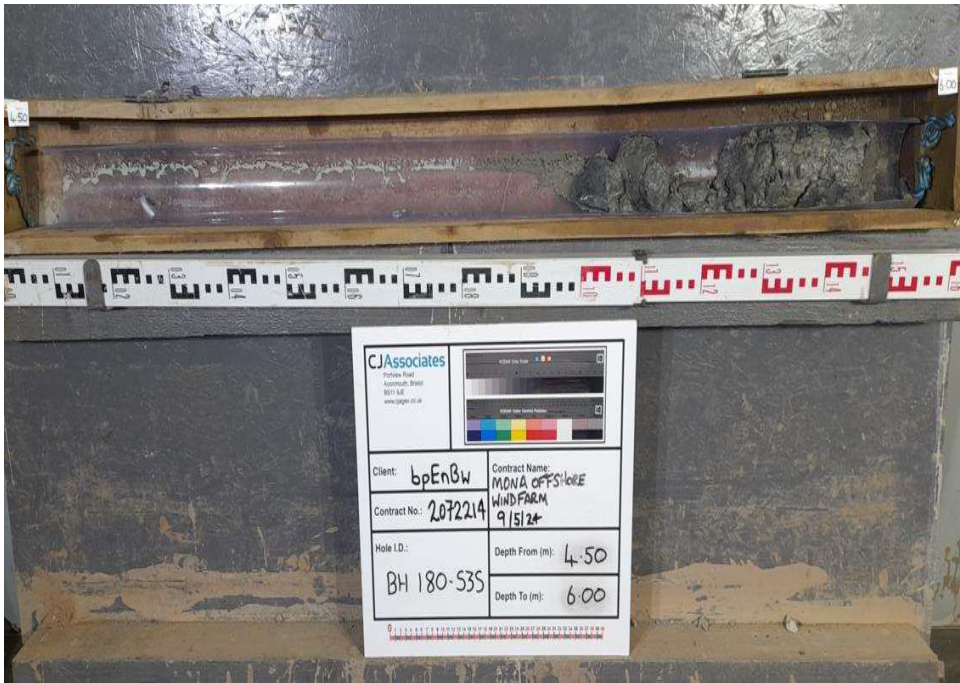
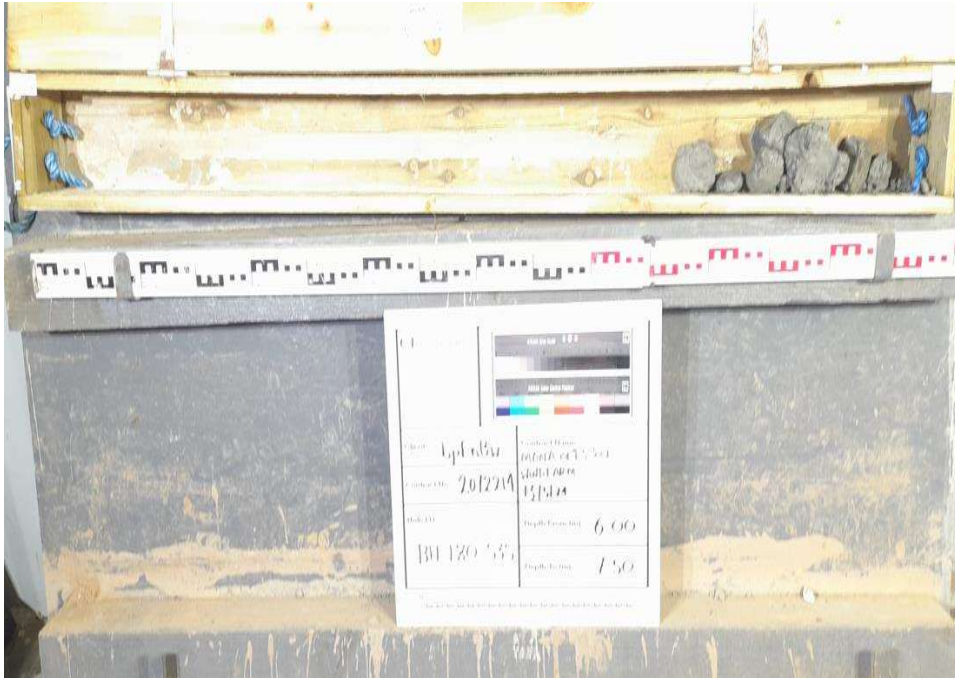
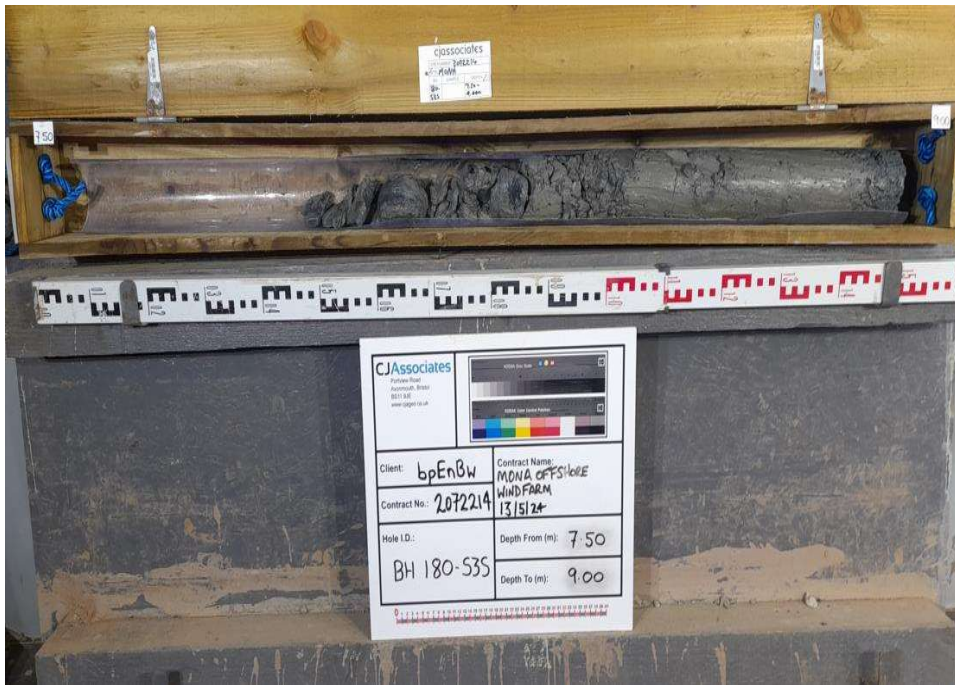
| Unit 3, Block 6 Newlands Avenue Brackla Industrial Estate Bridgend, CF31 2DA | Project Mona Offshore Wind Project Ground Investigation | Drawing Title BH180-S3S |

| Direction from Fishery | Borehole reference | Ground Elevation (m AOD) | Distance from Fishery (m) | Depth to base (m) | Logged rock/soil type | Average depth to groundwater (m bgl) | Hydrogeological Observations | Presumed Unit | Groundwater Data in R1, R2, R3 Depth to GW (m bgl) GW Level (mAOD) Height of GW column (m) |
|---|---|---|---|---|---|---|---|--|---|
| West of Fishery | BH180 | 178.23 | 1320 to SW | 20 Slotted 12m – 20m | Gravel to 17.50m bgl, then breccia to base. | 1.67 | Yellowy till at surface Till transitions into an apparently 'disturbed mudstone' [presumed Elwy Formation]. There are no fractures in the disturbed mudstone. The bedrock becomes more competent with depth, with breccia identified at 17.5m bgl. The breccia contains some horizontal fractures. | Till Elwy Fm mudstone (disturbed) | 1.52, 1.80, 1.70 176.71, 176.43, 176.53 18.48, 18.2, 18.3 |

- Shallow geology within the Onshore Cable Corridor on the western flank of Moelfre Isaf and to the south of the Tan-y-Mynydd Trout Fishery (BH180 to BH173 inclusive) is dominated by what is interpreted as a ‘disturbed mudstone’ (comprising irregular clasts of bedrock in a cohesive matrix) or more massive mudstone exhibiting limited non-drilling induced fracturing. These boreholes are located at a significantly higher elevation than the Fishery (55 m to 75 m higher). This section of the Onshore Cable Corridor is termed the Western/Central section.
