# **EAST YORKSHIRE SOLAR FARM**

**Volume 2, Appendix 7-4: Archaeological Trial Trenching Evaluation Report  
(Archaeological Services WYAS)  
Document Reference: EN010143/APP/6.2**

**Trial Trench Evaluation**

**Interim Report**

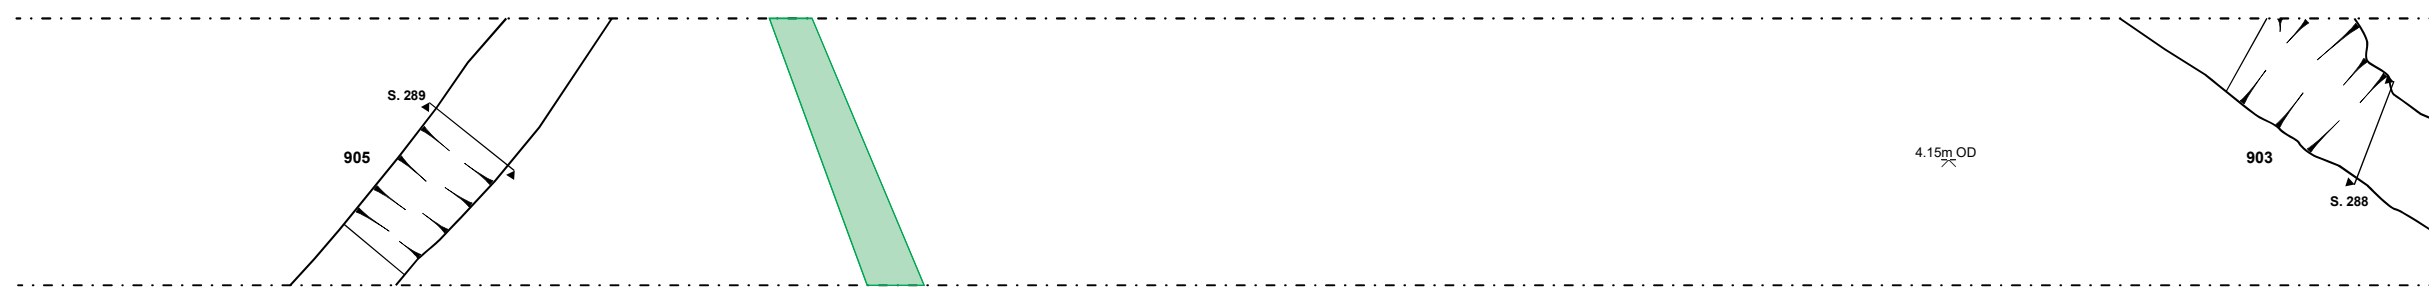
Project No. XK50  
 Project Code: EYS23  
 Fig. 22  
 Trench 9 plan and sections

Trench 9 contained two ditches. Ditch 903 (Fig. 22, S. 288) was orientated northeast to southwest and was V-shaped in profile with a concave base. The ditch measured 0.68m wide and 0.26m deep and contained a single dark brown silty clay fill (904) from which a single piece of slag was recovered. The ditch corresponds with any geophysical anomalies and is possibly a former field boundary ditch of unknown date.

Ditch 905 (Fig. 22, S. 905) was orientated northwest to southeast and was a shallow ditch with a concave base. The ditch measured 0.62m wide and 0.22m deep and contained a single mid-greyish brown silty clay fill (906) from which no artefacts were recovered. The ditch is not aligned with any geophysical anomalies but is on the same orientation as other geophysical linear trends which are thought to be furrows.

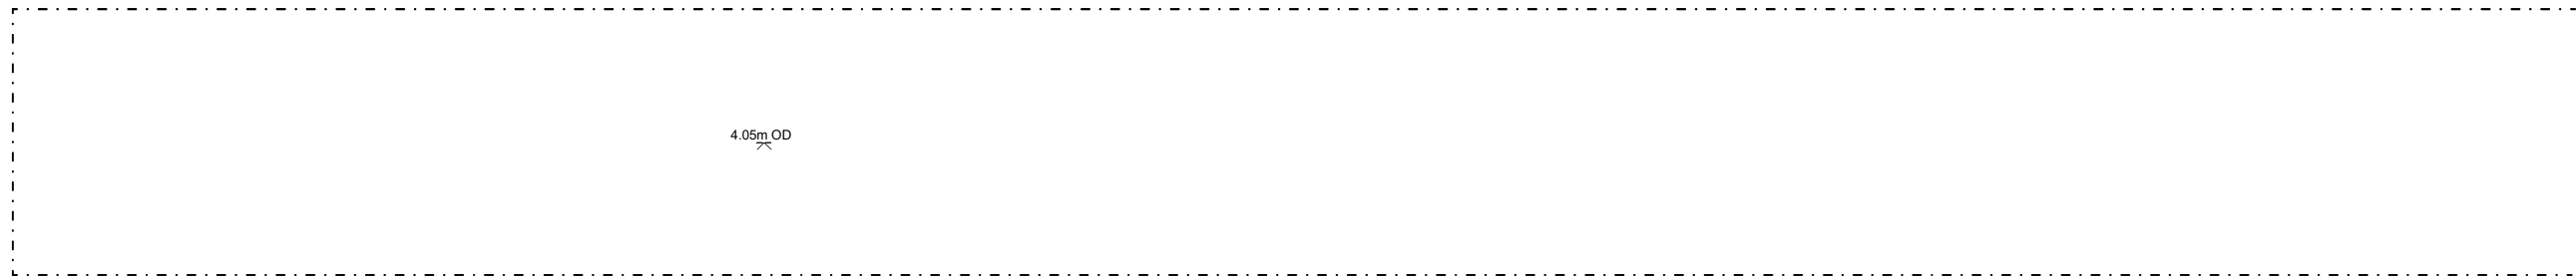
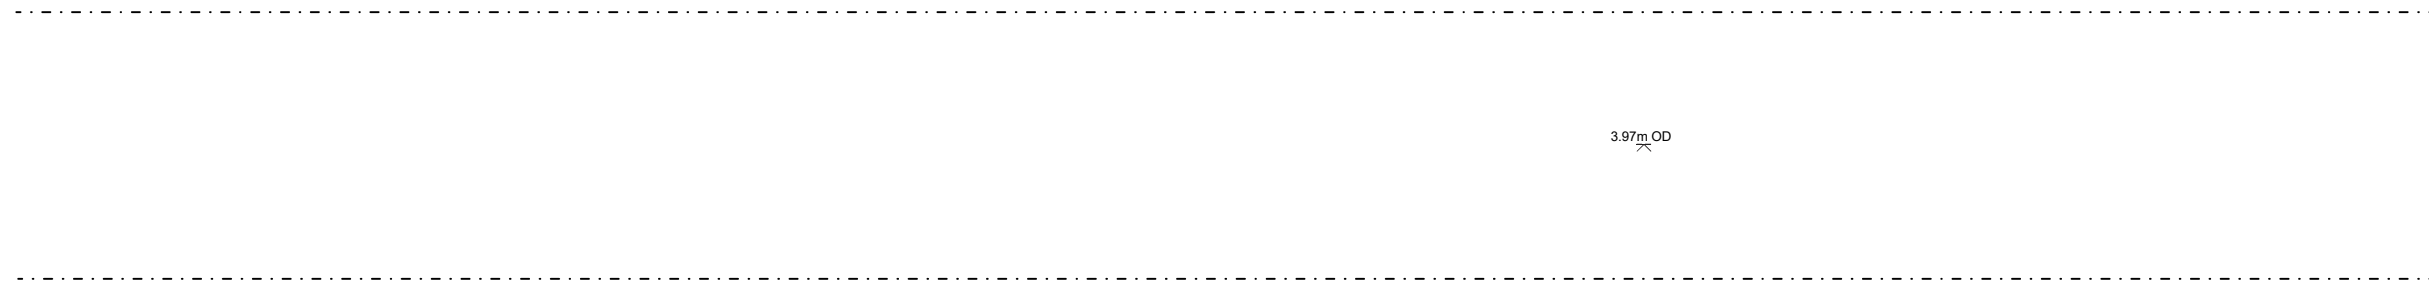
Fig. 29

Pit 1802 (Fig. 29, S. 245) was sub-oval in shape. It measured 0.84m long, 0.57m wide and 0.15m deep and contained a single light grey silty clay fill (1803) from which no artefacts were recovered. The pit does not correspond to any geophysical anomalies and is possibly related to modern agriculture.

Ditch 1804 (Fig. 29, S. 246) was orientated northwest to southeast. It measured 0.74m wide and 0.37m deep and contained a mid-grey silty clay fill (1805) from which pottery was recovered. Ditch 1804 was truncated by ditch 1806 which had the same orientation. Ditch 1806 measured 0.66m wide and 0.32m deep and contained a mid-grey silty clay fill (1807) from which animal bone and pottery was recovered. The ditch corresponds to a linear geophysical anomaly which appears to be an internal division within and sub-rectangular enclosure.

Ditch 1808 (Fig. 29, S. 247) was orientated northwest to southeast and had a broad V-shaped profile with a rounded concave base. It measured 0.85m wide and 0.30m deep and contained a dark blackish brown silty clay fill (1809) from which no artefacts were recovered. Ditch 1810 was situated immediately to the north of ditch 1808 on the same northwest to southeast orientation. It measured 0.77m wide and 0.44m deep and contained a mid-greyish black silty clay fill (1811) from which pottery and fragments of land drain were recovered. These ditches are aligned with a geophysical anomaly that appears to be part of a sub-rectangular enclosure.

Possible ditch terminus 1812 (Fig. 29, S. 248) was orientated northwest to southeast and was shallow with a flat base. It measured 1.02m wide and 0.08m deep and contained a single dark brownish black silty clay fill (1812) from which pottery was recovered. The ditch is not aligned with any geophysical anomaly and could represent a heavily, horizontally truncated ditch.

Ditch 1814 (Fig. 29, S. 243) was orientated northwest to southeast and was an irregular, broad V-shape in profile. It measured 2.08m wide and 0.55m deep and contained a single dark greyish black silty clay fill (1815) from which pottery sherds and pieces of slag were recovered. The ditch corresponds well with a curvilinear geophysical anomaly that possibly represents an enclosure ditch. Its shape in profile indicates that the ditch had possibly been re-cut, but this was not visible in the homogenous fill.

Ditch 1816 (Fig. 29, S. 251) was orientated northwest to southeast and although truncated, was likely V-shape in profile. The ditch measured 1.00m wide and 0.55m deep and contained a single dark brownish black silty clay fill (1817) from which pottery sherds and burnt bone

Ditch terminus 1820 (Fig. 29, S. 252) was orientated northeast to southwest and in plan, was truncated by ditch 1816/1818. It measured 0.33m wide and 0.08m and contained a single dark black silty clay fill (1821) from which pottery sherds were recovered. The ditch possibly represents a sub enclosure partition ditch and does not correspond with any geophysical anomalies.

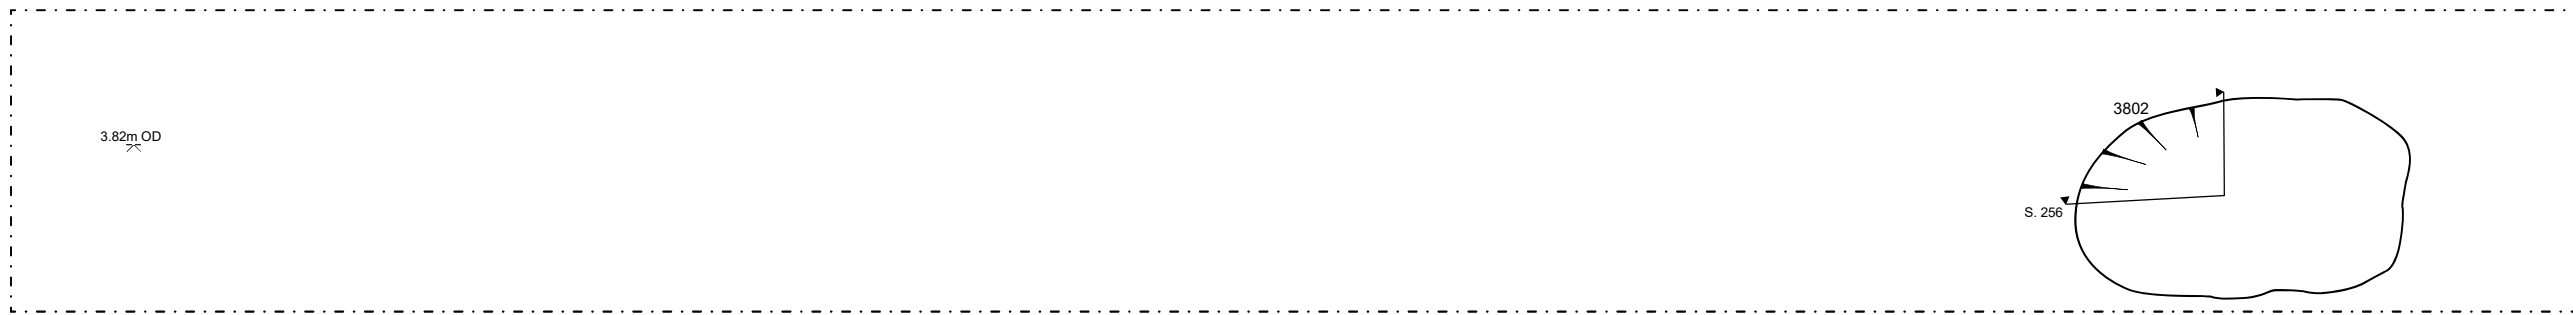
*Project No. XK50*      *Project Code: EYS23*  
*Fig. 38*  
*Trench 38 plan and section*

Trench 38 contained a modern deposit (3802; Fig. 38, S. 256) that was visible within the topsoil and contained modern CBM. This corresponds with a geophysical anomaly.

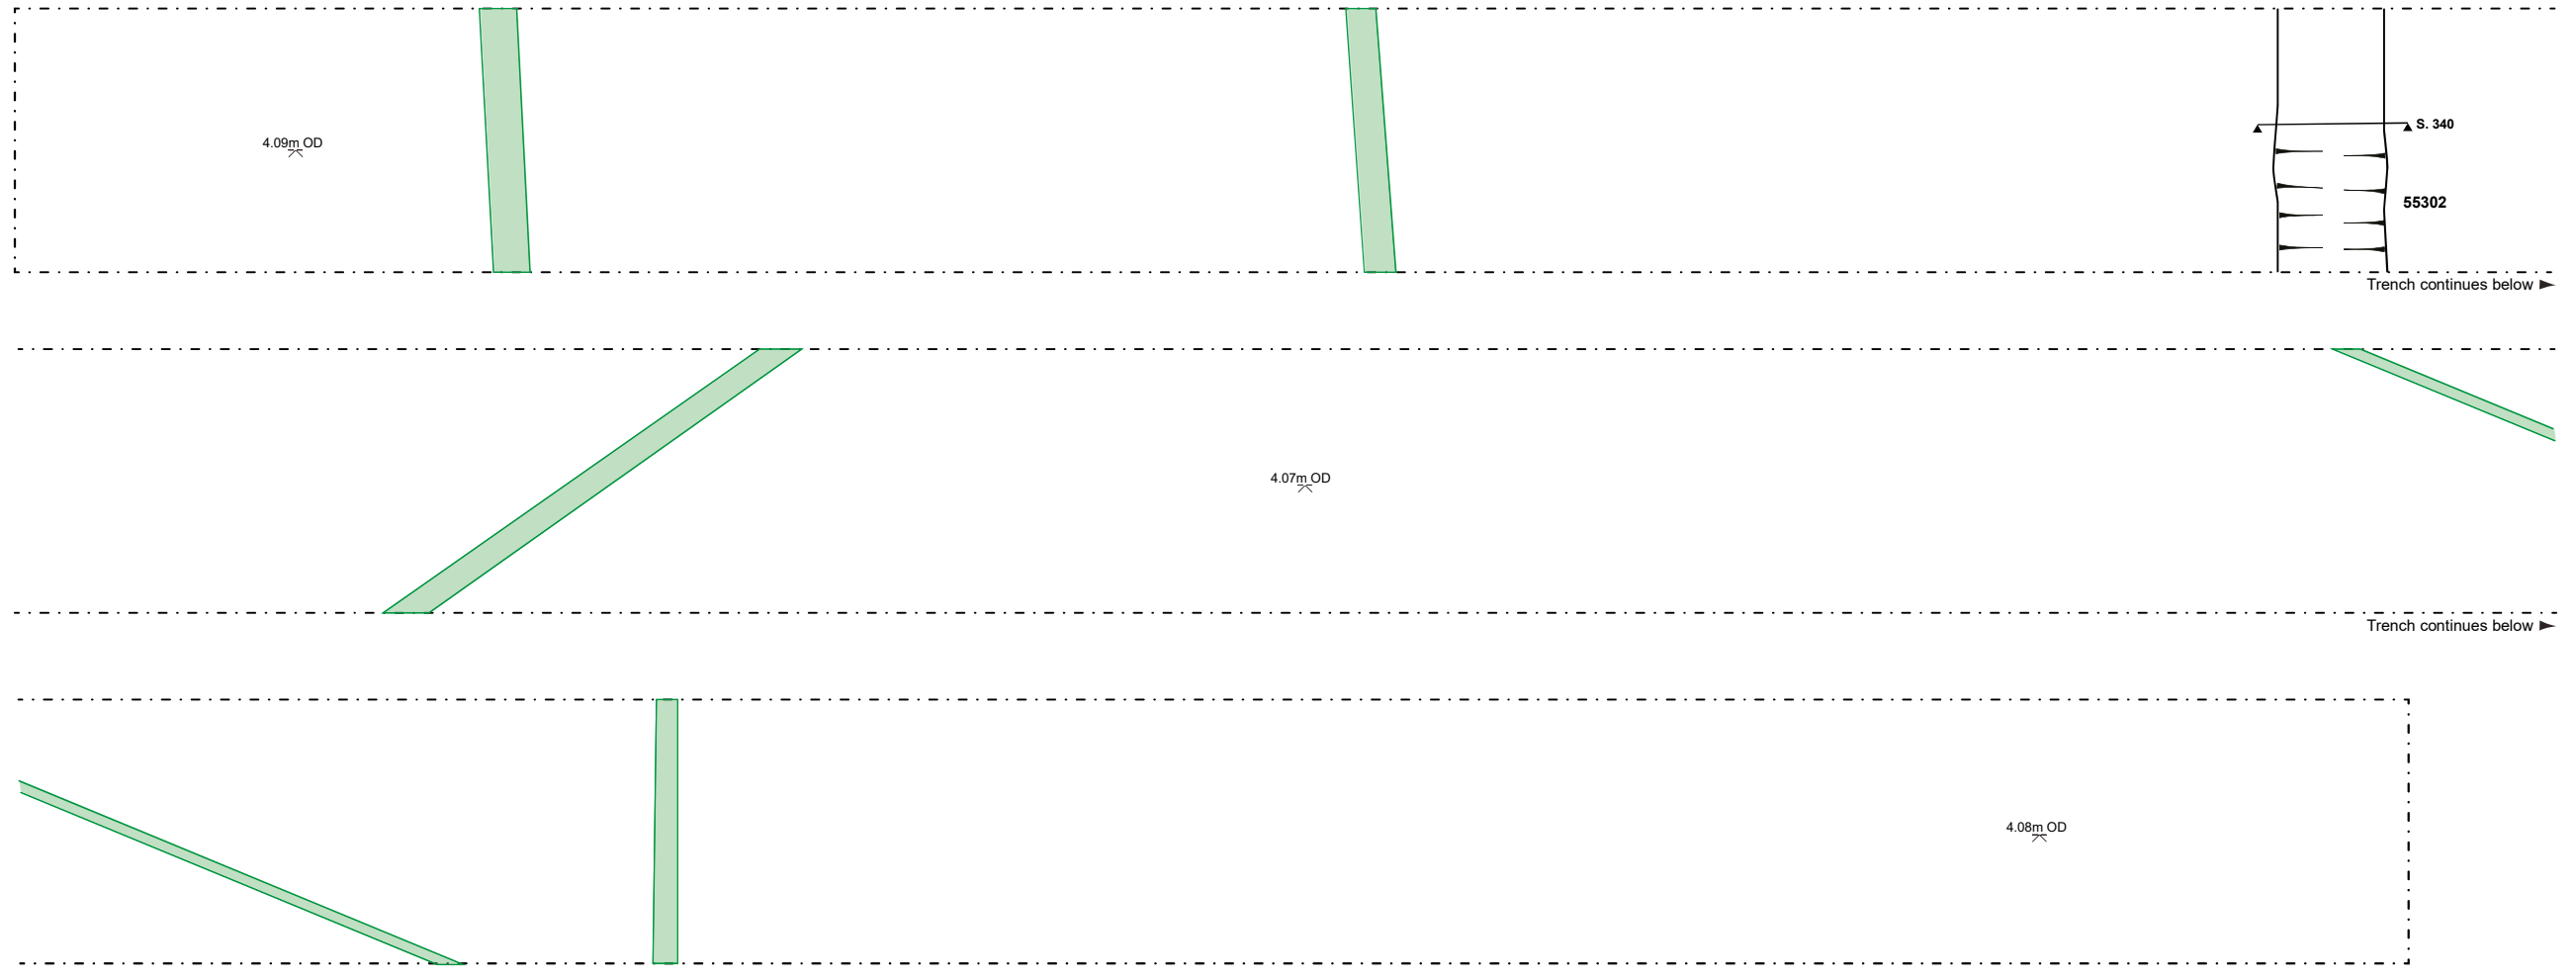
Project No. XK50      Project Code: EYS23  
 Fig. 107  
 Trench 553 plan and sections

Ditch 55302 (Fig. 107, S. 340) was orientated north to south and measured 0.60m wide and 0.28m deep, with a shallow V-shape in profile. The ditch had a single dark greyish brown silty clay fill (55303) which contained plastic in the top part of the fill. The ditch is aligned with a linear anomaly of the geophysical survey which corresponds to a former post-medieval field boundary on the historic OS mapping. Given the inclusion of plastic in the fill, it appears to have been backfilled in the modern period.

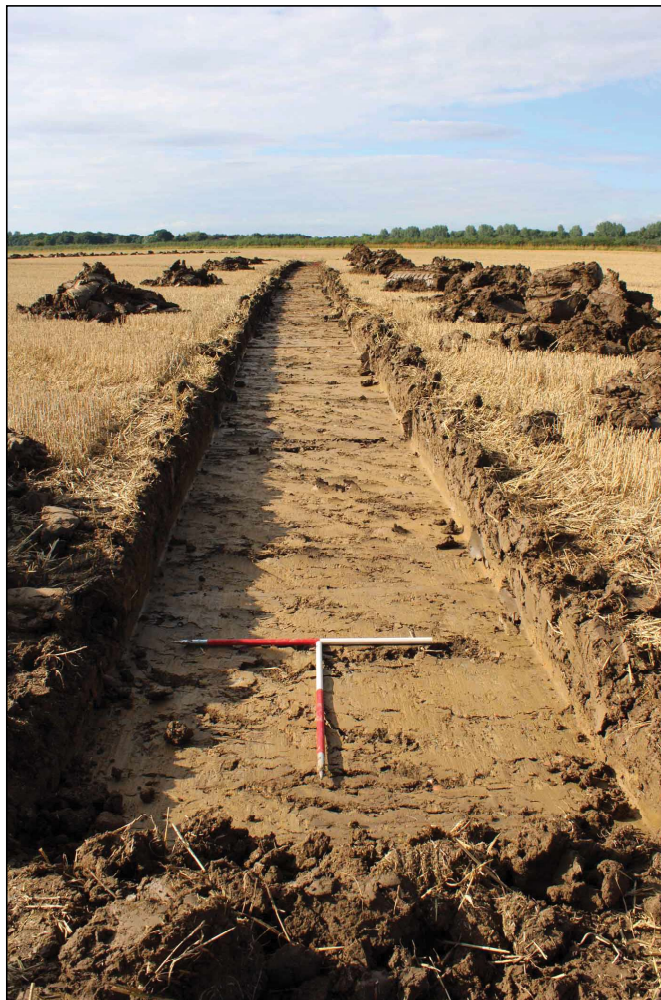
*Plate 1. Trench 285, looking southwest*

All features were sealed by a soft, dark black/brown clayey-sand topsoil. The underlying geology typically comprised a light yellow/brown clay (Plate 1) although variations in both colour and sand content were noted.

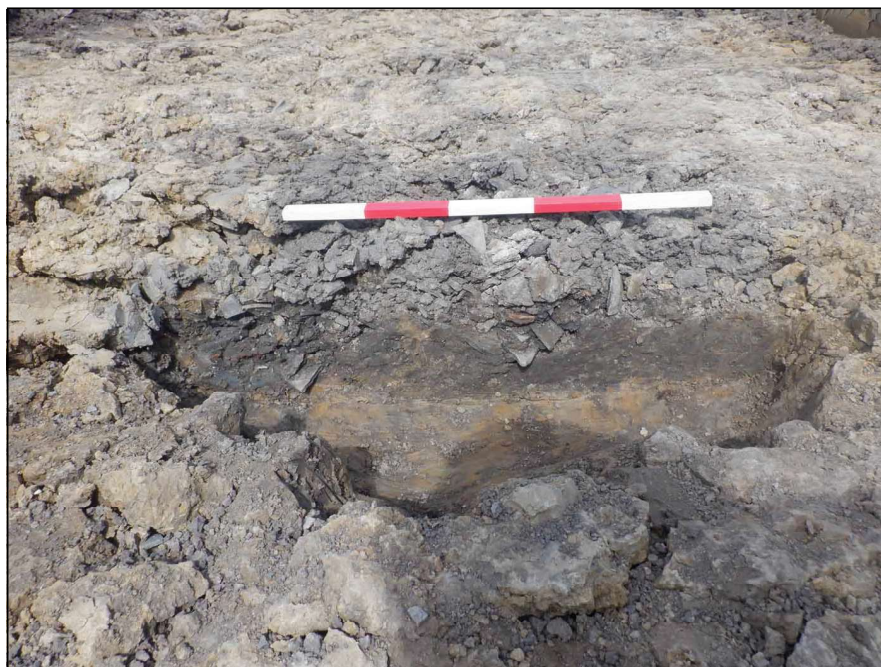
*Plate 2. Pit 6902, looking north*

Trench 69 contained multiple archaeological features. Pit 6902 was located towards the southern end of the trench and measured 0.85m by 0.70m and 0.30m deep with vertical sides and a flat base (Fig. 46, S. 2021; Plate 2). It contained a single mid-orangy grey silty clay fill (6903) which contained 703 sherds of Roman pottery. The deposition of so much pottery indicates a single episode of backfilling within a possible midden pit. The pit does not correlate with any geophysical anomaly.

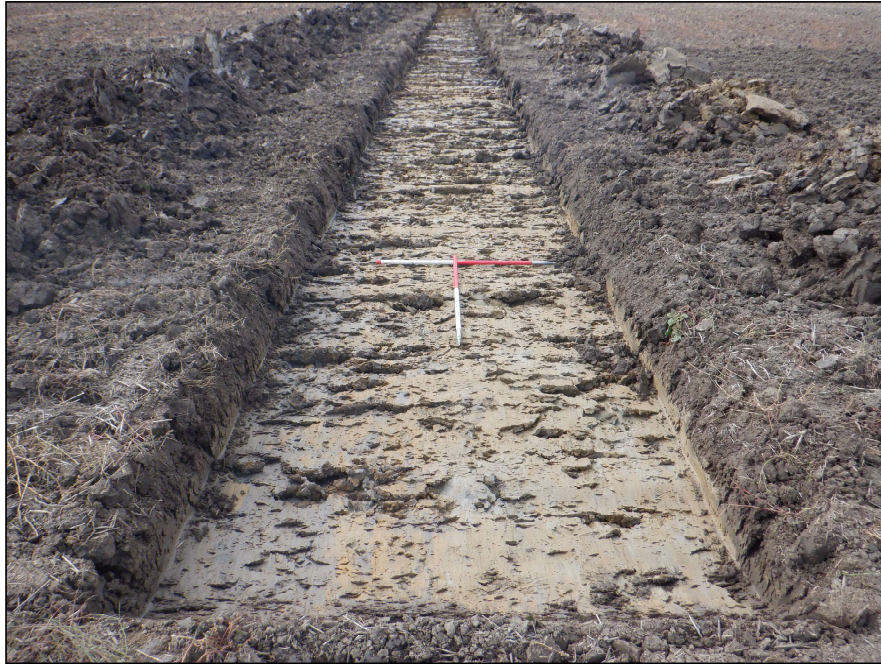
*Plate 5. Trench 214, looking west*

Trenches 212, 213, 215 (Plate 5) and 216 were devoid of archaeological remains.

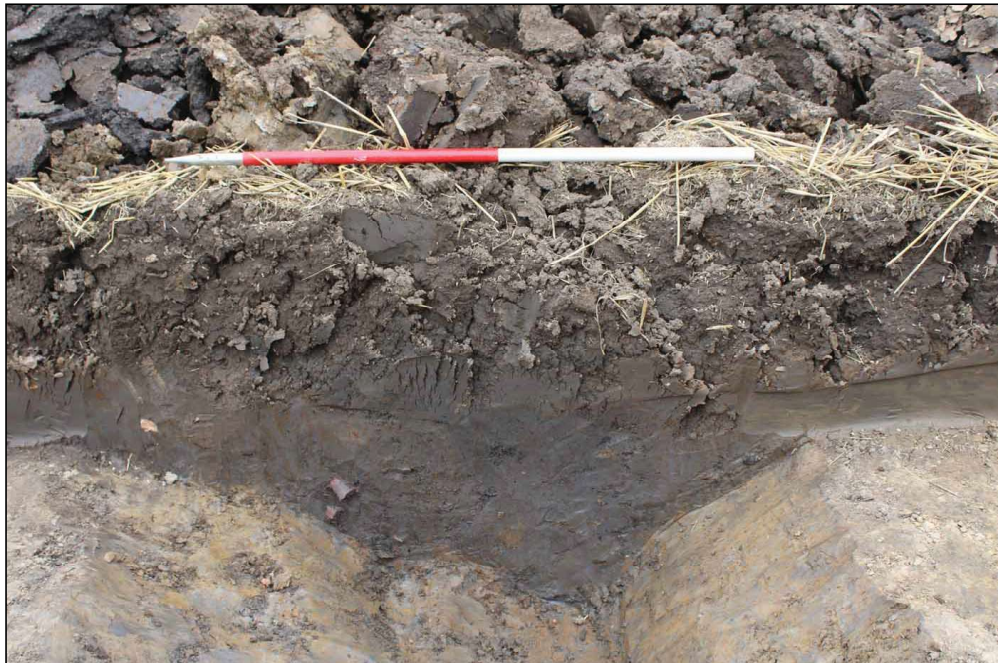
*Plate 6. Ditch 22807, looking northeast*

Ditch 22807 measured 1.36m wide and 0.37m deep (Fig. 75, S. 1008; Plate 6). It contained a bluish/brown silty clay material (22808). The fill contained some pottery sherds and some heat cracked pebbles. The ditch aligns with a small anomaly on the geophysical survey located towards the centre of the trench but a ditch of this size and depth would usually produce a more significant anomaly.

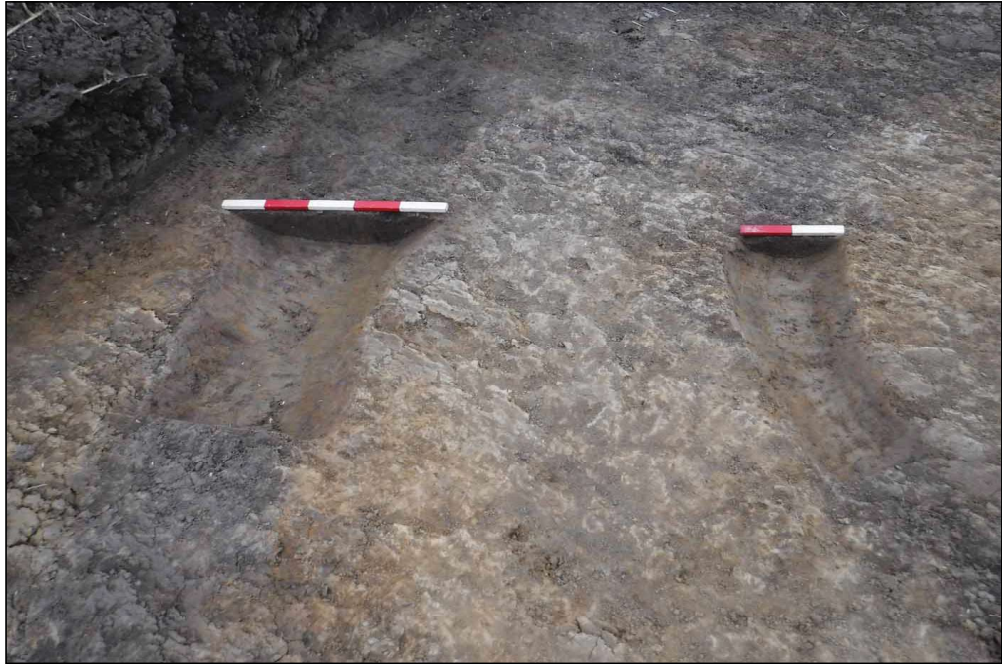
*Plate 7. Gullies 58117 and 58119, looking east*

Two curvilinear gullies (58117 and 58119; Fig. 109, S. 229; Plate 7) were partially exposed within the trench. Gully 58117 measured 0.44m wide and 0.08m deep and contained a single mid-greyish brown silty clay (58118) from which no artefacts were recovered. Gully 58119 measured 0.22m wide and 0.08m deep and contained a single mid-greyish brown silty clay fill (58120) from which pottery was recovered. In plan, it appeared that gully 58117 was truncated by gully 58119 but this relationship was not tested. The gullies possibly correspond to an irregular geophysical anomaly. The small diameter defined by the gullies would seem to preclude a round house structure, but the semi-circular appearance in plan is suggestive of a possible drip gully.

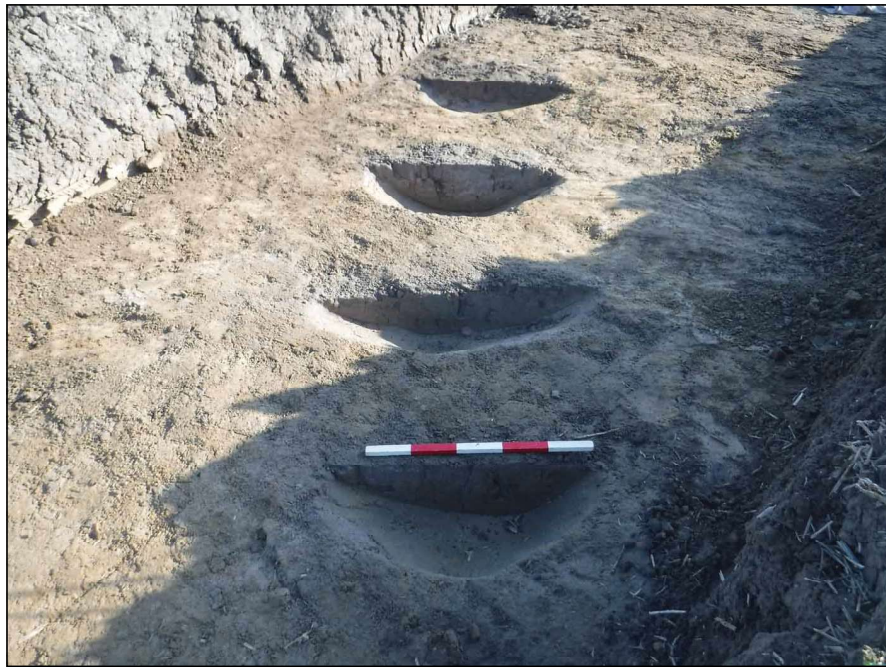
*Plate 8. Pits in Trench 21, looking north*

Pits 2119, 2121, 2123 and 2125 (Fig. 33, S. 310, 311, 312 and 313; Plate 8) were a series of pits orientated northeast to southwest. Pit 2119 was semi-circular in plan and measured 0.60m wide and 0.17m deep and contained a single light brownish grey silty clay fill (2120) which produced no artefacts. Pit 2121 was semi-circular in plan and measured 0.82m wide and 0.11m deep and contained a single light brownish grey silty clay fill (2122) which produced no artefacts. Pit 2123 was semi-circular in plan and measured 0.66m by 0.35m and was 0.20m deep. It contained a light brownish grey silty clay fill (2124) which produced no artefacts. Pit 2125 was semi-circular in plan and measured 0.66m wide and 0.11m deep and contained a single light brownish grey silty clay fill (2126) which produced no artefacts. The pits are almost certainly part of a structure within the enclosure.
