# Springwell Solar Farm

## Consultation Report

### Appendix L-1.8

# Appendix L-1.8 – Preliminary Environmental Information Report

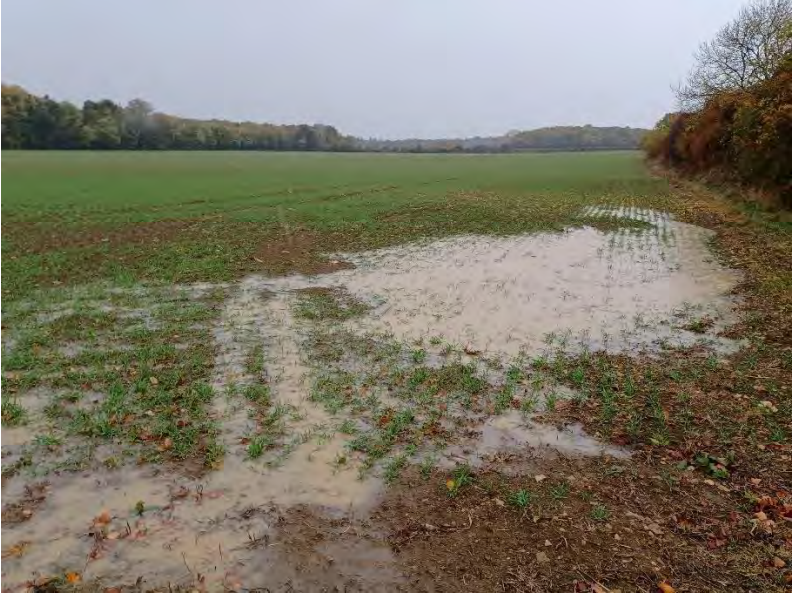
<b>Photo no.</b> 35	<b>Date:</b> 20/10/2022

North		
<b>Description:</b> Zone L3/L4 - View across field which forms part of the site, with some waterlogging observed.

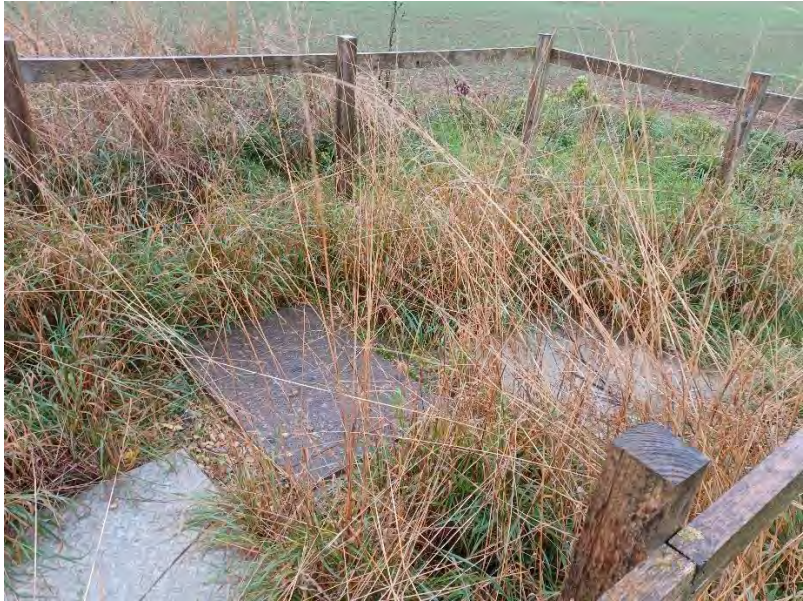
Zone I15 - Underground service covers noted.

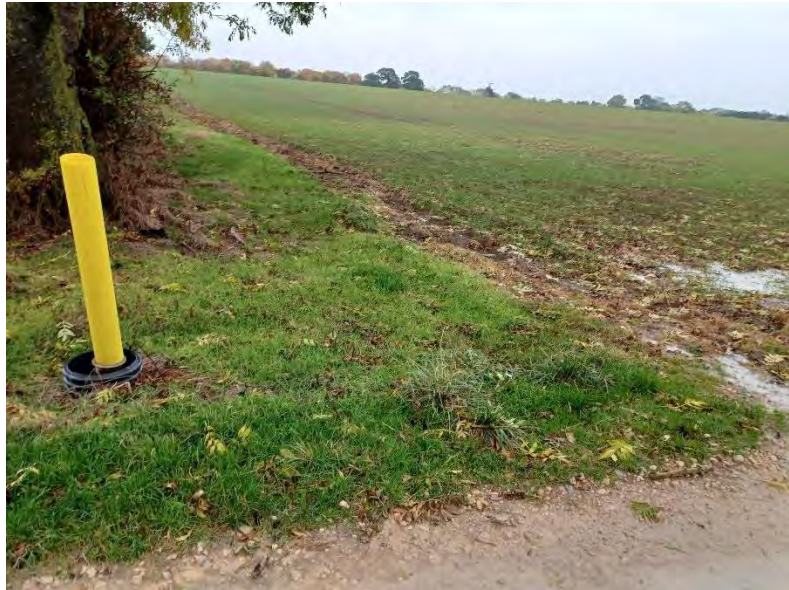
Zone I15 - Borehole noted.

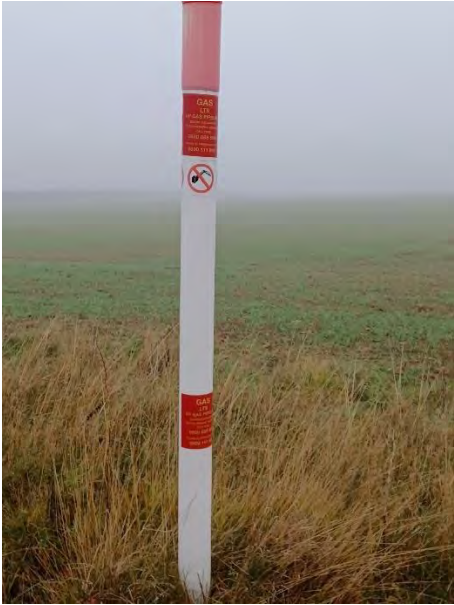
<b>Photo no.</b> 73	<b>Date:</b> 21/10/2022

North		
<b>Description:</b> Zone I6 - Gas pipeline marker noted.

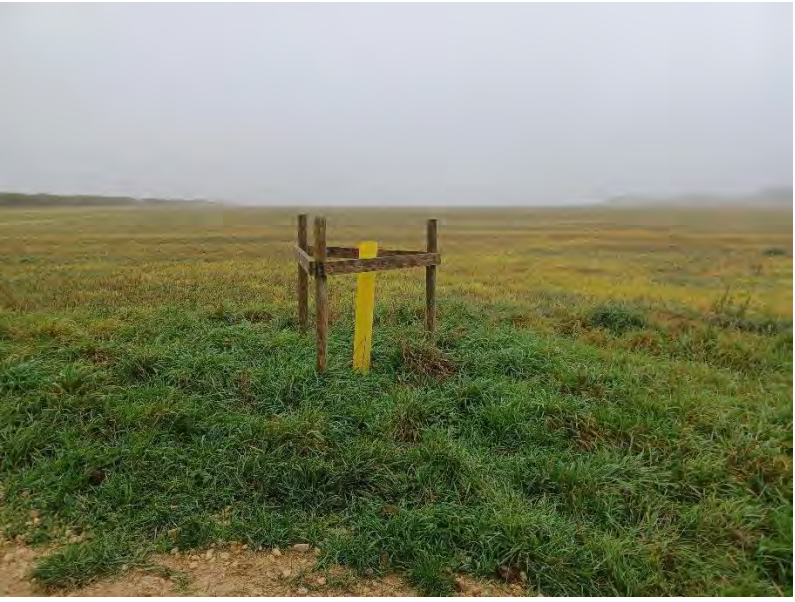
<b>Photo No.</b> 94	<b>Date:</b> 21/10/2022

North west		
<b>Description:</b> Zone E15 - Gas tap observed

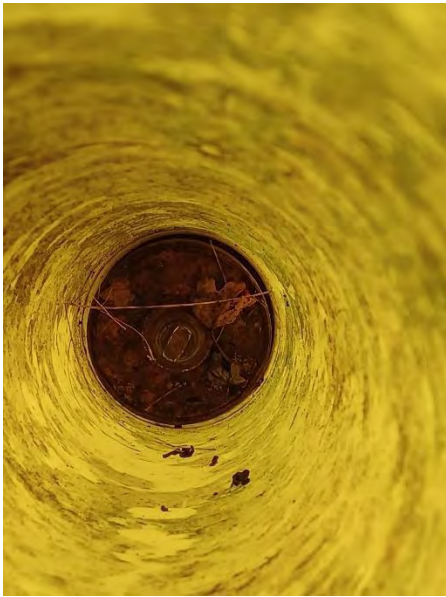
<b>Photo No.</b> 96	<b>Date:</b> 21/10/2022

N/A		
<b>Description:</b> Zone E15 - Gas tap observed
