# Springwell Solar Farm

## Environmental Statement

### Appendix 11.3: Detailed UXO Risk Assessment

## Detailed Unexploded Ordnance (UXO) Risk Assessment

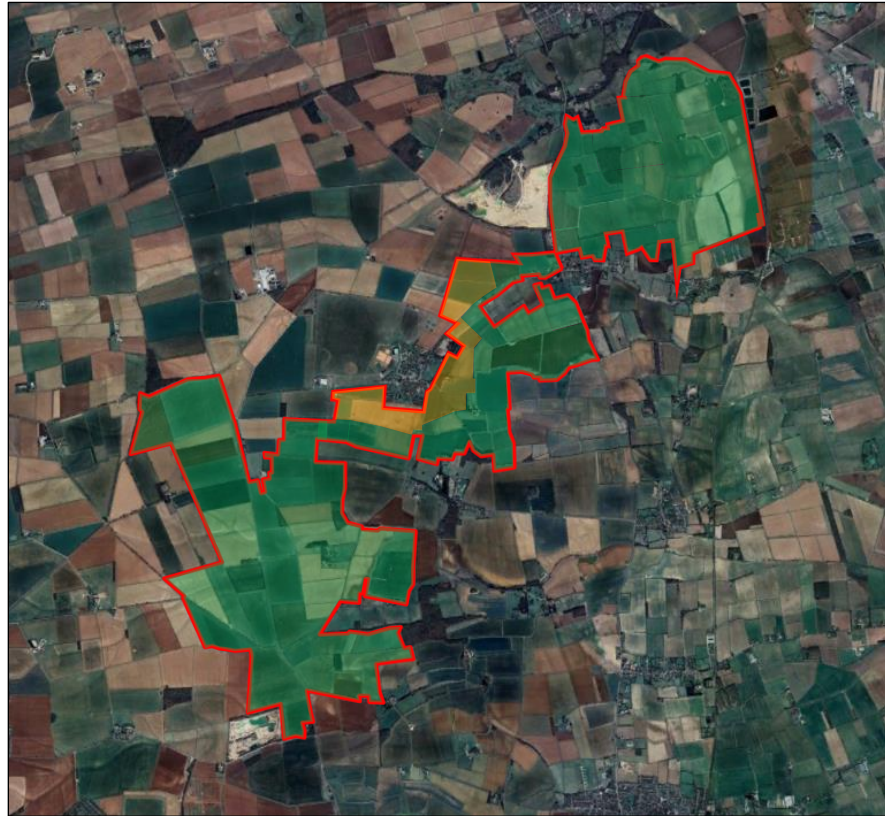
German UXO Risk Map

For indicative purposes – not to scale.

Please note that this assessed risk map may not take into account all post-war redevelopment/excavations on site.

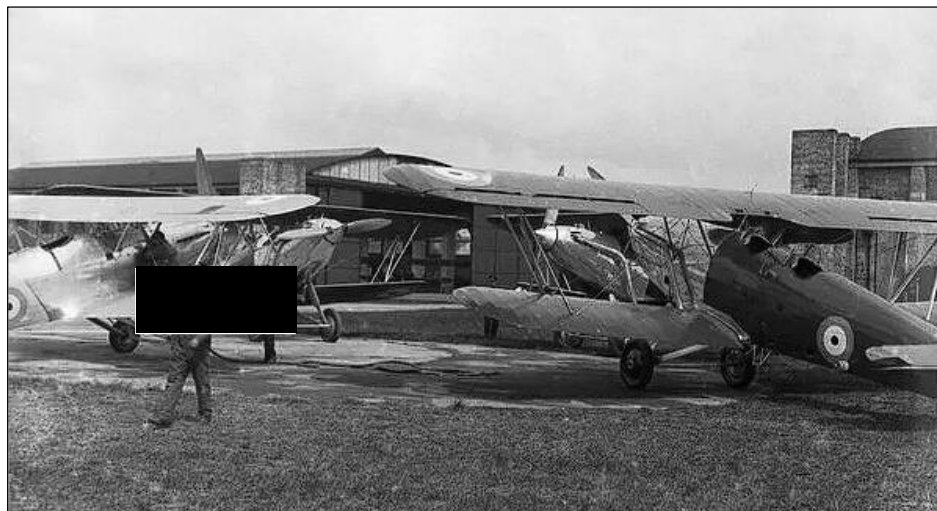
(Left) Several Hawker Hind light bombers parked on the apron at RAF Digby undergoing refuelling. Two Belfast Truss hangars can be seen in the background, circa 1935.

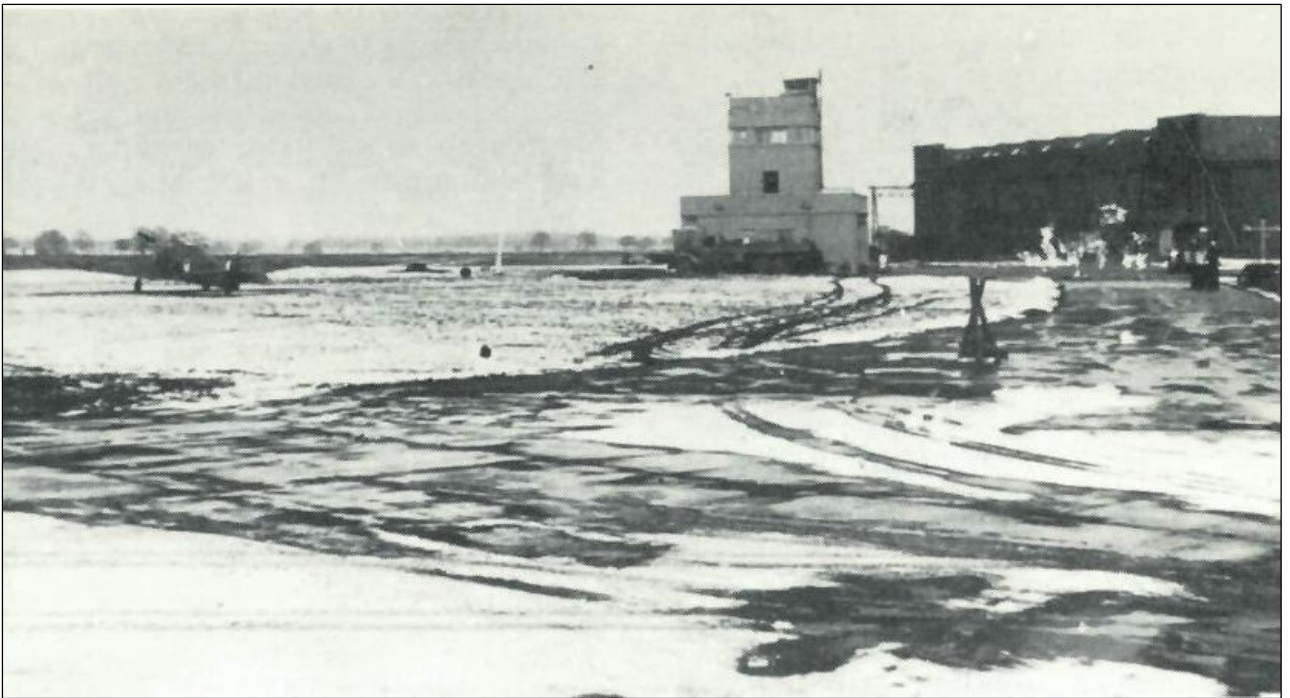
(Above) A snow covered RAF Digby during the winter of 1940 – 1941. A single Supermarine Spitfire can be seen, along with the fort style airfield control tower and a Belfast Truss type aircraft hangar.

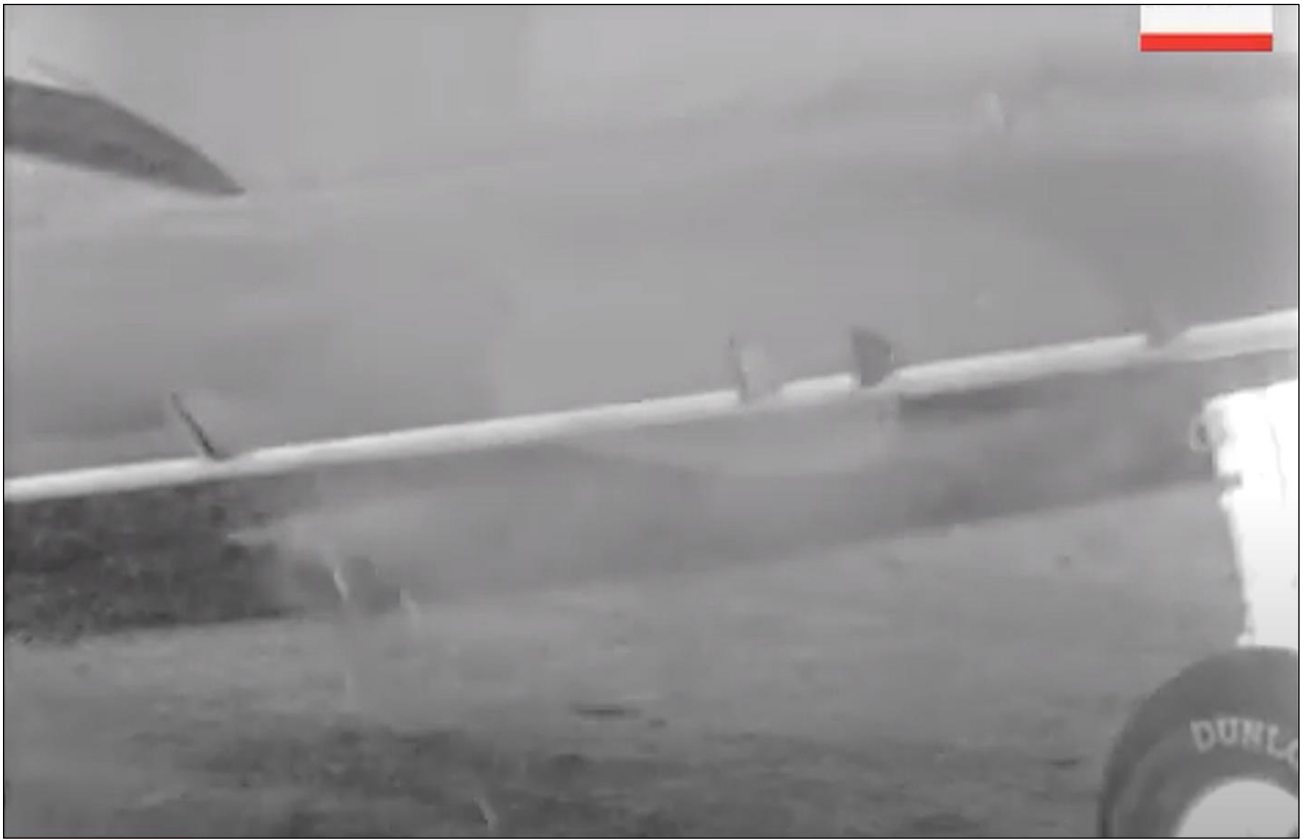
(Above) Four machine guns on the starboard wing of a Spitfire during test firing whilst parked at RAF Digby. Spent cartridges are shown to be ejected from under the wing, circa 12<sup>th</sup> January 1940.

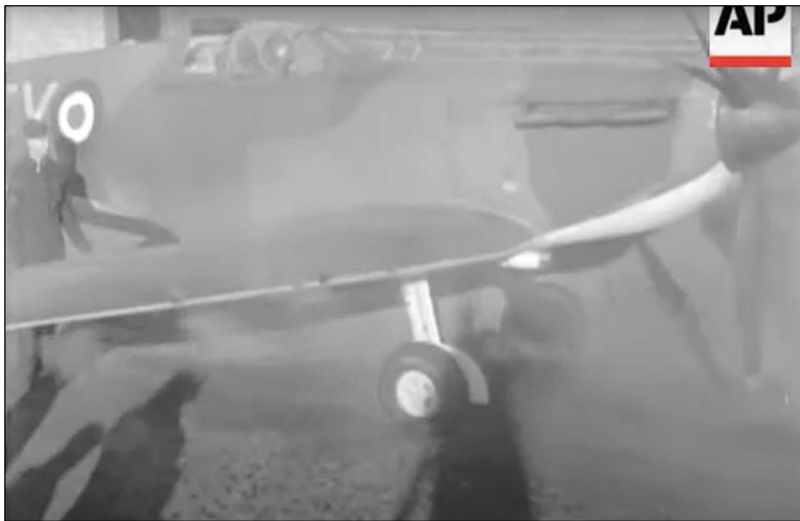
(Above) Four machine guns on the starboard wing of a Spitfire during test firing whilst parked at RAF Digby, circa 12<sup>th</sup> January 1940.

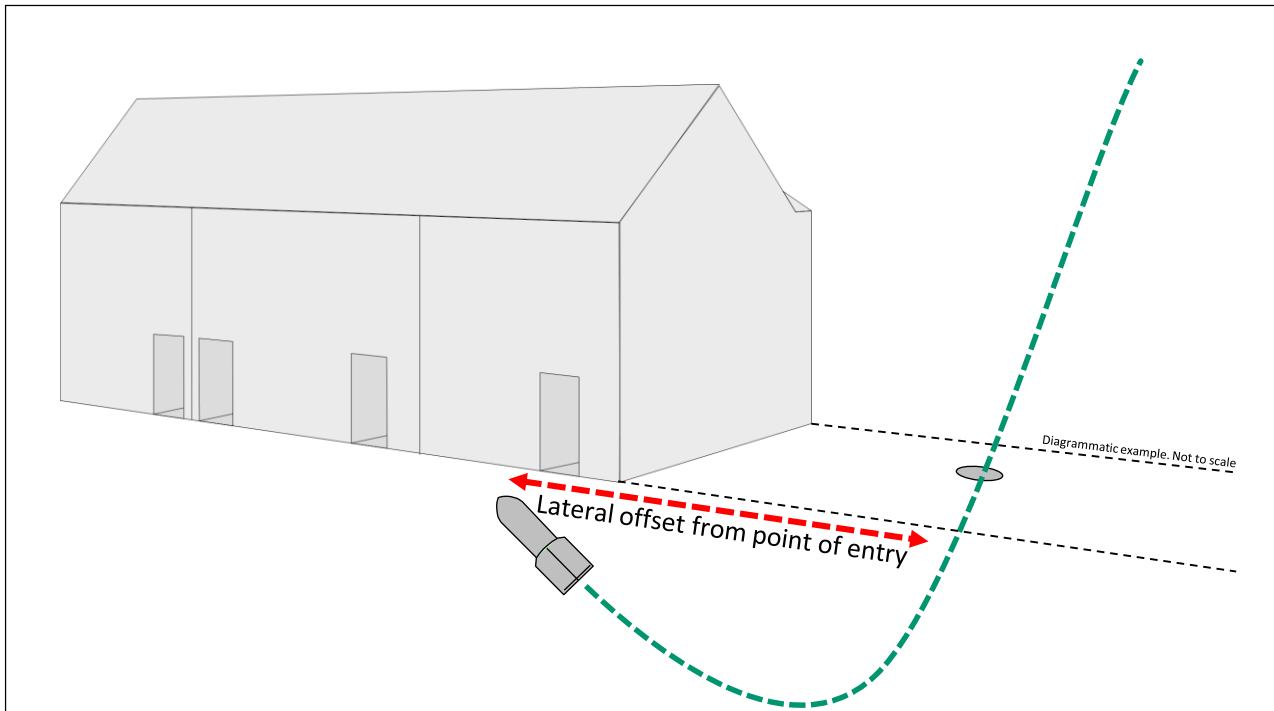
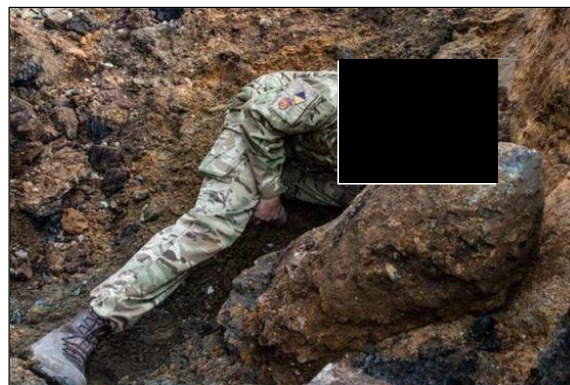
**Top:** J-curve Effect - Due to angle of entry, unexploded bombs would often end their trajectory at a lateral offset from point of entry, often ending up beneath adjacent extant structures/sites. The photograph above shows a 250kg unexploded bomb found in Bermondsey in 2015, pointing upwards, demonstrating 'J-curve'.

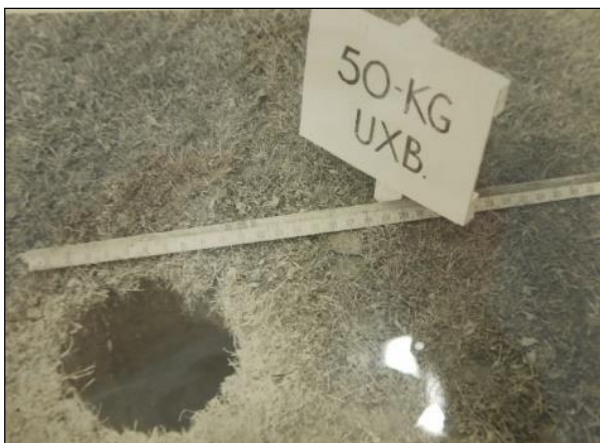
One of the most common scenarios for UXO going unnoticed was when a UXB fell into a 'bomb site' (such as the area shown **Top Left**), the entry hole of the bomb obscured by any debris and rubble present. Note that the entry hole of a 50kg UXB could be as little as 20cm in diameter (**Left**).

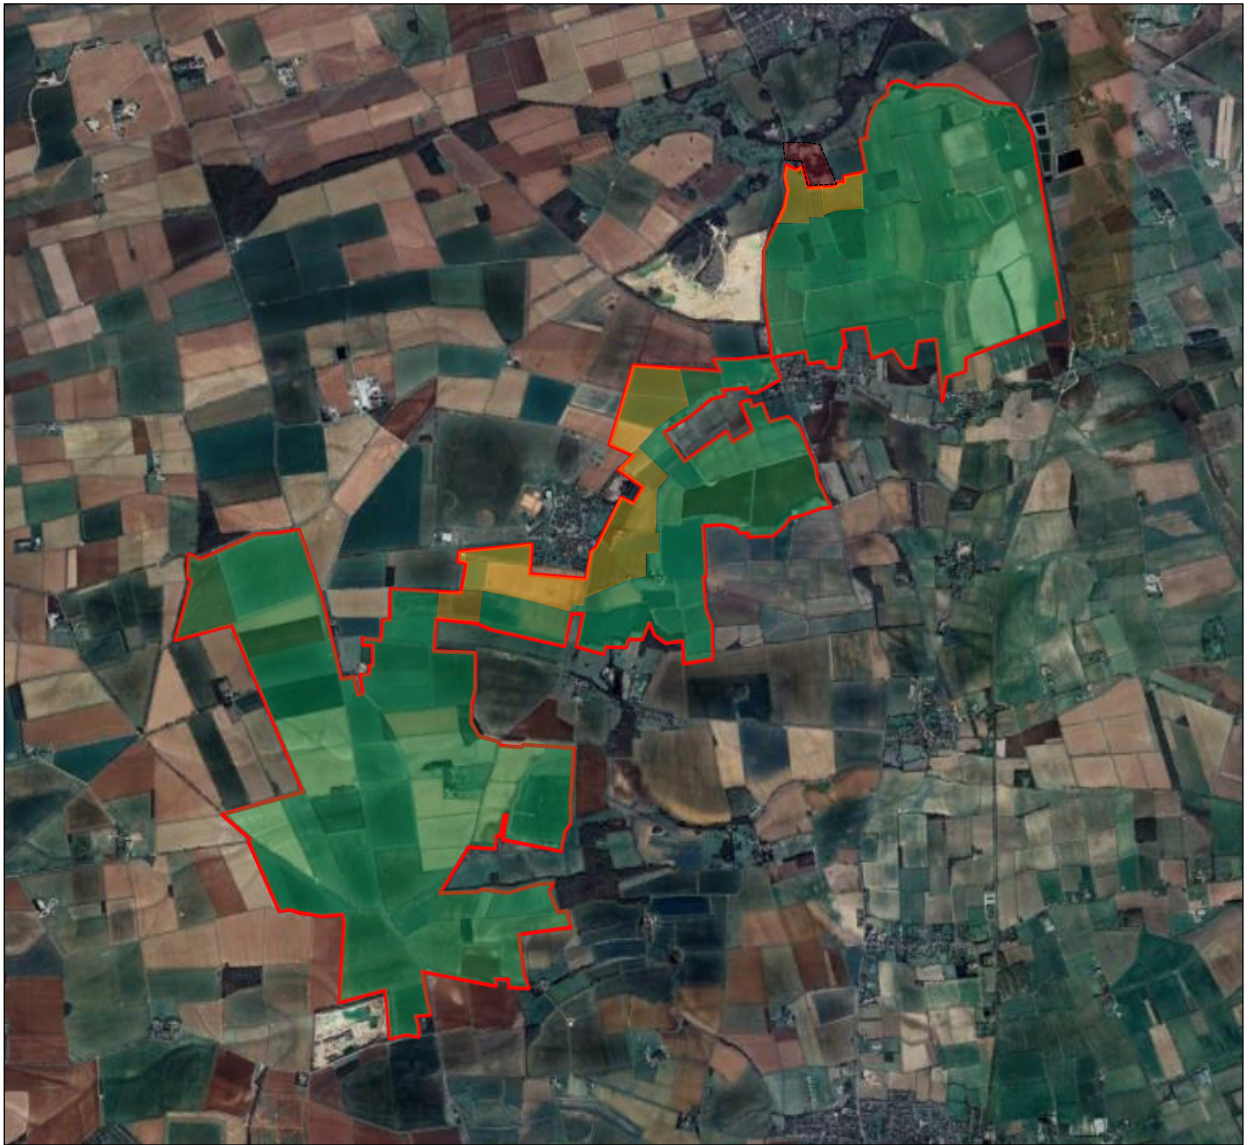
For indicative purposes – not to scale.  
 Please note that this assessed risk map may not take into account all post-war redevelopment/excavations on site.

- Low Risk
- Medium Risk

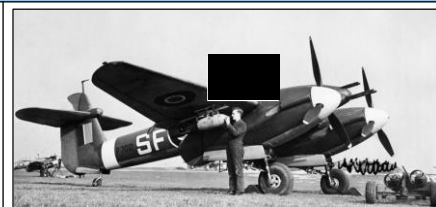
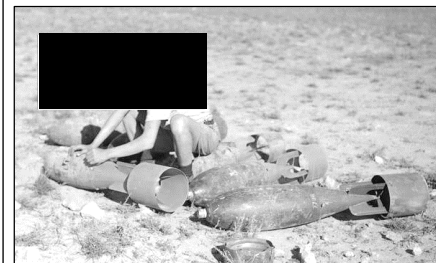
## 250lb General Purpose Bomb

Weight	247lbs
Explosive Weight	123lbs
Fuze Type	Nose fuses included the AM-M103, M118, and M119. Tail fuses included AM-M102A2 or the M114A1
Dimensions	28" x 10.3" (137.66cm x 71.12cm)
Use	The 250lbs bomb was used to target railways, small buildings, ammunition dumps, planes, and hangers. Bombs were typically mounted under the wings.
Remarks	Allied ordnance was typically 'lustreless' or 'olive drab'. Bombs were typically marked with a yellow ban across the nose or the tail.

Above - A Westland Whirlwind being armed with 250lbs underwing. Below - 250s in N. Africa

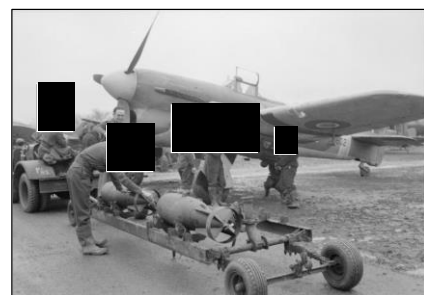
## 500lb General Purpose Bomb

Weight	509lbs
Explosive Weight	262lbs
Fuze Type	Nose fuses included the AM-M103, M118, and M119. Tail fuses included AM-M102A2 or the M114A1
Dimensions	35.7" by 13" (90.67cm x 33.02cm)
Use	The 500lbs general purpose bomb was the most commonly deployed item, of Allied aerially delivered ordnance. 1,729,611 500lbs were deployed by the allies.
Remarks	Allied ordnance was typically 'lustreless' or 'olive drab'. Bombs were typically marked with a yellow ban across the nose or the tail.

A Hawker Tempest being equipped with 500lbs general purpose bombs circa 1943 - 1945

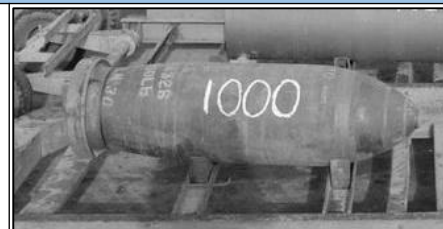
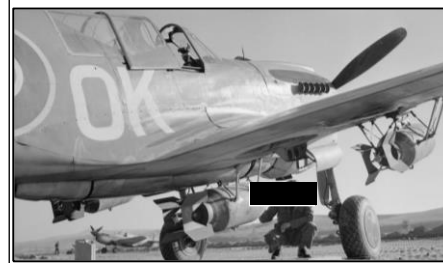
## 1000lb Medium capacity bomb

Weight	1,021lbs (464.09kg)
Explosive Weight	480lbs (approx. 47% of bomb weight)
Fuze Type	Nose fuses included the AM-M103, M118, and M119. Tail fuses included AM-M102A2 or the M114A1
Dimensions	72.6" x 52.5" (184.4cm x 133.35)
Use	The bomb was usually fitted under the wings of fighter aircraft and used for the tactical bombing of strategic targets. From 1944 the bomb was rationed for the purpose of supporting land operations.
Remarks	The bomb is made of case steel with an amatol 50/50 or 60/40 amtex filling.

Above, a 1000lbs. Below, a 1000lbs being fitted to a P-40 Warhawk

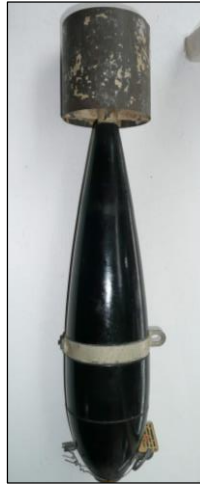
## 8.5 lb Practice Bomb

Bomb Weight	85 lb (approx. 3.9 kg)
Explosive Weight	1 lb (approx. 0.45 g)
Fuze Type	Explosive fuze and bursting charge.
Bomb Length	15.9 in (405 mm)
Body Diameter	Max. 2.95 in (75 mm)
Use	Dropped by Allied forces in order to practice bombing accuracy. Practice bombs used a small bursting charge to release smoke to mark their position.
Remarks	Had a moulded plastic shell. The Mk I had smoke filling and the Mk III had a flash filling, a mixture of gunpowder and magnesium turnings.

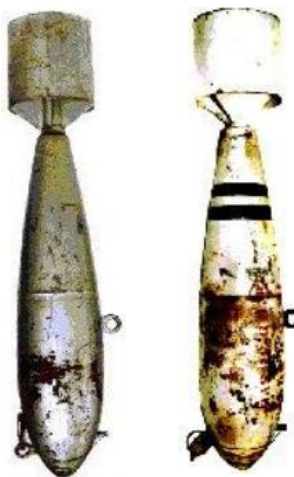
## 25 lb Practice Bomb

Bomb Weight	25 lb (11 – 11.5 kg)
Explosive Weight	1 lb (approx. 0.45 g)
Fuze Type	Explosive fuze and bursting charge.
Bomb Length	22 in (550 – 560 mm)
Body Diameter	4 in (100 mm)
Use	Dropped by Allied forces in order to practice bombing accuracy. Practice bombs used a small bursting charge to release smoke to mark their position.
Remarks	Mks I and IV had a smoke filling and Mks III and V had a flash filling for use at night. The 25 lb Practice Bomb was usually white with a cast iron nose.

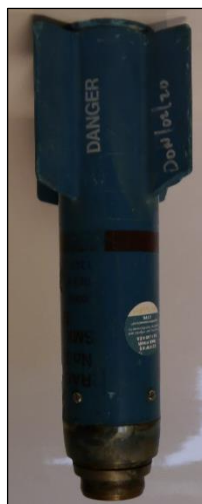
## 3 kg Practice Bomb

Bomb Weight	3 kg (approx. 6.6 lb)
Explosive Weight	Contains a smoke or flash filling.
Fuze Type	Varied
Bomb Length	386 mm (15.2 in)
Body Diameter	76 mm (3 in)
Use	Dropped by Allied forces in order to practice bombing accuracy. The 3kg Practice Bomb used a traditional detonator.
Remarks	Coloured banding around the casing denotes the filling of the bomb. The image to the left is a low explosive example.

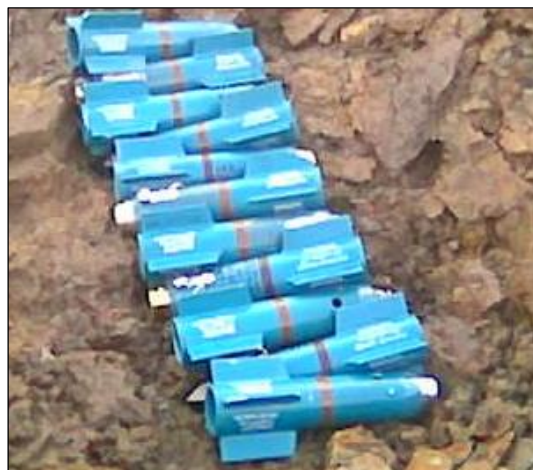
Examples of buried 3kg Practice Bombs.

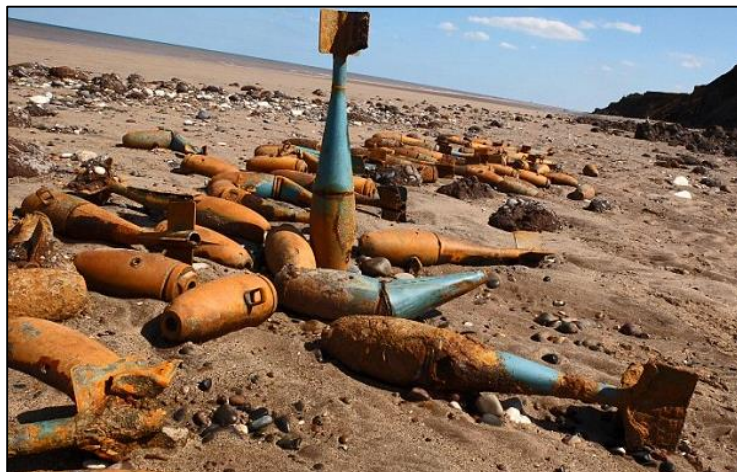
Practice bombs found after a landslide in Mappleton Beach.

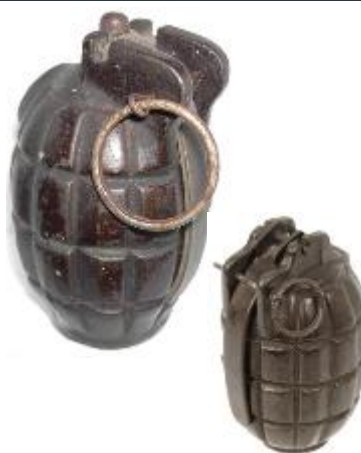
## No. 36 'Mills' Grenade

Weight	760g filled (1lb 6oz)
Explosive Weight	71g (2.5 oz) Baratol filling.
Fuze Type	4 second delay hand-throwing fuze
Dimensions	95 x 61mm (3.7 x 2.4in)
Use	Fragmentation explosive at approx. 30m range 100m range of damage.
Remarks	First introduced in 1915 its classic grooved 'pineapple' design was designed to provide uniform fragmentation. Approx. over 70million were produced.

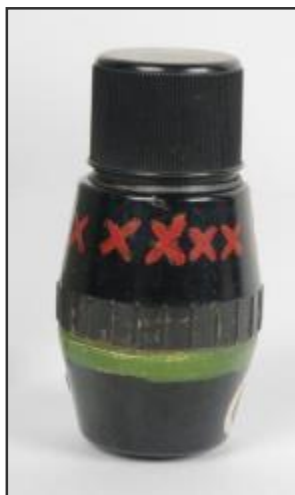
## No. 69 Grenade

Weight	383g (0.81lb)
Explosive Weight	93g (3.25 oz) of either Amatol, Baratol or Lyddite
Fuze Type	'All-ways' Fuze. Comprised of a safety cap, a weighted streamer attached to a steel ball bearing and a safety bolt designed to detonate from any point of impact.
Dimensions	114 x 60mm (4.5 x 2.4 in)
Use	A blast grenade for use as an offensive weapon.
Remarks	Introduced December 1940 and made from the plastic Bakelite as opposed to conventional metals. Detection is difficult due to this low metal content.

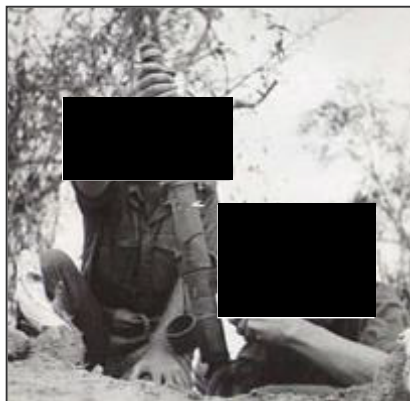
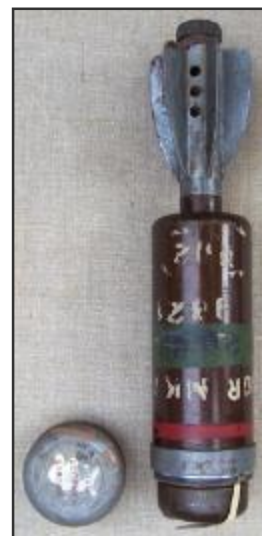
## Typical 2 Inch High Explosive Mortar

Weight	1.02kg (2.25lb)
Maximum Range	460m (500yards)
Filling	200g RDX/TNT
Dimensions	51 x 290mm (2in x 11.4 in )
Fuze Type	An impact fuze which detonates the fuze booster charge and in turn the high explosive charge.
Use	A small, portable mortar introduced into the British army in 1938. It had greater range and firepower over hand and rifle grenades, and was used to attack targets behind cover with high explosive rounds.
Remarks	Detonation causes the mortars bomb body to shatter producing optimum fragmentation and blast effect at the target.

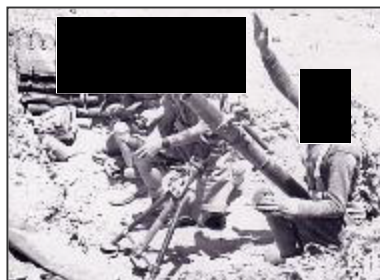
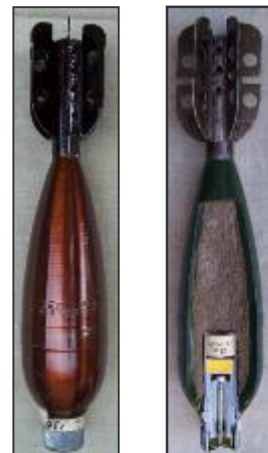
## Typical 3 inch Smoke Mortar

Weight	4.5kg (9lb 14oz)
Maximum Range	2515m ( 2,750 yards)
Filling	White phosphorus & smoke fill (also came in Explosive & Illuminating models)
Bomb Dimensions	490 x 76mm ( 19.3in x 3in)
Fuze Type	An impact fuze which initiates a bursting charge. This ruptures the mortar bomb 's body and disperses the phosphorus filler
Use	As a screening devices for unit movement or to impair enemy field of vision.
Remarks	This mortars long cylindrical body and tail sometimes causes it to be misrecognised as a German incendiary bomb.

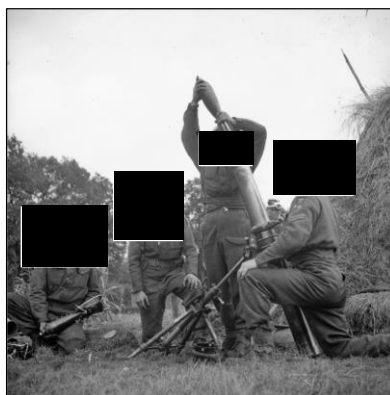
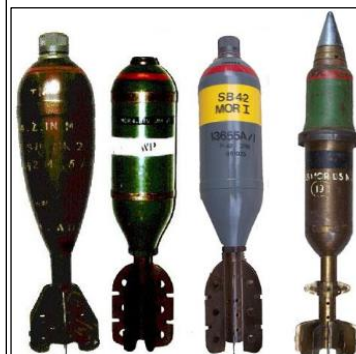
## ML 4.2 inch Mortar

Weight	9kg (19lb 13oz)
Maximum Range	3,750m (4,100 yards)
Filling	High explosive, smoke (white phosphorous or Titanium Tetrachloride) or chemical
Bomb Dimensions	500 x 105 mm (19 in x 4 in)
Fuze Type	Sensitive fuze with HE bursting charge.
Use	A widely used heavy motor which first saw use in 1942 and saw usage throughout the post-war period.
Remarks	Different markings denoted different fillings. See image to the right.

L to R: HE, Smoke, Chemical, Smoke BE.

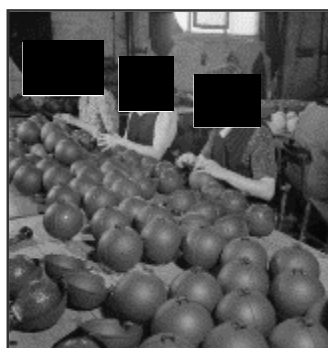
**No. 74 Grenade (Sticky Bomb)**

Weight	Approx. 1.1kg ( 2lb 4oz)
Filling	Approx. 600g Nobel's No.283 (Nitroglycerine)
Design	A glass ball on the end of a Bakelite (plastic) handle. The inside of the ball would contain the explosive filling and the outside a very sticky adhesive coating.
Use	An anti-tank grenade primarily issued to the home guard. It required the user to come in very close proximity with the target and smash the glass explosive container against it.
Remarks	One of a number of weapons developed for use as an <i>ad hoc</i> solution to the lack of sufficient anti-tank guns in the aftermath of the Dunkirk evacuation amid fear of German invasion.

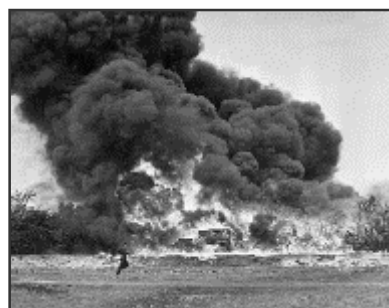
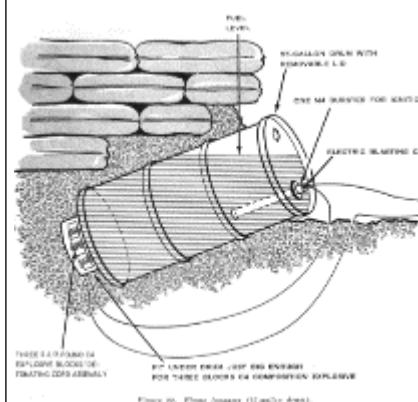
Figure 26. Flame Fougasse (12 gal/40 litres)

Weight	Various
Filling	Initially a mixture of 40% petrol and 60% gas. Ammonal provided the propellant charge.
Design	Usually constructed from a 40-gallon drum dug into a roadside and camouflaged.
Use	As an improvised anti-tank bomb. When triggered the Fougasse could project a beam of burning sticky fuel in a fixed direction from up to 3m (10ft) wide and 27m (30yards) long.
Remarks	A highly unorthodox weapon designed by the Petroleum warfare department to address a critical lack of weapons in 1940. 50,000 are estimated to have been distributed around the UK.

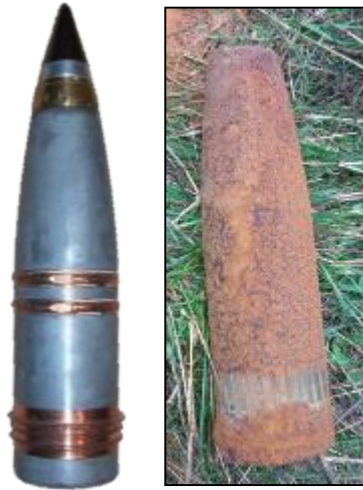
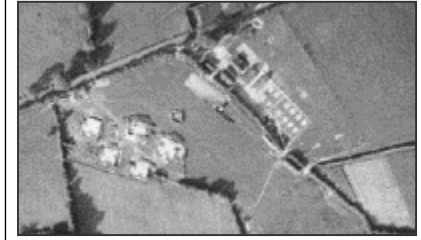
## QF 3.7 Inch WWII Anti-Aircraft Projectile

Projectile Weight	28lb (12.6 kg)
Explosive Weight	2.52lbs
Fuze Type	Mechanical Time Fuze
Dimensions	3.7in x 14.7in (94mm x 360mm)
Rate of Fire	10 to 20 rounds per minute
Use	High Explosive Anti-Aircraft projectile. 4.5in projectiles were also used in this role.
Ceiling	30,000ft to 59,000ft

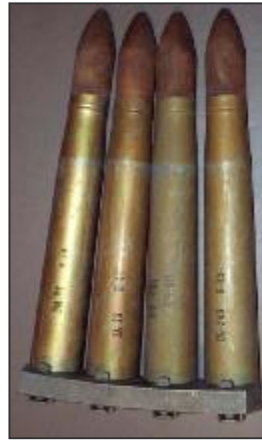
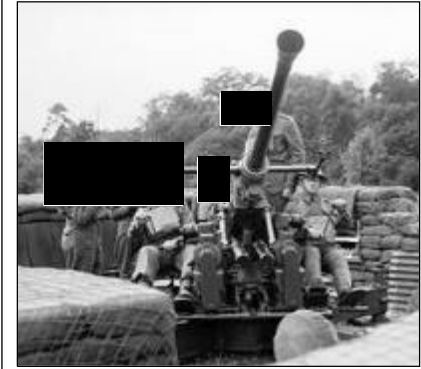
## 40mm Bofors Projectile

Projectile Weight	1.96lb (0.86kg)
Explosive Weight	300g (0.6lb)
Fuze Type	Proximity and Mechanical Time Fuze
Rate of Fire	120 rounds per minute
Projectile Dimensions	40mm x 310mm (1.6in x 12.2in)
Ceiling	23,000ft (7000m)

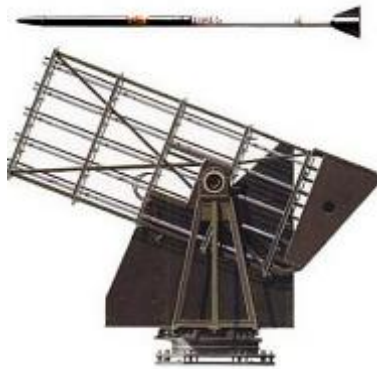
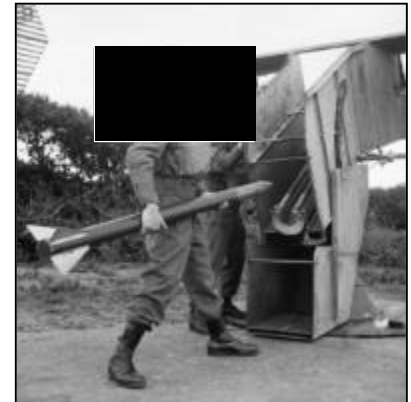
## Unrotated Projectile (UP) – Z Battery

Projectile Weight	84lb (24.5kg)
Warhead Weight	4.28lb (1.94kg)
Warhead	Aerial Mine with a No. 700 / 720 fuze
Filling	High Explosive
Dimensions	1930mm x 82.6mm (76 x 3.25in)
Use	As a short range rocket-firing anti-aircraft weapon developed for the Royal Navy. It was used extensively by British ships during the early days of World War II. The UP was also used in ground-based single and 128-round launchers known as Z Batteries.

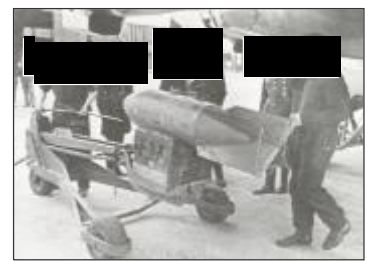
SC 250kg	
Bomb Weight	245-256kg (540-564lb)
Explosive Weight	125-130kg (276-287lb)
Fuze Type	Electrical impact/mechanical time delay fuze.
Bomb Dimensions	1640 x 512mm (64.57 x 20.16in)
Body Diameter	368mm (14.5in)
Use	Against railway installations, embankments, flyovers, underpasses, large buildings and below-ground installations.
Remarks	It could be carried by almost all German bomber aircraft, and was used to notable effect by the Junkers Ju-87 Stuka (Sturzkampfflugzeug or dive-bomber).

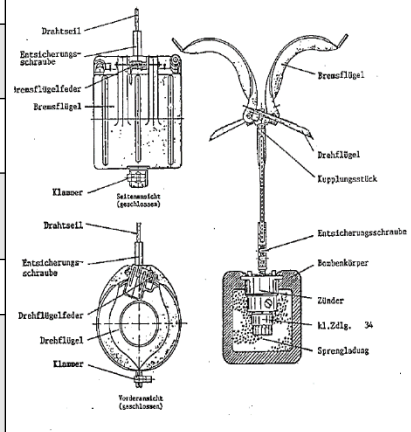
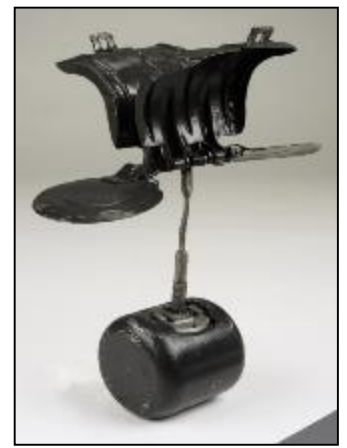
SD2 Butterfly Bomb	
Bomb Weight	2kg (4.41lb)
Explosive Weight	7.5oz (212.6 grams ) of TNT surrounded by a layer of bituminous composition.
Fuze Type	41 fuze (time) , 67 fuze (clockwork time delay) or 70 fuze (anti-handling device)
Bomb Dimensions	Length 240 mm Width 140 mm Height 310 mm
Body Diameter	3in (7.62 cm) diameter, 3.1in (7.874) long
Use	It was designed as an anti-personnel/fragmentation weapon. They were delivered by air, being dropped in containers that opened at a predetermined height, thus scattering the bombs.
Remarks	The smallest and most common conventional German bomb. Nearly 70% of bombs dropped on the UK were 50kg.

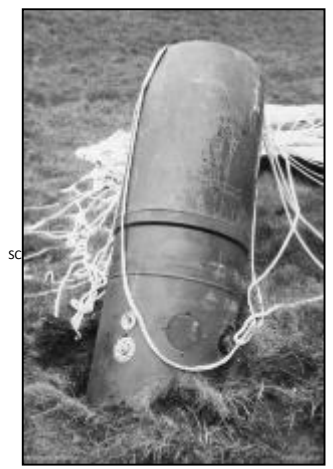
## Parachute Mine (Luftmine B / LMB)

Bomb Weight	987.017kg (2176lb)
Explosive Weight	125-130kg (276-287lb)
Fuze Type	Impact/ Time delay / hydrostatic pressure fuze
Bomb Dimensions	1640 x 512mm (64.57 x 20.16in)
Body Diameter	368mm (14.5in)
Use	Against civilian, military and industrial targets. Designed to detonate above ground level to maximise damage to a wider area.
Remarks	Parachute Mines were normally carried by HE 115 (Naval operations), HE 111 and JU 88 aircraft types. Deployed a parachute when dropped in order to control its descent.

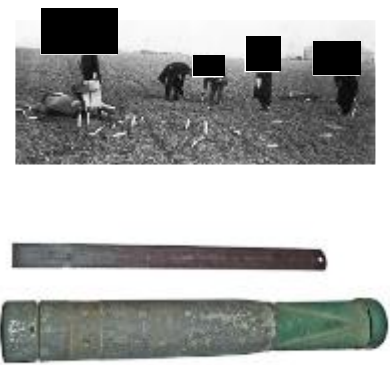
1kg Incendiary Bomb	
Bomb Weight	1.0 and 1.3kg (2.2 and 2.87lb)
Explosive Weight	680gm (1.3lb) Thermit
Fuze Type	Impact fuze
Bomb Dimensions	350 x 50mm (13.8 x 1.97in)
Body Diameter	50mm (1.97in)
Use	As incendiary – dropped in clusters against towns and industrial complexes
Remarks	Magnesium alloy case. Sometimes fitted with high explosive charge. The body is a cylindrical alloy casting threaded internally at the nose to receive the fuze holder and fuze.

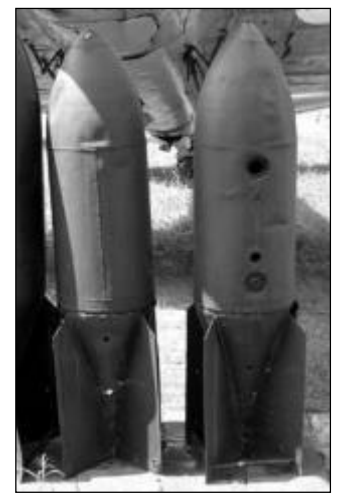
Flam C-250 Oil Bomb	
Bomb Weight	125kg (276lb)
Explosive Weight	1kg (2.2lb)
Fuze Type	Super-fast electrical impact fuze
Filling	Mixture of 30% petrol and 70% crude oil
Bomb Dimensions	1,650 x 512.2mm (65 x 20.2in)
Body Diameter	368mm (14.5in)
Use	Often used for surprise attacks on living targets, against troop barracks and industrial installations. Thin casing – not designed for ground penetration
