Springwell Solar Farm

Environmental Statement

Appendix 7.7: Riparian Mammal And
Aquatic Habitat Assessment

EN010149/APP/6.3
November 2024
Springwell Energyfarm Ltd

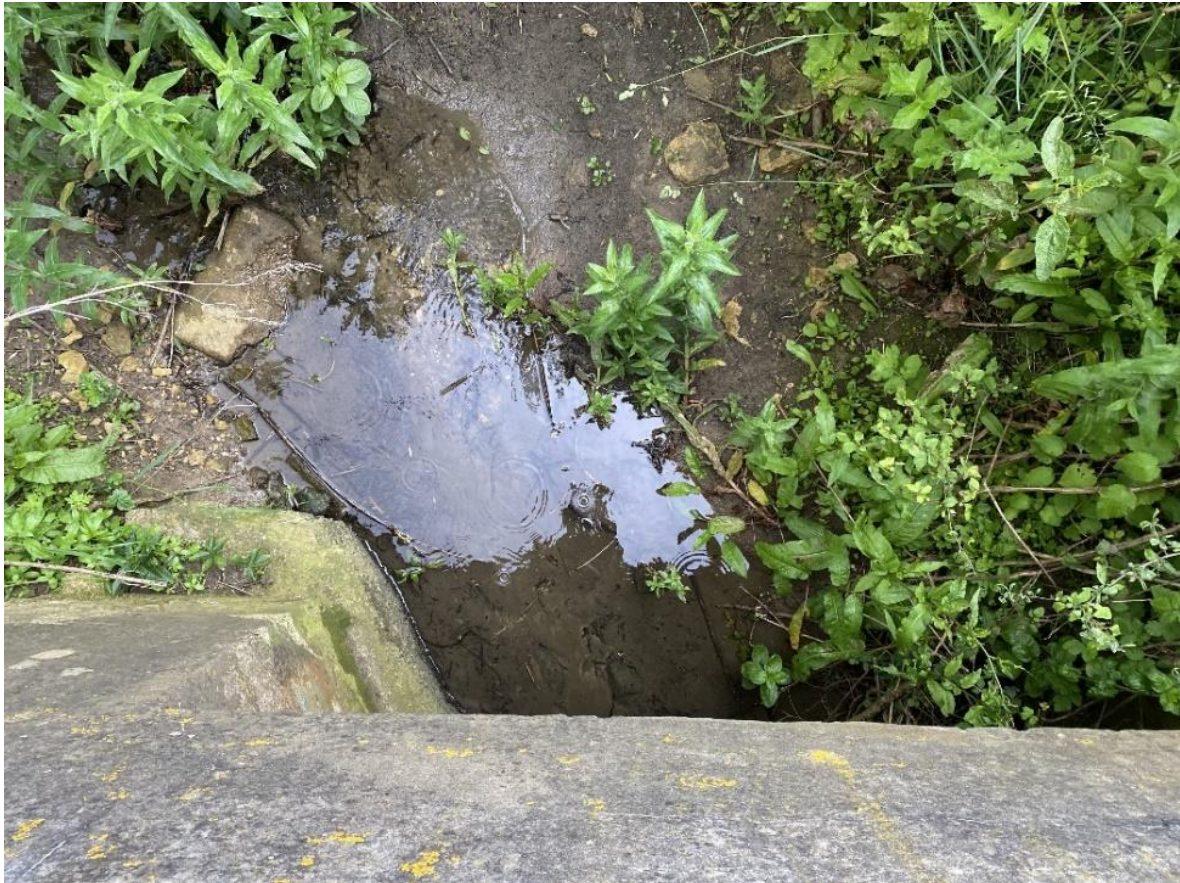
Plate 1 Culvert located at Crossing 1

4.2.1. The ditch at Crossing 1 was surveyed in three directions centring around the proposed crossing location close to a culvert beneath Acre Lane (**Plate 1**). To the north of the culvert a c.250m long surveyed section of ditch was dry and heavily choked with aquatic vegetation. The surveyed section to the east was c.220m in length and comprised a short section of shallow run, and a deeper section with no perceptible flow, reaching depths of up to 0.4m. A c. 200m section surveyed to the west of the culvert comprised predominately of shallow (< 0.1m depth) run leading to a vegetation choked area of no perceptible flow. The substrate primarily comprised silt and clay (**Figure 2**).

- 4.2.3. No evidence of otter, water voles, nor any other small mammal field signs were identified at Crossing 1. The ditch could not be accessed for a full survey due to the density of vegetation, although partial observations were possible. However, the habitat was considered unsuitable for water voles and otter as the banks do not provide suitable burrowing opportunities for water vole and much of the ditch was dry and completely choked with terrestrial vegetation (unsuitable for foraging otter) (**Figure 2**).

- 5.1.5. Given the potential for fish to be present it is recommended that an ecological clerk of works with aquatic experience be present at the installation of the crossings to supervise the works and provide ecological support if required. If crossing works are to be undertaken on wetted sections of the ditch, particularly when water levels are higher, then a fish rescue may also be required.

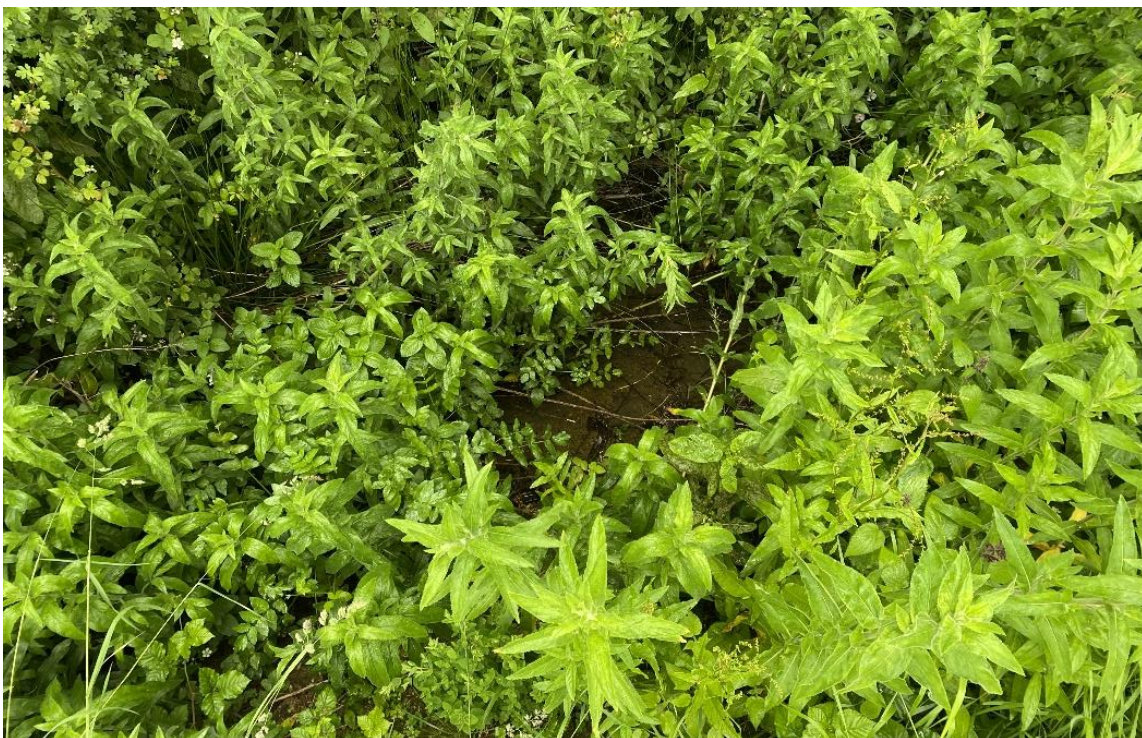
Plate 2 View of the choked dry channel at Crossing 2

- 4.3.1. The ditch located at Crossing 2 is located in Springwell East within the Order Limits, bordered by arable fields, modified grassland, hedgerows, and a line of trees. The ditch was surveyed in three directions centring around a culvert (TF 08067 59247). A section of ditch to the north of the culvert was c. 380m in length and comprised a long dry section that was heavily choked with dense vegetation and a small section that held shallow water with no perceptible flow, the substrate within the ditch was primarily composed of silt (**Plate 2**). To the east of the culvert the ditch is comprised of a short dry, choked section which leads to a c. 300m section of shallow water with no perceptible flow that is choked with emergent linear leaved vegetation. To the south there is a small section directly in front of the culvert that holds shallow water, which forms a shallow run (approximately 1cm deep), the remainder of the c. 280m section is comprised of shallow water

with no perceptible flow that is choked by vegetation. An additional culvert is present in the southern section of ditch, which runs under the road and leads to Crossing 3.

- 4.3.2. Habitat within the wetted sections of the Crossing 2 ditch had potential to support European eel and smaller fish species (i.e. three-spined stickleback), this is discussed in further detail in **Section 4**.
- 4.3.3. No evidence of otter, water voles, or any other small mammal field signs were recorded in any of the sections of this ditch. Full access to survey this ditch was not possible due to the density of vegetation. The habitat was considered unsuitable for water voles as the banks do not provide suitable burrowing opportunities and the ditch was completely choked with terrestrial vegetation (unsuitable for foraging otter).

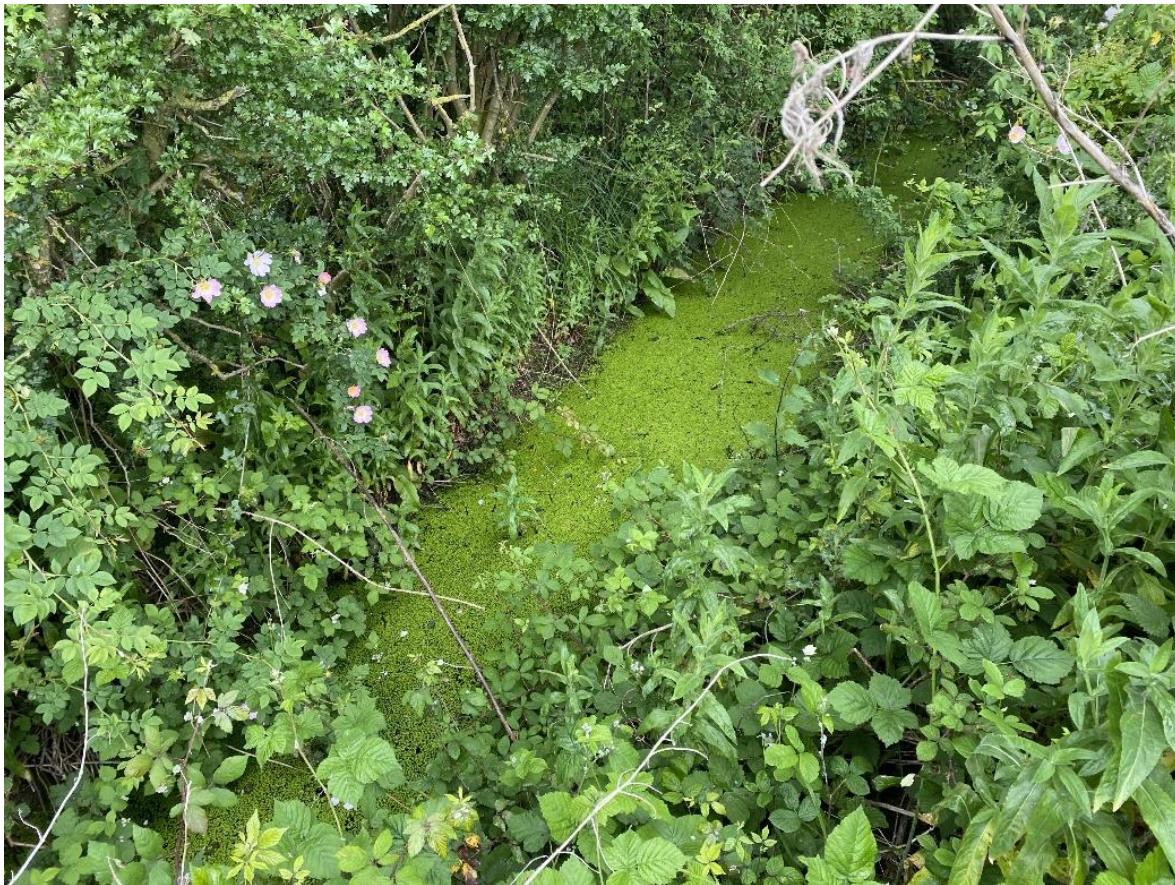
Plate 3 View of duckweed sp. in southern section of Crossing 3

- 4.4.1. The northern extent of the ditch at Crossing 3 is marked by a culvert, to the north of this a choked section of no perceptible flow is present which has been surveyed under Crossing 2. Habitats within the ditch to the south of the culvert are comparable to those present at Crossing 1 and 2, with the notable exception of the presence of macrophytes. Floating macrophyte, primarily duckweed (*Lemna* sp.) was present in several sections of the ditch, there is a small area of emergent linear-leaved macrophytes immediately to the south of the culvert. The entire length of the ditch (c. 800m long) holds water with depths reaching up to 0.2m, however there was no perceptible flow observed throughout the ditch (**Plate 3 and 4**). The substrate was a mix of silt and clay (**Figure 2**).

- 4.4.2. Habitat within the Crossing 3 ditch had potential to support European eel and smaller fish species (i.e. three-spined stickleback), this is discussed in further detail in **Section 4**.
- 4.4.3. No evidence of otter, water voles, or any other small mammal field signs were recorded in any sections of this ditch. Full access to survey this ditch was not possible due to the density of vegetation. The habitat was considered unsuitable for water voles as the banks do not suitable provide burrowing opportunities. The surrounding habitat was unsuitable for foraging otter and due to a lack of connectivity to the wider area it is unlikely that this location supports otter.

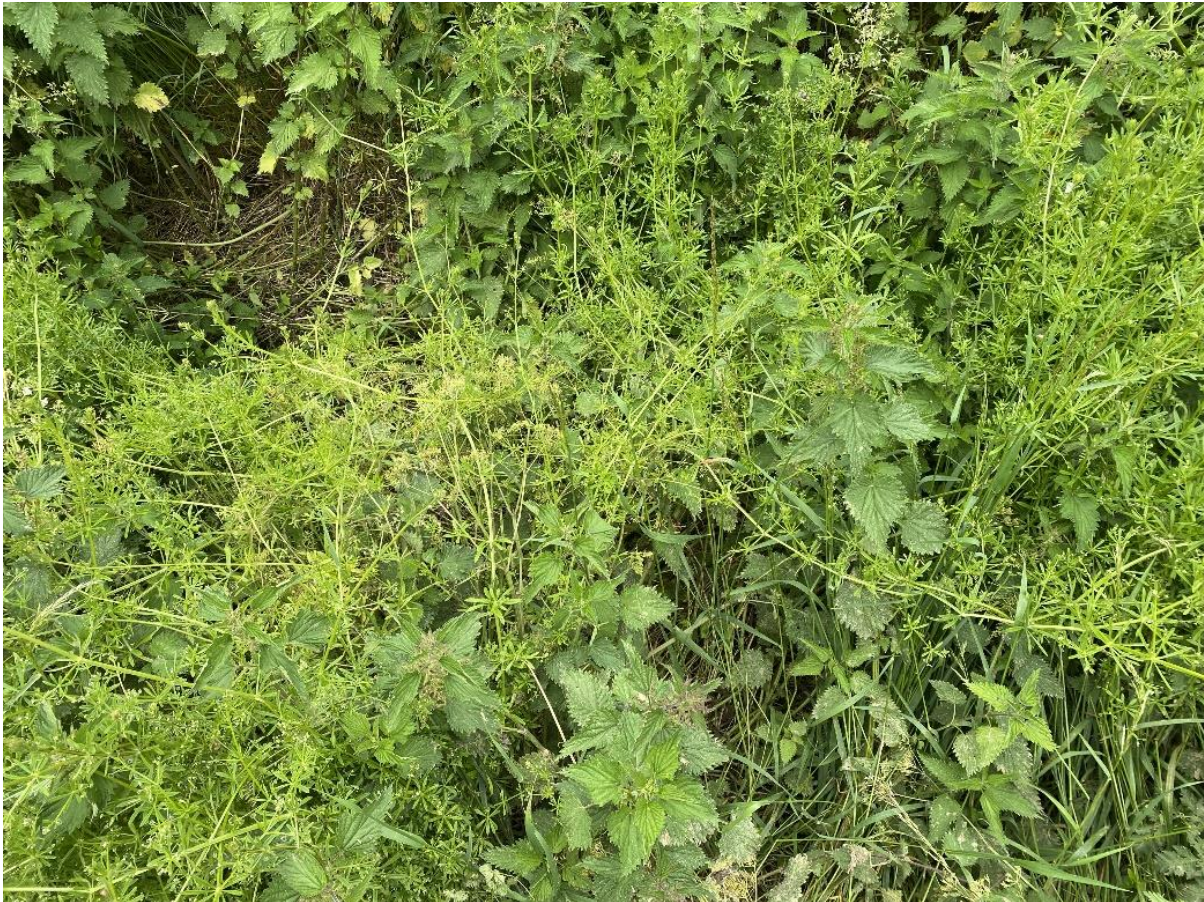
Plate 5 View of Crossing 4 ditch, choked with dense vegetation

- 4.5.1. Crossing 4 was located in Springwell East within the Order Limits, bordered by arable fields, hedgerow and a road. This ditch was c. 250m in length and was dry, heavily choked with dense vegetation, and had a substrate primarily composed of silt (**Plate 5**).

- 4.5.2. Crossing 4 was dry and therefore unsuitable for fish at the time of survey.
- 4.5.3. No evidence of otter, water voles or any other small mammal field signs were recorded during the June surveys. Full access to the survey ditch was not possible, however the ditch was dry at the time of surveying, making it unsuitable for water voles and otters and was also deemed unlikely to increase in suitability over the summer (i.e. likely to remain dry).

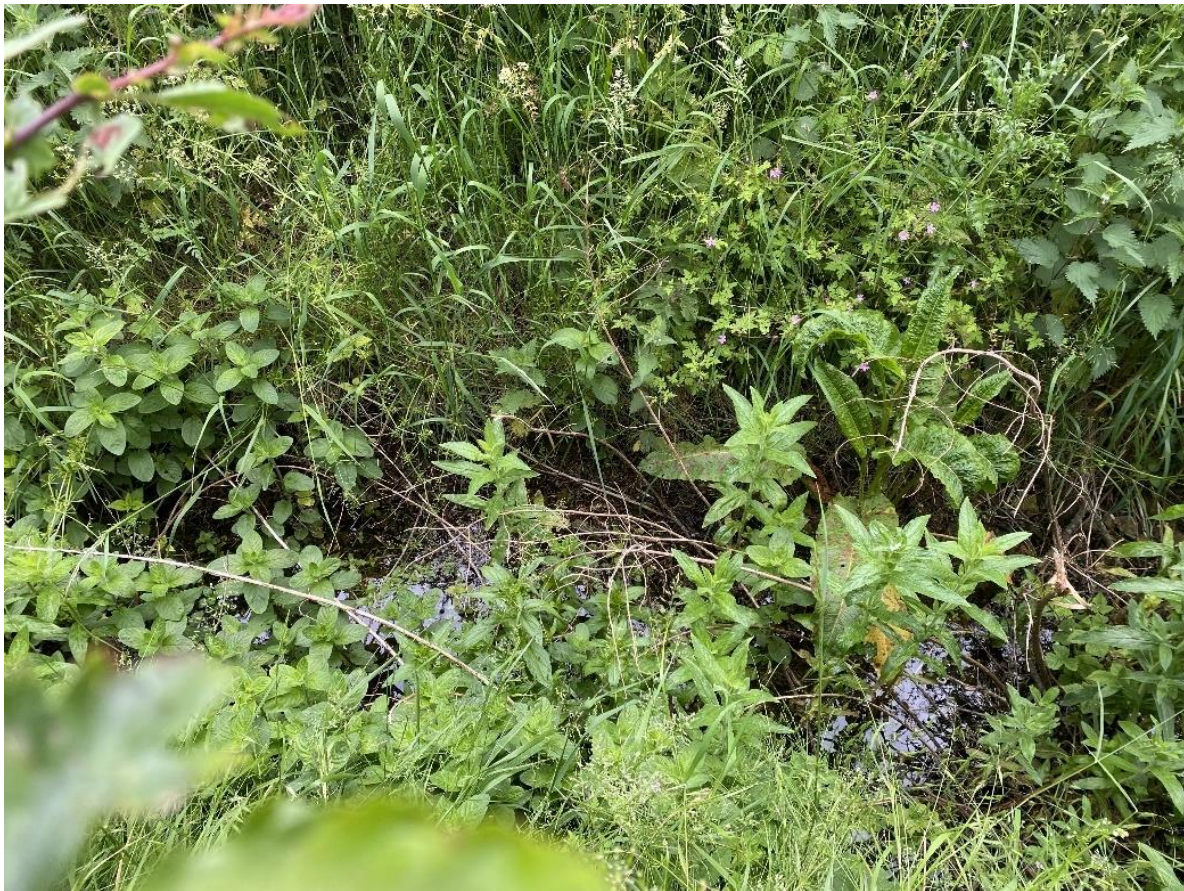
Plate 6 View of wetted section of ditch at Crossing 5

- 4.6.1. Crossing 5 was located in Springwell Central within the Order Limits, bordered by hedgerows, and arable fields. The primary section of this ditch runs adjacent to a farm track and is c. 600m in length. The ditch was primarily dry, heavily choked with dense vegetation, and had a substrate primarily composed of silt. Small, isolated sections of shallow water were visible with depths up to 0.1m and no perceptible flow (**Plate 6**). A culvert runs under the farm track forming a c. 250m southern section of this ditch, which comprised shallow areas of water with no perceptible flow, however the substrate was mix of gravel and silt (**Figure 2**).

- 4.6.2. Habitat within the wetted sections of the Crossing 5 ditch had potential to support European eel and smaller fish species (i.e. three-spined stickleback), this is discussed in further detail in **Section 4**.
- 4.6.3. No evidence of otter, water voles or any other small mammal field signs were recorded during the June surveys. The ditch was dry at the time of surveying, making it unsuitable for water voles and otters. It was also deemed unlikely to increase in suitability over the summer (i.e. likely to remain dry).

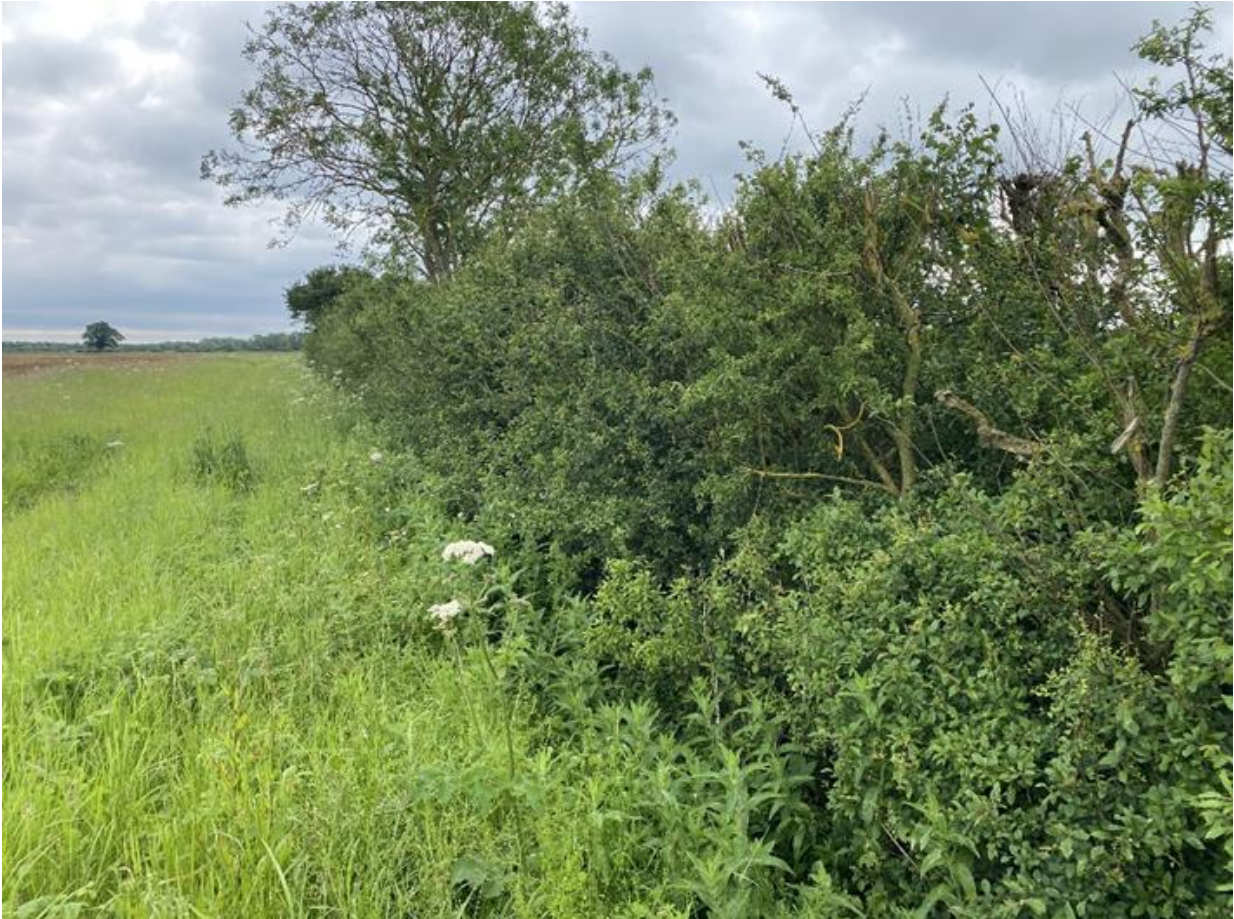
Plate 7 View of arable fields and hedgerow bordering Crossing 6

- 4.7.1. Crossing 6 was a c.700m section of ditch that is located in Springwell Central within the Order Limits, bordered by hedgerows and arable fields (**Plate 7**). This ditch was primarily dry, heavily choked with dense vegetation, and had a substrate primarily composed of silt. Short sections of shallow water were present with no perceptible flow (**Figure 2**).

- 4.7.2. Habitat within the wetted sections of the Crossing 6 ditch had potential to support European eel and smaller fish species (i.e. three-spined stickleback), this is discussed in further detail in **Section 4**.
- 4.7.3. No evidence of otter, water voles or any other small mammal field signs were recorded during the June surveys. There were sections of the ditch that could not be accessed in order to survey, however, it was dry at the time of surveying, and combined with the near vertical banks, this ditch was deemed unsuitable for water voles. It was also deemed unlikely to increase in suitability over the summer (i.e. likely to remain dry).
