Rosefield Solar Farm EIA Scoping Report

Volume 2 Appendices

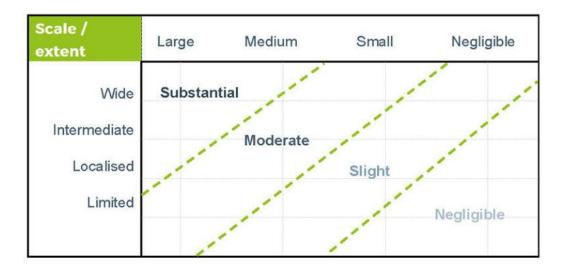
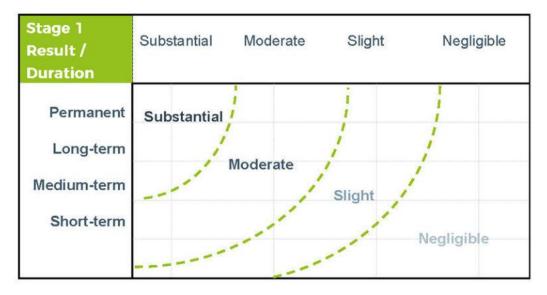
Figure D1 Scale of effect diagrams

In the LVIA, the magnitude of effects will be described as: Substantial, Moderate, Slight or Negligible. Where magnitude is judged to lie between levels, an intermediate assessment will be adopted.

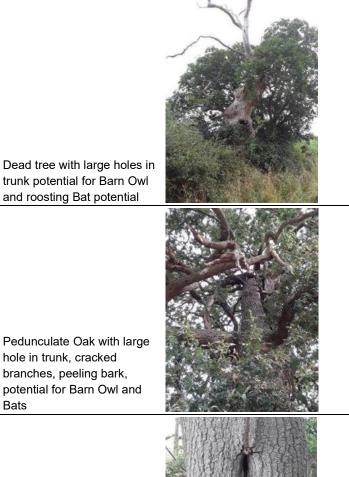
80

Pedunculate Oak with large hole in trunk, cracked branches, peeling bark, potential for Barn Owl and Bats

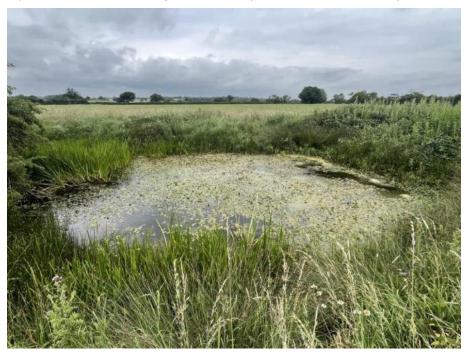
Plate 1 - Pond ID 10

- 3.1.1. Site 1 mainly consisted of arable cropland fields bordered by hedgerows. Additionally, there were permanently vegetated pasture with evidence of rotational grazing in fields primarily to the west, along with small areas of woodland and mixed scrub. Ponds found on Site were mostly shallow or dry and only occasionally deep. See **Figure 2** for the location Watercourses and Pond IDs at Site 1.
- 3.1.2. The shallow ponds, including Pond ID 9 and 10 were stagnant and approximately 1 10 cm in depth with broad floating, submerged and emergent linear leaved vegetation present. Some ponds were heavily poached and comprised of a silt clay layer, with herb and tall grass / scrub present on the bank tops.

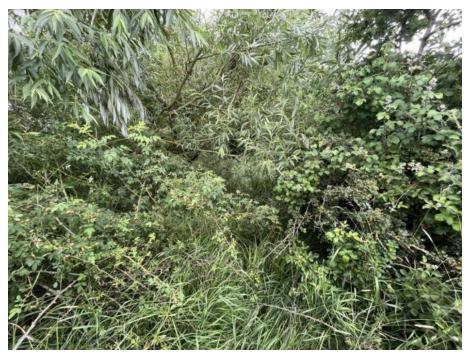
Plate 2 - Pond ID 18

3.1.3. The dry ephemeral ponds, including Pond ID 18 were densely overgrown with terrestrial vegetation including horse tail and dense scrub which caused the ponds to be completed shaded. These ponds were also bordered by woodland as well as arable and pasture fields.

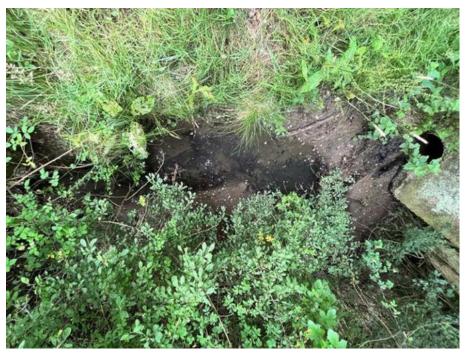
- 3.1.7. Just north of the extended RLB, Watercourse ID 3 was wet, with stagnant water and no perceptible flow. There was a culvert leading to the southern branch, and the channel width was less than 1 m, with a depth of 5 cm and a silt clay substrate. The banks were densely overgrown with scrub and trees, but there was no vegetation within the channel.

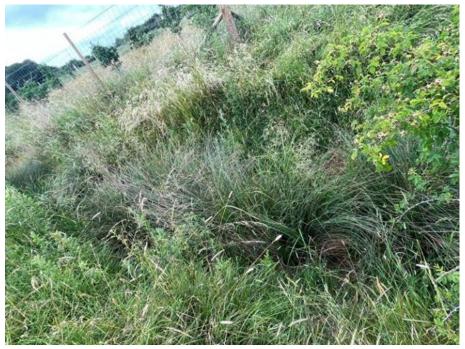
Plate 4 - Watercourse ID 15

3.1.8. Watercourse ID 15 running through the middle of Site 1 was a dry ephemeral ditch located in between arable and pasture fields, with terrestrial vegetation present within the channel. The ditch was choked with dense herbs, tall grass, and scrubs on both banks. In the southern section of the ditch, there was a small amount of stagnant water, approximately 1cm deep, leading to a pond.

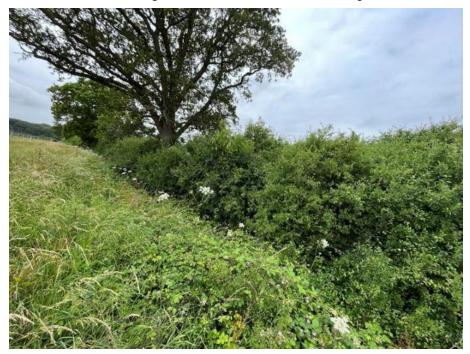
Plate 5 - Watercourse ID 24

- 3.2.1. The majority of Site 1a is made up of arable and pasture fields, bordered by hedgerows. See **Figure 2** for the location of Watercourses and Pond IDs at Site 1a.
- 3.2.2. Site 1a comprised of only one pond, Pond ID 39 which was dry and densely covered with terrestrial vegetation. The pond had an earth substrate and was completely shaded by vegetation and surrounding trees.
- 3.2.3. Site 1a contained only one ephemeral watercourse, Watercourse ID 23- 25 which runs along the northern boundary of the extended RLB. At the time of the survey, the watercourse was dry, densely surrounded by scrub and terrestrial vegetation in the channel, causing it to become choked and overgrown.

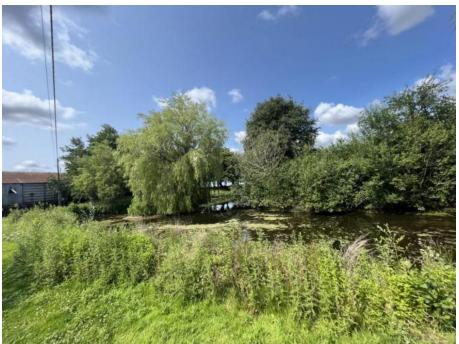
Plate 6 - Pond ID 4

- 3.3.1. The majority of Site 2 is made up of arable land, with pasture fields present in the south of the Site, bordered by hedgerows along with small areas of scrub and woodlands. See **Figure 2** for the location of Watercourses and Pond IDs at Site 2.
- 3.3.2. Along the northern extended RLB lie two large ponds, Pond 4 north of the boundary and Pond 68 to the south. Both are surrounded by agricultural land and a residential farmhouse. The ponds were 20 30 cm in depth and consist of gravel, sand, and silt substrate. Both ponds contained an island in the middle, fringed with riparian vegetation which resulted in low to moderate shading. Bankside trees, tall herb and short, maintained grasses surround the pond. Pond 68 also contained free-floating algal. The ponds were possibly ground water fed with low turbidity, with waterfowl also present.

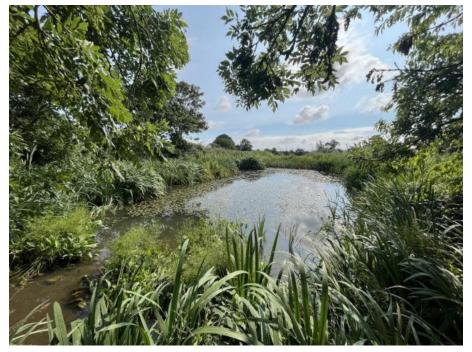
Plate 8 - Pond ID 6

3.3.3. Along the east boundary lies another large pond, Pond 6. The pond appeared to have a high level of silt substrate present and a depth greater than 30 cm. Within the pond, floating broadleaved and emergent linear plants were present. The vegetation along the banks included dense tall herbs, grasses, trees, and scrub, resulting in high shading. The pond is surrounded by agricultural land and seems

to form a series of interconnected ponds through culverts leading to a ditch. Additionally, there is a nearby broad-leaved woodland.

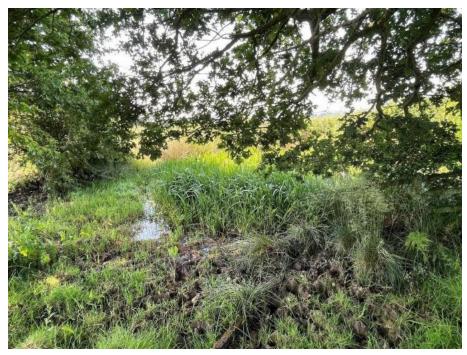
#### Plate 9- Pond ID 61

3.3.4. Pond ID 62 lies in along the east boundary of Site 2. It has shall margins <10 cm but is deeper in the middle with emergent linear-leaved, broad-leaved and rooted broad-leaved present. The pond is surrounded by trees, tall herbs, scrub and grass with low shading on the pond. Pond ID 61 lies in the southern section of Site 2, has a depth of > 15 cm and is choked with emergent linear vegetation. The pond is surrounded by agricultural land and is heavily poached. The pond is surrounded by dense tall herbs, grasses, trees and scrub which inhibits safe access.

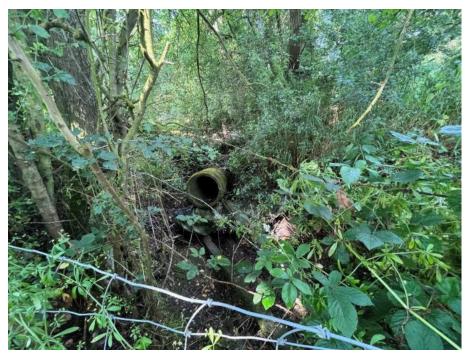
Plate 10 - Watercourse ID 36

- 3.3.5. Pond 5 also lies in the southern section of Site 2. It is a large pond with emergent linear, submerged fine-leaved and broad-leaved vegetation present. It is > 20 cm in depth and is bordered by tall herbs, grasses, trees and scrubs which create moderate shading. This pond is connected to two in / outlet ditches and is suitable for invertebrates only.
- 3.3.6. Watercourse ID 36 lies along the eastern boundary of Site 2 which is an ephemeral ditch with stagnant water ponding near the road bridge. This area is surrounded by agricultural land and features dense trees and scrubs, but vegetation was lacking from within the channel itself. The substrate in this watercourse consisted of earth and silt.

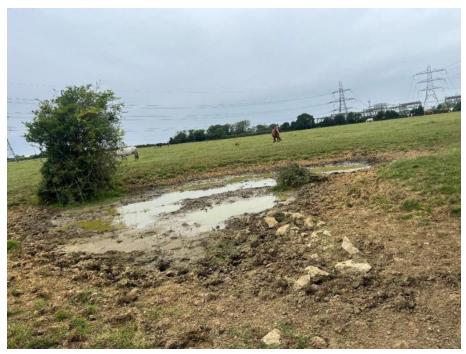
Plate 11 - Pond 8

- 3.4.1 The majority of Site 3 is made up of arable land in the south and pasture fields in the north, bordered by hedgerows along with small areas of scrub and woodland. See **Figure 2** for the location of Watercourses and Pond IDs at Site 3.
- 3.4.2 Site 3 only consists of three waterbodies. Note that Pond ID 80 could not be accessed due to barbed wire fencing. Pond ID 76 lies along the southern boundary and was shallow with silt and clay substrate with long linear-leaved and free-floating broad-leaved vegetation was present.
- 3.4.3 Pond ID 8, located along the south-east extended RLB, was a small, possibly ephemeral, stagnant pool heavily poached by horses.

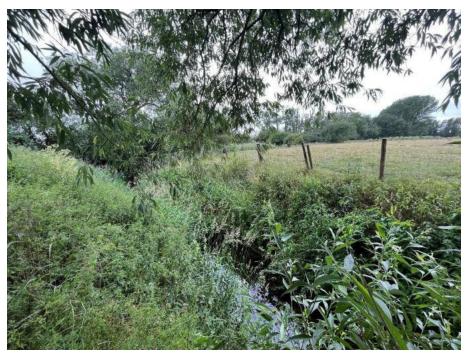
Plate 12 - Watercourse ID 48, northern end

- 3.4.1. Watercourse ID 48 lies along the northern and north eastern border of Site 3. It consists of a dry ephemeral ditch at the southern end and becomes a stagnant wet ditch with 5 cm depth and a silt / clay substrate at the northern end. The channel was choked with terrestrial and aquatic vegetation, and both banks had poor access due to the dense woodland scrub and steep bank.

- 3.4.2. Opposite the tributary (trib 26500), the channel is 1.5 3 m wide, with no perceptible flow, and a substrate of clay, silt, and some gravel / pebble. The area around the bridge was accessible, but elsewhere the channel was heavily vegetated and inaccessible with c. 2 m high, vertical banks. The northernmost upper branch was flowing and comprised of a glide and riffle with gravel substrate and no in-channel vegetation. Both banks are steep and over 3 m high. The northwest branch of the watercourse had steep banks and was wetted but choked with vegetation leading to a lack of perceptible flow. Several ditches branch off this channel and were dry.
