# Bramford to Twinstead Reinforcement

Document 8.3.11: Ecological Survey of the Temporary Access Route  
off the A131

Final Issue A  
September 2023

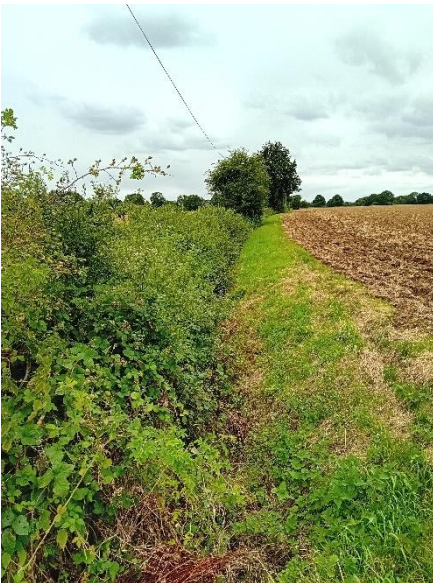
- H-H-30 and H-G-67 were low and narrow roadside hedgerows with a dry ditch present along both sides. The woody component of both hedges is fairly diverse with the following species recorded along their length: dog-rose (O), oak sp. (R), dogwood (O), willow sp. (R), hazel (O) and field maple (O). A comparatively species-rich ground flora was also present for both hedgerows comprising herbs such as hedgerow cranesbill (R), hedge bedstraw (R), knapweed (O), yarrow (O) and meadow vetchling (R).

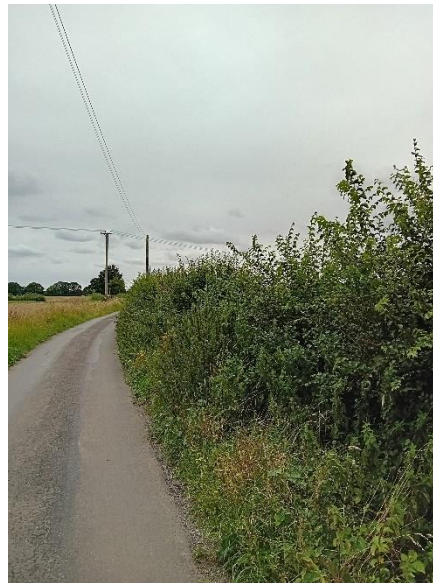
- H-H-31 was a roadside hedge with a dry ditch presence along its northern aspect. The woody component of the hedgerow was relatively species-rich comprising field maple (O), elm (R), elder (R), dog-rose (R), hazel (O) and holly (R). However, a tussocky ground flora was present indicative of nutrient enrichment with abundant false oat-grass, bramble and nettle.

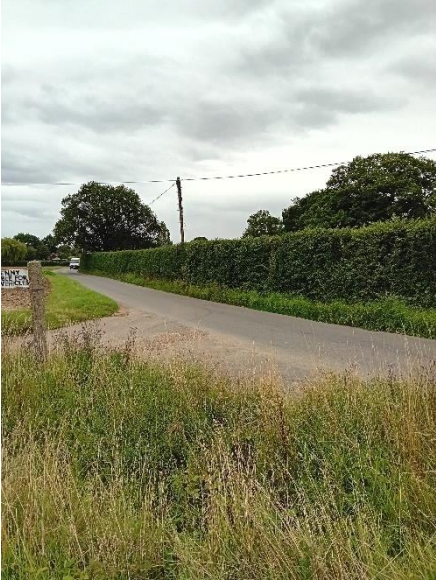
- H-H-32 and H-H-33 are adjacent roadside hedgerows separated by an existing gap. H-H-32 partly delineated a residential property and was well-managed hedgerow with outgrowth regularly trimmed and dimensions of approximately 4m tall and 2m wide. The ground flora could not be assessed in detail due to the presence of a busy road but several discernible species made up the woody component: field maple (O), elm (R), elder (R), hawthorn (F) and oak sp (O). H-H-33 was a less intensively managed hedgerow with tree species field maple (R), blackthorn (F), oak sp. (O), hazel (R), dog-rose (R), ash (O) and willow sp (R).

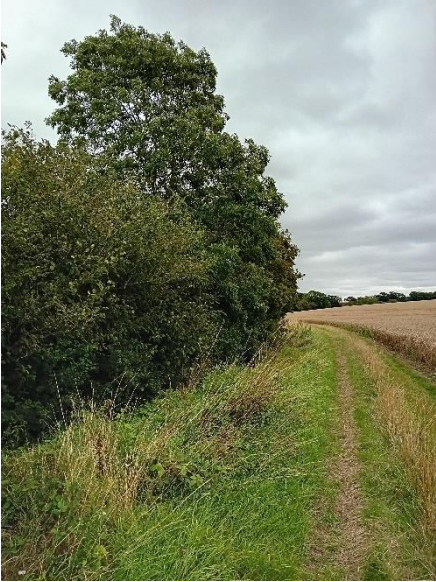
- H-H-34 was a field hedgerow situated on the border between two arable fields with an existing gap present where the proposed access route intersects. A partially wet ditch was also present along its entire south-eastern aspect (identified as W-H-20 in the otter and water vole survey in ES Appendix 7.2: Species Baseline Report [APP-112], and confirmed on site as having a low suitability for otter and water vole). The vegetation present within the gap comprised bramble scrub, false oat-grass (A), willowherb sp. (F), nettle (A) and common reed (R) where it was associated with the partially wet ditch. The woody component of H-H-34 was relatively species-rich comprising hazel (O), field maple (F), ash (O), blackthorn (F), elm sp. (R), and hawthorn (A).

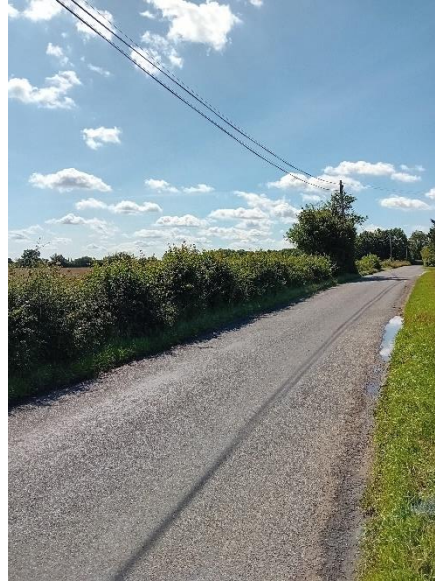
- H-H-35 was a roadside hedgerow. The woody component of the hedgerow comprised field maple (O), elm sp. (R), hawthorn (A), rosa sp. (R), oak (O), ash (R) and blackthorn (O). A relatively herb-rich ground flora was also present comprising knapweed (F), ragwort (R), field scabious (O), yarrow (O) and meadow vetchling (R). A dry ditch was also present along the eastern aspect of the hedgerow measuring approximately 0.8m x 0.5m.

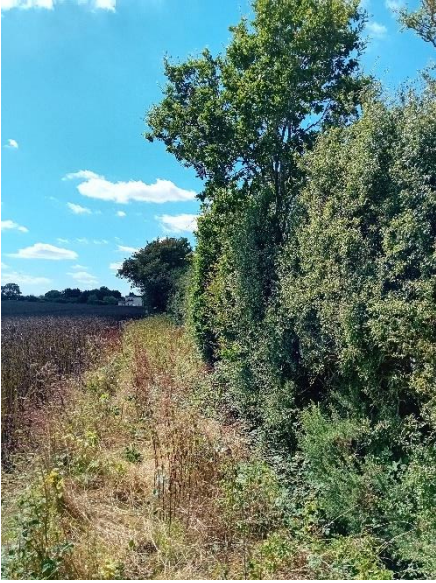
- H-H-36 was situated between an arable field and the A131 road. The woody component of the hedgerow comprised several immature and semi-mature trees with woody species recorded including blackthorn (F), oak sp.(F), gorse (LO), hawthorn

(A), field maple (O), elm sp. (R), dog-rose (R) and hazel (R). A partially wet ditch was present along its south-eastern aspect.

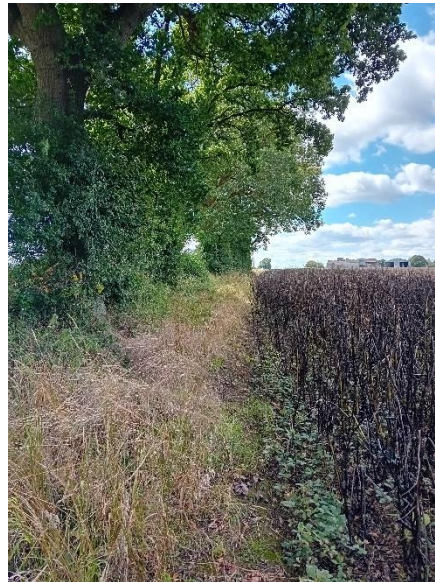
- LOT-H-12 was a line of six mature oak trees. Evidence indicative of breeding birds was also recorded associated with the line of trees with eggshells recorded at their base. A dry ditch ran along the south-western aspect of the tree line.
