**Application by National Grid Electricity Transmission (NGET) for an Order granting Development Consent for the Bramford to Twinstead Reinforcement (Case Reference: EN020002)**

**Examination Authority's note of Unaccompanied Site Inspection 5 undertaken on 10 October 2023 (USI5)**

Jason Rowlands and John McEvoy of the Examining Authority (ExA) undertook an Unaccompanied Site Inspection (USI5) on 10 October 2023 for the Examination of the application by National Grid Electricity Transmission for the proposed Bramford to Twinstead Reinforcement project. The inspection was undertaken on public roads in a single vehicle and on foot (where noted in Table 1).

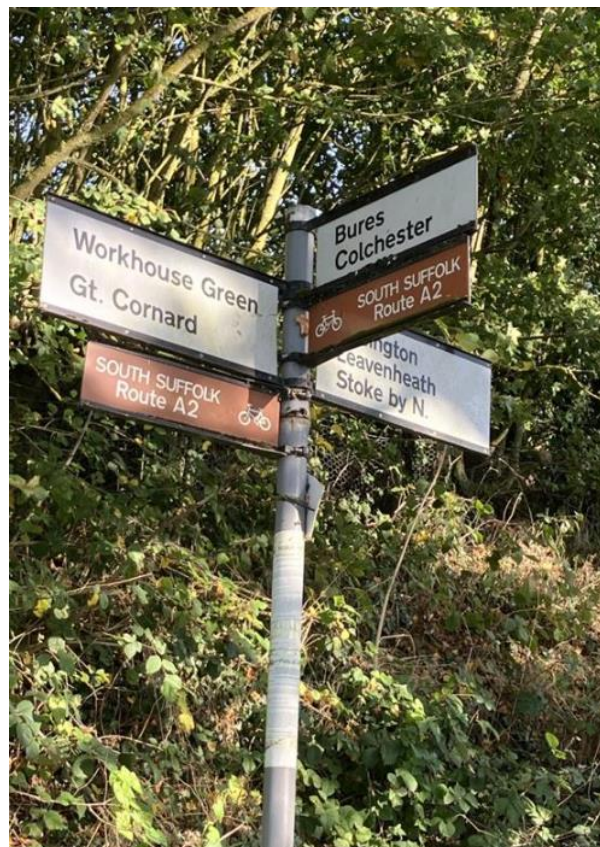
Site photo taken by the ExA

The ExA observed the road:

1. geometry, alignment, width;
2. prescribed traffic signs including a sign denoting 'Single track road'.

The ExA's measurement of the **width** of the carriageway:

- 4.3 metres at a point coincident with a road traffic sign.

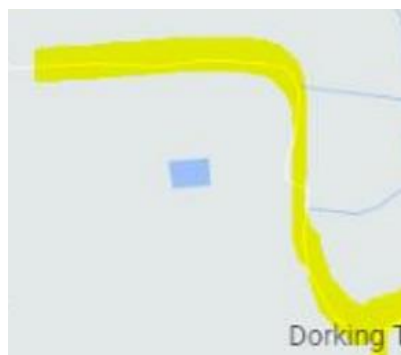
The ExA observed the road:

1. geometry, alignment;
2. width – single track road;
3. 'Quiet Lane' signage;
4. frontage of Yorley Farm Nursery School.

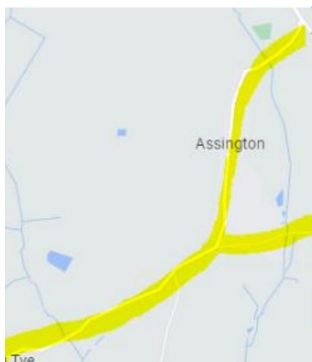
The ExA observed the road:

1. geometry, alignment;
2. width – The Street, single track road;
3. 20mph, The Street.

The ExA's measurement of the **width** of the carriageway:

- 3.9 metres at a point coincident with 30mph speed limit roundels, Bures Road.

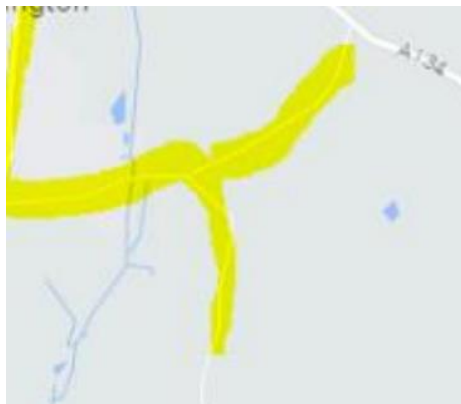
The ExA observed the road:

1. geometry, alignment;
2. width – single track roads;
3. 'Quiet Lane' signage, Marshalls Green.

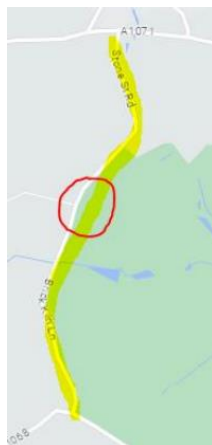
The ExA observed the road:

1. geometry, alignment;
2. width – single track road;
3. prescribed signage including a 7.5t weight limit advance notice sign.

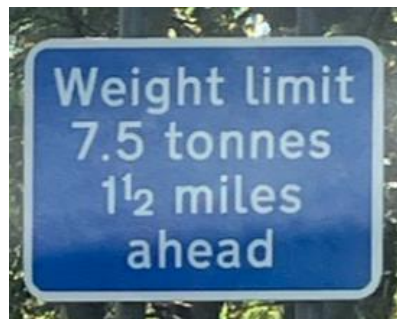
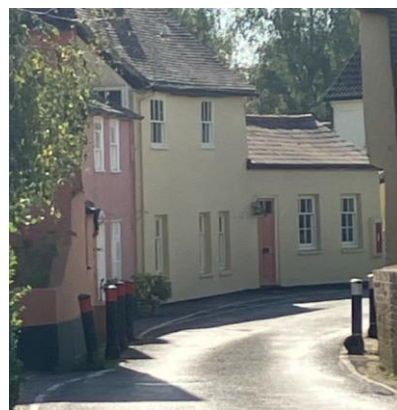
**Site photo taken by the ExA on Stone Street**

The ExA's measurement of the **width** of the carriageway:

- 3.05 metres at a point coincident with a road narrowing shown in the image above.

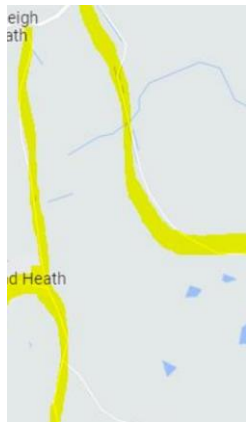
The ExA observed the road:

1. geometry, alignment;
2. width – single track on some sections;
3. vegetation.

The ExA's measurement of the **width** of the carriageway:

- 4.3 metres at a point coincident with a 30mph speed limit roundel.

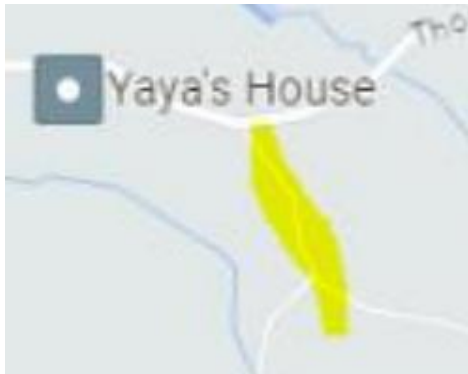
The ExA observed:

1. Two prescribed traffic signs positioned at the entrance off the A1071 to Pigeons Lane, stating '*Unsuitable for heavy goods vehicles*';
2. Single track road.

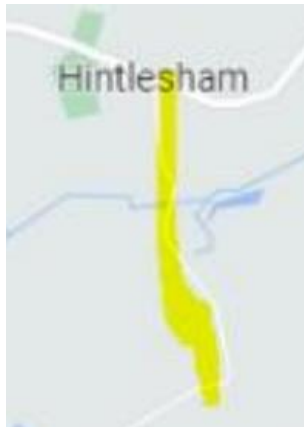
The ExA observed:

1. Prescribed traffic sign positioned at the entrance off the A1071 to Chattisham Lane stating '*Unsuitable for heavy goods vehicles*';
2. Single track road;
3. Sharp bends.

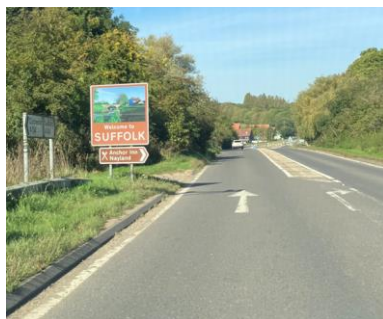
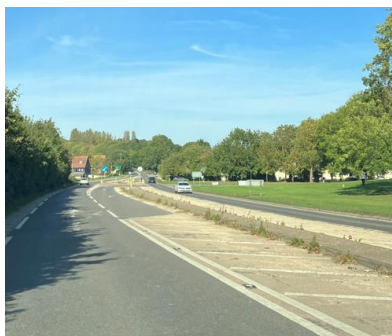
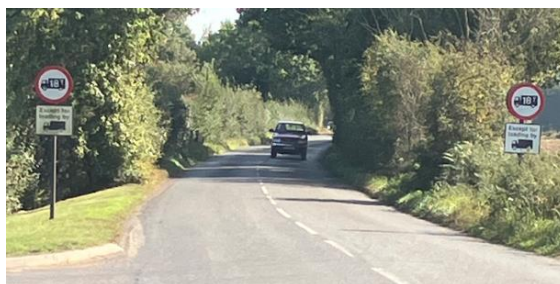
**Site photos taken by the ExA**

The ExA observed:

1. geometry, alignment, width;
2. junctions;
3. prescribed signs and markings;
4. 18t weight limit – B1068.

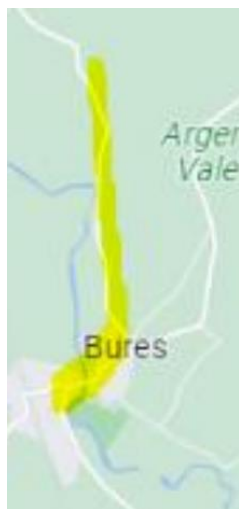
Extract from Figure A2 in PDA-007 shown below:

The ExA observed:

1. Prescribed traffic signs giving indication of the following hazards:
  - a. Bend ahead;
  - b. Road narrows on both sides ahead;
  - c. Junction on the outside of a bend;
  - d. Series of bends ahead (for 1 mile);
  - e. Pedestrians in the road;
2. Roadside mirrors;
3. Faded centre line markings;
4. 'Slow' markings;
5. On street parking restricting two-way traffic movement;
6. Junctions.

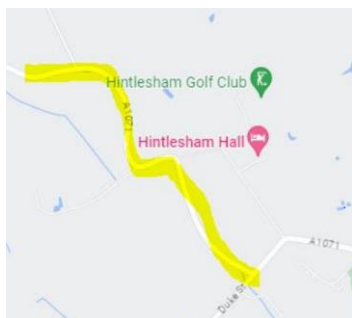
The ExA observed:

1. geometry, alignment, width;
2. traffic navigating the bend;
3. traffic navigating Dukes Street junction;
4. prescribed signs and markings.

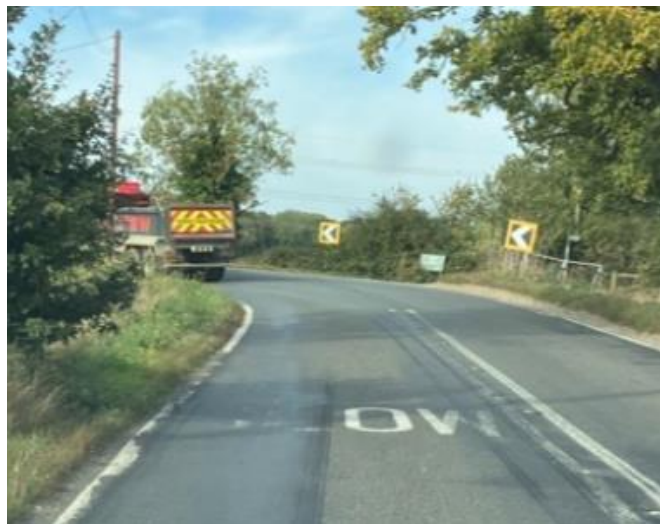
**Photo taken by the ExA of the road bend on the A1071 Back Road**

The ExA observed:

1. Geometry, alignment, width;
2. Prescribed signs and markings.

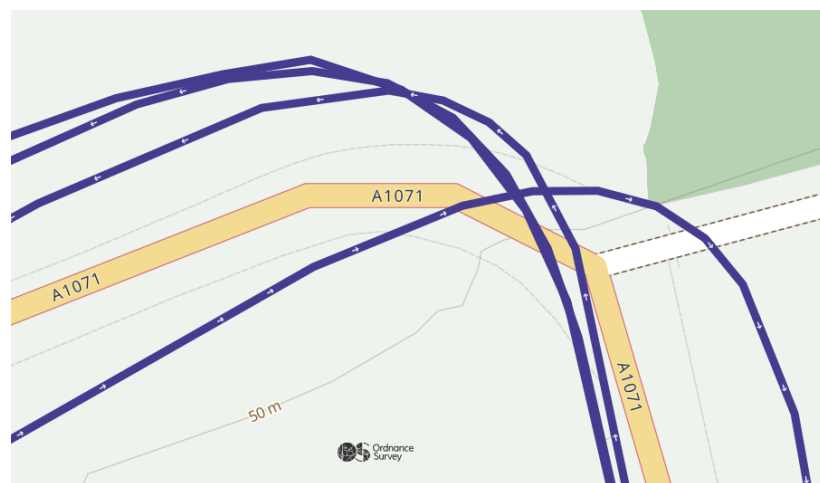
**Route driven by the ExA on the A1071 Back Road**

The ExA travelled the road bend on four occasions.

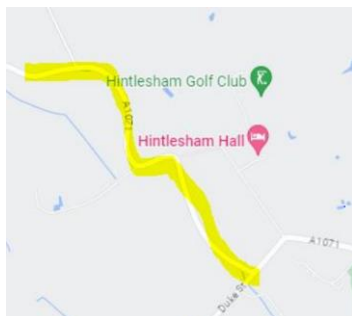
The ExA travelled the road bend on four occasions.

The ExA observed:

1. Geometry, alignment, width;
2. Prescribed signs and markings.

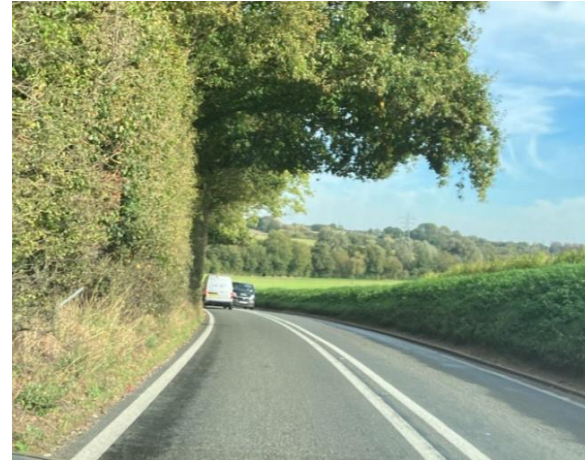
Photo taken by the ExA of the road geometry on the A1071 Thorpe's Hill

The ExA observed:

1. geometry, alignment, width;
2. junction with Pigeons Lane;
3. vegetation;
4. prescribed signs and markings.

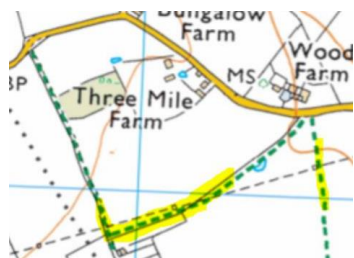
The ExA observed:

1. Public footpaths running beneath the high voltage transmission line;
2. Sub-standard layby area opposite the signpost indicating the roadside (Pond Hall Road) entry point to the footpaths;
3. Restricted visibility for pedestrians attempting to cross Pond Hall Road at this point.

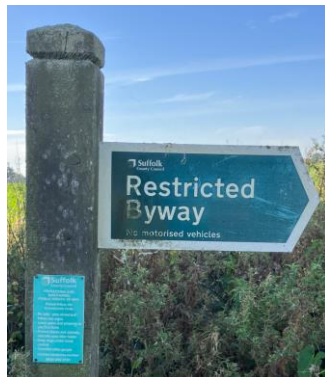
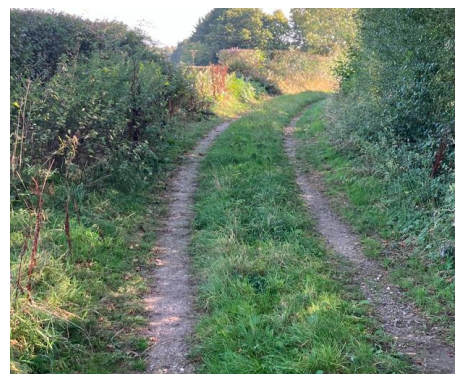
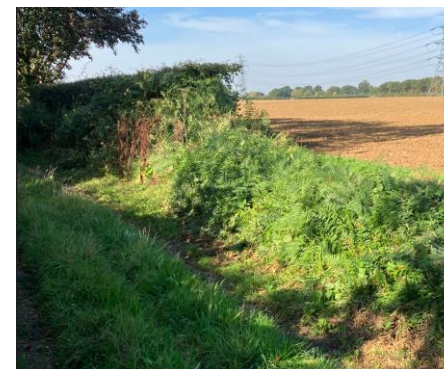
**Site photos taken by the ExA**

The ExA observed:

- vehicle tracks along the restricted byway;
- nearby high voltage transmission lines;
- vegetation/ hedgerow.

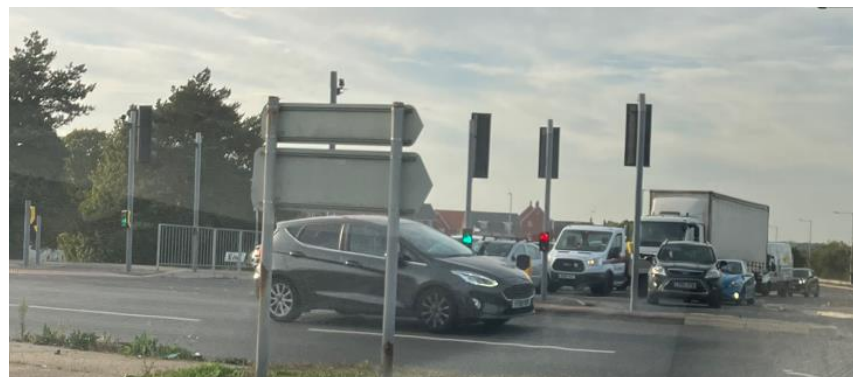
Photo taken by ExA on the A1214 London Road at 16:12:13

The ExA:

- drove through the signalised junction on two occasions;
- on the first occasion, joined the A1214 London Road northbound from the A1071;
- on the second occasion travel the return route onto the A1071 at 16:12PM;
- did not encounter any significant delays travelling through the signal junction.

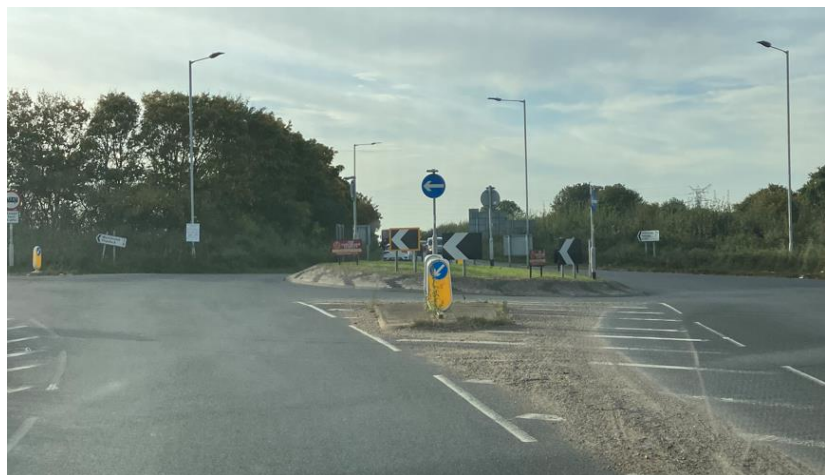
**Photo taken by ExA on the A1071 the approach to the roundabout at 16:14 PM**

The ExA:

1. drove through the junction on four occasions;
2. on the fourth occasion (16:14 PM) remained on the A1071 Hadleigh Road travelling east-west;
3. did not encounter a delay on the approach or while negotiating the junction on any of the four occasions.

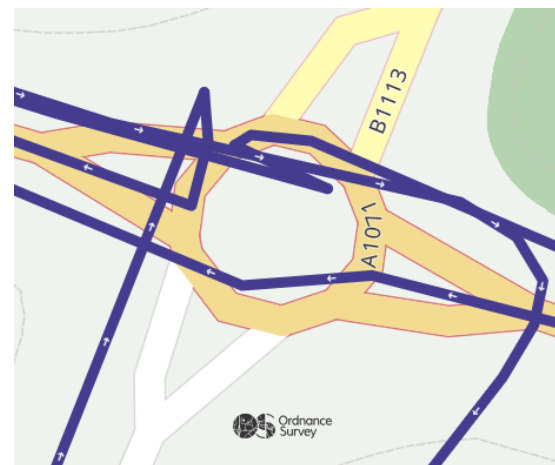
**Routes driven by the ExA through the roundabout junction**

- observed a prescribed traffic sign positioned on the A1071 approach to the priority junction: *‘Queues likely’*;
- joined a traffic queue on the A1071, extending from the priority junction, at 16:34 PM;
- exited the A1071 to join the A134 at 16:46 PM (a delay of 13 minutes);
- at the junction, observed a non-signalised marked priority junction with motorists on the A1071 relying on suitable gaps in traffic to join the A134.

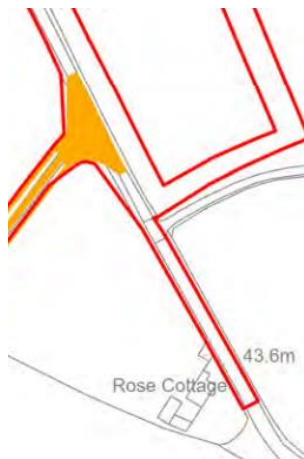
- observed the alignment of Church Hill at the site of a proposed temporary bell mouth entrance, shown on Sheet 02 of the General Arrangement Plans [APP-18] and the entrance to Rose Cottage.
- An extract from Sheet 02 is shown:

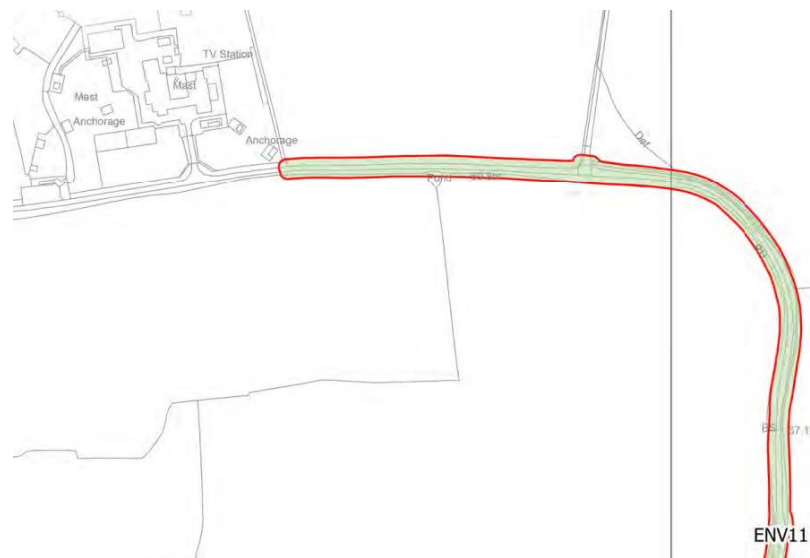
**An extract from Sheet 19 is shown below:**

- 1. the highway verges of Upper Road (shown as an environmental mitigation (ENV11) on Sheet 19 of the General Arrangement Plans [APP-18]);
- 2. frontage of Yorley Farm Nursery School.

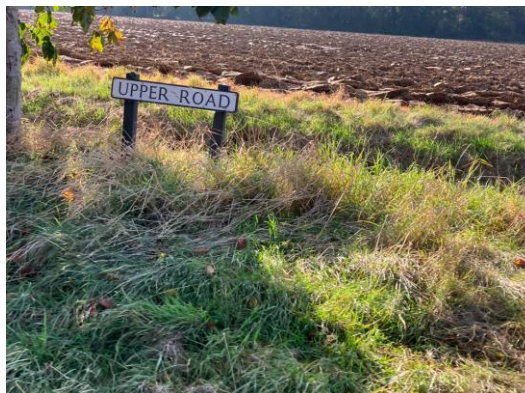
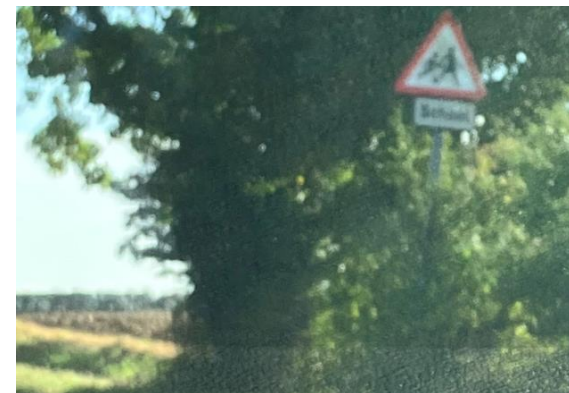
**Site photo images taken by the ExA**

The ExA observed:
