# Otter and Water Vole Report

National Grid (North Wales Connection Project)

### **Document 5.9.2.8 Otter and Water Vole Report**

Final September 2018

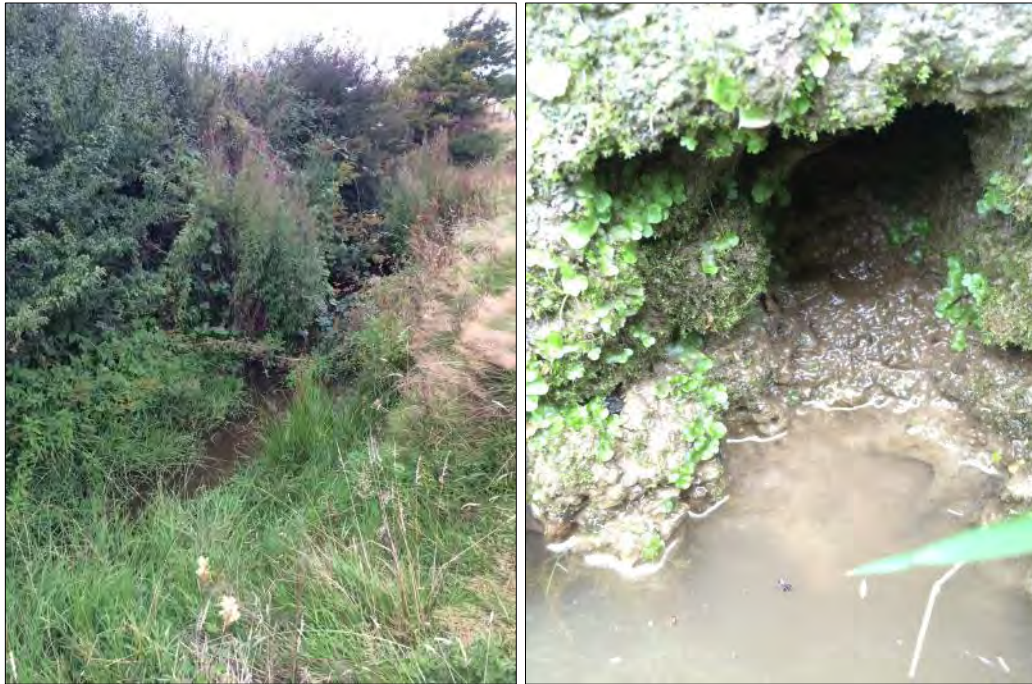
Plate 1 A & B: 4010-W028 Water Vole Presence Confirmed

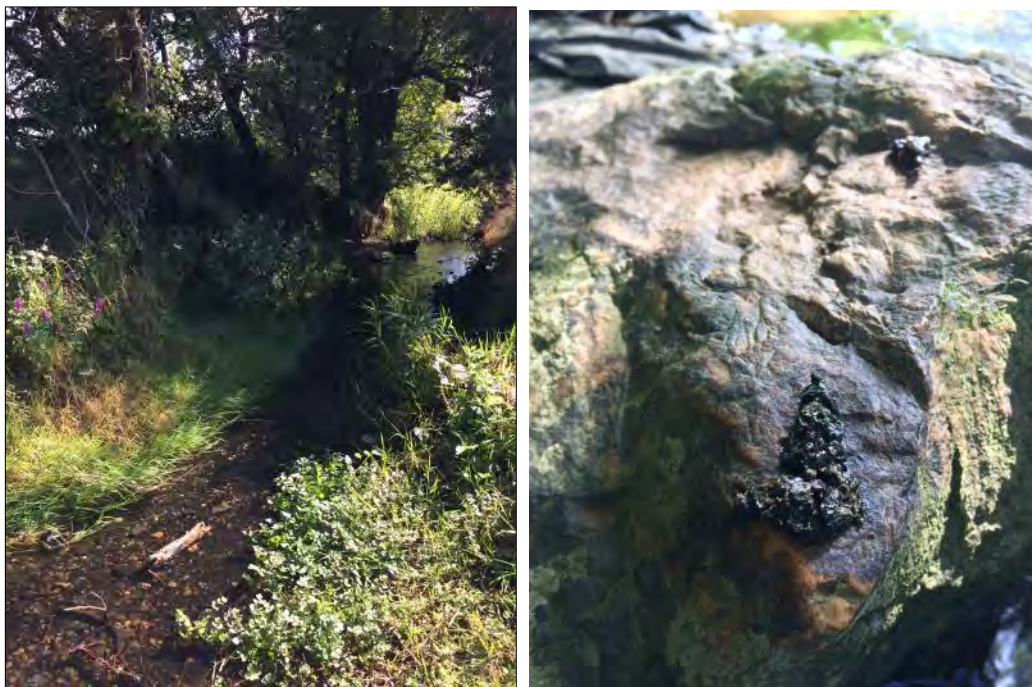
Plate 2 A & B: 2039-W005 Otter Presence Confirmed

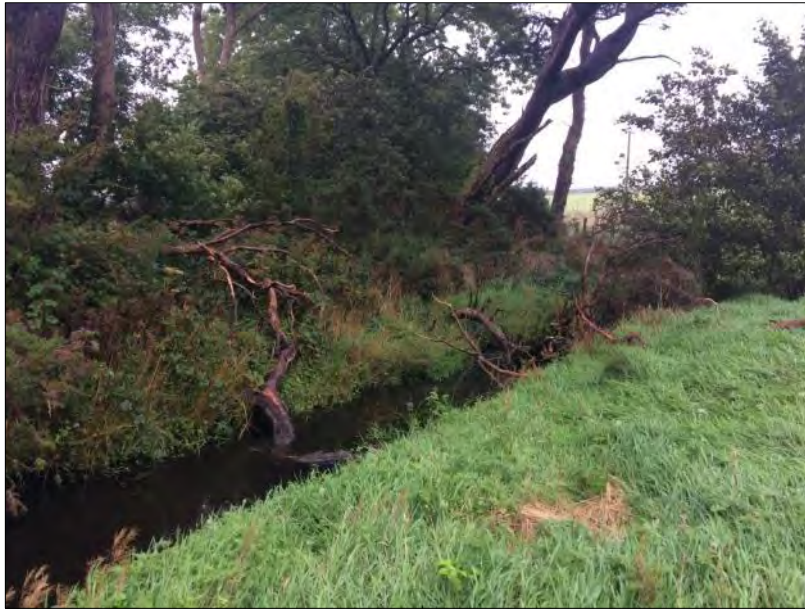
Plate 3: 4074-D148 Water Vole and Otter Potentially Present

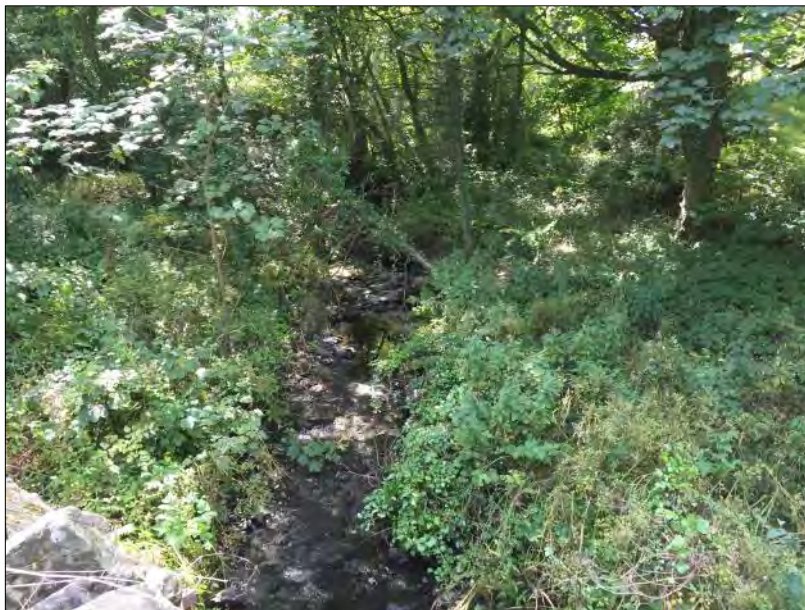
Plate 4: 1744-W041/B2 Otter Potentially Present
