AQUIND INTERCONNECTOR

Environmental Statement – Volume 3 – Appendix 16.3 Arboriculture Report

Document Ref: 6.3.16.3

DATE: 14 NOVEMBER 2019

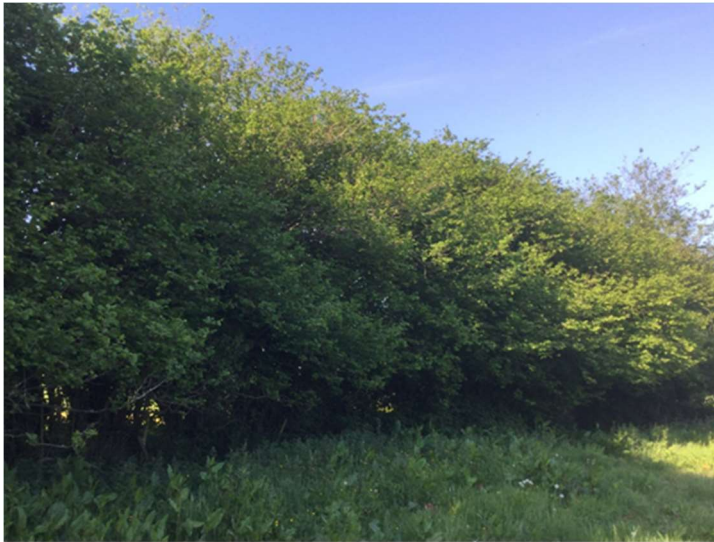
- 1.7.2.4. A total of 27 high value features were identified in the Study Area of Section 1. A proportionally high number of high value features are located within section 1. Located around the existing National Grid owned Lovedean Substation is Ancient Woodland and associated groups (W630, W667, W669, W690, W714, W887). Further to the west was a woodland group (G689) which exhibited similar characteristics to the designated ancient woodland. A significant ash tree (T532) with veteran features was located within G689.
- 1.7.2.5. Large mature trees were identified in groups and hedges as boundary features, such as G639 and G662.
- 1.7.2.6. H769 was a hedge of hazel coppice was assessed to be in excellent condition. The large size of the stools (or stumps) suggested these were old trees.

Plate 4 - H769 A high value hedge of hazel coppice

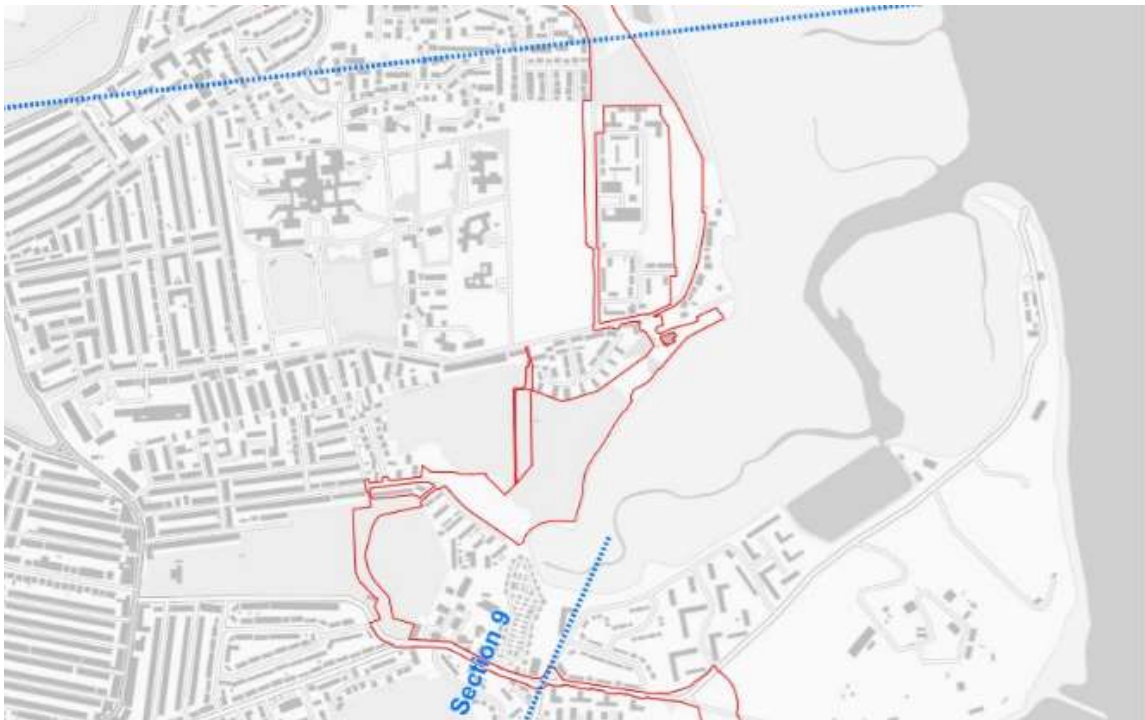
Plate 17 - Boundary of Section 9 Study Area (Section Limit - Blue Line)

- 1.7.10.1. Section 9 extends south From Moorings Way, Southsea through the University of Portsmouth campus at Langstone Sports Site, with flexibility to route through Furze Lane to the east of the campus through the sports pitches. From here, the proposal is for the Onshore Cable to run under the allotments (without trenching) via HDD, with flexibility at Kingsley Road or Yeo Court. South from here, the route crosses Milton Locks Nature Reserve and Bransbury Park to meet Bransbury Road, Southsea at the section's southern limit.

- 1.7.10.10. Poplar trees along Furze Lane are protected by a TPO. The majority of these features are in good to fair condition and a minimum RPA radius of 7.2 m, with one (T2034) in poor condition. Impacts are expected due to the cable passing near or through multiple RPA's. Final details of route alignment would be agreed on site under the supervision of the Environmental Clerk of Works.

- 1.7.10.13. In general, high and medium value features must be avoided where practicable. Design must seek to avoid positioning cables in conflict with RPAs of existing trees. Where significant incursion is unavoidable, trees must be replaced.

- 1.7.10.14. Through initial discussions with PCC, should the Proposed Development result in the loss of TPO features along Furze Lane, these features would be replaced with evenly spaced planting with a fastigate tree species in agreement with PCC. Opportunities would also be explored to remove trees in poor condition and, where appropriate, replace with other species in agreement with PCC.

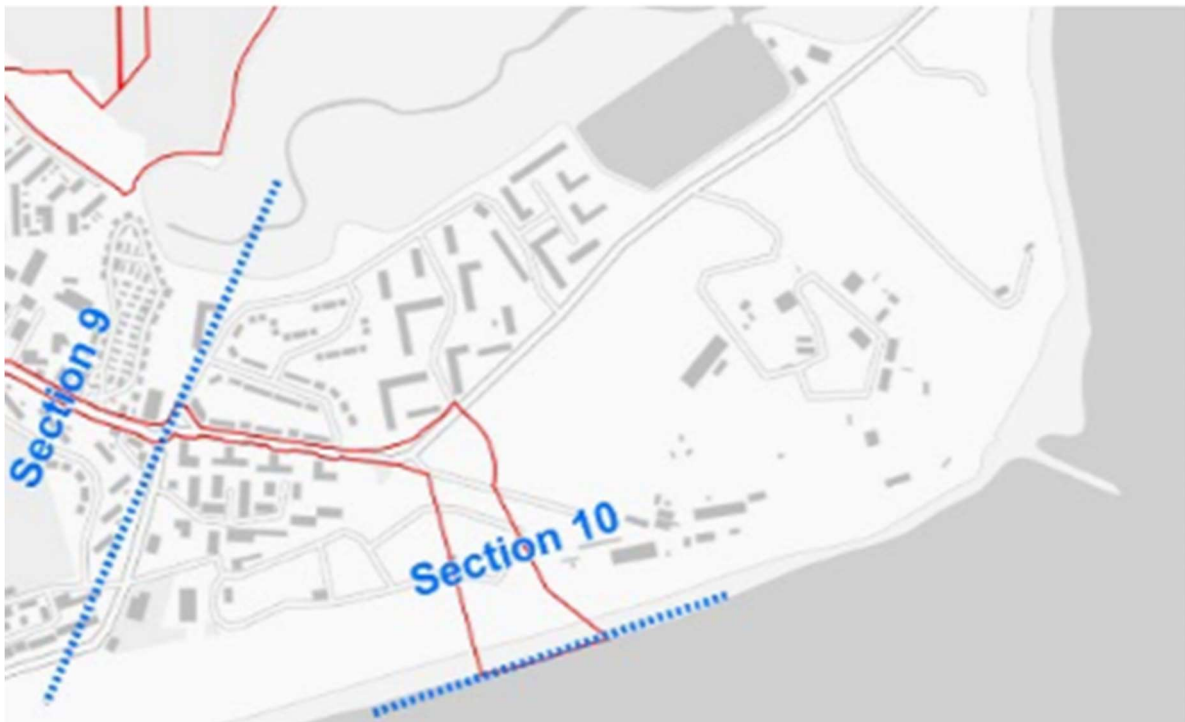
Plate 18 - Boundary of Section 10 Study Area (Section Limit – Blue Line)

- 1.7.11.1. Section 10 is the southernmost section that meets the coast at Eastney Beach. The north of this section is located at Henderson Road, Eastney. The south meets the beach at Eastney Beach on Fort Cumberland Road.
- 1.7.11.2. There are limited trees in this section, most likely due to coastal winds and salt spray. However, some early mature trees are located just inland on Henderson Road and Fort Cumberland Road on the periphery of the Order Limits and in private gardens within the section.

1.7.11.10. One semi-mature ash tree in fair condition (T6) would be retained. It must be noted however that Ash Dieback disease is in the area, and as such, this tree may be lost through natural processes associated with the Proposed Development.

1.7.11.13. Design must where practical avoid positioning cables in conflict with RPA's of existing trees. Where significant incursion is unavoidable, trees must be replaced. The northern (East bound) side of Henderson Road and Fort Cumberland Road would be a preferred choice for arboriculture to avoid impact on existing street trees in this section.
