AQUIND INTERCONNECTOR

Environmental Statement – Volume 3 – Appendix 16.5 Aquatic Ecology Scoping Assessment

Document Ref: 6.3.16.5

DATE: 14 NOVEMBER 2019

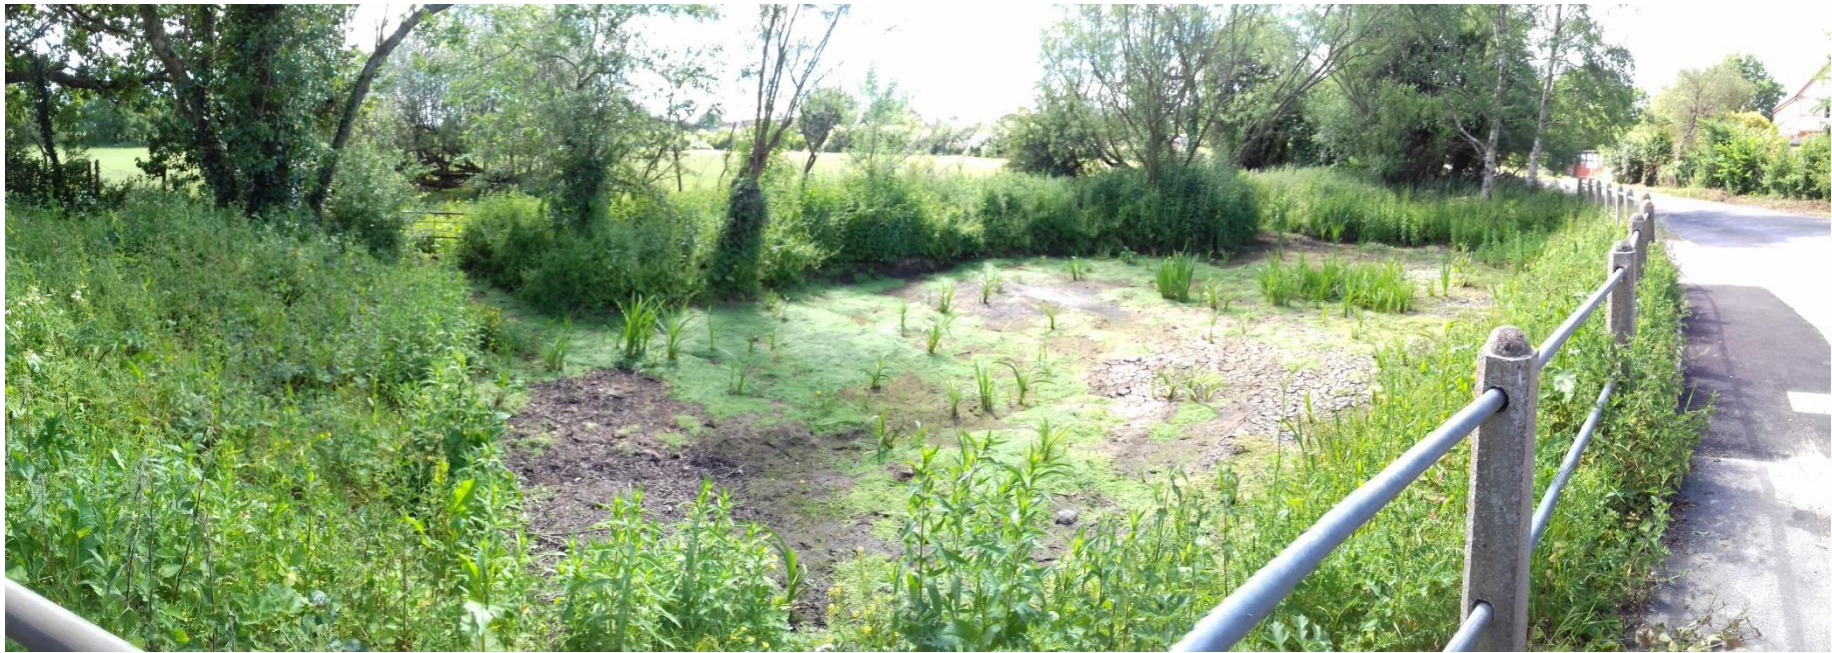
Plate 2– Section 1, Kings Pond.

3.2.1.1. At the time of the aquatic ecology assessment, Kings Pond was very dry with a deeply cracked bed. Some areas were observed in the middle of the pond where the ground still appeared to be wet, however, no standing water was visible (Plate 2).

3.2.1.5. Anmore Road passes closely around Kings Pond to the North, with a concrete and metal post and rail fence separating the pond from the pedestrian paving. This provides some indication that this is a long-established pond, due to built infrastructure being constructed around it and that on the day of the assessment it may not have represented its predominant ecological character (Plate 2).

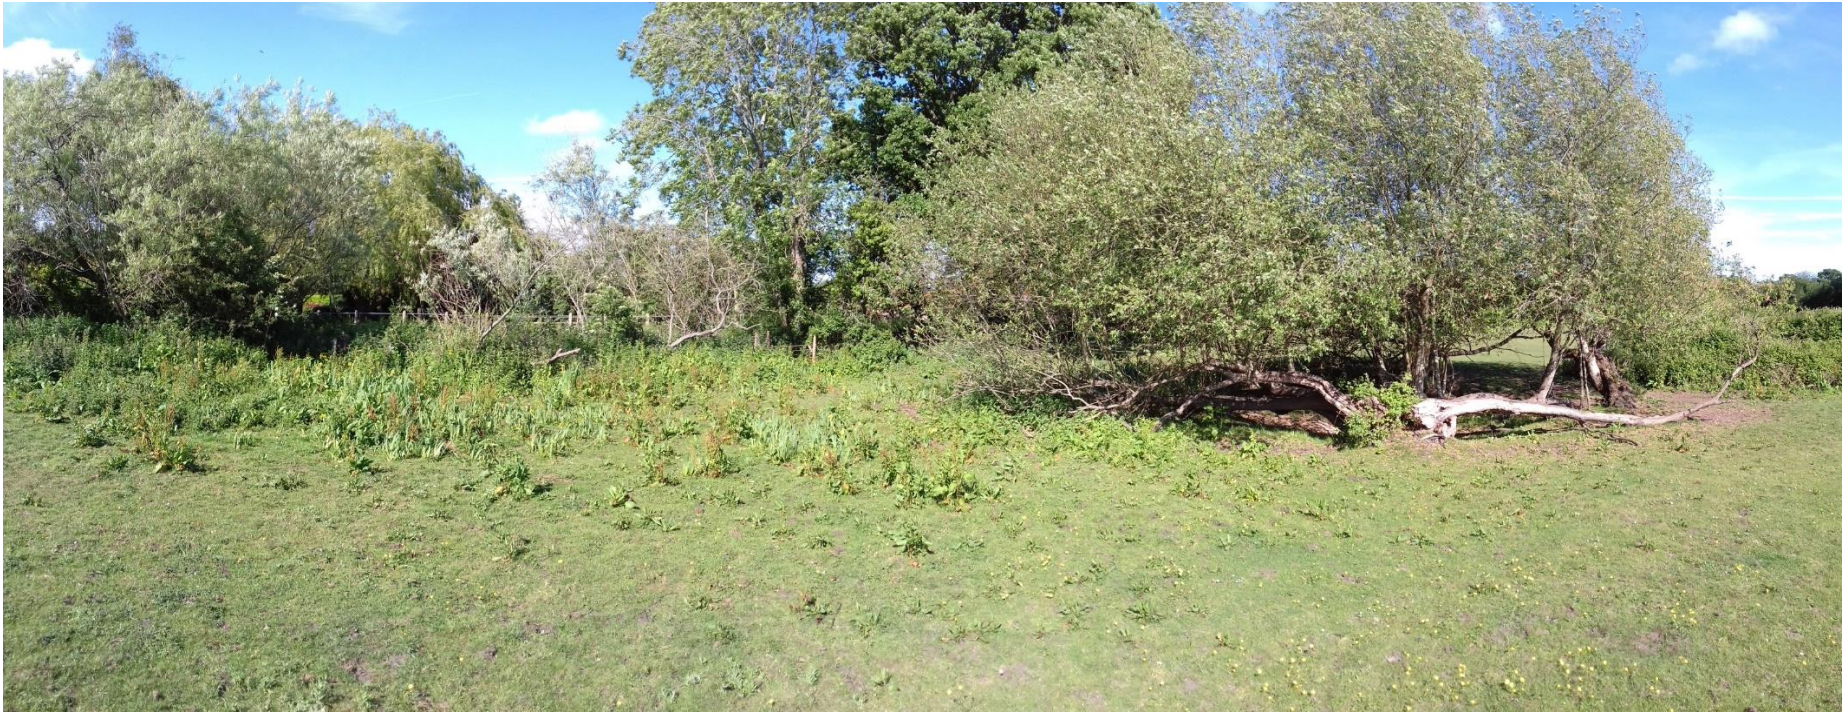
Plate 3 – Section 1, Kings Pond southern bankside depression.

3.2.1.4. To the south of the pond was a ground depression before leading into the confines of the start of the linear surface water network. This depression appeared to be the area in which the pond overtopped during periods of greater inundation. This area was dominated by yellow iris, dock *Rumex* sp. and grasses (Plate 3).

The depression, south of Kings pond where the pond overtops during periods of greater inundation (Plate 3), as described in section 3.2 above, adjoined the top end of this section.

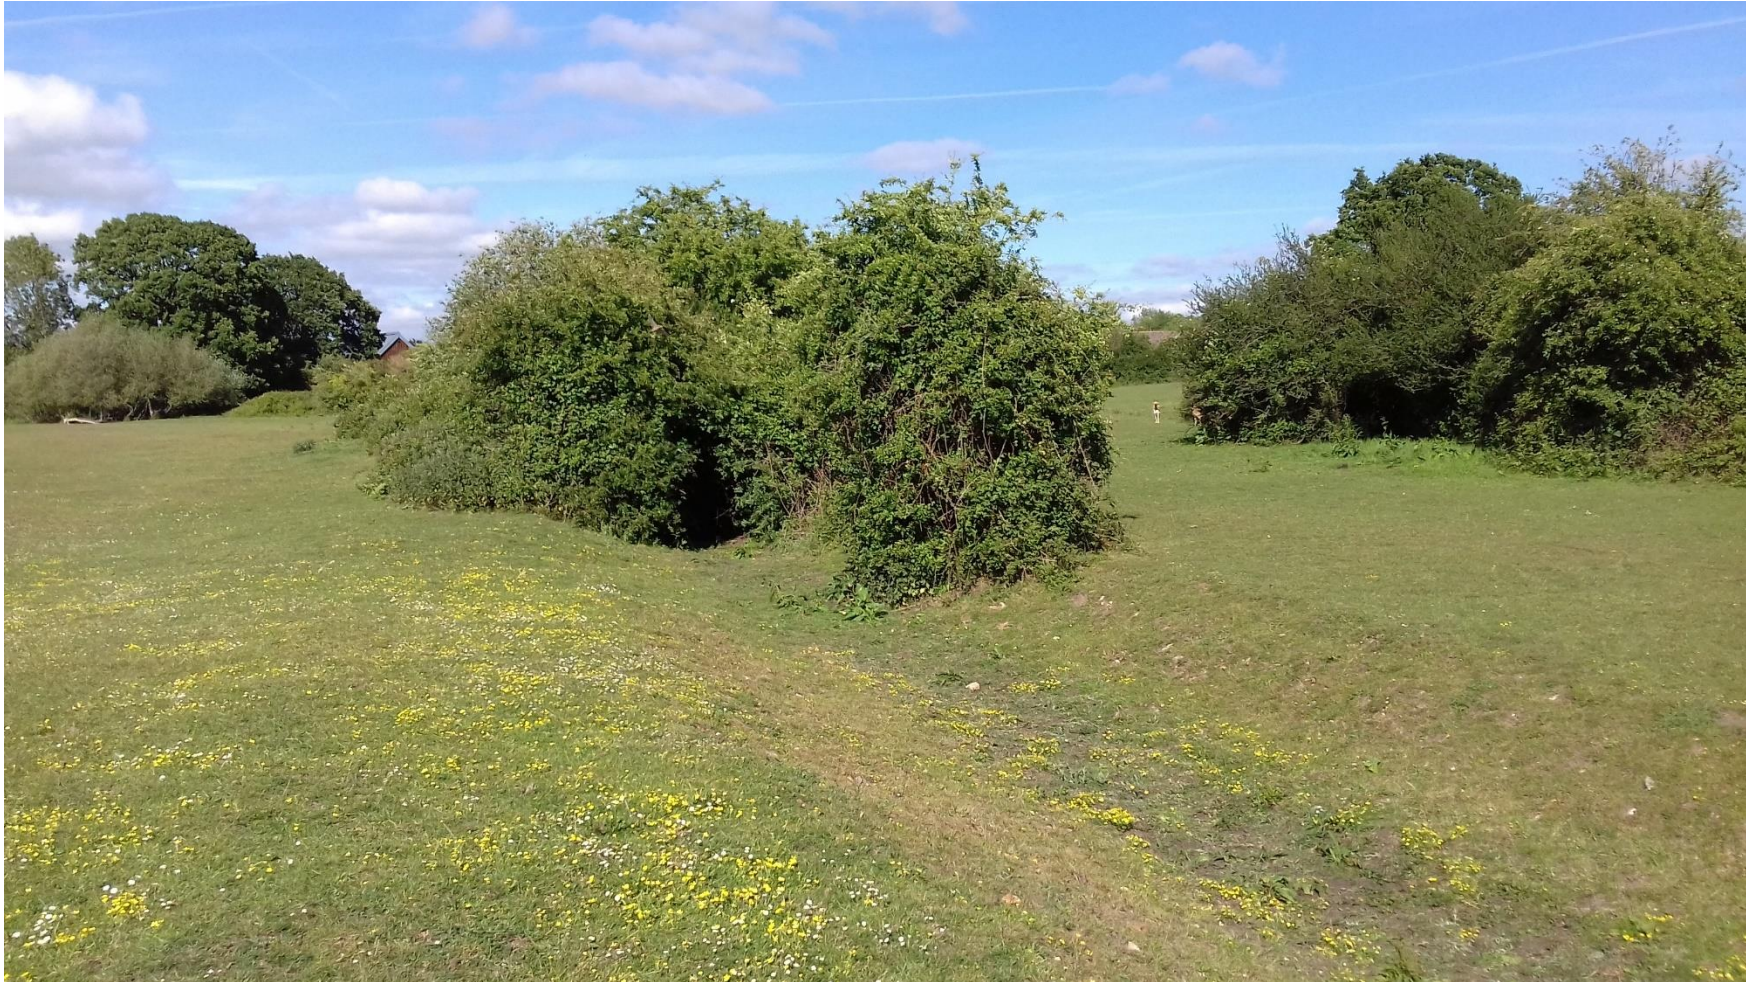
Plate 4 - Section 2, northern reach

The northern end of this section, past the confluence depicted in Plate 4 below Kings Pond, took the form of a ground depression. The in-channel vegetation was characteristic of terrestrial vegetation, and that of the adjacent land assemblages (Plate 4). Much of it was very overgrown with bramble and there was a short section of culvert beneath this dense vegetation stand (Plate 5).

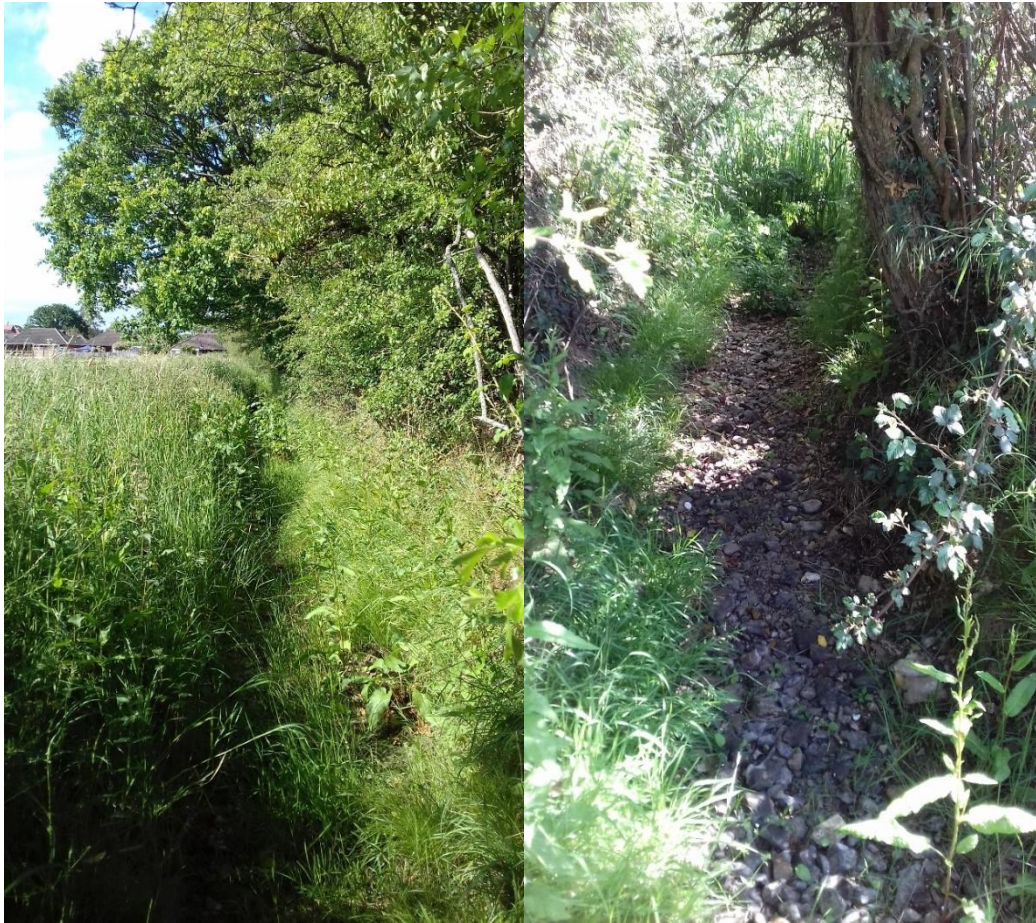
Plate 6 - Section 2, southern section Plate 7 Section 2, southern section

Further down this section, above the confluence with section 3, the channel was uniform and straight (Plate 6). It had primarily dry gravel substrate, with very few damp areas, save for that near a culverted field boundary crossing, where a clump of iris was observed (Plates 7 & 8).

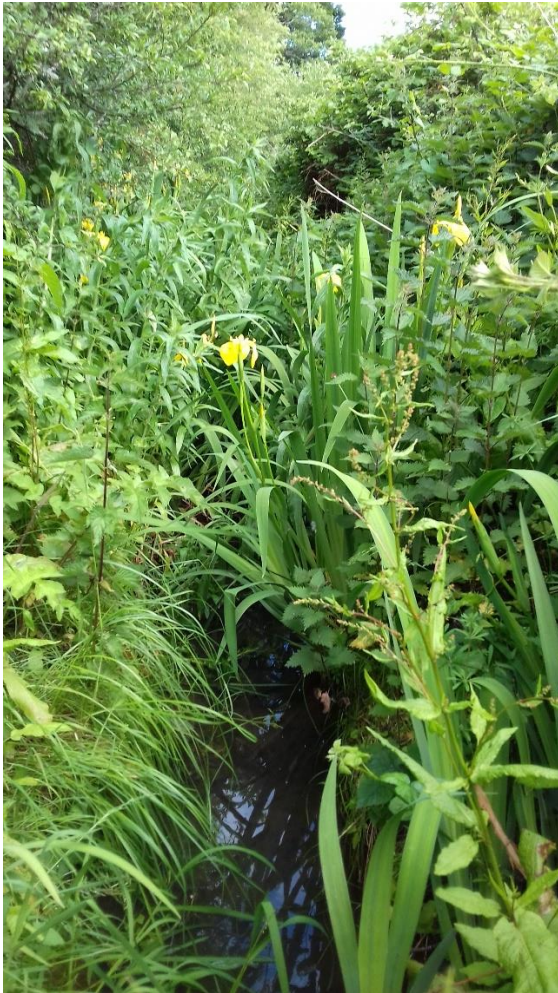
Plate 9 – Section 3, Lower

~Width (m)	~Depth (m)	Left bank Dominant Vegetation	Right bank Dominant Vegetation	In-Channel Vegetation
0.6	0.15	Bramble, nettle, wild dog rose, grasses	Blackthorn, hawthorn, wild dog rose	Rush, iris, sedge, water parsnip <i>Sium latifolium</i> , water plantain <i>Alisma plantago-aquaticae</i>
<p>Comments:</p> <p><i>This section was very straight and had a high depth to width ratio (Plates 10 & 11). It was very overgrown in places which made it difficult to view the entirety of the watercourse.</i></p> <p><i>The water clarity was good, and the substrate predominantly appeared to be silt over gravel (Plates 9 & 11).</i></p>

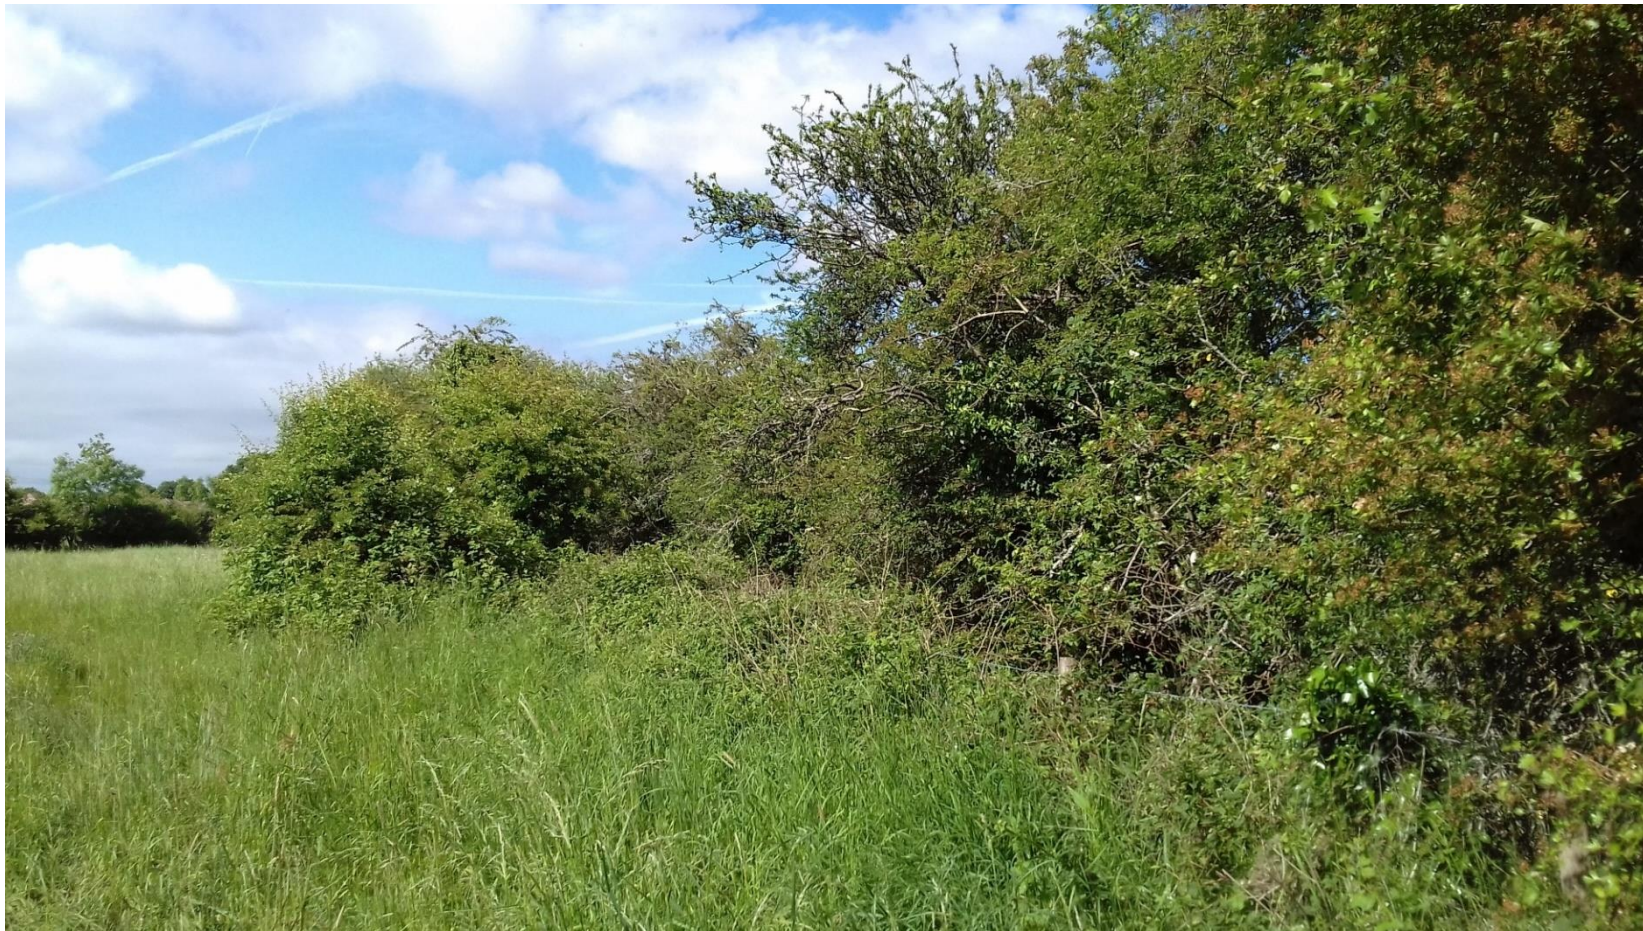
Plate 12 -- Section 4, overgrown channel.

Section 4 was very overgrown and over shaded (Plate 12). Due to the dense vegetation, much of this section was inaccessible to view the in-channel features. Predominant substrate appeared to be gravel and silt (Plate 13).

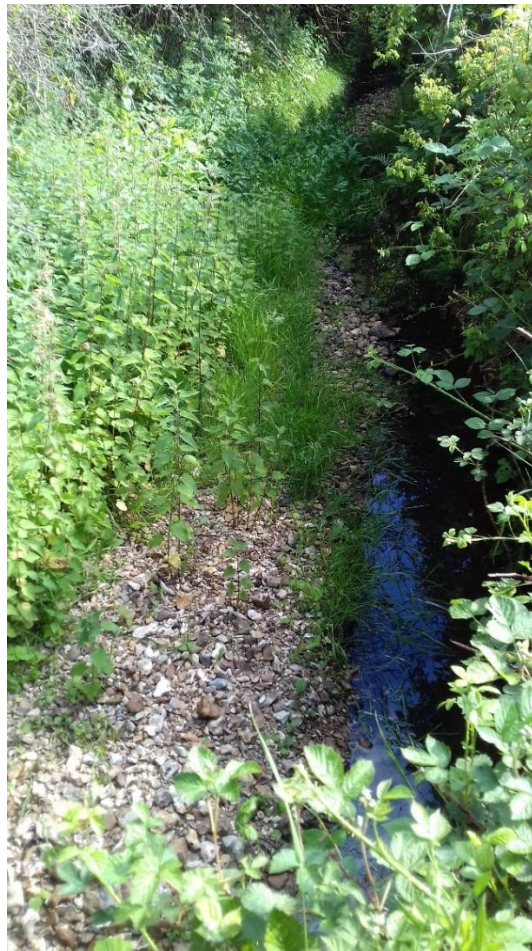
Plate 14 – Section 4, gravel bar

At the confluence between sections 3 and 4 was an exposed gravel point bar with extensive undercutting of the right bank, indicating that this channel experiences much higher flows than were visible on the day of the assessment (Plate 14). Further evidence of this was the culvert design which passed under Hambledon Road (B2150). This was constructed as a double culvert where the inline opening was set lower than the off-channel opening, apparently designed to improve conveyance under the road in high flow conditions (Plate 15).

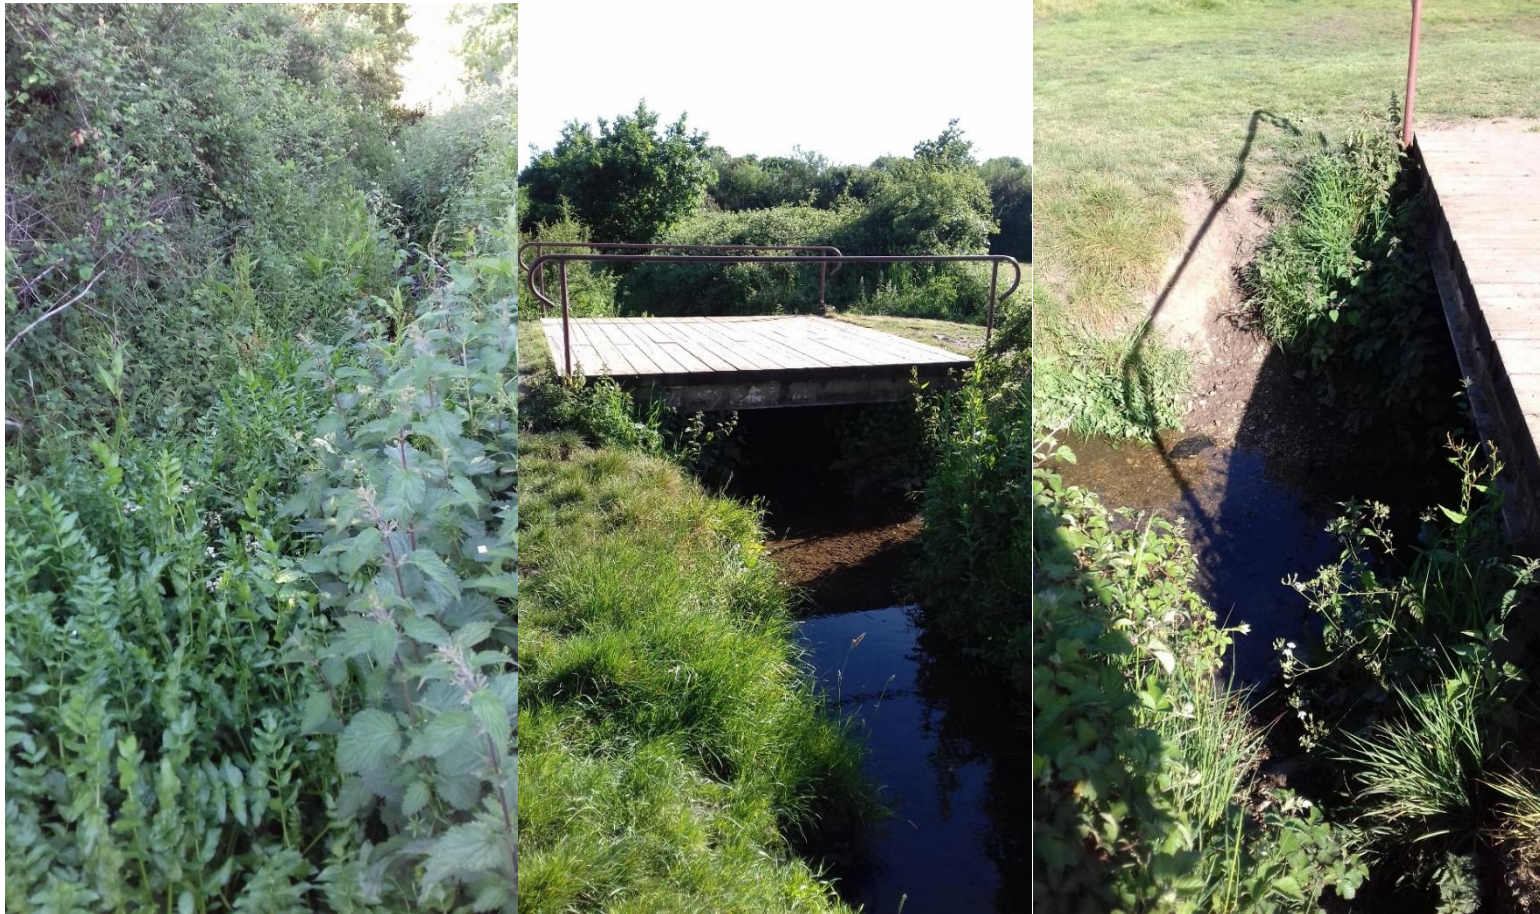
Plate 16 – Section 5, Overgrown Plate 17 – Section 5, Public crossing Plate 18 – Poaching

~Width (m)	~Depth (m)	Left bank Dominant Vegetation	Right bank Dominant Vegetation	In-Channel Vegetation
0.5	0.1	Grasses, oak saplings, gorse <i>Ulex europaeus</i>	Bramble, nettle, gorse, cow parsley, wild dog rose, rosebay willowherb, cleavers	Water parsnip, yellow iris
<p>Comments:</p> <p><i>The top of this section, leading from Hambledon Road, was very overgrown with bramble, making the channel inaccessible in places (Plate 16). The wider Survey Area was well used by dog walkers and there was evidence of this on the banks of the channel with significant poaching in areas (Plates 18 & 21). It was also clear that amenity vegetation management practises were undertaken on this Survey Area (Plate 20).</i></p> <p><i>There was a clear and obvious flow in this section as the watercourse began to widen and take on more riverine characteristics (Plates 17 & 19).</i></p> <p><i>Substrate was silt over gravel (Plate 19).</i></p>

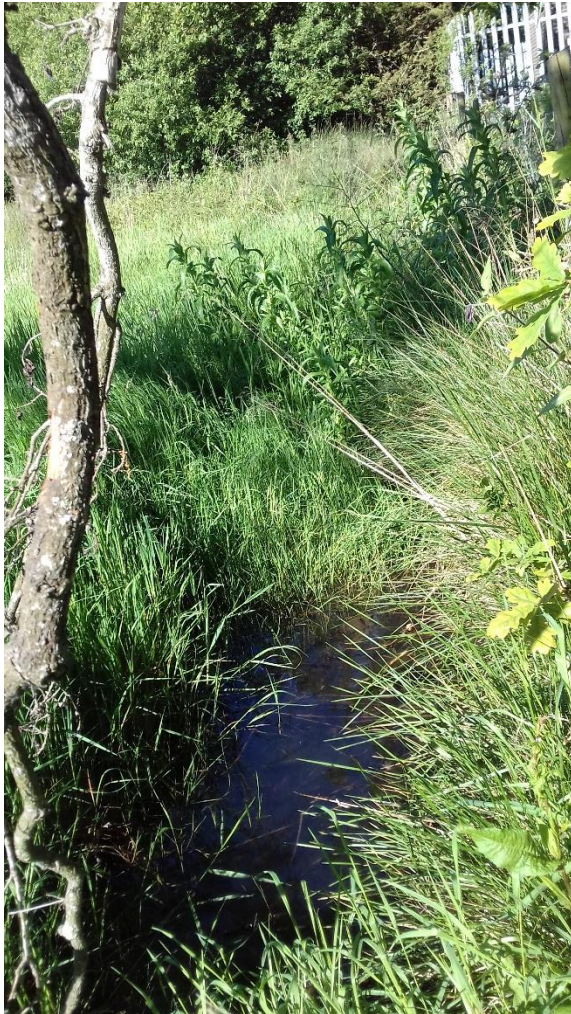
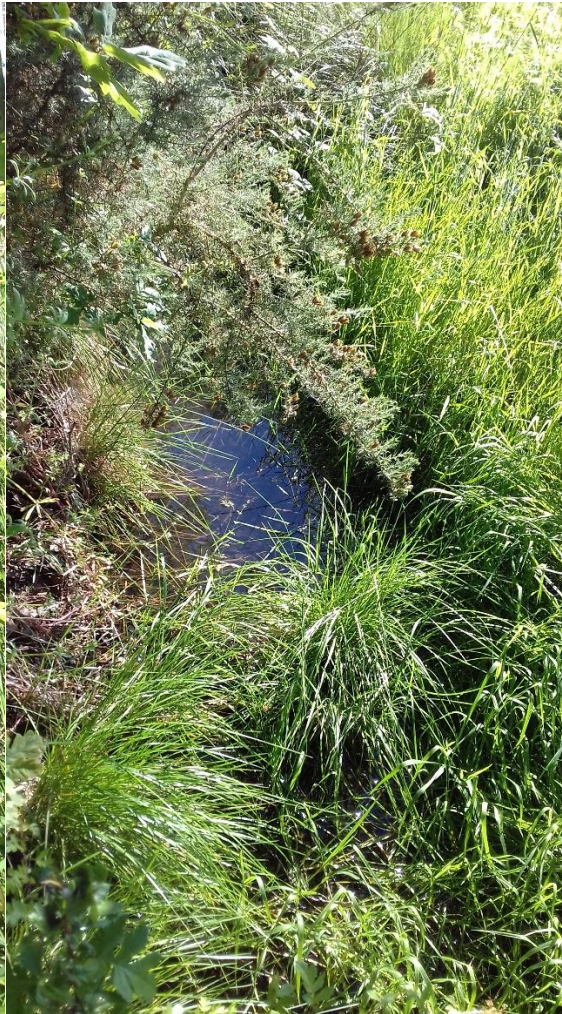
Section 6 emerged from Hambledon Road, moving south through the Survey Area. At the northern end, the water clarity was good (Plate 22 & 23) but the impacts of dog and human poaching appeared to have increased turbidity as the watercourse moved south (Plates 24 & 26).

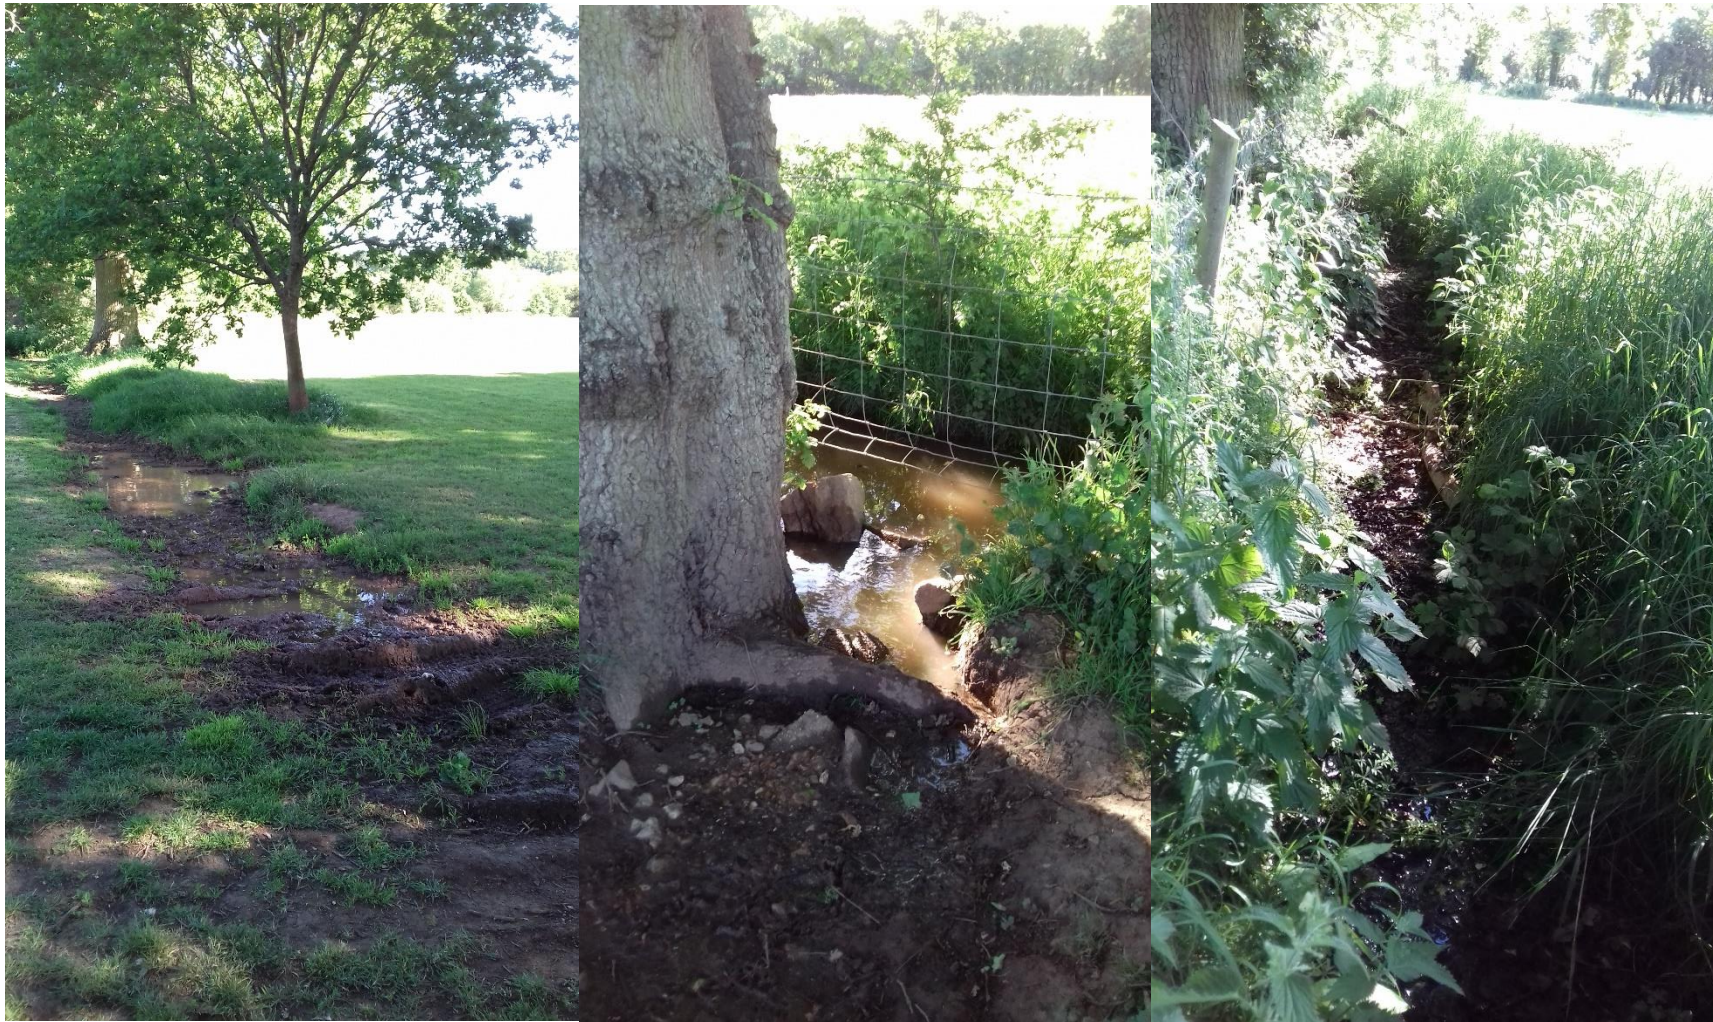
Plate 25 – Section 6, Overland flow

An overland flow joined this section about half way down, emanating from the direction of section 5 (Plate 25). There was also heavy poaching in the area where this drained into section 6 (Plate 26). Not far below this, the channel had dried up completely (Plate 27).
