# **AQUIND INTERCONNECTOR**

## **Environmental Statement – Volume 3 – Appendix 20.2 Onshore Water Framework Directive Assessment**

Document Ref: 6.3.20.2

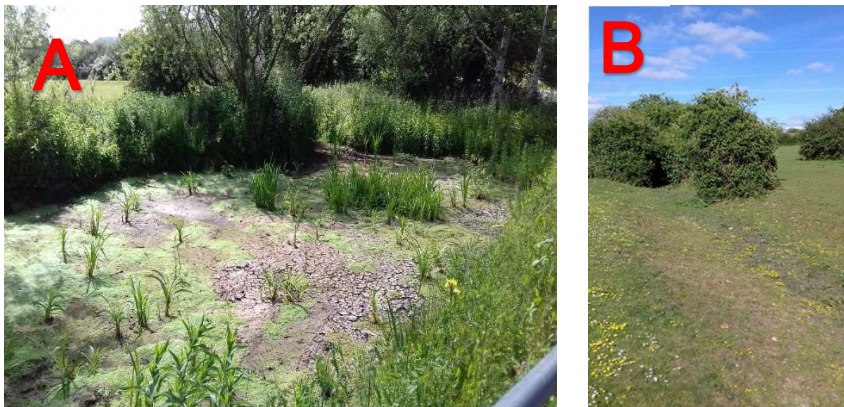
- 3.3.3.10. This pond and watercourse would not be crossed but is adjacent to the trenching and the HDD lay down area.

**Plate 3.1 - A - Kings Pond looking south (466745, 111775); B. Soake Farm North looking south (466755, 111770)**

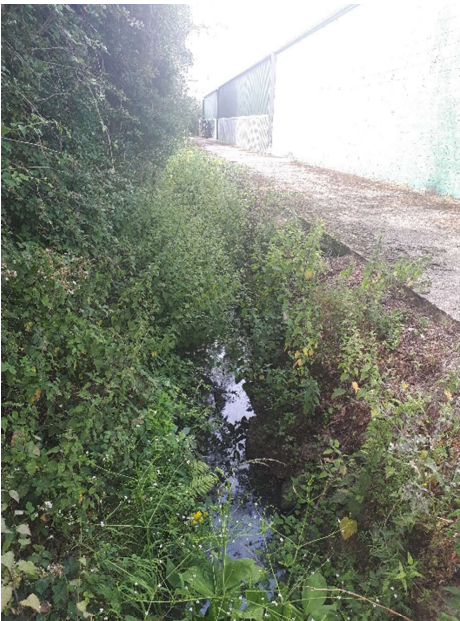
- 3.3.3.11. Soake Farm East is a main river within Section 3 of the Onshore Cable Corridor (area 3, Plate 2.6). It is a straight, trapezoid ditch, approximately 0.6 m wide and 0.15 m deep, with a mix of silt and gravel substrate and had no perceptible flow during the site visit in July 2019 (Plate 3.2). Both the left and right banks had simple vegetation including bramble, nettle, wild dog rose, blackthorn, hawthorn and grasses. In-channel vegetation included rush (*juncus* sp.) iris, sedge, water parsnip (*Sium latifolium*) and water plantain (*Alisma plantago-aquaticae*). The land surrounding the watercourse is improved grassland and farmyards / sheds along the right bank. Upstream of this watercourse is an online pond adjacent to the farm house that was stagnant during the July 2019 visit. This watercourse would be crossed via HDD.

**Plate 3.2 - Soake Farm East looking west (466800, 111240)**

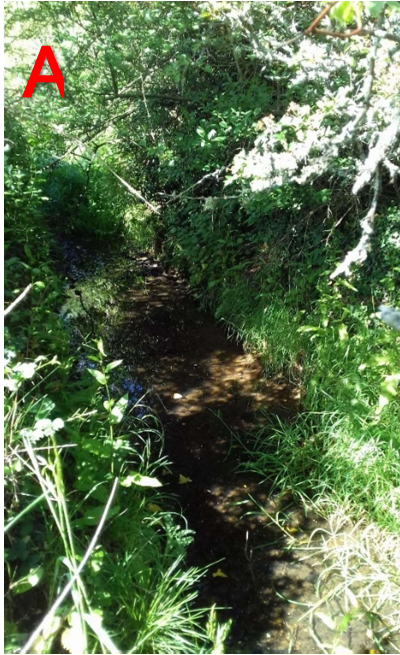
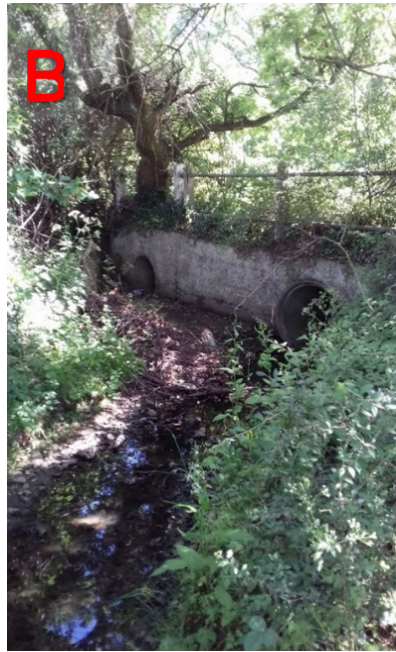
**Plate 3.3 - A. Soake Farm South over shaded channel looking north (466581, 111237);  
B. Soake Farm South looking south to double culvert under the B2150 (466574,  
111203)**

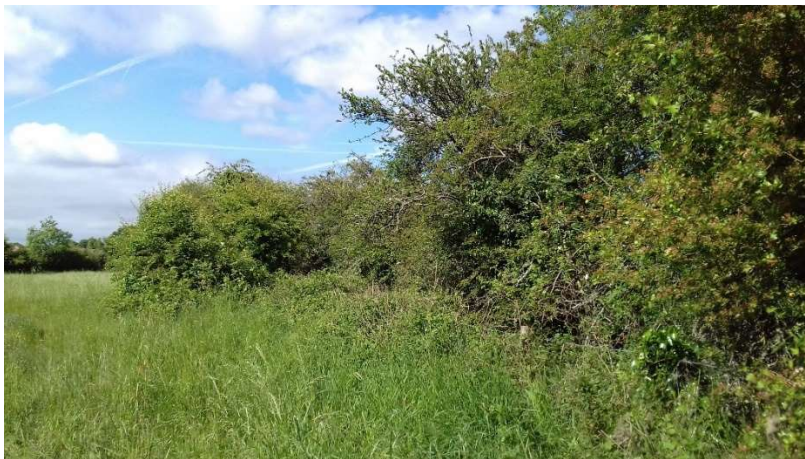
**Plate 3.4 - Soake Farm South looking north (466581, 111231)**

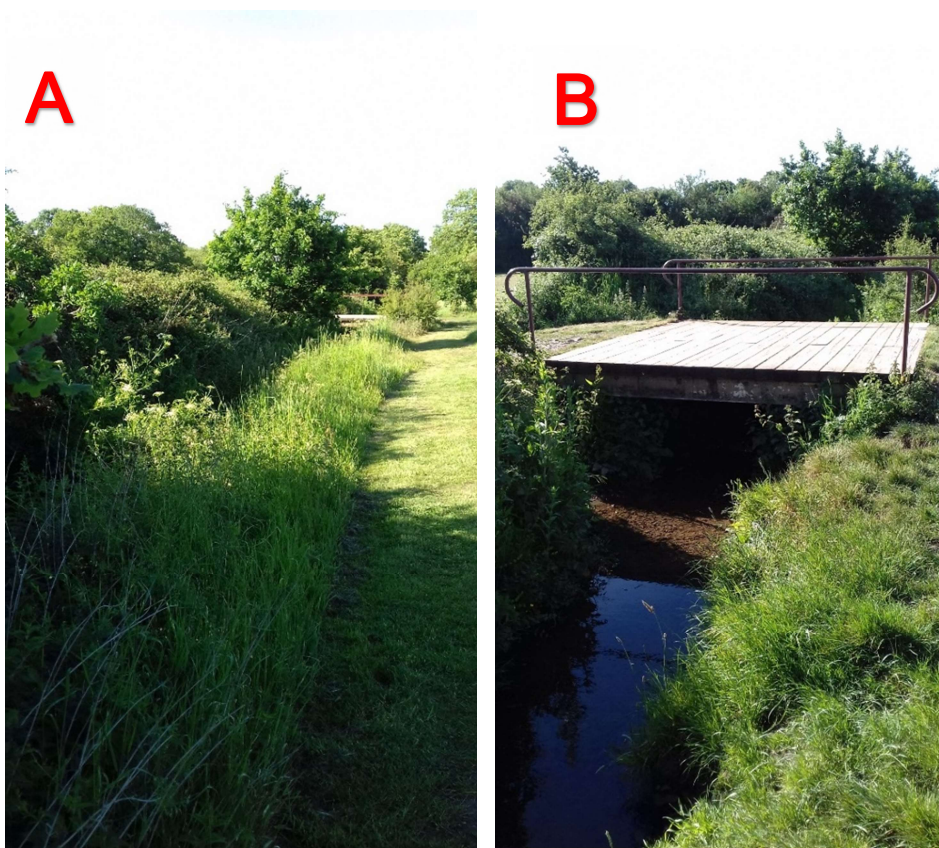
- 3.3.3.20. There was a clear and obvious flow in this section as the watercourse, below Hambledon Road, generally began to widen and take on more riverine, rather than ditch-like, characteristics (Plate 3.5 B).

**Plate 3.5 - A. Land South of Hambledon Road (B2150); narrow vegetation buffer (466522, 111098) B. Land South of Hambledon Road (B2150) indicative channel form, (466535, 111127)**

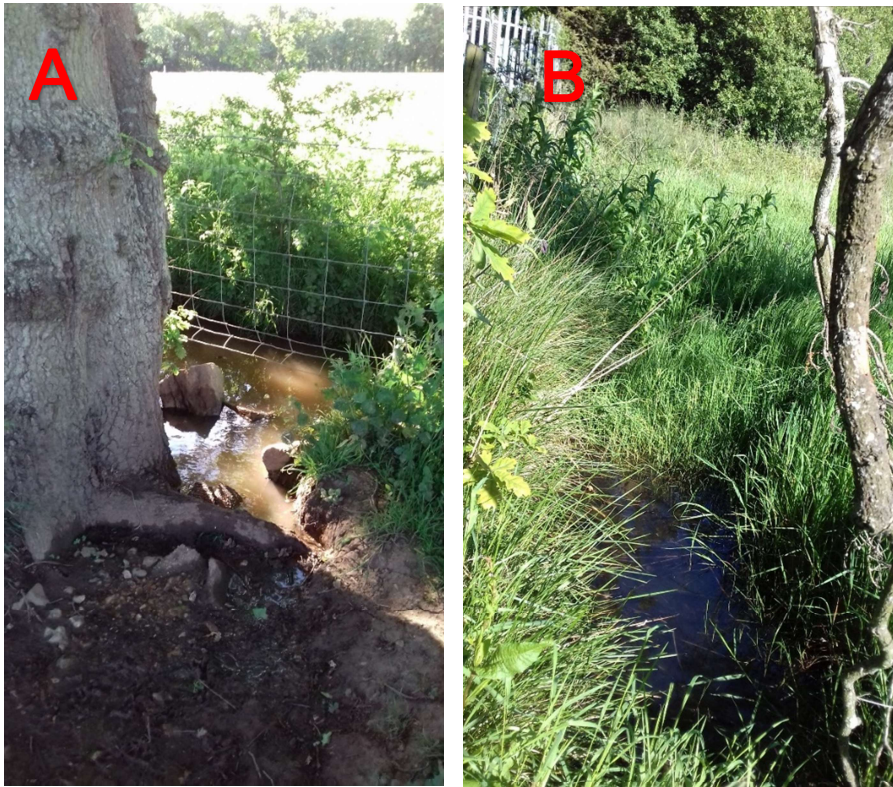
- 3.3.3.21. To the west of this land parcel and of the main watercourse there was an additional ditch, approximately 0.5 m wide and 0.1 m deep, which contained standing water for approximately half of its length with the southern half being dry at the time of survey (area 6, Plate 2.6). This section showed signs of similar poaching and land management pressures at several points along its course until connecting with the main channel at its southern extremity (Plate 3.6 A and B).

**Plate 3.6 - A. Land South of Hambledon Road (B2150) western boundary ditch, dog poaching (466469, 111150); B. Land South of Hambledon Road (B2150) western boundary ditch, northern section standing water (466520, 111190)**

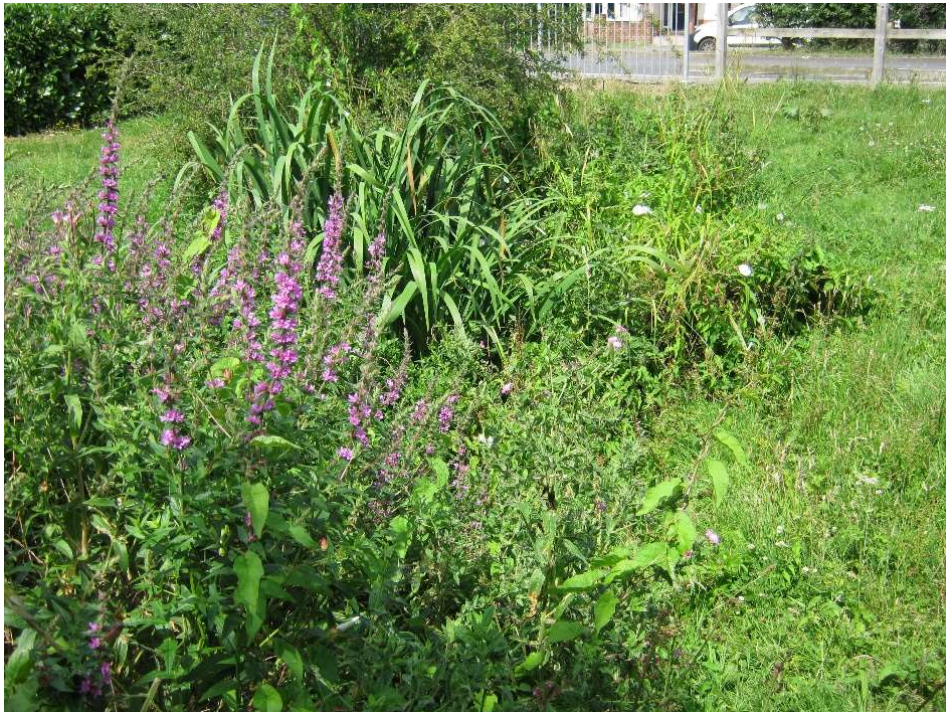
Old Park Stream is a main river within Section 4 of the Onshore Cable Corridor. The watercourse is a trapezoid ditch with a choked channel (Plate 3.8). It has a re-sectioned bank with an over deepened channel and a silty bed. During the visit in July 2019 there was no perceptible flow in Old Park Stream. The watercourse is culverted upstream from Hambledon Road after which point it passes through a small park in a suburban area. Approximately 200 m downstream of Hambledon Road Old Park Stream has been landscaped with riparian planting to create a wildflower meadow. No aquatic surveys have been carried out in this watercourse. This water course would be crossed via trenching above the culverts under B2150/Hambledon Road.

**Plate 3.8 - Old Park Stream looking north (467275, 110460)**

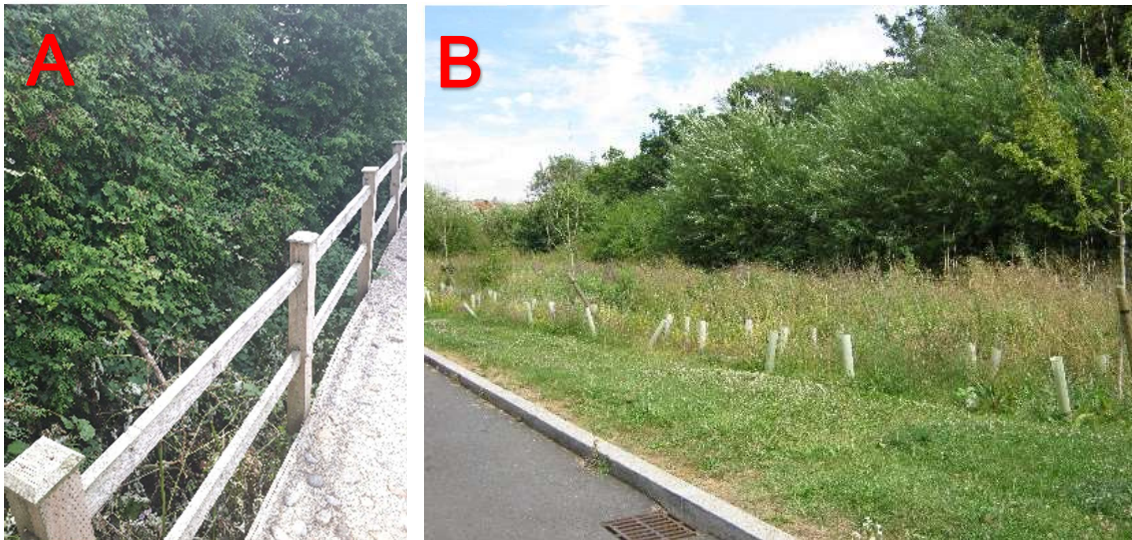
This watercourse is an ordinary river within Section 4 of the Onshore Cable Corridor and is mapped as an unnamed tributary of the River Wallington. The Unnamed Tributary is culverted under Hambledon Road and then flows along a trapezoid ditch until it reaches the landscaped area to the south (Plate 3.9 A). However, approximately 100 m downstream of Hambledon Road the Unnamed Tributary appears to merge with Old Park Stream. This area has been landscaped with riparian planting to create a wildflower meadow making access difficult to confirm channel alignment (Plate 3.9 B). No aquatic surveys have been carried out in this watercourse. This water course would be crossed via trenching above the culverts under B2150 / Hambledon Road.

**Plate 3.9 - A. Unnamed Tri Tributary of River Wallington looking south (467430, 110330); B. recent riparian planting south of Hambledon Road along Old Park Stream / Unnamed Tributary (467290, 110290)**

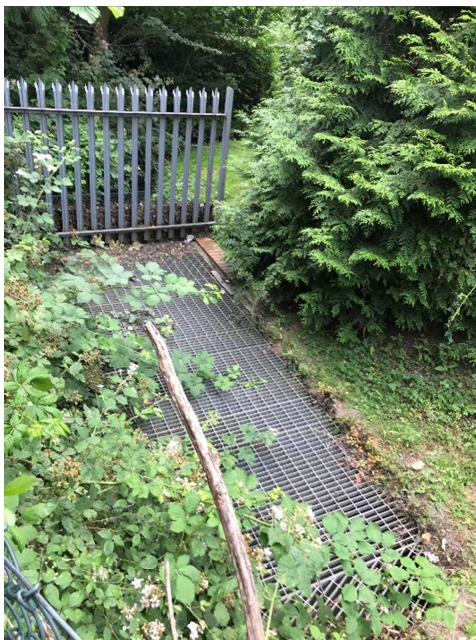
- 3.3.3.26. The River Wallington is culverted upstream of, and under Hambledon Road within Section 4 of the Onshore Cable Corridor. It then passes through a screened structure to the west and carries on as a trapezoid ditch (Plate 3.10). The watercourse was bordered by established tree vegetation on both banks downstream of Hambledon Road. Bed composition was not able to be determined due to the large screen and no access. No aquatic surveys have been carried out in this watercourse. This water course would be crossed via trenching above the culverts under B2150 / Hambledon Road.

**Plate 3.10 - River Wallington looking west from Hambledon Road (467830, 109650)**

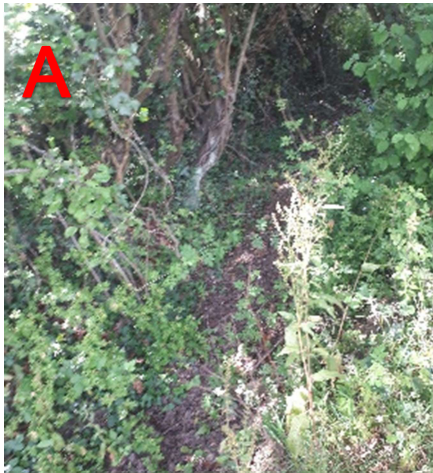
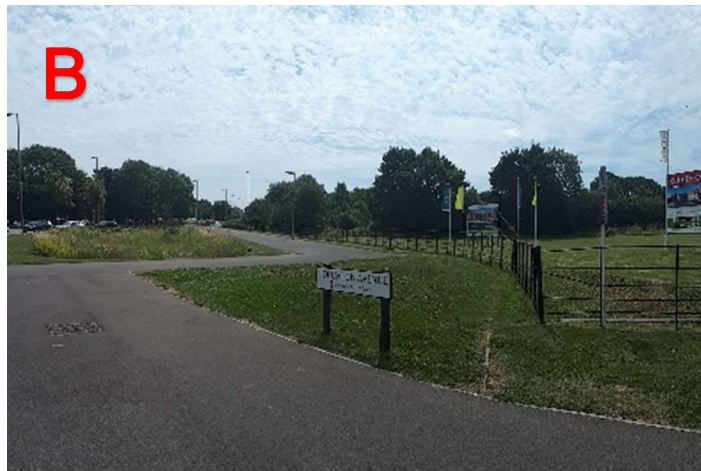
- 3.3.3.27. The unnamed Ordinary Watercourse is an overgrown small depression southwest of Maurepas Way within Section 4 of the Onshore Cable Corridor. No water was present during the site visit in July 2019 (Plate 3.11 A). Recent landscaping for a relatively new development has added an additional ditch which feeds into the start of the ordinary watercourse (Plate 3.11 B). This ditch has re-sectioned banks and was also a dry, choked channel in July 2019. Sustainable Drainage Systems ('SuDS') and highway drainage were also present in the area. No aquatic surveys have been carried out in this watercourse. This watercourse would not be crossed but lies adjacent to trenching works that would occur along Maurepas Way.

**Plate 3.11 - A. Unnamed Watercourse 1 looking south (467870, 109360); B. Looking southeast along Maurepas Way to the additional ditch (right) and SuDS pond (left) (467840, 109840)**

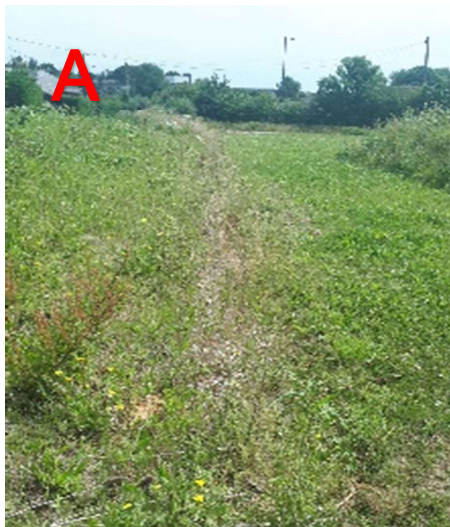
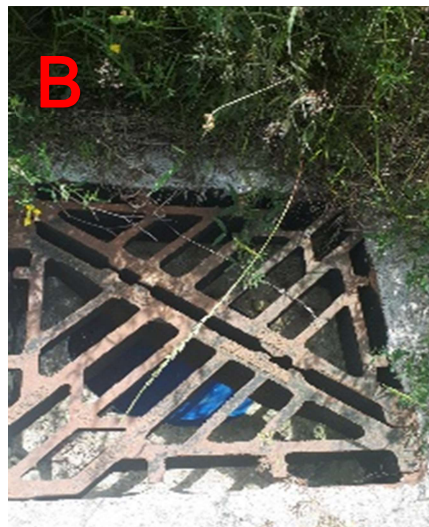
- 3.3.3.28. This Ordinary Watercourse is no longer present and is within Section 4 of the Onshore Cable Corridor. This has been piped and backfilled (Plate 3.12 A). A waterway gully grate was observed approximately 20 m west of the A3 / London Road (Plate 3.12 B). This water course would be crossed via trenching above the culverts under the A3/London Road.

**Plate 3.12 - A. Unnamed Watercourse 2 looking east towards A3 / London Road (467850, 109015); B. Gully grate approximately 20m west of the A3 / London Road (467870, 109010)**

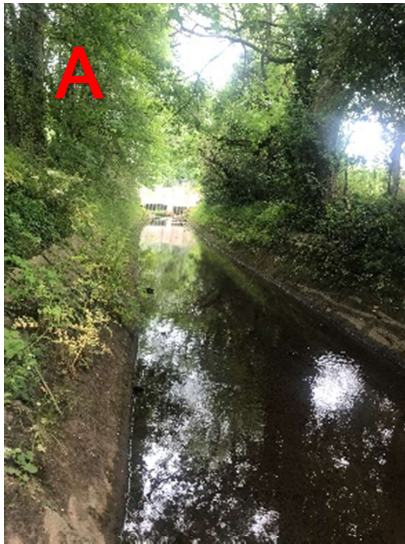
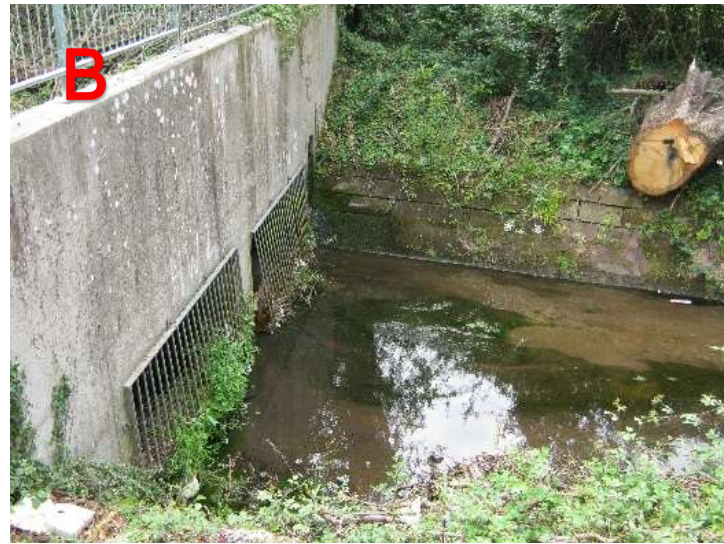
3.3.3.29. North Purbrook Heath (north) is a main river within Section 4 of the Onshore Cable Corridor. It is culverted under the A3 / London Road and is a concrete lined channel to the west after it passes through the screened culverts (Plates 3.13 A and B). Both banks are brick lined with a reinforced toe and re-sectioned top bank. A small amount of silt was built up but the watercourse maintained a smooth flow. The left bank had simple vegetation while the right bank had more complex vegetation. Upstream of the watercourse is suburban land with improved grassland adjacent to the left bank downstream of the A3 / London Road. No aquatic surveys have been carried out in this watercourse. This water course would be crossed via trenching above the culverts under the A3 / London Road.

**Plate 3.13 - A. North Purbrook Heath looking upstream (east) towards A3 / London Road (467150, 107790); B. Screened culverts where North Purbrook Heath exists culvert under A3/London Road (467180, 107780)**

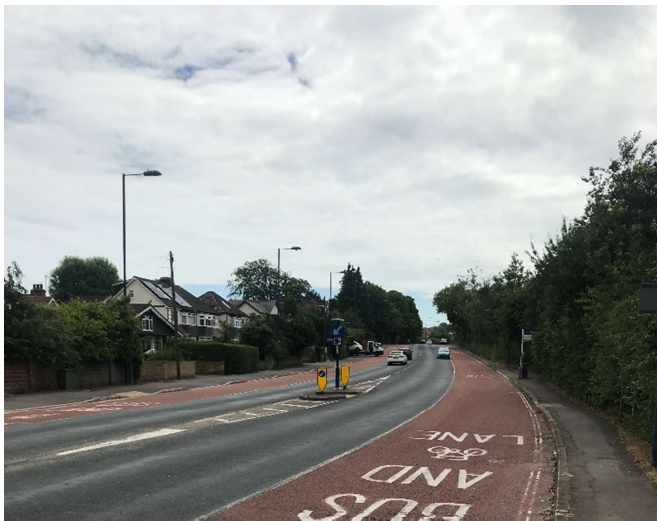
- 3.3.3.30. North Purbrook Heath (south) is also a main river and is culverted under the A3 / London Road within Section 4 of the Onshore Cable Corridor. Access was not possible during the July 2019 site visit and visibility of the watercourse was poor due to complex vegetation downstream of the A3 / London Road (Plate 3.14). The watercourse is assumed to be a trapezoid ditch. Surrounding land use south of the road is improved grassland with areas of complex vegetation. No aquatic surveys have been carried out in this watercourse. This water course would be crossed via trenching above the culverts under the A3 / London Road.

**Plate 3.14 - Looking south along A3/London Road with hedge and overgrown vegetation blocking access to the south branch of North Purbrook Heath (467175, 107730)**

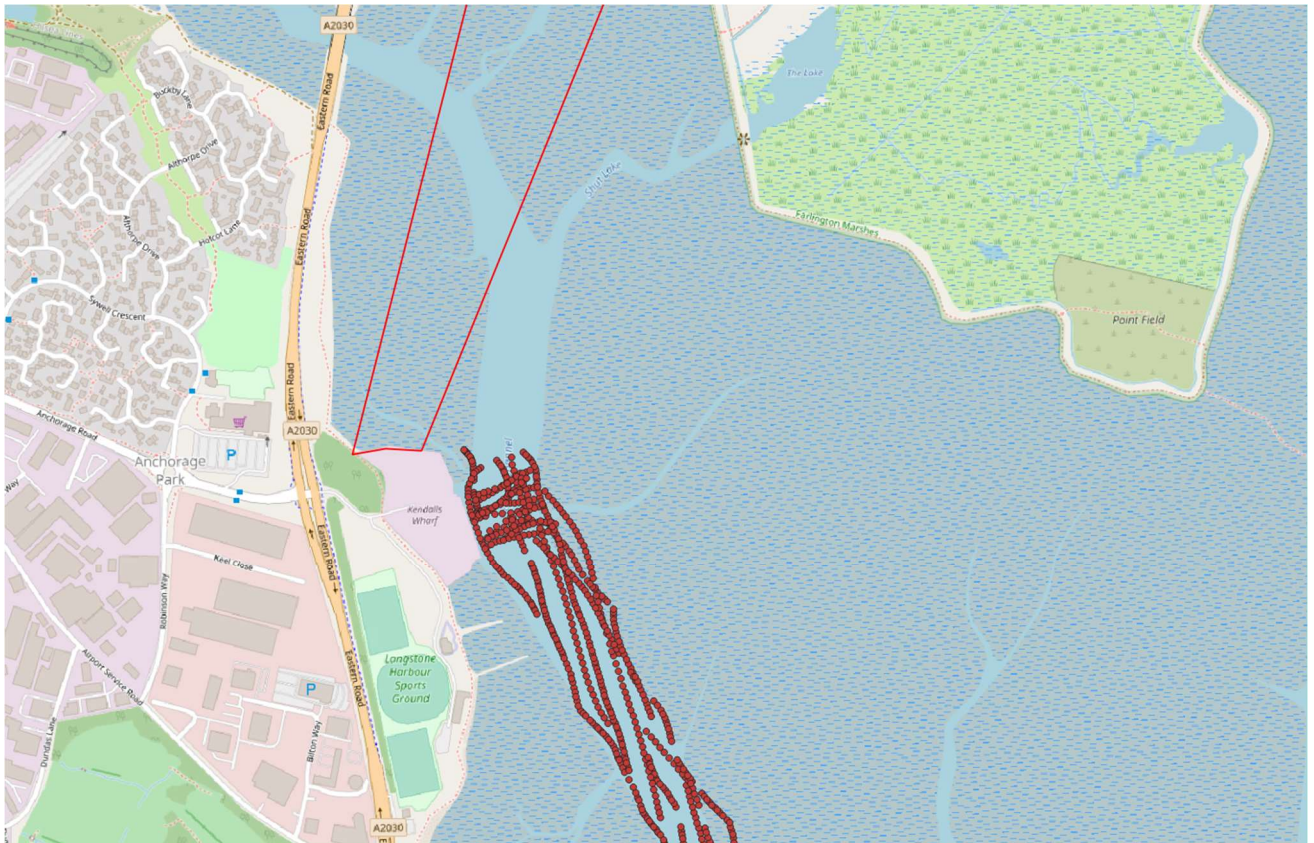
- 3.3.4.17. Multibeam bathymetry were obtained from the Admiralty Maritime Data Solutions web portal (Admiralty Maritime Data Solutions, 2019) for July 2002 (2002 2006-360174 Langstone Harbour Broom Channel) and February 2005 (2005 2006-362051 Langstone Harbour) to inform bed levels within Broom Channel. These bathymetry data contain public sector information, licensed under the Open Government License v3.0, from Langstone Harbour Authority and the Channel Coast Observatory.

**Plate 3.17 - Coverage of the 2002 2006-360174 Langstone Harbour Broom Channel bathymetry dataset in relation to the sea bed stability assessment region (red line)**

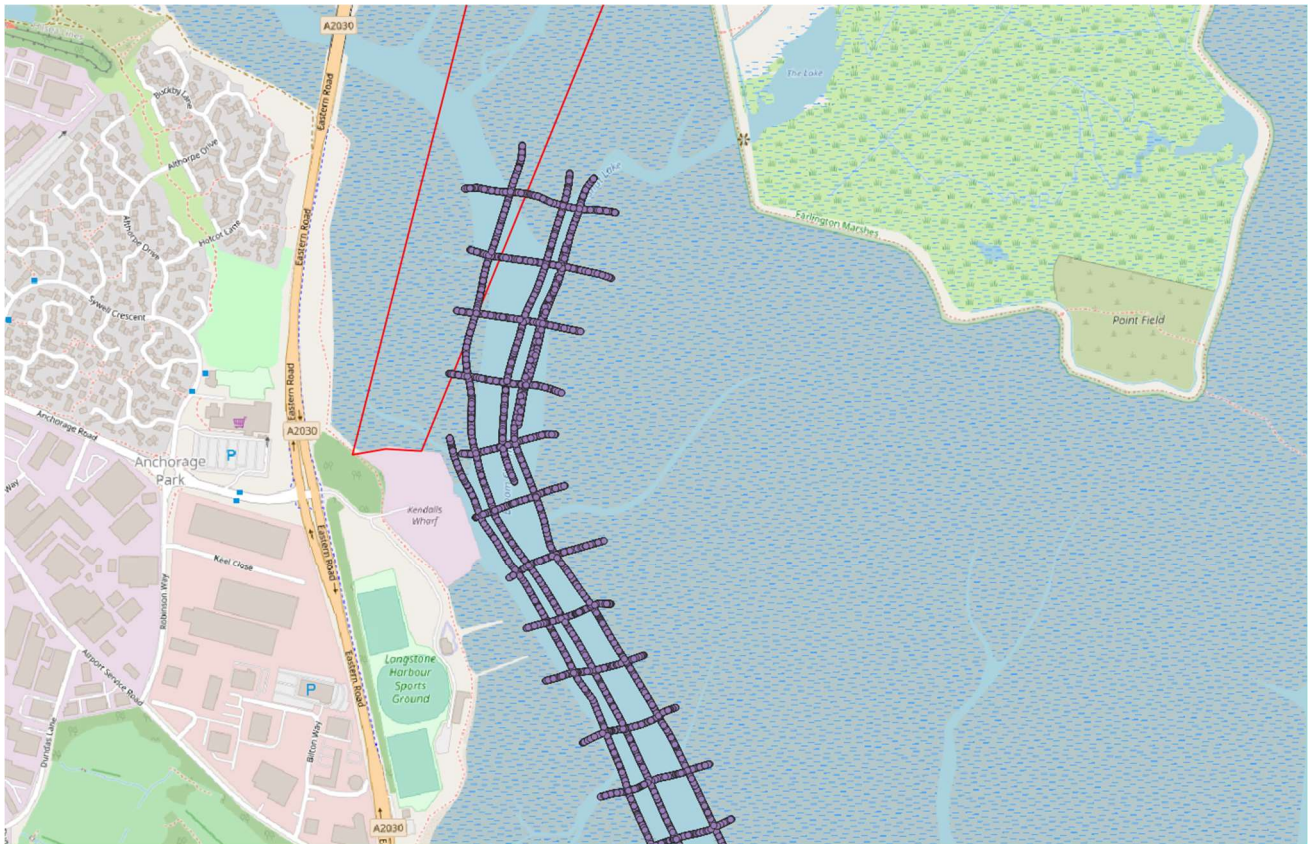
- 3.3.4.18. The February 2005 bathymetry data covers a portion of Broom Channel within the site boundary, however it has better coverage of Broom Channel south of the site towards Kendall's Wharf. The July 2002 bathymetry data does not cover Broom Channel within the site boundary, however it has reasonable coverage of Broom Channel at Kendall's Wharf. The spatial coverage of these bathymetry survey data is shown in Plate 3.17 and Plate 3.18. These bathymetry data were interpolated over their respective spatial coverage so that profiles could be extracted for further analysis. These data were supplied with a vertical reference of metres Chart Datum (mOD) and were converted to mOD using the conversion factor of -2.73 m.

**Plate 3.18 - Coverage of the 2005 2006-362051 Langstone Harbour bathymetry dataset in relation to the sea bed stability assessment region (red line)**

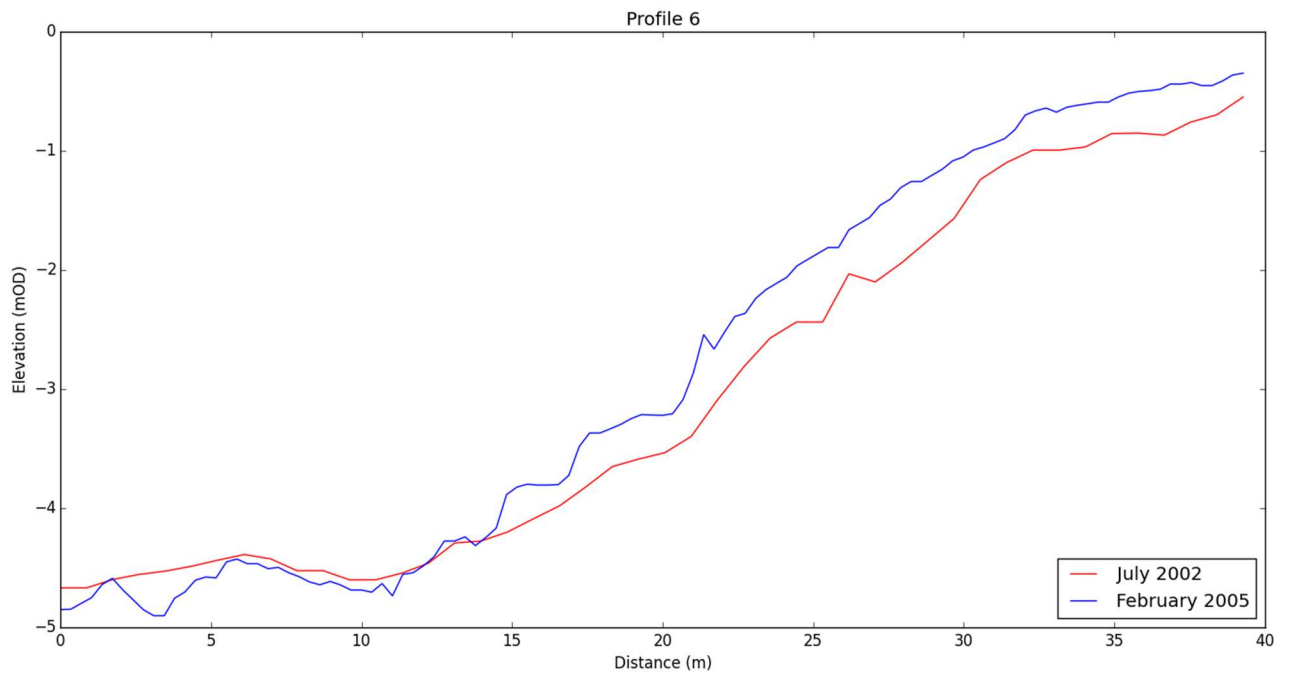
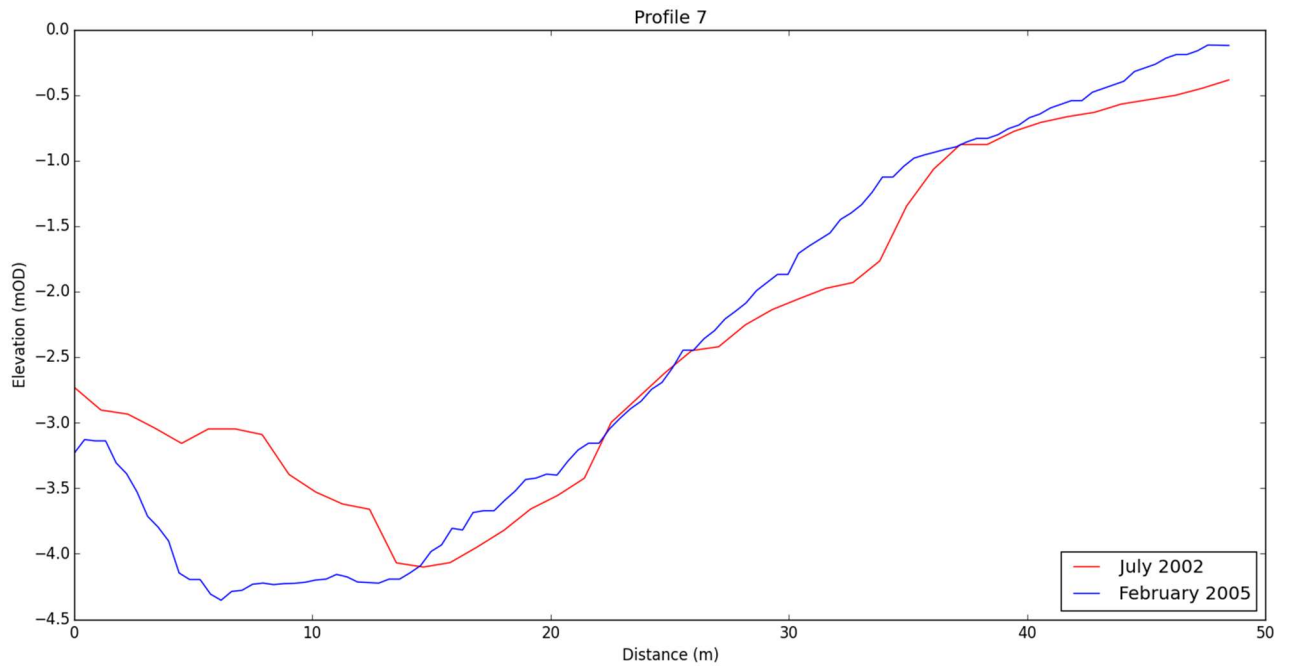
3.3.4.25. Plate 3.24 – Plate 3.27 shows bed elevations for bathymetry profiles 5-8 between July 2002 and February 2005. Kendall’s Wharf is located to the left of the plots while a large extensive mudflat is located to the right of the plot. This shows that there is greater variability observed in Broom Channel at this location when compared with the LiDAR profiles within the study site. However, it should be noted that while there is increased variability in the bed levels for bathymetry profiles 5-8, the change in the minimum bed level for each profile is relatively small. The narrow temporal window between available bathymetry survey data (2 years 8 months) creates uncertainty in the observed change in bed level. A comparison of a greater number of bathymetry survey data covering a wider time frame would reduce this uncertainty.

**Plate 3.24 - Bathymetry data between July 2002 and February 2005 for profile 5**

**Plate 3.25 - Bathymetry data between July 2002 and February 2005 for profile 6**

**Plate 3.26 - Bathymetry data between July 2002 and February 2005 for profile 7**

**Plate 3.27 - Bathymetry data between July 2002 and February 2005 for profile 8**

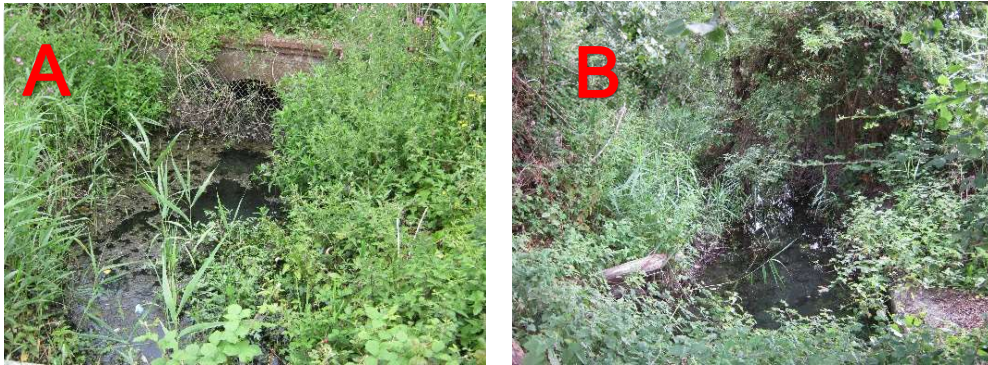
3.3.5.1. Farlington Marshes Gutter is an ordinary river feeding into main river within and adjacent to Section 7 of the Onshore Cable Corridor. No water was observed in the upstream extent of the ordinary river, but stagnant water was present at confluence with the main stem (Plate 3.28 A). The main river is an overgrown trapezoid ditch. Scrub is present on the banks and no perceptible flow was observed (Plate 3.28 B). The ordinary watercourse would be crossed via Trenchless techniques while the main stem will not be crossed but lies adjacent to trenching works.

**Plate 3.28 - A. Confluence of ordinary and main branches of Farlington Marshes Gutter with stagnant water present (467910, 104970); B. Looking south east downstream the main branch of Farlington Marshes Gutter (467915,104960)**

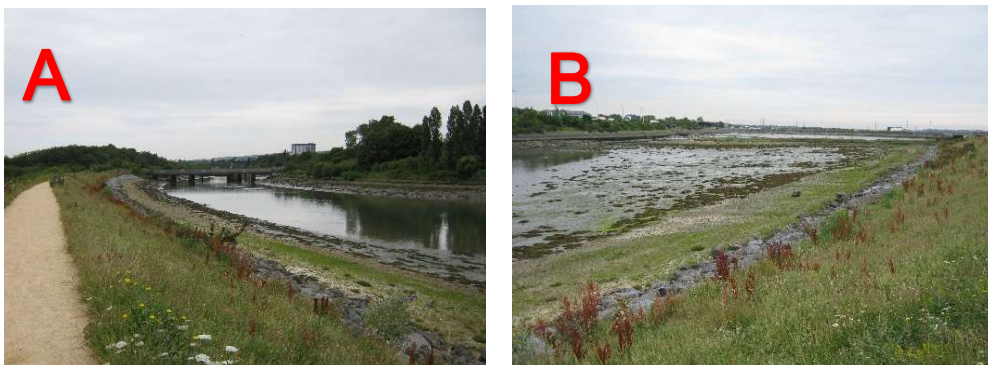
Langstone Harbour is a transitional water body within Section 7 of the Onshore Cable Corridor. Ports Creek is the north western upstream extent of Langstone Harbour where it passes under the A2030. The water body is heavily influenced by tides. Ports creek has undergone extensive re-sectioning with rip rap present on both banks (Plates 3.29 A and B). The left bank also has a reinforced toe with brick lining the left bank. At the time of visiting, the tide was on its way out thus exposing mudflats. Ports Creek feeds into Langstone Harbour, which would be crossed via HDD.

**Plate 3.29 - A. Ports Creek looking west (466980, 104090); B. Ports Creek looking east towards A2030 and main body of Langstone Harbour (466980, 104090)**

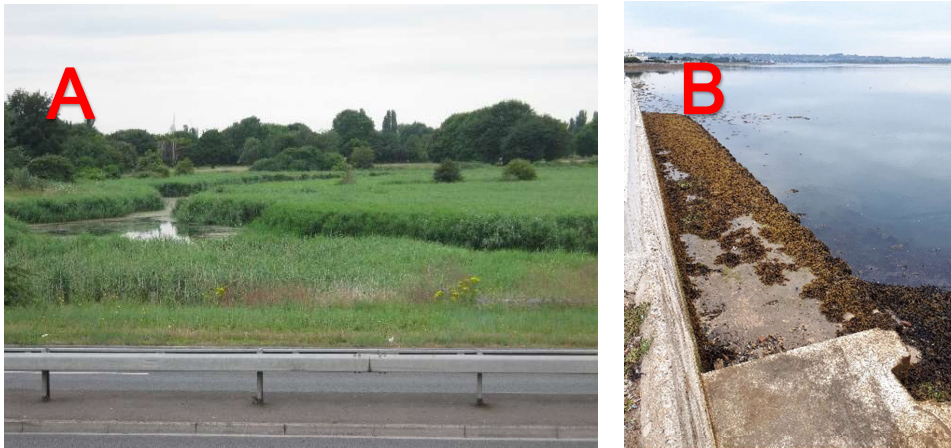
- 3.3.5.3. Concrete lined channel followed by onstream ponds within Section 8 of the Onshore Cable Corridor. The onstream ponds border the edge of Eastern Road where a pumping station is present to pump water from Great Salterns Drain into Langstone Harbour. The onstream ponds have an abundance of reeds present (Plate 3.30 A). No outfall was observed within immediate vicinity, so it is assumed the outfall extends further into the harbour (Plate 3.30 B). This water course would be crossed via trenching above the culverts under the A2030/Eastern Road.

**Plate 3.30 - A Looking west across A2030 / Eastern Road towards the onstream ponds of Great Salterns Drain (467650, 101790); B. looking north along the tidal defence adjacent to A2030 / Eastern Road downstream of Great Salterns Drain (467670, 101790)**
