AQUIND INTERCONNECTOR

Environmental Statement – Volume 3 – Appendix 20.2 Onshore Water Framework Directive Assessment - Low Resolution

Document Ref: 6.3.20.2

DATE: 14 NOVEMBER 2019

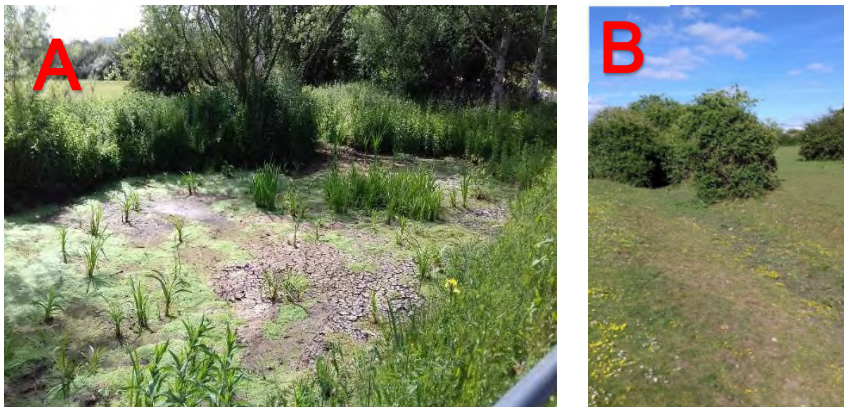
- 3.3.3.10. This pond and watercourse would not be crossed but is adjacent to the trenching and the HDD lay down area.

Plate 3.1 - A - Kings Pond looking south (466745, 111775); B. Soake Farm North looking south (466755, 111770)

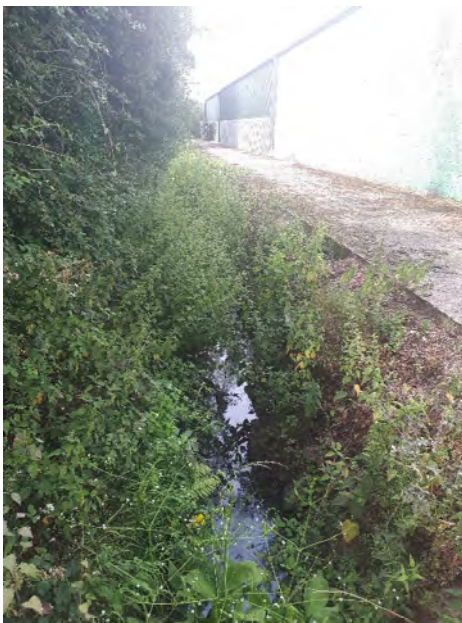
- 3.3.3.11. Soake Farm East is a main river within Section 3 of the Onshore Cable Corridor (area 3, Plate 2.6). It is a straight, trapezoid ditch, approximately 0.6 m wide and 0.15 m deep, with a mix of silt and gravel substrate and had no perceptible flow during the site visit in July 2019 (Plate 3.2). Both the left and right banks had simple vegetation including bramble, nettle, wild dog rose, blackthorn, hawthorn and grasses. In-channel vegetation included rush (*Juncus* sp.) iris, sedge, water parsnip (*Sium latifolium*) and water plantain (*Alisma plantago-aquaticae*). The land surrounding the watercourse is improved grassland and farmyards / sheds along the right bank. Upstream of this watercourse is an online pond adjacent to the farm house that was stagnant during the July 2019 visit. This watercourse would be crossed via HDD.

Plate 3.2 - Soake Farm East looking west (466800, 111240)

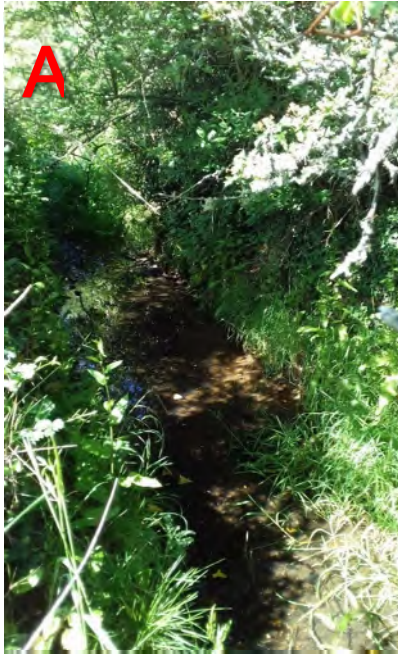
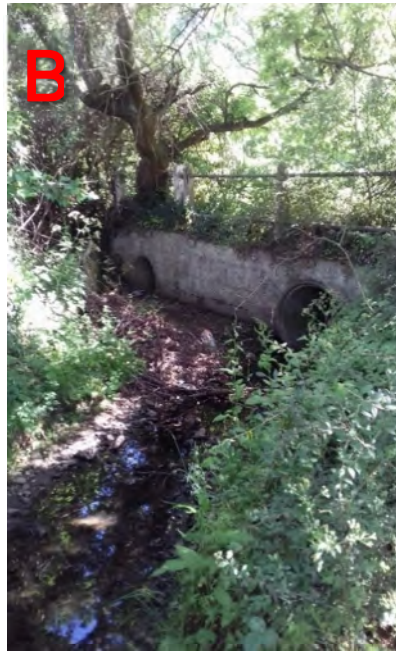
**Plate 3.3 - A. Soake Farm South over shaded channel looking north (466581, 111237);
B. Soake Farm South looking south to double culvert under the B2150 (466574,
111203)**

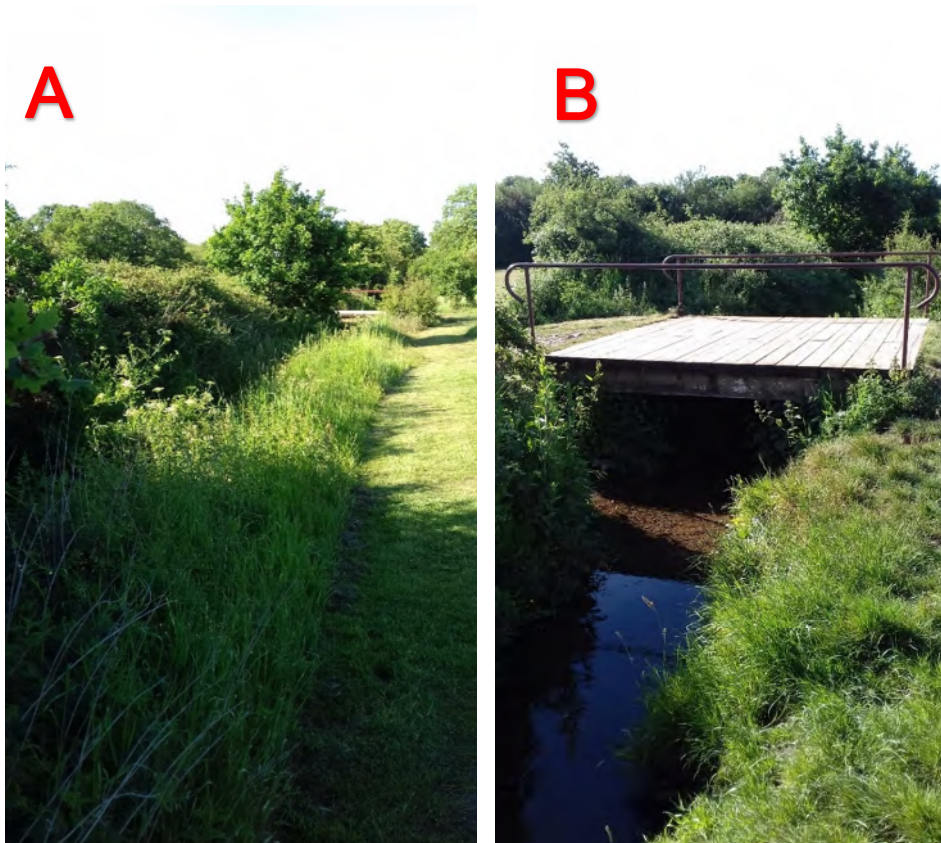
- 3.3.3.20. There was a clear and obvious flow in this section as the watercourse, below Hambledon Road, generally began to widen and take on more riverine, rather than ditch-like, characteristics (Plate 3.5 B).

Plate 3.5 - A. Land South of Hambledon Road (B2150); narrow vegetation buffer (466522, 111098) B. Land South of Hambledon Road (B2150) indicative channel form, (466535, 111127)

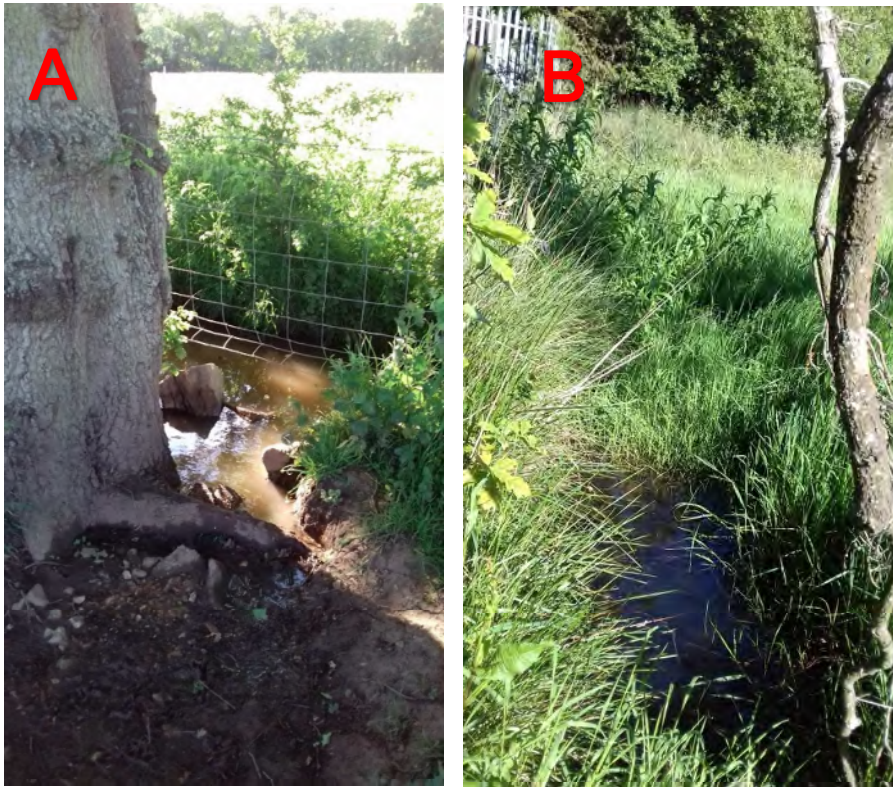
- 3.3.3.21. To the west of this land parcel and of the main watercourse there was an additional ditch, approximately 0.5 m wide and 0.1 m deep, which contained standing water for approximately half of its length with the southern half being dry at the time of survey (area 6, Plate 2.6). This section showed signs of similar poaching and land management pressures at several points along its course until connecting with the main channel at its southern extremity (Plate 3.6 A and B).

Plate 3.6 - A. Land South of Hambledon Road (B2150) western boundary ditch, dog poaching (466469, 111150); B. Land South of Hambledon Road (B2150) western boundary ditch, northern section standing water (466520, 111190)

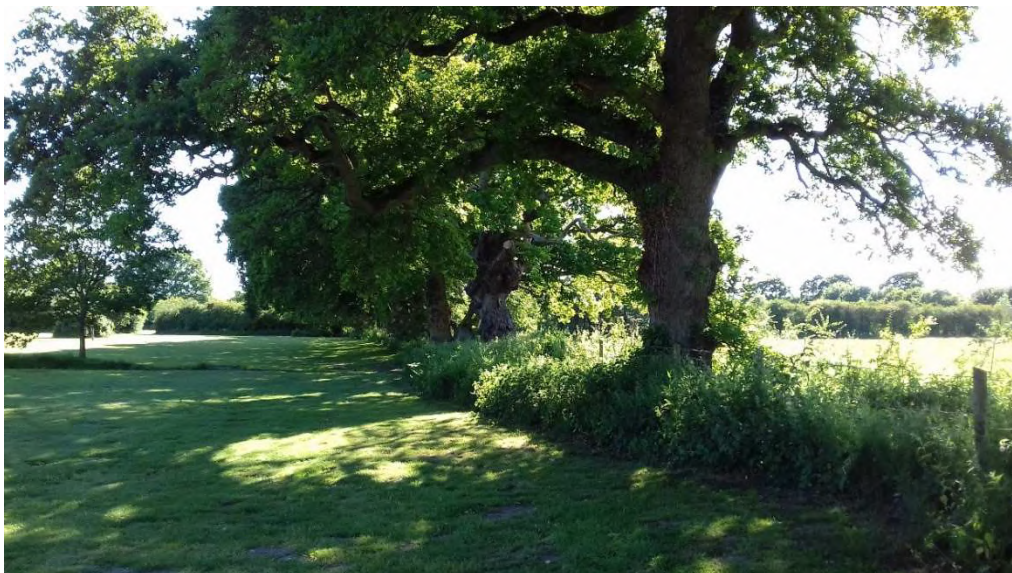
- 3.3.3.23. Dominant vegetation included nettles, cleavers, blackthorn and grasses with a row of mature oaks along its course (Plate 3.7).

Plate 3.7 - Land South of Hambledon Road (B2150) western boundary ditch, line of mature oaks and narrow vegetated buffer (466492, 111169)

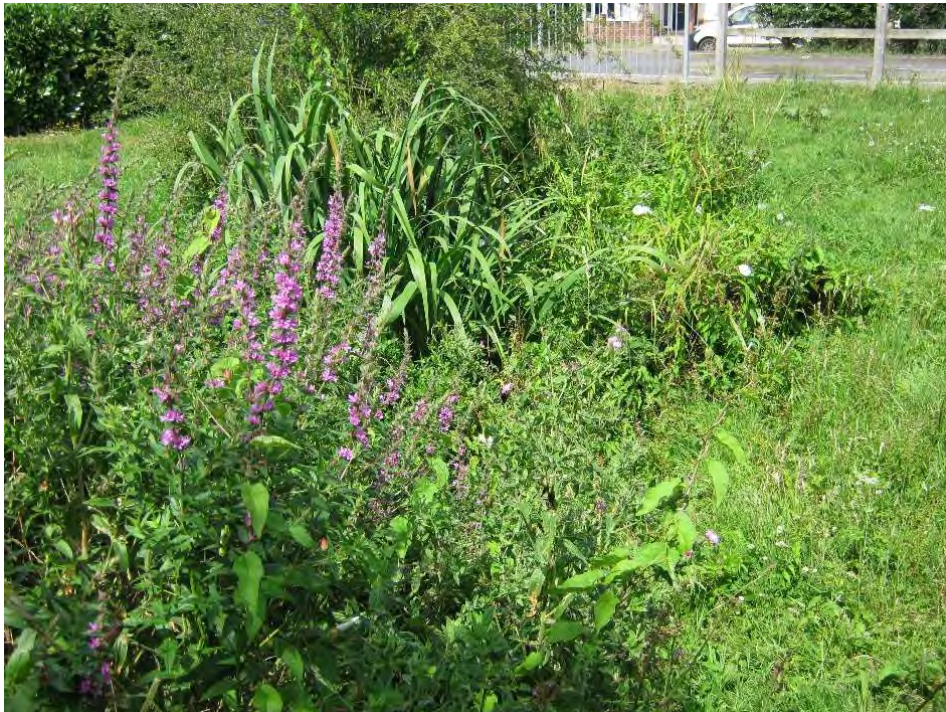
Old Park Stream is a main river within Section 4 of the Onshore Cable Corridor. The watercourse is a trapezoid ditch with a choked channel (Plate 3.8). It has a re-sectioned bank with an over deepened channel and a silty bed. During the visit in July 2019 there was no perceptible flow in Old Park Stream. The watercourse is culverted upstream from Hambledon Road after which point it passes through a small park in a suburban area. Approximately 200 m downstream of Hambledon Road Old Park Stream has been landscaped with riparian planting to create a wildflower meadow. No aquatic surveys have been carried out in this watercourse. This water course would be crossed via trenching above the culverts under B2150/Hambledon Road.

Plate 3.8 - Old Park Stream looking north (467275, 110460)

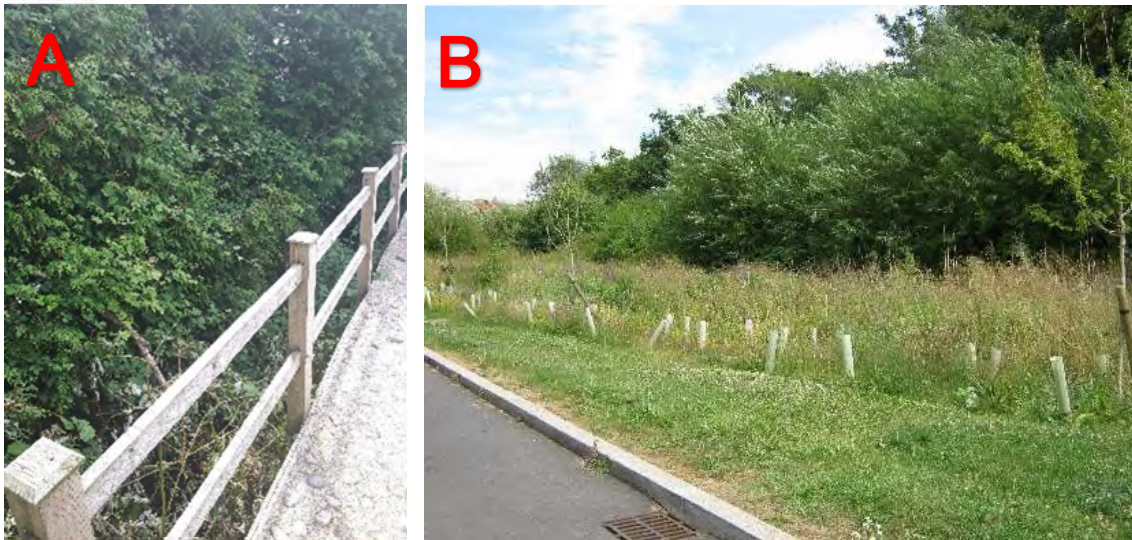
This watercourse is an ordinary river within Section 4 of the Onshore Cable Corridor and is mapped as an unnamed tributary of the River Wallington. The Unnamed Tributary is culverted under Hambledon Road and then flows along a trapezoid ditch until it reaches the landscaped area to the south (Plate 3.9 A). However, approximately 100 m downstream of Hambledon Road the Unnamed Tributary appears to merge with Old Park Stream. This area has been landscaped with riparian planting to create a wildflower meadow making access difficult to confirm channel alignment (Plate 3.9 B). No aquatic surveys have been carried out in this watercourse. This water course would be crossed via trenching above the culverts under B2150 / Hambledon Road.

Plate 3.9 - A. Unnamed Tri Tributary of River Wallington looking south (467430, 110330); B. recent riparian planting south of Hambledon Road along Old Park Stream / Unnamed Tributary (467290, 110290)

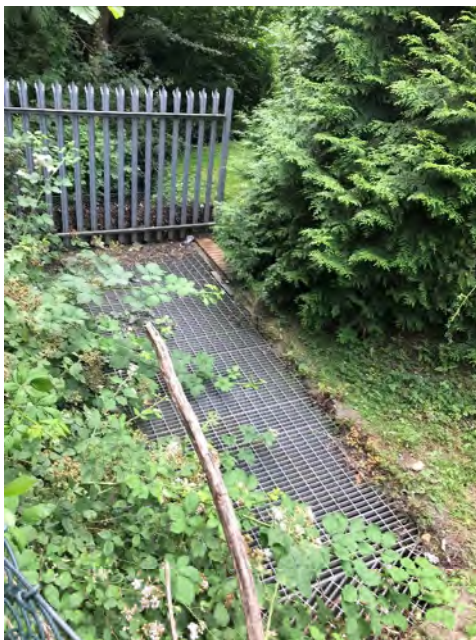
- 3.3.3.26. The River Wallington is culverted upstream of, and under Hambledon Road within Section 4 of the Onshore Cable Corridor. It then passes through a screened structure to the west and carries on as a trapezoid ditch (Plate 3.10). The watercourse was bordered by established tree vegetation on both banks downstream of Hambledon Road. Bed composition was not able to be determined due to the large screen and no access. No aquatic surveys have been carried out in this watercourse. This water course would be crossed via trenching above the culverts under B2150 / Hambledon Road.

Plate 3.10 - River Wallington looking west from Hambledon Road (467830, 109650)

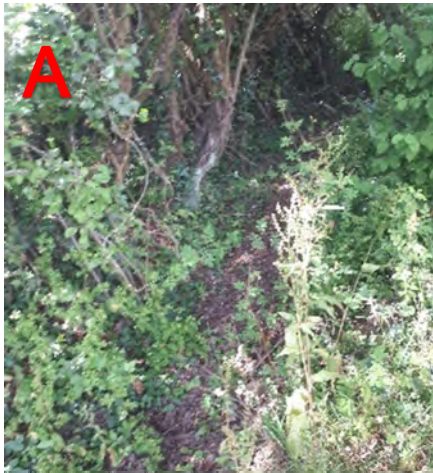
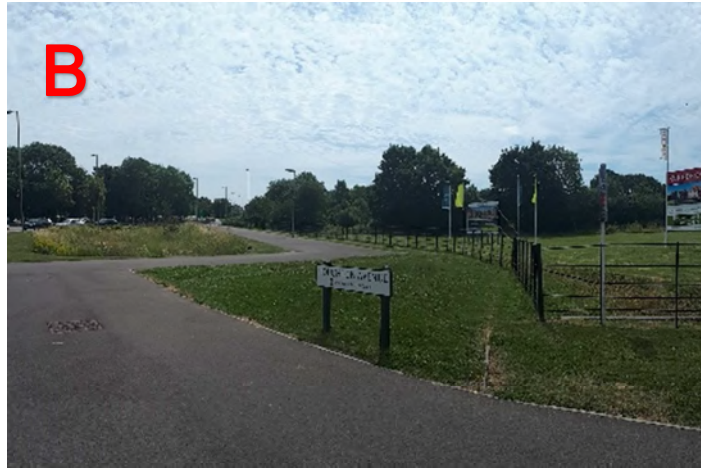
- 3.3.3.27. The unnamed Ordinary Watercourse is an overgrown small depression southwest of Maurepas Way within Section 4 of the Onshore Cable Corridor. No water was present during the site visit in July 2019 (Plate 3.11 A). Recent landscaping for a relatively new development has added an additional ditch which feeds into the start of the ordinary watercourse (Plate 3.11 B). This ditch has re-sectioned banks and was also a dry, choked channel in July 2019. Sustainable Drainage Systems ('SuDS') and highway drainage were also present in the area. No aquatic surveys have been carried out in this watercourse. This watercourse would not be crossed but lies adjacent to trenching works that would occur along Maurepas Way.

Plate 3.11 - A. Unnamed Watercourse 1 looking south (467870, 109360); B. Looking southeast along Maurepas Way to the additional ditch (right) and SuDS pond (left) (467840, 109840)

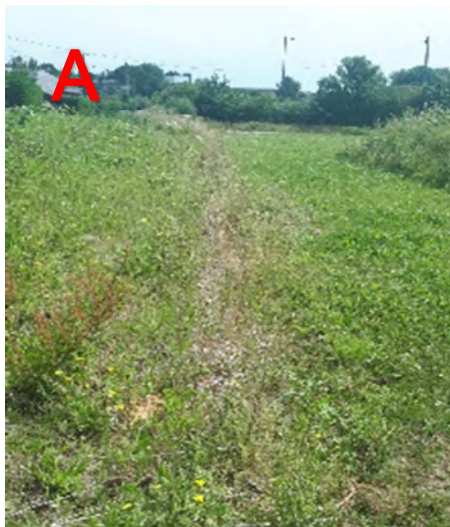
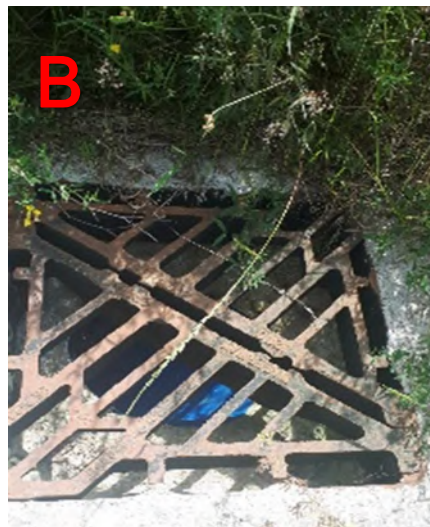
3.3.3.28. This Ordinary Watercourse is no longer present and is within Section 4 of the Onshore Cable Corridor. This has been piped and backfilled (Plate 3.12 A). A waterway gully grate was observed approximately 20 m west of the A3 / London Road (Plate 3.12 B). This water course would be crossed via trenching above the culverts under the A3/London Road.

Plate 3.12 - A. Unnamed Watercourse 2 looking east towards A3 / London Road (467850, 109015); B. Gully grate approximately 20m west of the A3 / London Road (467870, 109010)

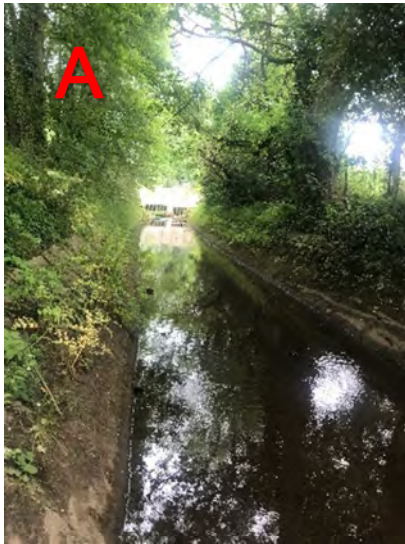
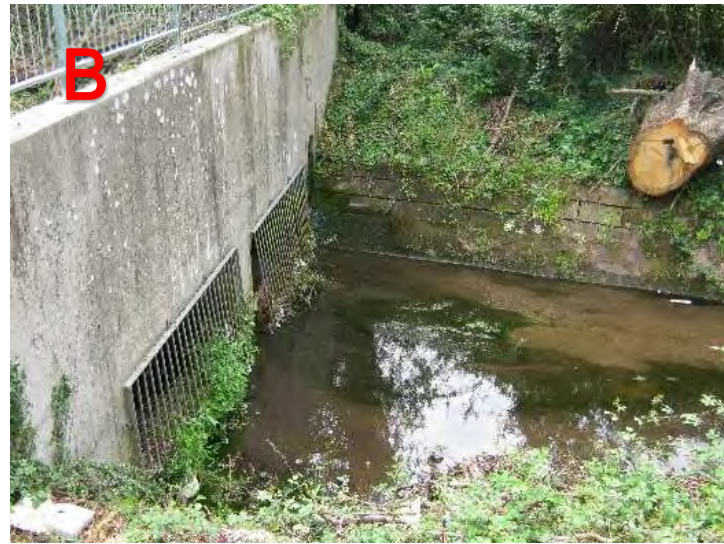
3.3.3.29. North Purbrook Heath (north) is a main river within Section 4 of the Onshore Cable Corridor. It is culverted under the A3 / London Road and is a concrete lined channel to the west after it passes through the screened culverts (Plates 3.13 A and B). Both banks are brick lined with a reinforced toe and re-sectioned top bank. A small amount of silt was built up but the watercourse maintained a smooth flow. The left bank had simple vegetation while the right bank had more complex vegetation. Upstream of the watercourse is suburban land with improved grassland adjacent to the left bank downstream of the A3 / London Road. No aquatic surveys have been carried out in this watercourse. This water course would be crossed via trenching above the culverts under the A3 / London Road.

Plate 3.13 - A. North Purbrook Heath looking upstream (east) towards A3 / London Road (467150, 107790); B. Screened culverts where North Purbrook Heath exists culvert under A3/London Road (467180, 107780)

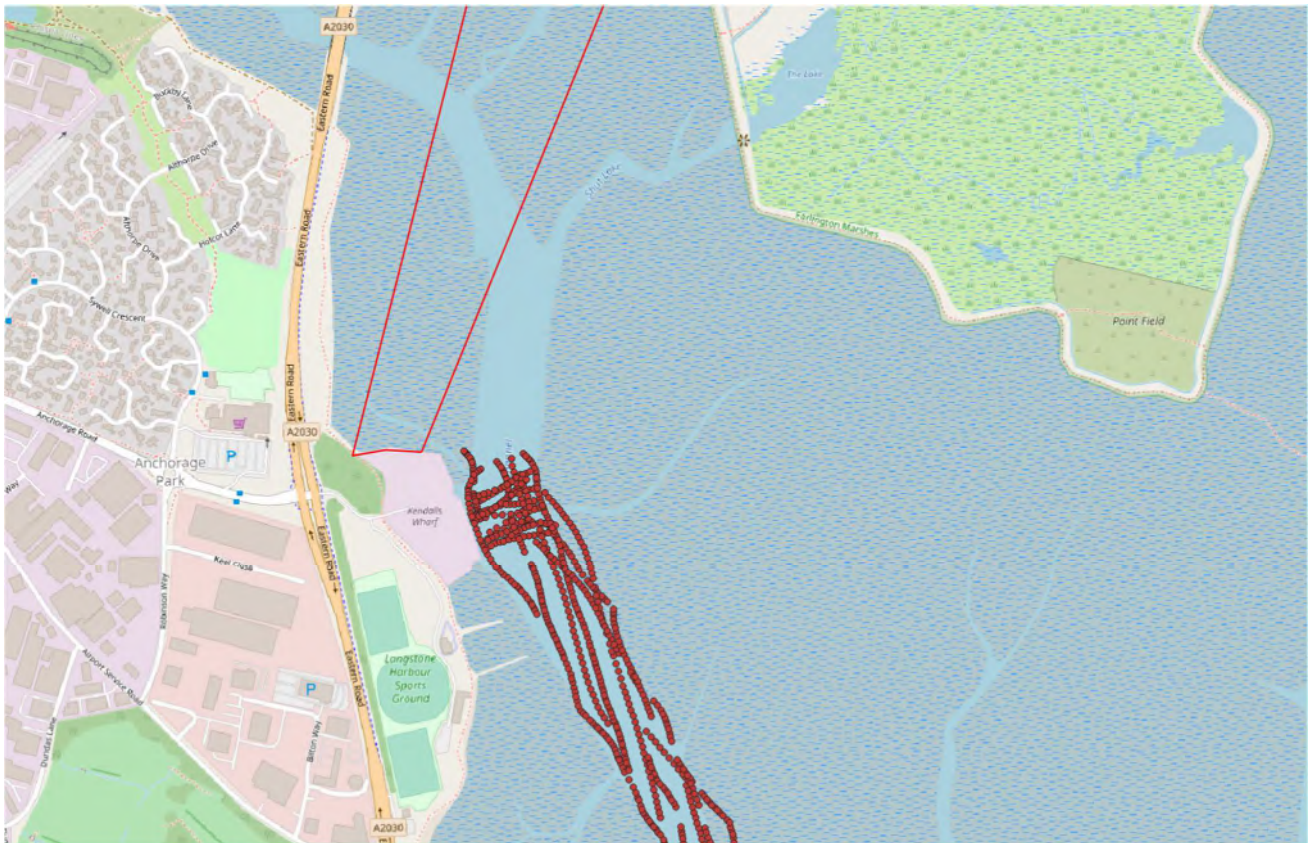
- 3.3.4.17. Multibeam bathymetry were obtained from the Admiralty Maritime Data Solutions web portal (Admiralty Maritime Data Solutions, 2019) for July 2002 (2002 2006-360174 Langstone Harbour Broom Channel) and February 2005 (2005 2006-362051 Langstone Harbour) to inform bed levels within Broom Channel. These bathymetry data contain public sector information, licensed under the Open Government License v3.0, from Langstone Harbour Authority and the Channel Coast Observatory.

Plate 3.17 - Coverage of the 2002 2006-360174 Langstone Harbour Broom Channel bathymetry dataset in relation to the sea bed stability assessment region (red line)

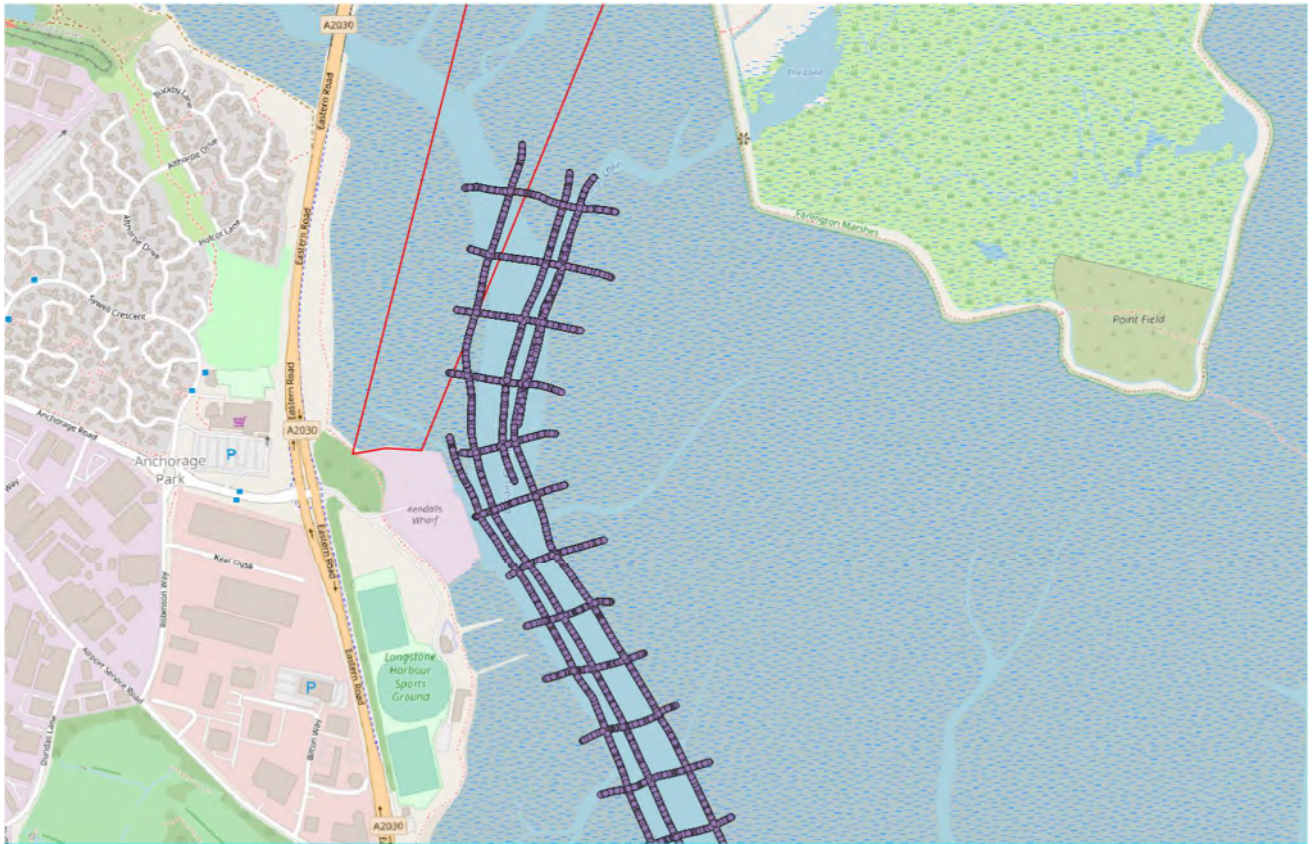
- 3.3.4.18. The February 2005 bathymetry data covers a portion of Broom Channel within the site boundary, however it has better coverage of Broom Channel south of the site towards Kendall's Wharf. The July 2002 bathymetry data does not cover Broom Channel within the site boundary, however it has reasonable coverage of Broom Channel at Kendall's Wharf. The spatial coverage of these bathymetry survey data is shown in Plate 3.17 and Plate 3.18. These bathymetry data were interpolated over their respective spatial coverage so that profiles could be extracted for further analysis. These data were supplied with a vertical reference of metres Chart Datum (mOD) and were converted to mOD using the conversion factor of -2.73 m.

Plate 3.18 - Coverage of the 2005 2006-362051 Langstone Harbour bathymetry dataset in relation to the sea bed stability assessment region (red line)

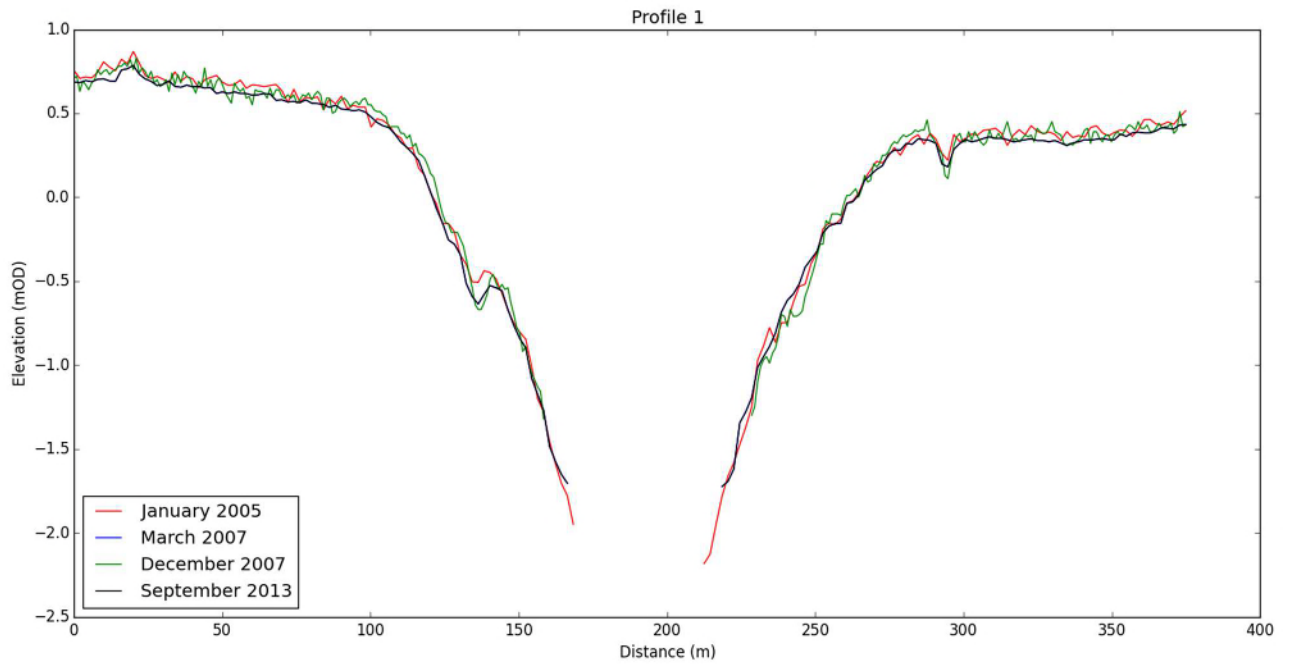
Plate 3.20 - LiDAR elevation data between January 2005 and September 2013 for profile 1

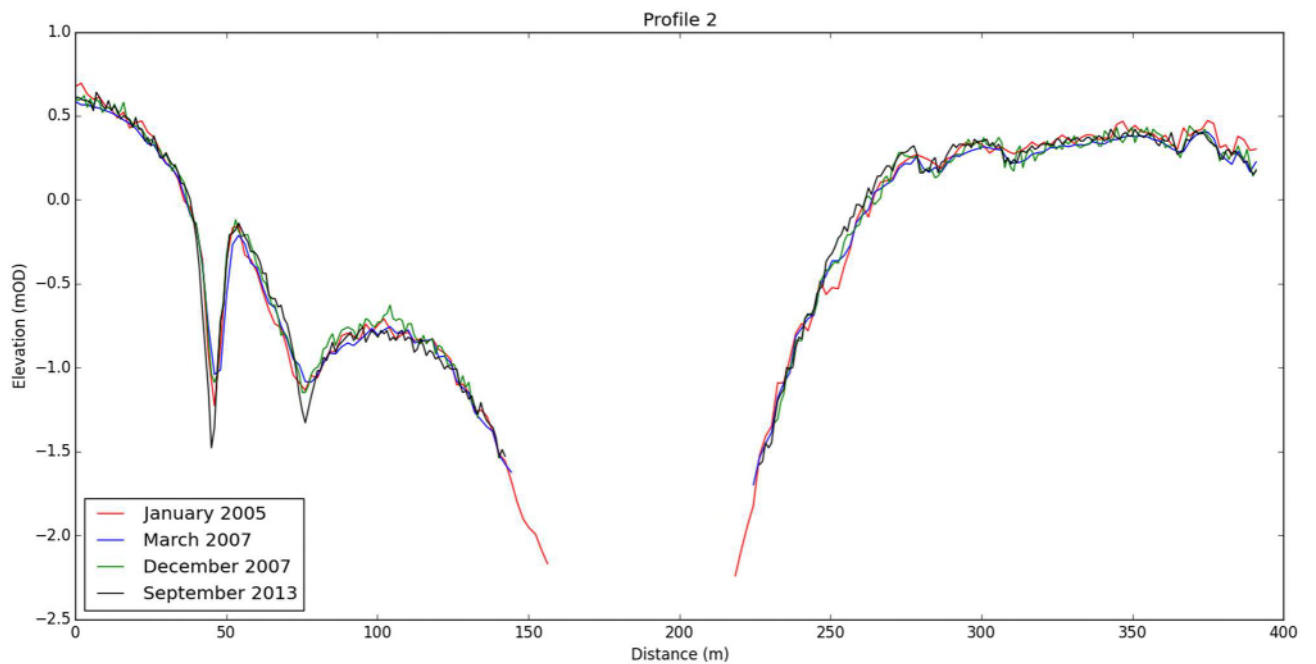
- 3.3.4.23. LiDAR profile 2 (Plate 3.21) shows that there has been some potential lowering of bed levels within the small creeks extending to the north from Broom Channel, with a maximum change in bed level of 0.58m. However, it should be noted that there is uncertainty associated with this change in bed levels, as the presence of water in the small creek at the time of the LiDAR survey will artificially raise the bed level so that a comparison against LiDAR data without the water present will result in an apparent change in bed levels. While the water surface has been removed from Broom Channel, due to the small size of these connecting creeks it has not been possible to identify and remove a water surface.

Plate 3.21 - Lidar elevation data between January 2005 and September 2013 for profile 2

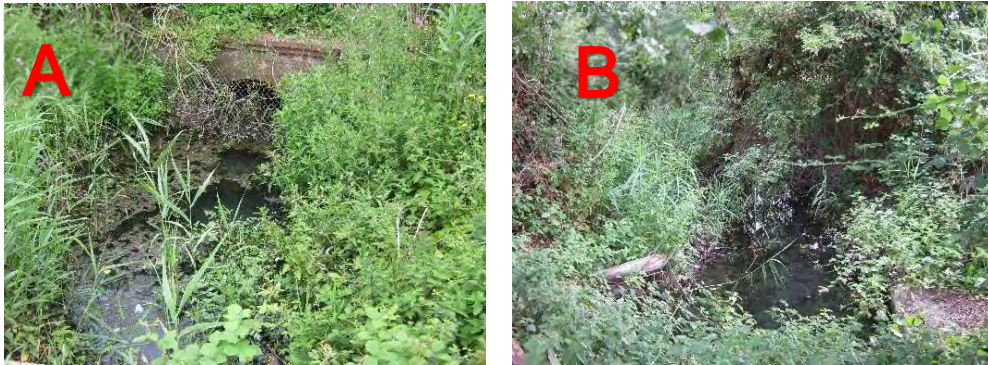
3.3.5.1. Farlington Marshes Gutter is an ordinary river feeding into main river within and adjacent to Section 7 of the Onshore Cable Corridor. No water was observed in the upstream extent of the ordinary river, but stagnant water was present at confluence with the main stem (Plate 3.28 A). The main river is an overgrown trapezoid ditch. Scrub is present on the banks and no perceptible flow was observed (Plate 3.28 B). The ordinary watercourse would be crossed via Trenchless techniques while the main stem will not be crossed but lies adjacent to trenching works.

Plate 3.28 - A. Confluence of ordinary and main branches of Farlington Marshes Gutter with stagnant water present (467910, 104970); B. Looking south east downstream the main branch of Farlington Marshes Gutter (467915,104960)

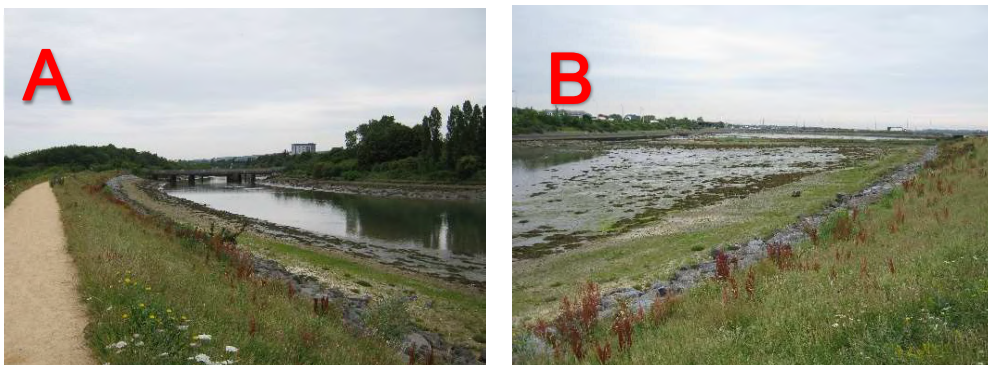
Langstone Harbour is a transitional water body within Section 7 of the Onshore Cable Corridor. Ports Creek is the north western upstream extent of Langstone Harbour where it passes under the A2030. The water body is heavily influenced by tides. Ports creek has undergone extensive re-sectioning with rip rap present on both banks (Plates 3.29 A and B). The left bank also has a reinforced toe with brick lining the left bank. At the time of visiting, the tide was on its way out thus exposing mudflats. Ports Creek feeds into Langstone Harbour, which would be crossed via HDD.

Plate 3.29 - A. Ports Creek looking west (466980, 104090); B. Ports Creek looking east towards A2030 and main body of Langstone Harbour (466980, 104090)

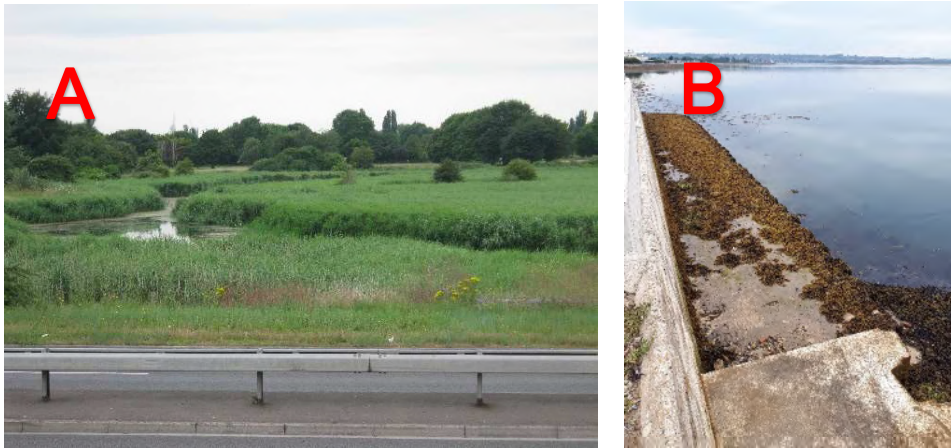
- 3.3.5.3. Concrete lined channel followed by onstream ponds within Section 8 of the Onshore Cable Corridor. The onstream ponds border the edge of Eastern Road where a pumping station is present to pump water from Great Salterns Drain into Langstone Harbour. The onstream ponds have an abundance of reeds present (Plate 3.30 A). No outfall was observed within immediate vicinity, so it is assumed the outfall extends further into the harbour (Plate 3.30 B). This water course would be crossed via trenching above the culverts under the A2030/Eastern Road.

Plate 3.30 - A Looking west across A2030 / Eastern Road towards the onstream ponds of Great Salterns Drain (467650, 101790); B. looking north along the tidal defence adjacent to A2030 / Eastern Road downstream of Great Salterns Drain (467670, 101790)
