AQUIND INTERCONNECTOR

Environmental Statement – Volume 3 – Appendix 16.3 Arboriculture Report - Low Resolution Part 1

Document Ref: 6.3.16.3

DATE: 14 NOVEMBER 2019

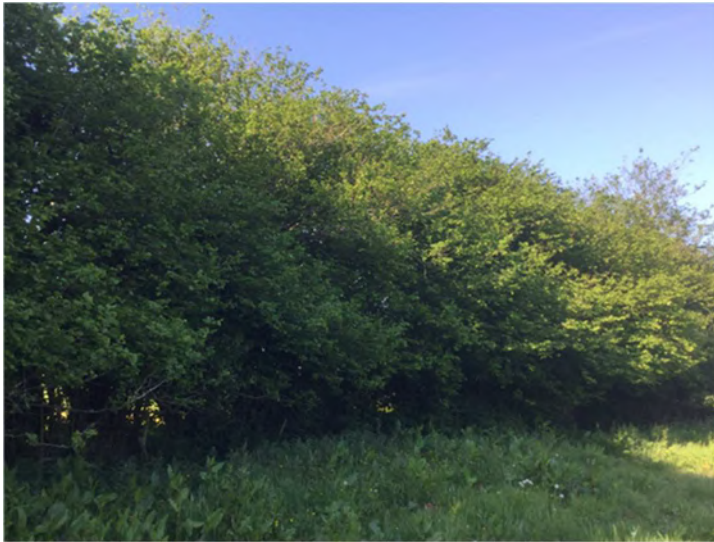
- 1.7.2.4. A total of 27 high value features were identified in the Study Area of Section 1. A proportionally high number of high value features are located within section 1. Located around the existing National Grid owned Lovedean Substation is Ancient Woodland and associated groups (W630, W667, W669, W690, W714, W887). Further to the west was a woodland group (G689) which exhibited similar characteristics to the designated ancient woodland. A significant ash tree (T532) with veteran features was located within G689.
- 1.7.2.5. Large mature trees were identified in groups and hedges as boundary features, such as G639 and G662.
- 1.7.2.6. H769 was a hedge of hazel coppice was assessed to be in excellent condition. The large size of the stools (or stumps) suggested these were old trees.

Plate 4 - H769 A high value hedge of hazel coppice
