AQUIND INTERCONNECTOR

Applicant's Response to the Examining Authority's
Further Written Questions (ExQ2) – Appendix 3
A27 HDD Crossing Farlington, UK – CD622
Documentation for Highways England (MG2.1.1)

A27 HDD CROSSING, FARLINGTON, UK

CD622 Documentation for Highways England

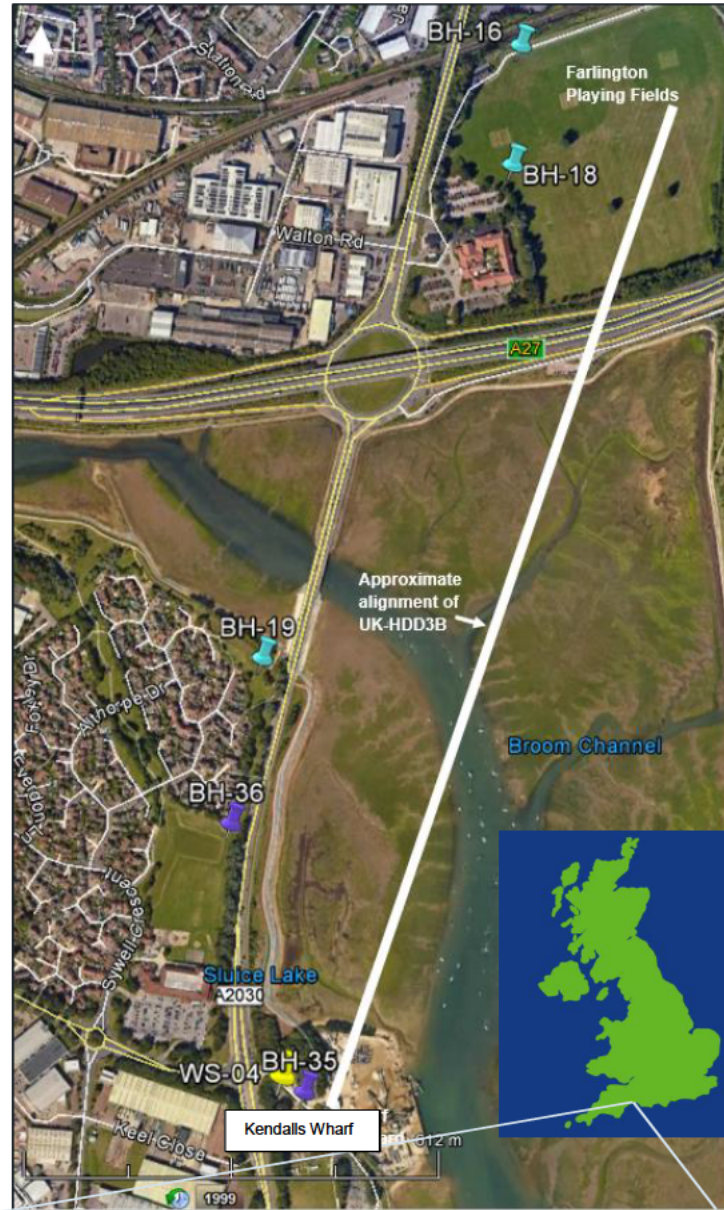
Figure 1: UK-HDD3B location plan (www.google.com)

This reporting focuses solely on the A27 HDD crossing at Farlington, herein known as UK-HDD3B, and is part of the section of the overall interconnector route (see Figure 1).

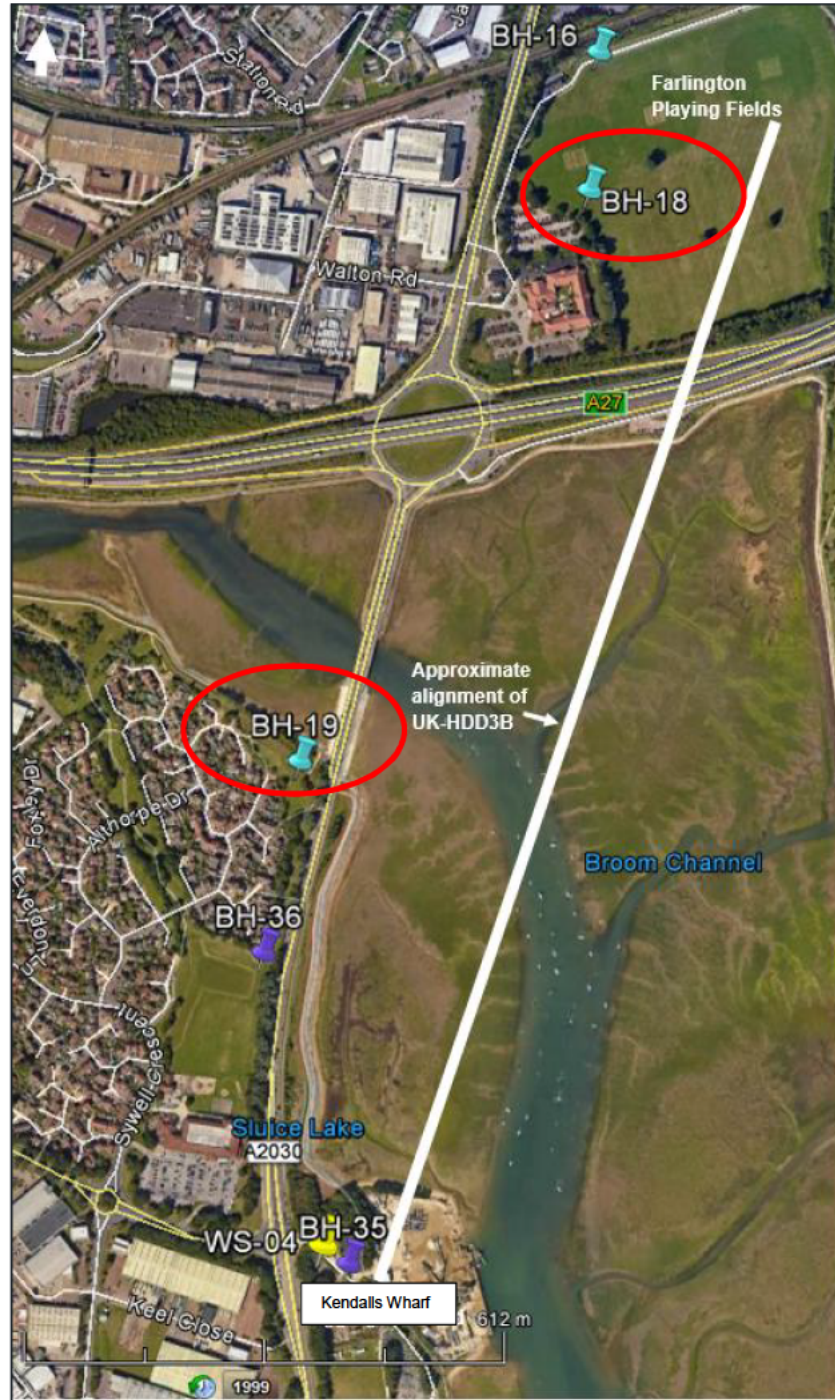
Figure 4: Borehole location plan [70019402-WSP-HGT-G-DR-GE-0117 presented in Appendix A]

The nearest boreholes to the HDD crossing of the A27 are BH18 and BH19 to the north and south of the A27 respectively, see Figure 4 and drawing 70019402-WSP-HGT-G-DR-GE-0117 presented in Appendix A.

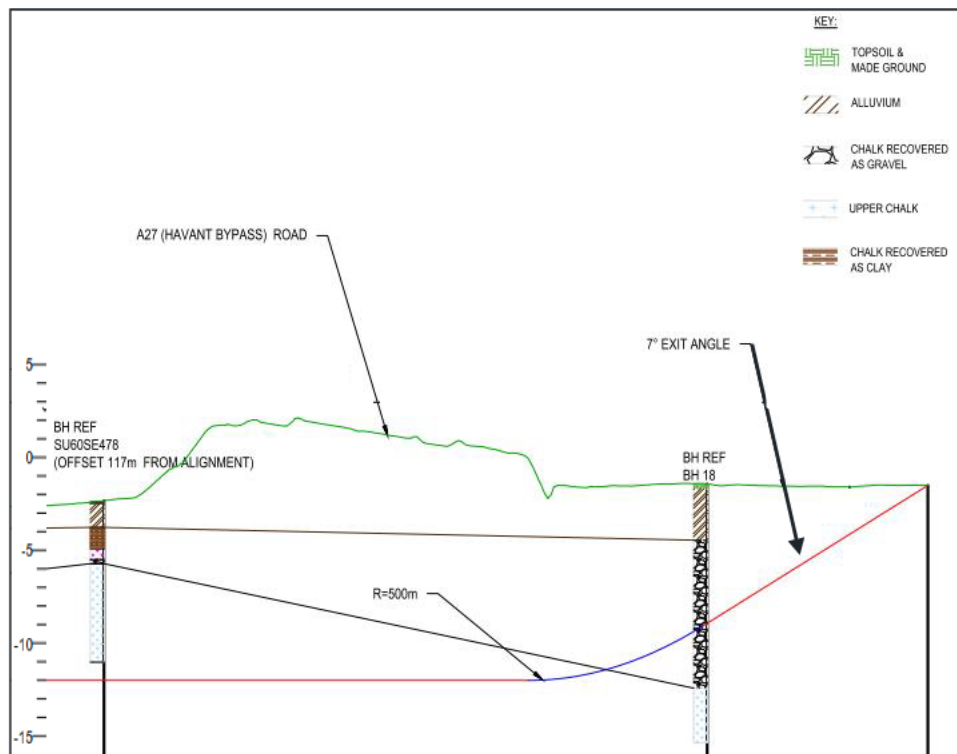
Figure 5: UK-HDD3B Section Extracted from Location Plan Drawing [12731-WIE-ZZ-XX-DR-C-90302-A01 presented in Appendix A]

Figure 5 shows the vertical relationship between the A27 (green) and the HDD bore (red and blue).

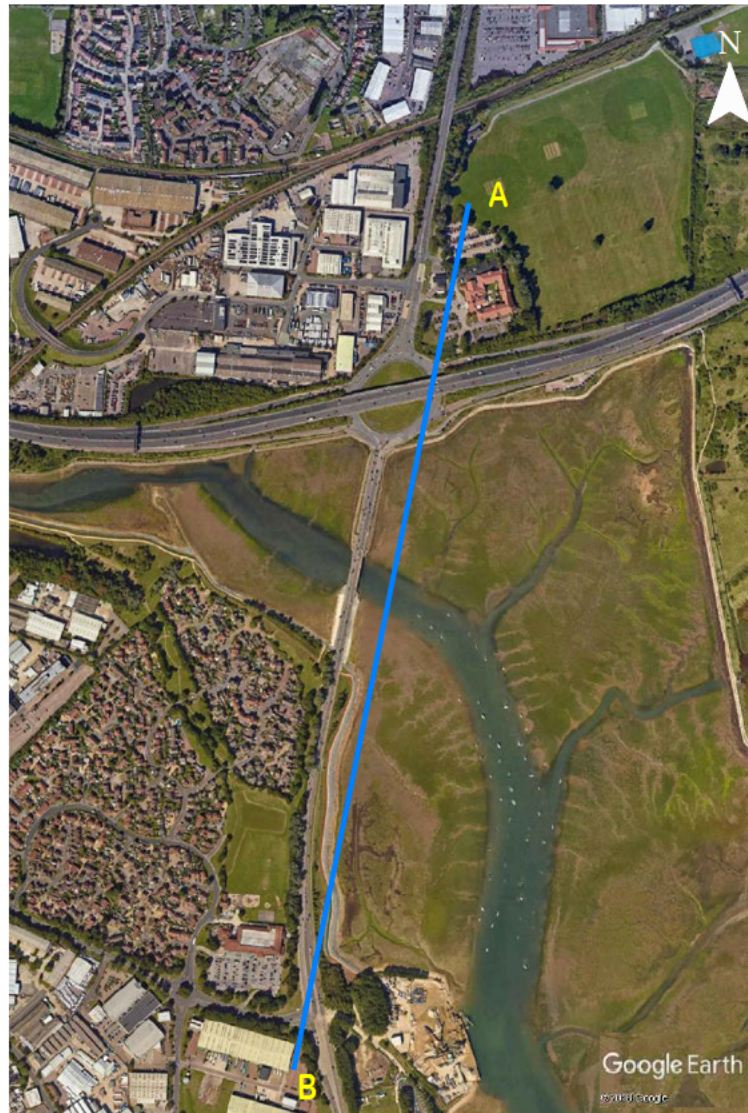
SATELLITE IMAGE OF HDD LOCATION (2017)

- ### CONSTRAINTS KEY
- SU61SE14 HISTORICAL BOREHOLE LOCATION
 - HISTORICAL INFILLED POND
 - HISTORICAL LANDFILL
 - HISTORICAL INDUSTRIAL LAND USE
 - ASSUMED HISTORICAL INDUSTRIAL LAND USE
 - ARCHAEOLOGICAL FEATURE
 - ASSUMED ARCHAEOLOGICAL FEATURE
 - RECLAIMED LAND
 - A+ PROVEN PRESENCE OF ASBESTOS THROUGH LABORATORY TESTING
