AQUIND INTERCONNECTOR

Environmental Statement Addendum – Appendix 13 Framework Management Plan for Recreational Impacts

Document Ref: 7.8.1.13

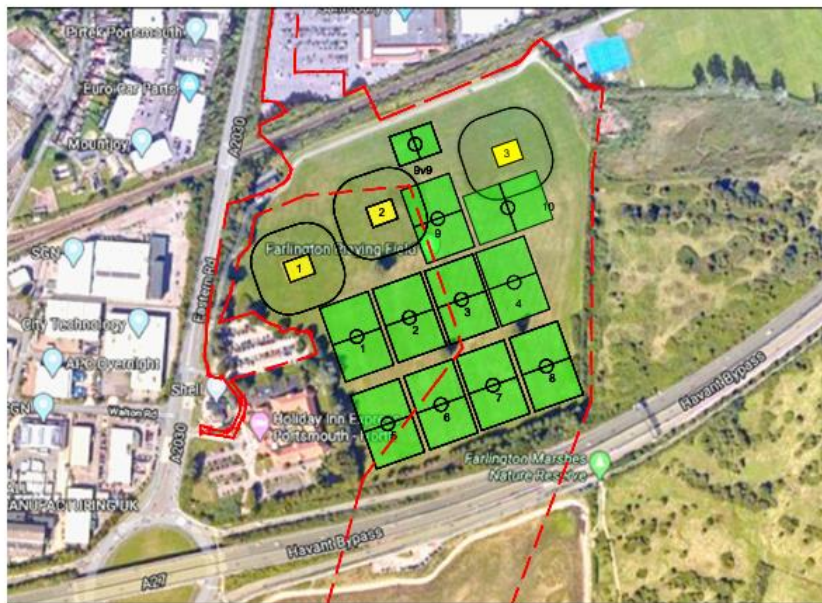
Plate 1 - Farlington Playing Fields

4.2.1.2. PSD note that Farlington Playing Fields is Sport England Pitch Grade Type 5 Pipe drained with sand slits, and comment that the site surveys observed that the existing slit drains installed in 2004 are no longer functional.

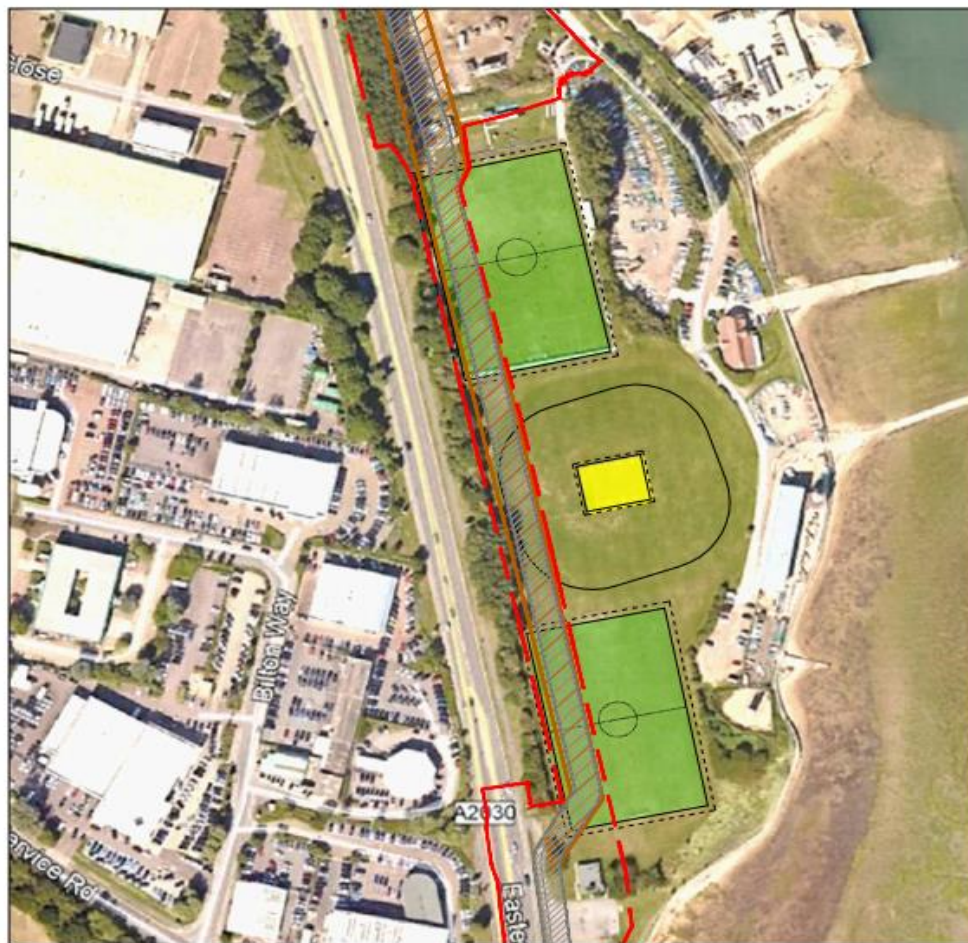
Plate 3 - Baffin Milton Rovers football ground and Langstone Harbour Sports Ground

- 4.2.2.1. Baffins Milton Rovers Football Club ('BMRFC') football ground and Langstone Harbour Sports Ground comprise two football pitches, of which the main pitch is at the northern end of the ground, and the secondary pitch to the south. A cricket pitch is situated between the two football pitches (see Plate 3).
- 4.2.2.2. PSD note that the southern football pitch is Sport England Pitch Grade Type 1 Undrained.

- 4.2.2.7. For trenching, temporary working areas could be positioned anywhere within the Order Limits, with the cable corridor typically no more than 15 m in width, and up to 450 m in length at this location, although this may be broken down into sections.

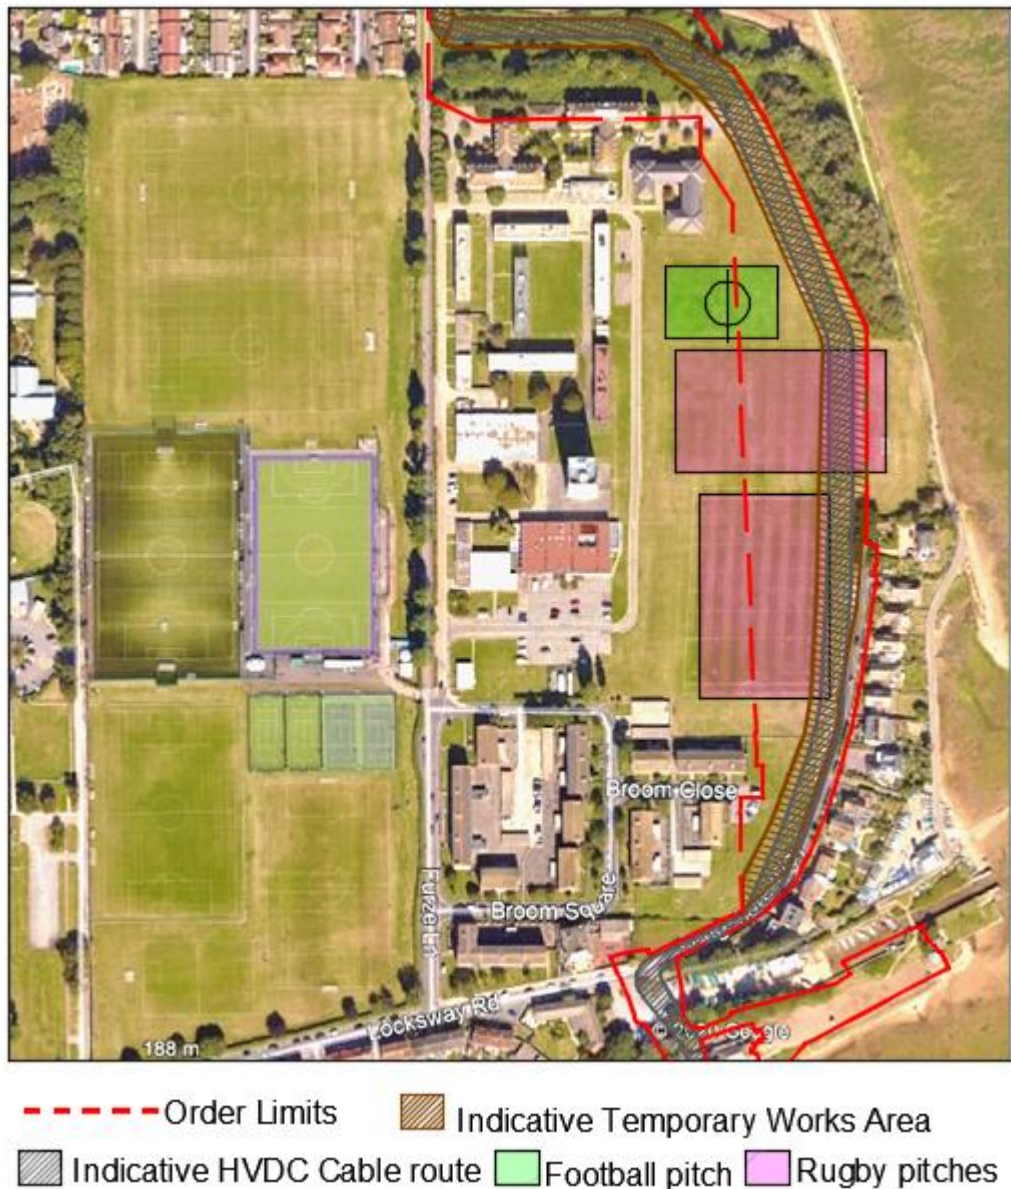
Plate 4 - University of Portsmouth playing fields

4.2.3.1. The University of Portsmouth Playing Fields are located in the eastern part of the Langstone Campus (see Plate 4). PSD note that the University of Portsmouth Playing Fields are Sport England Pitch Grade Type 1 undrained.

4.2.3.4. The PSD survey noted that no pitch markings were evident at the time of the visit, and it was reported that the site had been left for geese activity for the past 2 years. Extensive contamination of the surface by geese faeces was evident with damage to the sward noted caused by the geese ripping at the grass.

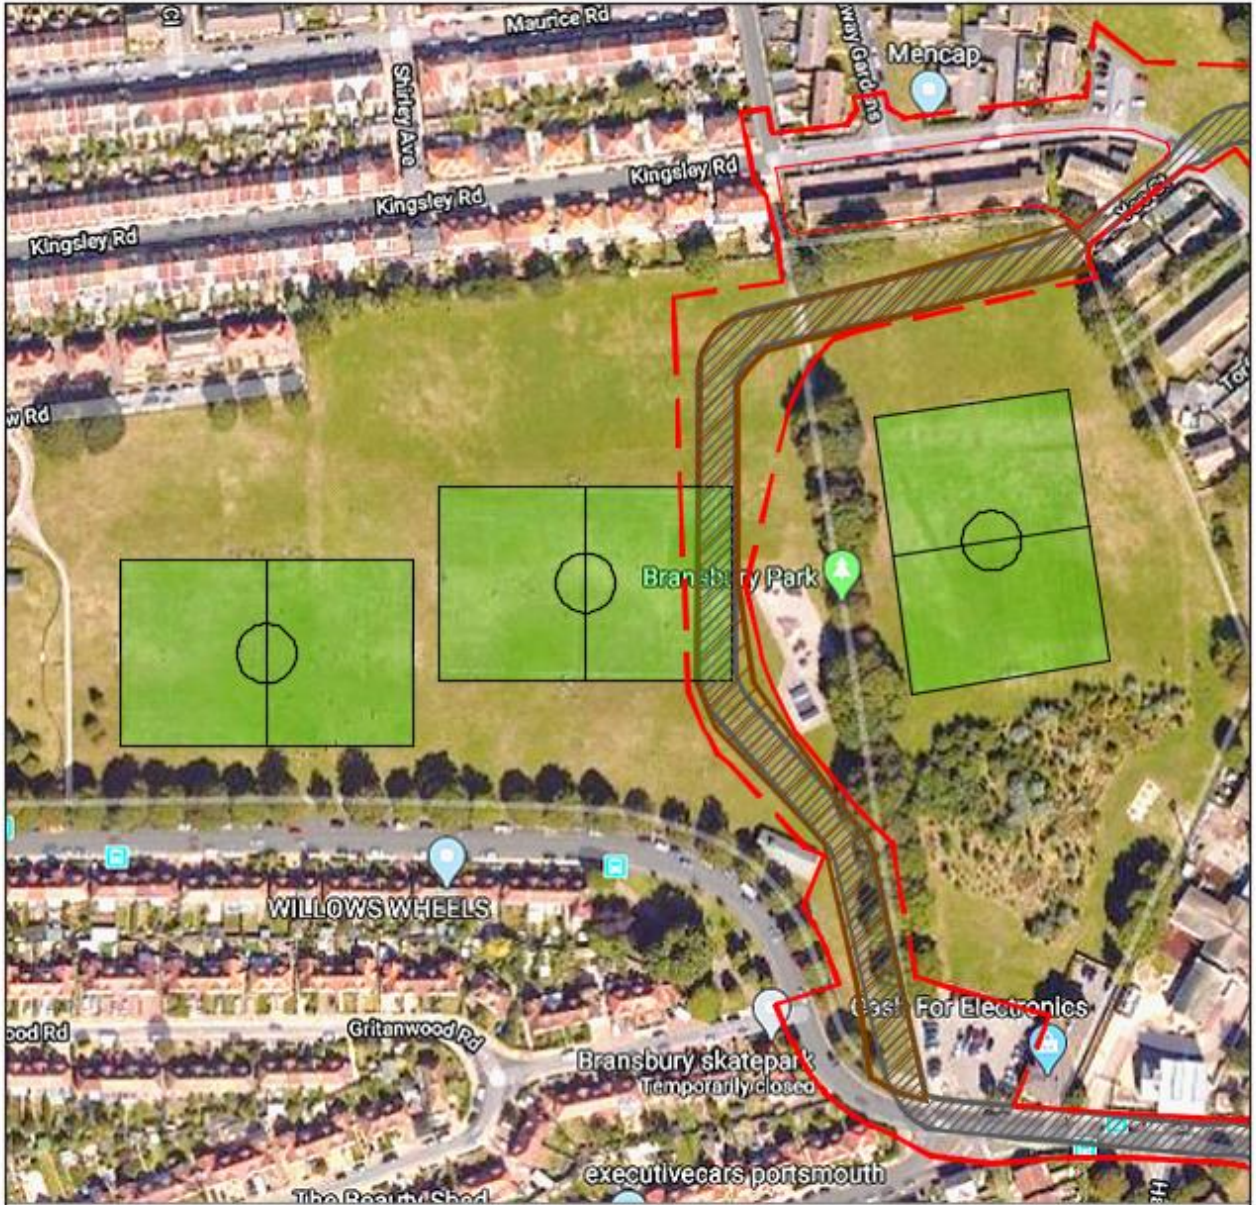
Plate 6 - Bransbury Park

4.2.4.1. Bransbury Park includes a flower garden, children’s play area, skate park, and three football pitches. The Order Limits impinge upon one of the football pitches and also a footpath that crosses the park (see Plate 6). Facilities within the park are publicly accessible, with the football pitches available for public use at all times for informal recreation.

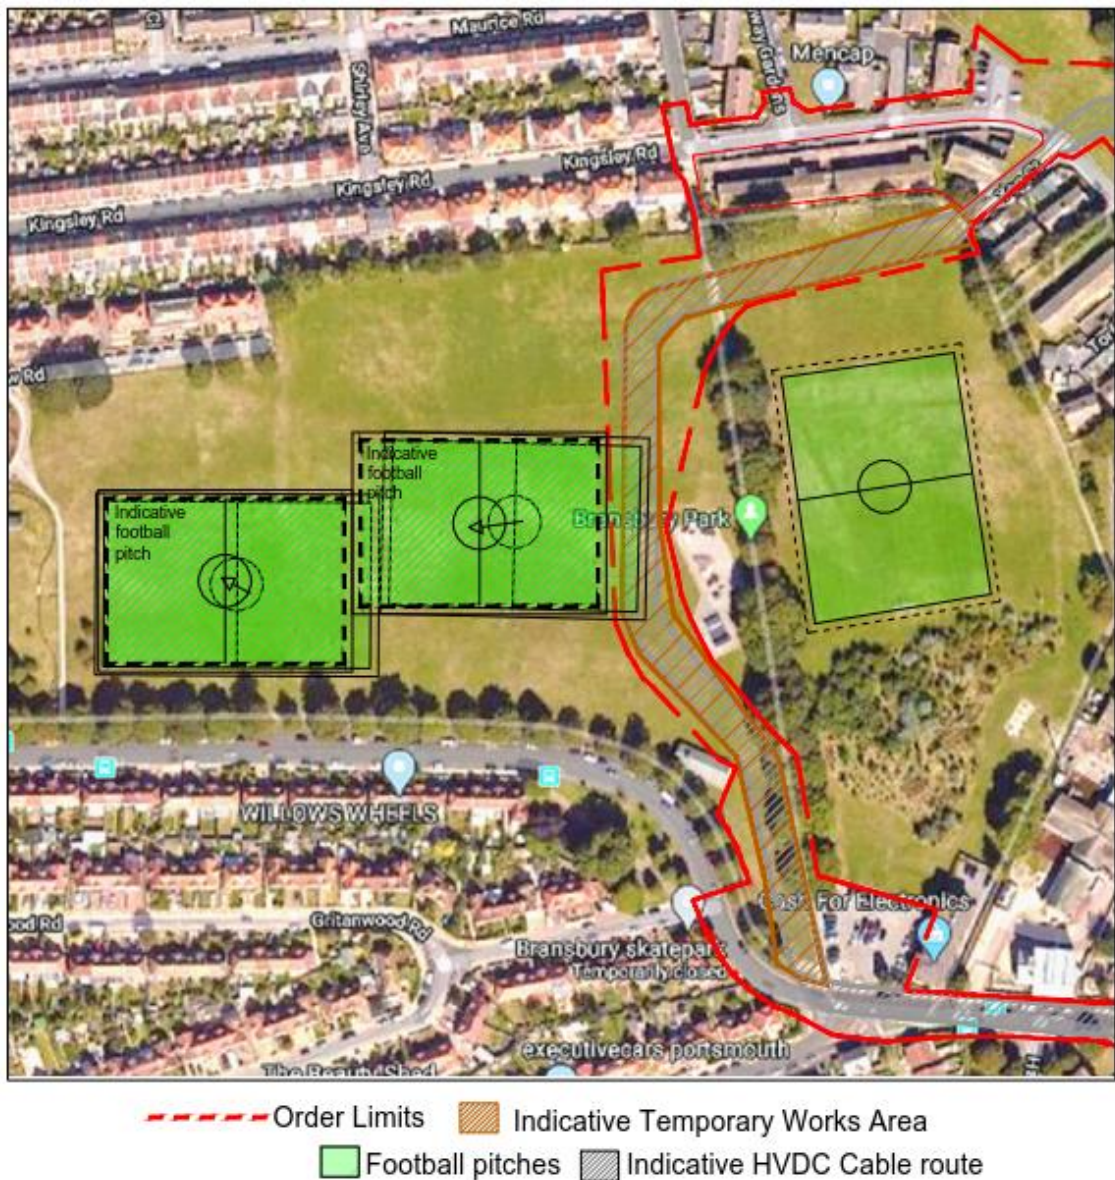
Plate 7 - Bransbury Park, indicative construction layout

- 4.2.4.10. If the middle pitch is not realigned, the worst case assessment is that it will be lost for up to 12 weeks (4 weeks construction period and an allowance of 8 weeks for reinstatement). This would be reduced if reinstatement can take place in the 2-3 weeks assessed by PSD. However, the recommendation is that middle and western football pitches are resized and reconfigured to be outside of the order limits, which would avoid recreational disturbance for users of the football pitches.

- 4.2.4.8. PSD's site survey noted that due to a group of 3 trees being present at the western end of the western pitch (preventing a western realignment), that temporary resizing of both the western and middle pitches was the most appropriate option for reconfiguration, providing one existing goalmouth (which will form part of the penalty area of the relocated central pitch) is reinstated at the end of the 2020/21 season, prior to the works taking place.

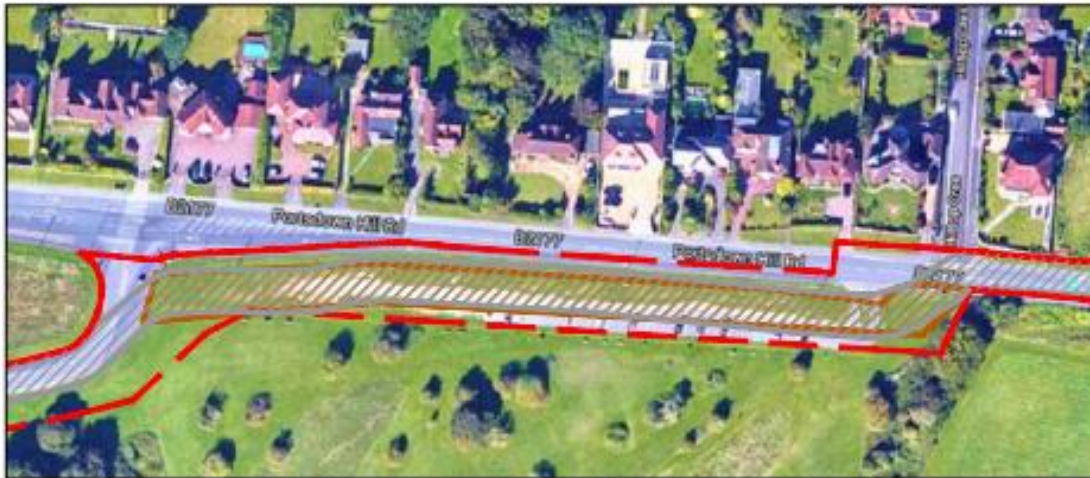
Plate 8 - Portsdown Hill and car park

4.2.5.1. Portsdown Hill is an informal recreation space with picnic benches and views south towards the sea. It is served by a car park accessed from Portsdown Hill Road (Plate 8).

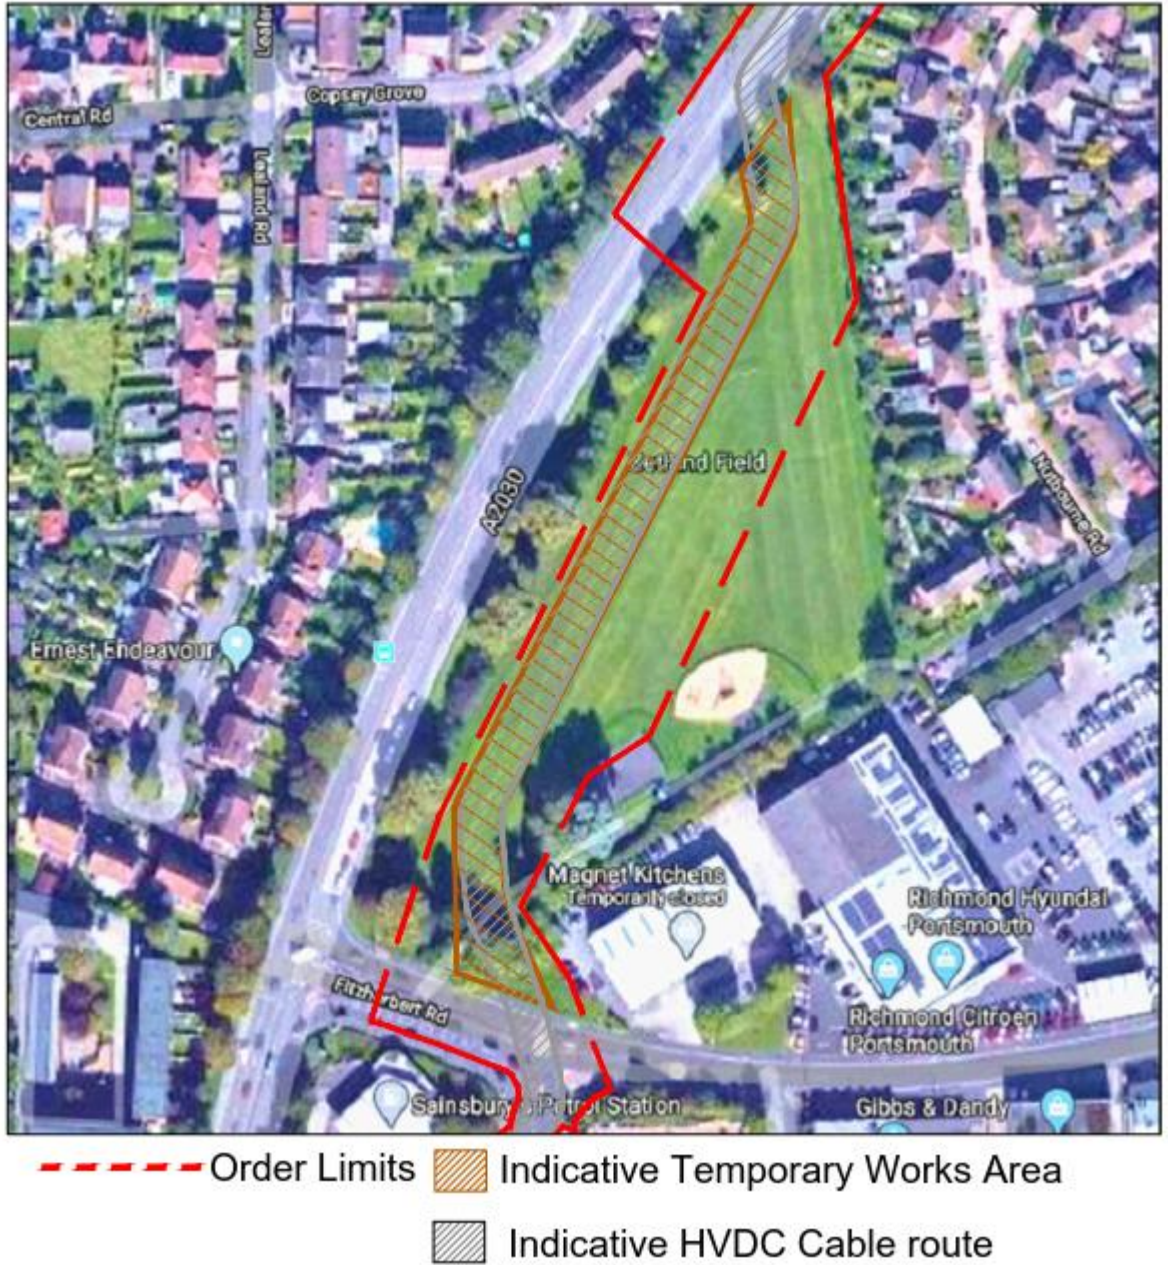
Plate 9 - Zetland Field, indicative construction layout

4.2.6.1. Zetland Field is a recreational open space which includes a playground and a single football goal, used for informal play (with no marked or formal football pitch) (see Plate 9).

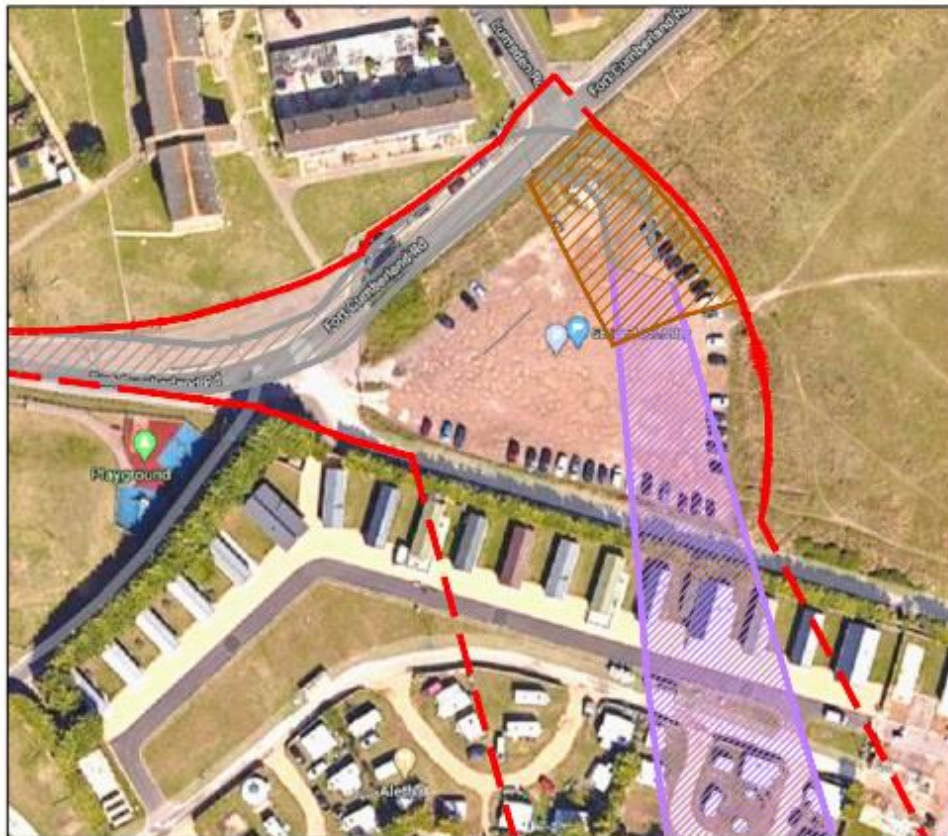
- 4.2.8.1. The Fort Cumberland Road car park may be used in connection with the adjacent Fort Cumberland Site of Importance for Nature Conservation (SINC), and to Eastney Beach. The car park has capacity for approximately 100 vehicles (in informal unmarked spaces). Construction activity in the Fort Cumberland Road car park would cause temporary loss of amenity and has the potential to impede access to the SINC and beach for recreational users.
- 4.2.8.2. Works would be undertaken for a period of up to 66 weeks (not continuously) and this would be dependent on weather conditions, due to its association to the offshore element of the Proposed Development. The site is shown in Plate 11.

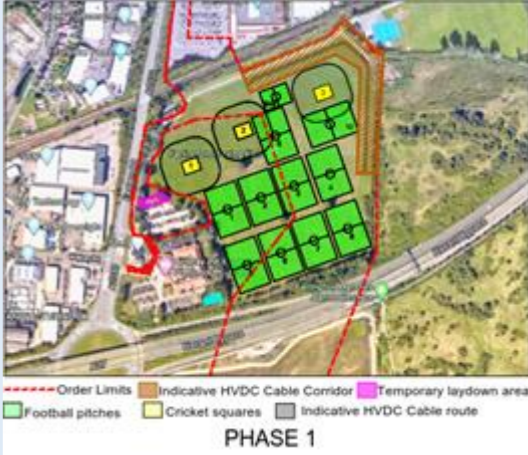
Phase	Works	Indicative construction Date	Description	Works footprint
1	Use of a small portion of the car park for initial plant and materials deliveries. Duct installation for both circuits (“CCTs”) contained within The Indicative High Voltage Direct Current (HVDC) Cable corridor which is 12m in width. Area outside footprint of cable trenches is protected with track matting.	April 2022 (2 weeks)	The Indicative Temporary Works area would affect the corner of football pitch 10, as well as the northern section of the car park

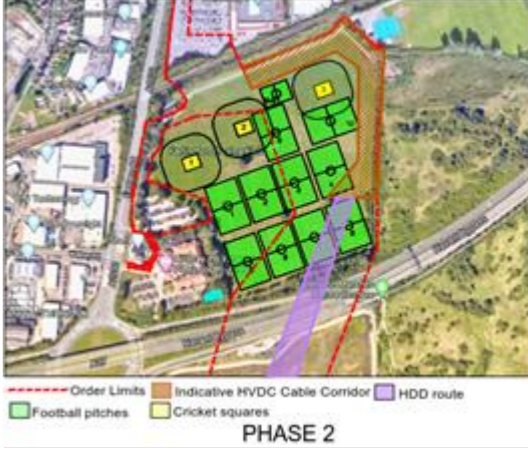
<p>PHASE 2</p>

<p>PHASE 1</p>
2	1st Circuit HDD3 duct stringing and welding contained within the Indicative HVDC cable corridor protected with track matting.	Mid-April – June 2022 (6 weeks)	The Indicative Temporary Works Area would directly impact football pitches 4, 8 and 10. The Indicative Temporary Works area adjacent to the 9v9 football pitch and cricket pitch 3.

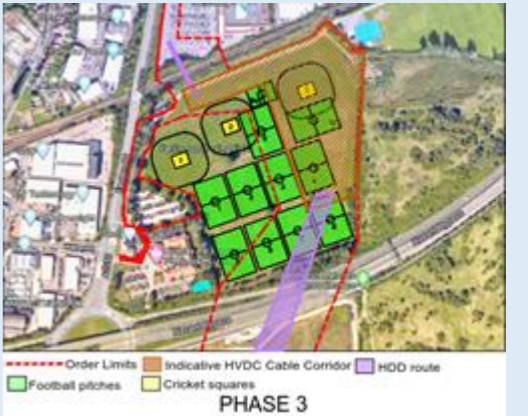
<p>PHASE 3</p>

3	The Indicative HVDC Cable Corridor includes construction compounds associated with HDD3 and HDD4 construction activities.	June 2022 – Mid August 2022 (13 weeks) Note- HDD4 requires 24/7 working to complete works within this duration	The Indicative Temporary Works Area would affect the 9v9 football pitch, football pitches 4, 8 and 10, and cricket pitch 3. The Indicative Temporary Works Area is adjacent to cricket pitch 2, along with football pitches 3, 7, and 9.

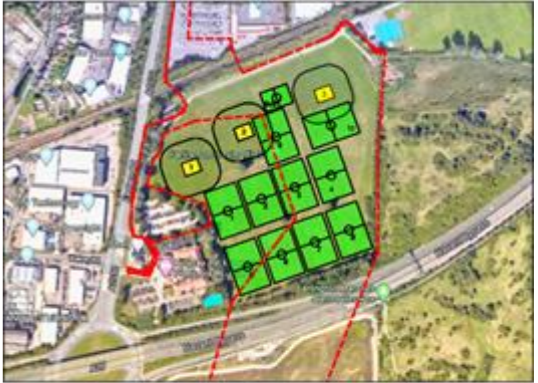
Phase	Works	Indicative construction Date	Description	Works footprint
4	HDD3 and HDD4 all clear for the Victorious Festival.	Late August 2022 (2 weeks)	The site is used for Victorious Festival off-site camping during August bank holiday.

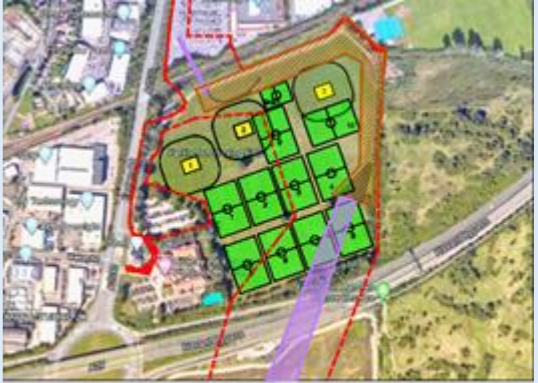
<p>Order Limits Football pitches Cricket squares PHASE 4</p>
5	Indicative HVDC Cable Corridor includes temporary working areas for connections from ducts to HDD3 and HDD4, Joint Bay Construction, HVDC cable installation, HVDC jointing, and joint bay back fill / reinstatement	September 2022 (4 weeks) An additional 8 weeks once the works are complete, for re-turfing.	The Indicative Temporary Works Area would affect the football pitches 4, 8, 10, the 9v9 football pitch and cricket pitch 3. . The Indicative Temporary Works area is adjacent to cricket pitch 2.

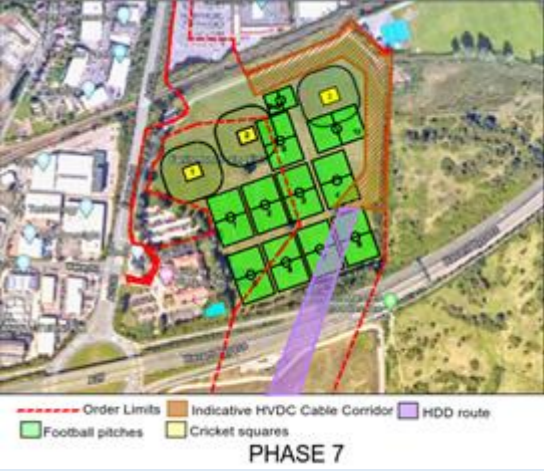
Phase	Works	Indicative construction Date	Description	Works footprint
7	2nd Circuit HDD3 duct stringing and welding contained within the Indicative HVDC Cable corridor protected with track matting.	Mid-April – June 2023 (6 weeks)	The Indicative Temporary Works Area would affect football pitches 4, 8 and 10, and is adjacent to the 9v9 football pitch and cricket pitch 3

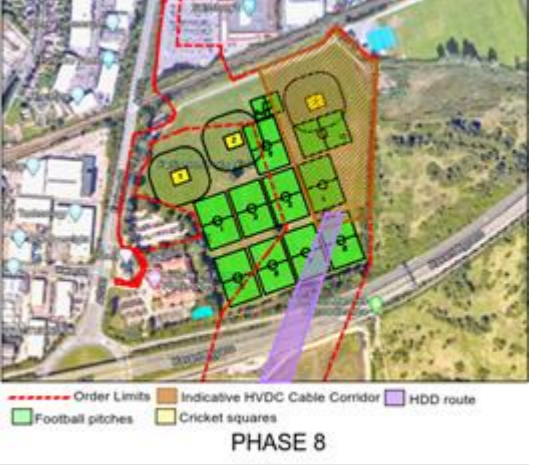
8	Indicative HVDC Cable Corridor includes construction compound associated with HDD3.	June 2023 – Mid Aug 2023 (13 weeks)	The Indicative Temporary Works Area would affect football pitches 4, 8, and 10, the 9v9 football pitch, Cricket pitch 3. The Indicative Temporary Works Area is adjacent to football pitches 3, 7, and 9.

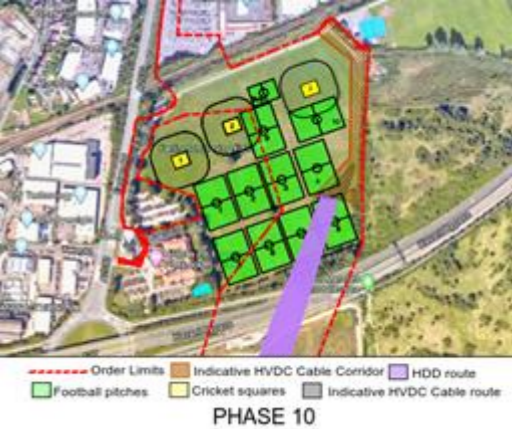
Phase	Works	Indicative construction Date	Description	Works footprint
10	Indicative HVDC Cable Corridor includes temporary working area for connections from ducts to HDD3, joint bay construction, HVDC cable installation, HVDC jointing and joint bay back fill / reinstatement for 2nd circuit.	September 2023 (4 weeks) An additional 8 weeks once the works are complete, for re-turfing.	The Indicative Temporary Works Area would affect football pitches 4 and 8. The Indicative Temporary Works Area is adjacent to football pitch 10.

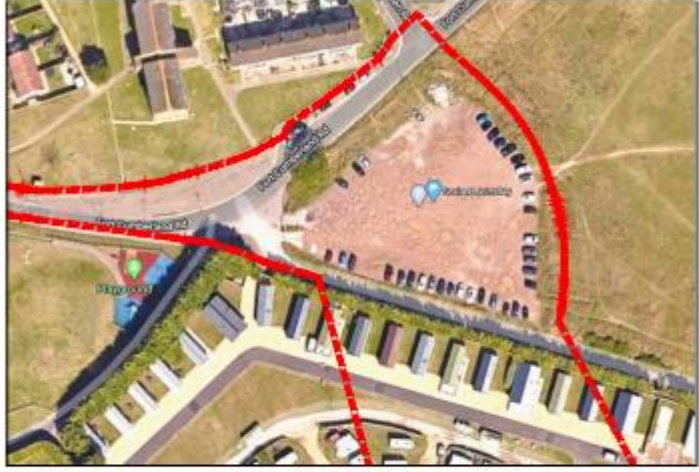
<p data-bbox="1792 890 1982 911">Order Limits</p> <p data-bbox="2101 926 2228 957">PHASE 3</p>
4	Construct TJB for 2 nd circuit, pull onshore and offshore cables, joint and permanently reinstate	5 weeks Q3 2022	50% of car park occupied

Phase	Works	Indicative Construction Date	Description	Works footprint
1	HDD assumed for all ducts	44 weeks Q3 2021 to Q2 2022	75% of car park occupied	<p style="text-align: center;">PHASE 1</p>
2	Construct TJB for 1 st circuit, pull onshore and offshore cables, joint and permanently reinstate	5 weeks Q2 2022	50% of car park occupied	<p style="text-align: center;">PHASE 2</p>

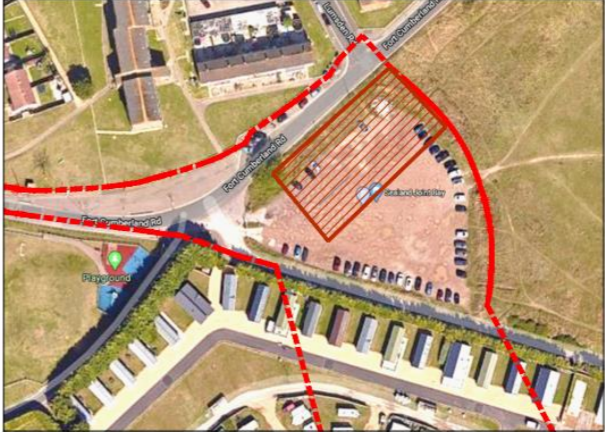
<p data-bbox="1804 856 2368 884">--- Order Limits ■ Indicative Temporary Works Area</p> <p data-bbox="2077 898 2196 926">PHASE 5</p>
6	Car park all clear	Q2 2023	-

Phase	Works	Indicative Construction Date	Description	Works footprint
5	Construct Optical Regeneration Station (ORS)	12 weeks winter 2022-2023	50% of car park occupied

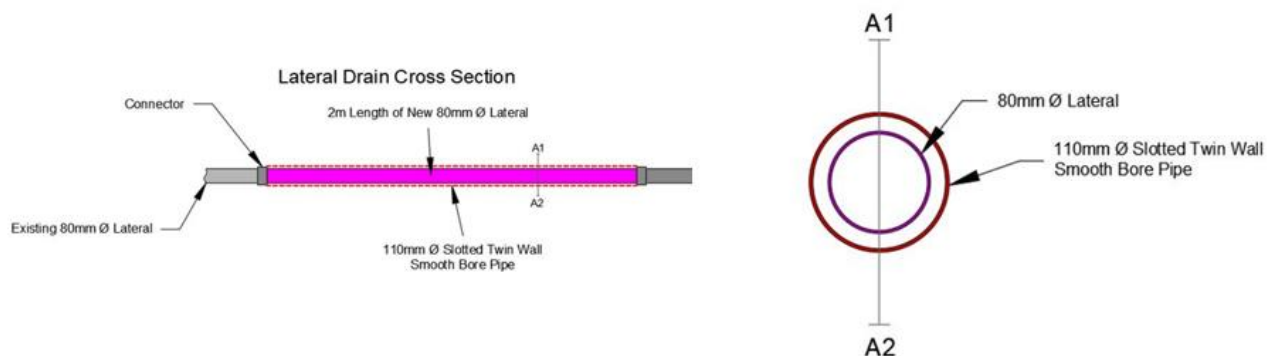
Plate 2 – Proposed lateral drain reinstatement

It is anticipated that the reinstatement of short lateral drainage runs affected during duct trench works will be undertaken using 80mm diameter uPVC perforated pipe sleeved inside a 100mm diameter slotted twin wall smooth bore pipe (see Plate 2) to ensure that existing pipes are securely reconnected with the twin wall pipe providing additional rigidity to mitigate against potential future settlement. This approach or a suitable alternative will be confirmed in the reinstatement plan.

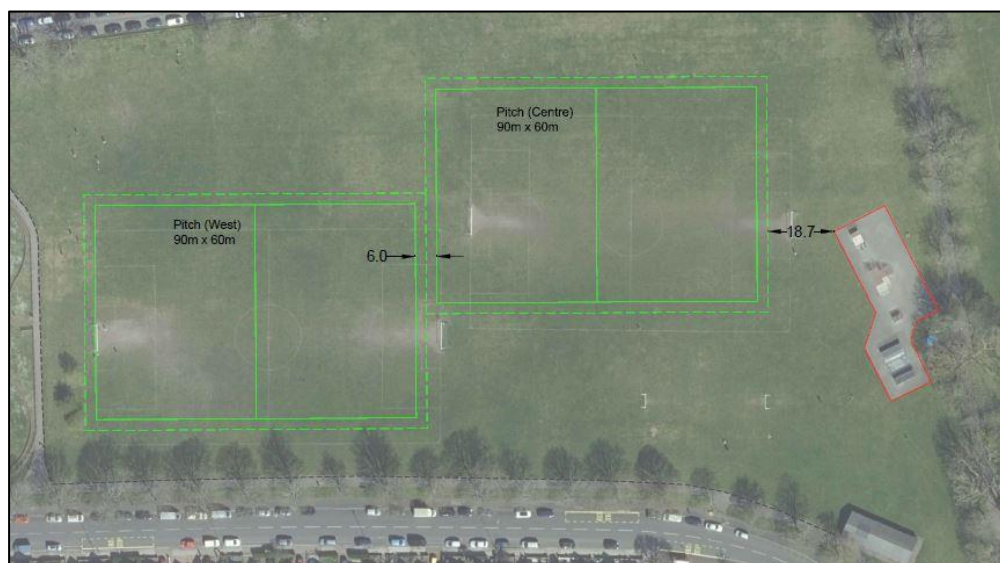
Plate 2: Bransbury Park proposed pitch layout

Seeding is not considered an option for this site due to the time of year.

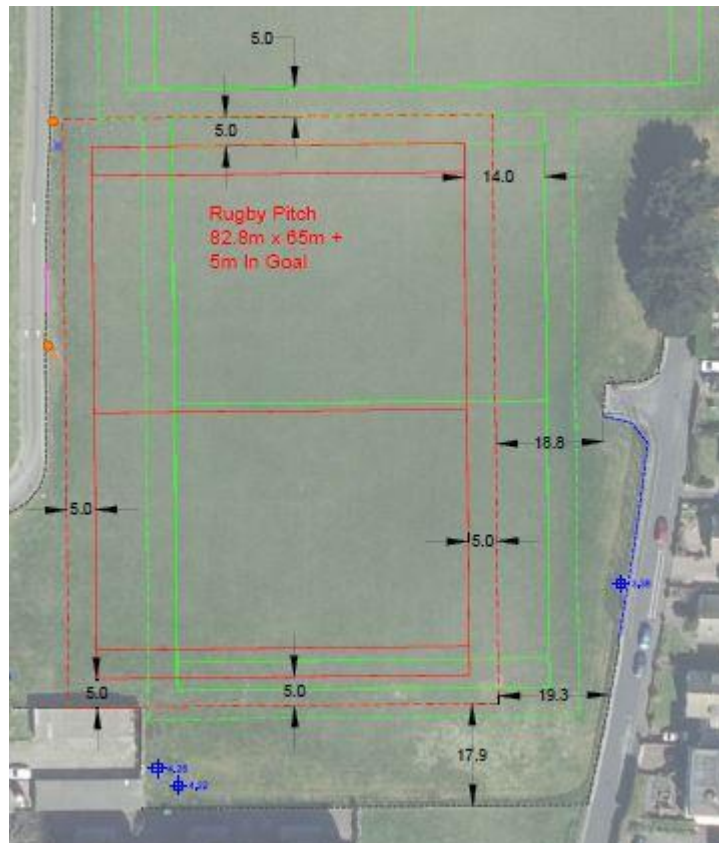
Plate 3: University of Portsmouth proposed temporary pitch layout

Seeding is not considered a feasible option for this site due to the time of year when works must be completed and potential stone contamination in the topsoil.

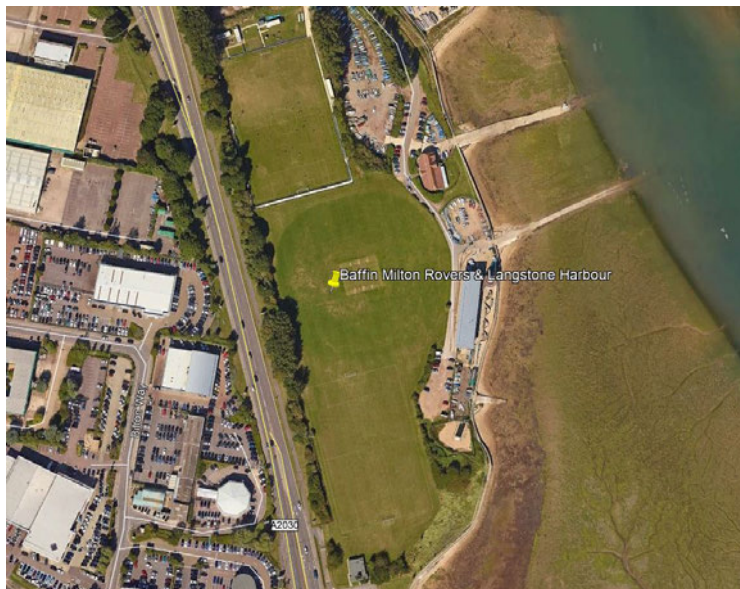
Plate 4: Langstone Harbour Sports Ground (note Baffins Milton Rovers FC to the north of the site)

With access to the work area crossing either the cricket outfield or the football pitch, use of appropriate trackway will be essential and ideally moved during the works to minimise the grass dying back.

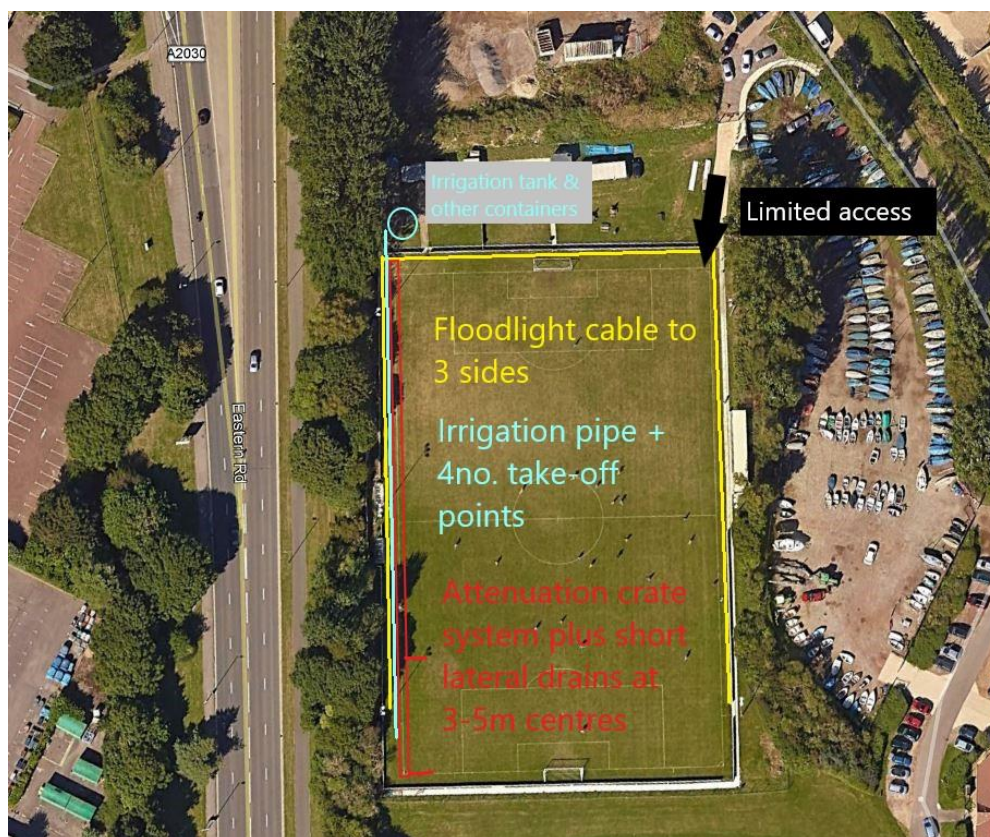
Plate 5: Baffins Milton Rovers FC – existing services

Other services and infrastructure that are present (see Plate 5 and Appendix 3) and should be noted are:

Subject to agreement with the Club, reinstatement could potentially be backfilling of excavated materials only although allowance should be made for the importing of topsoil or proprietary sand:soil rootzone if the excavated topsoil is of very poor quality.

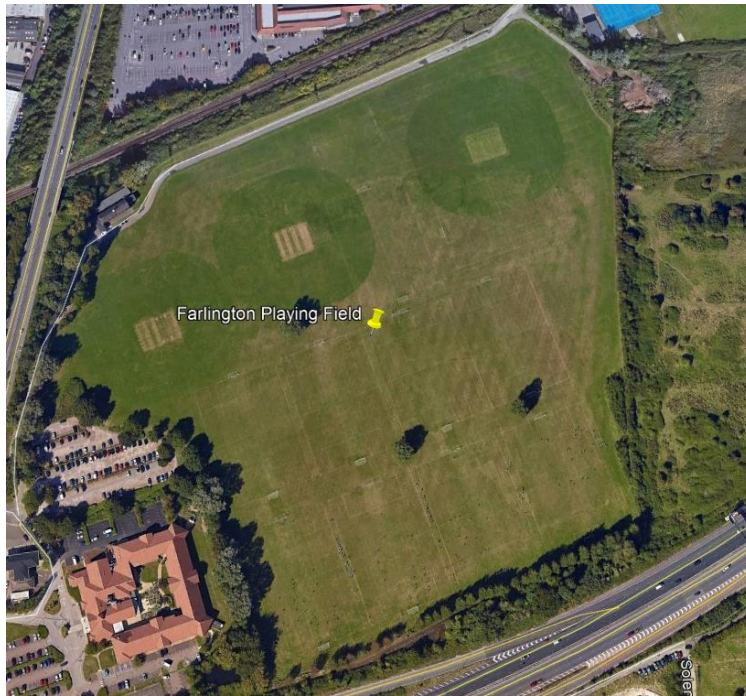
Plate 6: Farlington Playing Field

Pipe and slit drains capped with soil, infiltration tests recorded 0mm/hr in 9v9 proposed temporary location; gravel backfill of lateral drains clean and in good condition below 200mm; flow test excellent, suitable for connecting new secondary drainage into.

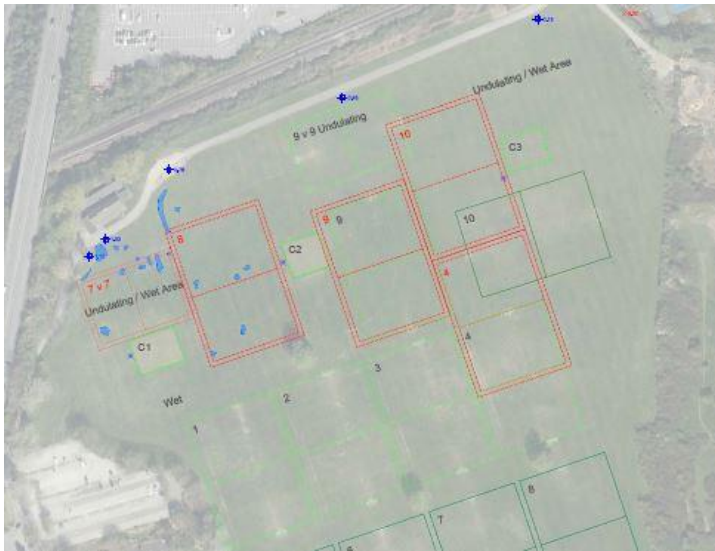
Plate 7: Farlington proposed pitch relocation mitigation as per FMP

It should be noted that reviewing the proposed pitch relocations, to move pitches 4 & 10 as currently proposed in Plate 7, Pitch 9 would also require moving west to provide sufficient space for 3m run-offs to all sides and an irrigation point for Cricket 3 would be in the field of play for Pitch 10. There is also insufficient space for a 73 x 45m 9v9 plus 3m run-offs to the north of Cricket 1 although a 61 x 43m 7v7 plus 3m run-offs would fit, though extensive ponding was evident here at the time of inspection.

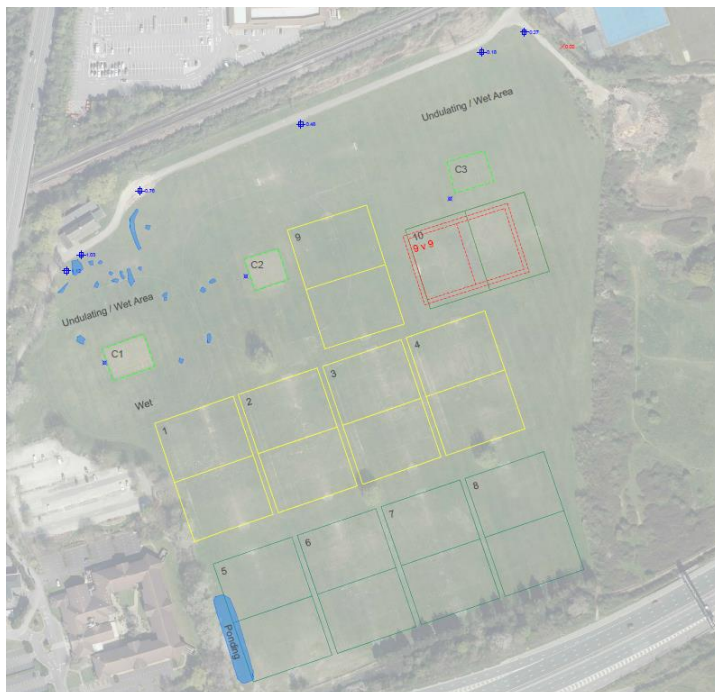
Plate 8: Farlington PSD proposed pitch relocation mitigation

It is also recommended that the cable duct trench route along the eastern elevation is realigned so that the trenches run parallel to the lateral drains allowing them to be installed between drains resulting in no disruption to the drainage in this area until the curve in the north east corner where disruption becomes unavoidable.

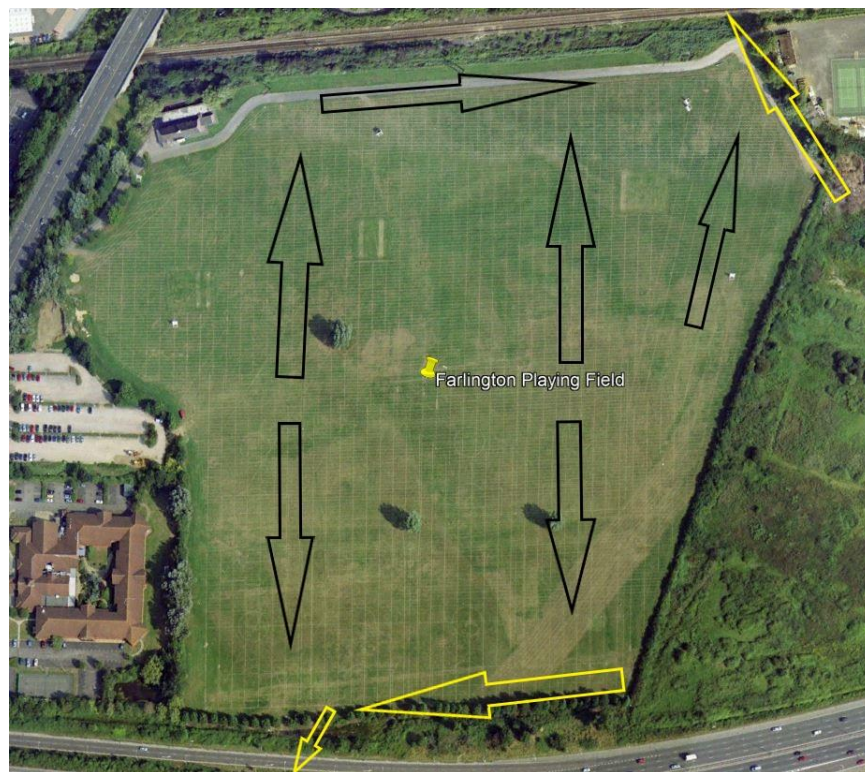
Plate 10: Overview of Farlington topography and surface flow

Plate 10 provides an overview of topography and surface water flow across the site.

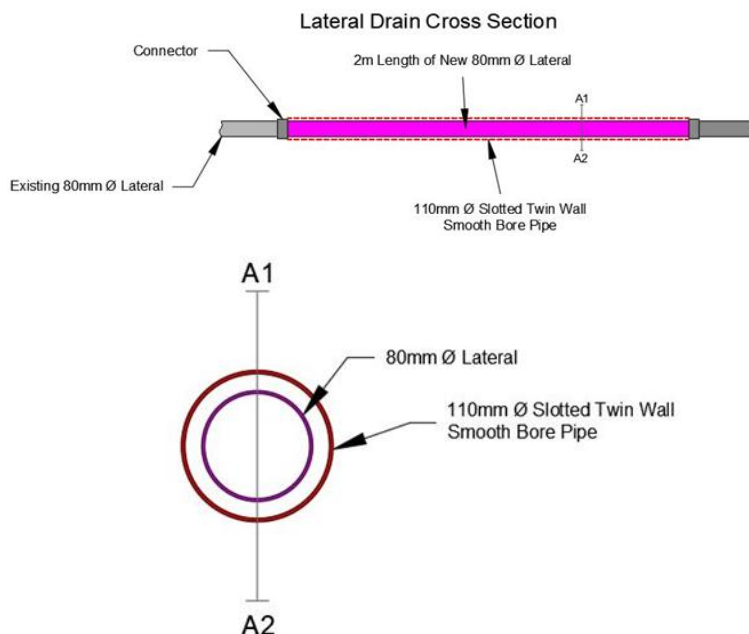
Plate 11: Proposed lateral drain reinstatement

Use of 100mm diameter twin wall smooth bore pipe connected to the existing main drain is recommended for the launch pit area. The timing of the disruption varies in accordance with the phasing of work but it is PSD's understanding that drainage reinstatement will be undertaken at the earliest opportunity upon completion of each section or phase e.g. the HVDC duct trench works in Phase 1 affects the most lateral drains but occurs over the shortest period of time (2 weeks, April 2022). As such it should be possible to cap severed drains, undertake the works and reinstate the drainage.

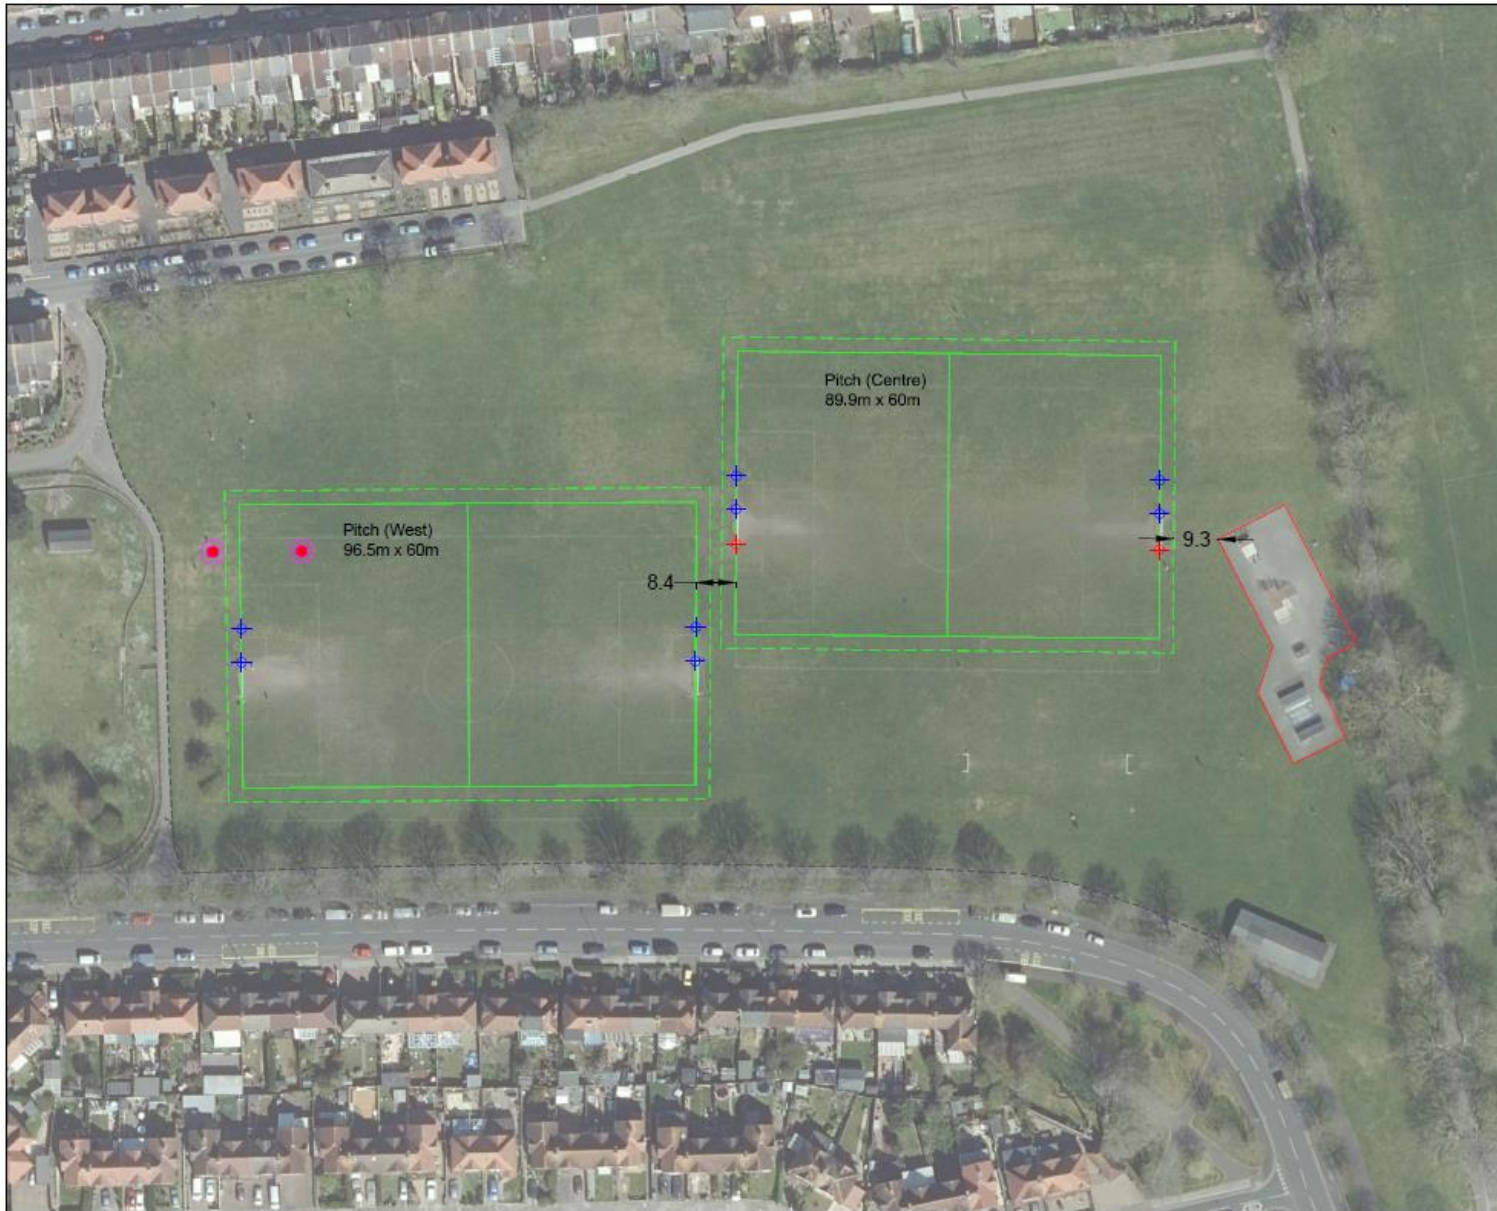
DRAWING **Bransbury Park - Existing Pitch Layout**

EXISTING and PSD PROPOSED TEMPORARY PITCH LAYOUT

Using GPS data taken from site, the existing layout (see Plate 2 below and Appendix 1) provides a gap of circa 9m from the skate park to the run-off for the centre pitch. PSD partially concur with the FMP recommendation of pitch realignment and re-sizing for this site subject to agreement with Portsmouth City Council (PCC).
