AQUIND INTERCONNECTOR

Environmental Statement Addendum – Appendix 13 Framework Management Plan for Recreational Impacts

Document Ref: 7.8.1.13

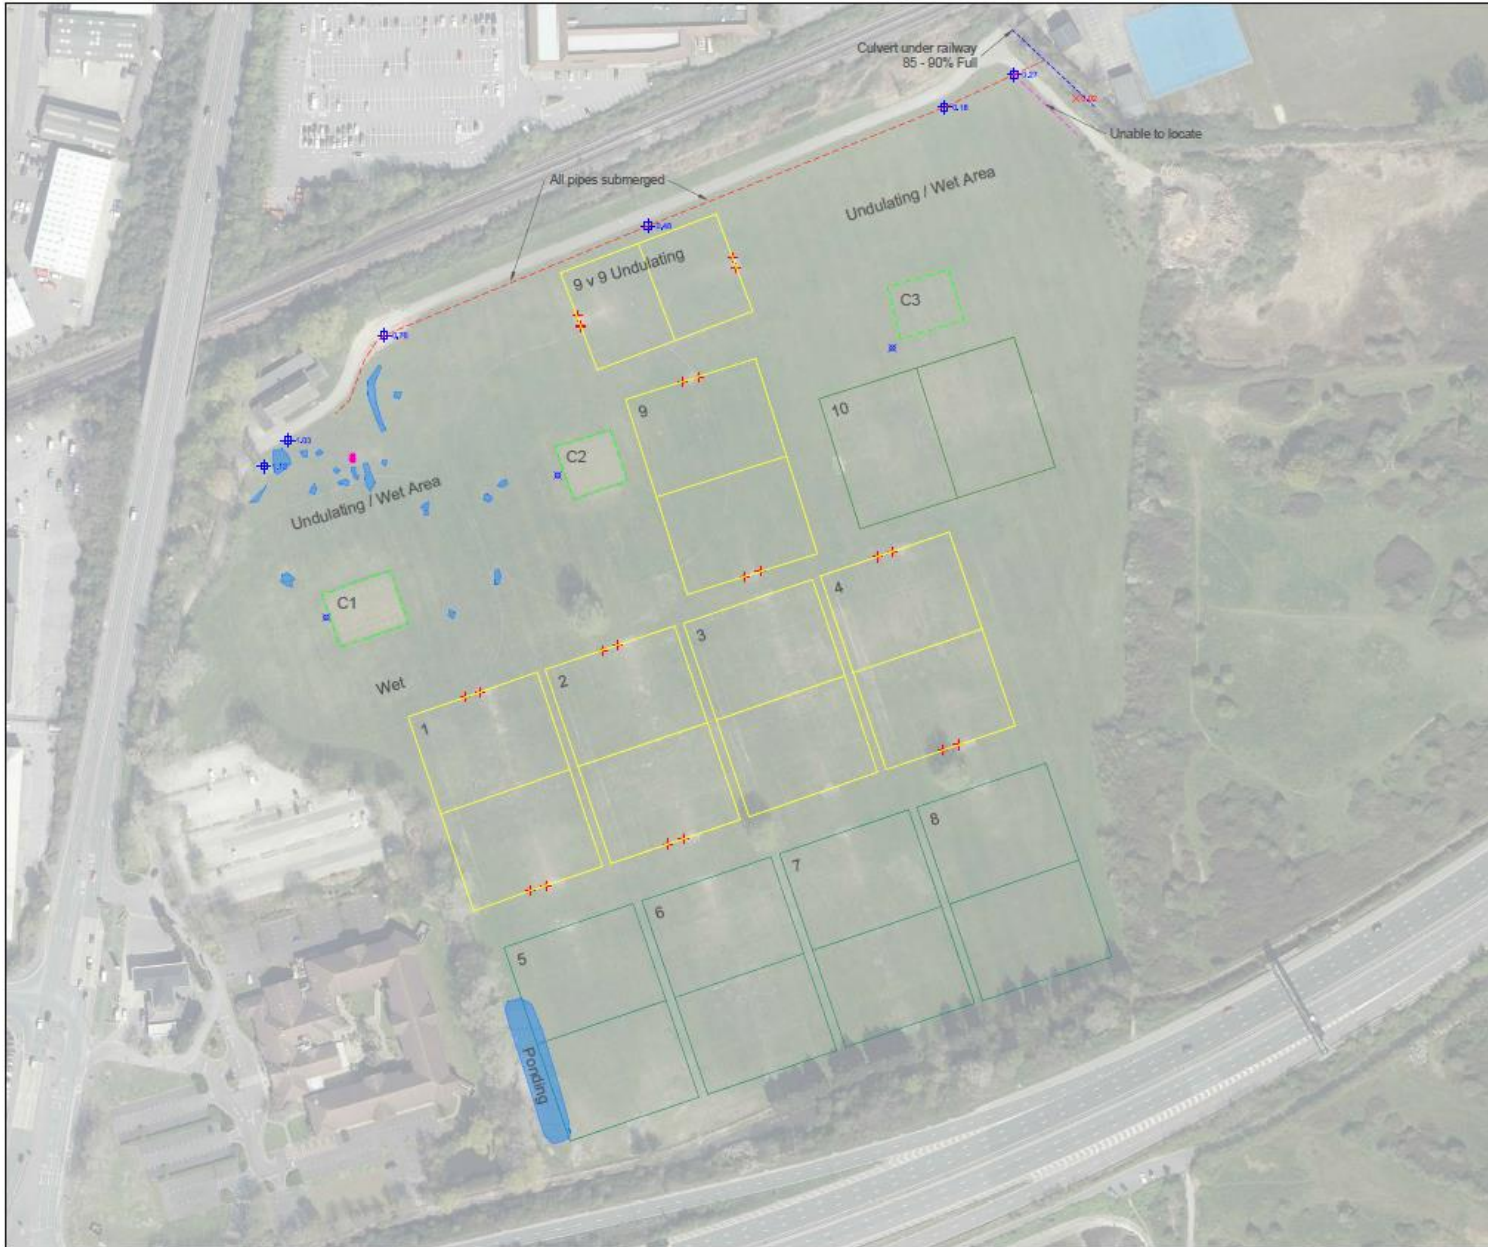
CLIENT	Aquind Limited		
PROJECT	Aquind Interconnector		
DRAWING	Farlington Playing Fields - Existing Pitch Layout		
SCALE	Prelim	ISSUED BY	GO
PROJECT No	1671	DATE	Jan 2021
PAPER SIZE	A1	SCALE	1:1000
REVISION	PI	DRAWING No	1671/001A

EXISTING, FMP & PSD PROPOSED LAYOUTS
