Aquind Interconnector Oral Submission to Compulsory Acquisition Hearing 3 Patrick O'Hara

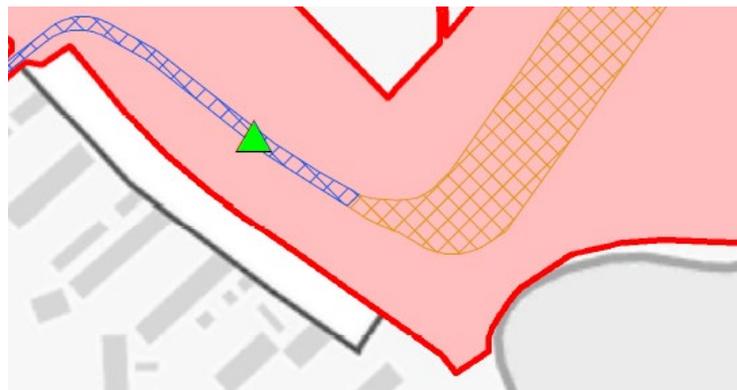
HDD 2 Reception

It is of deep concern then to read that in assessing the area of the HDD 2 reception area as follows. *historical landfill is noted adjacent and to the south-east of Milton and Eastney Allotments. Deposited waste included industrial, commercial and household waste. No further information is known for this historical landfill.*ⁱⁱⁱ

Prior to 1869 a finger of Eastney Lake extended as far west as Milton Road; a second finger extended north almost reaching Locksway Road. Map regression shows episodes of reclamation culminating in the 1960s and are contemporaneous with the infilling of Milton Common.

Parkman Environmental 1995 described the deeper areas of landfill to the centre and east of Milton Common as comprising *>4m of highly putrescible domestic waste that is highly variable but comprises mixtures of wood, paper, cardboard, brick, glass, metal, rubble and plastic etc, in a dark grey/black silty sandy gravel matrix with a strong anaerobic odour of decay.*ⁱⁱ

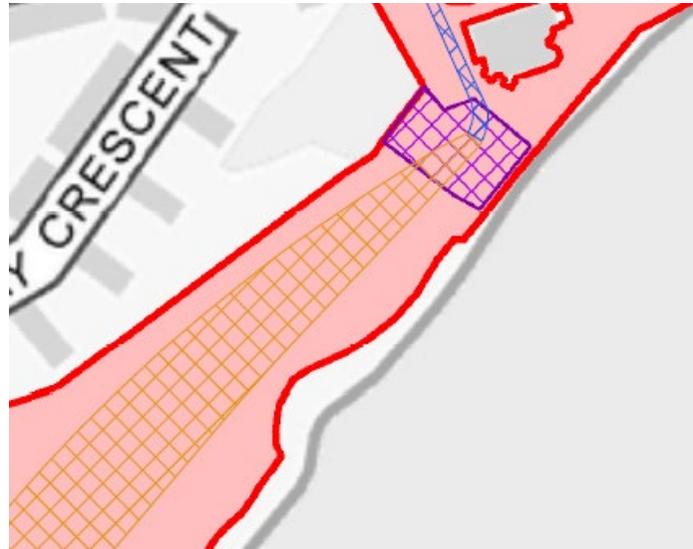
HDD 2 Launch

SW of the Launch Site an indent in the coastline marks the entrance to basins associated with The Portsea Canal. An idea of the canal's ambition can be gauged by the 230 ton bm (c 350 tons displacement) collier that reached the centre of Portsmouth on the opening day in 1823 and the 12 feet depth of the canal it required.^{iv} Dredged to 4 feet below low water mark the open gravelly nature of the subsoil required 3 feet of clay puddling to make impervious.

The canal was an unmitigated disaster and soon fell into disuse. To the east of the island there was no pressure on the land and the canal remained open into the twentieth century. Similarly, the basins lay open and it is highly likely that the some 4,000 sq metres of basins were merely backfilled and grassed over. The potential for archaeological discovery is considerable as indeed is the possibility of brick and stone structures buried to depth.
