# Yorkshire Green Energy Enablement (GREEN) Project

Document 5.3.10A ES Chapter 10 Appendix 10A - Walkover Survey  
Records

Final Issue A  
November 2022

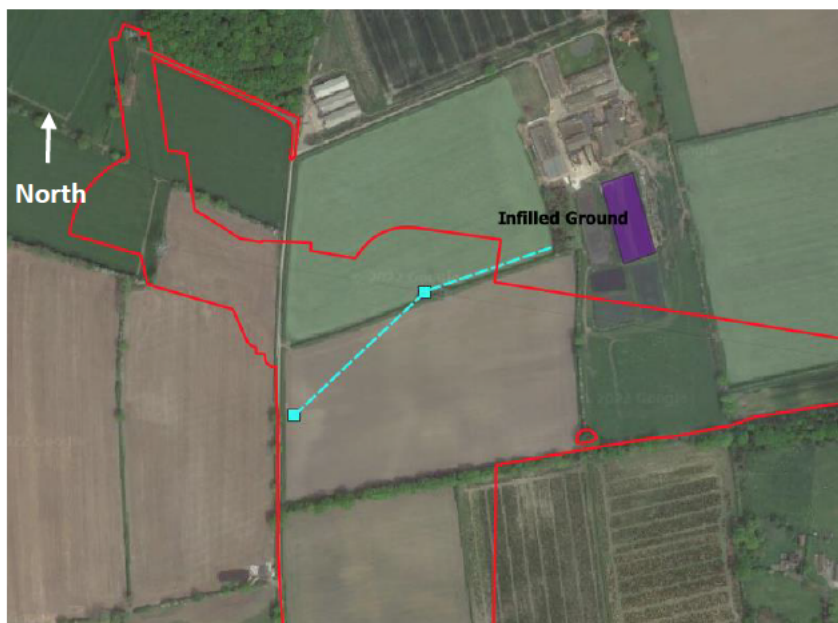
#### Graphic 10A.4 - Sewer and infilled ground at land parcel 1230

- 3.3.2 The northern most of these fields (immediately west of the farmyard) was left fallow with ankle length grasses. The ground was desiccated clay with occasional gravel inclusions. A manhole drain access was identified along the southern boundary of this field – the exact route of the drain is conjectured but may coincide (in plan view) with the proposed underground cable route in this area. A stockpile of demolition waste was identified near to the farmyard. This stockpile is made up of metal sheeting and reinforcement, foam insulation, timber, concrete breeze blocks, fibreglass sheet and plastic sheet. A small area of mature woodland is also at the eastern boundary of this field.

- 3.3.3 The field in the south-west corner was growing corn but there were several barren patches of ground, particularly in the west of the field which suggest poor growing conditions or previously flooded land which has restricted good growth. Another manhole drain access was identified in the western extent of this field and is likely to be linked to the one mentioned above. A putrid foul-drain smell was noted at this location. The southern boundary is a row of mature trees.

(Blue dashed line = conjectured sewer, blue squares = manhole sewer access, purple polygon = infilled ground).

- 3.3.1 This parcel was observed to be mixed-use agricultural land. Only the three fields in the south-west of the parcel and farmyard area (Newlands Farm) were investigated. The field to the south of the farmyard is mixed-use ground with an area of open scrub land; a large rectangular manure filter bed and several interlinked ponds. Land to the south of the ponds is a field of wildflowers. The ground is a desiccated clay soil with occasional gravel. Two further filter beds, that were identified on aerial photography, were not seen on site and were assumed to have been infilled. The area of infilled ground was mostly bare earth, with sparse grasses and weeds. This ground is likely to be soft and access to this area may require low-load bearing vehicles or ground bearing capacity testing.
