MORGAN AND MORECAMBE OFFSHORE WIND FARMS: TRANSMISSION ASSETS

Environmental Statement

Volume 3, Annex 1.1: Phase 1 Geo-environmental preliminary risk assessment

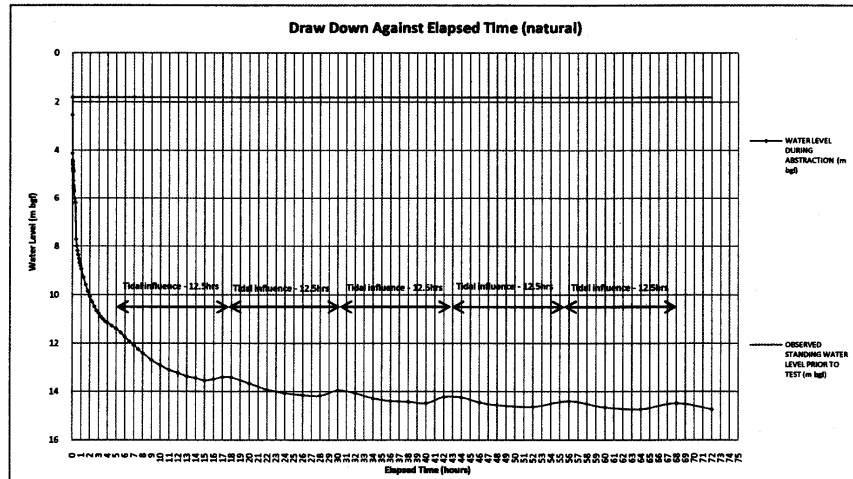
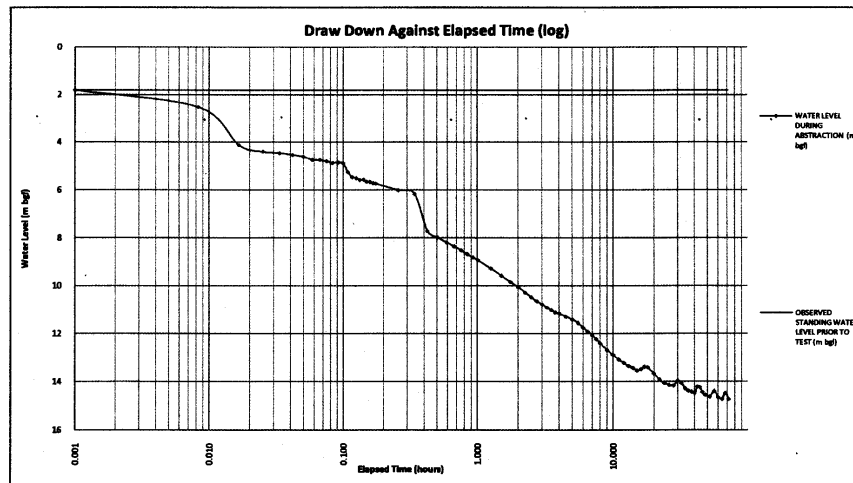
Site: Clifton Marsh Phase 4 C3 - Abstraction Well - Pumping Test
