# MORGAN AND MORECAMBE OFFSHORE WIND FARMS: TRANSMISSION ASSETS

Volume 3, Annex 3.4: River morphology survey technical report

Date September 2024  
Rev: ES Issue  
MOR001-FLO-CON-ENV-RPT-0055  
[MRCNS-J3303-RPS-10109]

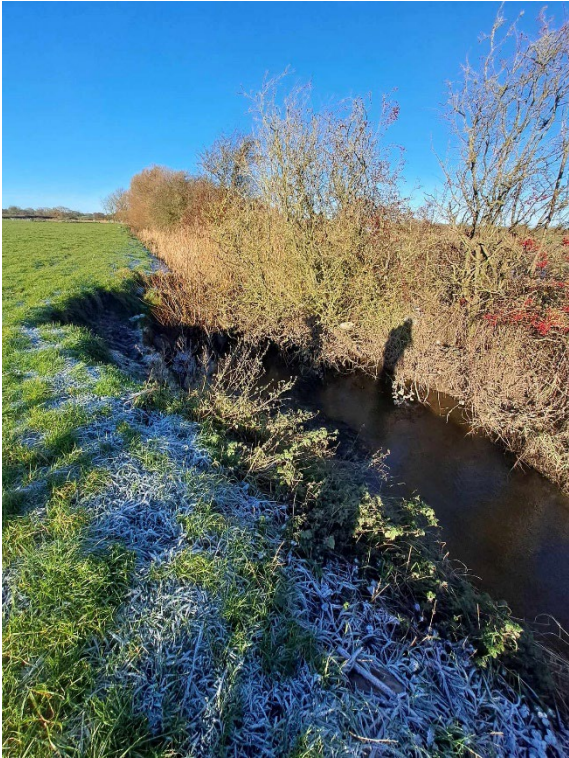
Watercourse ID	Middle Pool (watercourse reference S)	
	Upstream	Downstream

A photograph showing the upstream view of watercourse S. The water is dark and flows through a narrow channel. The banks are covered with green grass and some frost. There are several trees and bushes along the right bank, and a green field is visible in the background under a clear blue sky.	  A photograph showing the downstream view of watercourse S. The water is dark and flows through a narrow channel. The banks are covered with green grass and some frost. There are several trees and bushes along the left bank, and a green field is visible in the background under a clear blue sky.

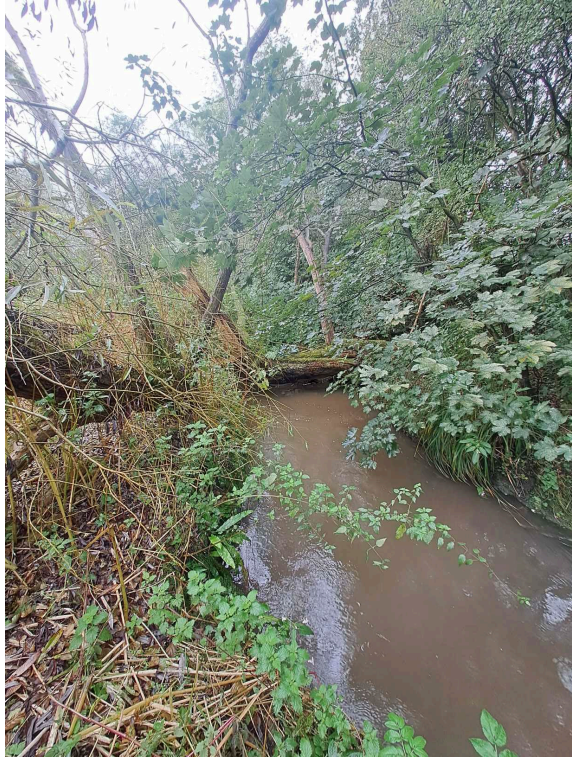
Watercourse ID	Mill Brook (watercourse references N and P)	
	Upstream	Downstream

A photograph showing the upstream view of Mill Brook. The water is brown and flows through a narrow channel. The banks are heavily vegetated with tall grasses and various green plants. The background shows a dense line of trees.

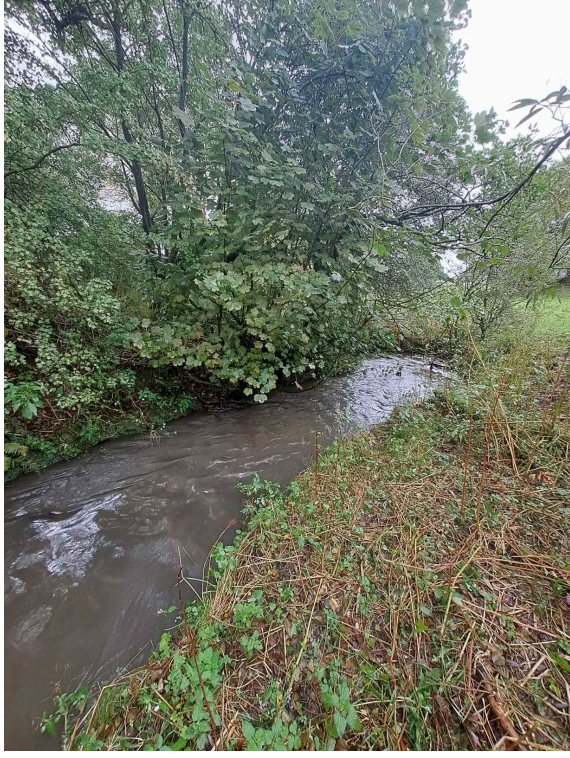
A photograph showing the downstream view of Mill Brook. The water is brown and flows through a narrow channel. The banks are heavily vegetated with tall grasses and various green plants. The background shows a dense line of trees.

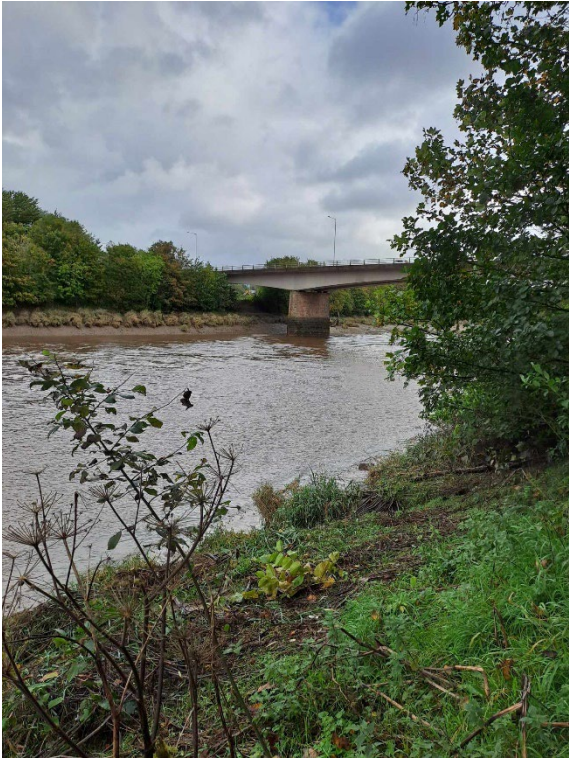
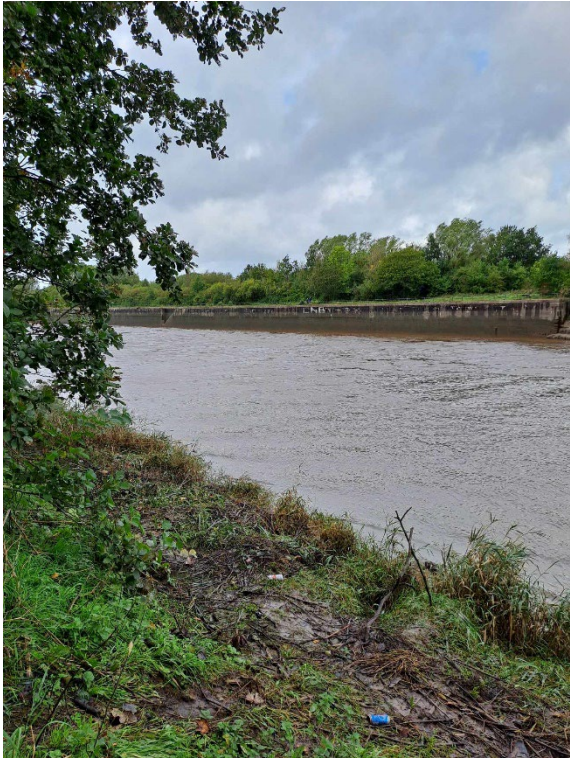
Watercourse ID	River Ribble (watercourse reference T)	
	Upstream	Downstream

SD 49548 27584	Mill Brook (2)		I	Moderate
	SD 49378 27655	Mill Brook (3)		I	Fairly Poor
	SD 49035 28611	Mill Brook (4)		K	Poor
T	SD 52352 29241	River Ribble (1)	Large main channel leading to the Ribble Estuary.	Navigable	Fairly Poor
	SD 50313 29271	River Ribble (2)		Navigable	Fairly Poor
	SD 51411 29331	River Ribble (3)		Navigable	Fairly Poor
