The Great Grid Upgrade

Grimsby to Walpole

Volume 2 - Scoping Report Appendices

Document Reference: GWNC-ARUP-ENV-REP-0002 - August 2024

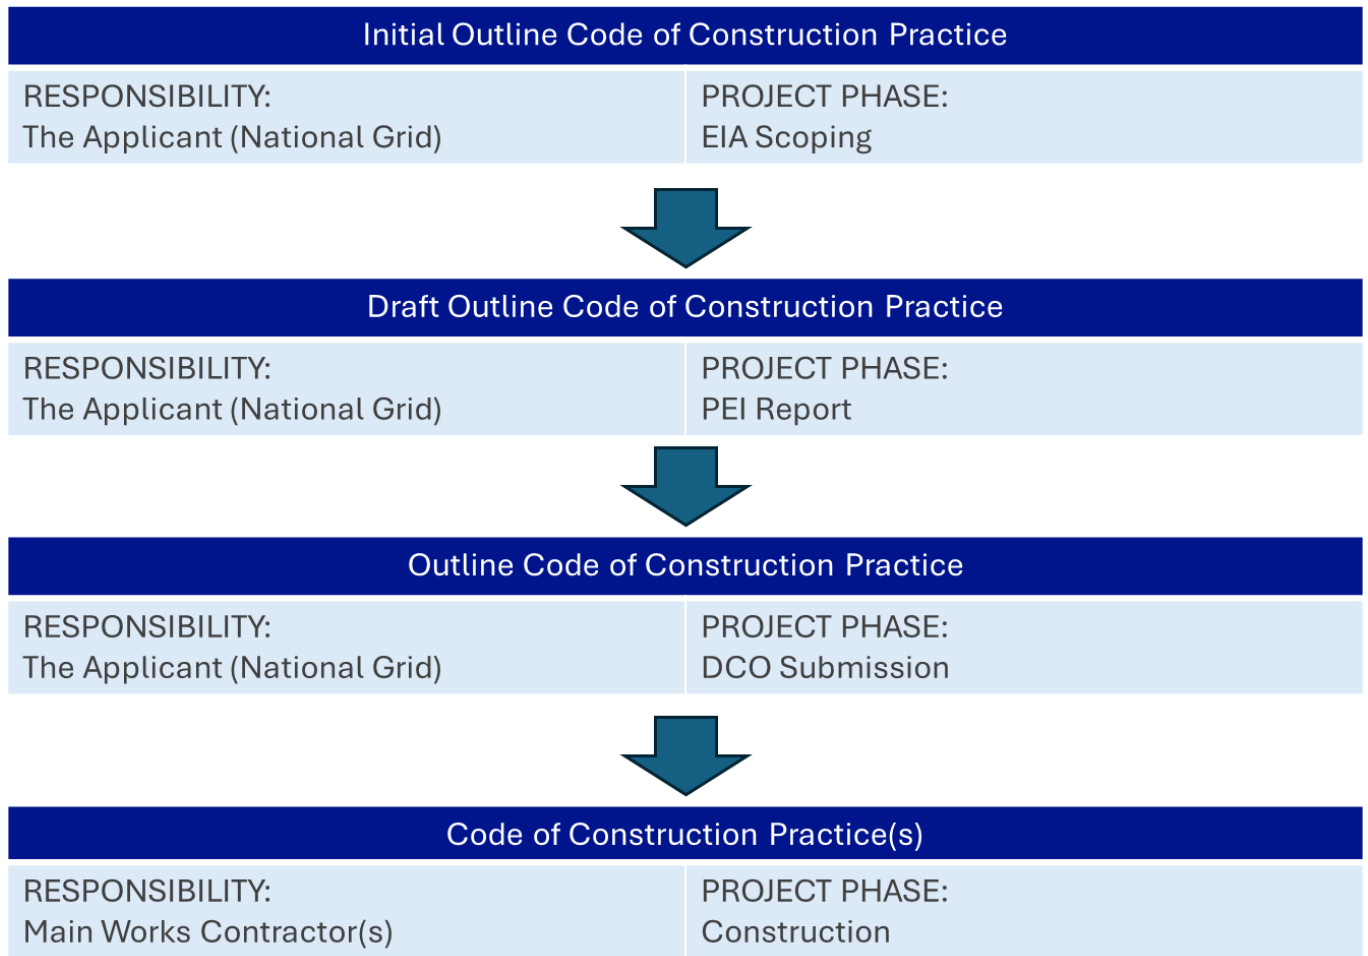
Image 4A.1: Code of Construction Practice Process

- 4A.3.7 The Outline CoCP will be developed into the CoCP (following detailed design) by the Main Works Contractor(s) to discharge a DCO Requirement. The CoCP will follow the same format as the Outline CoCP and will be developed, prior to commencement of the main construction and adhered to throughout the construction phase.
- 4A.3.8 The CoCP will include specific organisational information such as organograms, contact details of the Environmental Managers/Environmental Clerks of Works, specific organisational commitments etc.
- 4A.3.9 The ECPs will be developed by the Main Works Contractor(s) prior to the commencement of construction into final control plans and appended to the CoCP. Where relevant the ECPs will include contractor specific working methodologies.

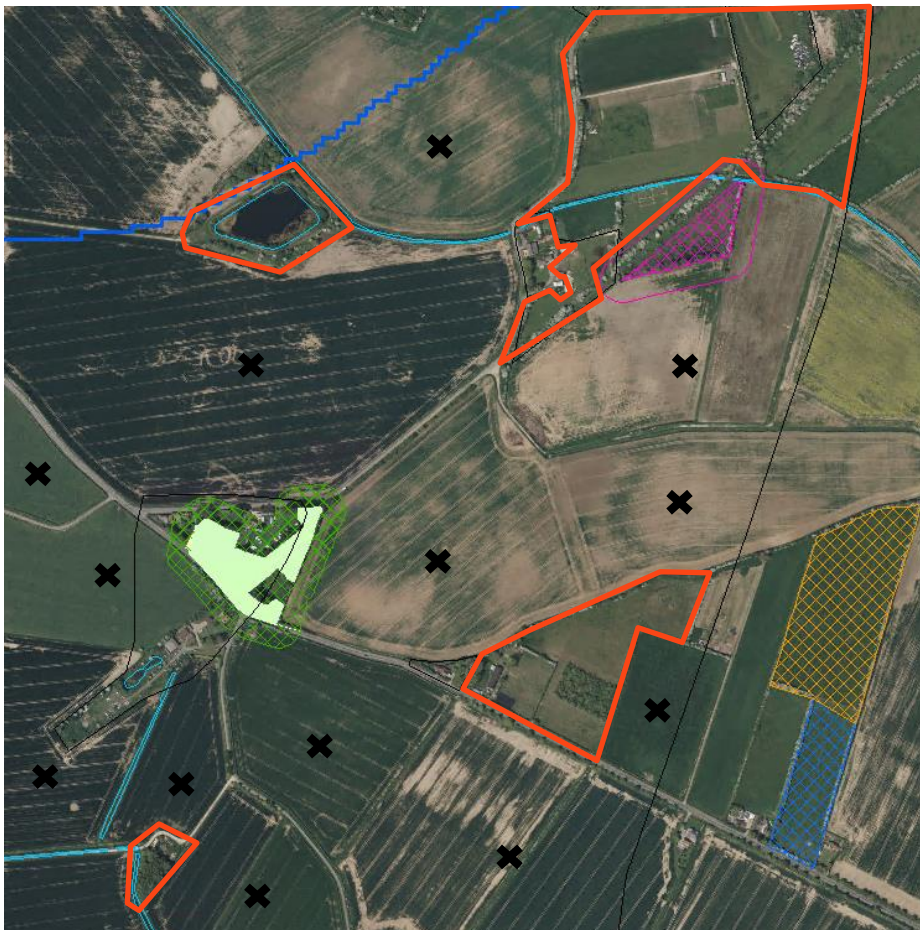
Badger Survey Example

1. Within Blue line - All habitats within the emerging preferred substation siting zones.
2. Within hatching - All areas within woodland (national Forest Inventory map) and grassland and heathland (priority habitat layer).
3. Orange lines - Other areas of woodland and grassland identified.

1. Land parcel indicated by 'X' – all areas of low quality habitat that are more than 30 m from substation siting zones or the areas of optimal habitat (woodland, grassland, heathland).

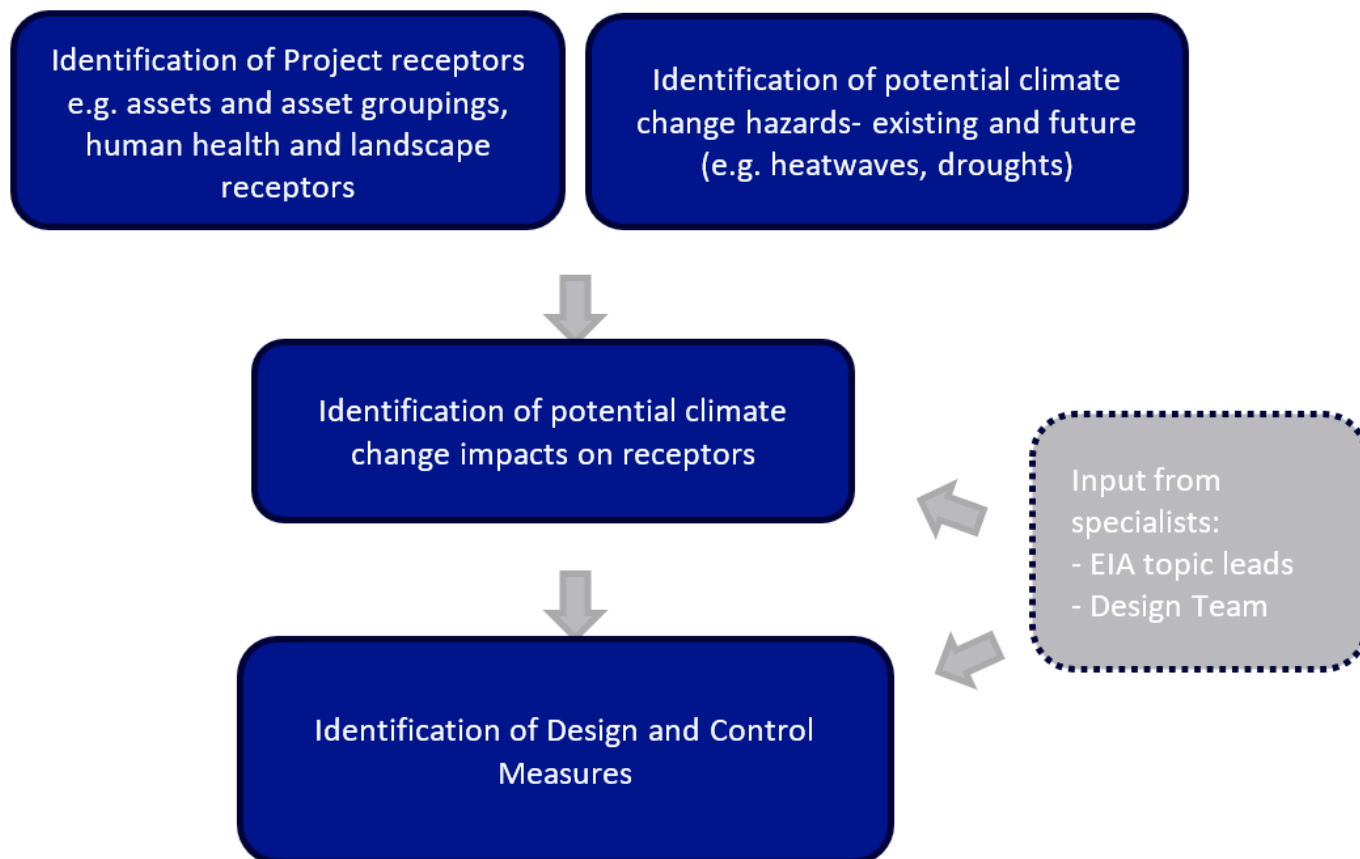
Image18A.1 CCR screening assessment methodology

18A.3.7 The methodology applied for the CCR screening assessment, as outlined in Image 18A.1 uses a combination of quantitative and qualitative information for climate change projections, and qualitative information related to the potential impacts.

The sections below outline the method shown in the diagram in more detail and provides details on assessment criteria.
