Southampton to London Pipeline Project

Environmental Statement (Volume D)
Appendix 8.3: Groundwater Dependent
Terrestrial Ecosystems

Application Document: 6.4

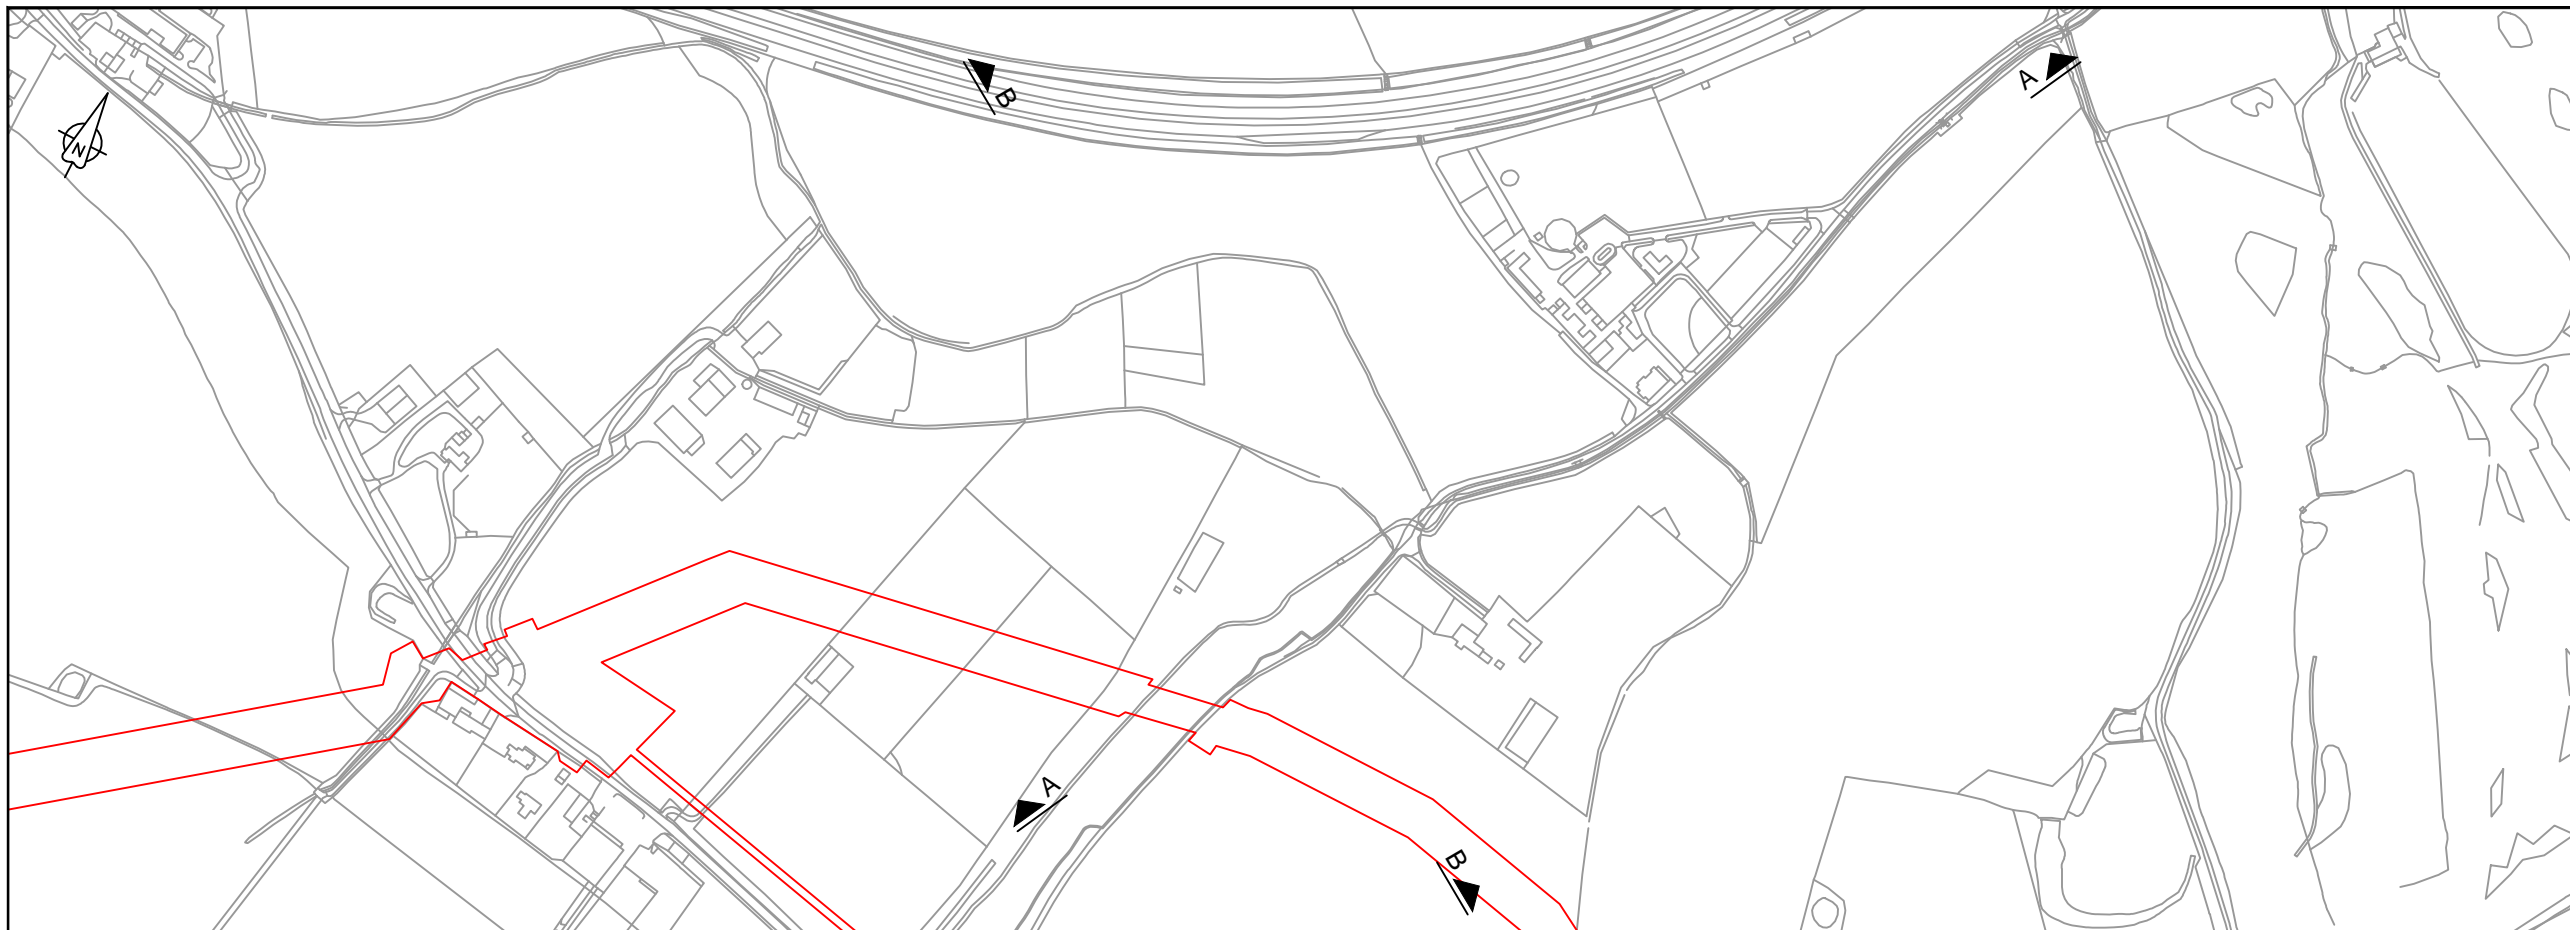
CAKER & LAVANT STREAM FLOODPLAIN LOCATION PLAN

Drawing title
 ENVIRONMENTAL STATEMENT
 NVC AND HABITAT SURVEY AND GROUNDWATER
 DEPENDENCY - CAKER AND LAVANT
 STREAMS FLOODPLAIN
 APFP Reg. (2009) 5(2)(l)
