Southampton to London Pipeline Project

Environmental Statement (Volume D)
Appendix 8.6: Water Framework Directive
Compliance Assessment

Application Document: 6.4

Planning Inspectorate Reference Number: EN070005

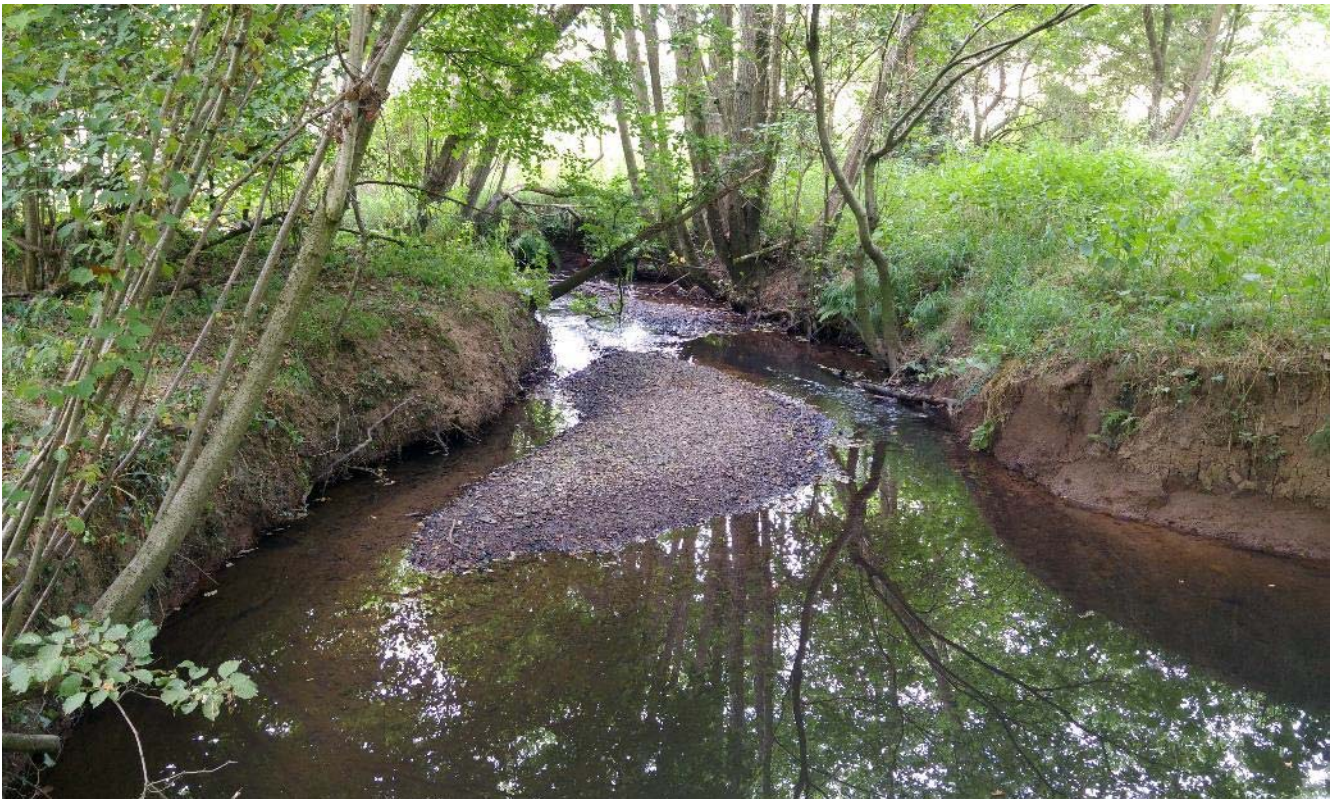
Photograph 8.6.1: Mid-channel bar causing bifurcation of flow, with some undercutting of both banks also evident. Ford Lake (facing downstream), 24/07/18, standard lens.

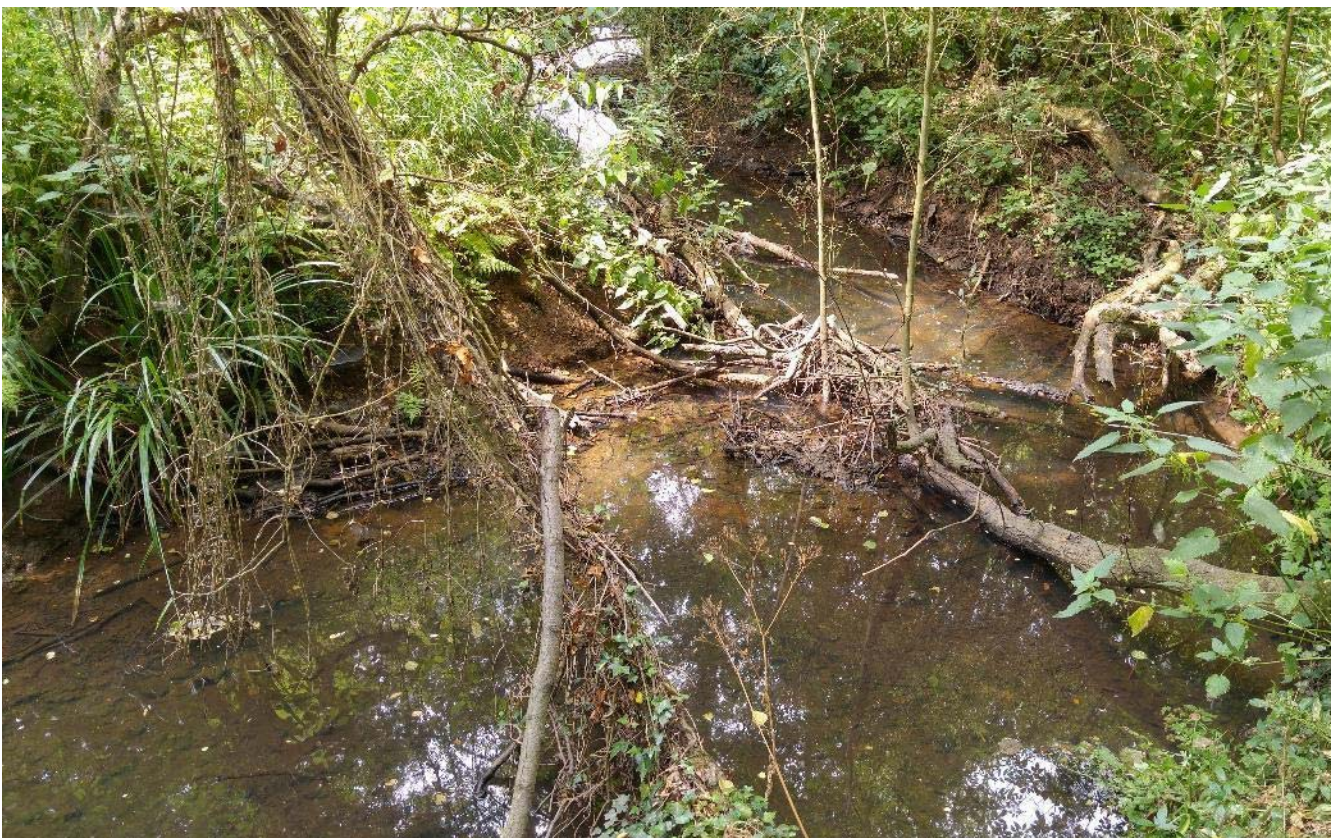
Photograph 8.6.2: A debris dam causing slowing of flow. Steep, well vegetated banks also evident typical of reach. Ford Lake (facing upstream), 24/07/18, standard lens.

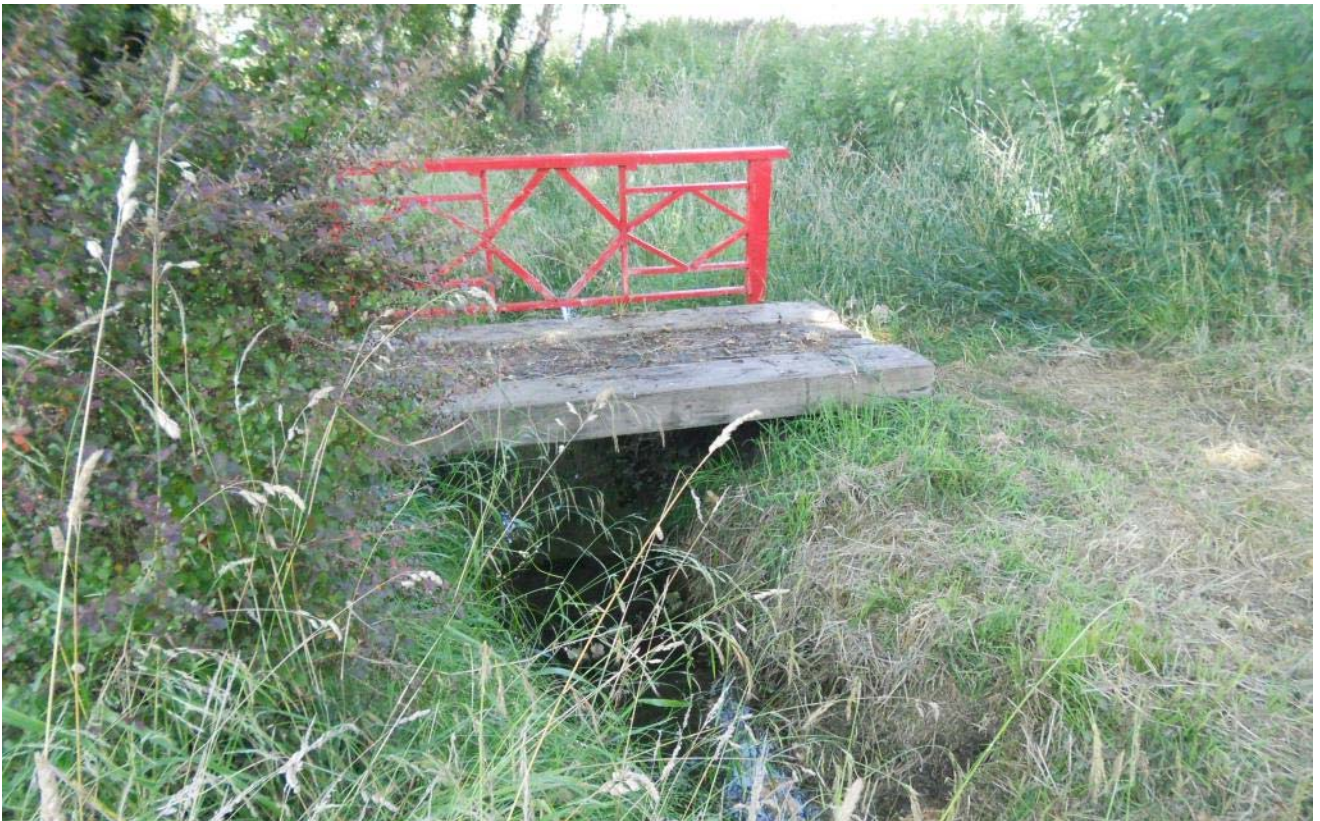
Photograph 8.6.3: Typical channel cross-section riparian vegetation cover. Unnamed Watercourse 5 (facing upstream), 24/07/18, standard lens.

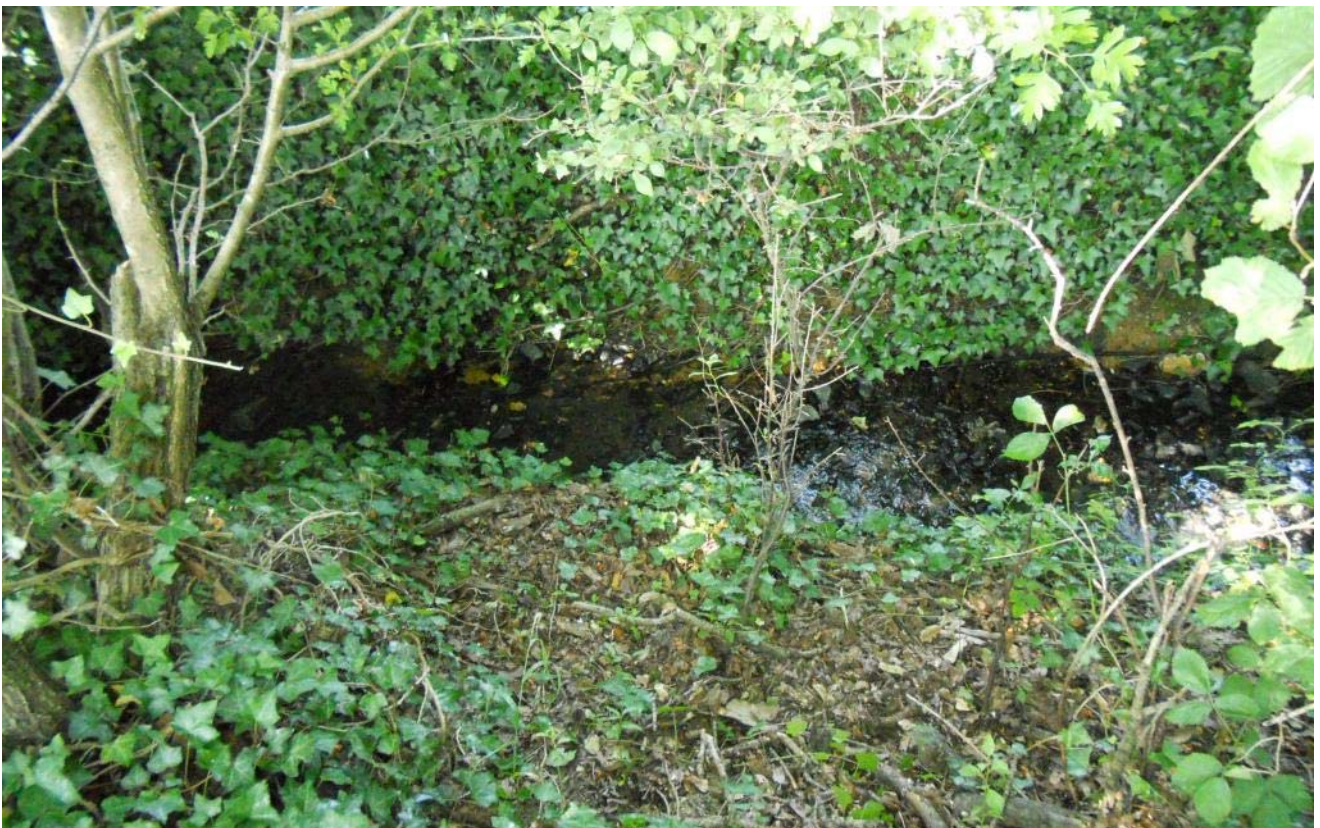
Photograph 8.6.4: Typical riparian vegetation cover and bank profiles. Watercourse at low flow, with some gravels just visible. Unnamed Watercourse 6 (facing from left to right bank), 24/07/18, standard lens.

Unnamed Watercourse 6	<p>Straight planform, which appears to have been re-sectioned in places to increase capacity. Low flow width was estimated at 0.4m, with a depth of less than 0.05m. Estimated bankfull dimensions were 0.3m (deep) and 0.8m (wide).</p> <p>Bed substrate was observed to be consolidated gravels and sands, resulting in some rippling of flow where gravels were present.</p> <p>No in-channel features were identified, and the vegetated riparian zone consisted primarily of mature trees with extensive ground coverage of ivy.</p> <p>The watercourse was assessed as being of moderate ecological sensitivity.</p> <p>Photograph 8.6.4 shows a typical section of the reach surveyed.</p>

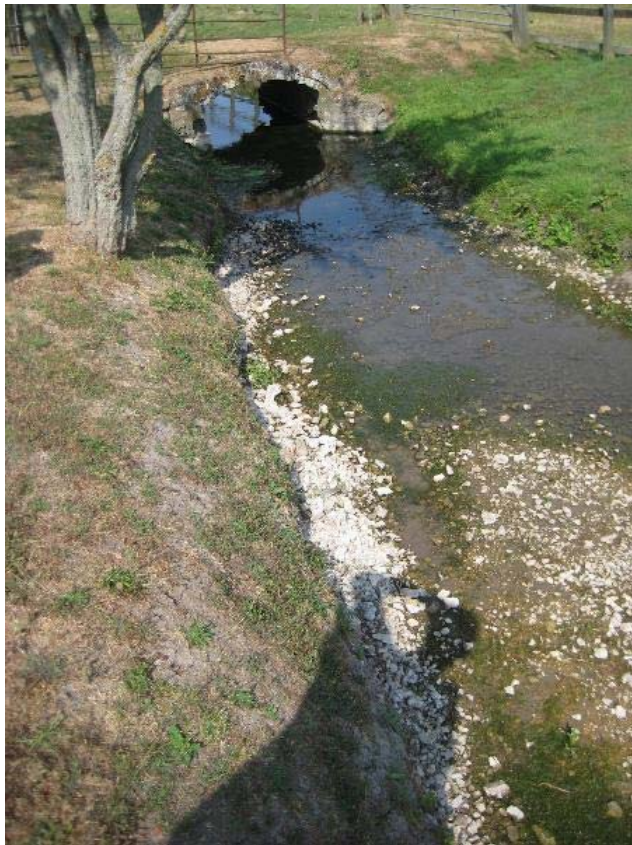
Photograph 8.6.5: Footbridge with a side bar starting to mature in the foreground. Caker Stream (facing downstream), 24/07/18, standard lens

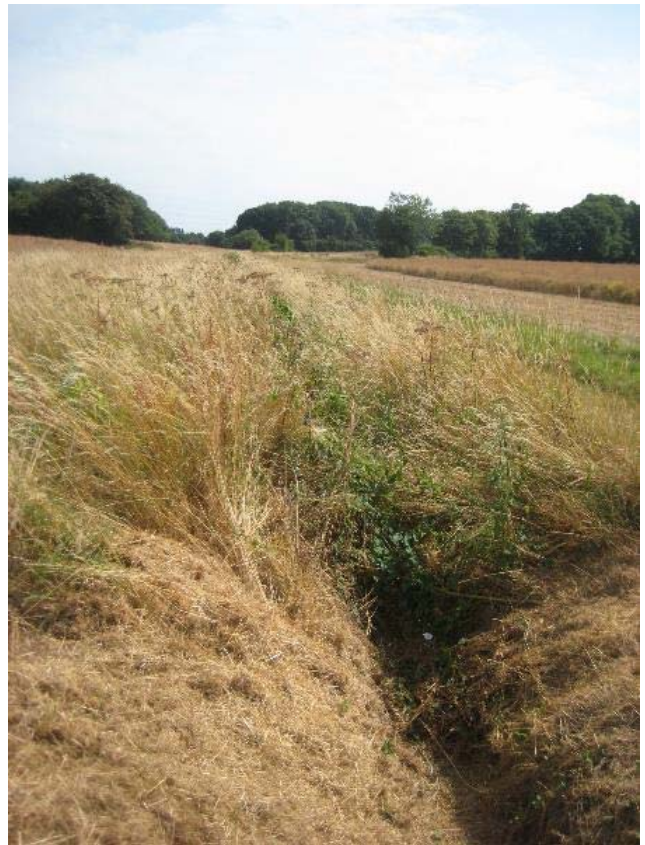
Photograph 8.6.6: Overgrown channel. Unnamed Watercourse 11 (facing upstream), 24/07/18, standard lens

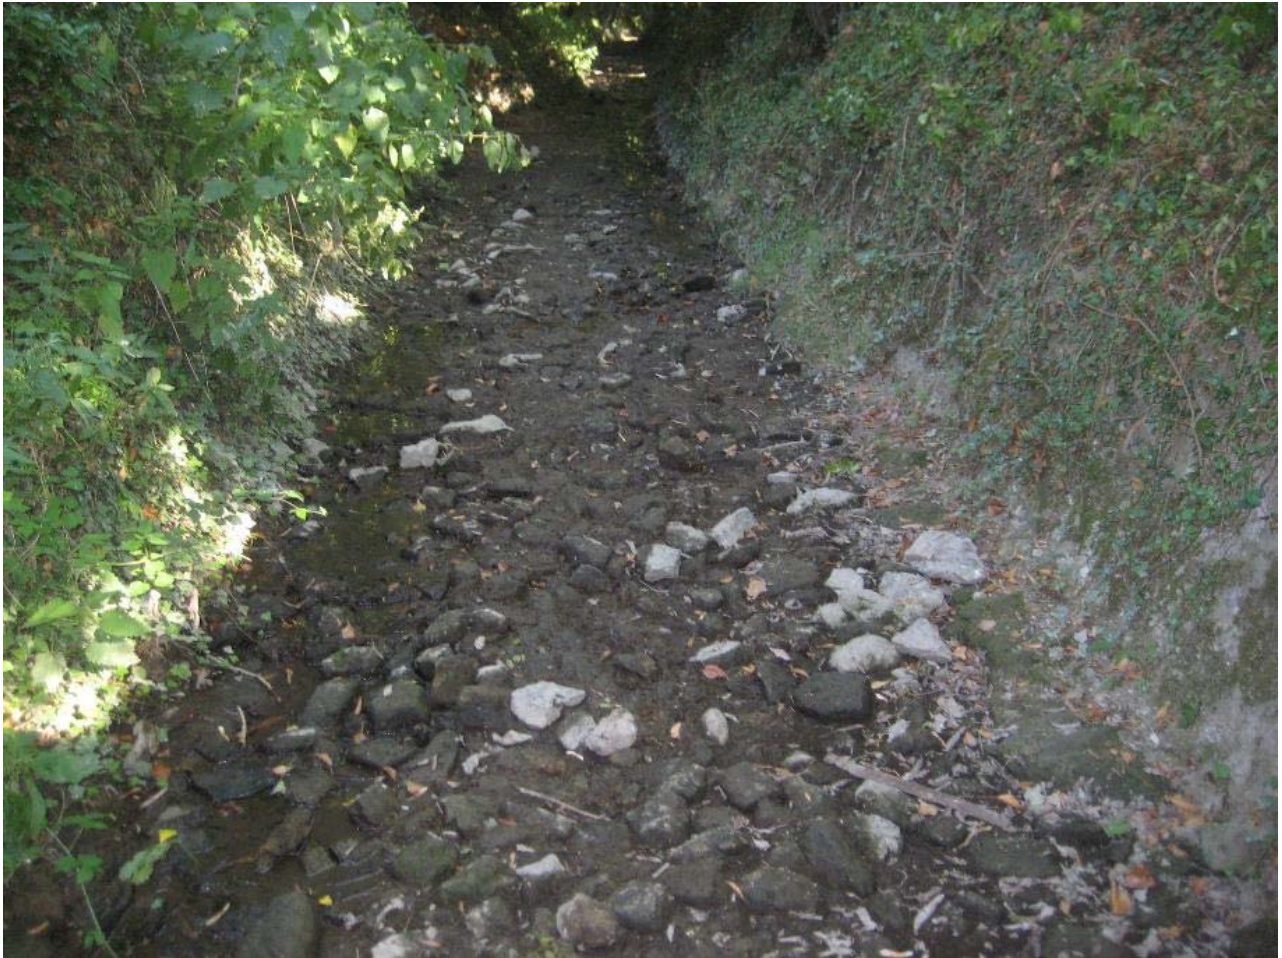
*Photograph 8.6.7: Channel bed comprising unconsolidated pebbles and cobbles. Water Lane (facing upstream)
24/07/18, standard lens*

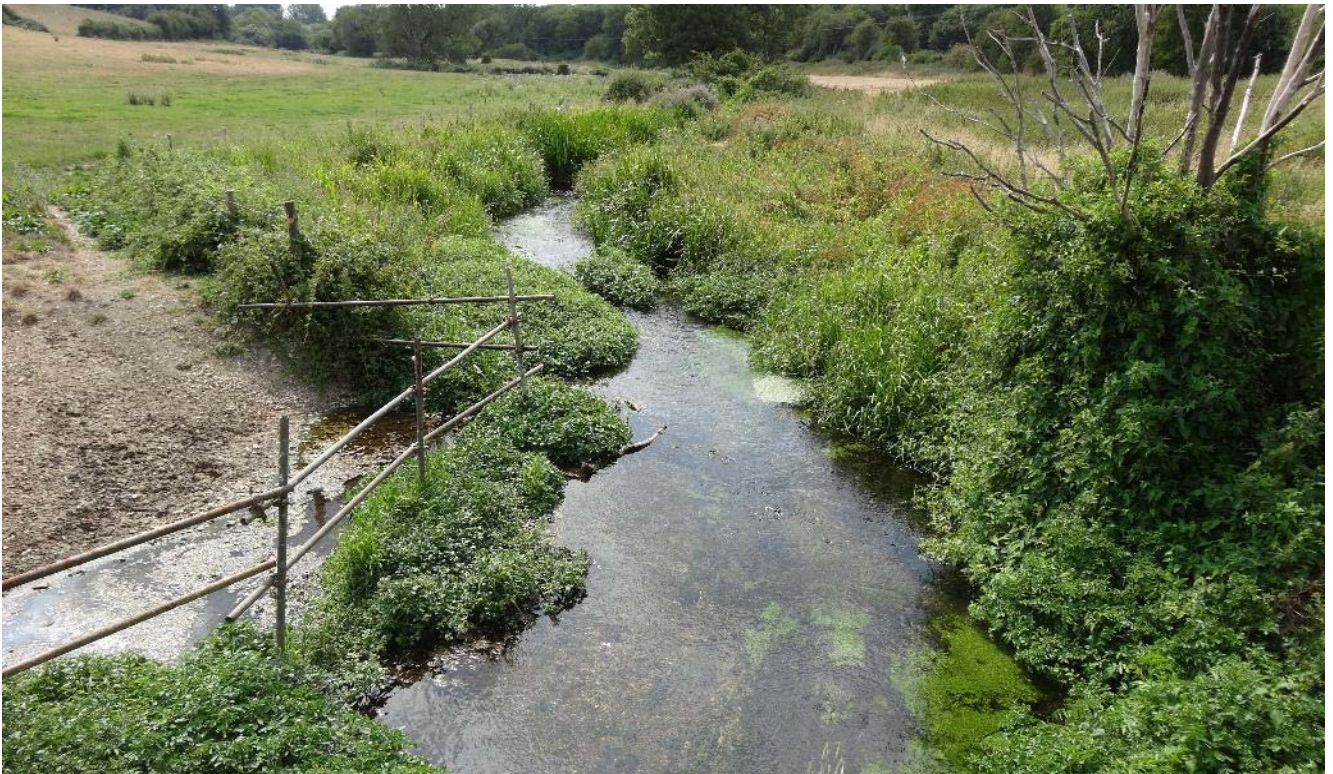
Photograph 8.6.8: Sinuous channel, with cattle access, gravels and aquatic vegetation all visible. River Wey (facing upstream), 24/07/18, standard lens.

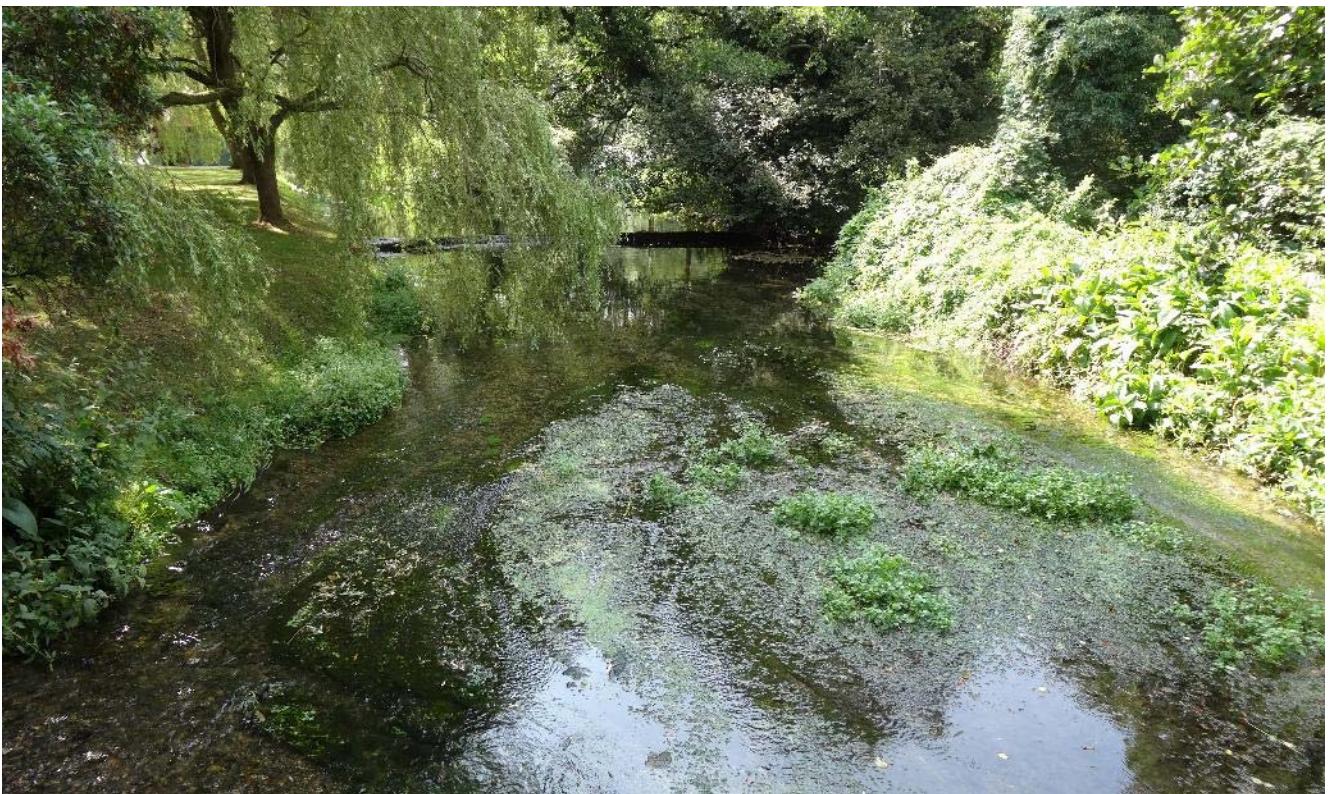
Photograph 8.6.9: Extensive stands of macrophytes in the foreground, with well managed riparian vegetation along the right bank. Weir visible in the background. River Wey (facing upstream), 24/07/18, standard lens.

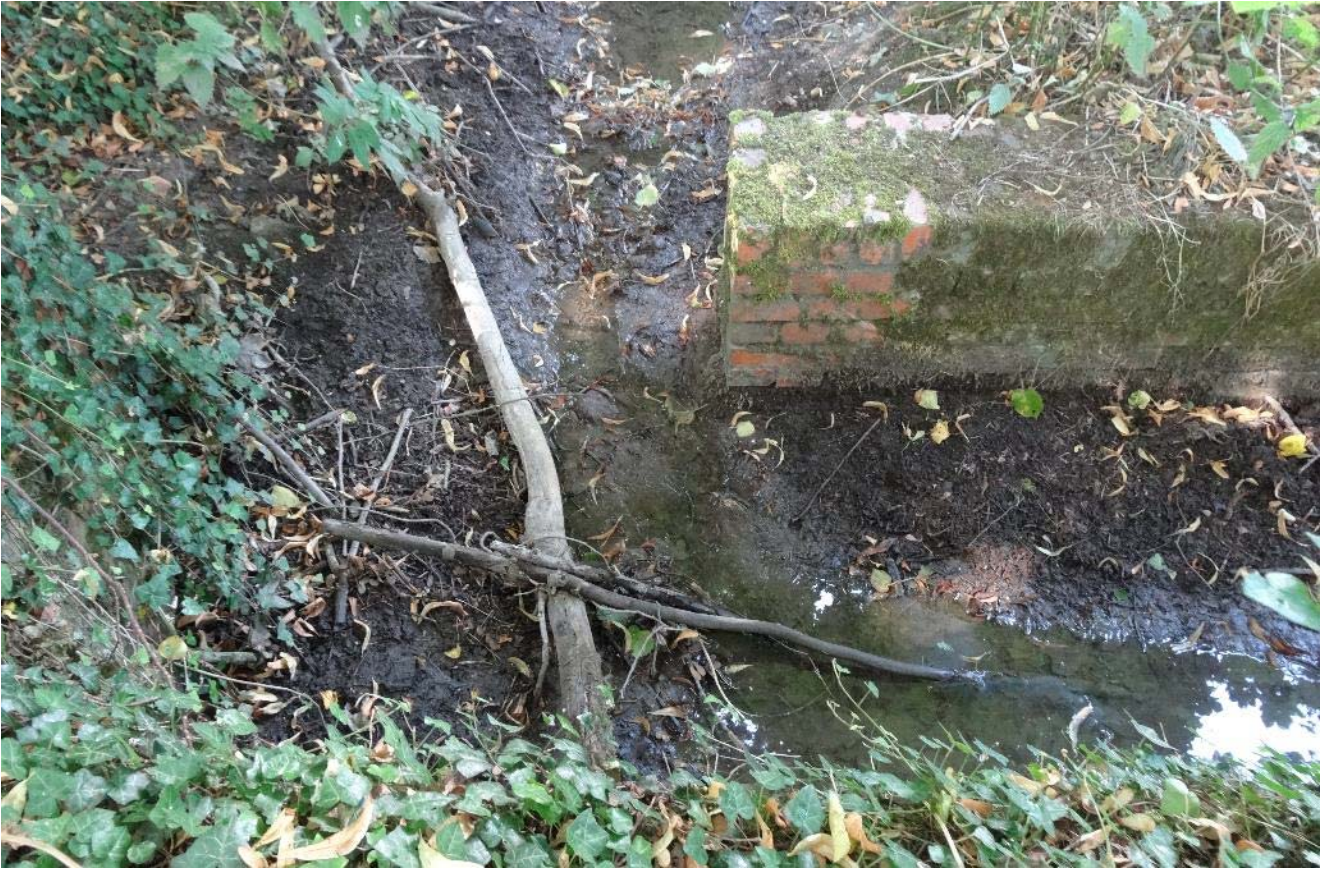
Photograph 8.6.10: Typical reach, with bank reinforcement evident along the left bank. Ryebridge Stream (facing upstream), 24/07/18, standard lens.

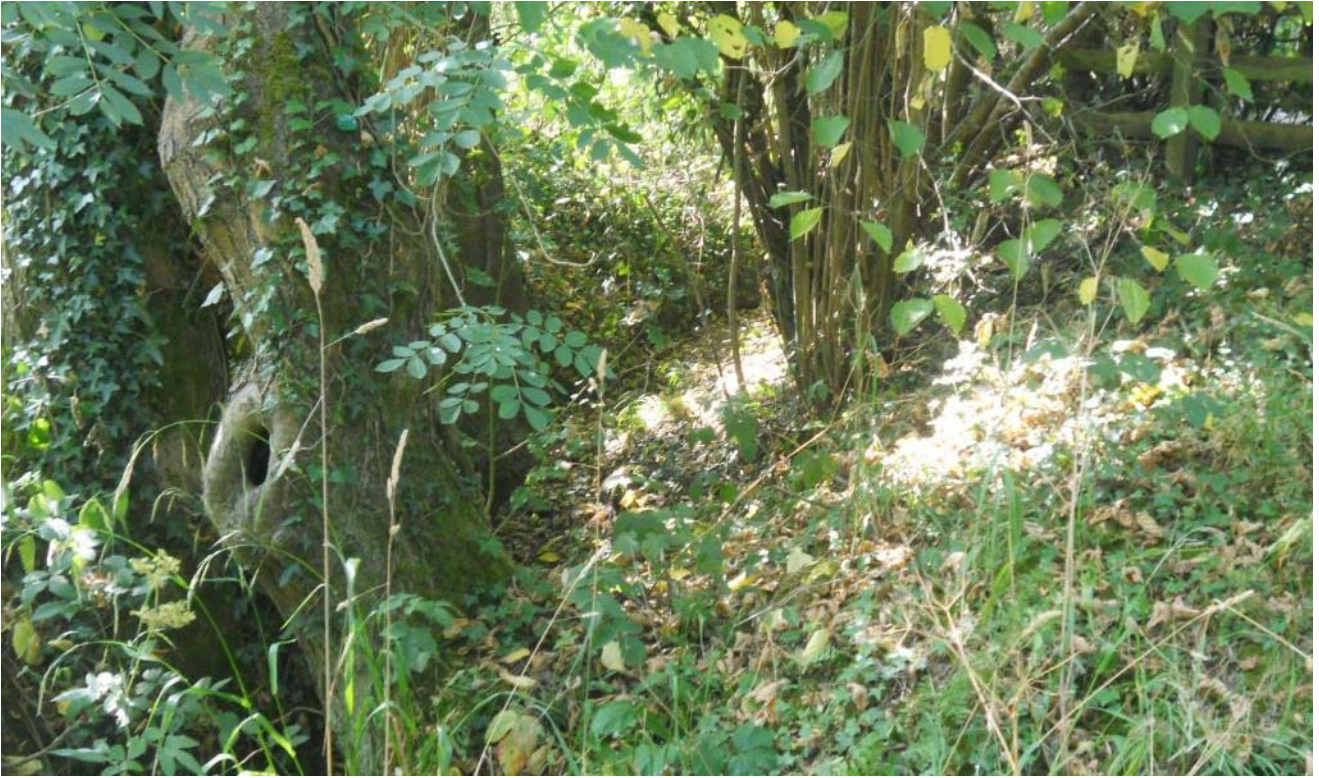
Photograph 8.6.12: Dry channel, with typical riparian vegetation cover. Unnamed Watercourse 25 (facing upstream), 25/07/18, standard lens.

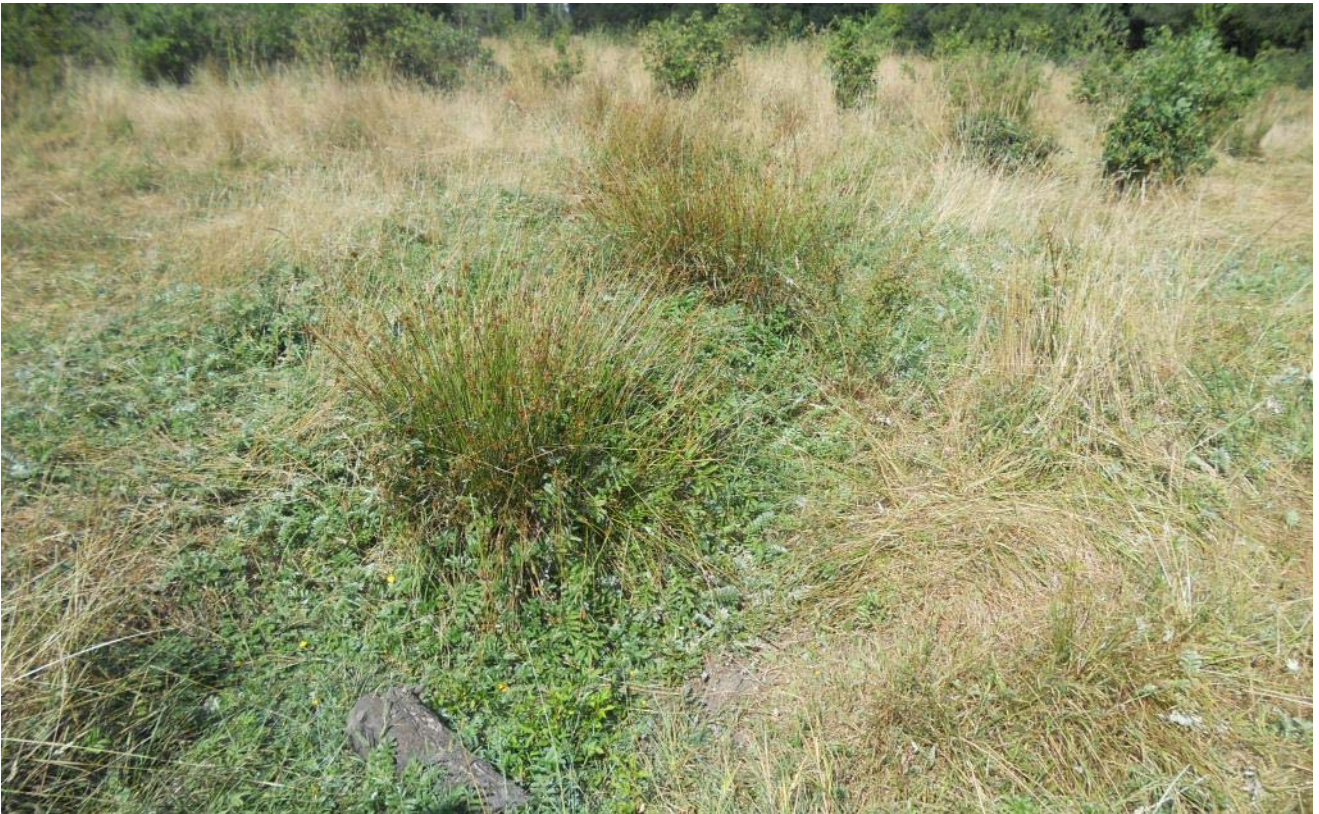
Photograph 8.6.13: The topographic depression through which the watercourse is likely to flow. Unnamed Watercourse 27 (facing upstream), 25/07/18, standard lens.

<p>Unnamed Watercourse 27</p>	<p>A poorly defined channel with an open and shallow cross-section. Flow along the channel likely to spill out, creating an area of wetter land. The channel was dry during the site visit, so no assessment of flow types could be made. No substrate was identified as the channel was well covered by grasses and other vegetation, which also populated the riparian zone.</p> <p>No ecological assessment was made as the watercourse was dry at the proposed crossing point during the survey period.</p> <p>Photograph 8.6.13 shows where the watercourse likely to flow.</p>

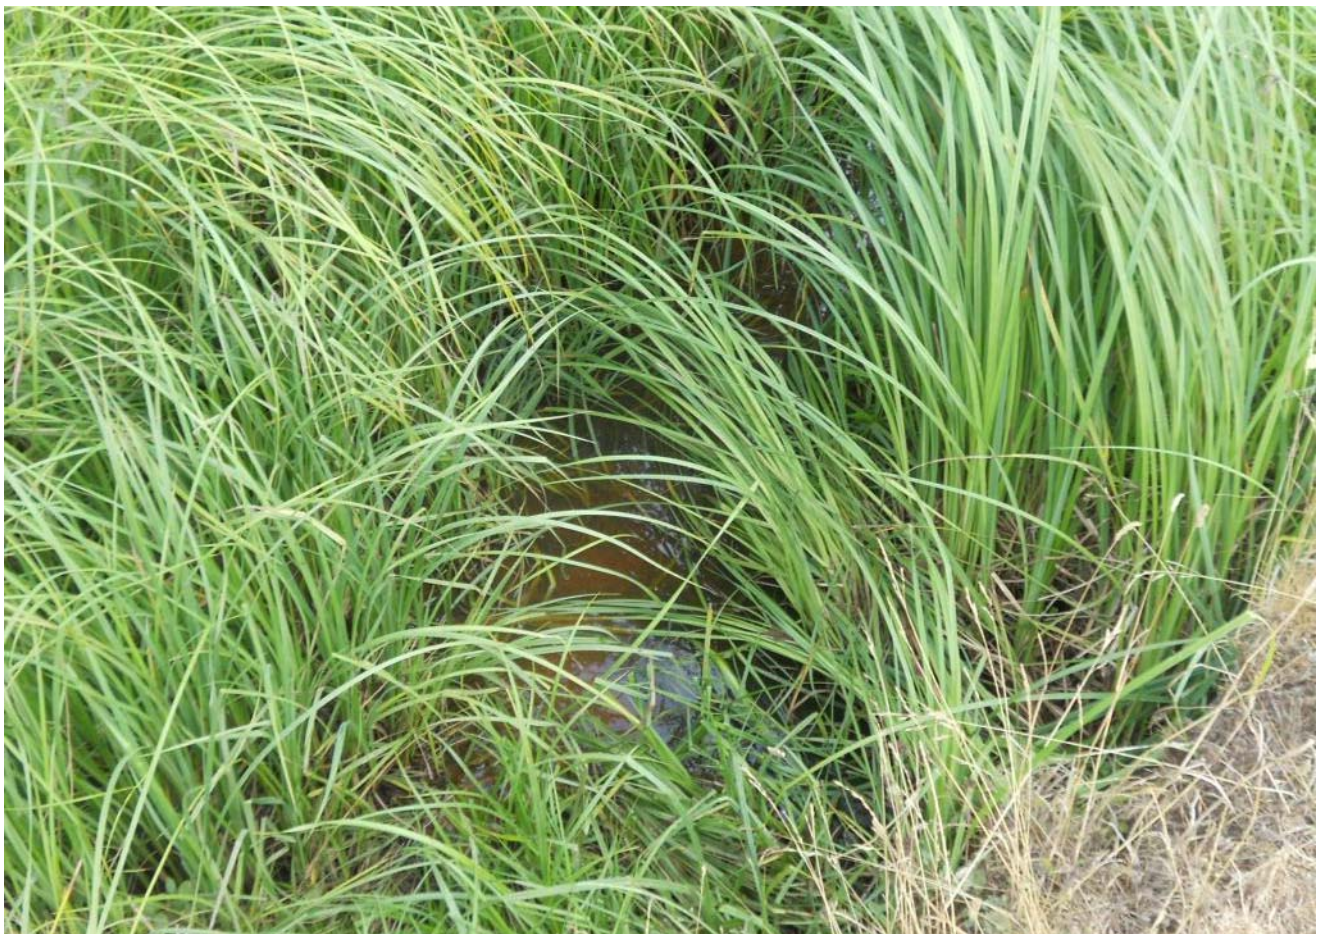
Photograph 8.6.14: Ochrous water with extensive marginal vegetation. Unnamed Watercourse 31 (facing downstream), 25/07/18, standard lens.

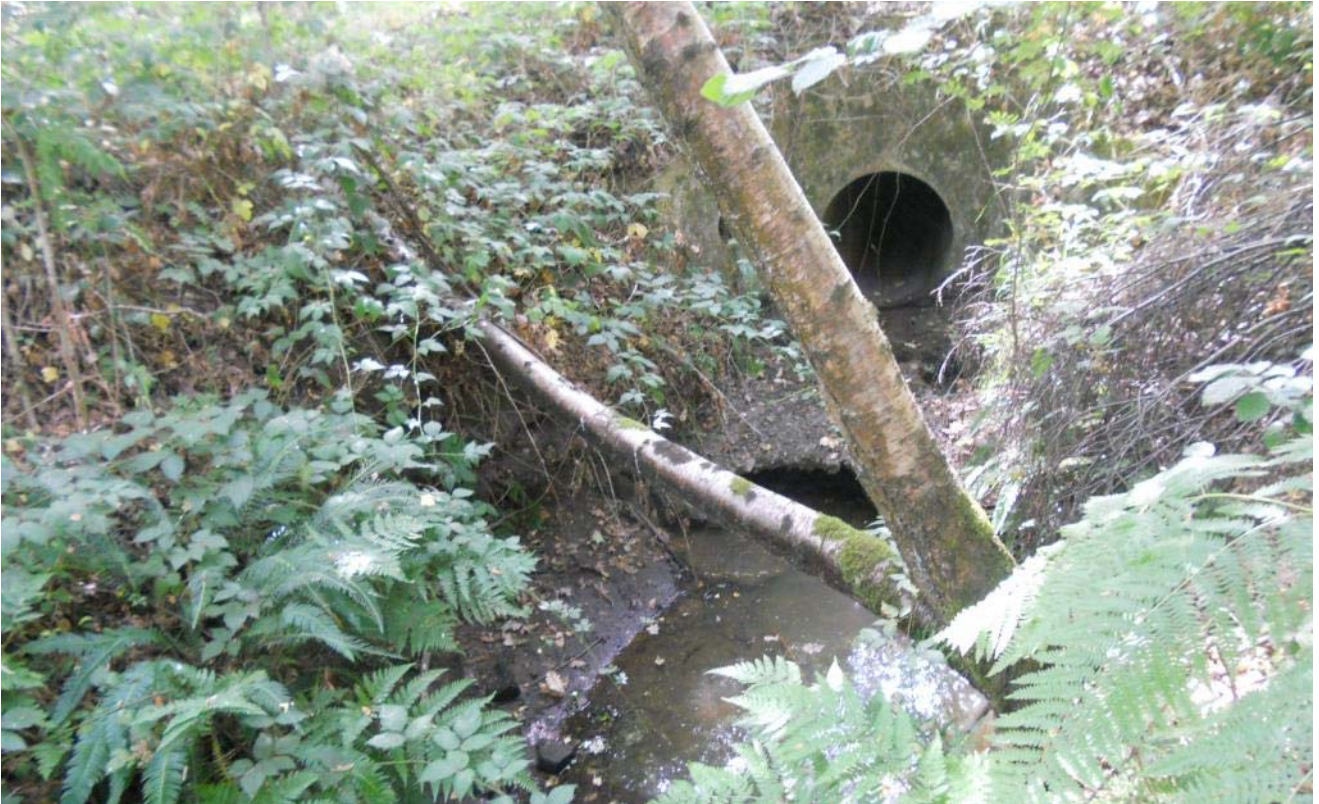
Photograph 8.6.15: The culvert beneath Aldershot Road, with undercutting of the downstream apron visible between the branch in the tree in the foreground. Gelvert Stream (facing upstream), 25/07/18, standard lens.

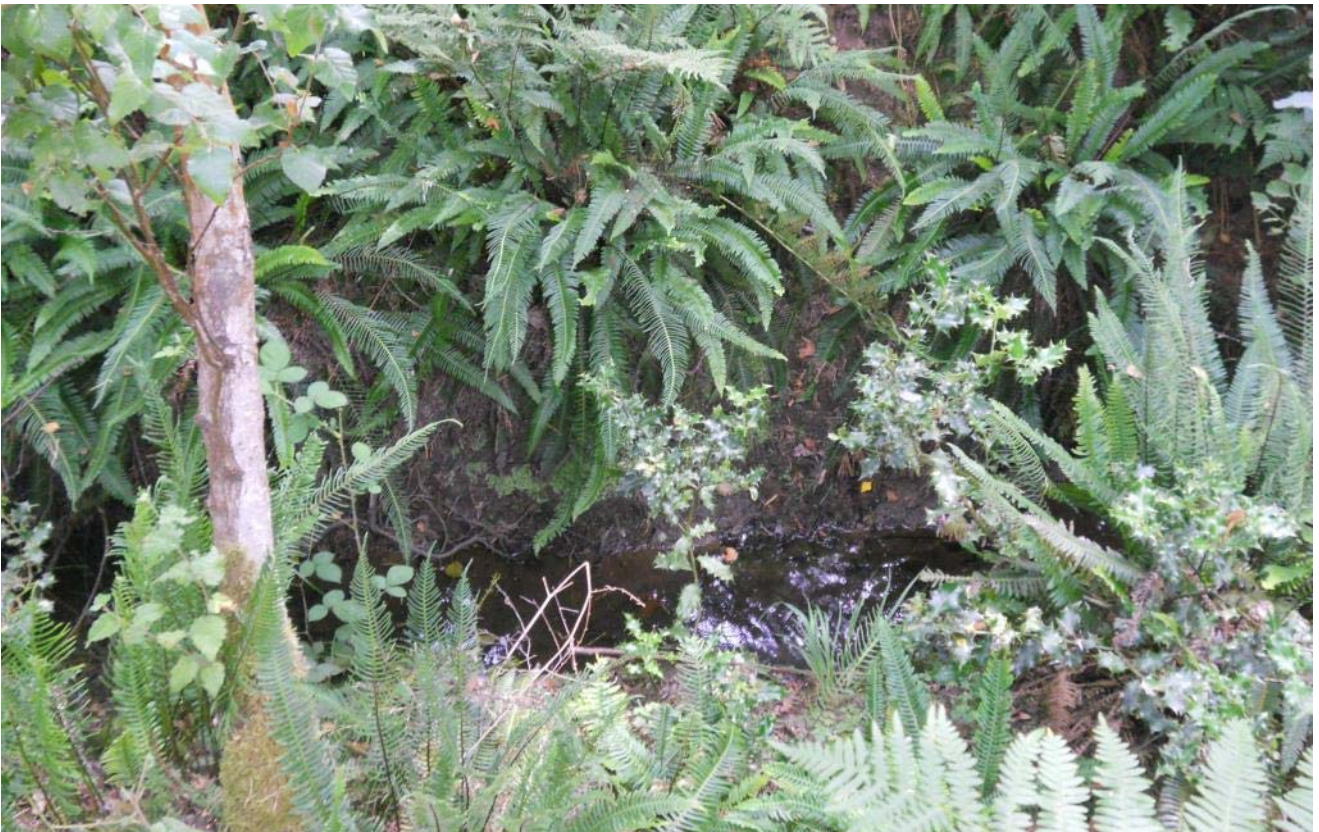
Photograph 8.6.16: Typical riparian vegetation cover and bank form. Gelvert Stream (facing from left bank to right bank), 25/07/18, standard lens.

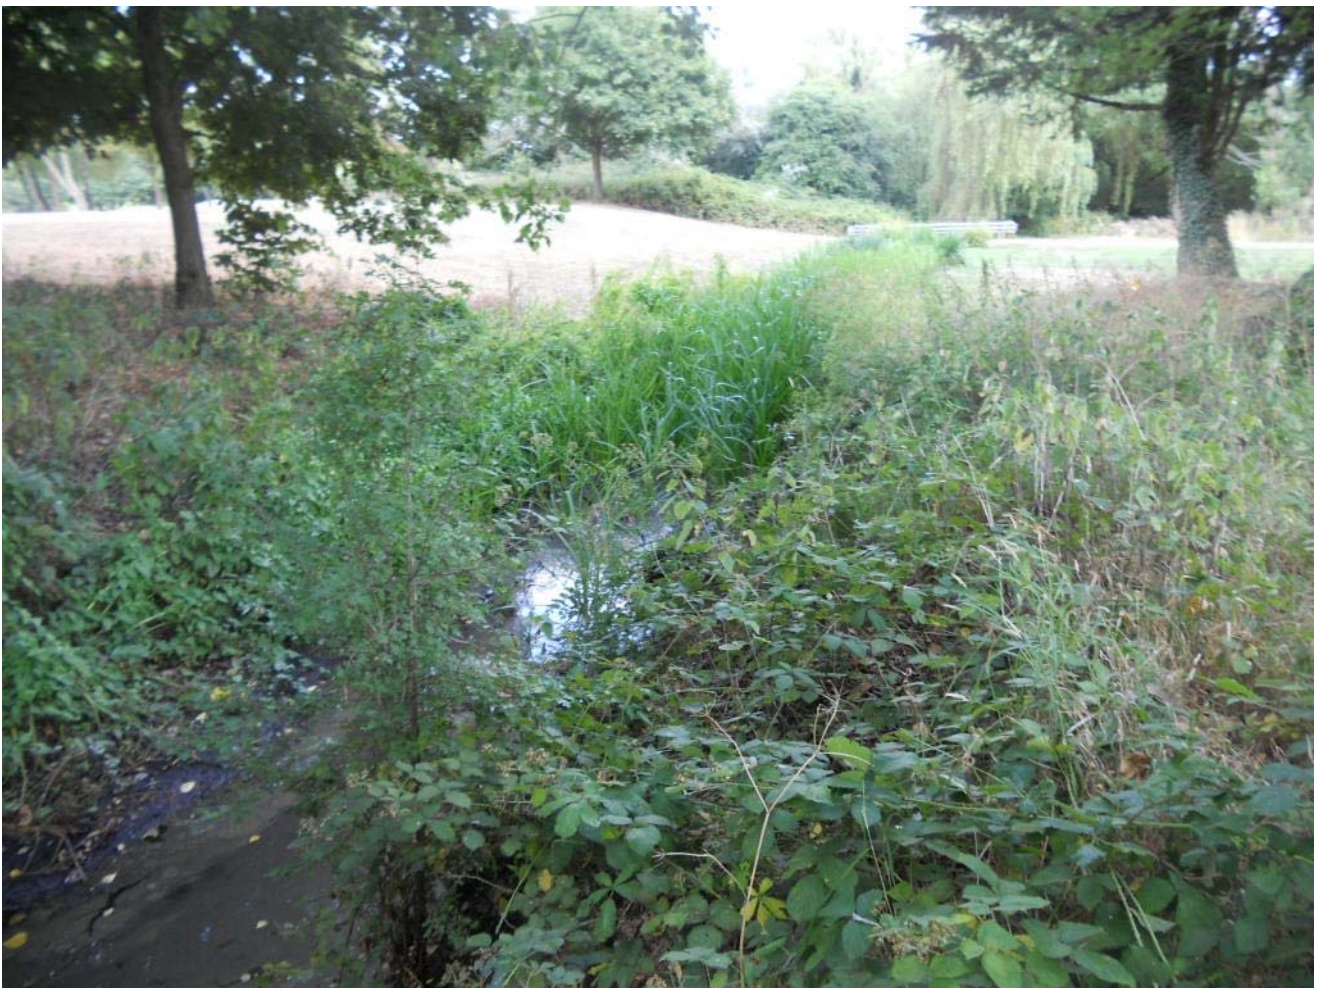
Photograph 8.6.17: Typical riparian and marginal vegetation coverage, with shallow, slow-flowing water. Ively Brook (facing downstream), 26/07/18, standard lens.

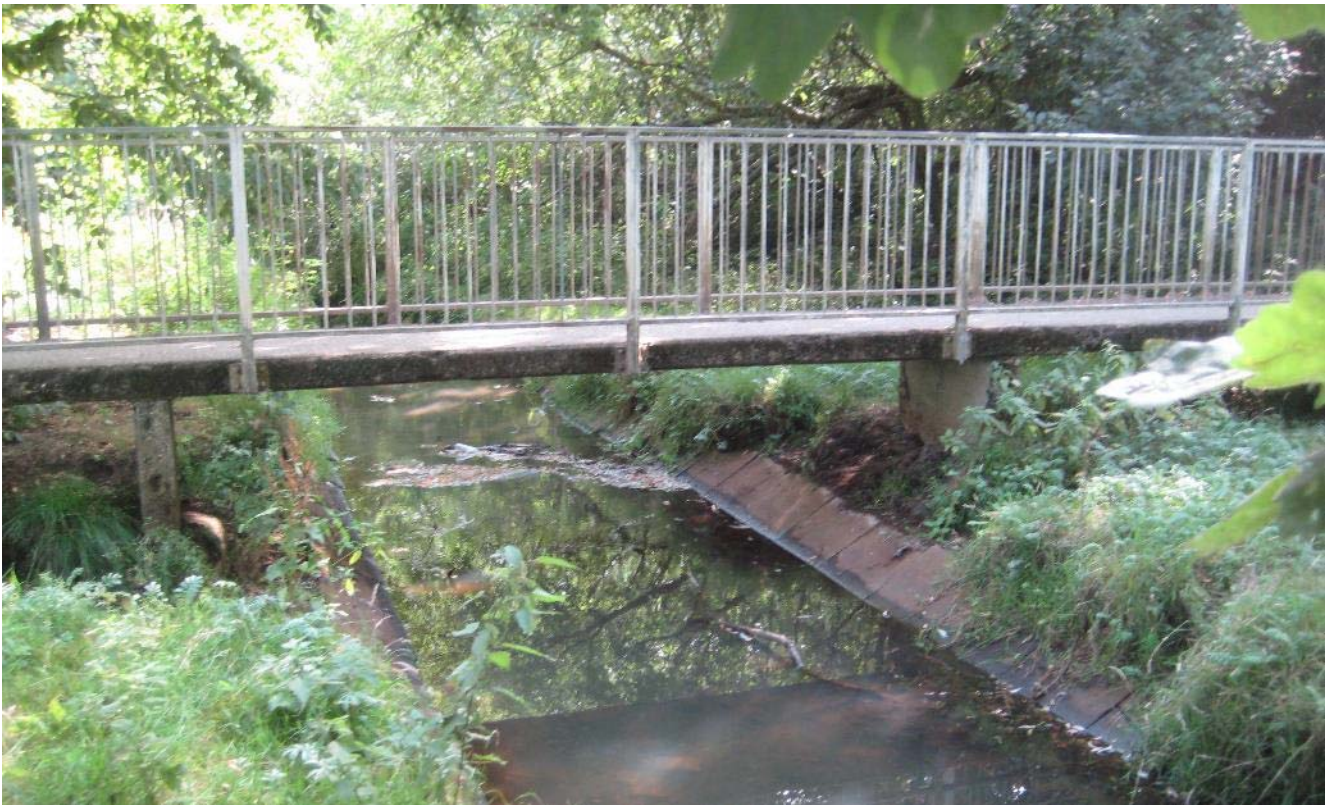
Photograph 8.6.18: Typical upstream reach, with footbridge and reinforcement evident along both banks. Cove Brook (facing downstream), 25/07/18, standard lens.

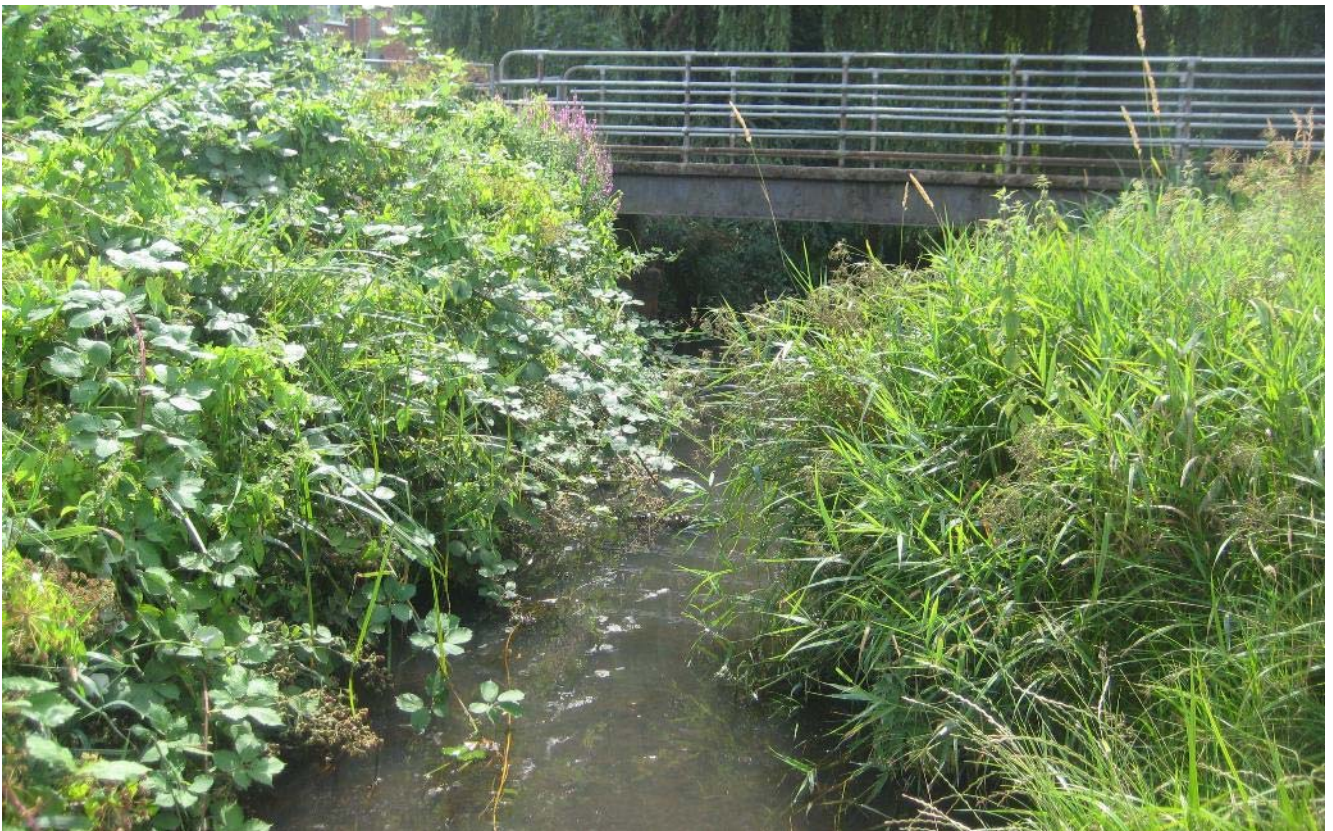
Photograph 8.6.19: Slow flowing, turbid watercourse, with heavily vegetated banks and footbridge crossing. Cove Brook (facing upstream), 25/08/18, standard lens.

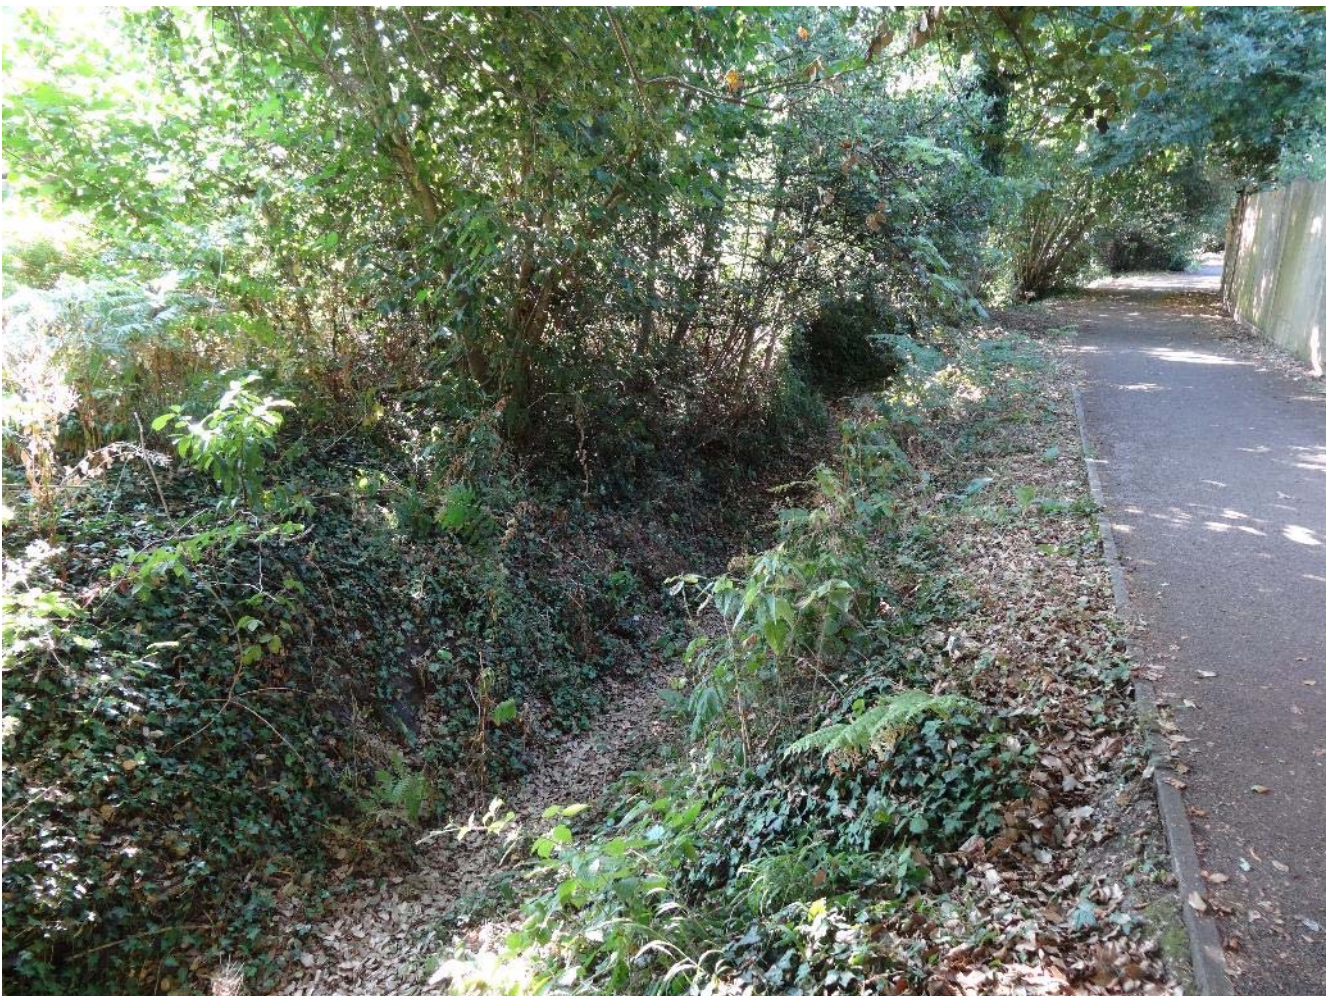
Photograph 8.6.20: Dry channel, with typical riparian vegetation cover and footpath along right bank. Unnamed Watercourse 44 (facing downstream), 25/07/18, standard lens.

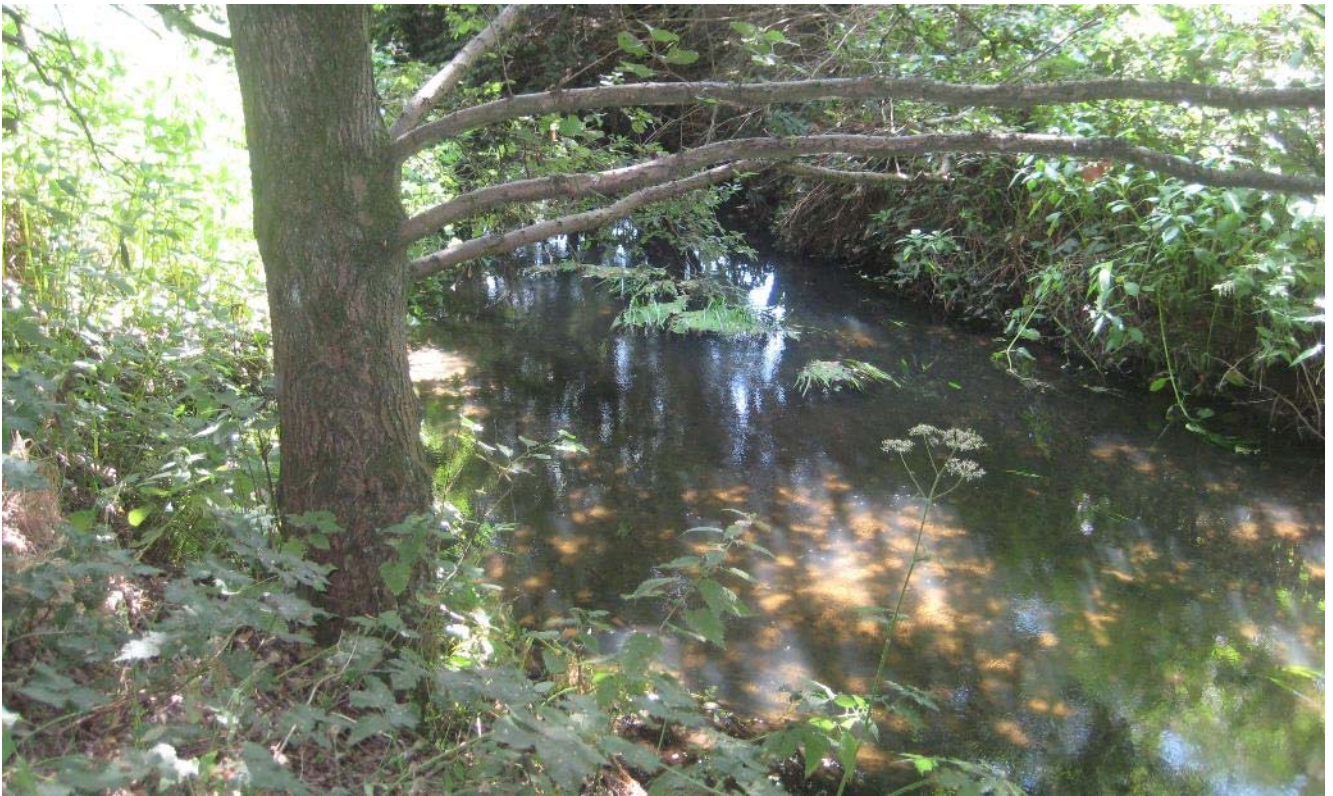
Photograph 8.6.21: Typical reach, with well vegetated riparian zone and some aquatic vegetation. River Blackwater (facing upstream), 25/07/18, standard lens.
