Southampton to London Pipeline Project

Environmental Statement (Volume D)
Appendix 8.6: Water Framework Directive
Compliance Assessment

Application Document: 6.4

Planning Inspectorate Reference Number: EN070005

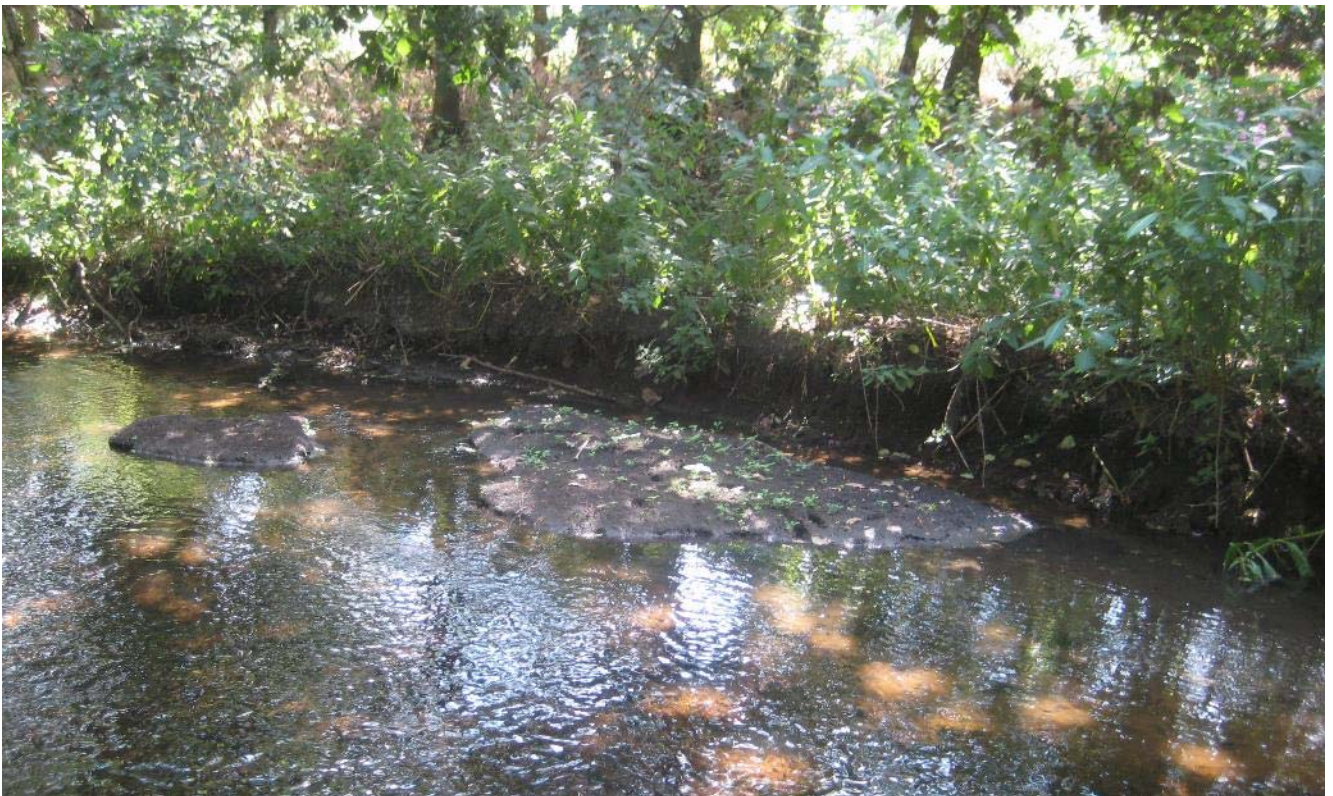
Photograph 8.6.22: Depositional feature showing signs of vegetation. Left bank is showing signs of undercutting. River Blackwater (right bank to left bank), 25/07/18, standard lens.

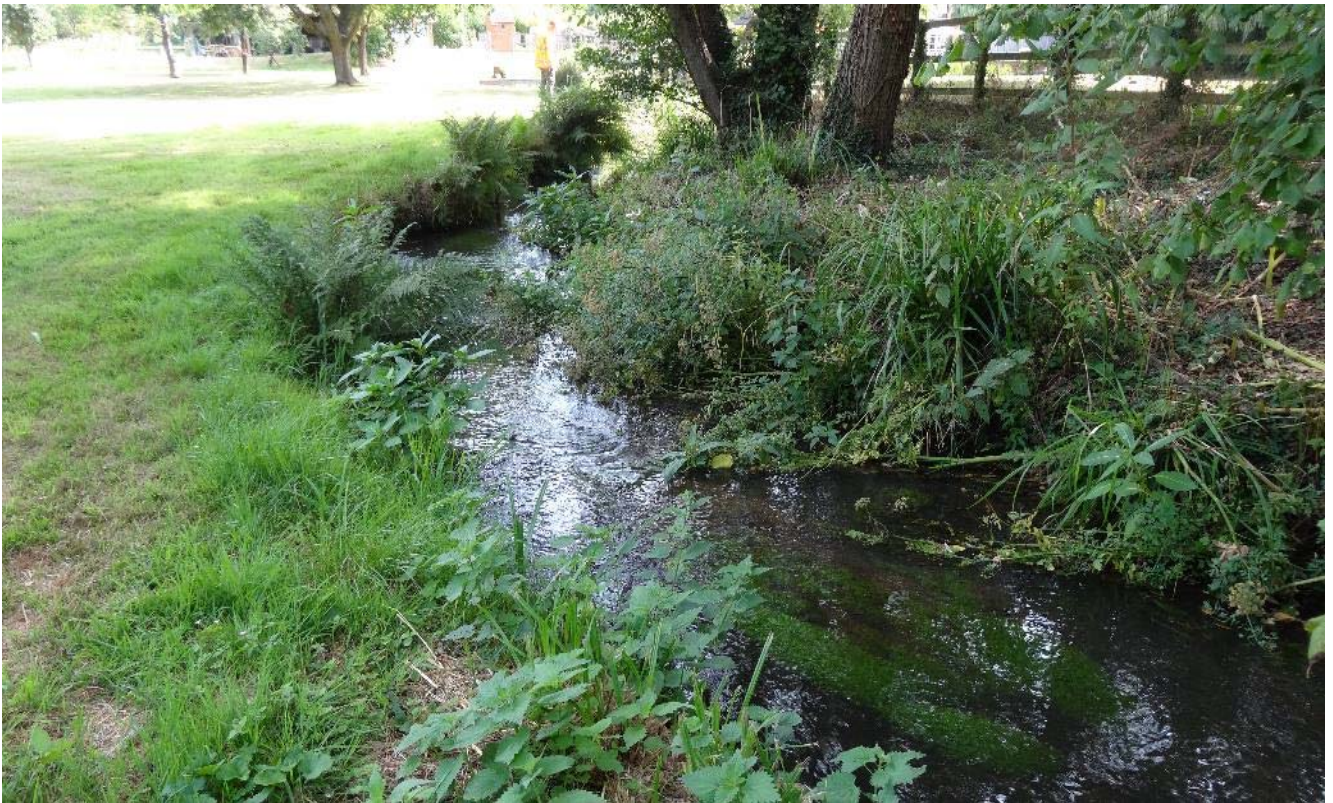
Photograph 8.6.23: Typical upstream reach, with minimal riparian vegetation and sinuous channel. Hale Bourne (facing downstream), 25/07/18, standard lens.

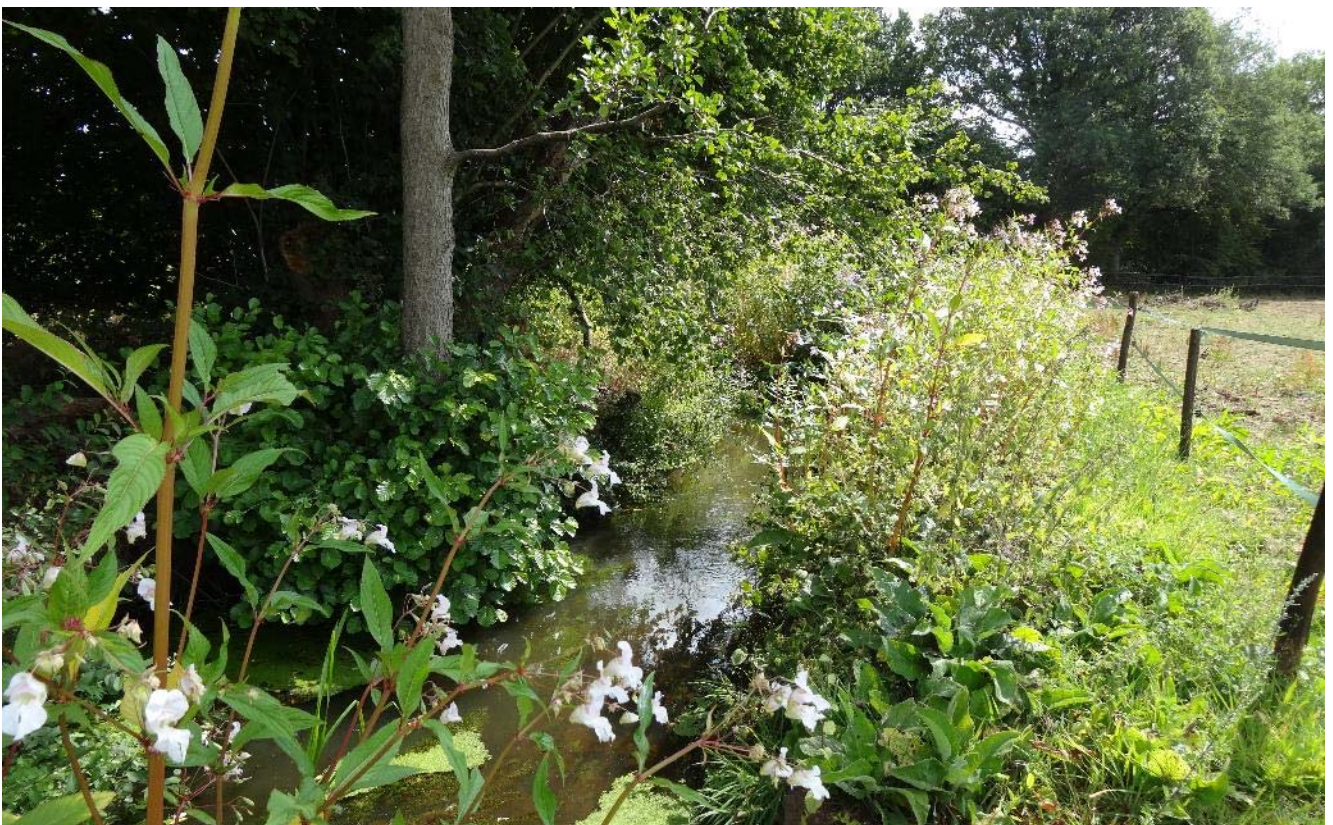
Photograph 8.6.24: Typical downstream reach, with established riparian vegetation and straight channel. Hale Bourne (facing downstream), 25/07/18, standard lens.

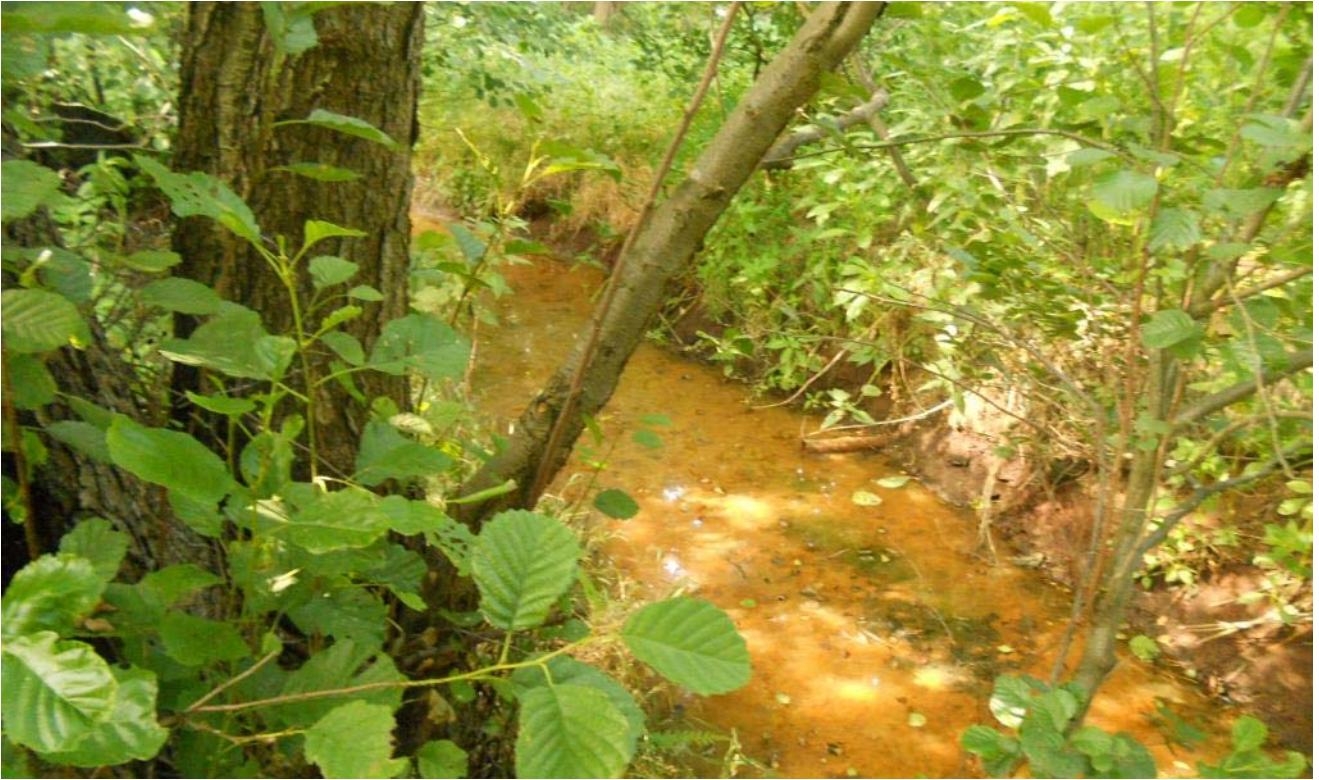
Photograph 8.6.25: Well established riparian vegetation and straight channel, with ochrous coloured water. Clappers Brook (facing upstream), 26/07/18, standard lens.

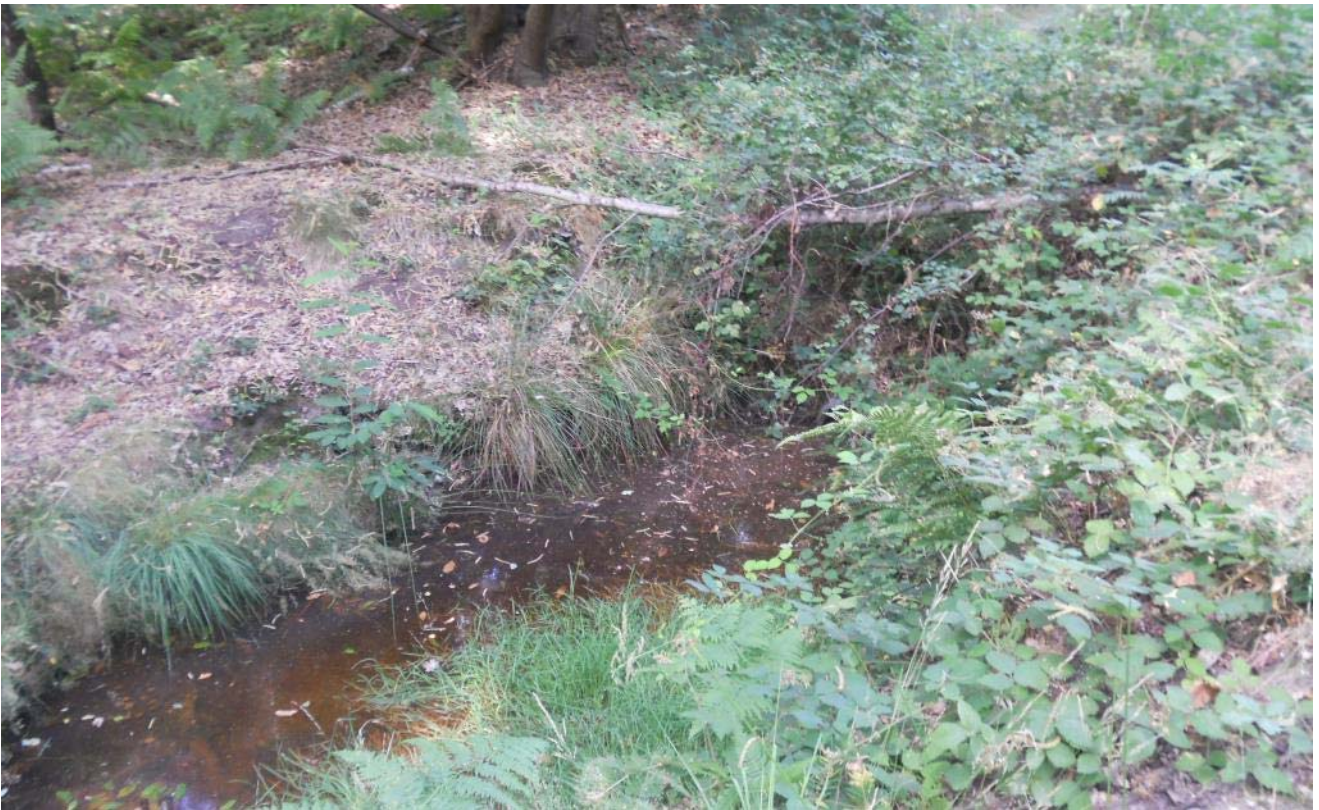
Photograph 8.6.26: Straight channel with discoloured water. Unnamed Watercourse 57 (facing upstream), 26/07/18, standard lens.

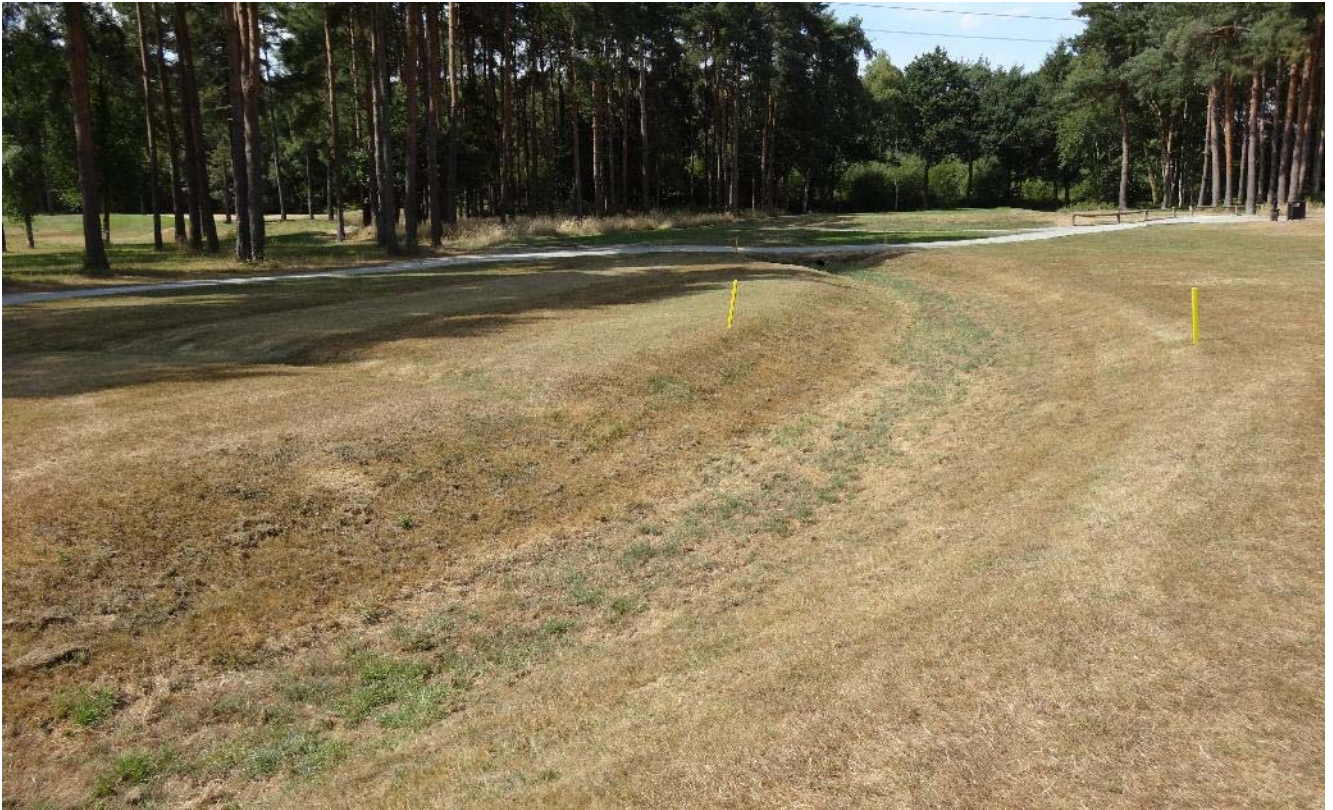
Photograph 8.6.27: Dry channel. Unnamed Watercourse 62 (facing upstream), 25/07/18, standard lens.

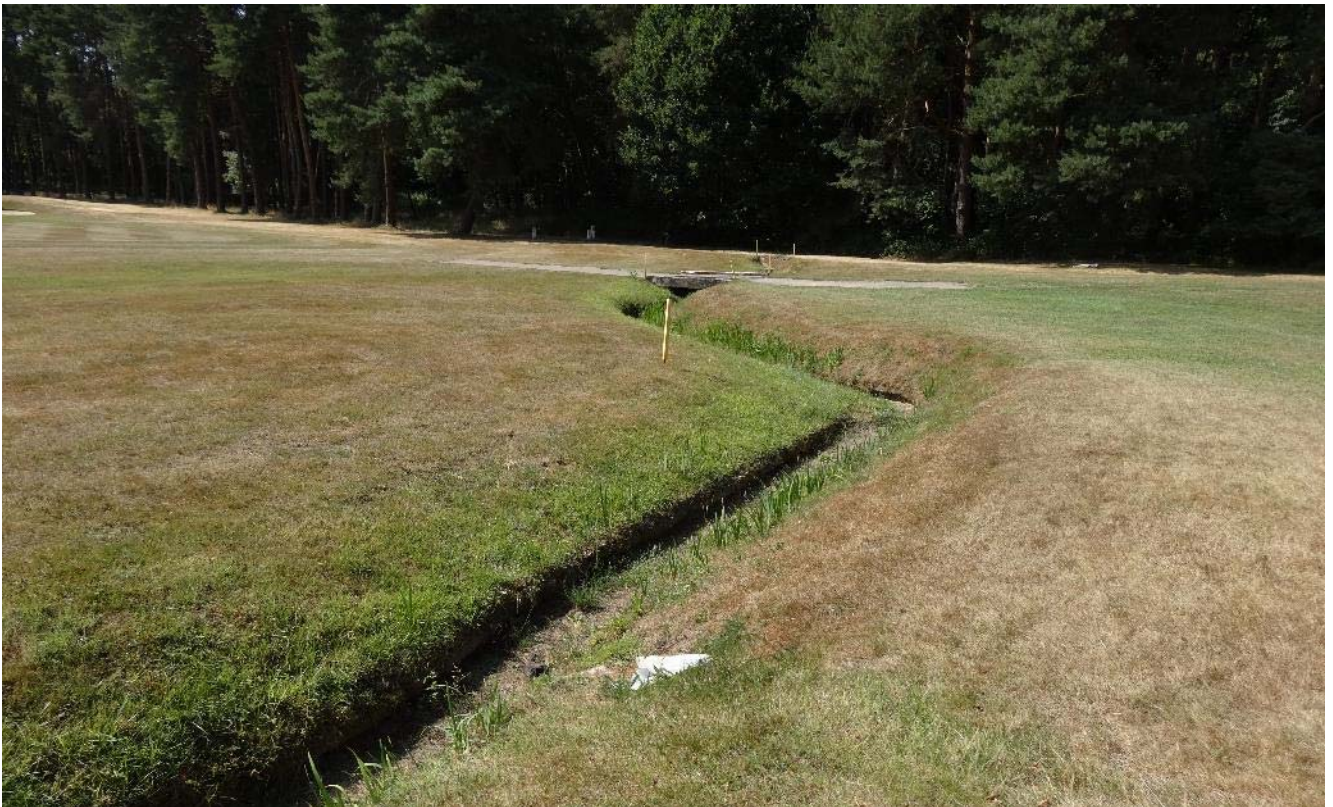
Photograph 8.6.28: Dry channel. Unnamed Watercourse 63 (facing upstream), 25/07/18, standard lens.

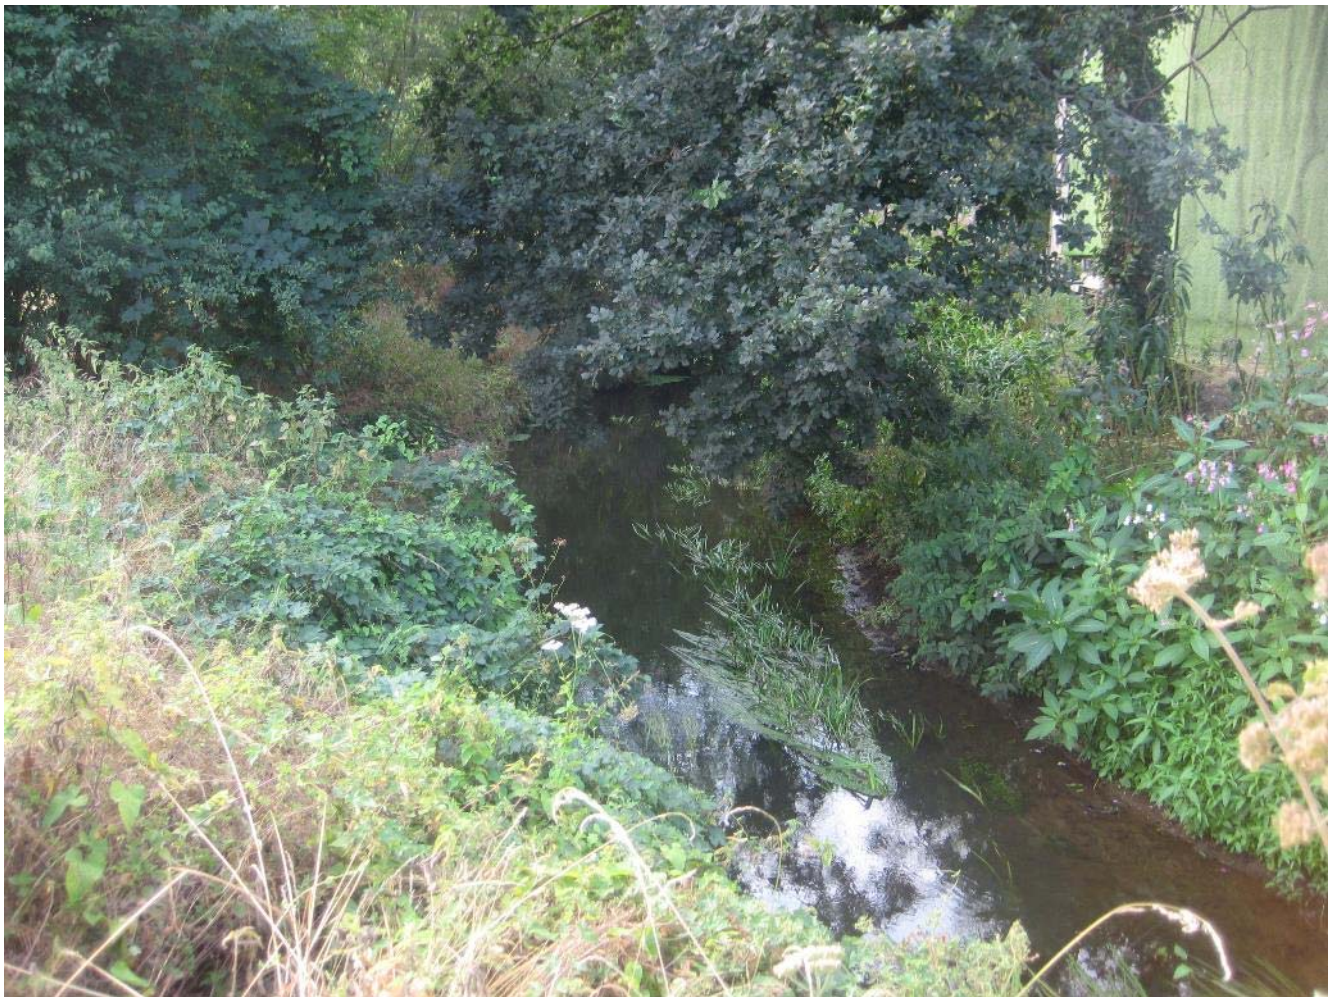
Photograph 8.6.29: Meander bend, with overgrown banks and macrophytes present mid-channel. Chertsey Bourne (facing upstream), 26/07/18, standard lens.

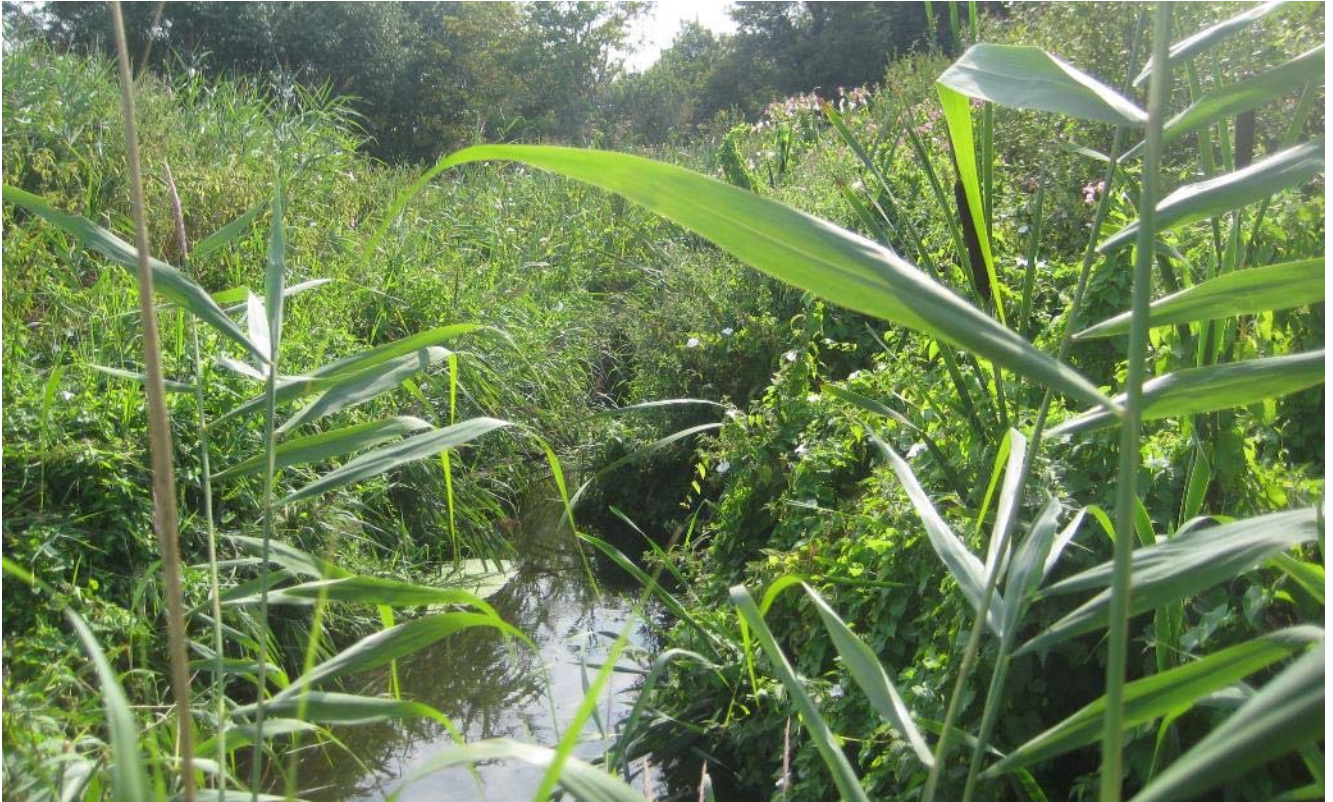
Photograph 8.6.30: Marginal and bankside vegetation encroaching on the channel. Chertsey Bourne (facing downstream), 26/07/18, standard lens.

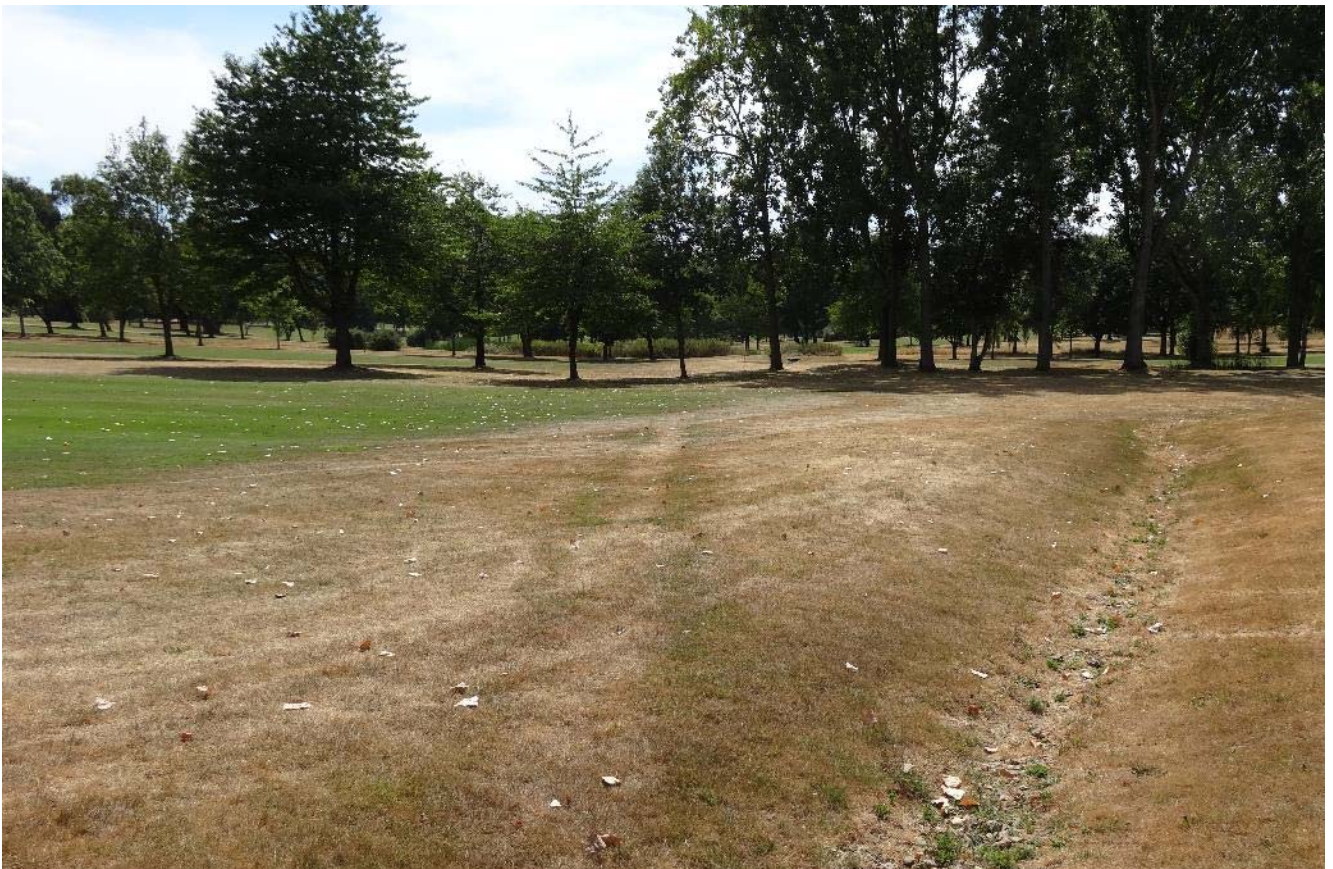
Photograph 8.6.31: Dry channel. Unnamed Watercourse 64 (facing upstream), 25/07/18, standard lens.

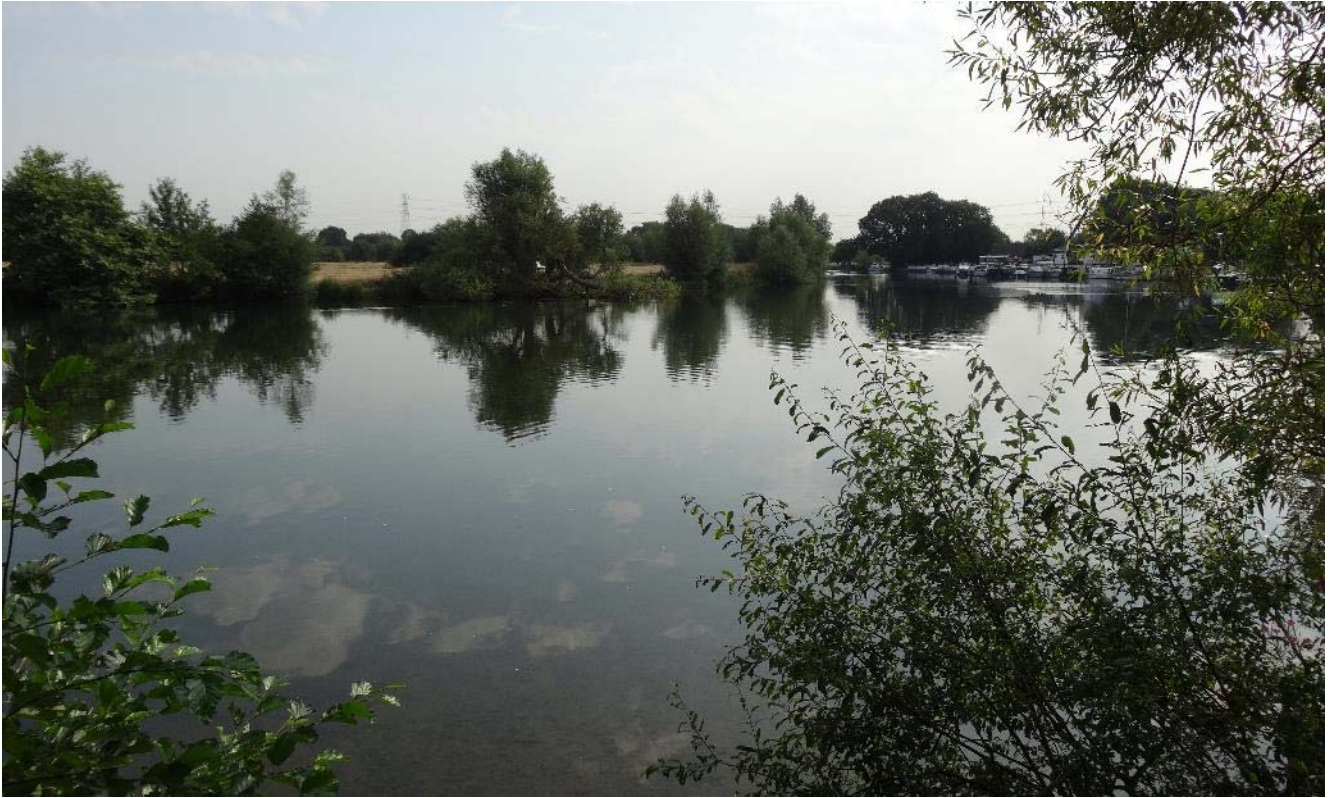
Photograph 8.6.32: View of left bank, with semi-continuous riparian vegetation visible. Boats are also present along the right bank. River Thames (facing left bank), 26/07/18, standard lens.

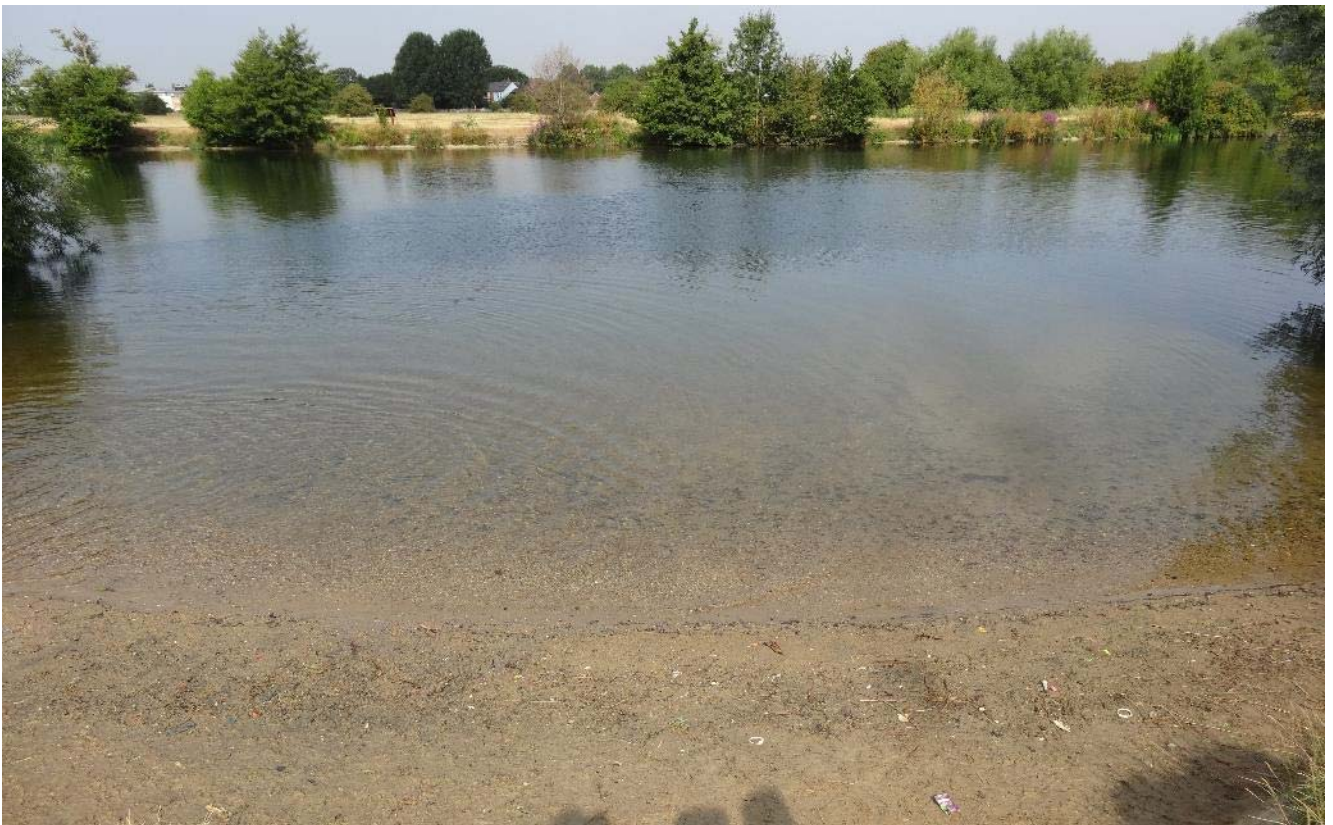
Photograph 8.6.33: View of left bank from river beach. River Thames (facing left bank), 26/07/18, standard lens.

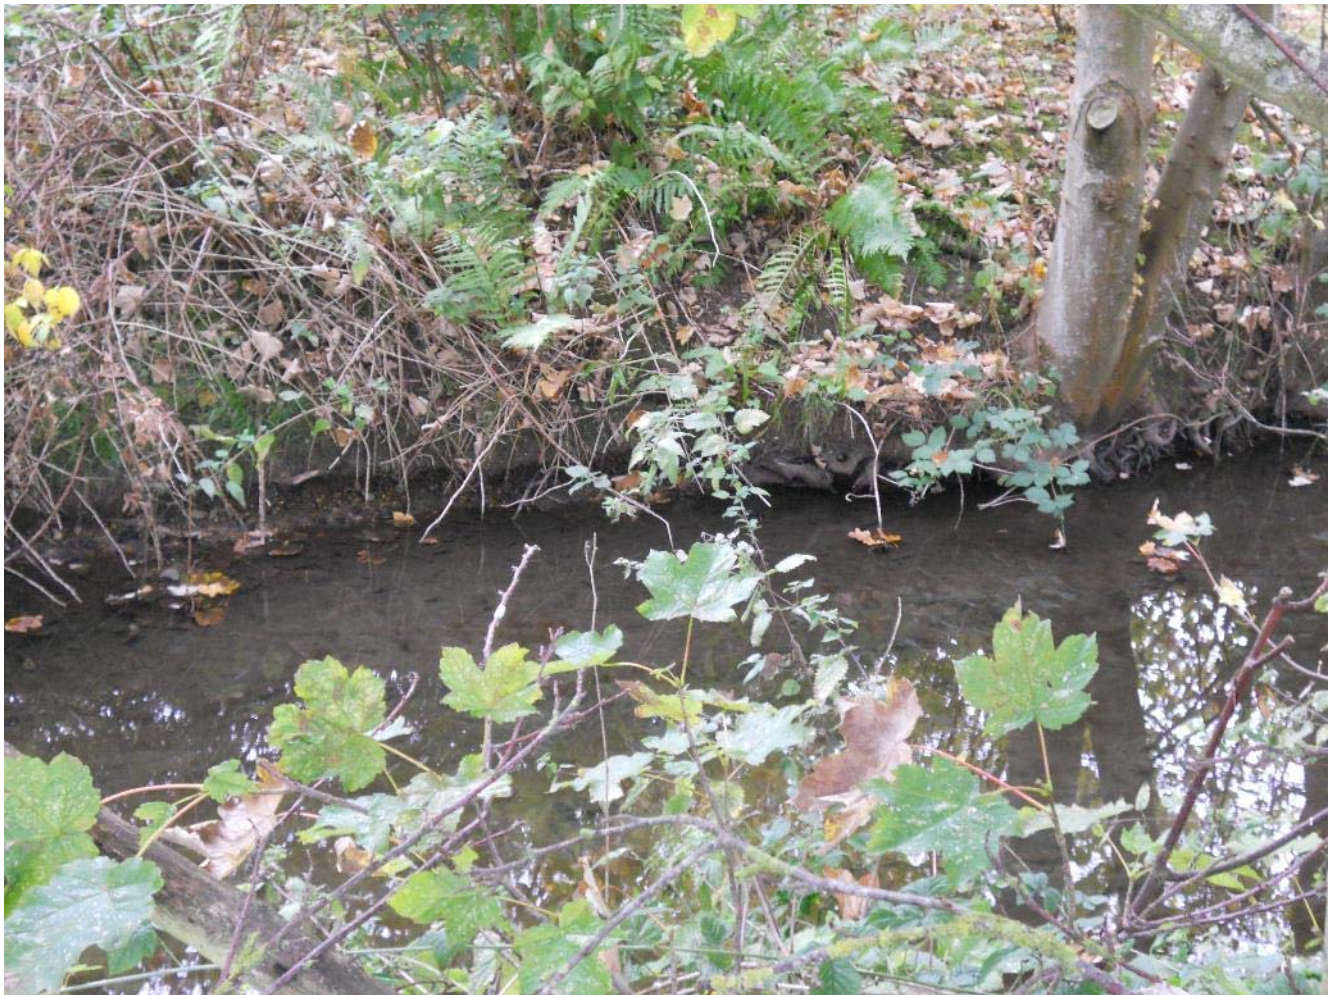
Photograph 8.6.34: Typical section of watercourse as it passed Queen Mary Reservoir. River Ash (facing right bank), 04/10/18, standard lens.

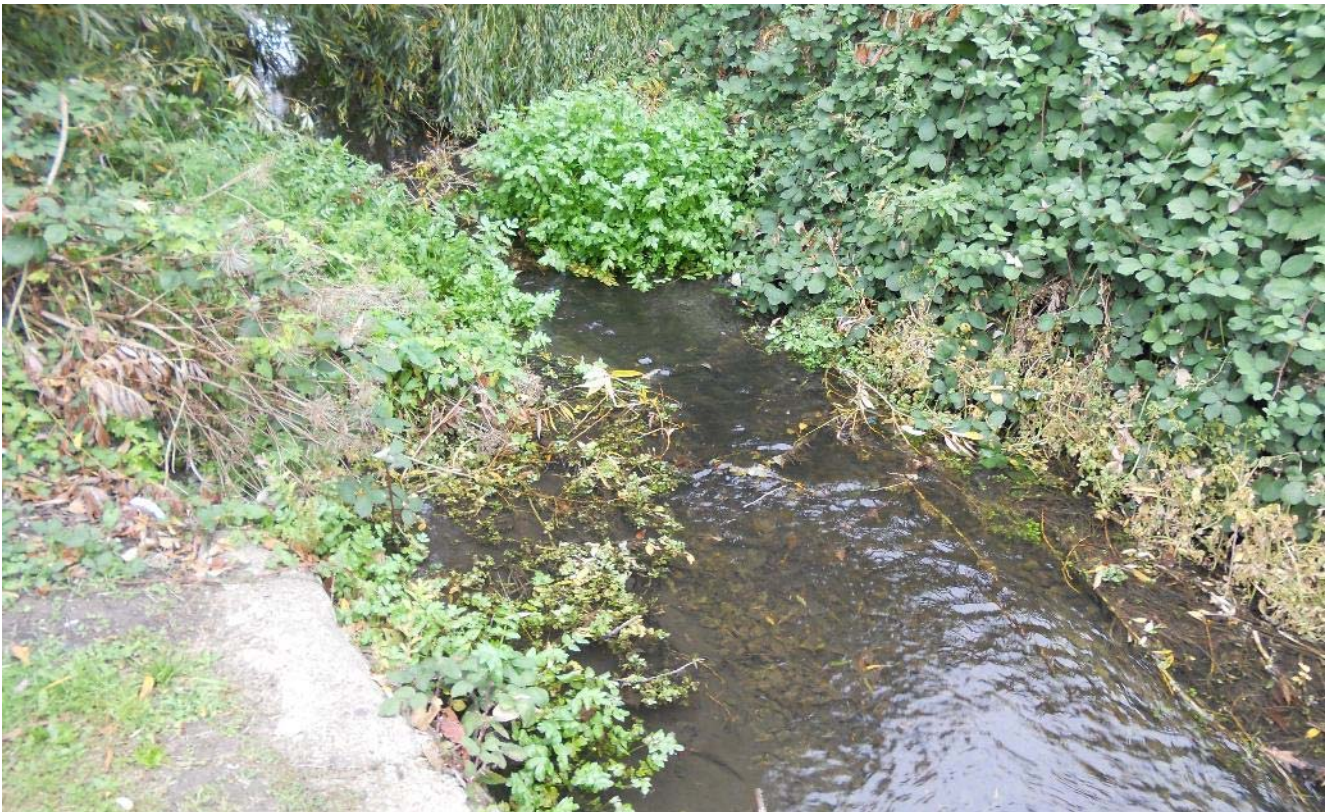
Photograph 8.6.35: Location of spot check, upstream of Queen Mary Reservoir. Bank reinforcement present on the right bank, with some flow diversity and fine gravels visible. River Ash (facing upstream), 04/10/18, standard lens.

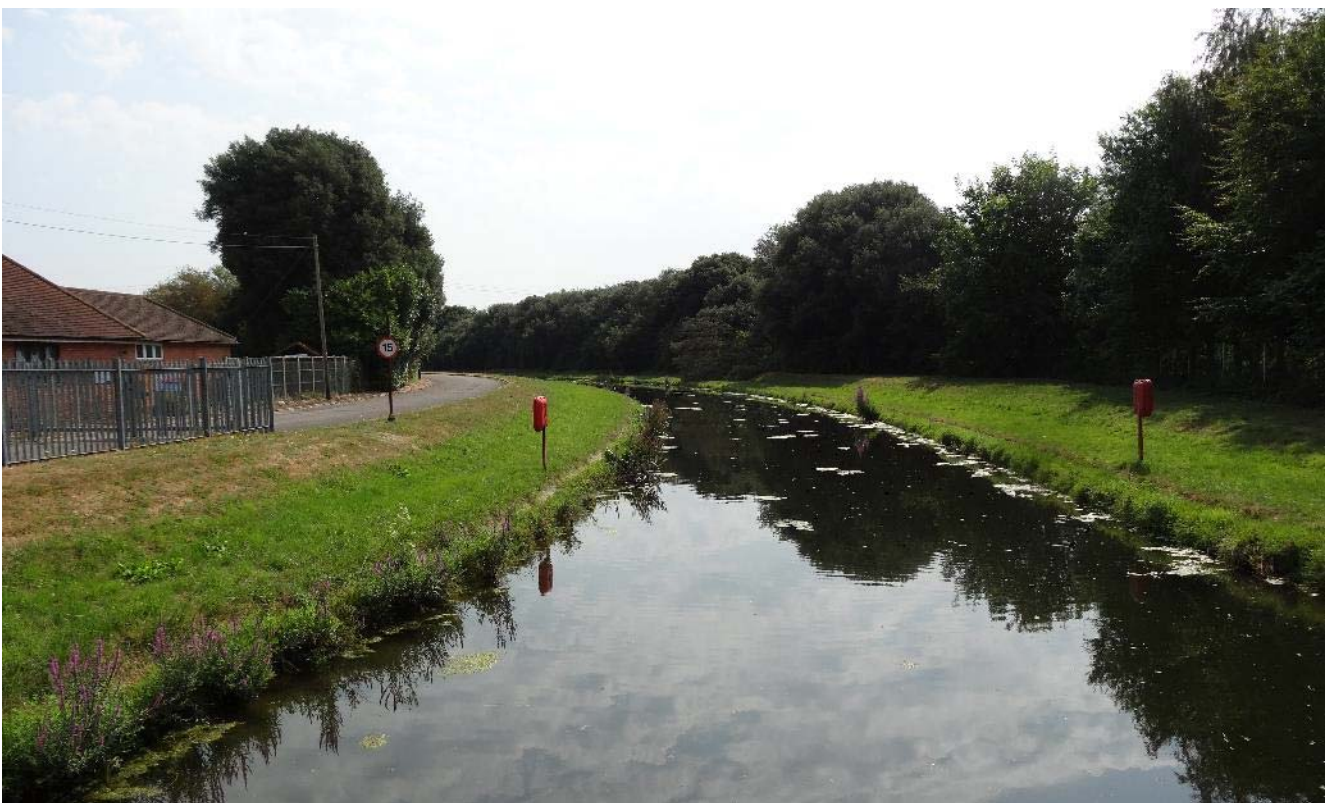
Photograph 8.6.36: Typical reach, with maintained riparian zone. Queen Mary Reservoir intake channel (facing downstream), 26/07/18, standard lens.

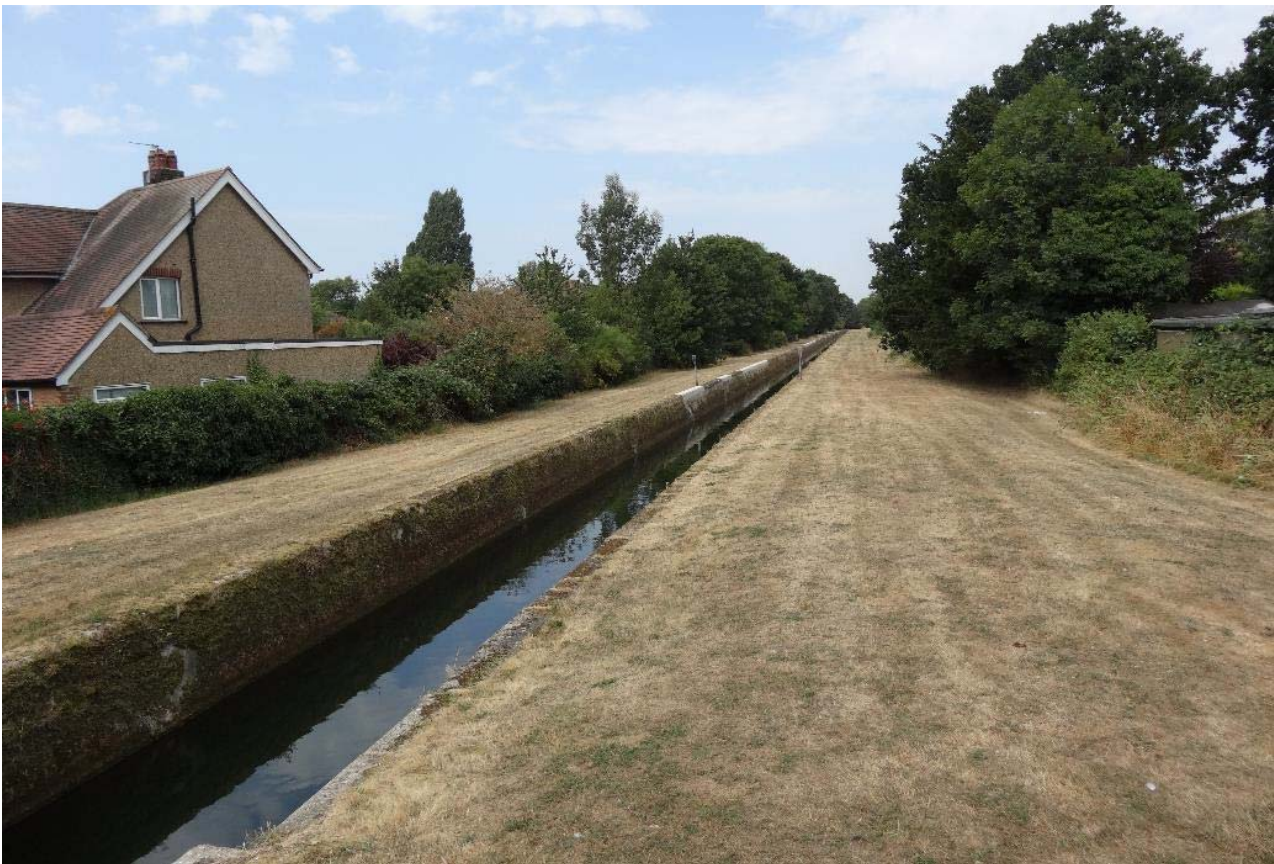
Photograph 8.6.38: Typical reach, with maintained riparian zone. King George VI Reservoir Water Transfer (facing upstream), 26/07/18, standard lens.
