# Southampton to London Pipeline Project

## Volume 6

Environmental Statement  
Habitat Regulations Assessment (2 of 2)

Application Document: 6.5

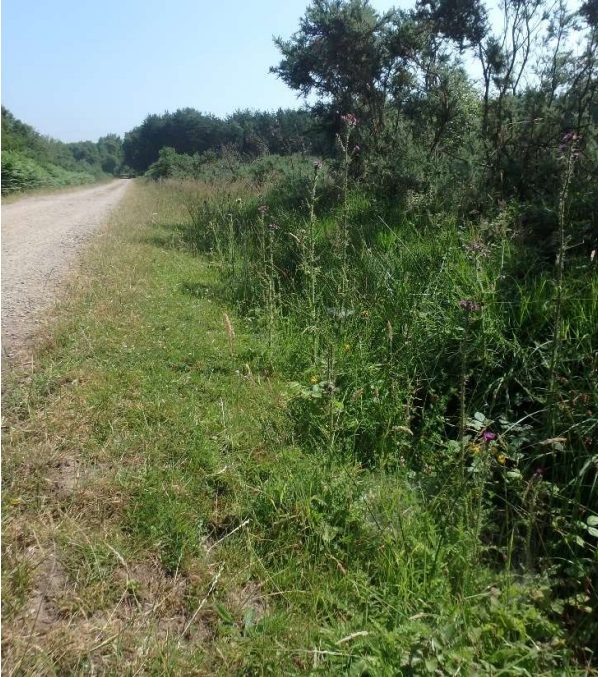
Photograph 7.1.34 : Track looking northeast and zonation of adjacent habitats on verge, ditch and bank. Photograph location shown in Figure F4. 28/06/2018, standard lens.

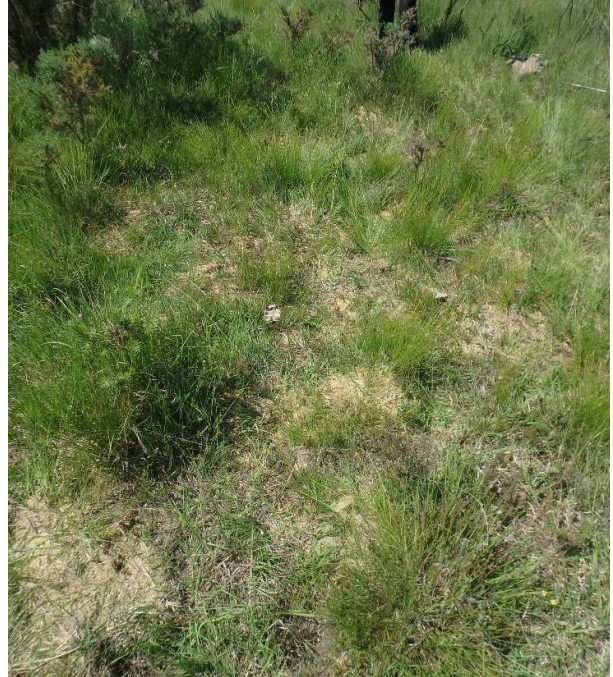
Photograph 7.1.35: Richer wet heath in ground hollows to north of track, with abundant Sphagnum. Photograph location shown in Figure F4. 28/06/2018, standard lens.

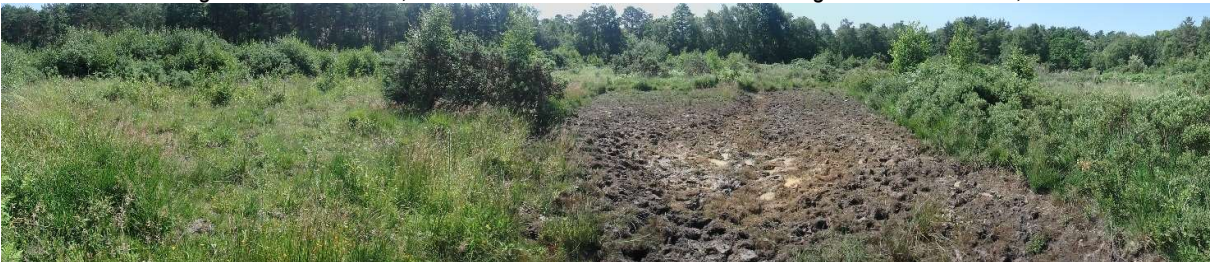
Photograph 7.1.36: Coarse wet heath and scrape. Photograph location shown in Figure F4. 28/06/2018, standard lens.

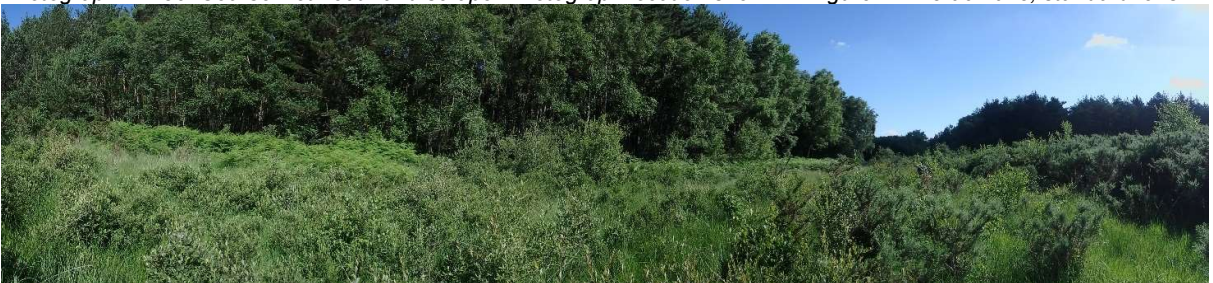
Photograph 7.1.37: Species-poor wet heath to north of track. Photograph location shown in Figure F4. 22/06/2018, standard lens.

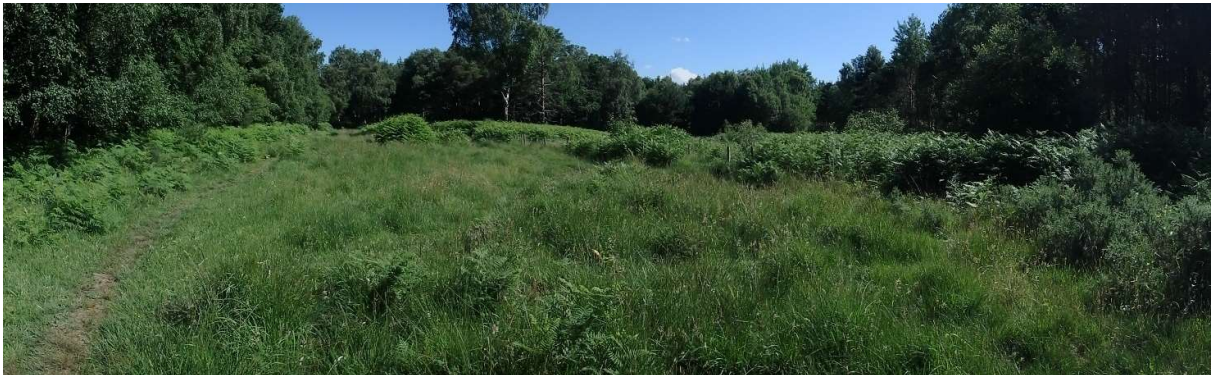
Photograph 7.1.38: Purple moor-grass grassland north of track, looking north. Photograph location shown in Figure F4. 22/06/2018, standard lens.

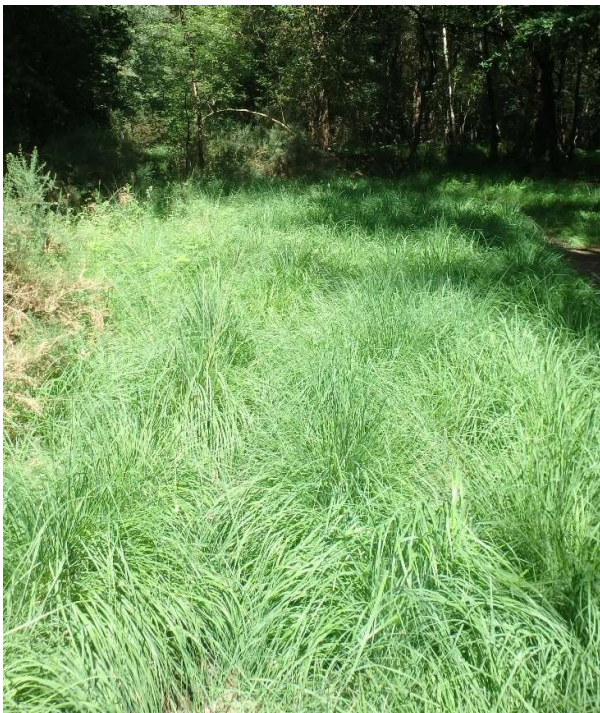
Photograph 7.1.39: Purple moor-grass-dominated wet heath, looking northeast into woodland along existing Esso pipeline route. Photograph location shown in Figure F4. 22/06/2018, standard lens.

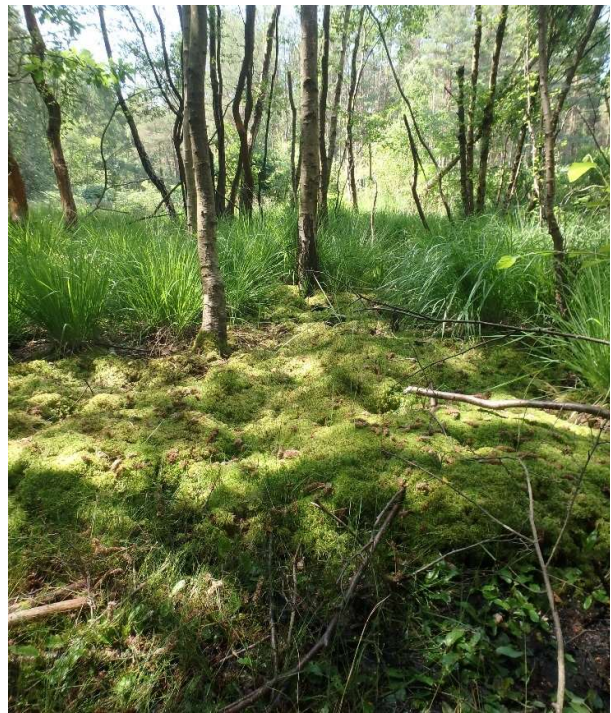
Photograph 7.1.40: Wet woodland in valley bottom with abundant Sphagnum in ground flora. Photograph location shown in Figure F4. 28/06/2018, standard lens.

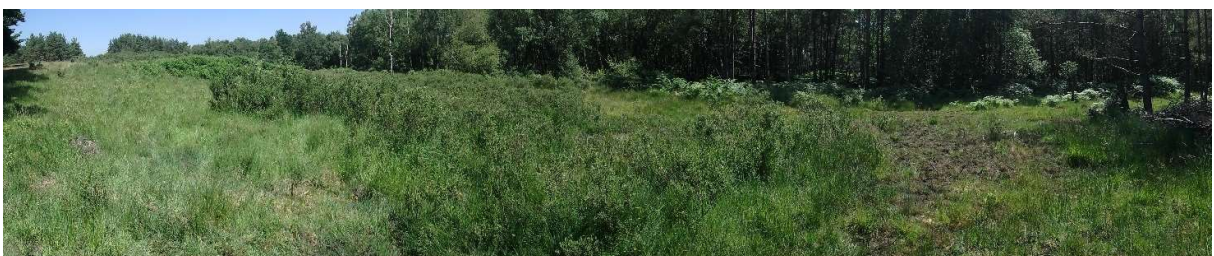
Photograph 7.1.41: Zonation of heathland habitats associated with seepage, looking northeast. Top-left to right: dry dwarf shrub heath, wet heath and valley mire. 28/06/2018, , standard lens.

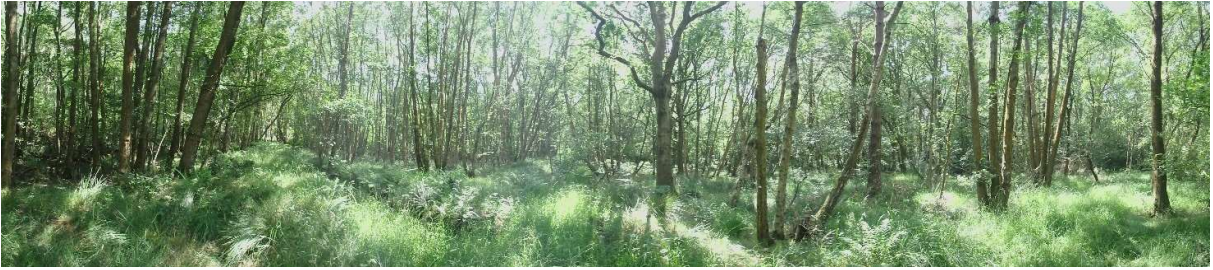
*Photograph 7.1.42: Wet woodland around where the existing Esso pipeline meets the Gelvert Stream. Photograph location shown in Figure F4. 28/06/2018, standard lens.*

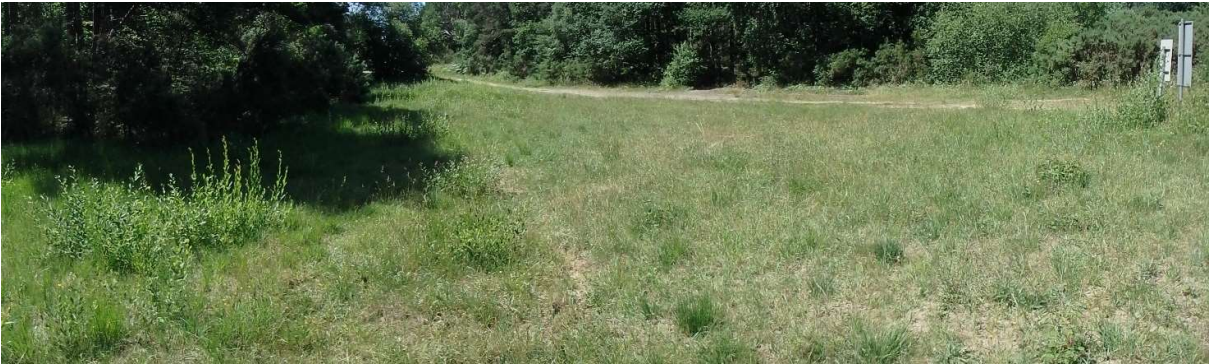
*Photograph 7.1.43: Disturbed purple moor-grass-dominated grassland along forestry ride, looking southwest from northeastern end of survey site. Photograph location shown in Figure F4. 22/06/2018, standard lens.*

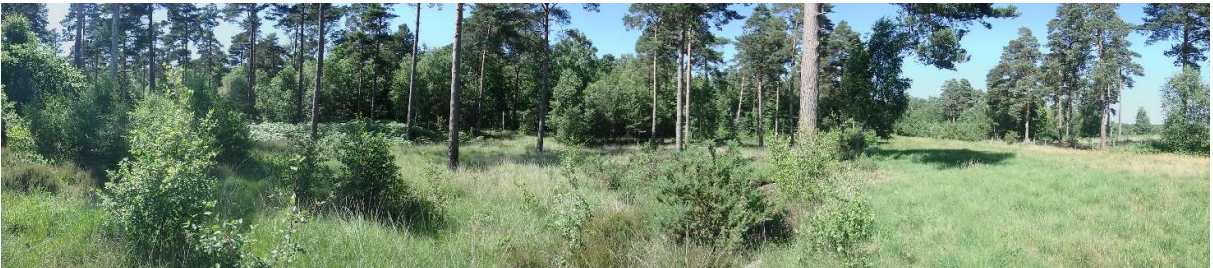
*Photograph 7.1.44: Easement (right) and thinned Scots pine plantation (left), looking northeast. Photograph location shown in Figure F4. 25/06/2018, standard lens.*

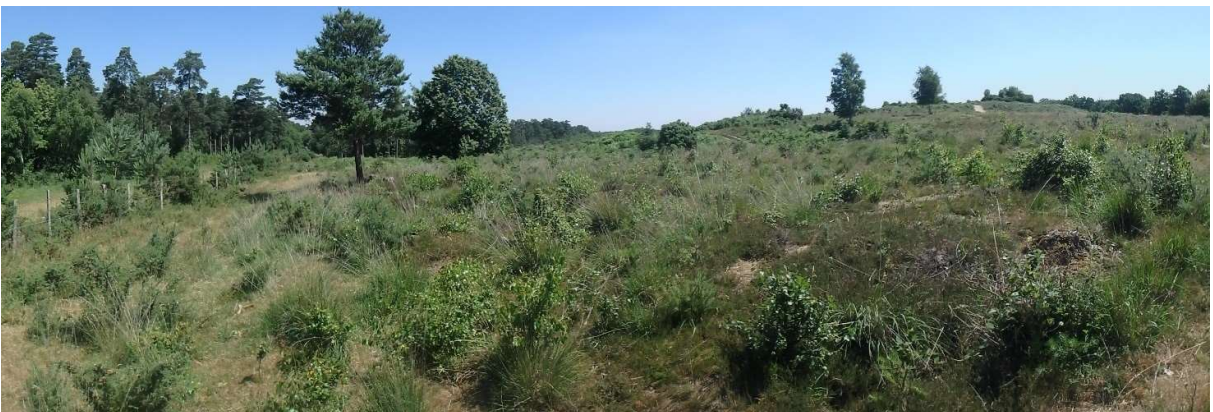
*Photograph 7.1.45: Heathland habitats to the east of the easement, looking north, the fencing visible on the left. Acid grassland in parched, disturbed area (left) and dry dwarf shrub heath vegetation on bank (right). Photograph location shown in Figure F4. 26/06/2018, standard lens.*

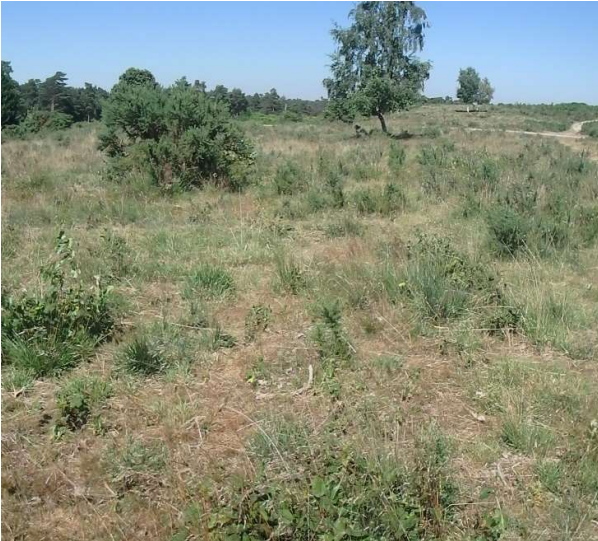
*Photograph 7.1.46: Patchy acid grassland with scattered scrub in managed area of heathland. Photograph location shown in Figure F4. 27/06/2018, standard lens.*

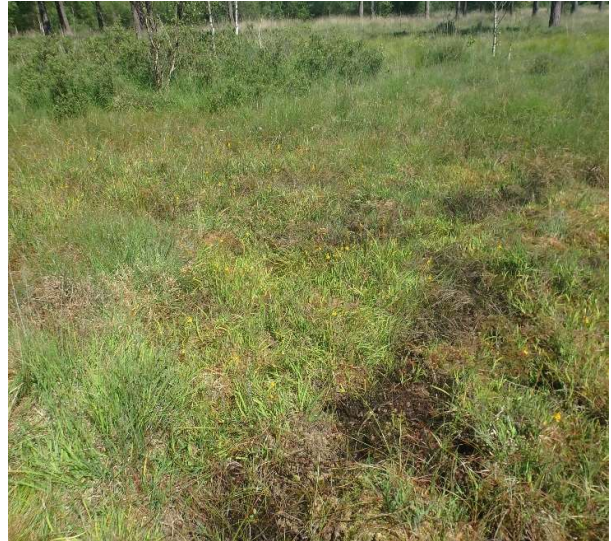
*Photograph 7.1.47: Valley mire vegetation in ground hollow, with yellow flowers of bog asphodel. Photograph location shown in Figure F4. 26/06/2018, standard lens.*

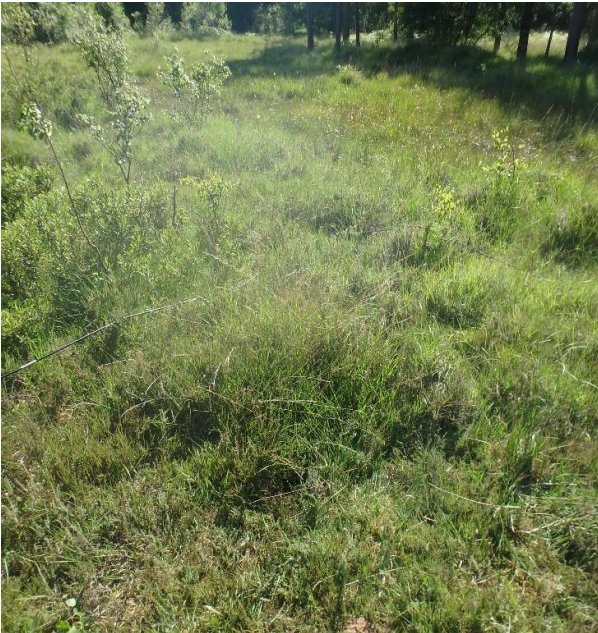
*Photograph 7.1.48: Grazed wet heath vegetation to east of valley mire. Photograph location shown in Figure F4. 26/06/2018, standard lens.*

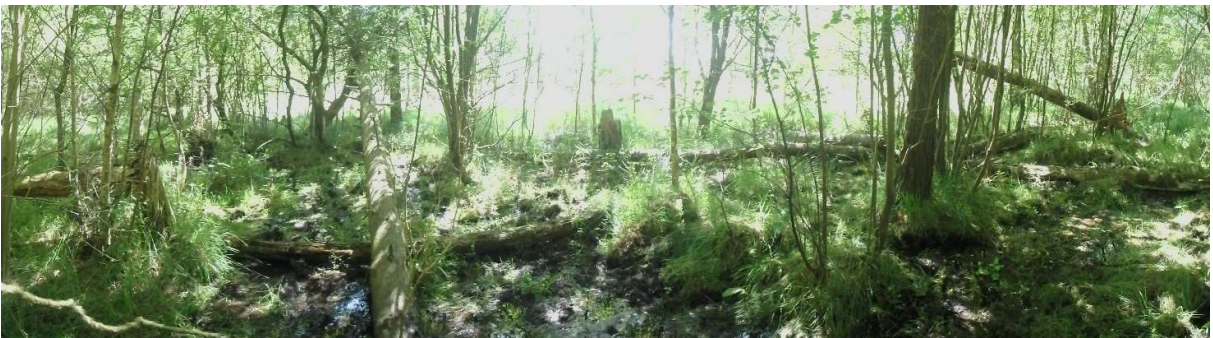
*Photograph 7.1.49: Swampy wet woodland along watercourse to the south of Aldershot Road. Photograph location shown in Figure F4. 27/06/2018, standard lens.*

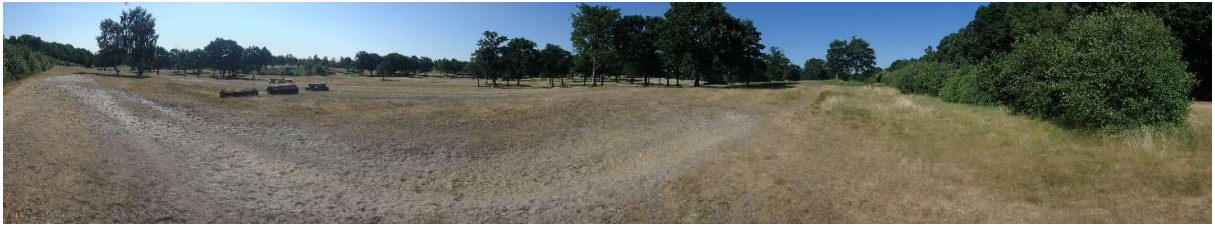
*Photograph 7.1.50: Tweseldown Racecourse. Heavily disturbed acid grassland within Unit 4 of Bourley and Long Valley SSSI, looking south. Planted hedgerow to right. Photograph location shown in Figure F4. 29/06/2018, standard lens.*

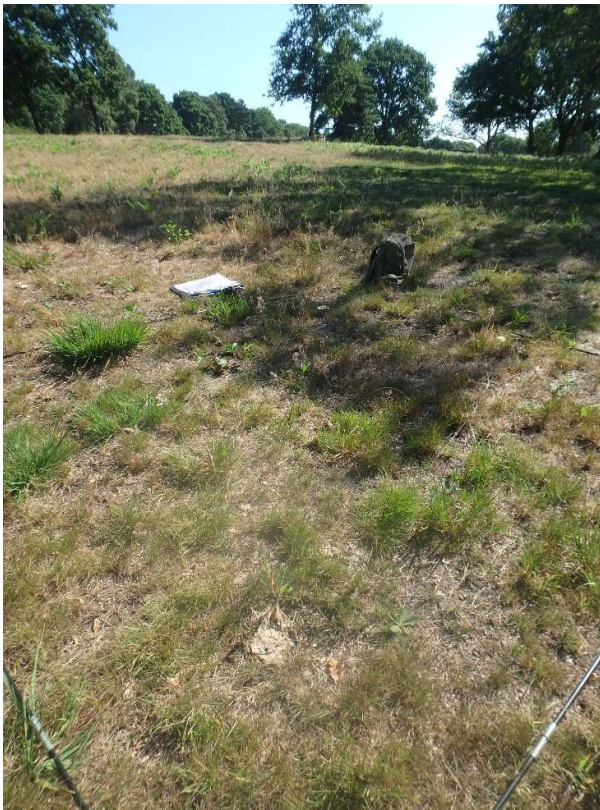
*Photograph 7.1.51: Tweseldown Racecourse. Patchy species-poor acid grassland within Unit 4 of Bourley and Long Valley SSSI. Photograph location shown in Figure F4. 29/06/2018, standard lens.*

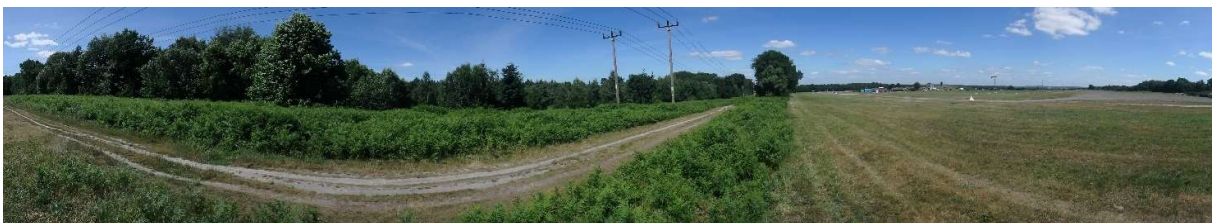
*Photograph 7.1.52: Tweseldown Racecourse, outside Bourley and Long Valley SSSI, looking north. Large area of amenity grassland (right) and dense bracken (left). Photograph location shown in Figure F4. 29/06/2018, standard lens.*

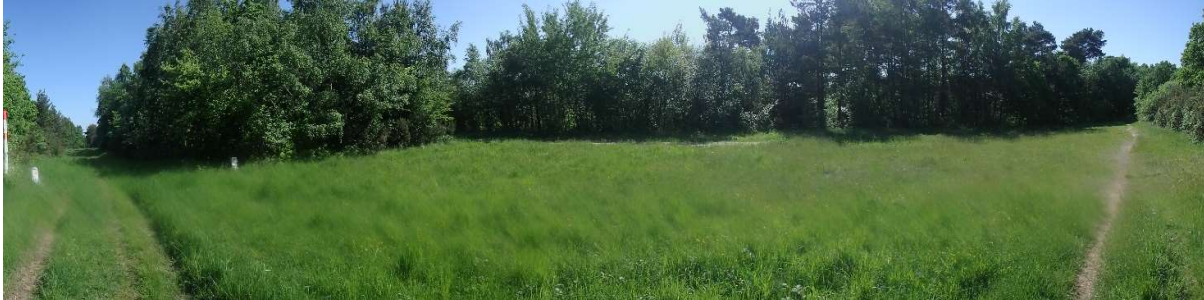
*Photograph 7.1.80: Southwestern end of Order Limits within SSSI, subsite 1, looking northeast. Open area of neutral grassland adjacent to plantation woodland, with purple moor-grass dominated grassland extending north along easement of existing pipeline (left). Photograph location shown in Figure F8. 17/05/2018, standard lens.*

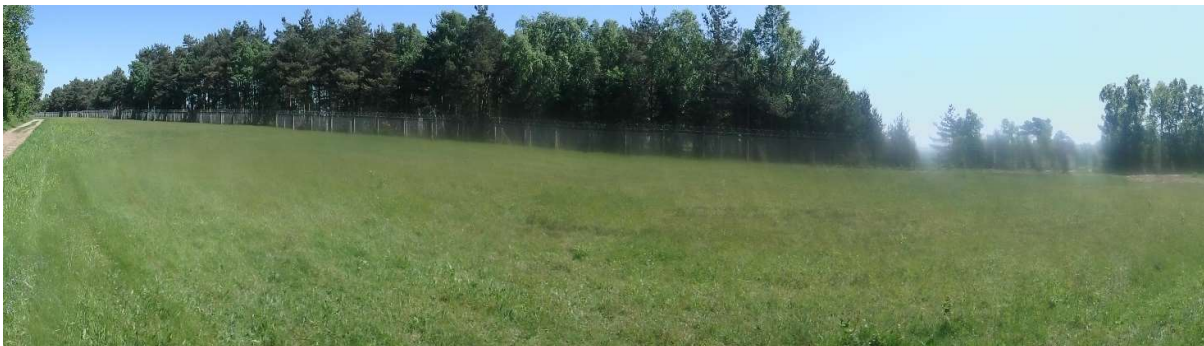
*Photograph 7.1.82: Broad area of acid grassland in southwestern part of Order Limits, looking northeast. Photograph location shown in Figure F8. 17/05/2018, standard lens.*

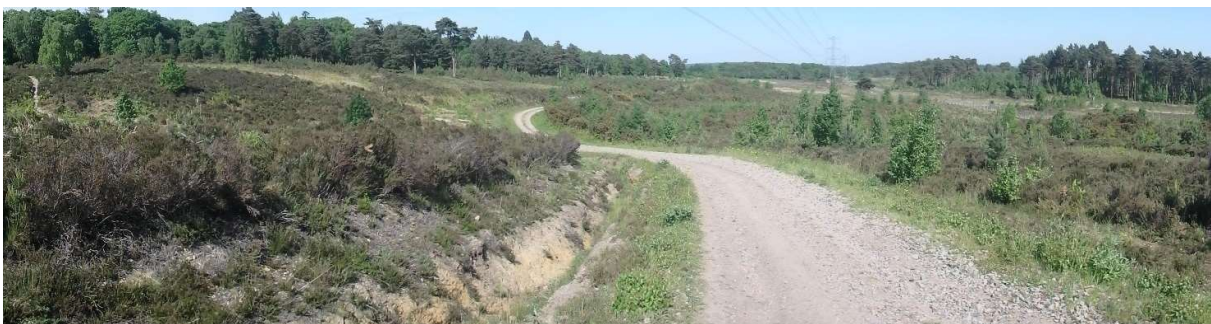
*Photograph 7.1.83: View northeast over dry dwarf shrub heath of subsite 2, showing bank and MoD track. Photograph location shown in Figure F8. 17/05/2018, standard lens.*

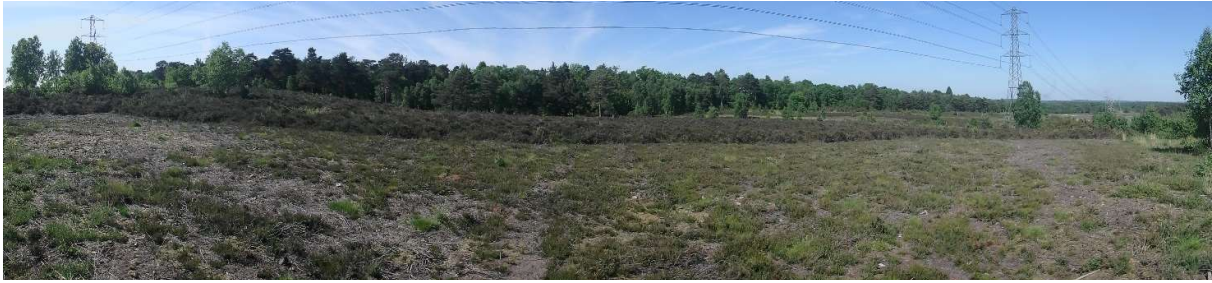
*Photograph 7.1.84: Scraped/mown dry dwarf shrub heath vegetation. Photograph location shown in Figure F8. 17/05/2018, standard lens.*

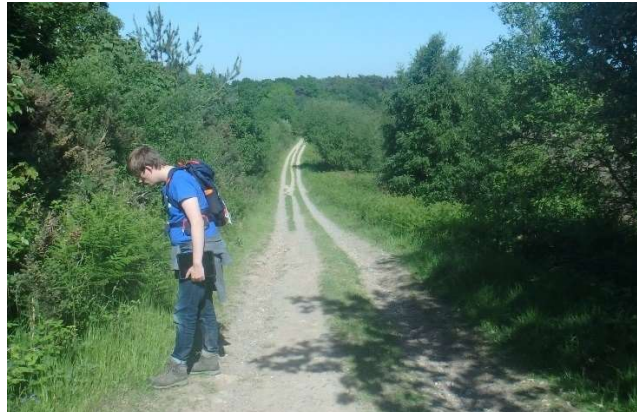
*Photograph 7.1.85: Scrub along the MoD track in the northeastern part of subsite 2, looking east. Photograph location shown in Figure F8. 17/05/2018, standard lens.*

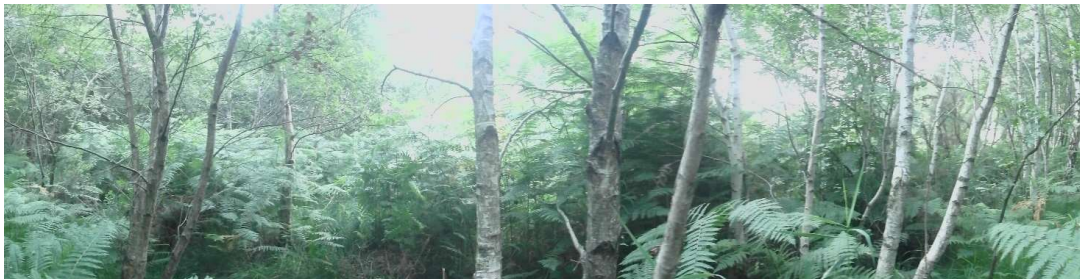
*Photograph 7.1.86: Young birch woodland in the northeast of the subsite 2, dominated by birch. Photograph location shown in Figure F8. 13/07/2018, standard lens.*

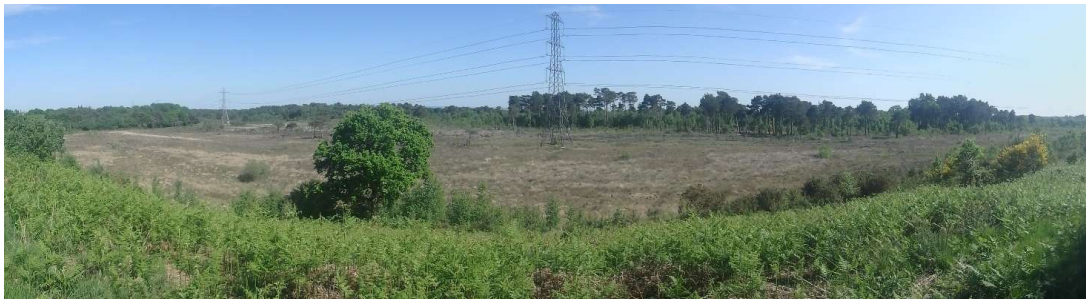
*Photograph 7.1.87: View southeast over Folly Bog from the MoD track, with bracken dominated slope in foreground. Areas of dense black bog-rush are visible as paler strips of vegetation. Photograph location shown in Figure F8. 17/05/2018, standard lens.*

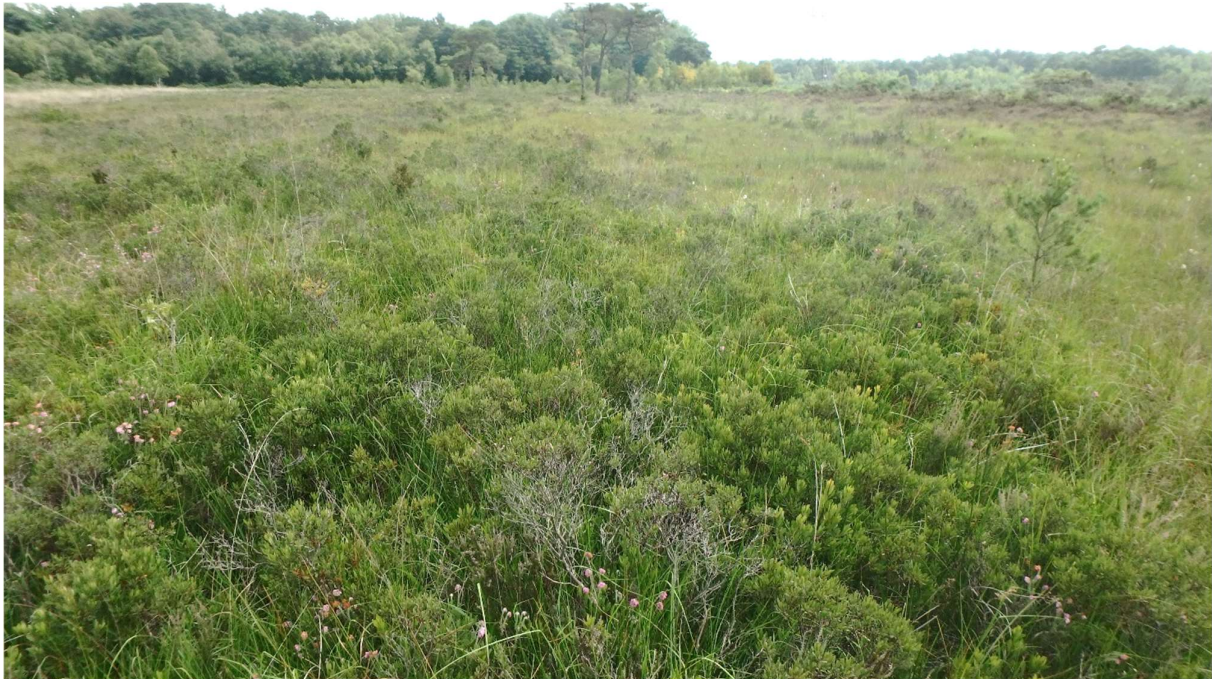
*Photograph 7.1.88: Patterning of vegetation within the eastern half of Folly Bog, looking east. From right to left: wet heath, darker vegetation dominated by subshrubs; short, grazed valley mire, with fruiting heads of common cottongrass (white); coarser, taller valley mire dominated by bog myrtle; black bog-rush dominated vegetation, top-left, pal straw-coloured strip. Photograph location shown in Figure F8. 12/07/2018, standard lens.*

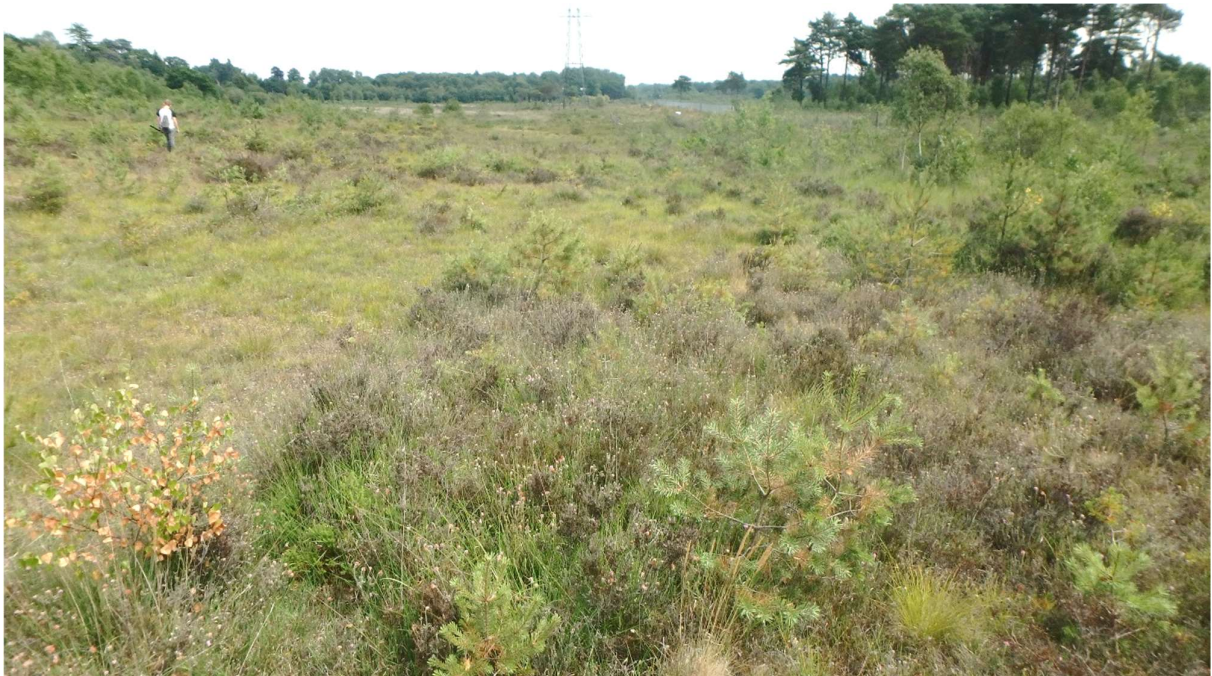
*Photograph 7.1.89 : Short open wet heath at the southwestern end of Folly Bog, looking east. Photograph location shown in Figure F8. 12/07/2018, standard lens.*

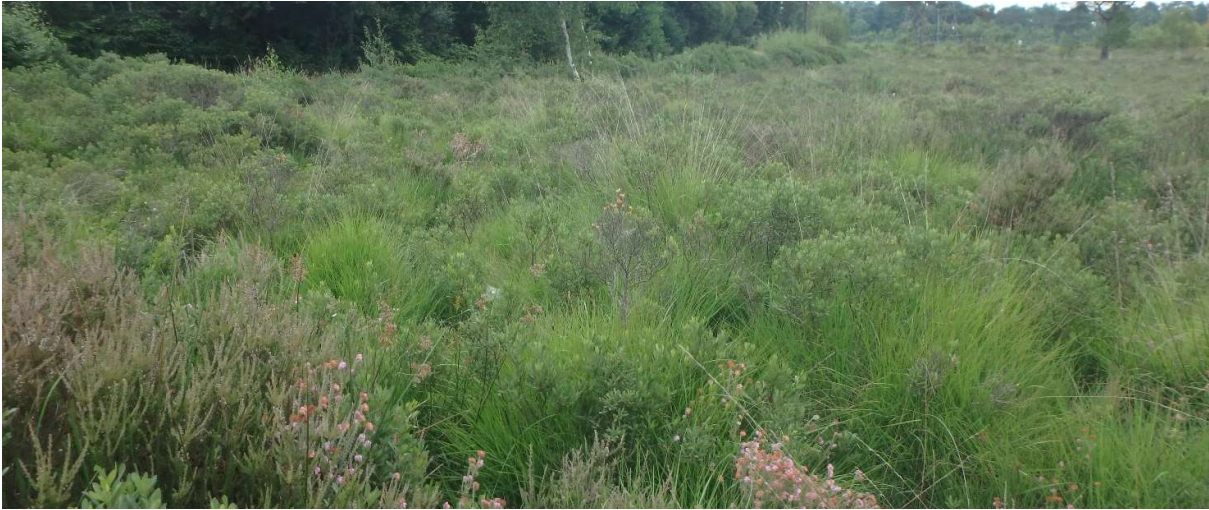
*Photograph 7.1.90: Rank species-poor wet heath and valley mire in the northeast of Folly Bog, looking southeast, dominated by tussocks of purple moor-grass and bog myrtle. Photograph location shown in Figure F8. 12/07/2018, standard lens.*

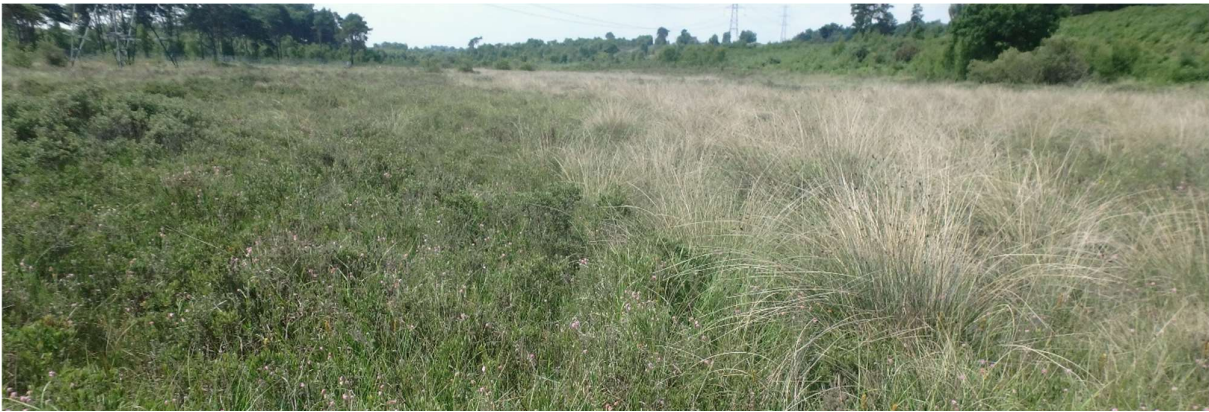
*Photograph 7.1.91: Sharply-defined boundary between black bog-rush-dominated vegetation (right) and the main vegetation of the valley mire (left). Photograph location shown in Figure F8. 12/07/2018, standard lens.*

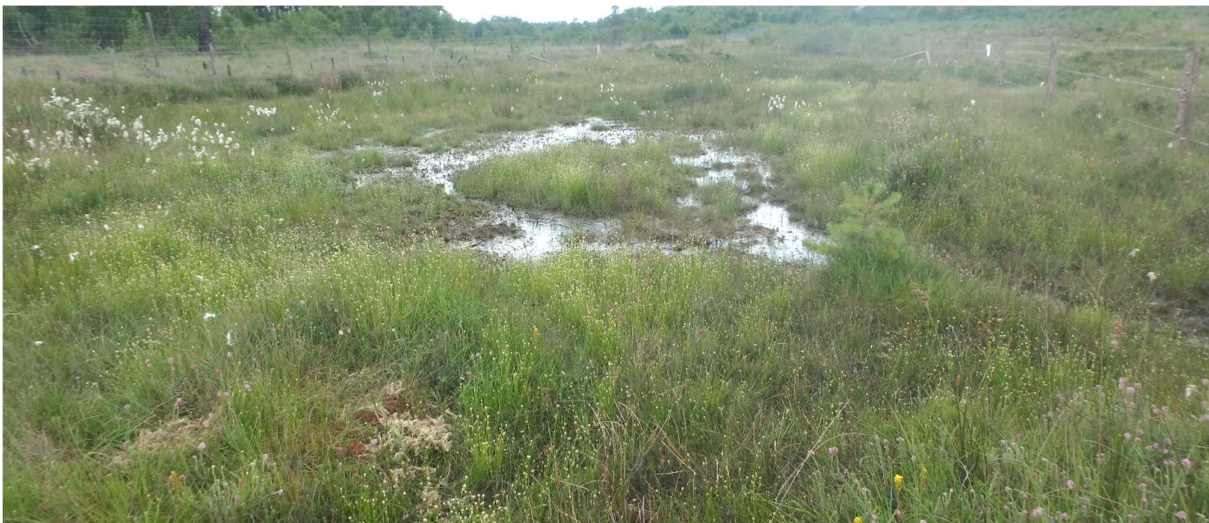
*Photograph 7.1.92: Open vegetation around collects and runnels in the southwest of Folly Bog, with abundant white beak-sedge. Photograph location shown in Figure F8. 09/07/2018, standard lens.*

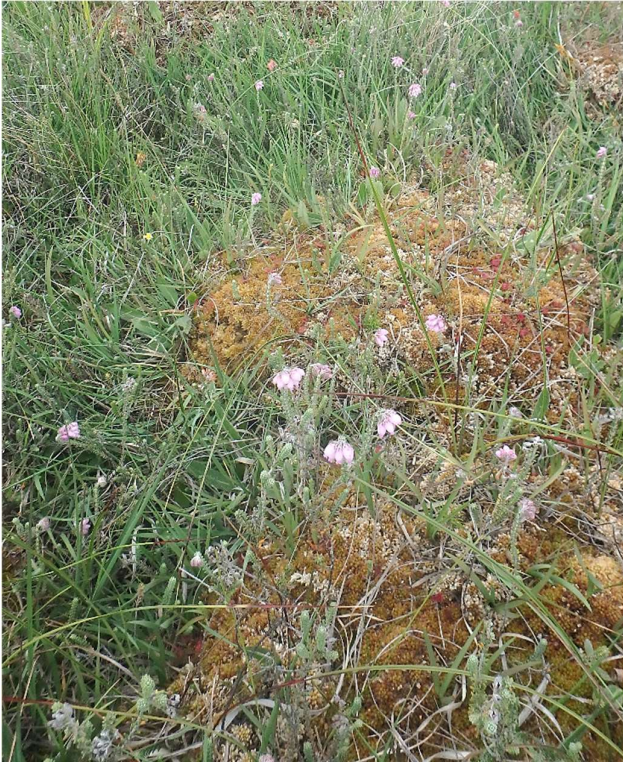
*Photograph 7.1.93: Large hummocks of Sphagnum papillosum (orange) supporting growths of vascular plants such as cross-leaved heath (pink), meadow thistle and round-leaved sundew. Photograph location shown in Figure F8. 11/07/2018, standard lens.*

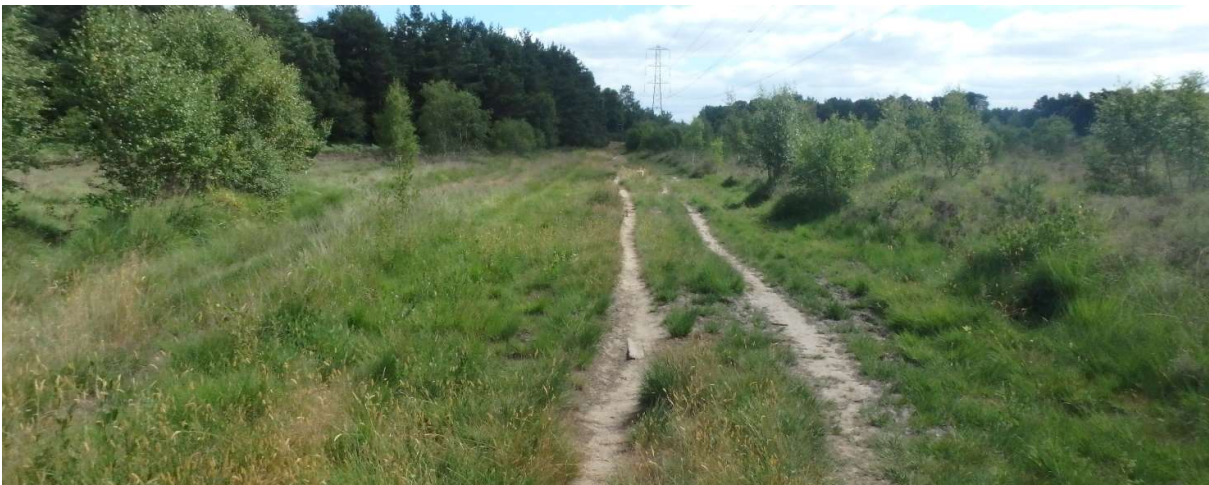
*Photograph 7.1.94: MoD track through Brentmoor Heath, unit 6 of Colony Bog and Bagshot Heath SSSI, looking east. Areas of wet heath to north (left) and south (right) of track with short, disturbed wet heath vegetation dominated by purple moor-grass along track. Photograph location shown in Figure F8. 10/07/2018, standard lens.*

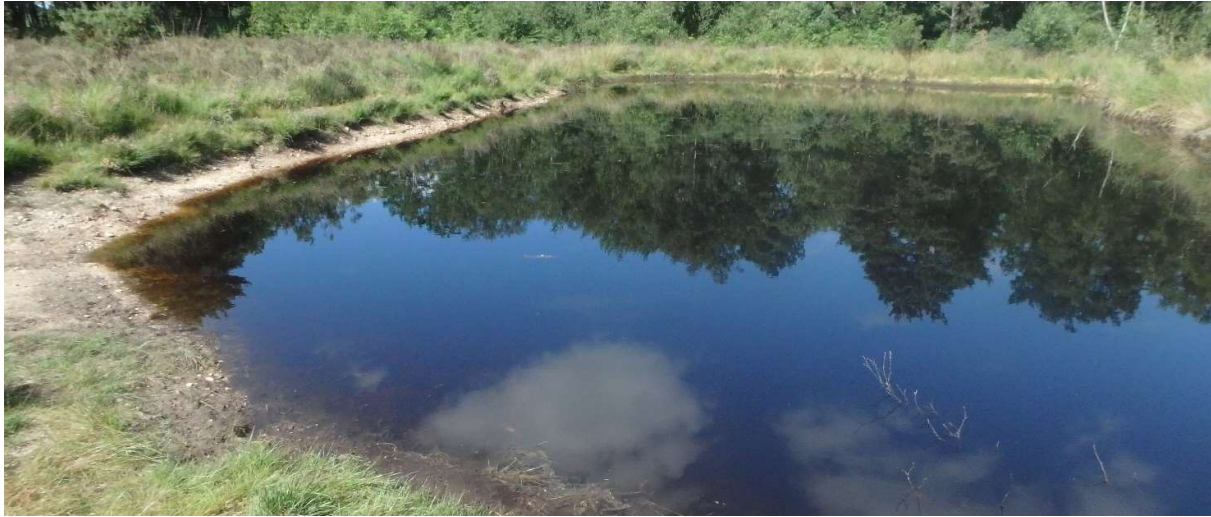
*Photograph 7.1.95: Pond within Brentmoor Heath, to the north of MoD track. Photograph location shown in Figure F8.*

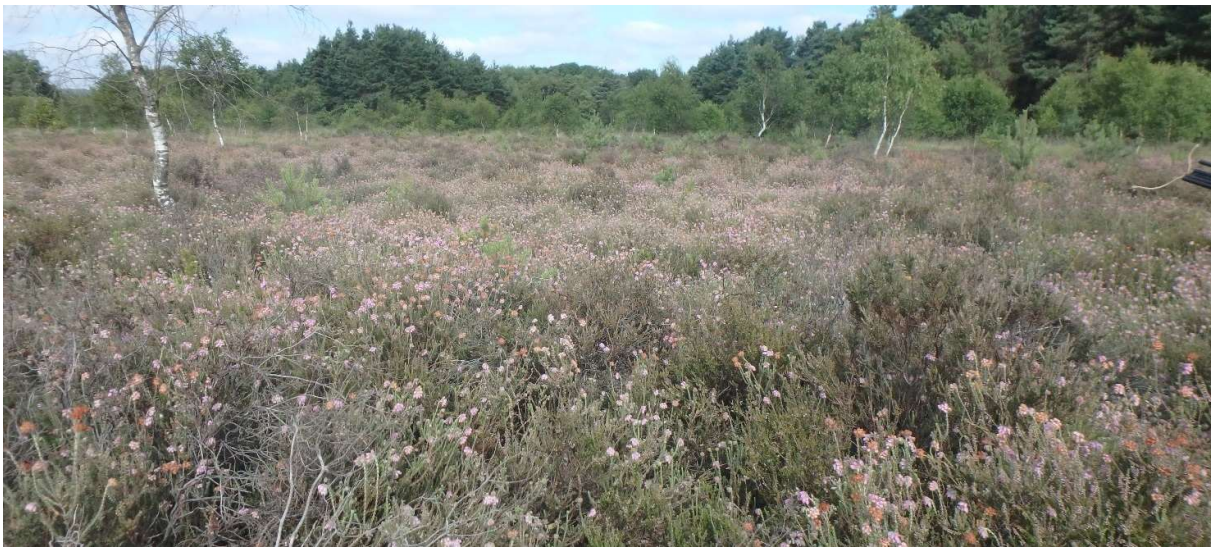
*Photograph 7.1.96: Cross-leaved heath and heather dominated wet heath, Brentmoor Heath, to the south of the MoD track. Photograph location shown in Figure F8. 11/07/2018, standard lens.*

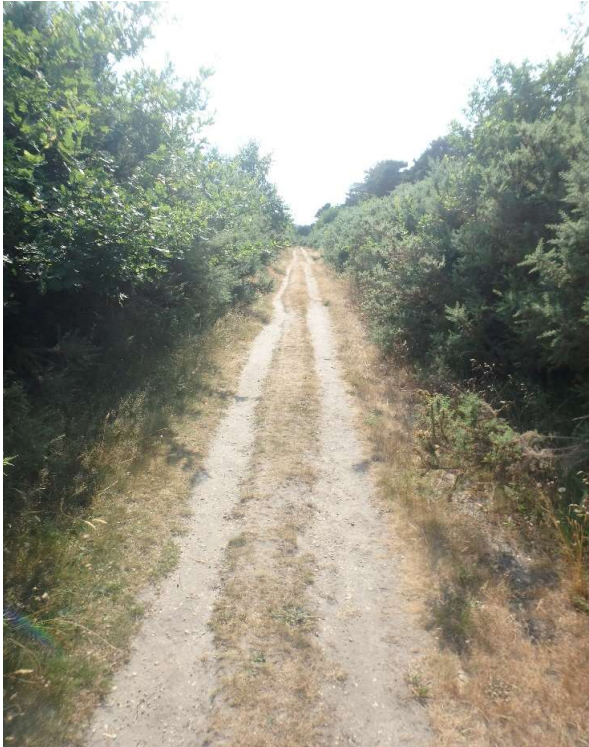
*Photograph 7.1.97: Strips of dense common gorse along footpath, Turf Hill. Photograph location shown in Figure F8. 09/07/2018, standard lens.*

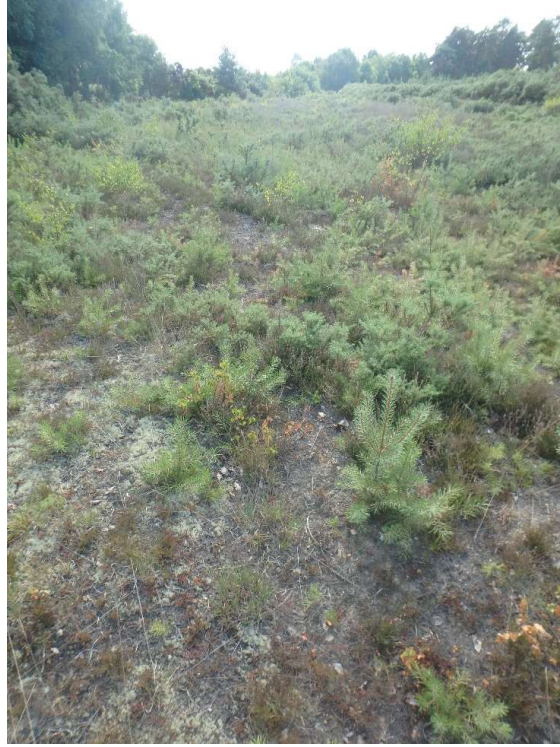
*Photograph 7.1.98: Mown dry dwarf shrub heath of wayleave of overhead powerlines, with abundant saplings of Scots pine. Photograph location shown in Figure F8. 09/07/2018, standard lens.*

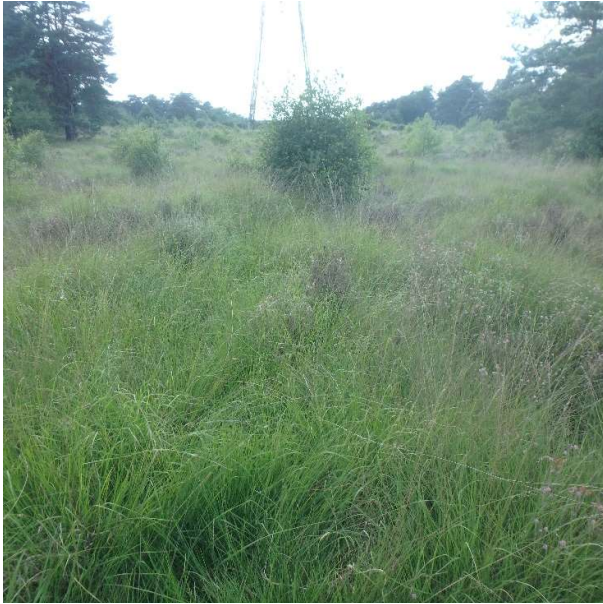
*Photograph 7.1.969: Rank wet heath dominated by purple moor-grass and cross-leaved heath, eastern end of Turf Hill. Photograph location shown in Figure F8. Photograph location shown in Figure F8. 09/07/2018, standard lens.*

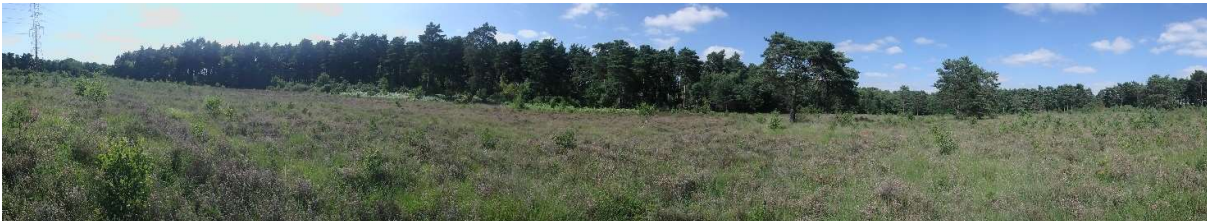
*Photograph 7.1.100: Wet heath in the valley to north of powerlines, Turf Hill, looking west. Photograph location shown in Figure F8. 10/07/2018, standard lens.*

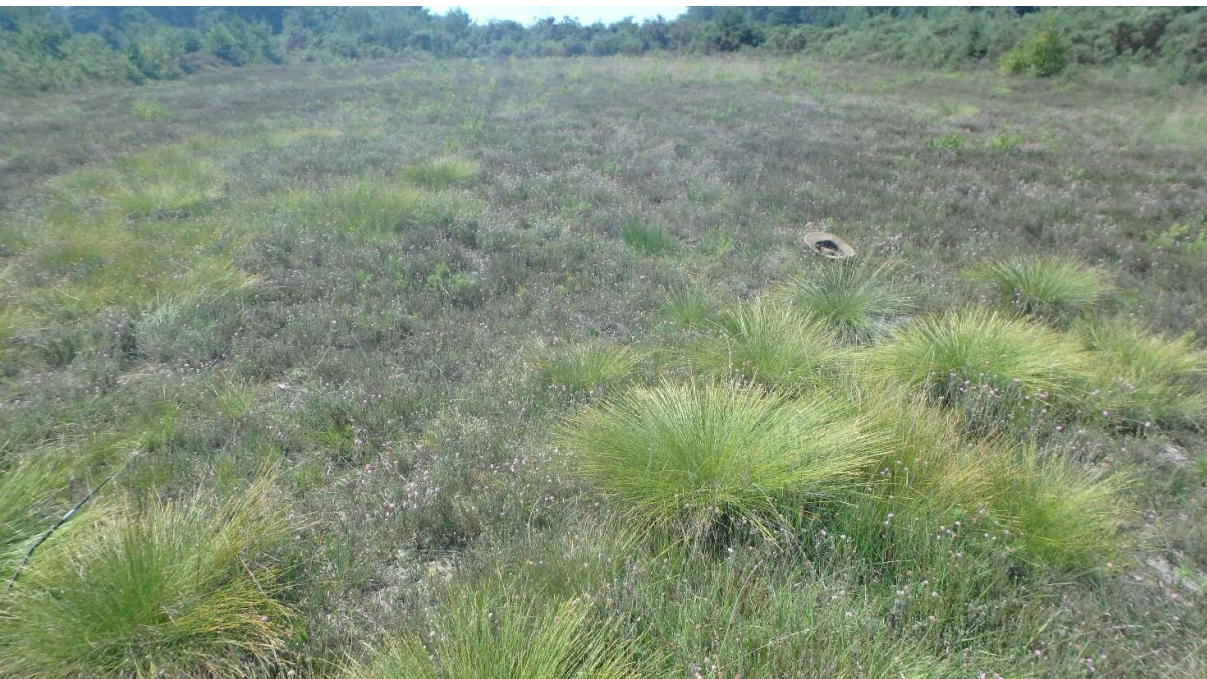
*Photograph 7.1.101: Mown wet heath, looking west from eastern end of wayleave of powerlines, with abundant deergrass. Photograph location shown in Figure F8. 10/07/2018, standard lens.*

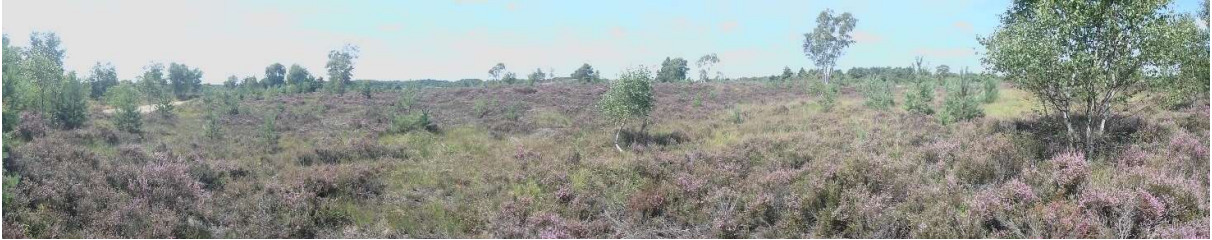
Photograph 7.1.106: View over dry dwarf shrub heath, with scattered trees. Photograph location shown in Figure F12. 01/08/2018, standard lens.

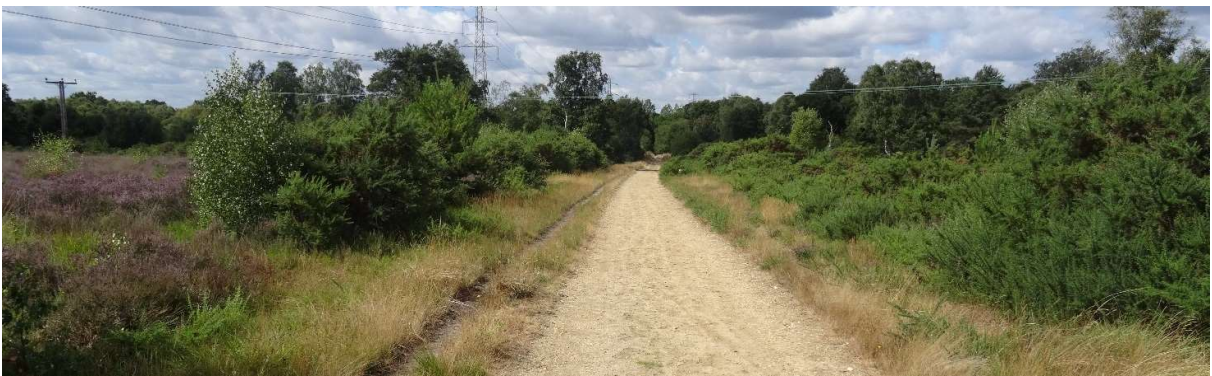
Photograph 7.1.107: Western end of track, looking southwest. Photograph location shown in Figure F12. 31/07/2018, standard lens.

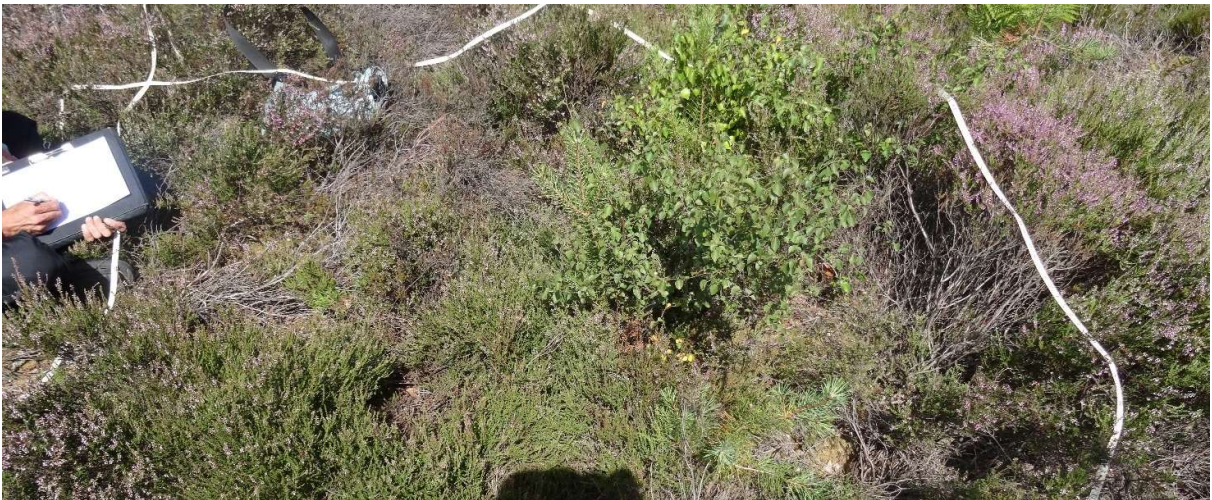
Photograph 7.1.108: Species-poor mature heather-dominated dry dwarf shrub heath. Photograph location shown in Figure F12. 01/08/2018, standard lens.

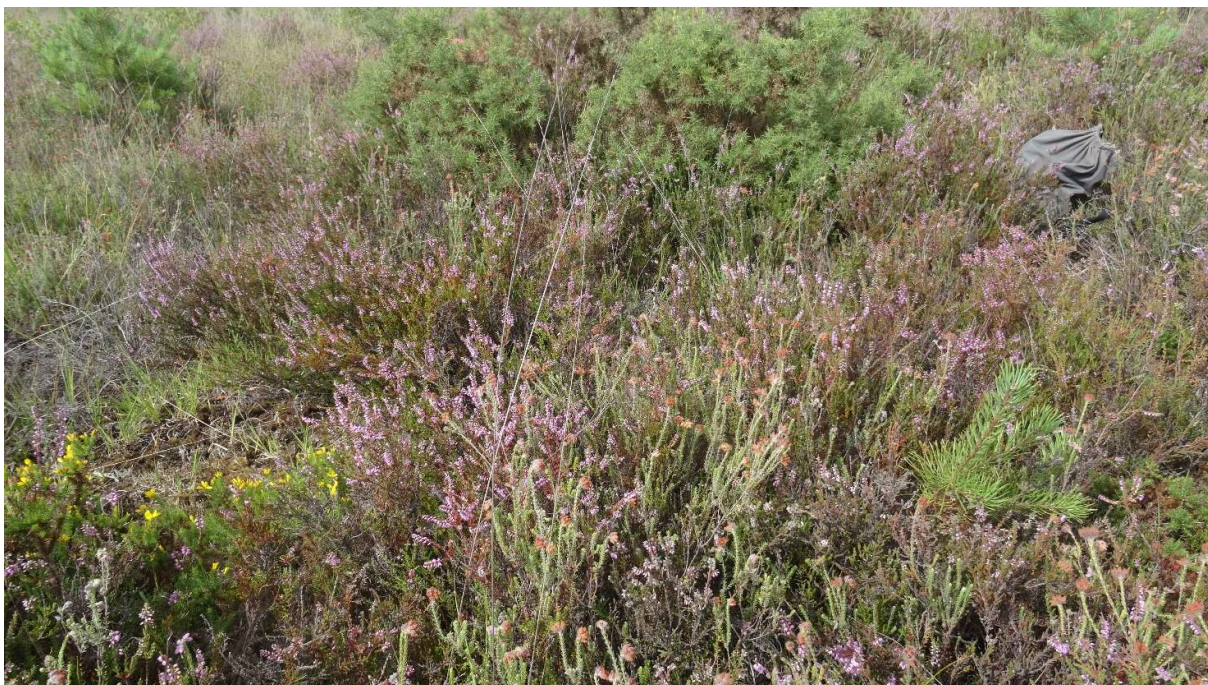
*Photograph 7.1.109: Dry dwarf shrub heath with cross-leaved heath, dwarf gorse, heather and purple moor-grass. Photograph location shown in Figure F12. 30/07/2018, standard lens.*

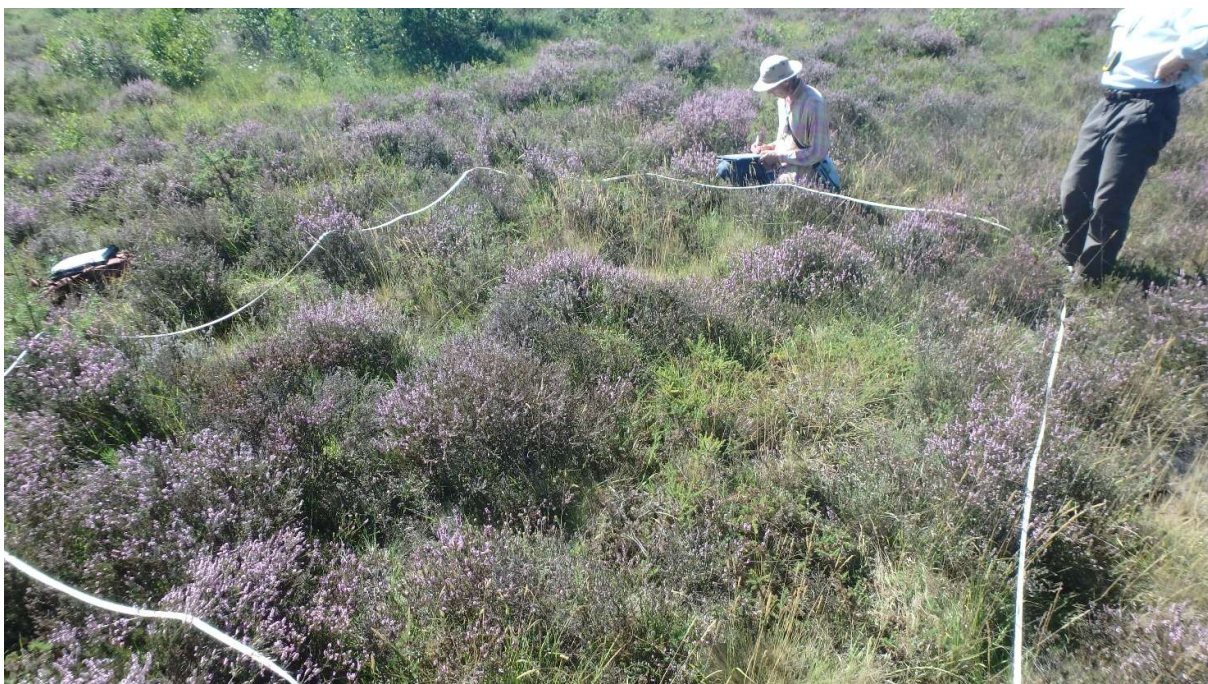
*Photograph 7.1.110: Dry dwarf shrub heath with abundant bristle bent. Photograph location shown in Figure F12. 02/08/2018, standard lens.*
