# Southampton to London Pipeline Project

## Volume 6

Environmental Statement  
Habitat Regulations Assessment (2 of 2)

Application Document: 6.5

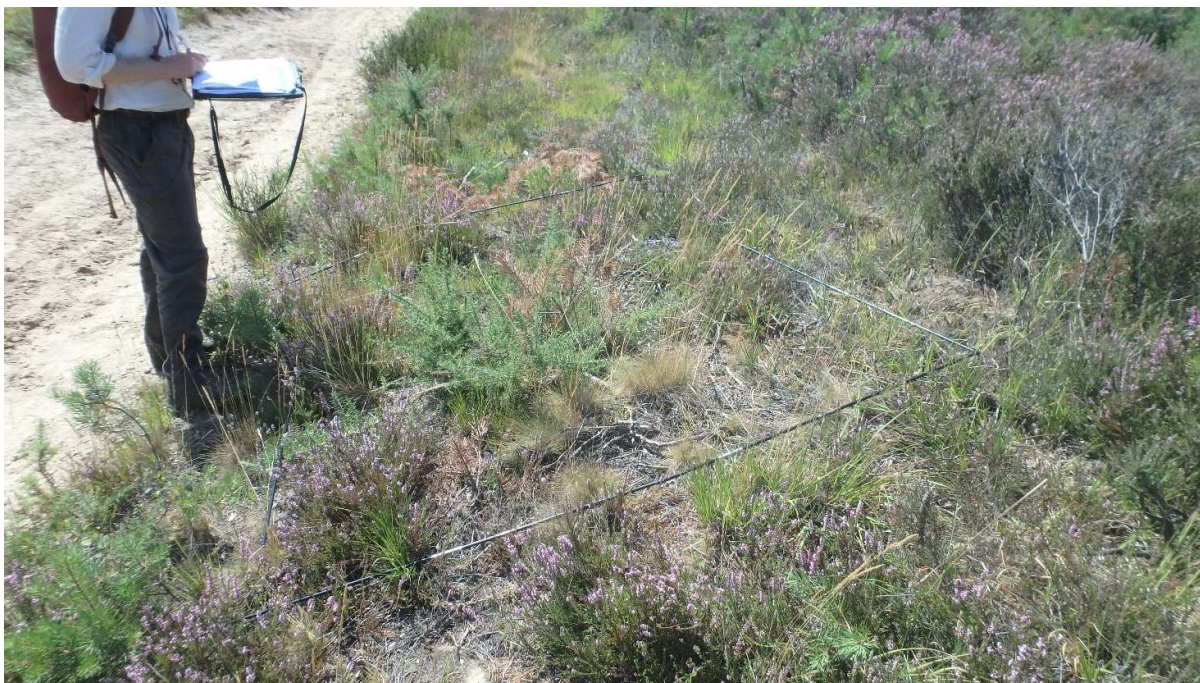
*Photograph 7.1.111: Shortly mown dry dwarf shrub heath with bristle bent along edge of track. Photograph location shown in Figure F12. 01/08/2018, standard lens.*

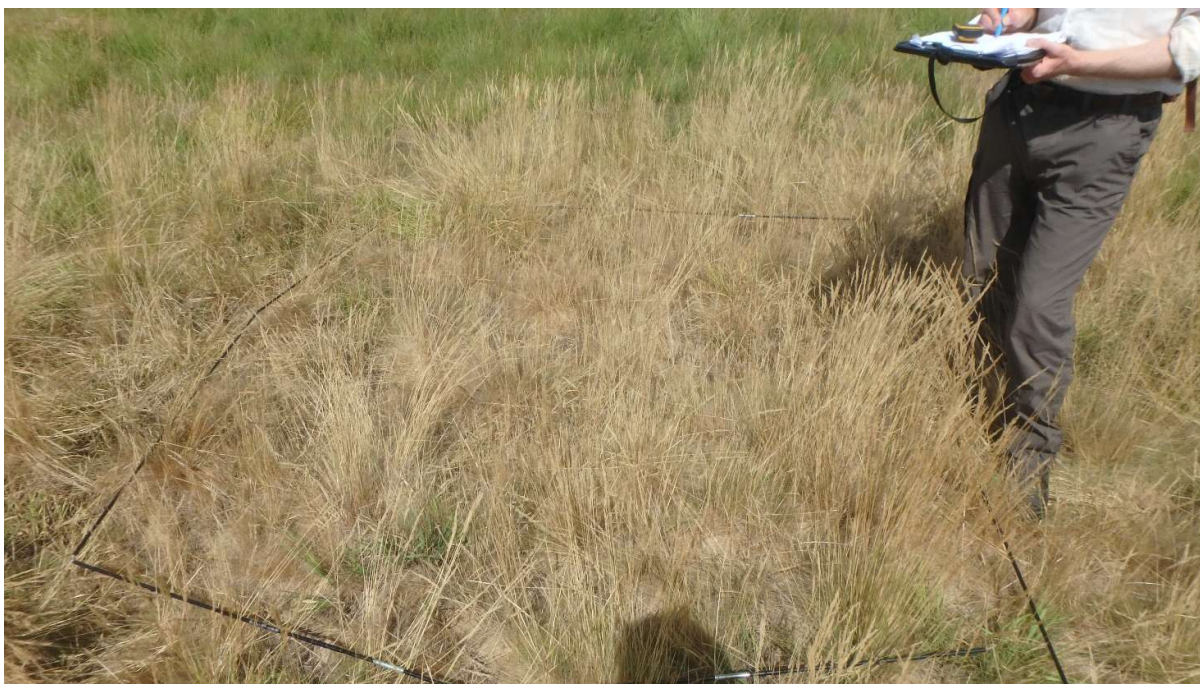
*Photograph 7.1.112: Acid grassland dominated by bristle bent adjacent to the track. Photograph location shown in Figure F12. 01/08/2018, standard lens.*

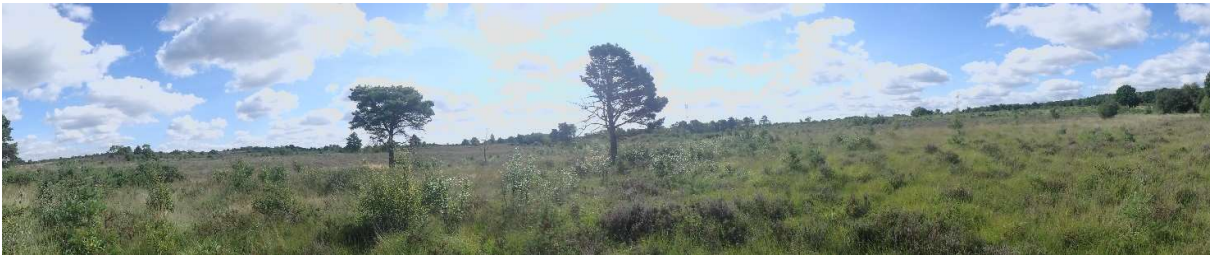
*Photograph 7.1.113: Rank wet heath in valley bottom dominated by purple moor-grass with scattered heather, scrub and trees. Photograph location shown in Figure F12. 01/08/2018, standard lens.*

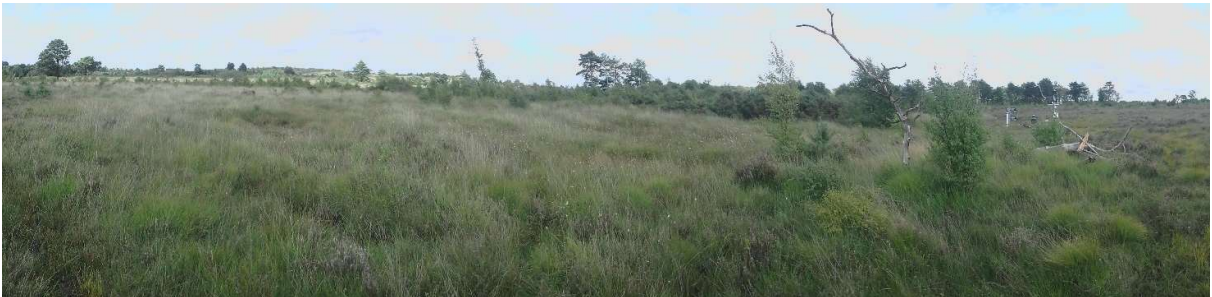
*Photograph 7.1.114: Rank wet heath in valley bottom dominated by purple moor-grass with patches of cottongrass in damper areas. Photograph location shown in Figure F12. 30/07/2018, standard lens.*

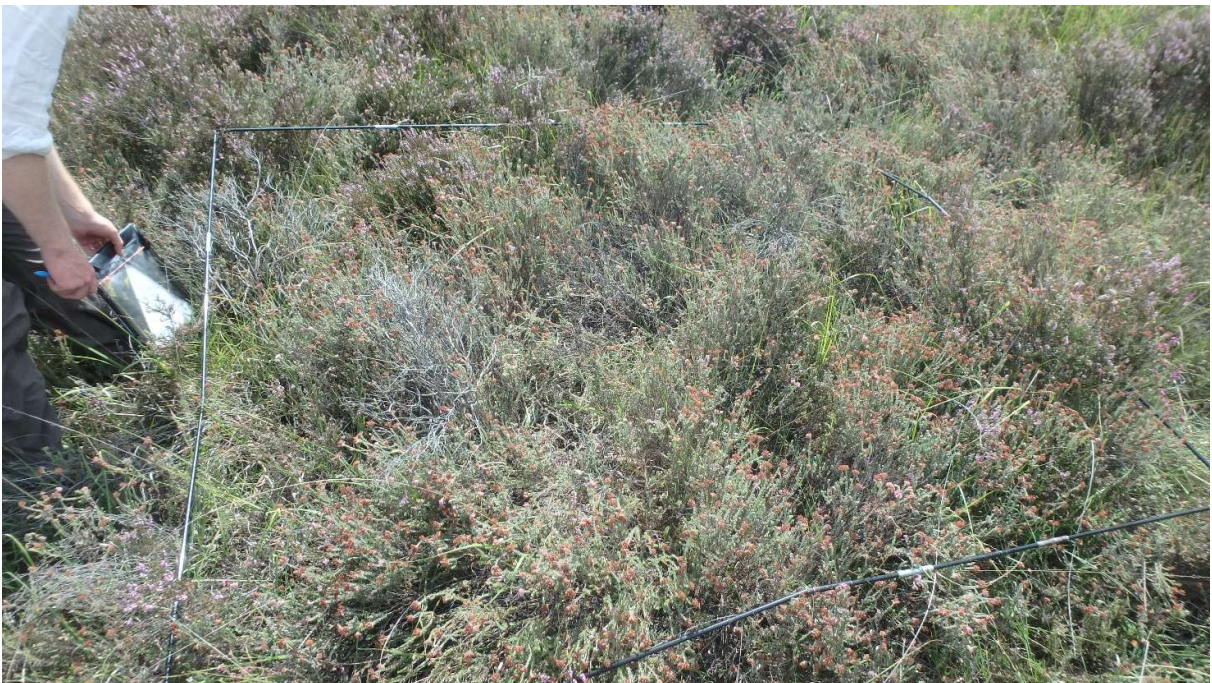
*Photograph 7.1.115: Wet heath vegetation dominated by cross-leaved heath. Photograph location shown in Figure F12. 01/08/2018, standard lens.*

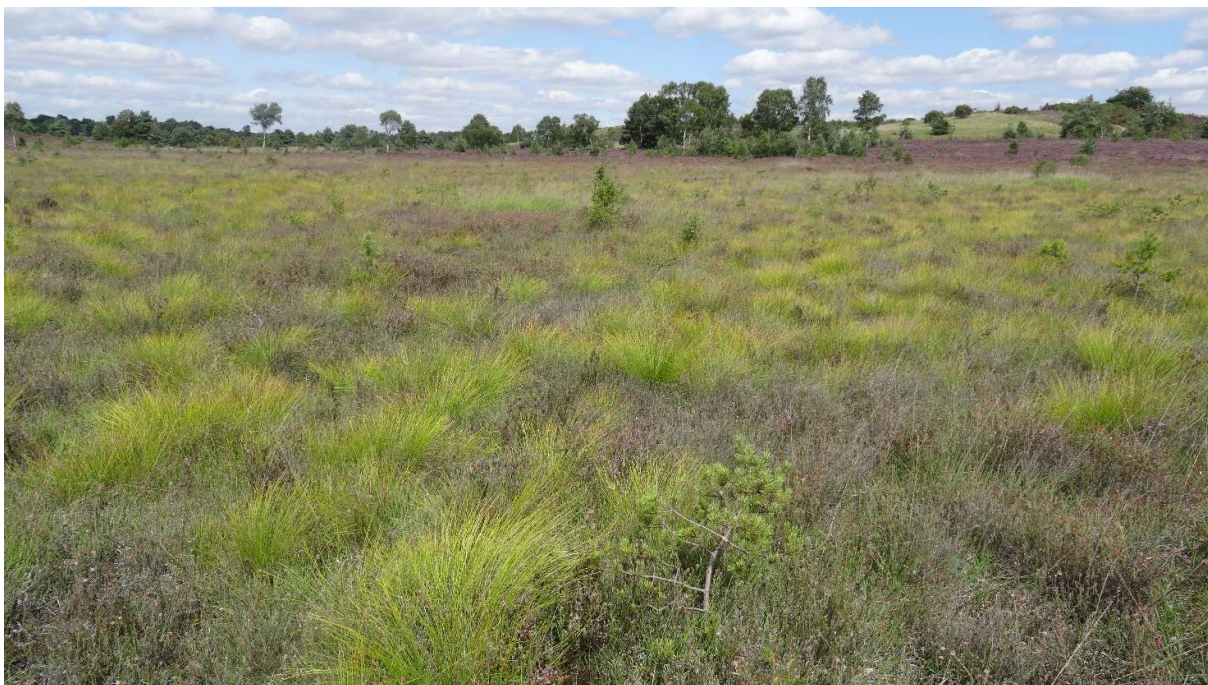
*Photograph 7.1.116:: Short open wet heath vegetation with abundant deergrass. Photograph location shown in Figure F12. 01/08/2018, standard lens.*

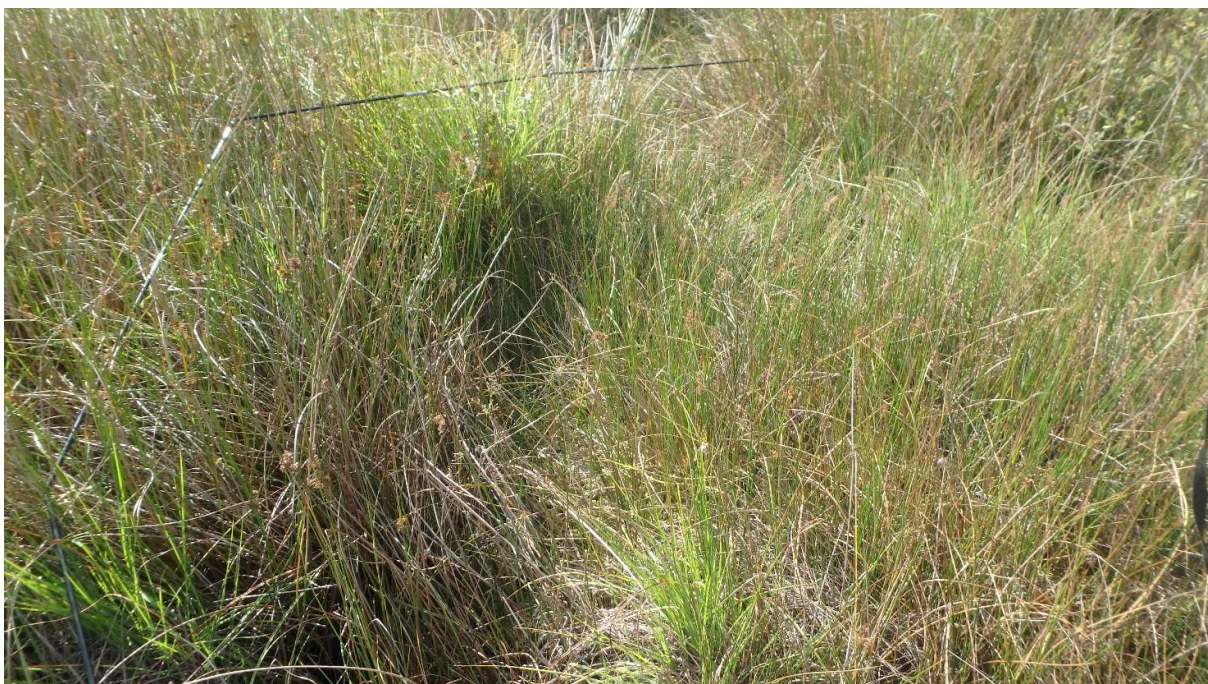
*Photograph 7.1.117: Rank vegetation dominated by purple moor-grass and rushes, with abundant Sphagnum. Photograph location shown in Figure F12. 01/08/2018, standard lens.*

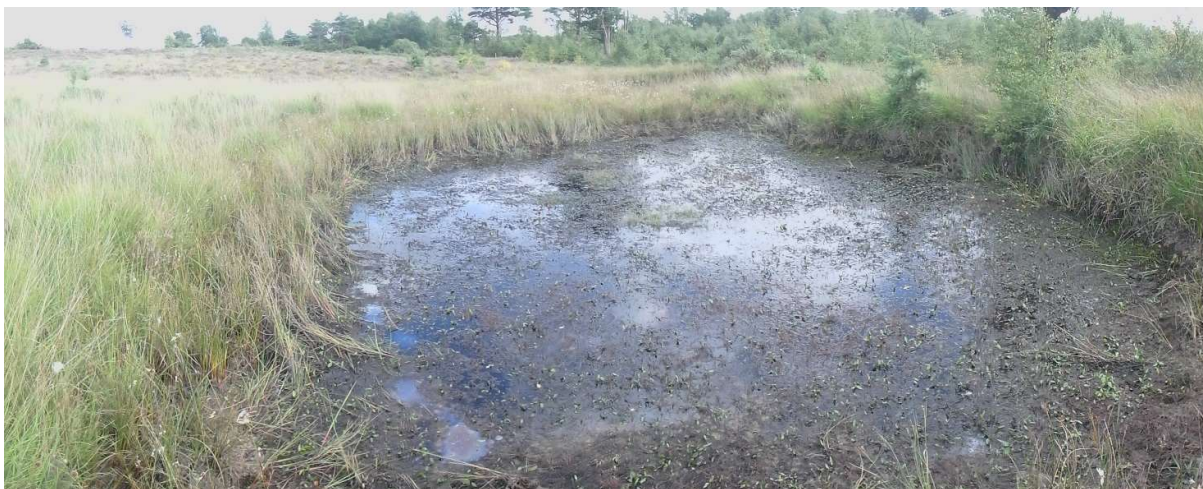
*Photograph 7.1.118: Pond within wet heath, dominated by bog pondweed and bulbous rush. Photograph location shown in Figure F12. 30/07/2018, standard lens.*

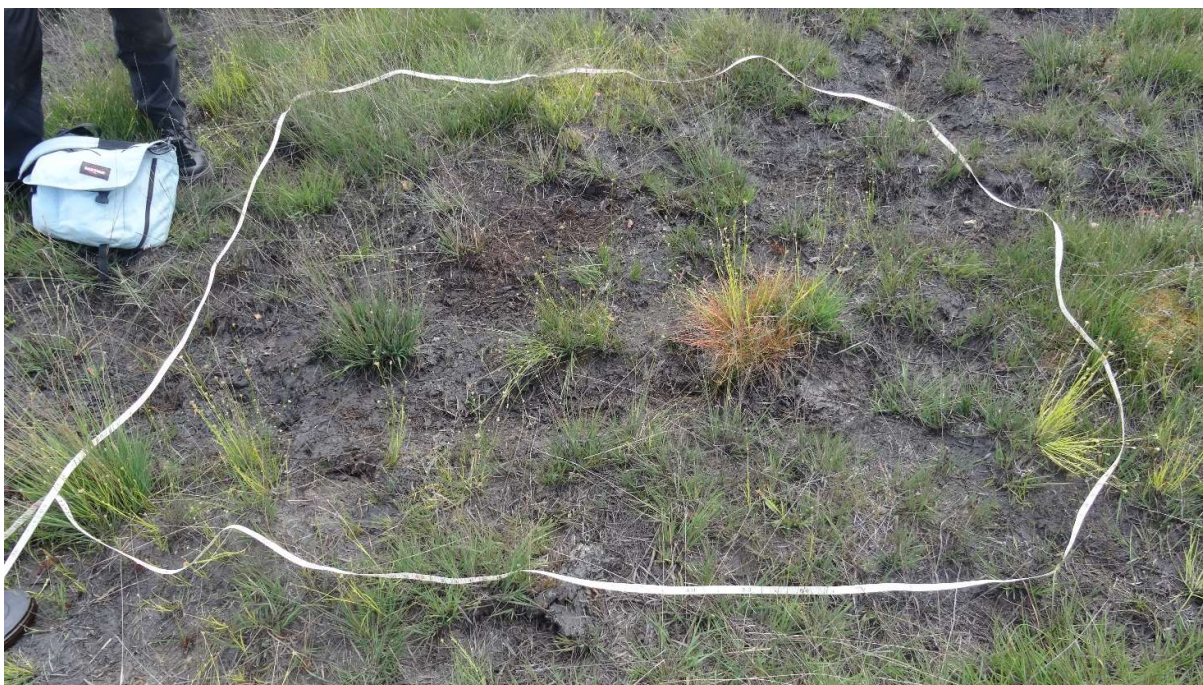
*Photograph 7.1.119: Open wet heath with abundant white beak-sedge at edge of ponded area. Photograph location shown in Figure F12. 31/07/2018, standard lens.*

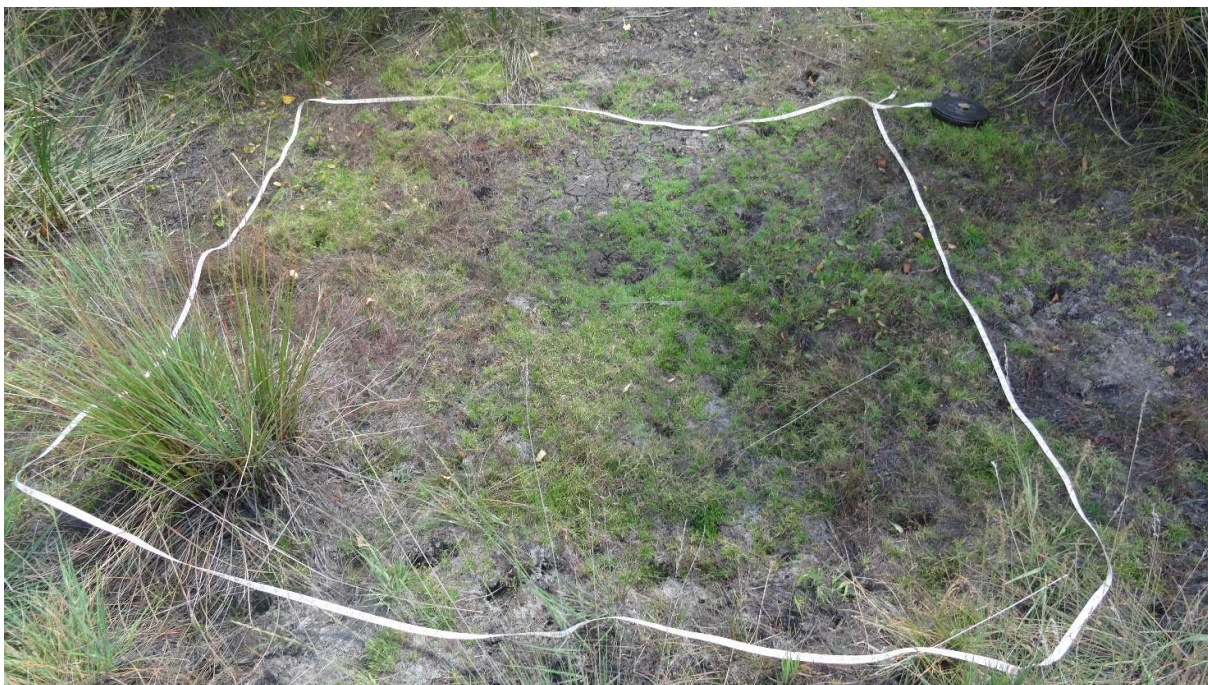
*Photograph 7.1.120: Seasonal pond dominated by floating club-rush and many-stalked spikerush. Photograph location shown in Figure F12. 31/07/2018, standard lens.*

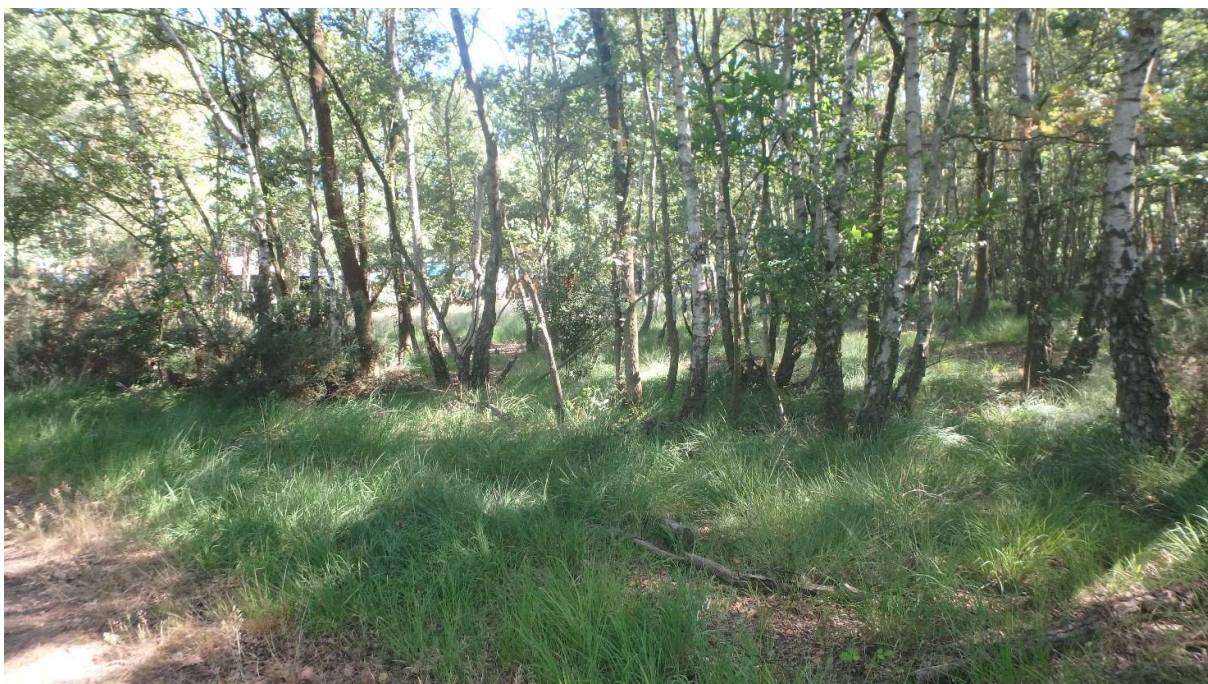
*Photograph 7.1.121: Young woodland dominated by birch with species-poor ground layer dominated by purple moor-grass. Photograph location shown in Figure F12. 02/08/2018, standard lens.*

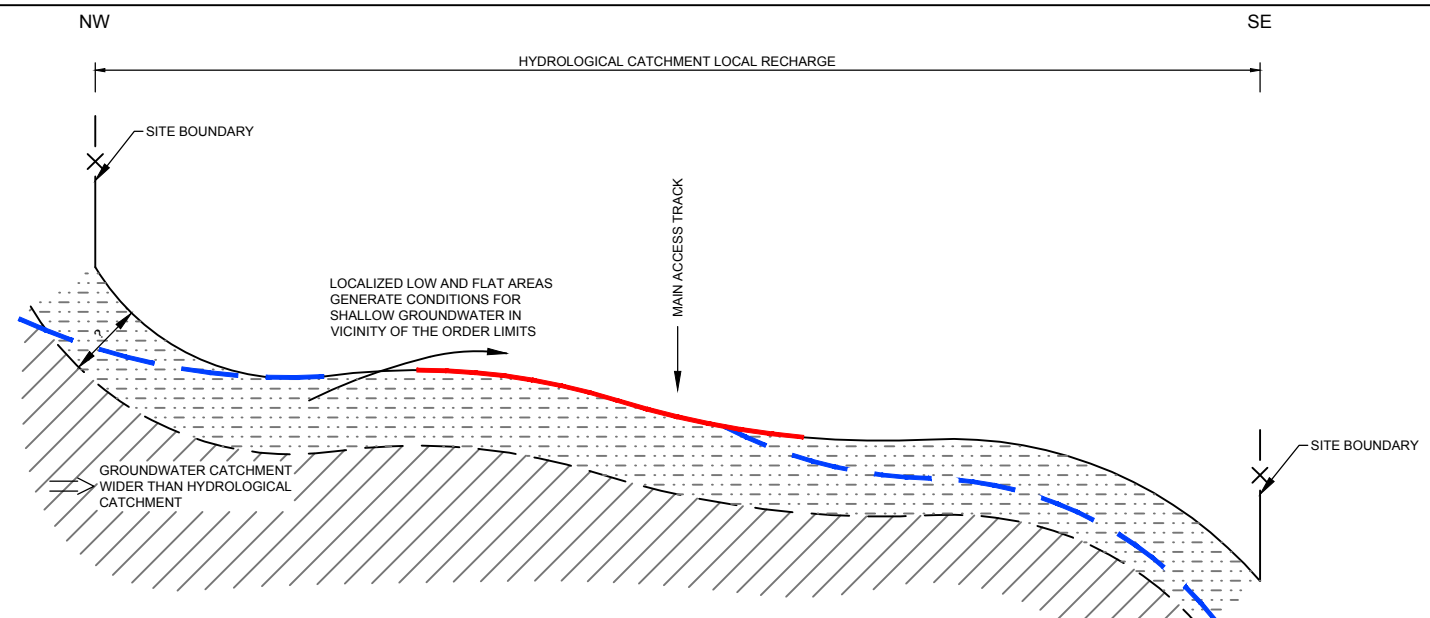
TYPICAL SECTION B-B  
 CROSS SECTION PERPENDICULAR TO THE MAIN ACCESS TRACK

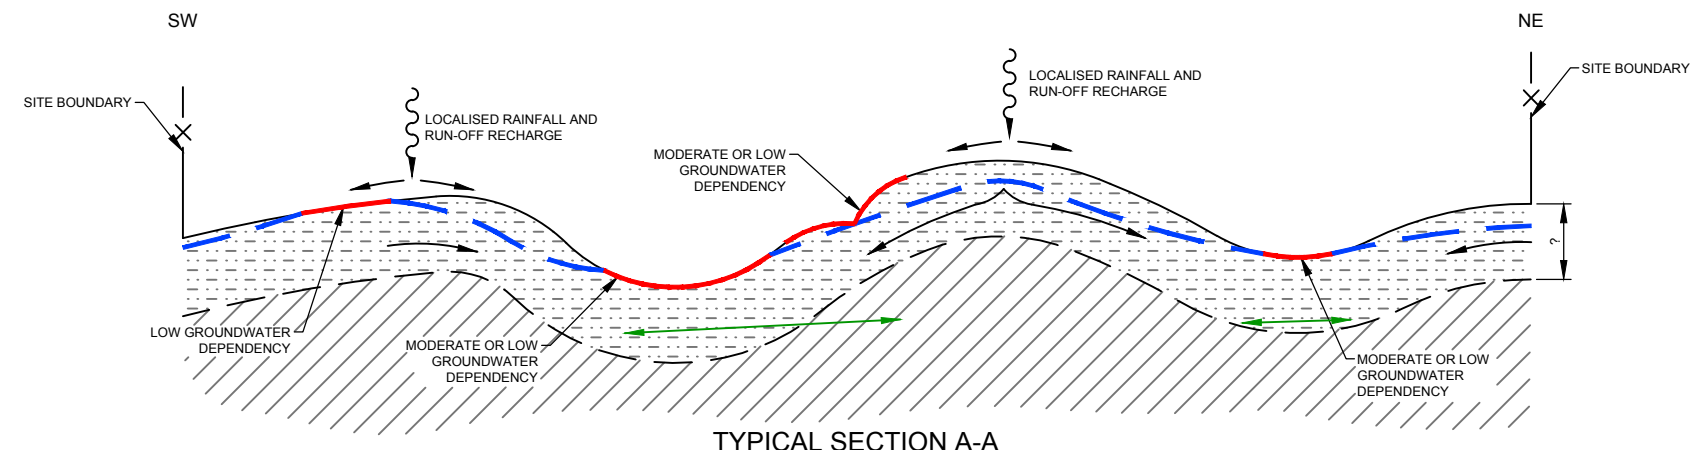
TYPICAL SECTION A-A  
 LONG SECTION ALONG THE MAIN ACCESS TRACK
