Appendix 11.6 Ground Investigation Report

HyNet Carbon Dioxide Pipeline DCO

Document Reference Number D.6.3.11.6

LBA CCS Transport and Storage Project Ground Investigations - Geoenvironmental Interpretive Report

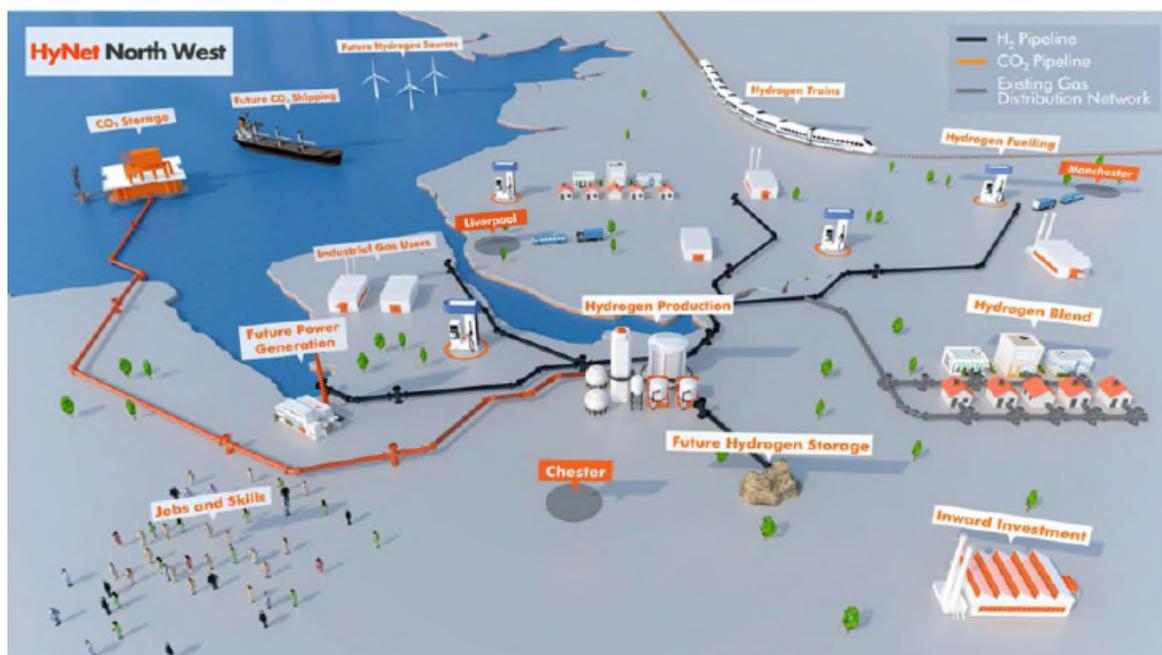
Figure 1.1: Liverpool Bay Facilities Overview

The orange pipeline onshore is the focus of this appraisal. The Liverpool Bay project includes;

- A 20" diameter section of pipe northeast of Stanlow;
- Repurposing of the existing onshore 24" diameter Point of Ayr (PoA) to CQY natural gas line to carry CO₂ in the opposite direction;
- Development of the onshore assets at PoA to provide onshore compression, which will be expanded in later phases;
- Repurposing of existing sub-sea natural gas pipelines for CO₂ service. In later years pipelines will be replaced as required for expansion;
- Development of the Douglas, Hamilton Main, Hamilton North and Lennox platforms, in an incremental manner for CO₂ sequestration service;
- Development of the Hamilton Main, Hamilton North and Lennox reservoirs for CO₂ storage.

An overview of the Liverpool Bay project is presented in Figure 1.1 taken from ENI's project specification 104900BLSC80011.

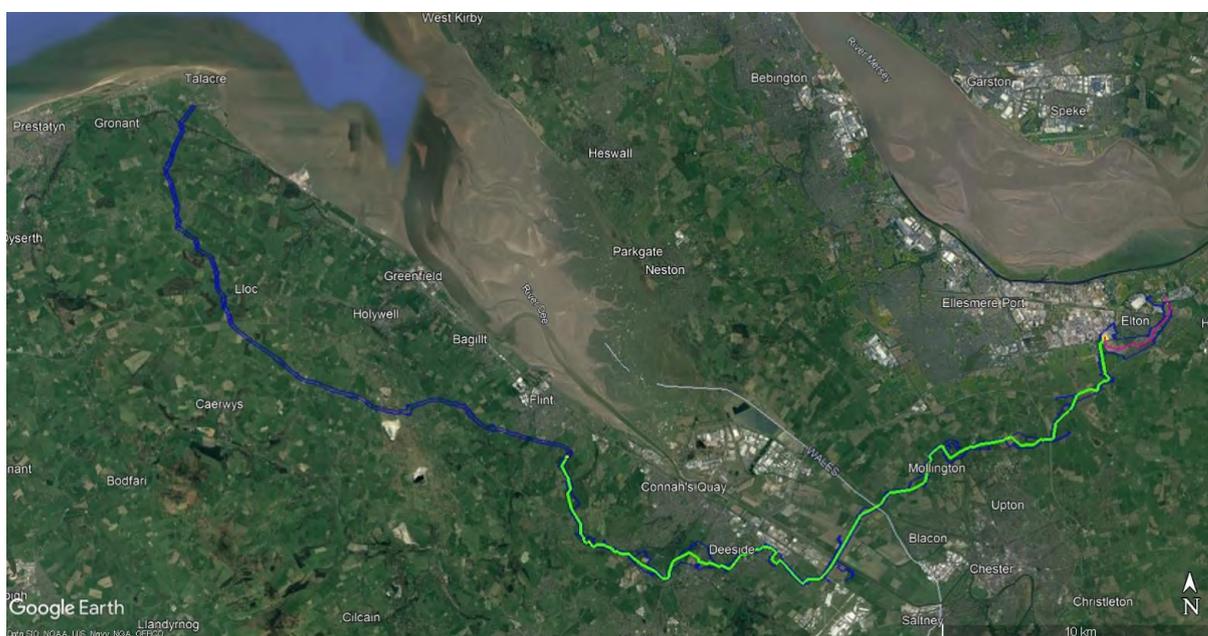
Figure 2.1: Location Overview; Green is 36 inch Pipeline Route; Blue is an outline for proposed Section 7 and 8 and; Pink is the Alcohol Site to Grinsome Road AGI

The site is located in the northwest of England, running between Chester and Ellesmere Port into Wales near Deeside then up to Point of Ayr. The new section of pipeline route covers approximately 35 km from Elton to Flint as seen in Figure 2.1. The first section of 20" pipe starts at Grinsome Road (Grid Ref. 346913, 376149) heading west to Stanlow (Grid Ref. 344628, 374925). This is where the 36" pipe starts and this continues to just outside Flint at (Grid Ref. 325218, 370893). At this point it connects into some existing pipework which finishes at Point of Ayr (Grid Ref. 312266, 383977). Along this latter section three additional Block Valve Stations (BVS's) will be added to assist with maintenance.

A general location plan and detailed location maps of the sections in which boreholes were undertaken are present in Appendix B.1.
