HyNet North West

ENVIRONMENTAL STATEMENT (VOLUME III)

Appendix 18.1 Baseline Information

HyNet North West Carbon Dioxide Pipeline DCO

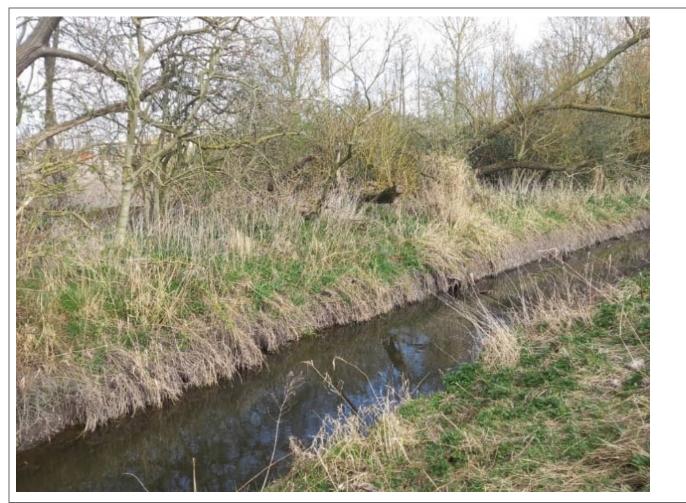
2.1. EAST CENTRAL DRAIN

Catchment area	1.02km ²
Key hydraulic connections	Flows into West Central Drain
River Condition Score	Moderate
Catchment description	The catchment mostly comprises grassland with some arable and horticultural land uses. A smaller proportion of built-up land cover and woodland. The catchment has an elevation between -4.9 - 40 mAOD).
Study reach description	The watercourse is a trapezoidal artificial channel which is incised and not connected with the floodplain. Water depth is between 0.5 – 0.8m whilst bankfull width is 5- 6.5m. Bed material is silt and organic matter.

The riparian zone on the left bank is grazed, whilst the right bank is woodland. In-channel vegetation is limited.
	The East Central Drain has provided drainage for the Ince
	Marshes since at least 1885. The East Central Drain has maintained a similar planform since 1885, to present day.
Interaction with the DCO Proposed Development	Ince AGI is located within 8m of this watercourse and the surface water drainage system from this AGI will connect to this watercourse.

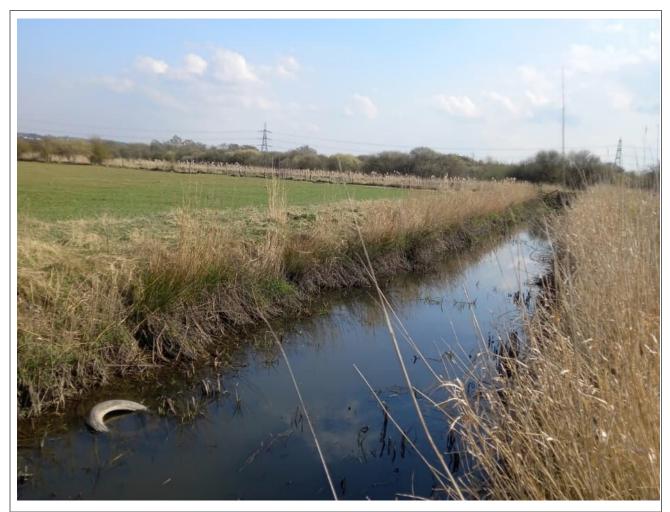
2.2. WEST CENTRAL DRAIN

Catchment area	0.55km ²
Key hydraulic connections	Drains the Elton Marsh Drains (1-13), joined by Hapsford Brook and East Central Drain at Ince Marshes. Flows northwards towards the Manchester Ship Canal where water is pumped into the canal at high flows. The watercourse discharges to Hoolpool Gutter.
River Condition Score	Fairly Poor
Catchment description	The West Central Drain forms the main stem off the Elton Marsh Drains $(1 - 13)$. The channel drains a small catchment of farm and agricultural land.
Study reach description	The watercourse is a trapezoidal artificial channel with bankfull width varying between 5-6m and water depth approximately 0.8m. It has a

mixture of steep and shallow banks through the Newbuild Infrastructure Boundary. Bed material is predominantly silt and organic matter. The riparian zone comprises grazed grassland which is frequently wet. There are tall grasses along both banks of the watercourses.
	The West Central Drain has provided drainage for the Ince Marshes since at least 1885. The Western Central Drain has maintained a similar form since 1914.
Interaction with the DCO Proposed Development	West Central Drain will be crossed by the Newbuild Carbon Dioxide Pipeline in one location via open cut. The watercourse would also be crossed by vehicles using existing access tracks over existing culverts in the Newbuild Infrastructure Boundary.

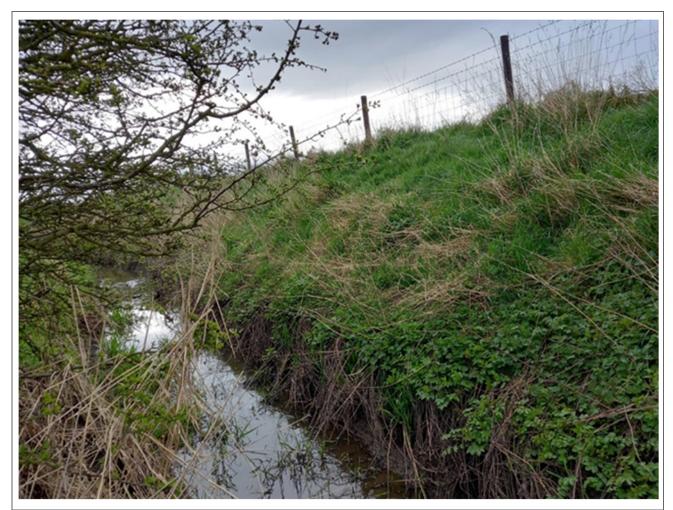
2.4. GALE BROOK

Catchment area	6.64km ²
Key hydraulic connections	The Gale Brook drains into the River Gowy. The channel is disconnected from its floodplain as it is incised and flows through a network of culverts.
River Condition Score	Moderate
Catchment description	The Gale Brook drains agricultural and pastural land in the headwaters and urban/ suburban areas at its confluence with the Gowy. The land use is mostly arable and horticultural.
	The Gale Brook flows northwest to the River Gowy, with headwaters starting around 1.18 km north west of Dunham-on-the-Hill (10 mAOD).

Study reach description	The channel appears to have been artificially straightened and is a trapezoidal cut channel in the study area. Bankfull width varies between 2.5 and 6 m, with water depth approximately 0.2 - 0.3 m. The channel bed material is homogenously silty. The riparian zone is characterised by a lack of riparian habitat and vegetation complexity. It is comprised of mostly tilled arable land on both banks with a narrow buffer comprising short and tall herbs and grasses. There are some areas of scrub, shrub and trees. Downstream of the study reach, the Gale Brook was reconfigured to flow beneath the Essar Stanlow Refinery but has maintained its planform
	since 1945.
Interaction with the DCO Proposed Development	The Gale Brook is crossed by the Newbuild Carbon Dioxide Pipeline via open cut.

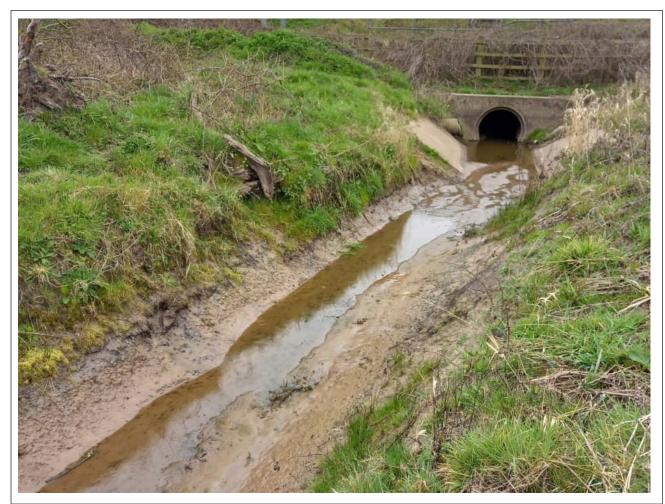
2.5. THORNTON UPLANDS

Catchment area	2.32km ²
Key hydraulic connections	Thornton Uplands flows northwards to River Gowy. It is joined by Halls Green Lane Brook and Thornton Marsh Central.
River Condition Score	Fairly Poor
Catchment description	Thornton Uplands drains agricultural and pastural land in the headwaters and is culverted as it flows under Ince Lane and track lanes. The channel rises from farm ditches, around 1.4 km southwest of Dunham-on-the-Hill (10 mAOD).
Study reach description	The watercourse is a trapezoidal cut channel, with obviously reshaped earth banks, with bankfull width between 3- 3.5 m and water depth approximately 0.03 m (within Newbuild Infrastructure Boundary).

The bed material is a mixture of sediment, with the presence of gravel – pebble sized sediments. There is evidence of some sand, with extensive silt and clay components. No organic materials were present at the time of survey.
	The riparian zone is mostly farmland with some residential and farm building. The banks comprise extensive bare earth, with some short creeping herbs and grasses, tall herbs and grasses. Scrubs, shrubs and a few trees and saplings were also noted on the bank top.
	The channel has maintained a similar planform since 1884 – 1900.
Interaction with the DCO Proposed Development	Thornton Uplands will be crossed by the Newbuild Carbon Dioxide Pipeline via open trench.

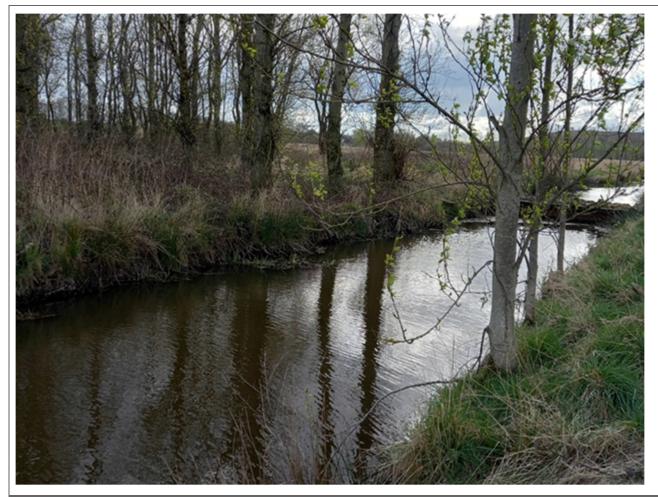
Catchment area	3.00km ²
Key hydraulic connections	Thornton Ditches 5 – 12 drain into the Thornton Main Drain. The Thornton Main Drain joins the River Gowy at the A5117.
River Condition Score	Fairly Poor
Catchment description	Thornton Main Drain drains agricultural and pastural land in its headwaters, with the surrounding land uses being farmland, agricultural buildings and settlement, a landfill site, and a peat bog. The channel rises from farm ditches, around 0.7 km northwest of
	Wimbolds (6 mAOD).

Study reach description	The watercourse is an artificial cut channel, which has been artificially straightened and lacks geomorphic diversity. Bankfull width varies between 4.5 – 6m and depth between 0.8 - 1m.
	Bed material is mostly silt with extensive cover of unvegetated bare sediment, some emergent reeds and floating aquatic vegetation.
	The riparian zone is characterised by short herbs and grasses, extensive cover of tall herbs and grasses, emergent reeds and linear-leaved plants. Concrete bank protection and sheet piling farms the banks of the channel on the approach to the M56 culvert.
	The channel has maintained a similar planform since 1884 – 1900.
Interaction with the DCO Proposed Development	Thornton Main Drain is crossed by the Newbuild Carbon Dioxide Pipeline via open cut.

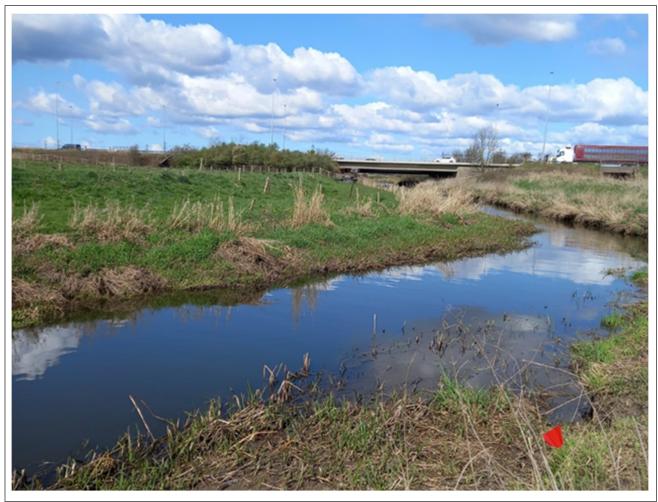
2.7. RIVER GOWY

Catchment area	150km ²
Key hydraulic connections	The River Gowy is fed by the Barrow Brook, Back Brook, Milton Brook, Salters Brook and Ashton Brook upstream of the DCO Proposed Development. Downstream of the DCO Proposed Development, the River Gowy is joined by Thornton Main Drain, Thornton Uplands, Stanney Mill Brook and Gale Brook. The River Gowy flows into the River Mersey. The river is disconnected from its floodplain due to flood defences through most of its middle and lower course.
River Condition Score	Moderate
Catchment description	The River Gowy drains the surrounding arable and horticultural land, in addition to a landfill site, settlement and peat bog.

There are a variety of geomorphic pressures (e.g. poor soil, nutrient, and livestock management, contaminated land, ecological discontinuity, ground water abstraction, pollution from wastewater industry and landfill). The catchment has a maximum elevation of 43 m ASL (Helsby Hill).
Study reach description	The channel is heavily modified, with generally shallow channel banks, obviously reshaped, and with set-back embankments. Bankfull width is 6.5 - 8 m and water depth is 0.8 - 1m. Some berms and eroding cliffs were noted within the Newbuild Infrastructure Boundary. Nest holes were observed in the channel banks.
	Bed material is silt with extensive cover of unvegetated bare sediment and some emergent and submerged aquatic vegetation. The riparian zone is mostly grazed pasture comprising predominantly grasses, creeping herbs and taller vegetation. The riparian zone is frequently wet.
	The confluence of the Gowy and Mersey has remained in the same place since at least 1892. However, the course of the Gowy upstream of this point has been heavily modified with evidence of straightening and realignment. The middle course of the channel has been canalised and flood embankments existing on both banks of the Gowy through the study reach.

Interaction with the DCO Proposed Development	The Gowy will be crossed by the Newbuild Carbon Dioxide Pipeline via trenchless methods (TRS-09).

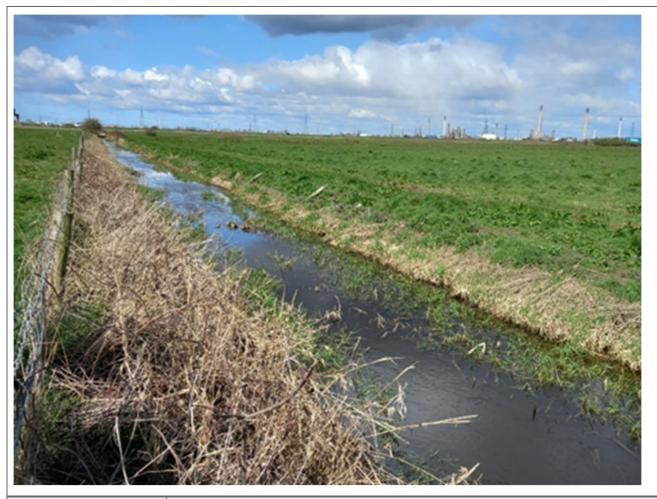
2.8. STANNEY MAIN DRAIN

Catchment area	<1km ²
Key hydraulic connections	This is an artificial drain within the River Gowy floodplain. It is connected to Thornton Ditch (1,2), Mill Brook, Mill Brook Tributary (1,2) and Gowy Tributary (1,2). It joins the River Gowy at the A5117.
River Condition Score	Fairly Poor
Catchment description	Stanney Main Drain drains agricultural and pastural land in its headwaters, with the surrounding land use being farmland, agricultural buildings and roadways. The catchment is boggy in the headwaters. The channel rises from farm ditches, around 0.47 km west of Bridge Trafford. It has a maximum catchment altitude of 6 mAOD.
Study reach description	Stanney Main Drain is a trapezoidal, cut and over deepened ditch that appears to have been artificially straightened. Bankfull width is

approximately 5.5 m and water depth approximately 0.5 m, with benches present on the banks of the channel.
	Bed material is silt with extensive cover of bare sediment. The riparian zone is grazed farmland comprising short grasses with some tall herbs and grasses, shrubs and scrub and some emergent reeds/linear-leaved/horsetails on the banks.
	The channel has retained its planform, as a network of cut ditches, since 1885 though some sections have been realigned. Following construction of the Ellesmere Port Oil Refinery (post 1949 –1965), the confluence with the Gowy was moved further upstream to the south of the A5117 (approx., 420 m downstream from the contemporary position).
Interaction with the DCO Proposed Development	Stanney Main Drain will be crossed by the Newbuild Carbon Dioxide Pipeline via open cut.

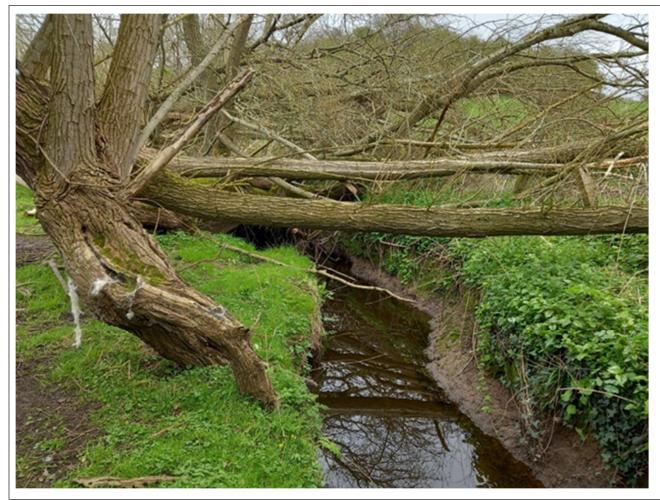
2.10. BACKFORD BROOK

Catchment area	4.97 km ²
Key hydraulic connections	There are three tributaries of Backford Brook which drain land south of Dunkirk and the M56. Backford Brook is culverted beneath the Shropshire Union Canal and then joins Finchetts Gutter.
River Condition Score	Fairly Good upstream of field culvert. Fairly Poor downstream of field culvert.
Catchment description	The catchment is predominantly rural, with the main land uses being pasture, grassland, and woodland. Elevation varies from 38m to 19mAOD.
Study reach description	Upstream of the field culvert, the channel varies in width and depth, but it has approximately 0.5m and bankfull width is approximately 1.1m throughout the studied reach. The Backford Brook has a sinuous channel, with step-pools created by log jams, thus providing good in-

channel habitat diversity. In addition, there are mature trees lining the channel with fallen trees and extensive large wood habitat along the reach upstream of the field boundary culvert.
	Downstream of the field culvert the watercourse flows through a modified reach featuring armoured banks and a trapezoidal cross section. The riparian zone in this reach has fewer trees and fallen trees and uninterrupted flow.
	The river bed substrate is made of sand and silt, with traces of organic matter. The riparian zone is mostly pasture, with a single line of mature trees along the bank top of the watercourses. The treeline is more mature in the reach upstream of the field culvert.
	No change in planform can be seen from existing online maps (from 1982 onwards).
Interaction with the DCO Proposed Development	Backford Brook will be crossed by the Newbuild Carbon Dioxide Pipeline via open cut.

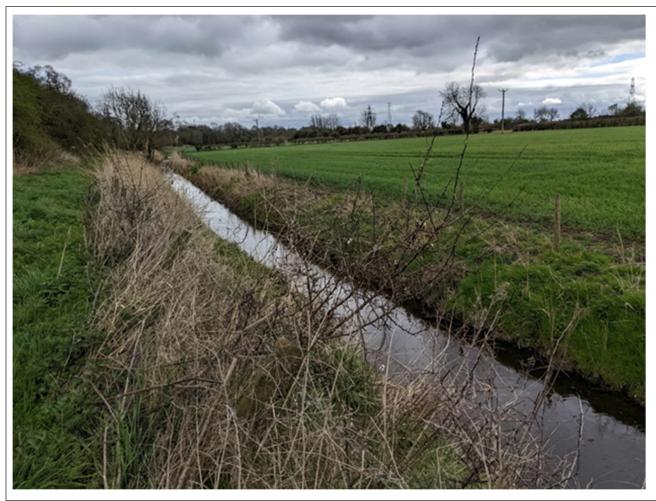
2.11. SEAHILL DRAIN

Catchment area	3.03 km ²
Key hydraulic connections	This watercourse has several tributaries and merges with the Garden City Gutter before reaching the River Dee.
River Condition Score	Fairly poor
Catchment description	The Seahill Drain catchment has a high degree of human influence on watercourses and landscape, with the land use being arable agriculture and permanently vegetated recreational. Elevation varies from ~ 25m to 5mAOD.
Study reach description	Seahill Drain is a linear watercourse, with no significant variation in water depth and along the investigated reach. Mean water depth and width are 0.45m and 2.1m, respectively.

The riverbed morphology is slow-glide with silt as the dominant particle size. The riparian zone is arable agriculture.
Interaction with the DCO Proposed Development	Seahill Drain will be crossed by the Newbuild Carbon Dioxide Pipeline via open cut.

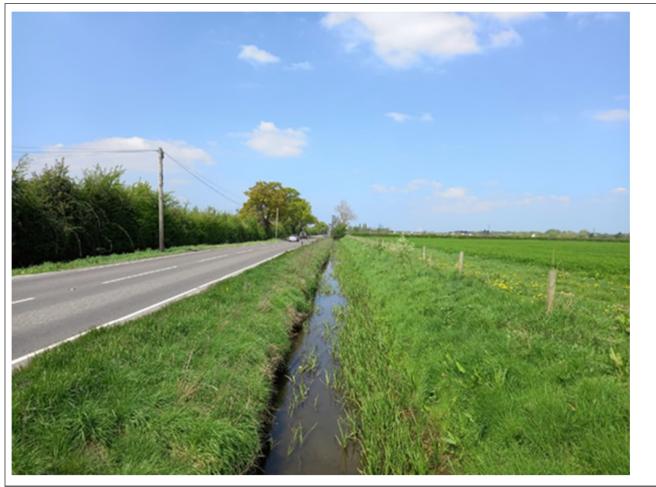
2.15. BROUGHTON BROOK

Catchment area	11.72km ²
Key hydraulic connections	The Broughton Brook flows to the River Dee at Station Road. Along the B5129 it is joined by several tributaries flowing north-eastwards from Hawarden. There are drains along Chester Road which connect to the Broughton Brook prior to it joining the River Dee.
	The watercourse is disconnected from its floodplain is it is within an incised channel.
River Condition Score	Fairly Poor
Catchment description	The catchment has a high degree of human influence on watercourses and the landscape, with the surrounding land use predominantly arable farming, improved grassland and woodland. Elevation varies from ~ 157 mAOD to 8mAOD.

Study reach description	Broughton Brook channel is a cut trapezoidal drainage ditch, with consistent a bankfull width and water depth of 2m and 0.25m, respectively.
	The bed material is predominantly silt with some gravels and pebbles. Whilst the watercourse has a bare channel bed, there are some emergent reeds/ linear leaved or horsetails. The riparian zone is homogenous throughout the study area, with taller grasses on bank face and bank top, the B5129 on one bank and arable farming on the other. The planform of the channel has remained unchanged since 1913.
Interaction with the DCO Proposed	The Broughton Brook will be crossed by the Newbuild Carbon Dioxide Pipeline via trenchless methods (TRS-30).
Development

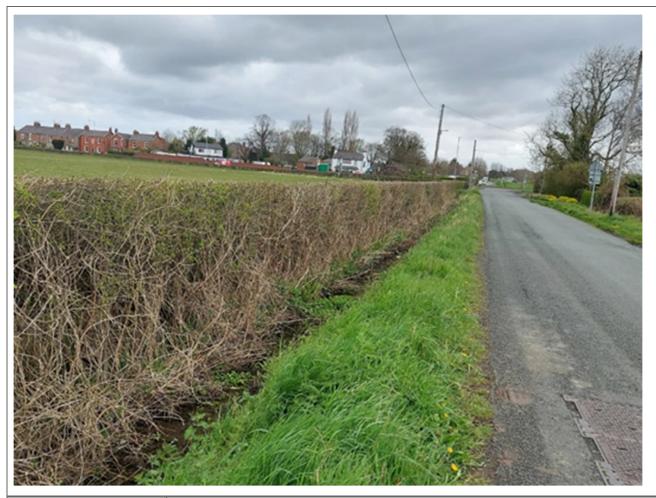
2.16. SANDYCROFT DRAIN

Catchment area	2.99km ²
Key hydraulic connections	Onward connection into Broughton Brook. It receives flows from roadside ditches of Moor Lane.
River Condition Score	Fairly Poor
Catchment description	The catchment drains the surrounding roads, urban areas, and arable fields and is relatively flat, with the elevation varying from 80 - 8 mAOD.
Study reach description	The channel is a cut trapezoidal drainage ditch that appears to have been artificially straightened. The channel has a consistent bankfull width and water depth (1m and 0.05m, respectively).
	The bed material is predominantly silt with some sands. Whilst the channel bed sediment is bare, there are some emergent broadleaved and amphibious plants. The riparian zone is homogenous, with a

hedgerow between the channel and the adjacent pastoral fields on one bank. The majority of the riparian zone is fields or road infrastructure. The planform of the channel has remained unchanged since 1913.
Interaction with the DCO Proposed Development	The Sandycroft Drain will be crossed by the Newbuild Carbon Dioxide Pipeline via trenchless methods (TRS-30) where it is parallel with Broughton Brook. At Moor Lane, the watercourse will be crossed by the Newbuild Carbon Dioxide Pipeline via open cut.

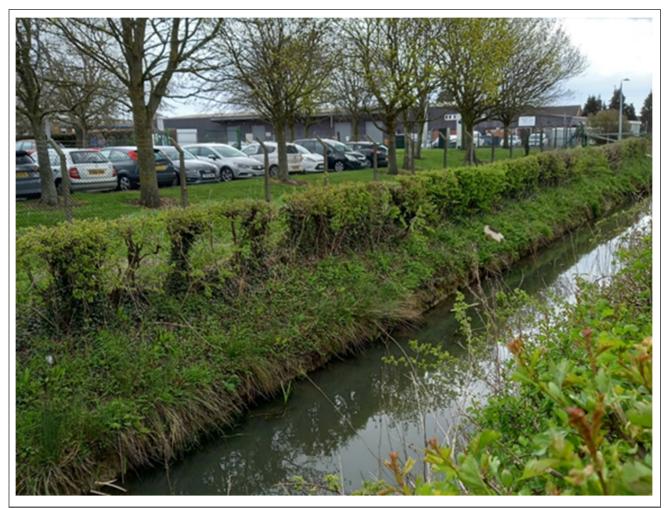
2.17. CHESTER ROAD DRAIN NORTH

Catchment area	1.67 km ²
Key hydraulic connections	This watercourse is hydraulically connected to both the Broughton Brook (southeast) and Aston Hall Brook (Northwest). The channel is not connected to the floodplain.
River Condition Score	Poor
Catchment description	The catchment drains farmland and arable fields, with extensive urbanisation north of the watercourse. The catchment is relatively flat catchment, with the elevation varying from $80 - 8$ mAOD.
Study reach description	Large sections of the watercourse are culverted or in an artificially incised channel with steep banks, with no variation in channel width (bankfull width 4 m) and depth (0.3 m) within the study area.

The watercourse has a silt substrate, with a lack of geomorphic bed features. There is a lack of diversity in the riparian vegetation; however, in the open sections there is defunct hedgerow on the bank top with road and car parking within the riparian zone. There is bare earth on the bank faces, with some short creeping herbs and grasses
	Despite becoming progressively culverted, the channel has retained its contemporary planform since at least 1892.
Interaction with the DCO Proposed Development	This watercourse is within the Newbuild Infrastructure Boundary. The pit for the proposed trenchless crossings of Chester Road (TRS-31 and TRS-32) would be adjacent to this watercourse.

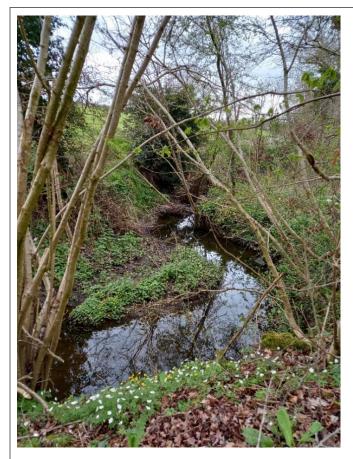
Fairly Good section within Newbuild Infrastructure Boundary

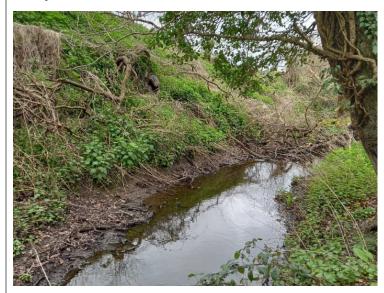
Moderate section within Newbuild Infrastructure Boundary

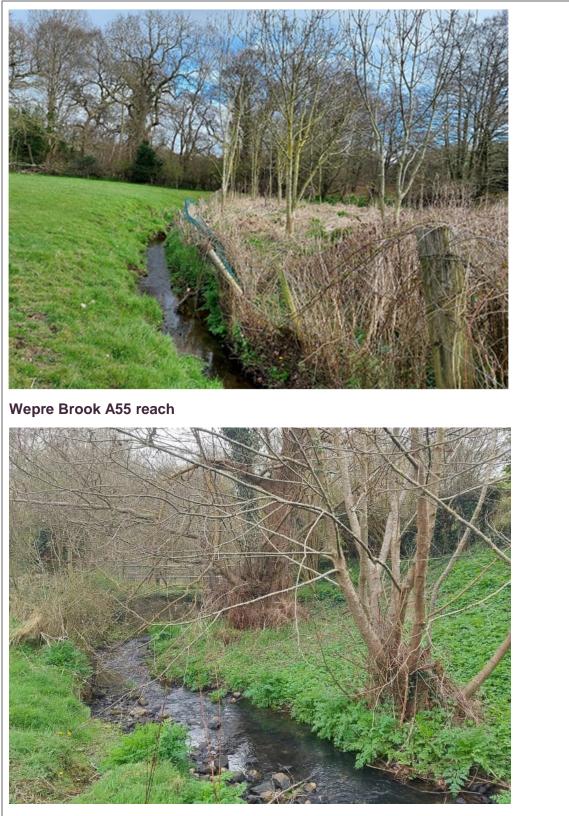
Wepre Brook Brookside reach

Catchment area	9.57km ²
Key hydraulic connections	Wepre Brook has several tributaries, mostly from the south of the catchment. The Alltami Brook and New Inn Brook both connect to the Wepre Brook downstream of the study area.
River Condition Score	A55 reach: moderate; Brookside reach: fairly poor; Northrop Hall reach: fairly poor
Catchment description	The majority of the catchment is rural and agricultural. There are small settlements in the catchment (Northop, Northop Hall and Soughton). The A55 and Brookside run parallel to the Wepre Brook through the study reach.
Study reach description	At the A55 reach the channel is narrow (approximately 1m width and 0.3m water depth). Through Brookside and Northop Hall reaches the watercourse is wider (width up to 2m and water depth 0.2m). The bed material is well mixed generally, with areas of both gravel-pebble mix and cobbles. Some areas of sand were observed overlaying armoured substrate in the A55 reach.
