ENVIRONMENTAL STATEMENT (VOLUME III)

Appendix 18.3 Water Framework Directive Assessment

HyNet Carbon Dioxide Pipeline DCO

Document Reference Number D.6.3.18.3

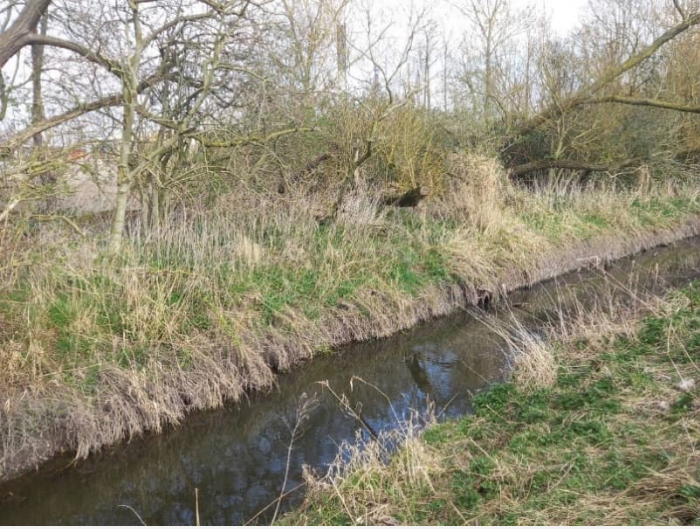
Watercourse name	East Central Drain

Water feature type: Main River
	Catchment area: 1.02km ²
	Key hydraulic connections: Flows into West Central Drain
	Surrounding land use: Mostly pastoral fields with stands of plantation woodland and an industrial estate. Access tracks and paved roads are present.
	River Condition Score: Moderate
Catchment Characteristics	The catchment mostly comprises grassland with some arable and horticultural land uses. A smaller proportion of the catchment has built-up land use and woodland. The catchment has an elevation between 4.9 - 40mAOD).
Catchment Geology and Soils	The bedrock geology comprises Kinnerton sandstone formation (sandstone). The East Central Drain is underlain by superficial

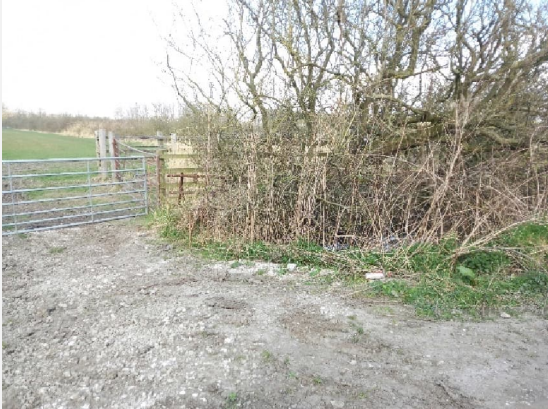
Watercourse name	Elton Lane Ditch 1

Water feature type: Ordinary Watercourse
	Catchment area: <math><1\text{km}^2</math>
	Key hydraulic connections: Artificial field drain collecting overland flow and discharging to West Central Drain
	Surrounding land use: Farming and agricultural, track roads
	Ditch Condition Score: Fairly Poor
Catchment Characteristics	The channel drains a small catchment of farm and agricultural land, dissected by track roads.
Catchment Geology and Soils	<p>The bedrock geology comprises Kinnerton sandstone formation (sandstone). Elton Lane Ditch 1 is underlain by superficial deposits of clay, silt and sand, formed from tidal flat deposits at the Quaternary shoreline.</p> <p>The catchment features loamy and sandy soils with naturally high groundwater and a peaty surface. These soils drain well into local shallow groundwater. These soils are vulnerable to pollution from nutrients, pesticides and wastes applied to the land.</p>

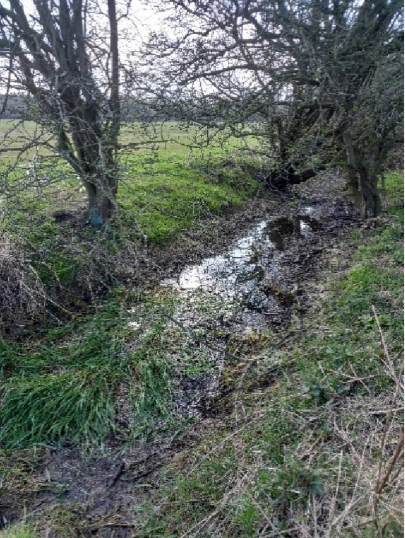
Watercourse name	Elton Lane Ditch 4

Water feature type: Ordinary Watercourse
	Catchment area: <1km ²
	Key hydraulic connections: artificial field drain collecting overland flow and discharging to West Central Drain
	Surrounding land use: Farming and agricultural, track roads
	Ditch Condition Score: Fairly Poor
Catchment Characteristics	The channel drains a small catchment of farm and agricultural land dissected by track roads.
Catchment Geology and Soils	<p>The bedrock geology comprises Kinnerton sandstone formation (sandstone). Elton Lane Ditch 4 is underlain by superficial deposits of clay, silt and sand, formed from tidal flat deposits at the Quaternary shoreline.</p> <p>The catchment features loamy and sandy soils with naturally high groundwater and a peaty surface. These soils drain well into local</p>

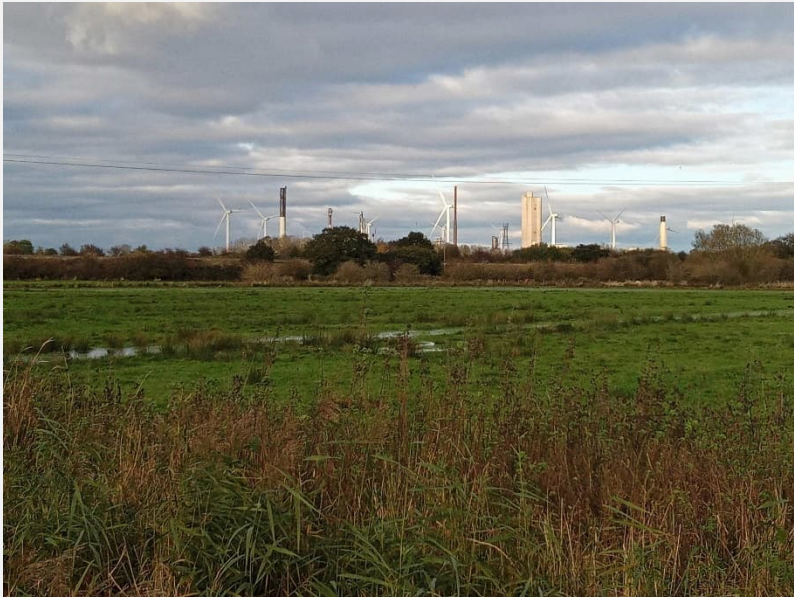
Watercourse name	Elton Marsh 1 and 2

Water feature type: Ordinary Watercourse
	Catchment area: <1km ²
	Key hydraulic connections: flows into the West Central Drain
	Surrounding land use: Farming and agricultural, trainline
	Ditch Condition Score: Poor
Catchment Characteristics	The channels drain a small catchment of farm and agricultural land to the south of the Great Northern and London and North Western Joint Railway.
Catchment Geology and Soils	The bedrock geology comprises Kinnerton sandstone formation (sandstone). Elton Marsh 1 and 2 are underlain by superficial deposits of clay, silt and sand, formed from tidal flat deposits at the Quaternary shoreline.

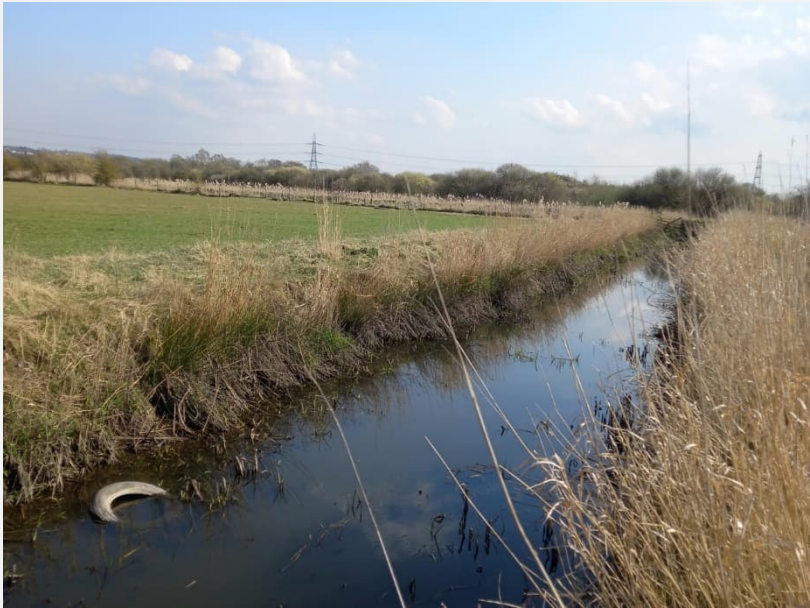
Watercourse name	West Central Drain

Water feature type: Main River
	Catchment area: 0.55km ²
	Key hydraulic connections: Drains the Elton Marsh Drains (1-13), joined by Hapsford Brook and East Central Drain at Ince Marshes. Flows northwards towards the Manchester Ship Canal where water is pumped into the canal at high flows. The watercourse discharges to Hoolpool Gutter.
	Surrounding land use: Mostly pastoral fields, industrial estates and car parks, track and paved roads, permanently vegetated agriculture, some plantation woodland.
	River Condition Score: Fairly Poor
Catchment Characteristics	The West Central Drain forms the main stem off the Elton Marsh Drains (1 –13). The channel drains a small catchment of farm and agricultural land. The West Central Drain flows under the Great Northern and London, and North Western Joint Railway line.
Catchment Geology and Soils	The bedrock geology comprises Kinnerton sandstone formation (sandstone). The West Central Drain are underlain by superficial deposits of clay, silt and sand, formed from tidal flat deposits at the

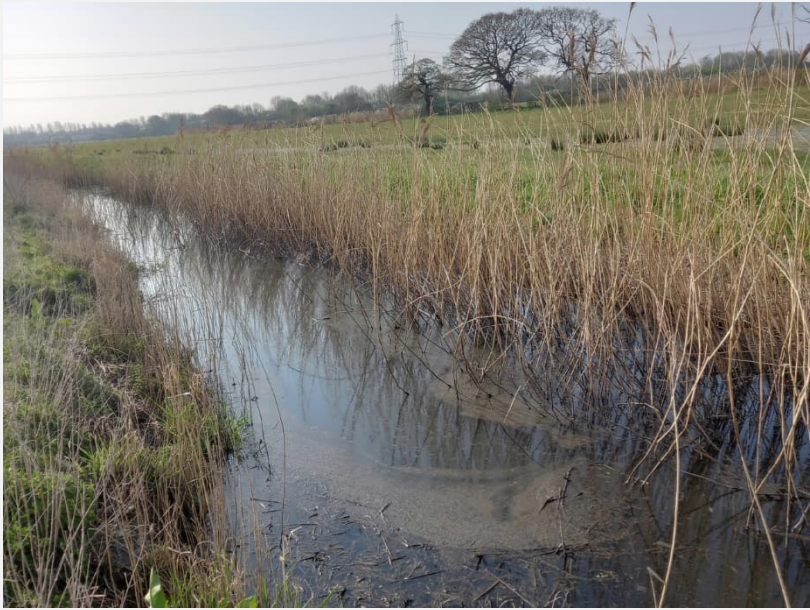
Watercourse name	Hapsford Brook

Water feature type: Main River
	Catchment area: 2.87km ²
	Key hydraulic connections: Connects to Elton Marsh Drains 9 to 13 in peak flow and discharges to West Central Drain.
	Surrounding land use: Farming and agricultural, M56 to the south, paved road network, suburban.
	River Condition Score: Moderate
Catchment Characteristics	<p>The Hapsford Brook drains the Elton Marshes between Hapsford Lane and the M56. The channel drains a catchment consisting of the suburban area of Elton, rural village of Hapsford and a lorry service station. The Hapsford Brook flows under the Great Northern and London and North Western Joint Railway line. The catchment consists mostly of arable and horticultural grasslands, with some areas of development (Hapsford and Elton). The M56 (junction 14) and A5117 roads dissect the channel south of Elton.</p>

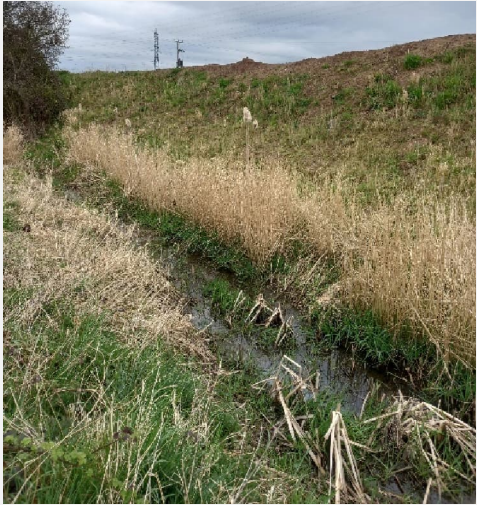
Watercourse name	Elton Brook Tributary 1

Water feature type: Ordinary Watercourse (Ditch)
	Catchment area: <1km ²
	Key hydraulic connections: Flows westwards into Gale Brook
	Surrounding land use: Urban, A5117 road, travellers' site, arable and horticultural
	Ditch Condition Score: Poor
Catchment Characteristics	Elton Brook Tributary 1 drains arable and horticultural land to the south of the A5117. The channel drains a catchment that features the Essar Stanlow Refinery and the suburb of Elton.
Catchment Geology and Soils	The bedrock geology of the channel consists of the Chester Formation. This geology comprises sandstone, pebbly (gravelly) sedimentary bedrock. These deposits were formed in fluvial environments. They are detrital, ranging from coarse- to fine-grained and form beds and lenses of deposits reflecting the

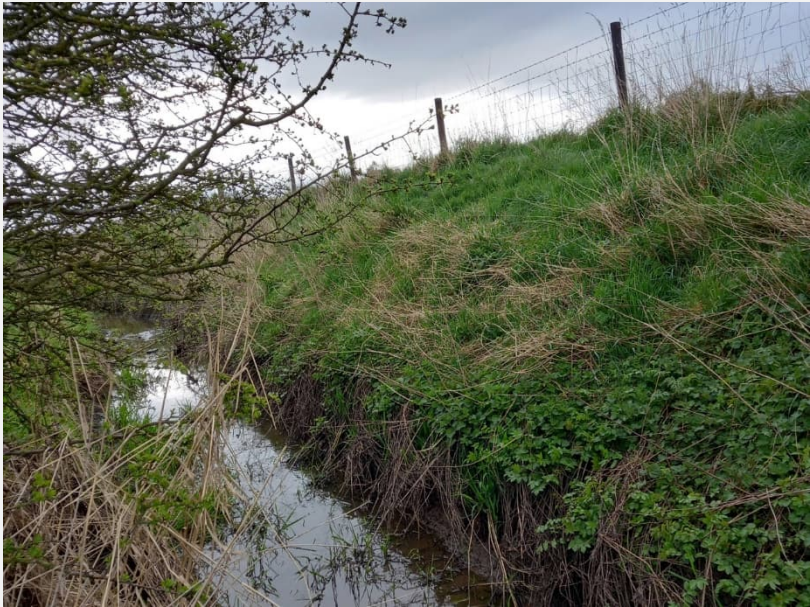
Watercourse name	Gale Brook

Water feature type: Main River
	Catchment area: 6.64km ²
	Key hydraulic connections: The Gale Brook drains into the River Gowy.
	Surrounding land use: Urban and suburban at the confluence of with the Gowy. Pockets of broadleaved, mixed and yew woodlands. In the headwaters, the land use is mostly arable and horticultural.
Catchment Characteristics	River Condition Score: Moderate The Gale Brook drains agricultural and pastoral land in the headwaters. The channel flows through a network of culverts, under the M56, B5132, and the A5117. The channel is culverted as it flows under the Essar Stanlow Refinery. The Brook surfaces from the culvert north of the Great Northern and London, and North-Western Joint Railway line. The Gale Brook rises south-west around 1.18 km of Dunham-on-the-Hill (10mAOD).

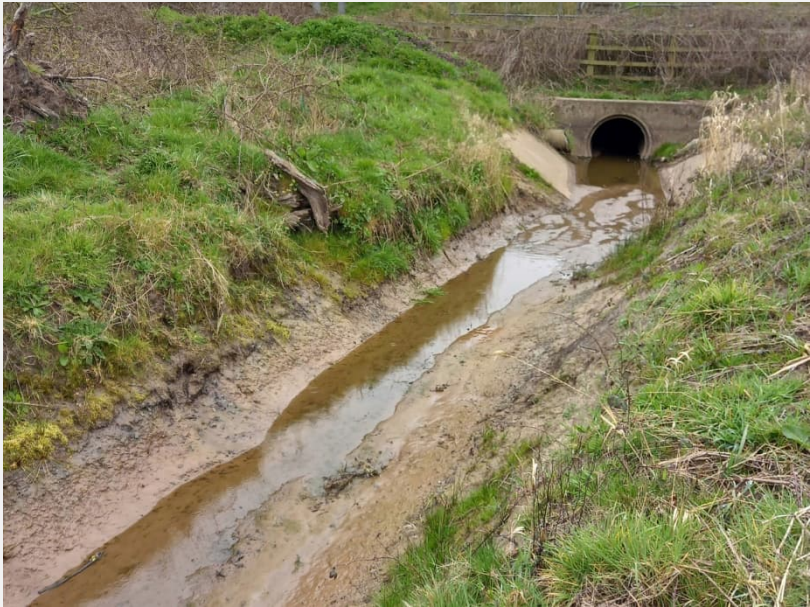
Watercourse name	Thornton Uplands

Water feature type: Main River
	Catchment area: 2.32km ²
	Key hydraulic connections: Flows northwards to River Gowy. It is joined by Halls Green Lane Brook and Thornton Marsh Central.
	Surrounding land use: Farmland, agricultural buildings, M56 road, industrial power generation.
	River Condition Score: Fairly Poor
Catchment Characteristics	Thornton Uplands drains agricultural and pastoral land in the headwaters. The channel flow through a network of culverts, under the M56. The channel is culverted as it flows under Ince Lane and track lanes. The channel rises from farm ditches, around 1.4km southwest of Dunham-on-the-Hill (10 mAOD). The channel flows adjacent to a refinery. Along these reaches, the channel is surrounded by embankments.

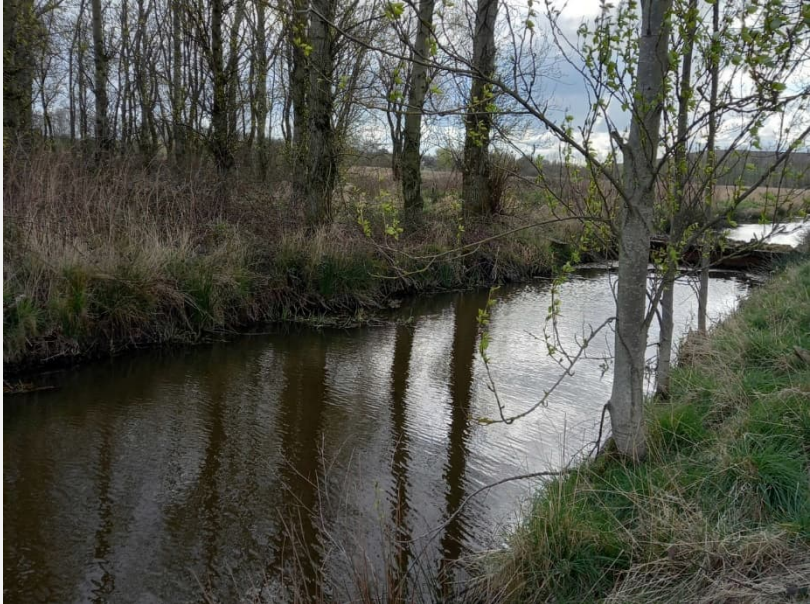
Watercourse name	Thornton Main Drain

Water feature type: Main River
	Catchment area: 3.00km ²
	Key hydraulic connections: Thornton Ditch 5 – 12 drain into the Thornton Main Drain. Thornton Main Drain continues northwards and joins the River Gowy at the A5117.
	Surrounding land use: Farmland, agricultural buildings and settlement, landfill site, and peat bog.
	River Condition Score: Fairly Poor
Catchment Characteristics	Thornton Main Drain drains agricultural and pastoral land in its headwaters. The channel flows through a network of culverts, under the M56. The channel rises from farm ditches, around 0.7km northwest of Wimbolds (6mAOD). Potentially some peat bog, surficial water storage within the farmland adjacent to the channel. The entirety of the Gowy Landfill Site falls within the catchment of

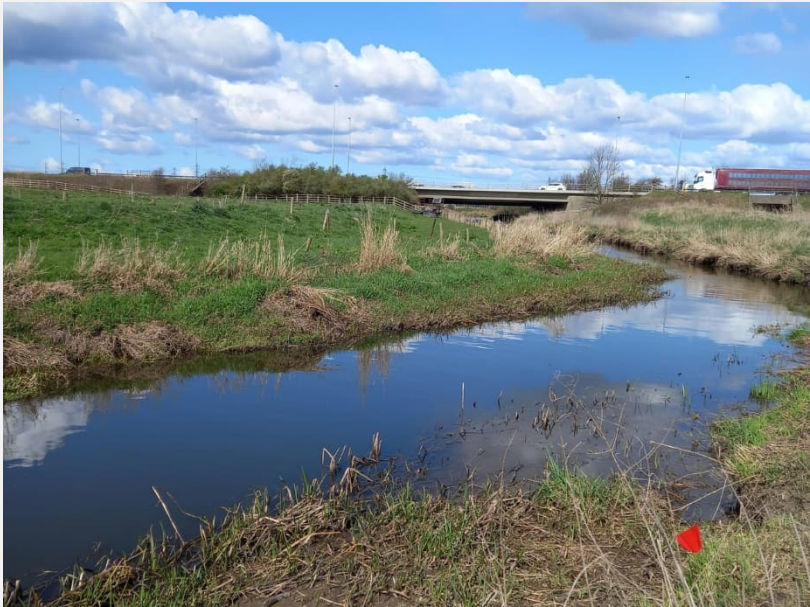
Water feature type: Main River
	Catchment area: 150km ²
	Key hydraulic connections: The River Gowy is the largest river in the region. Upstream of the DCO Proposed Development, it is fed by the Barrow Brook, Back Brook, Milton Brook, Salters Brook and Ashton Brook. The Gowy joined downstream of the DCO Proposed Development by Thornton Main Drain, Thornton Uplands, Stanney Mill Brook and Gale Brook, before it flows into the River Mersey.
	Surrounding land use: Farmland, agricultural buildings, landfill site, settlement, peat bog.
Catchment Characteristics	River Condition Score: Moderate
	Heavily modified channel, variety of geomorphic pressures (e.g., poor soil, nutrient, and livestock management, contaminated land, ecological discontinuity, ground water abstraction, pollution from wastewater industry and local government). The catchment has a maximum elevation of 43m ASL (Helsby Hill). The channel is contained within embankments along most of the channel course. Heavily confined north of the A5117, as the channel passes adjacent to the gasworks.

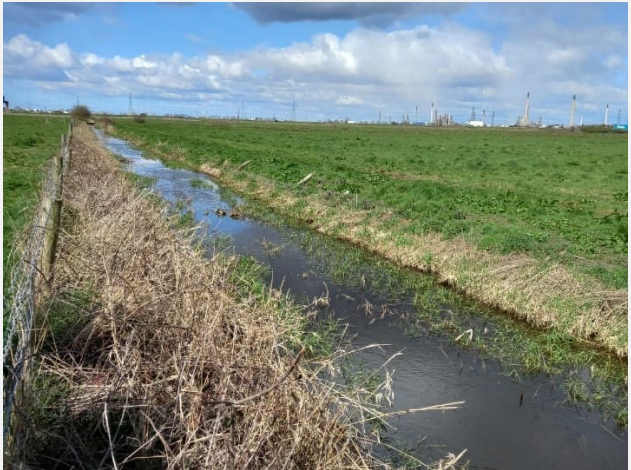
Watercourse name	Stanney Main Drain

Water feature type: Main River
	Catchment area: <1km ²
	Key hydraulic connections: This is an artificial drain within the River Gowy floodplain. It is connected to Thornton Ditch (1,2), Mill Brook, Mill Brook Tributary (1,2) and Gowy Tributary (1,2). It joins the River Gowy at the A5117.
	Surrounding land use: Farmland, agricultural buildings, roadways, peat bog.
	River Condition Score: Fairly Poor
Catchment Characteristics	Stanney Main Drain drains agricultural and pastoral land in its headwaters. The channel flows through a culvert under the M56. The channel rises from farm ditches, around 0.47km west of Bridge Trafford. Potentially some peat bog, surficial water storage within the farmland adjacent to the channel. It has a maximum catchment altitude of (6mAOD).
Catchment Geology and Soils	The bedrock geology of the Thornton Main Drain catchment consists of sandstone; the Chester Formation (pebbly and gravelly). These sediments are fluvial in origin. Further downstream, the channel is underlain by the Wilmslow Sandstone Formation consisting of

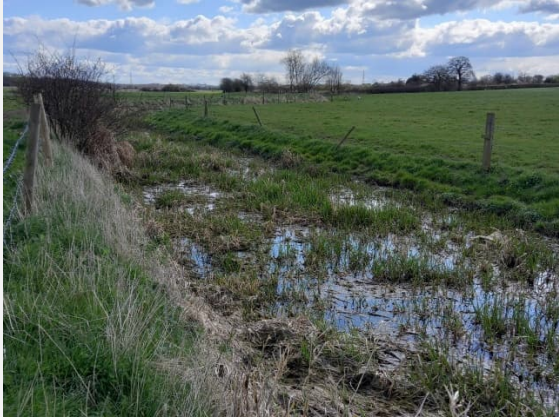
Watercourse name	Stanney Mill Brook

Water feature type: Main River
	Catchment area: 6.95km ²
	Key hydraulic connections: Gowy Tributary 2 connects Stanney Mill Brook and Stanney Main Drain. Picton Brook flows into the Stanney Mill Brook. The Stanney Mill Brook drains into the Gowy downstream of the A5117.
	Surrounding land use: Farmland, agricultural buildings, roadways, Suburban (Picton, Mickle Trafford), Peat bogs.
Catchment Characteristics	River Condition Score: Moderate – Fairly Poor Stanney Mill Brook drains agricultural and pastoral land. The channel flows through a culvert under the M56. The channel rises north of Mickle Trafford. It has a maximum catchment altitude of (45mAOD). There is a wastewater treatments works on the Stanney Mill Brook south of the A5117.
Catchment Geology and Soils	The bedrock geology of the Stanney Mill Brook catchment consists of sandstone; the Chester Formation (pebbly and gravely). These

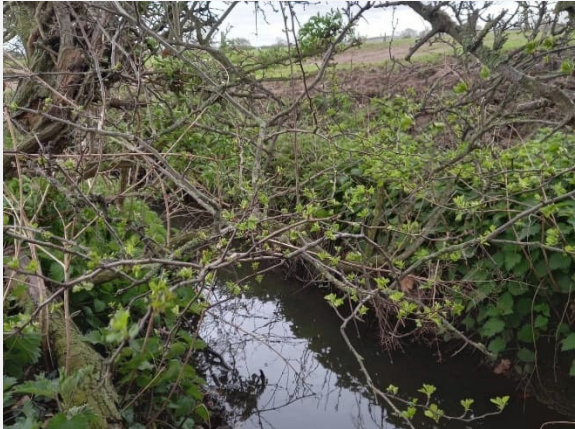
Watercourse name	Gowy Tributary 2

Water feature type: Ordinary Watercourse
	Catchment area: 1.1 km ²
	Key hydraulic connections: Gowy Tributary 2 flows into Stanney Mill Brook and the River Gowy.
	Surrounding land use: Farmland, agricultural buildings, roadways.
	River Condition Score: Access reach: Moderate Stoak reach: Fairly Poor.
Catchment Characteristics	Gowy Tributary 2 drains agricultural and pastoral land. The channel flows through a culverts under the M53, Fox Covert Lane and Picton Lane. The channel rises west of Upton Health. It has a maximum catchment altitude of (42mAOD).
Catchment Geology and Soils	The bedrock geology of the Gowy Tributary 2 catchment consists of sandstone; the Chester Formation (pebbly and gravelly). These sediments are fluvial in origin. The superficial deposits within the catchment include Devensian tills.

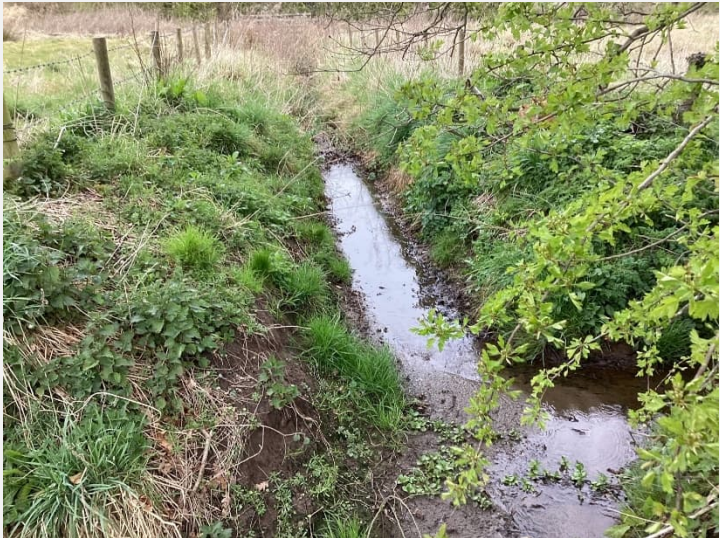
Watercourse name	Wervin Hall Ditch Tributary

Water feature type: Ordinary Watercourse
	Catchment area: <math><1\text{km}^2</math>
	Key hydraulic connections: Flows into Wervin Hall Ditch which flows under the Shropshire Union Canal and joins Canal Ditch; part of Finchetts Gutter water body.
	Surrounding land use: Farmland, agricultural buildings, roadways, Shropshire Union Canal, plantation woodland.
	Ditch Condition Score: Poor
Catchment Characteristics	Wervin Hall Ditch Tributary drains agricultural and pastoral land. The channel rises east of Caughall Road. Maximum catchment altitude of (circa 39mAOD).
Catchment Geology and Soils	The bedrock geology of the Wervin Hall Ditch Tributary catchment consists of sandstone; the Chester Formation (pebbly and gravely). These sediments are fluvial in origin.

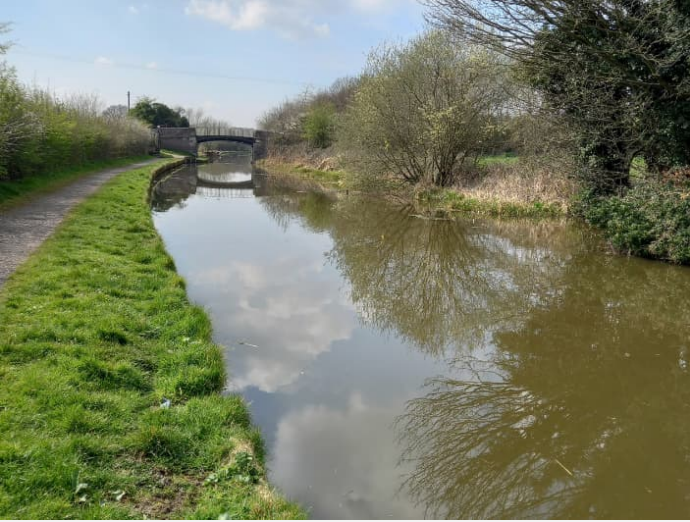
Watercourse name	Shropshire Union Canal

Water feature type: Canal
	Catchment area: n/a (artificial canal system)
	Key hydraulic connections: The canal joins the Manchester Ship Canal to the River Dee at Chester.
	Surrounding land use: Rural (farmland, arable and pastoral), woodland, urban, industrial, recreational (golf courses, etc)
	River Condition Score: Fairly poor
Catchment Characteristics	Artificial channel built in the late 18 th century for industry and trade. Ellesmere and Chester canal branches. 16 locks separate Manchester Ship Canal from River Dee.
Catchment Geology and Soils	n/a (artificial canal)
Catchment Hydrology	Series of weirs and locks controls water level throughout the canal system.

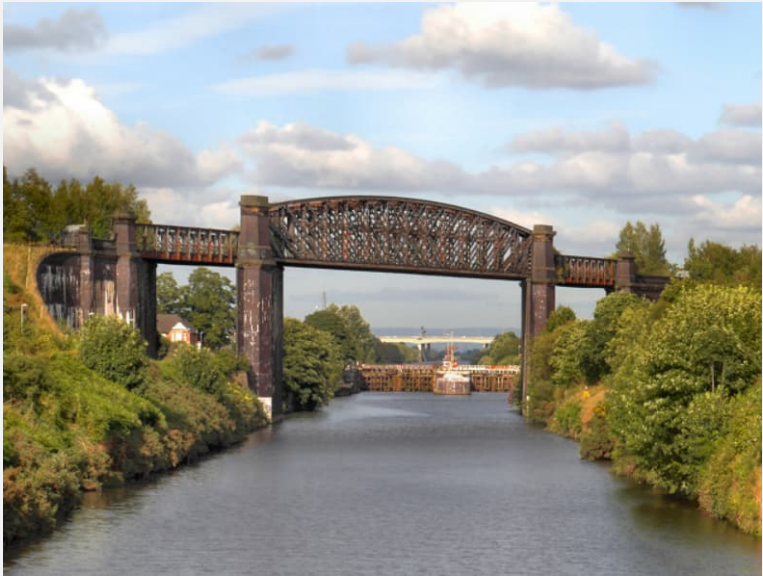
Watercourse name	Manchester Ship Canal

Water feature type: Canal
	Catchment area: n/a (artificial canal)
	Key hydraulic connections: River Irwell; River Irk; River Medlock
	Surrounding land use: Major industrial and urban centres in canal catchment. Large areas of farmland.
	River Condition Score: Not surveyed
Catchment Characteristics	Major artificial canal, extensively used for shipping and trade.
Catchment Geology and Soils	n/a (artificial canal)
Catchment Hydrology	Multiple locks and sluices maintain water levels within the channel.
Historical Channel Change	Channel construction in the late 19 th century, no changes to course in intervening years.

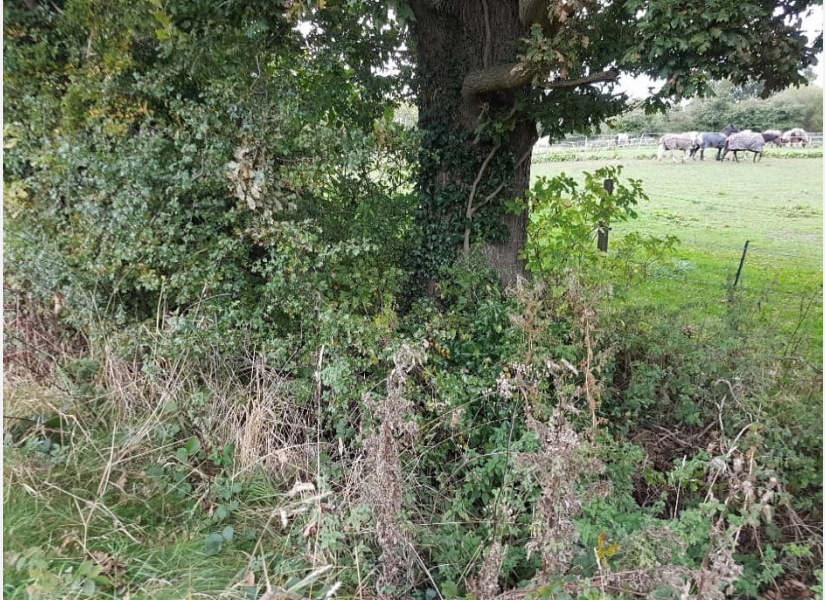
Watercourse name	Collinge Wood Brook

Water feature type: Ordinary Watercourse
	Catchment area: <1km ²
	Key hydraulic connections: Onward connection to canal ditch and is likely culverted beneath Shropshire Union Canal to join Finchetts Gutter.
	Surrounding land use: Farm buildings and tracks, improved grassland, arable and horticultural land, some broadleaved, mixed and yew woodland
Catchment Characteristics	Drains agricultural and pastoral land. It has a maximum catchment altitude of (~ 42mAOD - ~11mAOD).
Catchment Geology and Soils	Bedrock geology comprising the Chester Formation (sandstone, pebbly, gravelly). The superficial geology of the catchment consists

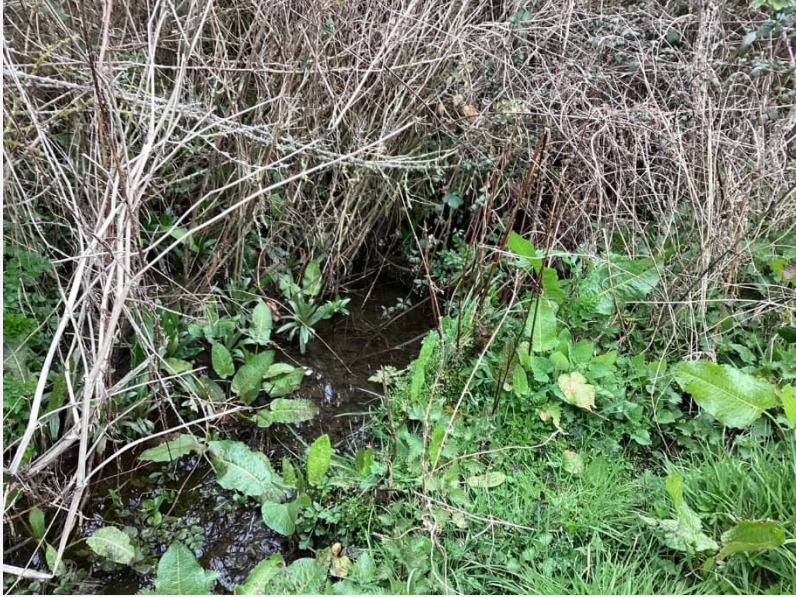
Watercourse name	Rake Lane Brook

Water feature type: Ordinary Watercourse
	Catchment area: 3.3km ²
	Key hydraulic connections: This watercourse flows beneath the Shropshire Union Canal and joins Finchetts Gutter.
	Surrounding land use: Pasture, grassland, and woodland.
	River Condition Score: Moderate.
Catchment Characteristics	The watercourse is ~ 0.7km long. Elevation varies from 24m to 20mAOD.
Catchment Geology and Soils	Geology is dominated by sandstone and conglomerate. Soils in the catchment are slightly acid loamy and clayey soils with impeded drainage and slowly permeable seasonally wet slightly acid but base-rich loamy and clayey soils

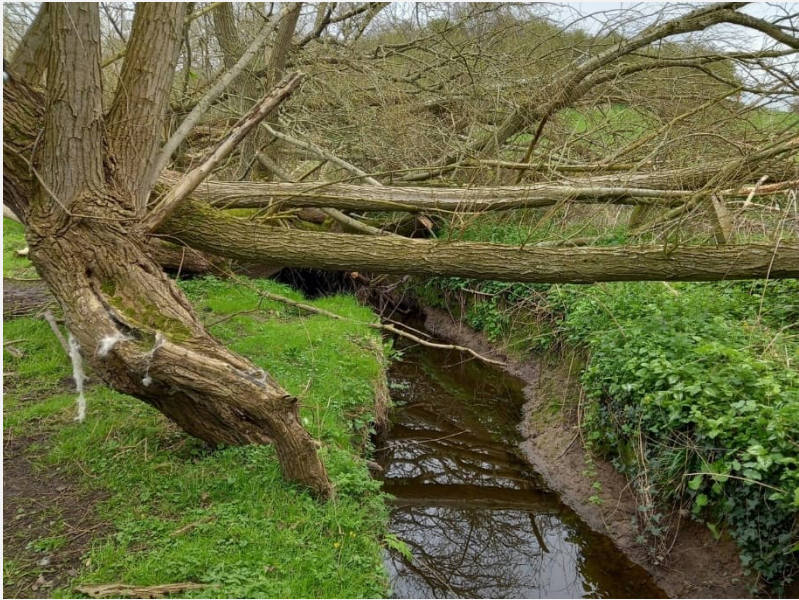
Watercourse name	Backford Brook

Water feature type: Main River
	Catchment area: 4.97km ²
	Key hydraulic connections: There are three tributaries of Backford Brook which drain land south of Dunkirk and the M56. Backford Brook is culverted beneath the Shropshire Union Canal and then joins Finchetts Gutter.
	Surrounding land use: Pasture, grassland, and woodland.
	River Condition Score: Fairly Good upstream of field culvert. Fairly Poor downstream of field culvert.
Catchment Characteristics	Elevation varies from 38m, to 19mAOD. The catchment is predominantly rural.
Catchment Geology and Soils	Geology is dominated by sandstone and conglomerate. Soils in the catchment are slightly acid loamy and clayey soils with impeded drainage and loamy and sandy soils with naturally high groundwater and a peaty surface

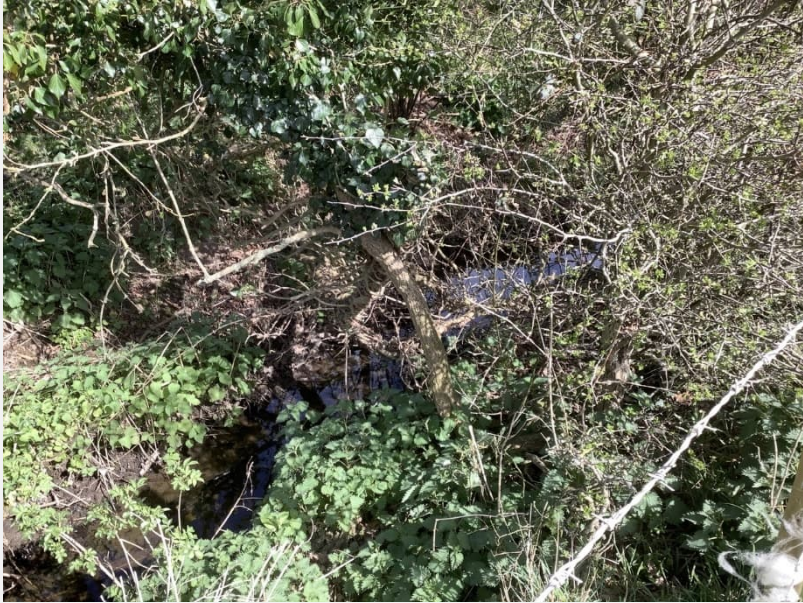
Water feature type: Ordinary Watercourse
	Catchment area: 0.135km ²
	Key hydraulic connections: This watercourses flow southeast, under the Shropshire Union Canal and connects to Finchetts Gutter.
	Surrounding land use: Pasture, grassland, and woodland.
	River Condition Score: Fairly Good
Catchment Characteristics	The watercourse drains a catchment south of Lea-by-Backford. The elevation ranges from 12m to 25mAOD.
Catchment Geology and Soils	Geology is dominated by sandstone and conglomerate. Soil in the catchment is slightly acid loamy and clayey soils with impeded drainage.
Catchment Hydrology	No gauge records are available for this catchment.

Watercourse name	Friars Park Ditch
Historical Channel Change	No change in planform can be seen from existing online maps (from 1982 onwards).
<u>Biological</u>	
Fish	Scoped out due to lack of suitable fish habitat identified during the aquatic habitat walkover survey.
Invertebrates	Scoped out due to lack of suitable invertebrate habitat identified during the aquatic habitat walkover survey.
Macrophytes & Phytoplankton	Scoped out due to lack of suitable macrophyte and phytoplankton habitat identified during the aquatic habitat walkover survey.
<u>Physico-Chemical</u>	
Thermal Conditions	No data is available for this watercourse.
Oxygenation Conditions	No data is available for this watercourse.
Salinity	No data is available for this watercourse.
Acidification Status	No data is available for this watercourse.
Nutrient Conditions	No data is available for this watercourse.
Priority Hazardous Substances	No data is available for this watercourse.

Watercourse name	Friars Park Ditch
<u>Hydromorphological</u>	
Quantity and Dynamics of Flow	Flow within the channel is predominantly smooth with some rippled flow and broken standing waves.
River Continuity	The watercourse is in a deep channel much lower than the surrounding pasture. The watercourse is culverted beneath the Shropshire Union Canal.
River Depth and Width Variation	River depth varies from 0.03m to 0.15m, and river width from 0.3m to 0.5m.
Structure and Substrate of the River Bed	The watercourse substrate is dominated by silt with organic matter overlaying the silt.
Structure of the Riparian Zone	The riparian zone is primarily composed of permanently vegetated agriculture. There is a line of mature trees along the bank top of the watercourse, with more vegetation on the bank face.

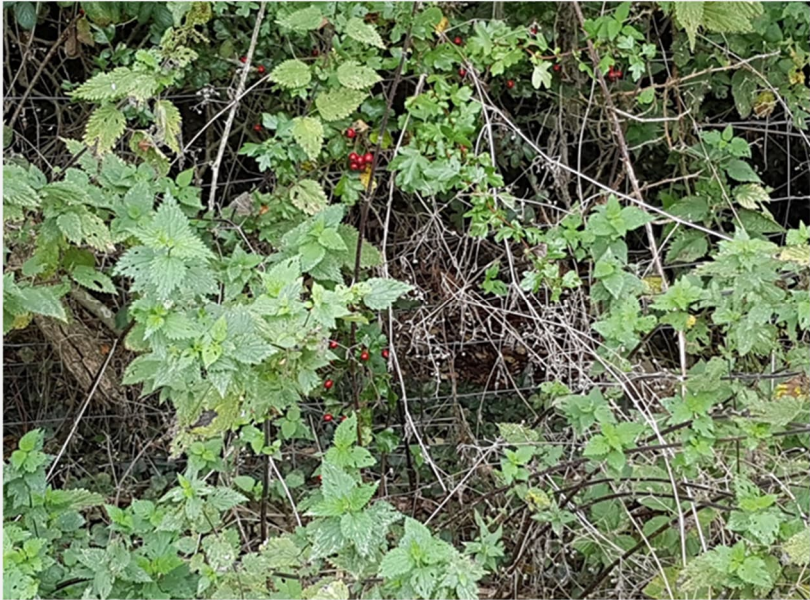
Water feature type: Ordinary Watercourse
	Catchment area: 1.51km ²
	Key hydraulic connections: Network of hedgerow ditches, which flows southeast, beneath the Shropshire Union Canal and then joins Finchetts Gutter.
	Surrounding land use: Improved grassland, neutral grassland, arable and horticultural land, broad, mixed and yew woodland, urban development (Lea by Backford)
	River Condition Score: No survey completed
Catchment Characteristics	The catchment includes local farmland and arable fields. It has an elevation range between 14m and 41mAOD.
Catchment Geology and Soils	The bedrock geology of the catchment includes the Chester Formation, comprising sandstones, and pebbly/ gravelly sediments. Superficial deposits consist of diamicton formed under ice age conditions. Soils within the comprising slightly acid loamy and clayey

Watercourse name	Gypsy Lane Brook
	soils with impeded drainage. The catchment also comprises Slowly permeable seasonally wet slightly acid but base-rich loamy and clayey soils.
Catchment Hydrology	No gauge records are available for this catchment. The channel is culverted as it flows beneath Grove Road and Station Road.
Historical Channel Change	The channel appears to have been artificially straightened as it follows the natural boundary of the arable fields. The channel has retained its planform since 1892.
<u>Biological</u>	
Fish	Scoped out due to lack of suitable fish habitat identified during the aquatic habitat walkover survey.
Invertebrates	Scoped out due to lack of suitable invertebrate habitat identified during the aquatic habitat walkover survey.
Macrophytes & Phytoplankton	Scoped out due to lack of suitable macrophyte and phytoplankton habitat identified during the aquatic habitat walkover survey.

Watercourse name	Gypsy Lane Brook
Salinity	No data is available for this watercourse.
Acidification Status	No data is available for this watercourse.
Nutrient Conditions	No data is available for this watercourse.
Priority Hazardous Substances	No data is available for this watercourse.
<u>Hydromorphological</u>	
Quantity and Dynamics of Flow	This is an ephemeral watercourse. When there is water in the channel it is likely to have no perceptible flow.
River Continuity	There are no artificial impoundments on the watercourse however it is culverted beneath Grove Road and Station Road, as well as the Shropshire Union Canal. It flows through an overdeepened channel along a hedgerow.
River Depth and Width Variation	The watercourse has a straight channel planform and rectangular and trapezoidal cross section. It has been resectioned, over-deepened and disconnected from floodplain. Channel depth is around 1.5 m, and bankfull width is around 1.5m

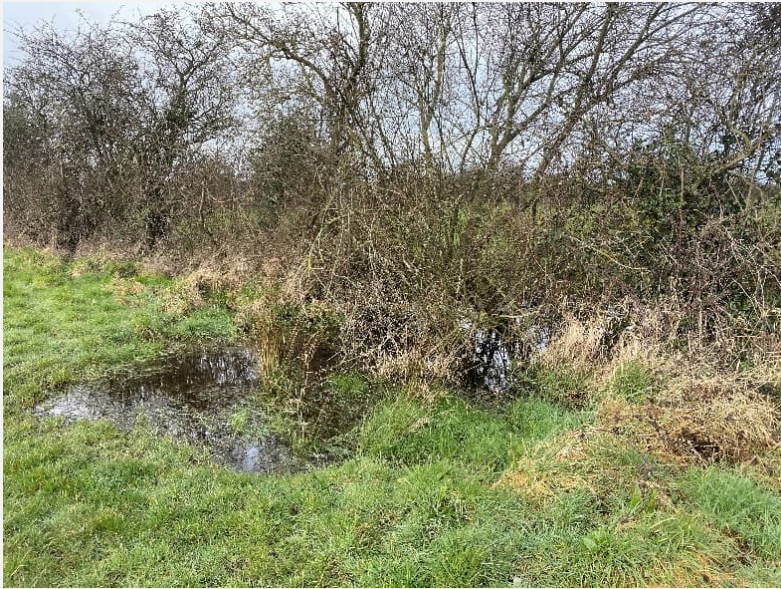
Water feature type: Ordinary Watercourse (Hedgerow Ditch)
	Catchment area: <math><1\text{km}^2</math>
	Key hydraulic connections: Overwood Ditch flows southwards towards Finchetts Gutter Tributary. There is a pond which flows into Overwood Ditch.
	Surrounding land use: The ditch flows through a field used for pastoral farming. The wider area is predominantly rural.
	River Condition Score: No survey completed
Catchment Characteristics	This is a small catchment which is dominated by agricultural land uses.
Catchment Geology and Soils	The bedrock geology of the catchment includes the Chester Formation, comprising sandstones, and pebbly/ gravelly sediments. Superficial deposits consist of diamicton formed under ice age conditions. The catchment comprises slowly permeable seasonally wet slightly acid but base-rich loamy and clayey soils.

Watercourse name	Overwood Ditch
Catchment Hydrology	This watercourse drains a small catchment which has predominantly rural and agricultural land use.
Historical Channel Change	The channel appears to have been artificially straightened as it follows the natural boundary of the arable fields. The channel has retained its planform since 1892.
<u>Biological</u>	
Fish	Scoped out due to lack of suitable fish habitat identified during the aquatic habitat walkover survey.
Invertebrates	Scoped out due to lack of suitable invertebrate habitat identified during the aquatic habitat walkover survey.
Macrophytes & Phytoplankton	Scoped out due to lack of suitable macrophyte and phytoplankton habitat identified during the aquatic habitat walkover survey.
<u>Physico-Chemical</u>	
Thermal Conditions	No data is available for this watercourse.
Oxygenation Conditions	No data is available for this watercourse.
Salinity	No data is available for this watercourse.

Watercourse name	Overwood Ditch
Nutrient Conditions	No data is available for this watercourse
Priority Hazardous Substances	No data is available for this watercourse.
<u>Hydromorphological</u>	
Quantity and Dynamics of Flow	This is an ephemeral watercourse. When there is water in the channel it is likely to have no perceptible flow.
River Continuity	The watercourse has not major impoundments downstream of the DCO Proposed Development, other than culverts beneath small roads.
River Depth and Width Variation	The watercourse has a straight channel planform and rectangular and trapezoidal cross section. It has been resectioned, over-deepened and disconnected from floodplain.
Structure and Substrate of the River Bed	At time of survey there was an obscured view of the channel bed, precluding identification of the channel bed material. Based on catchment land use and gradients, bed material is likely to be fine material such as silt.

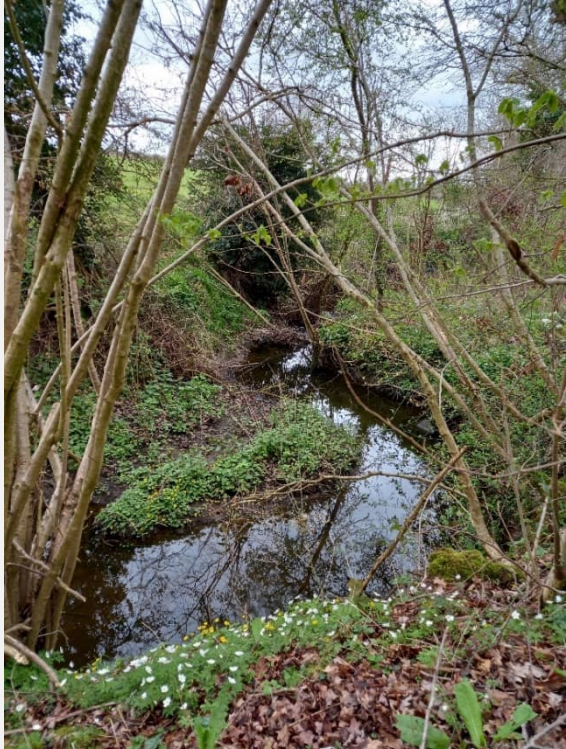
Watercourse name	Finchetts Gutter Tributary

<p data-bbox="230 1118 999 1193">Fairly Good section within Newbuild Infrastructure Boundary</p>	Water feature type: Ordinary Watercourse
	Catchment area: 3.21km ²
	Key hydraulic connections: Finchetts Gutter Tributary flows southeast towards Blacon, under which it is culverted. It joins the Finchetts Gutter south of Saughall Road.
	Surrounding land use: Within the Newbuild Infrastructure Boundary, the land use is predominantly arable and horticultural land, improved grassland, neutral grassland, some broadleaved mixed and yew woodland. There is urban development in Mollington and along Parkgate Road.
	River Condition Score: Fairly good in the upper reach and moderate in the lower reach within the Newbuild Infrastructure Boundary.

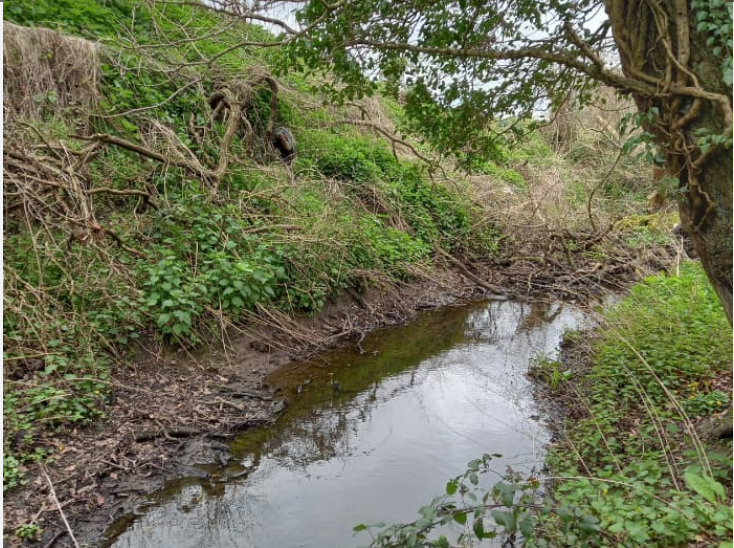
<p data-bbox="250 778 981 858">Moderate section within Newbuild Infrastructure Boundary</p>	
Catchment Characteristics	<p data-bbox="1048 898 2049 1018">The watercourse is approximately 7km in length, with an elevation range between 10m and 46mAOD. The catchment drains local farmland and arable fields.</p> <p data-bbox="1048 1042 2049 1201">The catchment is rural in nature, with mainly open farmland and has some small areas of trees standing. Relatively shallow gradient and unconfined floodplain. Channel slightly sinuous, although realigned for agriculture in the past.</p>
Catchment Geology and Soils	<p data-bbox="1048 1249 2049 1321">Bedrock composed of the Kinnerton Sandstone formation. Superficial geology composed of Devensian till and diamicton.</p>

Watercourse name	Finchetts Gutter Tributary
Catchment Hydrology	The catchment rises to the north west near Capenhurst, flowing south east. Runoff from greenfield contributes to flow. There are no observed impoundments to flow present other than culverts beneath small roads.
Historical Channel Change	No significant changes in channel course since the 1 st edition OS maps (1888)
<u>Biological</u>	
Fish	An e-DNA sample collected from within the proposed Order Limits on 16 Feb 2022 did not produce any target reads, with only common contaminant sequences detected. Therefore, no baseline data is available for this watercourse.
Invertebrates	Invertebrate sampling was undertaken within the proposed Order Limits on 19 May and 20 September 2021. Results indicated that the site had low conservation value, with the predominant presence of scoring taxa primarily associated with a heavily sedimented watercourse and flowing/standing water. There was no strong dominance by pollutant tolerant or intolerant taxa.

<u>Hydromorphological</u>	
Quantity and Dynamics of Flow	Within the surveys area in the Newbuild Infrastructure Boundary, there are variable flow types, ranging from smooth flows to unbroken standing waves, with one small reach of chute flow.
River Continuity	There were no artificial impoundments or structures to impede flow and sediment continuity observed within surveyed reach.

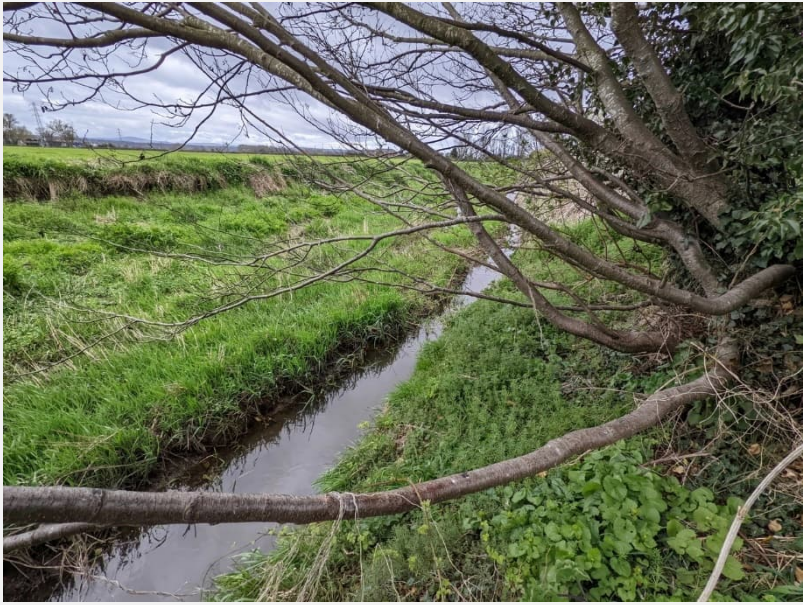
Water feature type: Main River
	Catchment area: 6.74km ²
	Key hydraulic connections: The Sealand Main Drain receives water from the Seahill Drain and the Garden City Gutter before flowing to the River Dee.
	Surrounding land use: Tilled farm land, pasture, grassland, woodland and urban. There is a golf course on the right bank of the watercourse, close to the DCO Proposed Development.
	River Condition Score: Fairly poor
Catchment Characteristics	The catchment is marked by several artificial watercourses; therefore, it is unlikely to reflect the original geometry.
Catchment Geology and Soils	Catchment geology is sandstone and conglomerate. The catchment soil is loamy and clayey soils of coastal flats with naturally high groundwater.
Catchment Hydrology	No gauge records are available for this catchment.

Watercourse name	Sealand Main Drain
Historical Channel Change	No change in planform can be seen from existing online maps (from 1982 onwards).
<u>Biological</u>	
Fish	Natural Resource Wales (NRW) advised that one SPI, European eel, is present in this watercourse. The reach within the proposed Order Limits was however scoped out of further survey due to a lack of suitable fish habitat identified during the aquatic habitat walkover survey.
Invertebrates	Invertebrate sampling was undertaken within the proposed Order Limits on 09 April and 20 September 2021. Results indicated that the site had low conservation value, with the predominant presence of scoring taxa primarily associated with and heavily sedimented watercourse and flowing/standing water. There was a slight dominance by pollutant tolerant taxa.
Macrophytes & Phytoplankton	Scoped out due to lack of suitable macrophyte and phytoplankton habitat identified during the aquatic habitat walkover survey.

Watercourse name	Sealand Main Drain
Oxygenation Conditions	When sampled on 09 April and 20 September 2021, the dissolved oxygen level was recorded as 7.71mg/L (65.3% saturation) and 32.5mg/L (no saturation level recorded), respectively. No long-term monitoring data is available for this watercourse.
Salinity	When sampled on 09 April 2021, salinity was recorded as 0.72 ppt. No long-term monitoring data is available for this watercourse
Acidification Status	When sampled on 09 April and 20 September 2021, pH was recorded as 7.79 and 7.52, respectively. No long-term monitoring data is available for this watercourse.
Nutrient Conditions	No data is available for this watercourse.
Priority Hazardous Substances	No data is available for this watercourse.
<u>Hydromorphological</u>	
Quantity and Dynamics of Flow	Resectioned straight drain with low water level. Flow is generally smooth.
River Continuity	No impoundments have been recorded. Therefore, continuity is good. The channel is incised artificially in order to store and channel flood flows to the River Dee through the floodplain. Therefore, the watercourse is disconnected from its floodplain.

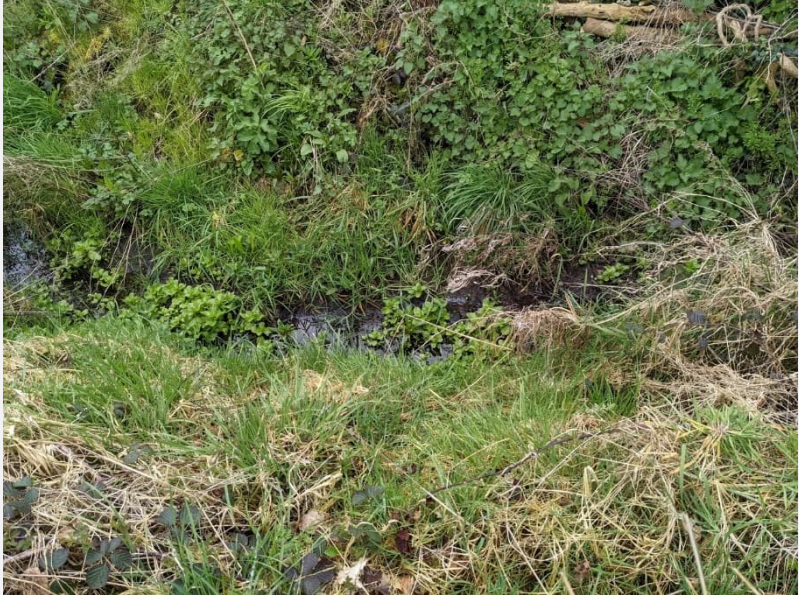
Water feature type: Ordinary Watercourse
	Catchment area: 0.270km ²
	Key hydraulic connections: There is no upstream watercourse draining into it. This watercourse joins the Seahill Drain at its downstream end.
	Surrounding land use: Arable agriculture.
	River Condition Score: Fairly poor
Catchment Characteristics	Highly modified catchment. The total watercourse length is 0.5km, and the elevation changes from 5m to 20m.
Catchment Geology and Soils	Catchment geology is sandstone. Catchment soil is slightly acid loamy and clayey soils with impeded drainage.

Watercourse name	Seahill Tributary 2
Catchment Hydrology	No gauge records are available for this catchment.
Historical Channel Change	No change in planform can be seen from existing online maps (from 1982 onwards).
<u>Biological</u>	
Fish	Scoped out due to lack of suitable fish habitat identified during the aquatic habitat walkover survey.
Invertebrates	Scoped out due to lack of suitable invertebrate habitat identified during the aquatic habitat walkover survey.
Macrophytes & Phytoplankton	Scoped out due to lack of suitable macrophyte and phytoplankton habitat identified during the aquatic habitat walkover survey.
<u>Physico-Chemical</u>	
Thermal Conditions	No data is available for this watercourse.
Oxygenation Conditions	No data is available for this watercourse.
Salinity	No data is available for this watercourse.
Acidification Status	No data is available for this watercourse.
Nutrient Conditions	No data is available for this watercourse.

Watercourse name	Seahill Tributary 2
Priority Hazardous Substances	No data is available for this watercourse.
<u>Hydromorphological</u>	
Quantity and Dynamics of Flow	Narrow tributary of main drain running through pasture. The flow is slow and, in some sections, not perceptible.
River Continuity	The watercourse does not experience any artificial impoundment throughout the study area.
River Depth and Width Variation	Watercourse geometry is minimal throughout the study area. Water width is ~ 0.5m, and water depth is ~ 0.02m.
Structure and Substrate of the River Bed	The bed is dominated by silt particles and low morphological diversity.
Structure of the Riparian Zone	The riparian zone is primarily arable agriculture.

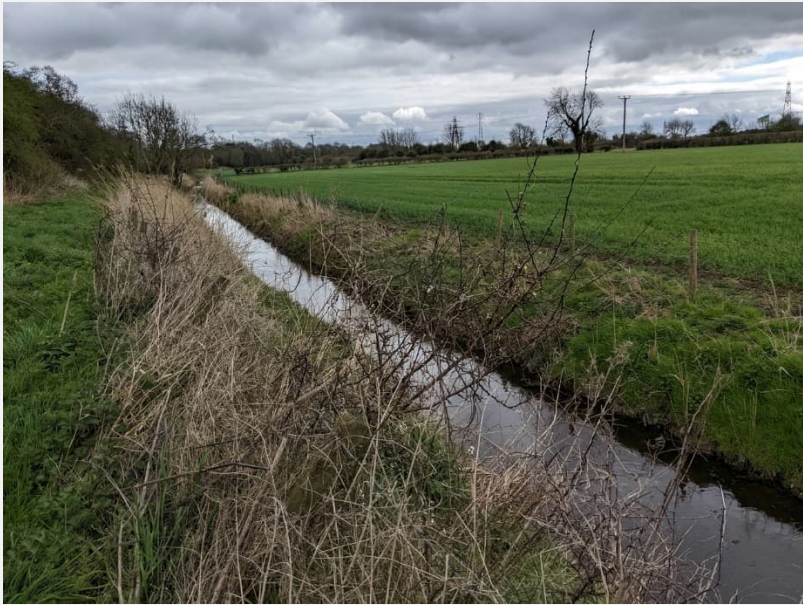
Water feature type: Main River
	Catchment area: 3.03km ²
	Key hydraulic connections: This watercourse has several tributaries and merges with the Garden City Gutter before reaching the River Dee.
	Surrounding land use: Arable agriculture and permanently vegetated recreational.
	River Condition Score: Fairly poor
Catchment Characteristics	Catchment with high degree of human influence on watercourses and landscape. Elevation varies from ~ 25m to 5m.
Catchment Geology and Soils	Catchment geology is sandstone and conglomerate. Catchment soil is slightly acid loamy and clayey soils with impeded drainage.
Catchment Hydrology	No gauge records are available for this catchment.

Watercourse name	Seahill Drain
Historical Channel Change	No change in planform can be seen from existing online maps (from 1982 onwards).
<u>Biological</u>	
Fish	The e-DNA from four species of coarse fish were detected in the sample collected from within the proposed Order Limits on 17 February 2022. This included one SPI, the European eel, and one INNS, the Eurasian or common/Amur carp <i>Cyprinus carpio/Cyprinus rubrofuscus</i> (species level could not be determined during e-DNA analysis). Although introduced, common carp are considered a naturalised species.
Invertebrates	Invertebrate sampling was undertaken within the proposed Order Limits on 09 April and 20 September 2021. Results indicated that the site had low (spring sample) to moderate (autumn sample) conservation value, with the predominant presence of scoring taxa primarily associated with slow flowing/standing water. There was slight dominance by pollution tolerant taxa in both samples.

Watercourse name	Seahill Drain
Thermal Conditions	When sampled on 09 April and 20 September 2021, the water temperature recorded was 8.2°C and 14.5°C, respectively. No long-term monitoring data is available for this watercourse.
Oxygenation Conditions	When sampled on 09 April and 20 September 2021, the recorded dissolved oxygen level was 11.22mg/L (95.5% saturation) and 11.1mg/L (saturation level not recorded). No long-term monitoring data is available for this watercourse.
Salinity	When sampled on 09 April and 20 September 2021, salinity was recorded as 0.43 ppt and 0.54 ppt, respectively. No long-term monitoring data is available for this watercourse.
Acidification Status	When sampled on 09 April and 20 September 2021, pH was recorded as 8.18 and 7.09, respectively. No long-term monitoring data is available for this watercourse.
Nutrient Conditions	No data is available for this watercourse.
Priority Hazardous Substances	No data is available for this watercourse.
