ENVIRONMENTAL STATEMENT (VOLUME III)

Appendix 18.3 Water Framework Directive Assessment

HyNet Carbon Dioxide Pipeline DCO

Document Reference Number D.6.3.18.3

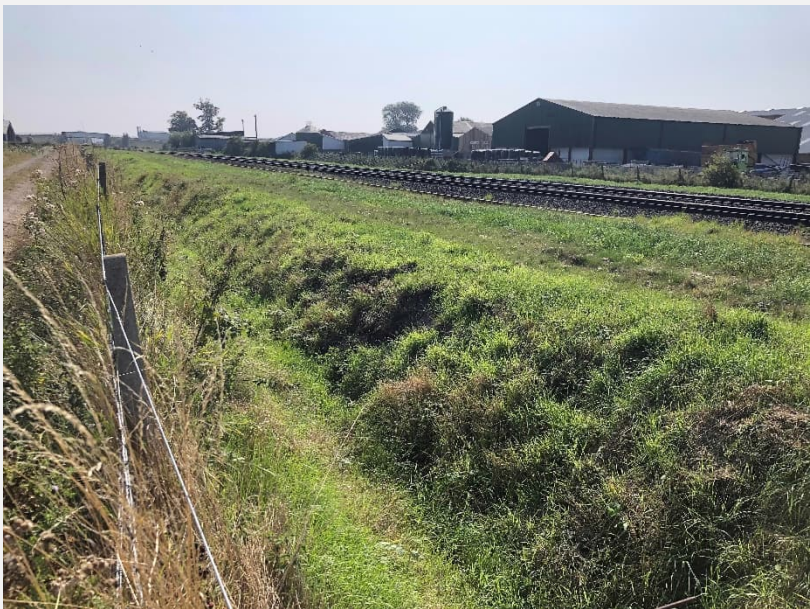
Water feature type: Ordinary Watercourse
	Catchment area: <1km ²
	Key hydraulic connections: The railway ditches are ephemeral. It is assumed that they connect to Hawarden Brook which flows northwards to the Dee Estuary.
	Surrounding land use: Predominantly arable and horticultural land use, with some urban development.
	Ditch Condition Score: Poor
Catchment Characteristics	Small catchment modified by artificial drains and the railway.
Catchment Geology and Soils	The channel flows over a variety of bedrock geologies, including Kinnerton sandstone formation, Etruria Formation (Mudstone, sandstone and conglomerate) from riverine environments.

Watercourse name	Railway Ditches
	Superficial deposits also include tidal flat deposits (clay, silt and sand). The soils within the catchment comprise loamy and clayey soils of coastal flats with naturally high groundwater.
Catchment Hydrology	Within the study area, the cut channel drains the surrounding road and arable fields and mitigates for the loss of hydraulic connection across the catchment due to the railway embankment. The watercourse is ungauged.
Historical Channel Change	Since 1913, the channel has retained its planform as a cut ditch aside the London and North Wales Railway.
<u>Biological</u>	
Fish	NRW advised that one SPI, European eel, is present in these watercourses. However, both ditches were dry when the aquatic habitat walkover survey was conducted and consequently they have been scoped out of further survey.
Invertebrates	Scoped out due to lack of suitable invertebrate habitat identified during the aquatic habitat walkover survey.

Watercourse name	Railway Ditches
Oxygenation Conditions	No data is available for this watercourse.
Salinity	No data is available for this watercourse.
Acidification Status	No data is available for this watercourse.
Nutrient Conditions	No data is available for this watercourse.
Priority Hazardous Substances	No data is available for this watercourse.
<u>Hydromorphological</u>	
Quantity and Dynamics of Flow	The ditches were dry at the time of survey and therefore are ephemeral. It is likely flow is not perceptible when water is present.
River Continuity	The channels are dry ditches, with little flow continuity. The ditches are cut to drain the landscape and therefore are not well connected to the floodplain.
River Depth and Width Variation	These are small ditches which are ephemeral.
Structure and Substrate of the River Bed	Bed material is mostly silt and organic matter.
Structure of the Riparian Zone	A lack of emergent, submerged and floating leaved plants. An absence of marginal vegetation along most of the ditches. There is a railway embankment on one side of the ditch and farmland on the other side, therefore a heavily modified riparian zone.

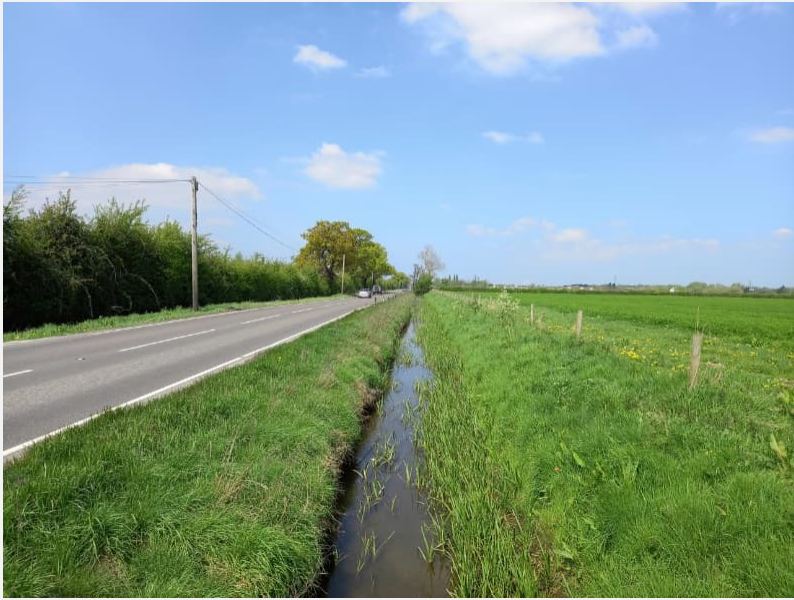
Water feature type: Main River
	Catchment area: 11.72km ²
	Key hydraulic connections: The Broughton Brook flows south of Hawarden towards Broughton. Along the B5129 it flows northwards towards Station Road where it flows to the River Dee. Along the B5129 it is joined by several tributaries flowing north-eastwards from Hawarden. There are drains along Chester Road which connect to the Broughton Brook prior to it joining the River Dee.
	Surrounding land use: within the Newbuild Infrastructure Boundary the surrounding land use is arable farming. Land comprises improved grassland, some broadleaved, mixed and yew woodland, arable and horticultural land, urban and suburban settlements.
Catchment Characteristics	River Condition Score: Fairly Poor
Catchment Geology and Soils	The catchment has a high degree of human influence on watercourses and the landscape. Elevation varies from ~ 157m to 8m.

The channel flows over a variety of bedrock geologies, including Kinnerton sandstone formation, Etruria Formation (Mudstone, sandstone and conglomerate) from riverine environments. The channel is also underlain by bedrock geologies of Pennine Middle and Lower

Watercourse name	Broughton Brook
	11.47mg/L (95.5% saturation), respectively. No long-term monitoring data is available for this watercourse.
Salinity	When sampled on 7 September 2021 and 02 March 2022, salinity was recorded as 0.51 ppt and 0.34 ppt, respectively. No long-term monitoring data is available for this watercourse
Acidification Status	When sampled on 02 March 2022, pH was recorded as 8. No long-term monitoring data is available for this watercourse.
Nutrient Conditions	No data is available for this watercourse.
Priority Hazardous Substances	No data is available for this watercourse.
<u>Hydromorphological</u>	
Quantity and Dynamics of Flow	At the time of survey, the watercourse demonstrated smooth flows.
River Continuity	River continuity is good as there are no artificial or natural impoundments through the study area. There are some culverted sections where the channel flows beneath roads and residential areas. The watercourse is disconnected from its floodplain as it is within an incised channel.

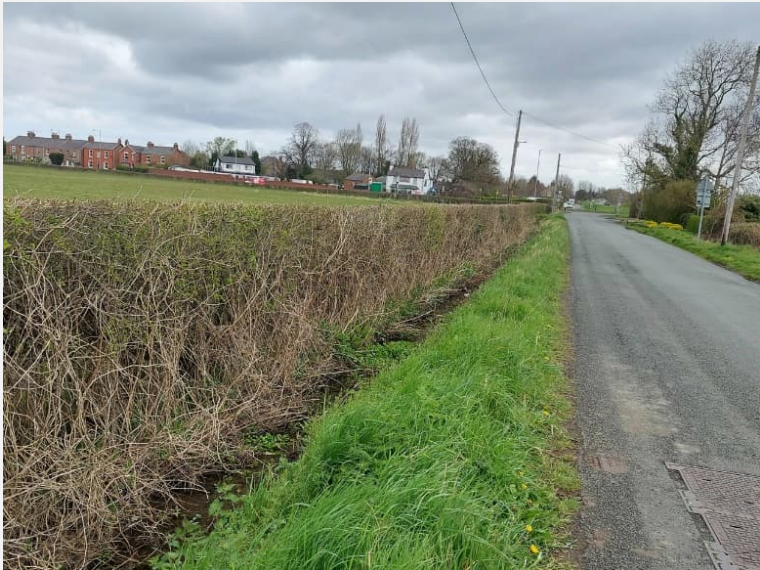
Water feature type: Main River and ordinary watercourse
	Catchment area: 2.99km ²
	Key hydraulic connections: Onward connection into Broughton Brook. It receives flows from roadside ditches of Moor Lane.
	Surrounding land use: arable and horticultural
	River Condition Score: Fairly Poor
Catchment Characteristics	Catchment with high degree of human influence on watercourses and landscape. Elevation varies from 80 - 8 mAOD. Relatively flat catchment.
Catchment Geology and Soils	The channel flows over a variety of bedrock geologies, including Kinnerton sandstone formation, Etruria Formation (Mudstone, sandstone and conglomerate) from riverine environments. The channel is also underlain by bedrock geologies of Pennine Middle Coal

Watercourse name	Sandycroft Drain
	<p>Measures Formation - Mudstone, Siltstone and Sandstone, from swamps, estuarine and delta environments</p> <p>Superficial geologies consisting of Devensian tills from ice age conditions, and tidal flat deposits.</p> <p>Soils comprised of slowly permeable seasonally wet slightly acid but base-rich loamy and clayey soils and loamy and clayey soils of coastal flats with naturally high groundwater.</p>
Catchment Hydrology	<p>Within the study area, the cut channel drains the surrounding roads, urban areas, and arable fields. The channel appears to have been artificially straightened and flows through a culvert as it passes under the B5129. The watercourse is ungauged.</p>
Historical Channel Change	<p>Since 1913, the channel has retained its planform as a cut road-side ditch within the study area.</p>
<u>Biological</u>	
Fish	<p>Scoped out due to lack of suitable fish habitat identified during the aquatic habitat walkover survey.</p>

Watercourse name	Sandycroft Drain
	flowing/standing water. There was no dominance by pollutant tolerant or intolerant taxa.
Macrophytes & Phytoplankton	Scoped out due to lack of suitable macrophyte and phytoplankton habitat identified during the aquatic habitat walkover survey.
<u>Physico-Chemical</u>	
Thermal Conditions	No data is available for this watercourse. No long-term monitoring data is available for this watercourse.
Oxygenation Conditions	When sampled on 05/05/2022, the dissolved oxygen level was recorded as 10.29mg/L (94.7% saturation). No long-term monitoring data is available for this watercourse.
Salinity	No data is available for this watercourse.
Acidification Status	When sampled on 05/05/2022, pH was recorded as 8.50. No long-term monitoring data is available for this watercourse.
Nutrient Conditions	No data is available for this watercourse.
Priority Hazardous Substances	No data is available for this watercourse.

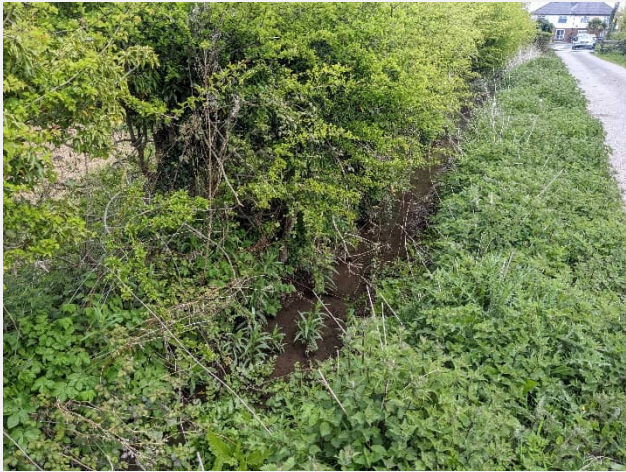
Watercourse name	Mancot Brook

<p>Downstream reach</p>	Water feature type: Ordinary Watercourse
	Catchment area: 1.66km ²
	Key hydraulic connections: Onward connection into Chester Road Drain South, which flows beneath the B5129 to join the Broughton Brook.
	Surrounding land use: The watercourse primarily flows through pasture. This comprises improved and neutral grassland, broadleaved, mixed and yew woodland.
	River Condition Score: Moderate

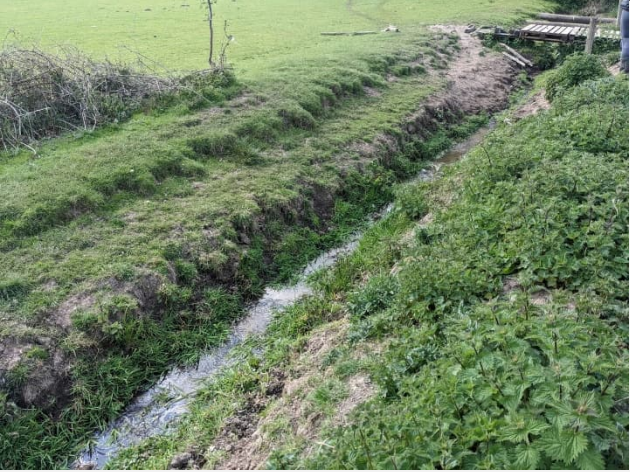
<p data-bbox="206 699 436 735">Upstream reach</p>	
Catchment Characteristics	The catchment drains farmland and arable fields. Elevation varies from 80 - 8mAOD. Relatively flat catchment which is predominantly rural.
Catchment Geology and Soils	<p>The channel flows over a variety of bedrock geologies, including Kinnerton sandstone formation, Etruria Formation (Mudstone, sandstone and conglomerate) from riverine environments. The channel is also underlain by bedrock geologies of Pennine Middle and Lower Coal Measures Formation - Mudstone, Siltstone and Sandstone, from swamps, estuarine and delta environments, Bowland Shale Formation (Mudstone, formed in open seas with pelagite deposits), and Gwespys Sandstone formed within swamps, estuaries, and deltas.</p> <p>Superficial deposits also include tidal flat deposits (clay, silt and sand), Devensian tills, and glaciofluvial deposits.</p>

Watercourse name	Mancot Brook
	Soils consisting of slowly permeable seasonally wet slightly acid but base-rich loamy and clayey soils.
Catchment Hydrology	Within the study area, the cut channel drains the surrounding pastures. The channel appears to have been artificially straightened to follow the line of field boundaries.
Historical Channel Change	Since 1913, the channel has retained its planform as a drainage channel to the surrounding arable land. The channel has been elongated to follow field boundaries, therefore resulting in a shallower gradient compared to its likely natural state.
<u>Biological</u>	
Fish	Scoped out due to lack of suitable fish habitat identified during the aquatic habitat walkover survey.
Invertebrates	Invertebrate sampling was undertaken within the proposed Order Limits on 05 May 2022. Results indicated low conservation value, with the predominant presence of scoring taxa primarily associated with a sedimented watercourse and slow flowing/standing water. There was no strong dominance by pollution tolerant or intolerant taxa in either sample.

Watercourse name	Mancot Brook
Thermal Conditions	No data is available for this watercourse.
Oxygenation Conditions	When sampled on 05 May 2022, the dissolved oxygen level was recorded as 10.07mg/L (107.2% saturation). No long-term monitoring data is available for this watercourse.
Salinity	When sampled on 05 May 2022, salinity was recorded as 0.38 ppt. No long-term monitoring data is available for this watercourse.
Acidification Status	When sampled on 05 May 2022, pH was recorded as 8.55. No long-term monitoring data is available for this watercourse.
Nutrient Conditions	No data is available for this watercourse.
Priority Hazardous Substances	No data is available for this watercourse.
<u>Hydromorphological</u>	
Quantity and Dynamics of Flow	Rippled flows further upstream at proposed open cut location where the gradient is steeper, with smooth flows further downstream where another proposed open cut is located.

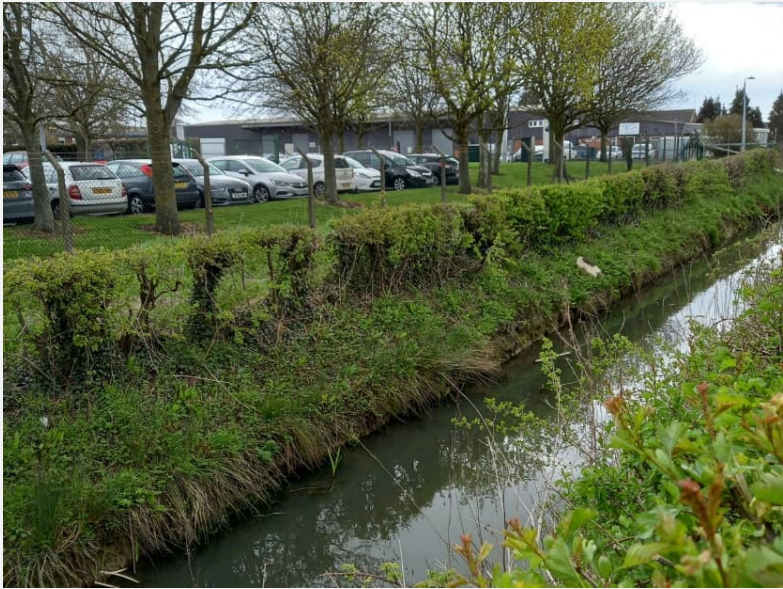
Water feature type: Main River
	Catchment area: 1.67km ²
	Key hydraulic connections: This watercourse is a drain for the local area which is hydraulically connected to both the Broughton Brook (southeast) and Aston Hall Brook (Northwest). The direction of flow is not known as flow was not perceptible during time of survey and lidar data shows ground levels are very flat in this area.
	Surrounding land use: Mostly suburban (residential and industrial) land use but receiving flows from watercourses which flow through rural areas.
Catchment Characteristics	The catchment drains farmland and arable fields. Elevation varies from 80 – 8mAOD. Relatively flat catchment with extensive urbanisation north of the watercourse.
Catchment Geology and Soils	The channel flows over bedrock geologies, including Etruria Formation (mudstone, sandstone and conglomerate) from riverine environments. The channel is also underlain by bedrock geologies of Pennine Middle

Watercourse name	Chester Road Drain North
	<p>Coal Measures Formation - Mudstone, Siltstone and Sandstone, from swamps, estuarine and delta environments.</p> <p>Superficial deposits of Tidal Flat Deposits – comprising clay, Silt and Sand.</p> <p>Soils comprised of Loamy and clayey soils of coastal flats with naturally high groundwater.</p>
Catchment Hydrology	<p>Within the study area, the cut channel drains the surrounding arable fields, local housing estates, and industrial estate. The channel has been artificially straightened and culverted as it passes under the B5129 and industrial property. The watercourse is ungauged.</p>
Historical Channel Change	<p>The channel has retained its contemporary planform since at least 1892. The channel has become progressively more culverted as the areas has urbanised, with private gardens paving over the watercourse.</p>
<u>Biological</u>	
Fish	<p>Suitable fish habitat was identified during the aquatic habitat walkover survey. However, fish surveys could not be conducted due to health and safety and access issues arising from the steep, densely vegetated banks. Fish have remained scoped in as a precautionary measure.</p>

Watercourse name	Chester Road Drain North
Macrophytes & Phytoplankton	Scoped out due to lack of suitable macrophyte and phytoplankton habitat identified during the aquatic habitat walkover survey.
<u>Physico-Chemical</u>	
Thermal Conditions	No data is available for this watercourse.
Oxygenation Conditions	No data is available for this watercourse.
Salinity	No data is available for this watercourse.
Acidification Status	No data is available for this watercourse.
Nutrient Conditions	No data is available for this watercourse.
Priority Hazardous Substances	No data is available for this watercourse.
<u>Hydromorphological</u>	
Quantity and Dynamics of Flow	No perceptible flows were noted during the survey. This is due to the shallow long-profile gradient.
River Continuity	Large sections of this watercourse are culverted or in an artificially incised channel with steep banks. Therefore, the channel is not connected to the floodplain. There are no impoundments other than culverts.

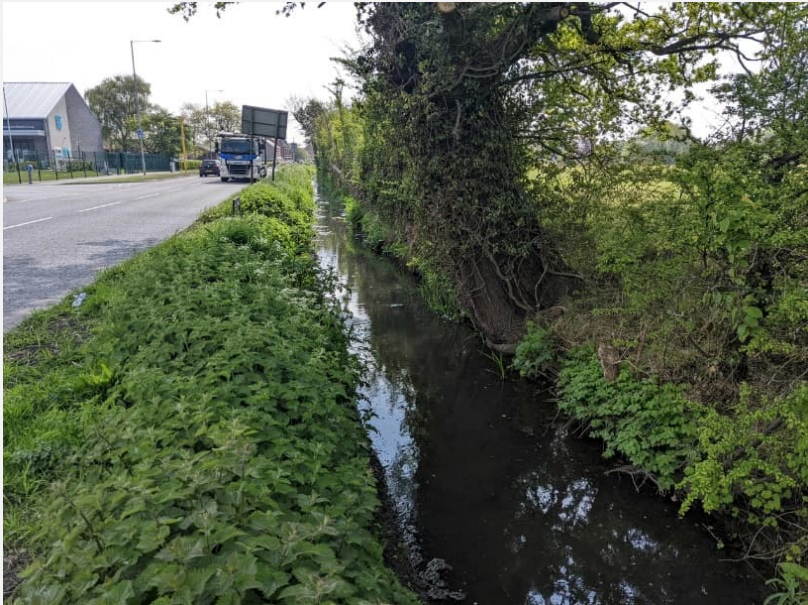
Water feature type: Main River
	Catchment area: <1km ²
	Key hydraulic connections: Onwards connection to Chester Road Drain North.
	Surrounding land use: Arable fields, roadway, urban areas.
	River Condition Score: Fairly Poor
Catchment Characteristics	Catchment drains farmland and arable fields as well as urban areas. Elevation varies from 80 - 8mAOD. It has a relatively flat catchment with extensive urbanisation to the north of the watercourse.
Catchment Geology and Soils	The channel flows over bedrock geologies, including Etruria Formation (Mudstone, sandstone and conglomerate) from riverine environments. The channel is also underlain by bedrock geologies of Pennine Middle

Watercourse name	Chester Road Drain Tributary 1
	<p>Coal Measures Formation - Mudstone, Siltstone and Sandstone, from swamps, estuarine and delta environments.</p> <p>Superficial deposits of Tidal Flat Deposits – comprising clay, Silt and Sand. Devensian Tills are also present within the catchment.</p> <p>Soils comprised of loamy and clayey soils of coastal flats with naturally high groundwater. The channel also drains Loamy and clayey soils of coastal flats with naturally high groundwater.</p>
Catchment Hydrology	<p>Within the study area, the cut channel drains the surrounding arable fields, local housing estates, and industrial estate. The channel has been artificially straightened and culverted as it passes under the B5129 and Mancot Lane. The watercourse is ungauged.</p>
Historical Channel Change	<p>The channel has retained its contemporary planform since at least 1892. The channel has become progressively more culverted as the areas has urbanised.</p>

Watercourse name	Chester Road Drain Tributary 1
Macrophytes & Phytoplankton	Scoped out due to lack of suitable macrophyte and phytoplankton habitat identified during the aquatic habitat walkover survey.
<u>Physico-Chemical</u>	
Thermal Conditions	No data is available for this watercourse.
Oxygenation Conditions	No data is available for this watercourse
Salinity	No data is available for this watercourse.
Acidification Status	No data is available for this watercourse.
Nutrient Conditions	No data is available for this watercourse.
Priority Hazardous Substances	No data is available for this watercourse.
<u>Hydromorphological</u>	
Quantity and Dynamics of Flow	At the time of the survey there was no perceptible flows.
River Continuity	The channel is culverted at its confluence with Chester Road Drain North. The channel has a rectangular cross section and is disconnected from its floodplain.
River Depth and Width Variation	The channel has a consistent bankfull river width of 2.5m and water depth of 0.25m.

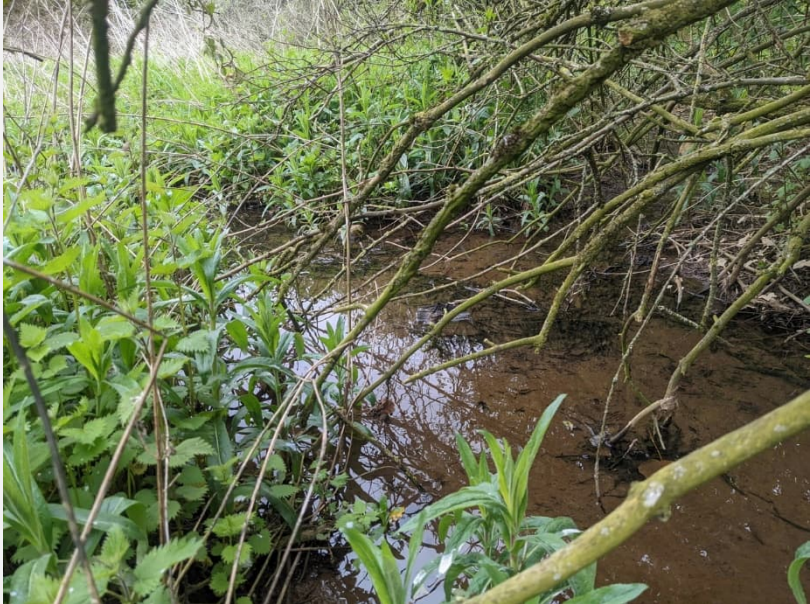
Water feature type: Ordinary Watercourse
	Catchment area: 2.68km ²
	Key hydraulic connections: Downstream connectivity to Wepre Brook
	Surrounding land use: Predominantly rural landscape with some residential and agricultural buildings. Land cover comprising broadleaved, mixed and yew woodland, improved grassland and pasture.
Catchment Characteristics	River Condition Score: Fairly Good
	The catchment drains farmland and arable fields. Elevation varies from 166 - 62mAOD. There is extensive urbanisation in the upper catchment(Buckley) and more rural land use in the lower catchment before connecting to the Wepre Brook.

Watercourse name	New Inn Brook
Catchment Geology and Soils	<p>The bedrock geology of the catchment comprises Pennine Middle Coal Measures Formation (Mudstone, Siltstone And Sandstone), Hollin Rock (Sandstone), Gwespyr (sandstone), Bowland Shale Formation (mudstone), Pennine Lower Coal Measures Formation (Mudstone, Siltstone and Sandstone), Etruria Formation (Sandstone).</p> <p>The superficial geology consists of Devensian tills, alluvium (clay, silt, sand and gravel), glaciofluvial deposits, and head (clay, silt, sand and gravel).</p> <p>The catchment consists of slowly permeable seasonally wet slightly acid but base-rich loamy and clayey soils and slowly permeable seasonally wet acid loamy and clayey soils.</p>
Catchment Hydrology	The watercourse is ungauged.
Historical Channel Change	Through the study area, the channel has retained a similar planform since 18988. The channel has been culverted where developments have been implemented (post 1949).

Watercourse name	New Inn Brook
Nutrient Conditions	No data is available for this watercourse.
Priority Hazardous Substances	No data is available for this watercourse.
<u>Hydromorphological</u>	
Quantity and Dynamics of Flow	Within the study area the watercourse has predominantly smooth flow with some sections of rippled flow where the gradient steepens.
River Continuity	The watercourse is culverted where the channel flows beneath the road network. There is no impoundment of the watercourse upstream of the Wepre Brook. In the study area the watercourse is connected to the floodplain on the left bank.
River Depth and Width Variation	The watercourse has shallow channel banks, a bankfull width around 0.7m and channel depth around 0.2m. At the downstream end of the reach within the Newbuild Infrastructure Boundary the watercourse becomes multi-thread.
Structure and Substrate of the River Bed	The channel has predominantly a silt substrate with some clays and sands. The channel bed has some linear leaved vegetation growing at the margins. The channel is highly shaded and the channel bed is covered in fine layer of debris.

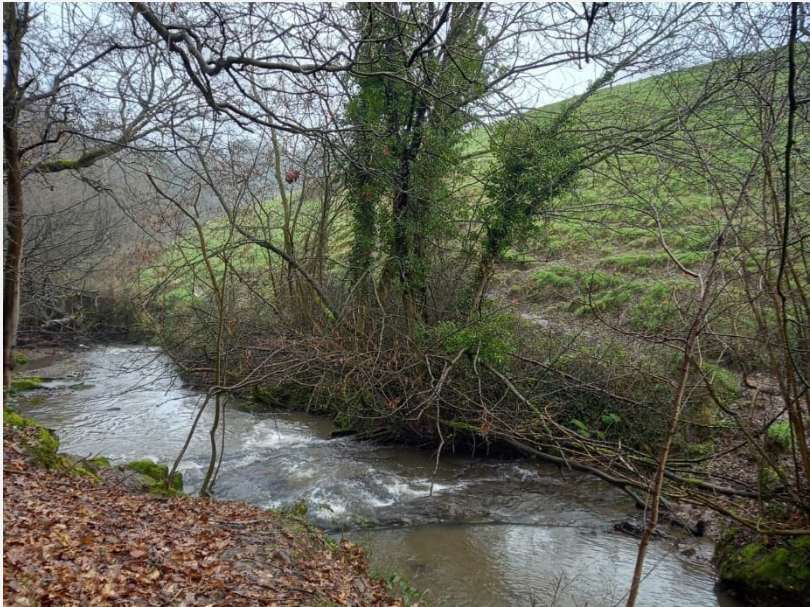
Water feature type: Ordinary Watercourse
	Catchment area: 6.52km ²
	Key hydraulic connections: the Alltami Brook joins Wepre Brook downstream of the Newbuild Infrastructure Boundary.
	Surrounding land use: Predominantly rural settlement and pastoral farming. There is a clay quarry in the upper catchment. Land cover is mostly improved grassland, settlement, broadleaved, mixed and yew woodland, arable and horticultural fields.
Catchment Characteristics	River Condition Score: Fairly Good
Catchment Geology and Soils	The catchment drains farmland and arable fields. Elevation varies from 170 - 76mAOD. There is extensive urbanisation in the upper catchment (Buckley, New Brighton). Downstream the watercourse flows through a narrow gorge to Wepre Brook. There is a clay quarry within the catchment.
The bedrock geology of the catchment comprises Pennine Middle Coal Measures Formation (Mudstone, Siltstone and Sandstone),

Watercourse name	Alltami Brook
Structure and Substrate of the River Bed	The predominant structure of the river bed is bedrock which is overlain with some boulders, cobble, gravel and silts, with some bedrock outcrops throughout the reach. The Alltami Brook has an unvegetated channel bed. There was no aquatic vegetation noted during the survey and the channel is extensively shaded channel.
Structure of the Riparian Zone	The banks are mostly bare showing exposed bedrock and earth. There are some mosses and lichens, with short herbs and grasses on the lower banks and saplings and trees on the upper banks. There is evidence of bank erosion, as trees are leaning and some trees have fallen across the channel and on the bank top. On the bank top the riparian zone comprises mature woodland on the left bank and pasture on the right bank.

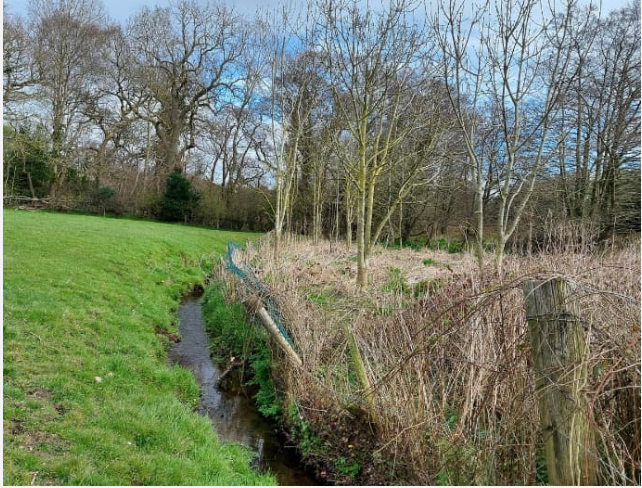
<p data-bbox="203 852 566 887">Wepre Brook A55 reach</p>	<p>Water feature type: Ordinary watercourse within the Newbuild Infrastructure Boundary. It becomes a Main River downstream of its confluence with Alltami Brook.</p>
	<p>Catchment area: 9.57km²</p>
	<p>Key hydraulic connections: Wepre Brook has several tributaries, mostly from the south of the catchment. The Alltami Brook and New Inn Brook both connect to the Wepre Brook downstream of the study area.</p>
	<p>Surrounding land use: Predominantly rural and agricultural land use. The A55 and Brookside run parallel to the Wepre Brook through the study reach. There are residential areas north of the watercourse through the study reach.</p>
	<p>River Condition Score:</p> <p>A55 reach: moderate;</p> <p>Brookside reach: fairly poor;</p> <p>Northrop Hall reach: fairly poor</p>

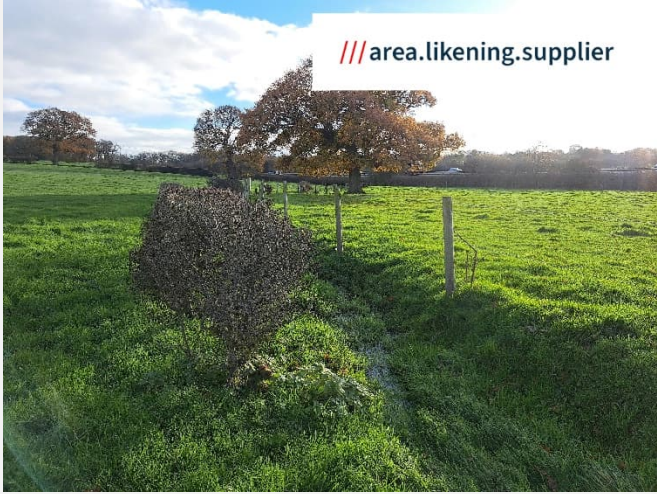
Water feature type: Ordinary watercourse
	Catchment area: <0.5km ²
	Key hydraulic connections: This watercourse flows in a southeast direction and joins Wepre Brook downstream of the A55.
	Surrounding land use: Predominantly agricultural land use. The A55 runs parallel to the Wepre Brook through the study reach.
	River Condition Score: Fairly poor
Catchment Characteristics	The catchment is mostly comprised of arable and horticultural land. The catchment's elevation ranges between approximately 91m to 123m AOD.
Catchment Geology and Soils	Bedrock geology consists of the Pennine Lower Coal Measures Formation - Mudstone, Siltstone And Sandstone. Superficial geology largely composed of Devensian till and diamicton.
Catchment Hydrology	No gauging station located within catchment.

Watercourse Name	Wepre Brook Tributary 1
Historical Channel Change	The watercourse has been on the same alignment since 1900. It has been culverted beneath the A55.
<u>Biological</u>	
Fish	NRW advised on possible presence of European Eel, however, during the site survey Wepre Brook Tributary 1 was dry. Therefore the presence of European Eel is unlikely due to the ephemeral nature of the watercourse.
Invertebrates	No data is available for this watercourse.
Macrophytes & Phytoplankton	No data is available for this watercourse.
<u>Physico-Chemical</u>	
Thermal Conditions	No data is available for this watercourse.
Oxygenation Conditions	No data is available for this watercourse.
Salinity	No data is available for this watercourse.
Acidification Status	No data is available for this watercourse.
Nutrient Conditions	No data is available for this watercourse.
Priority Hazardous Substances	No data is available for this watercourse.

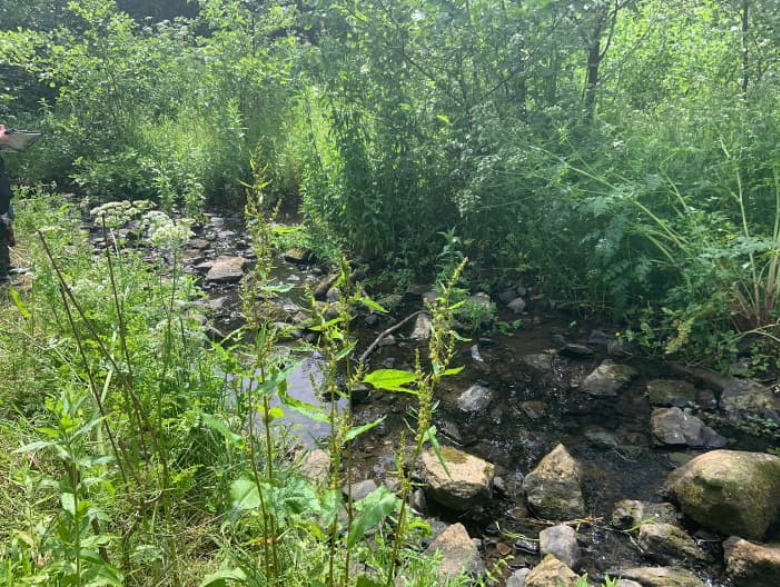
Water feature type: Ordinary watercourse
	Catchment area: 4.31km ²
	Key hydraulic connections: The Nant-y-Fflint has several unnamed tributaries mostly from the south of the catchment which join the watercourse upstream of the DCO Proposed Development.
	Surrounding land use: Mainly rural farmland (arable and pastoral, forestry)
	River Condition Score: Fairly Good
Catchment Characteristics	The catchment is relatively steep, with a confined floodplain in a wooded valley. The catchment is predominantly rural with small settlements in Pentre Halkyn and Halkyn.
Catchment Geology and Soils	Somewhat complex bedrock geology, consisting of areas of mudstone and sandstone from different formations. Superficial deposits poorly recorded in this

Watercourse name	Nant-y-Fflint
	area, but evidence of glacial till and small areas of alluvium in the downstream reaches.
Catchment Hydrology	No gauge recorded in the catchment. The steepness of valley suggests this is likely a flashy catchment.
Historical Channel Change	No significant areas of channel change recorded since 1 st edition OS maps (1888)
<u>Biological</u>	
Fish	Scoped out due to lack of suitable fish habitat identified during the aquatic habitat walkover survey.
Invertebrates	Invertebrate sampling was conducted within the proposed Order Limits on 16 June 2022. Results indicated that the site is of low conservation value, with the predominant presence of scoring taxa primarily associated with slightly sedimented watercourses and slower flows. There was no strong dominance by pollution tolerant or intolerant taxa.
Macrophytes & Phytoplankton	Scoped out due to lack of suitable macrophyte habitat identified during the aquatic habitat walkovers.

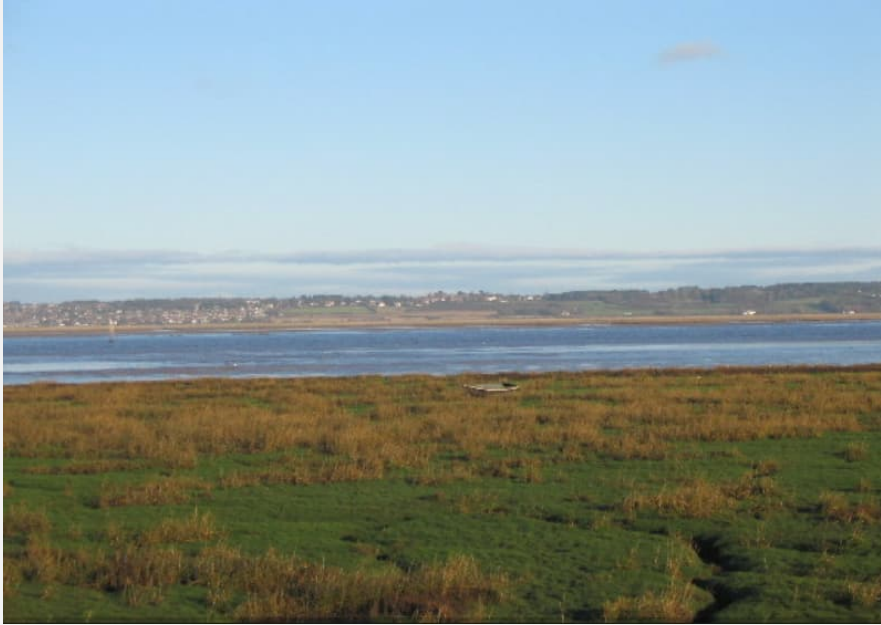
Water feature type: Transitional
	Catchment area: 136.7km ²
	Key hydraulic connections:
	Surrounding land use: Rural, industrial, urban
	River Condition Score:
Catchment Characteristics	Major estuary with extensive mudflats and saltmarsh habitat, with entire estuary area designated as a SAC, SSSI and SPA. Land use is a mix of rural agriculture, industrial, urban areas (Flint, West Kirby, Neston, Heswall, Connah's Quay and the city of Chester at the historic head of the estuary).

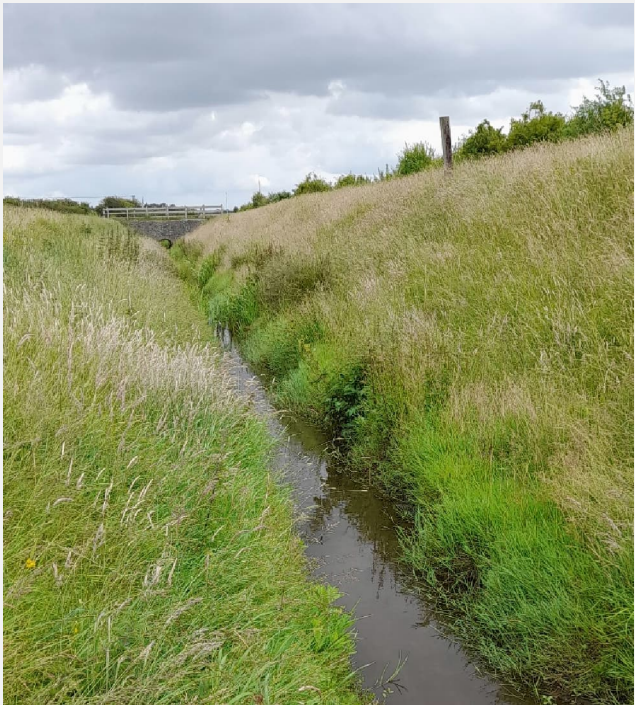
Water feature type: Main River
	Catchment area: <math><1\text{km}^2</math>
	Key hydraulic connections: The Hawarden Brook discharges to the River Dee.
	Surrounding land use: The predominant land use is pastoral farming
	River Condition Score: Not surveyed due to land access restrictions
Catchment Characteristics	This watercourse and a small low-lying catchment which heavily modified by the constriction of the Dee and the draining of the floodplain.
Catchment Geology and Soils	The Kinnerton sandstone formation bedrock underlies the watercourse and it catchment.

Watercourse name	Hawarden Brook
	<p>Superficial deposits also include tidal flat deposits (clay, silt and sand).</p> <p>The soils within the catchment comprise loamy and clayey soils of coastal flats with naturally high groundwater.</p>
Catchment Hydrology	The catchment is small and drains the low-lying land which would naturally be floodplain of the Dee. The catchment is heavily modified by the construction of the Airbus factory and runway.
Historical Channel Change	The channel has mostly remained unchanged since 1988 however the construction of the airfield has resulted in the watercourse being culverted upstream of the railway.
<u>Biological</u>	
Fish	Scoped out due to lack of suitable fish habitat identified during the aquatic habitat walkover survey.
Invertebrates	Suitable invertebrate habitat was identified during the aquatic habitat walkover. However, due to land access issues, the watercourse could not be surveyed within the proposed Order Limits or accessed during invertebrate sampling seasons. Therefore, no sampling was undertaken and consequently no ecological baseline was established. Invertebrates remain scoped in for this watercourse as a precaution

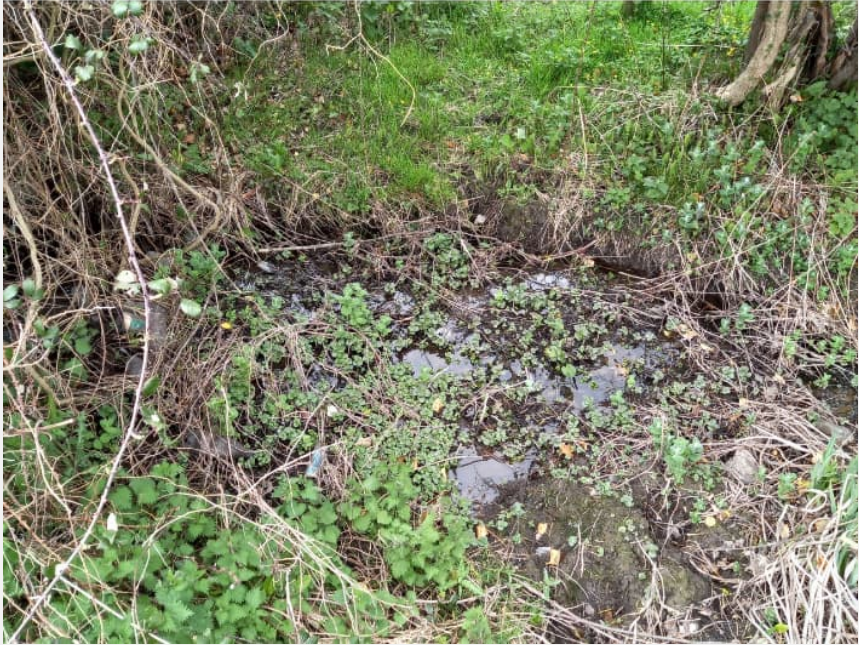
Water feature type: Ordinary Watercourse
	Catchment area: 0.55km ²
	Key hydraulic connections: The Willow Park Brook flows north-eastwards to Chester Road Drain North.
	Surrounding land use: The watercourse mostly flows through land used as a petting farm.
	River Condition Score: Upper reach: Fairly poor Lower reach: Moderate
Catchment Characteristics	Relatively small, rural and suburban catchment with mixed land use.
Catchment Geology and Soils	Bedrock composed of Pennine Lower Coal Measures Formation - Mudstone, Siltstone and Sandstone.

Watercourse name	Willow Park Brook
Priority Hazardous Substances	No data is available for this watercourse.
<u>Hydromorphological</u>	
Quantity and Dynamics of Flow	Small ,shallow channel through farmland. Flow generally smooth with some locations where there is no perceptible flow.
River Continuity	There is a small on-line pond which likely acts to attenuate flow and sediment and limit its movement downstream.
River Depth and Width Variation	Bankfull channel width varies between 1m and 2m. Depth varies between 0.3m and 1.5m.
Structure and Substrate of the River Bed	The substrate primarily comprises gravels and pebbles, with some silt and sand deposits, potentially introduced due to poaching activity.
Structure of the Riparian Zone	The channel is extensively poached, with hardcore/rubble used for partial bank protection on the right bank. Riparian vegetation is mostly short grasses and isolated trees on the right bank with hedgerow on the left bank. The bank top land use is pastoral farming.

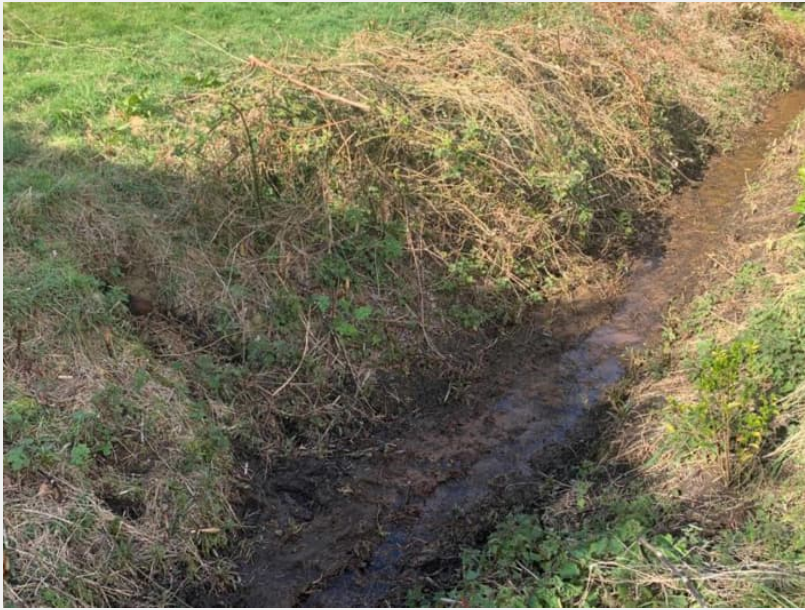
Water feature type: Ordinary Watercourse
	Catchment area: <math><0.5\text{km}^2</math>
	Key hydraulic connections: this watercourse flow north-eastwards towards Deeside. It is joined by two tributaries before joining the Dee.
	Surrounding land use: Mostly rural farmland and suburban residential
	River Condition Score: Fairly poor
Catchment Characteristics	Very small ungauged catchment.
Catchment Geology and Soils	Bedrock composed of Pennine Lower Coal Measures Formation - Mudstone, Siltstone And Sandstone. Superficial geology composed of Glaciofluvial Deposits, Devensian - Sand And Gravel.
Catchment Hydrology	No gauges present in catchment. The watercourse is potentially ephemeral.

Watercourse name	Aston Hall Brook
Nutrient Conditions	No data is available for this watercourse.
Priority Hazardous Substances	No data is available for this watercourse.
<u>Hydromorphological</u>	
Quantity and Dynamics of Flow	Flow observed to be rippled throughout surveyed reach, with some areas of smooth and no perceptible flow.
River Continuity	No impoundments or attenuating features on surveyed reach. The valley is steep so the watercourse is not connected to a floodplain.
River Depth and Width Variation	Shallow water depth of approximately 0.05m at the time of survey. Bankfull width observed to be between 1.5m and 3m. The channel is over deepened by residential owners.
Structure and Substrate of the River Bed	Mainly composed of sand and silt, with some concrete reinforcement on bed through some private gardens.
Structure of the Riparian Zone	On the right bank is short grasses and pastoral farming. The right bank comprises private gardens with a mixture of vegetation. The channel is heavily shaded in parts.

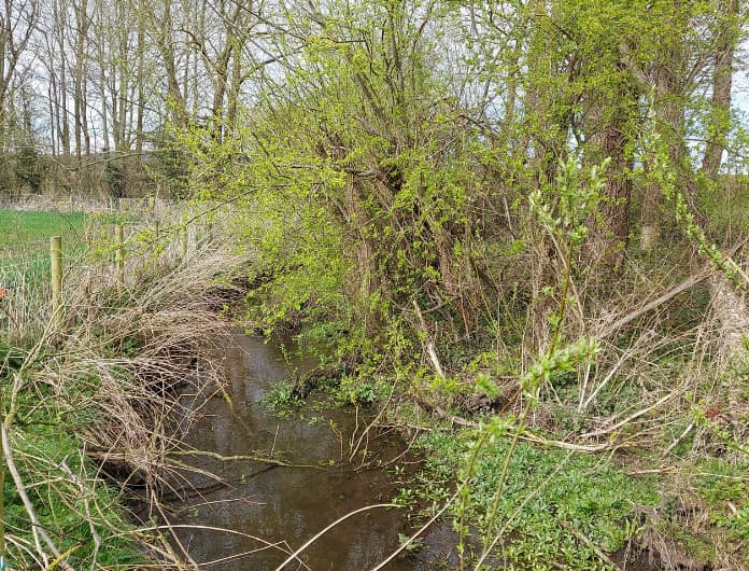
Water feature type: Ordinary Watercourse
	Catchment area: 0.98km ²
	Key hydraulic connections: Northop Brook flows northwards and becomes the Lead Brook before joining the Dee.
	Surrounding land use: Mainly rural, with some settlement (village of Northrop)
	River Condition Score: Moderate
Catchment Characteristics	The catchment is predominantly rural with land used for pastoral and arable farming. The catchment is steep towards the Dee Estuary. The watercourse flows through agricultural land before entering a wooded gorge. There is an artificial lake/reservoir at the lower end of catchment.
Catchment Geology and Soils	Bedrock composed of the Pennine Lower Coal Measures Formation - Mudstone, Siltstone And Sandstone.

Watercourse name	Northop Brook
	Superficial geology composed of both Devensian till and diamicton.
Catchment Hydrology	There are no gauges present in catchment. The watercourse is impounded downstream by an artificial lake/reservoir, although appears to have a limited backwater effect.
Historical Channel Change	1 st edition OS map (1888) shows minimal channel changes. The reservoir was also in-situ at this time too.
<u>Biological</u>	
Fish	NRW advised that two SPIs, European eel and brown trout, are present within Northop Brook. e- NRW advised that two SPIs, European eel and brown trout, are present within Northop Brook. A composite water sample was collected within the proposed Order Limits on 31 May 2022 for e-DNA analysis, however, the sample failed to amplify. Therefore, no baseline data could be obtained.
Invertebrates	Scoped out due to lack of suitable invertebrate habitat identified during the aquatic habitat walkover survey.

Watercourse name	Northop Brook
Oxygenation Conditions	No data is available for this watercourse.
Salinity	No data is available for this watercourse.
Acidification Status	No data is available for this watercourse.
Nutrient Conditions	No data is available for this watercourse.
Priority Hazardous Substances	No data is available for this watercourse.
<u>Hydromorphological</u>	
Quantity and Dynamics of Flow	Flow is generally rippled, with some areas of smooth flow through the study reach.
River Continuity	No artificial impoundments or attenuating features are present in the surveyed reach (although there is an online reservoir approximately 2.5km downstream). There is a large tree in the channel which potentially causes continuity issues in peak flows. The watercourse flows through a steep valley and is therefore not connected to a floodplain.
River Depth and Width Variation	Channel width varies between 2m and 3m. Water depth is approximately 0.5m.

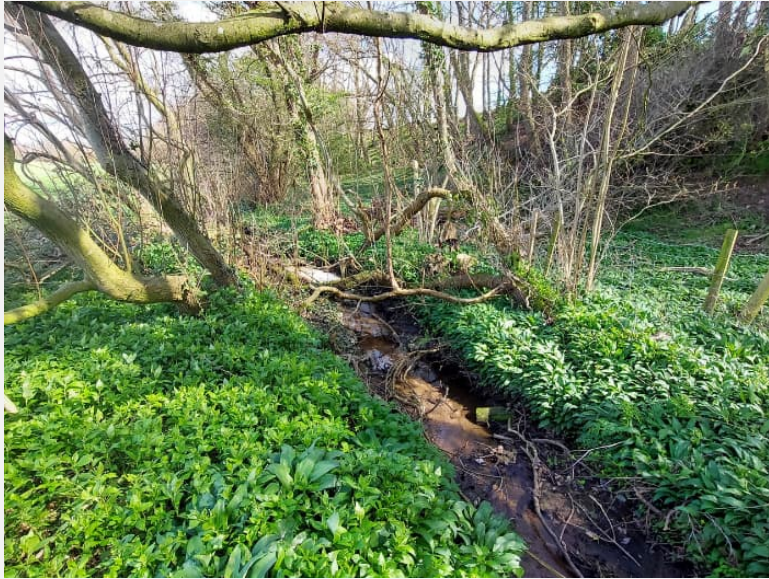
Water feature type: Ordinary Watercourse
	Catchment area: 0.51km ²
	Key hydraulic connections: this watercourse flows northwards towards the Dee Estuary
	Surrounding land use: Rural (farmland, arable and pastoral land)
	River Condition Score: Moderate
Catchment Characteristics	A small catchment which is dominated by agriculture with no suburban areas. This is a steep catchment which slopes towards the Dee. There is a small on-line pond attenuating flow upstream of the study reach.
Catchment Geology and Soils	Bedrock is composed of the Pennine Lower Coal Measures Formation - Mudstone, Siltstone And Sandstone. Superficial geology is composed of Devensian aged till and diamicton.

Watercourse name	Little Lead Brook
Catchment Hydrology	There is an online pond in the catchment which attenuates flow. There are no gauges present in the catchment.
Historical Channel Change	Channel course unchanged since 1 st edition OS maps, although online pond is relatively recent (post 1971).
<u>Biological</u>	
Fish	NRW advised that two SPIs, European eel and brown trout, are present in this watercourse. The reach within the DCO Proposed Development was however scoped out of further survey due to a lack of suitable fish habitat identified during the aquatic habitat walkover survey.
Invertebrates	Scoped out due to lack of suitable invertebrate habitat identified during the aquatic habitat walkover survey.
Macrophytes	Scoped out due to lack of suitable macrophyte and phytoplankton habitat identified during the aquatic habitat walkover survey.
Phytoplankton	
<u>Physico-Chemical</u>	
Thermal Conditions	When sampled on 16 June 2022, the water temperature was 13.8. No long-term monitoring data is available for this watercourse.

Watercourse name	Little Lead Brook
Oxygenation Conditions	When sampled on 16 June 2022, the dissolved oxygen level was recorded as 4.21mg/L (40.9% saturation). No long-term monitoring data is available for this watercourse.
Salinity	No data is available for this watercourse.
Acidification Status	When sampled on 116 June 2022, the pH was recorded as 7.68. No long-term monitoring data is available for this watercourse.
Nutrient Conditions	No data is available for this watercourse.
Priority Hazardous Substances	No data is available for this watercourse.
<u>Hydromorphological</u>	
Quantity and Dynamics of Flow	In the study reach flow is generally rippled with some areas of smooth flow.
River Continuity	There is an impoundment on the watercourse upstream of the study reach. There are no culverts through the study reach and there is no floodplain to be connected to the watercourse.
River Depth and Width Variation	Channel bankfull width is approximately 1m throughout the survey reach. Water depth is very shallow (0.05m).
