## ENVIRONMENTAL STATEMENT (VOLUME III)

### Appendix 18.3 Water Framework Directive Assessment

HyNet Carbon Dioxide Pipeline DCO

Document Reference Number D.6.3.18.3

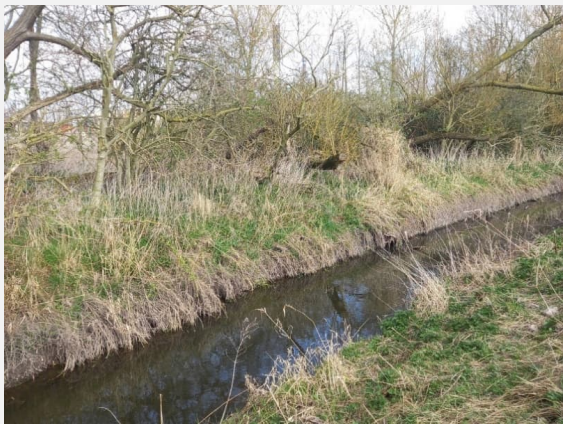
Watercourse name	East Central Drain

Water feature type: Main River
	Catchment area: 1.02km <sup>2</sup>
	Key hydraulic connections: Flows into West Central Drain
	Surrounding land use: Mostly pastoral fields with stands of plantation woodland and an industrial estate. Access tracks and paved roads are present.
	River Condition Score: Moderate
<b>Catchment Characteristics</b>	The catchment mostly comprises grassland with some arable and horticultural land uses. A smaller proportion of the catchment has built-up land use and woodland. The catchment has an elevation between 4.9 - 40mAOD).
<b>Catchment Geology and Soils</b>	The bedrock geology comprises Kinnerton sandstone formation (sandstone). The East Central Drain is underlain by superficial

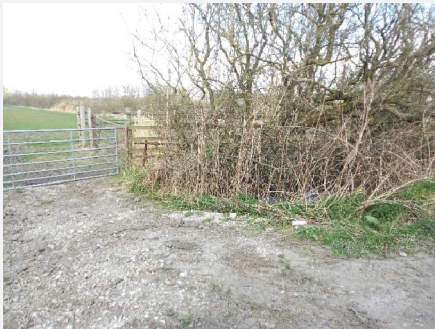
<b>Watercourse name</b>	<b>Elton Lane Ditch 1</b>

Water feature type: Ordinary Watercourse
	Catchment area: <1km <sup>2</sup>
	Key hydraulic connections: Artificial field drain collecting overland flow and discharging to West Central Drain
	Surrounding land use: Farming and agricultural, track roads
	Ditch Condition Score: Fairly Poor
<b>Catchment Characteristics</b>	The channel drains a small catchment of farm and agricultural land, dissected by track roads.
<b>Catchment Geology and Soils</b>	<p>The bedrock geology comprises Kinnerton sandstone formation (sandstone). Elton Lane Ditch 1 is underlain by superficial deposits of clay, silt and sand, formed from tidal flat deposits at the Quaternary shoreline.</p> <p>The catchment features loamy and sandy soils with naturally high groundwater and a peaty surface. These soils drain well into local shallow groundwater. These soils are vulnerable to pollution from nutrients, pesticides and wastes applied to the land.</p>

- 1.3.24. It is proposed that an existing culvert on Elton Lane Ditch 1 would be replaced with a longer culvert. This is currently a culverted ditch to provide access to the field. The culvert requires lengthening for access vehicles to Ince AGI. This is located within the Ince Marshes WFD surface water body.

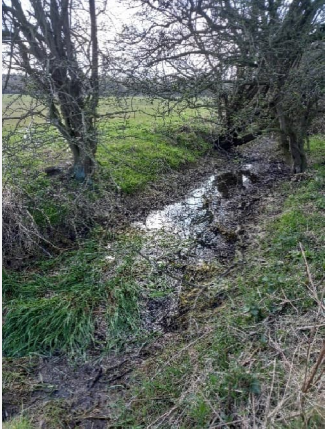
<b>Watercourse name</b>	<b>Elton Lane Ditch 4</b>

Water feature type: Ordinary Watercourse
	Catchment area: <1km <sup>2</sup>
	Key hydraulic connections: artificial field drain collecting overland flow and discharging to West Central Drain
	Surrounding land use: Farming and agricultural, track roads
	Ditch Condition Score: Fairly Poor
<b>Catchment Characteristics</b>	The channel drains a small catchment of farm and agricultural land dissected by track roads.
<b>Catchment Geology and Soils</b>	<p>The bedrock geology comprises Kinnerton sandstone formation (sandstone). Elton Lane Ditch 4 is underlain by superficial deposits of clay, silt and sand, formed from tidal flat deposits at the Quaternary shoreline.</p> <p>The catchment features loamy and sandy soils with naturally high groundwater and a peaty surface. These soils drain well into local</p>

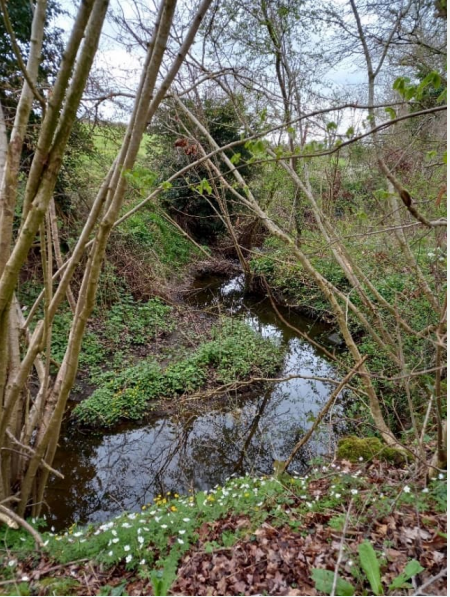
<p><b>Fairly Good section within Newbuild Infrastructure Boundary</b></p>	<p>Water feature type: Ordinary Watercourse</p>
	<p>Catchment area: 3.21km<sup>2</sup></p>
	<p>Key hydraulic connections: Finchetts Gutter Tributary flows southeast towards Blacon, under which it is culverted. It joins the Finchetts Gutter south of Saughall Road.</p>
	<p>Surrounding land use: Within the Newbuild Infrastructure Boundary, the land use is predominantly arable and horticultural land, improved grassland, neutral grassland, some broadleaved mixed and yew woodland. There is urban development in Mollington and along Parkgate Road.</p>
	<p>River Condition Score: Fairly good in the upper reach and moderate in the lower reach within the Newbuild Infrastructure Boundary.</p>

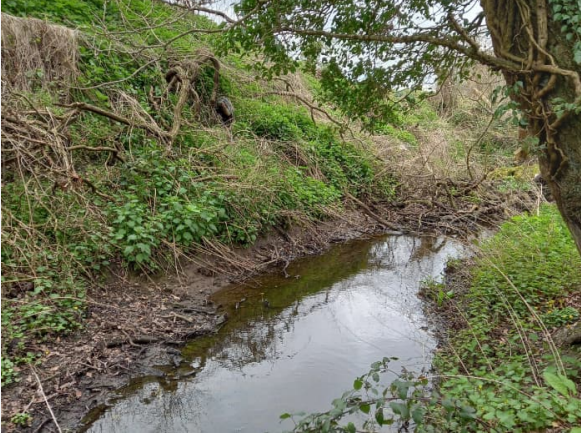
<p data-bbox="197 778 786 842"><b>Moderate section within Newbuild Infrastructure Boundary</b></p>	
<b>Catchment Characteristics</b>	<p data-bbox="837 874 1585 970">The watercourse is approximately 7km in length, with an elevation range between 10m and 46mAOD. The catchment drains local farmland and arable fields.</p> <p data-bbox="837 991 1630 1118">The catchment is rural in nature, with mainly open farmland and has some small areas of trees standing. Relatively shallow gradient and unconfined floodplain. Channel slightly sinuous, although realigned for agriculture in the past.</p>
<b>Catchment Geology and Soils</b>	<p data-bbox="837 1150 1621 1214">Bedrock composed of the Kinnerton Sandstone formation. Superficial geology composed of Devensian till and diamicton.</p>

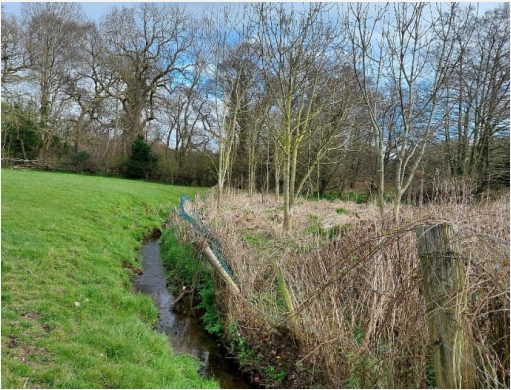
<p><b>Wepre Brook A55 reach</b></p>	<p>Water feature type: Ordinary watercourse within the Newbuild Infrastructure Boundary. It becomes a Main River downstream of its confluence with Alltami Brook.</p>
	<p>Catchment area: 9.57km<sup>2</sup></p>
	<p>Key hydraulic connections: Wepre Brook has several tributaries, mostly from the south of the catchment. The Alltami Brook and New Inn Brook both connect to the Wepre Brook downstream of the study area.</p>
	<p>Surrounding land use: Predominantly rural and agricultural land use. The A55 and Brookside run parallel to the Wepre Brook through the study reach. There are residential areas north of the watercourse through the study reach.</p>
	<p>River Condition Score:  A55 reach: <b>moderate</b>;  Brookside reach: <b>fairly poor</b>;  Northrop Hall reach: <b>fairly poor</b></p>
