HYDROGEOLOGICAL IMPACT APPRAISAL OF OPEN CUT CROSSING, ALLTAMI BROOK

HyNet Carbon Dioxide Pipeline DCO

Document Reference Number D.7.36

Applicant: Liverpool Bay CCS Limited

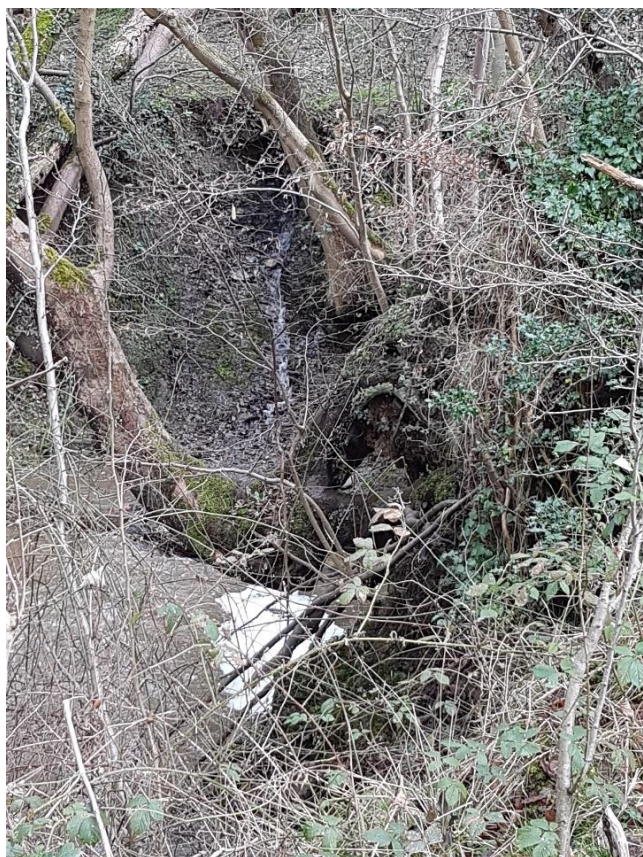
Seepage through made ground creating small waterfall

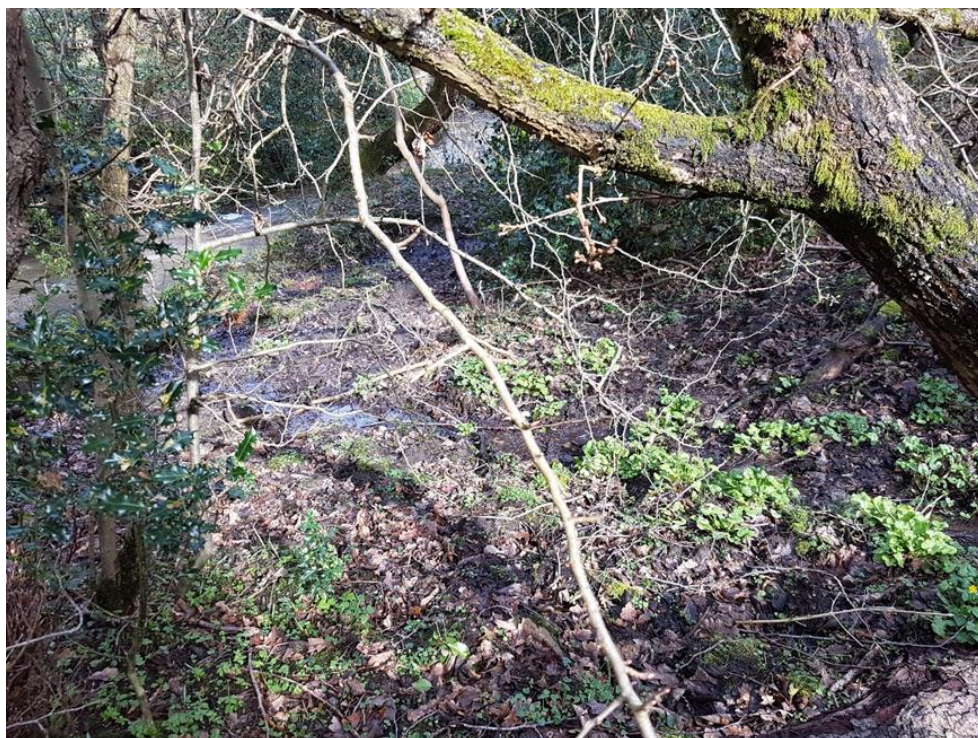
Seepage from made ground discharging into Alltami Brook

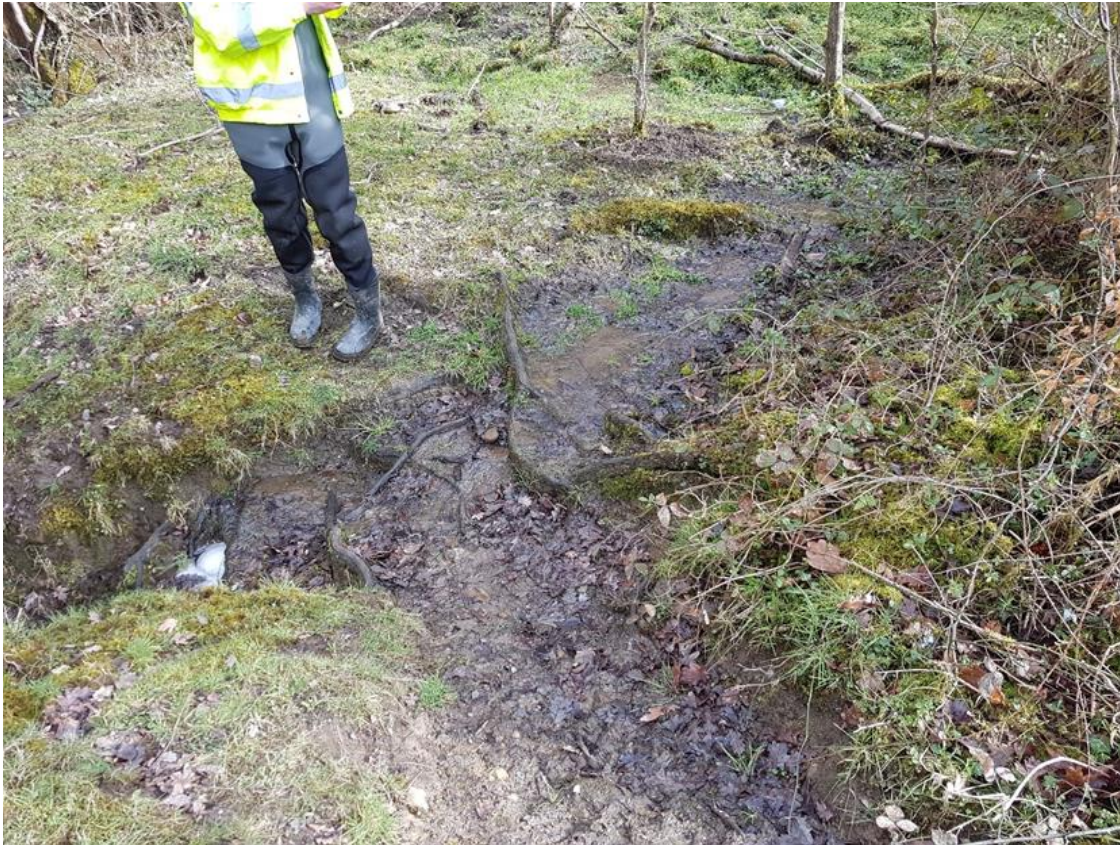
Saturated made ground/seepage

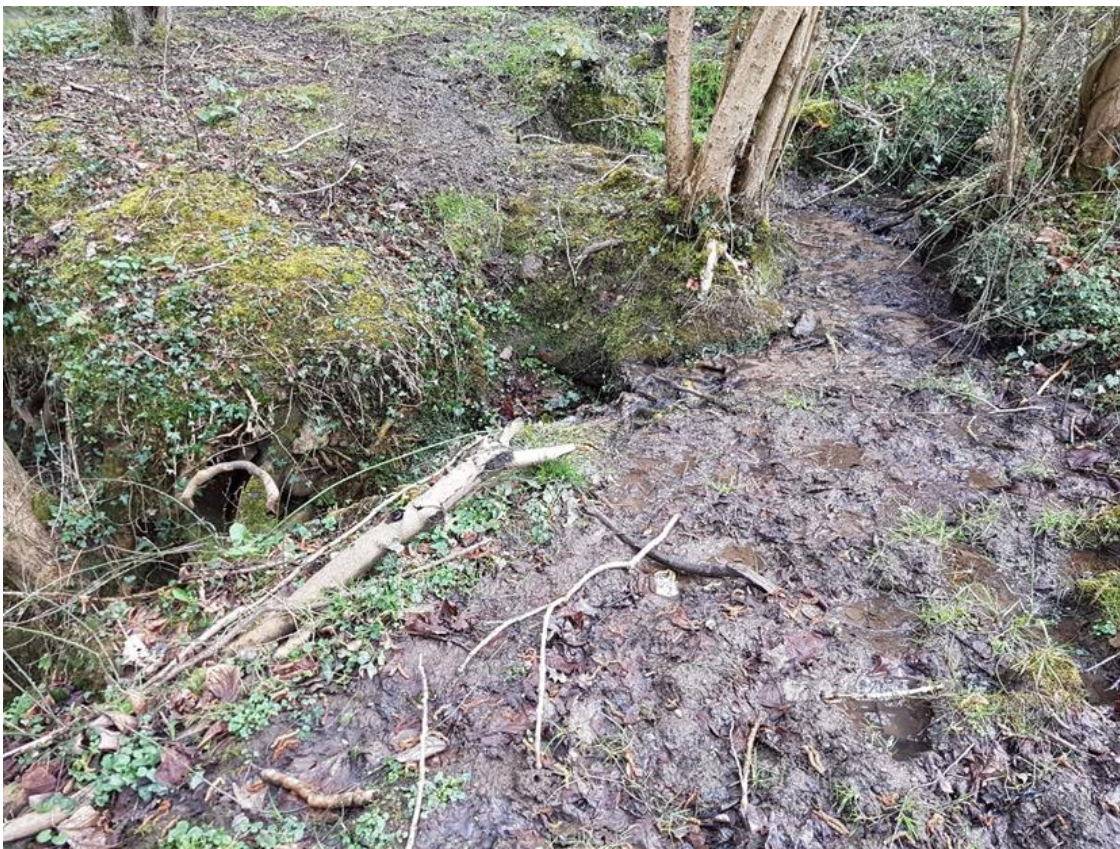
Saturated made ground/seepage

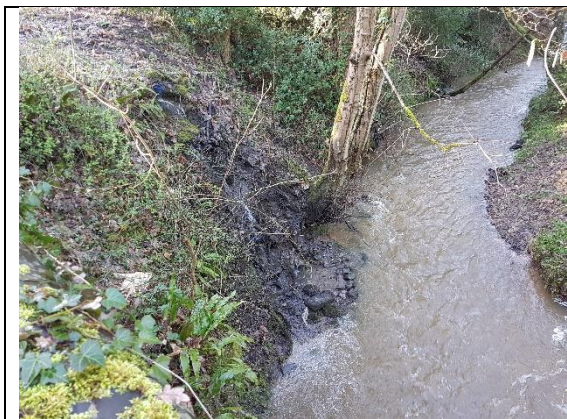
View looking upstream of the minor road bridge. Spate flow following heavy overnight rain on saturated ground. Deep v-shaped channel in otherwise flat landscape. A minor tributary of land drainage is discharging into the Alltami Brook on the right bank.

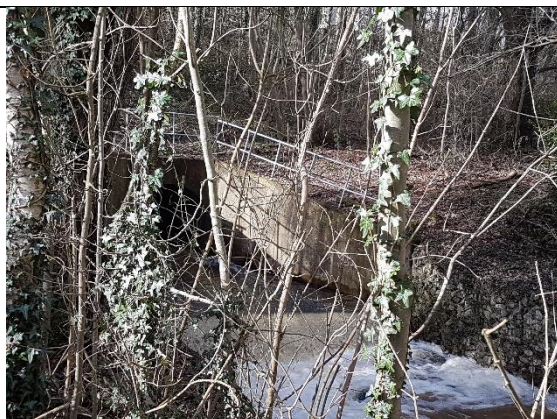
Outlet of the A55 culvert. Large pipe culvert discharging onto a concrete slab perched above bed level. Banks are lined with gabion baskets. Fast-flowing water and high step from concrete ledge to natural bed (height difficult to estimate due to elevated flows but possibly 0.3-0.3m). Bedrock channel with boulders and gravel deposits downstream of the step along with trash (tyre observed in the middle of the channel).

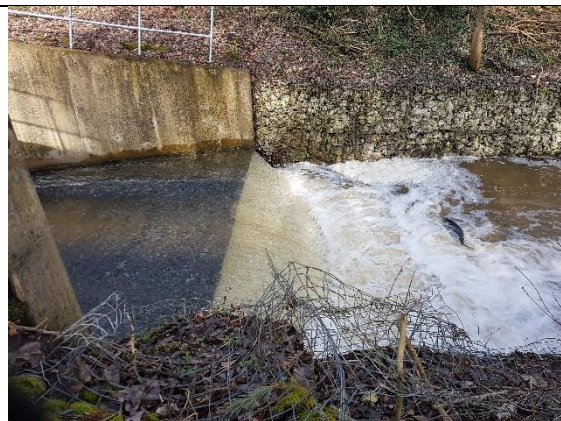
Immediately downstream of the A55 culvert outlet. Concrete wingwalls and gabion mattress bank reinforcement on both banks. Concrete slab at the culvert outlet and high step down to the natural channel. It is likely that this culvert structure arrangement is not passable to fish.

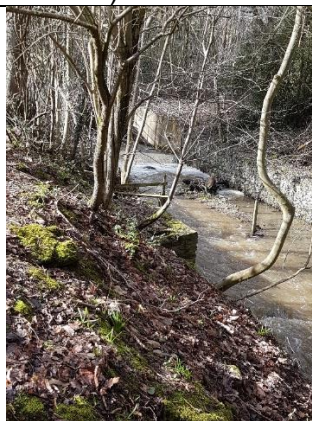
View looking upstream towards the A55 culvert outlet showing the transition from the modified reach with gabion basket bank reinforcement to natural banks. Bedrock was observed on the left bank face downstream of the culvert where the bank renaturalised.

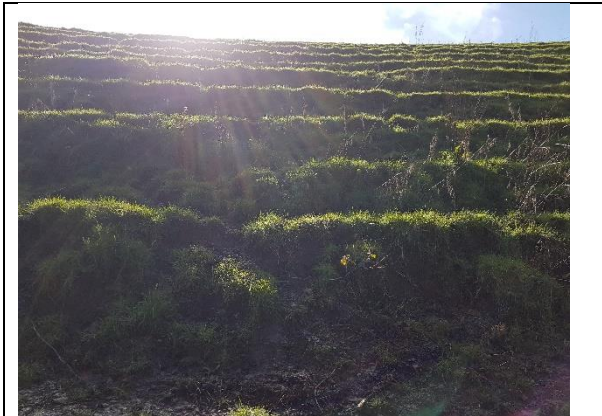
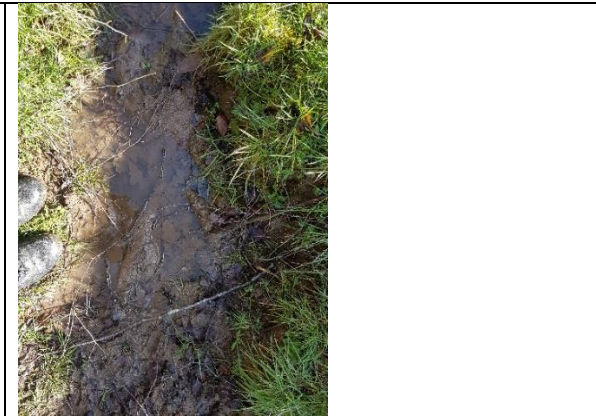
<p>Made ground on the right bank. Very high and steep engineered bank with a composite bank profile due to creep.</p>	<p>The made ground was saturated with extensive surface water puddling.</p>

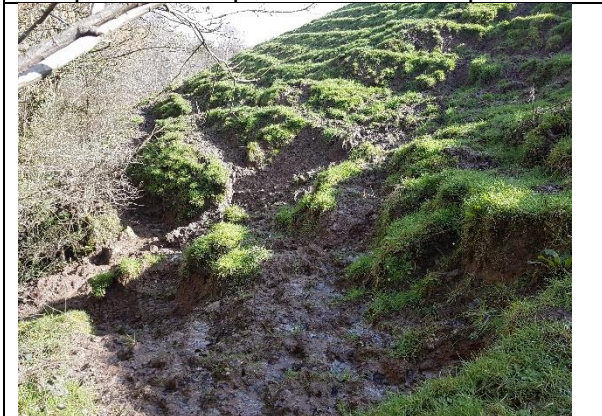
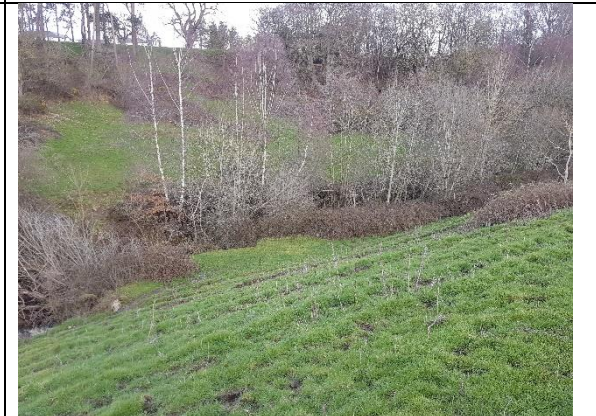
<p>Made ground bank profile with surface water puddling due to saturation of the earth.</p>	<p>View looking down to the Alltami Brook from the top of the made ground on the right bank. View looking downstream. The left bank is also steep and high but possibly a more natural landscape feature. Approximate crossing location for the pipeline.</p>

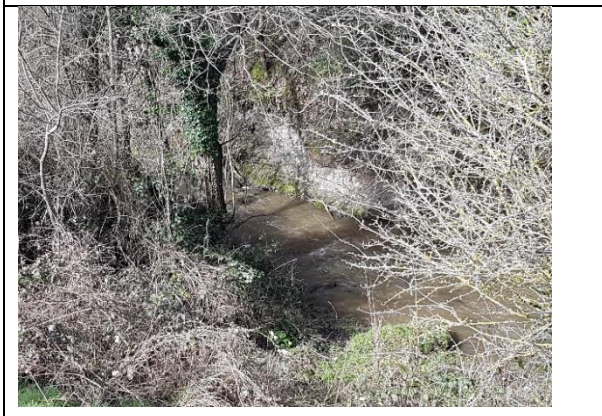
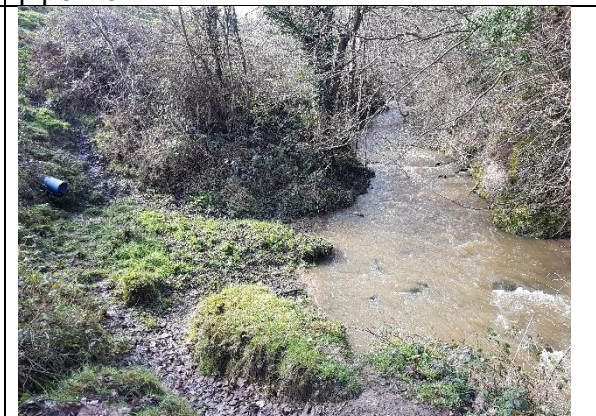
<p>Seepage observed from bedrock on the left bank face immediately upstream of SJ 27726 67182.</p>	<p>Land drainage pipe discharging water into the brook on the right bank face. Small volume of water seeping from the pipe. SJ 27726 67182. Bedrock and boulder channel</p>

bed. Chute and broken standing wave flow types observed.

- 2.7.9. Springs occur at the junctions of the jointed sandstone with underlying mudstones and shales (**Ref 12**). During the site walkover, groundwater seepage issuing from the bedrock was observed at NGR SJ 27726 67182 (see photos in Annex A). This is located at the boundary of the Lower Coal Measures Formation (mudstone) and the Gwespyr Sandstone according to the geological map. This observation suggests that the Gwespyr Sandstone in the area is likely to be saturated and may contribute baseflow to the Alltami Brook.
