## ENVIRONMENTAL STATEMENT (VOLUME III)

### Appendix 18.3 Water Framework Directive Assessment (Clean)

HyNet Carbon Dioxide Pipeline DCO

Document Reference Number D.6.3.18.3

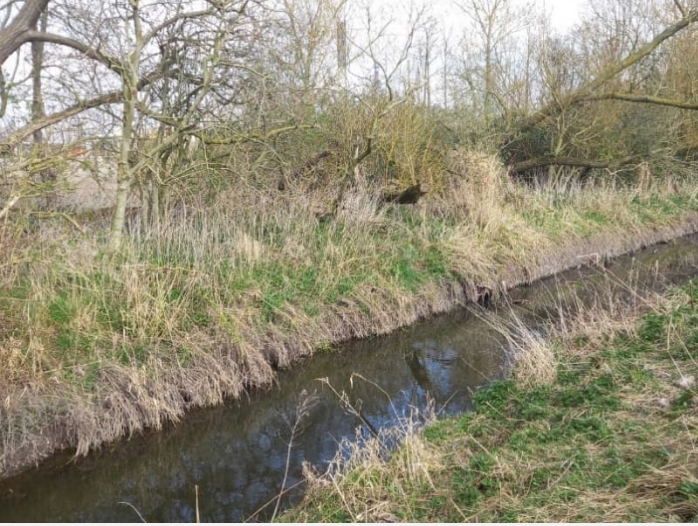
<b>Watercourse name</b>	<b>East Central Drain</b>

Water feature type: Main River
	Catchment area: 1.02km <sup>2</sup>
	Key hydraulic connections: Flows into West Central Drain
	Surrounding land use: Mostly pastoral fields with stands of plantation woodland and an industrial estate. Access tracks and paved roads are present.
	River Condition Score: Moderate
<b>Catchment Characteristics</b>	The catchment mostly comprises grassland with some arable and horticultural land uses. A smaller proportion of the catchment has built-up land use and woodland. The catchment has an elevation between 4.9 - 40mAOD).
<b>Catchment Geology and Soils</b>	The bedrock geology comprises Kinnerton sandstone formation (sandstone). The East Central Drain is underlain by superficial

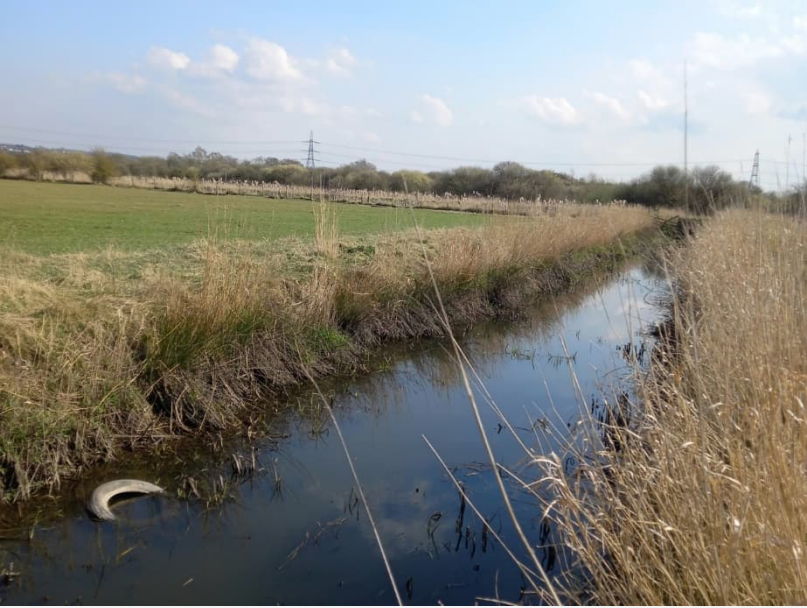
Water feature type: Main River
	Catchment area: 0.55km <sup>2</sup>
	Key hydraulic connections: Drains the Elton Marsh Drains (1-13), joined by Hapsford Brook and East Central Drain at Ince Marshes. Flows northwards towards the Manchester Ship Canal where water is pumped into the canal at high flows. The watercourse discharges to Hoolpool Gutter.
	Surrounding land use: Mostly pastoral fields, industrial estates and car parks, track and paved roads, permanently vegetated agriculture, some plantation woodland.
	River Condition Score: Fairly Poor
<b>Catchment Characteristics</b>	The West Central Drain forms the main stem off the Elton Marsh Drains (1 –13). The channel drains a small catchment of farm and agricultural land. The West Central Drain flows under the Great Northern and London, and North Western Joint Railway line.
<b>Catchment Geology and Soils</b>	The bedrock geology comprises Kinnerton sandstone formation (sandstone). The West Central Drain are underlain by superficial deposits of clay, silt and sand, formed from tidal flat deposits at the

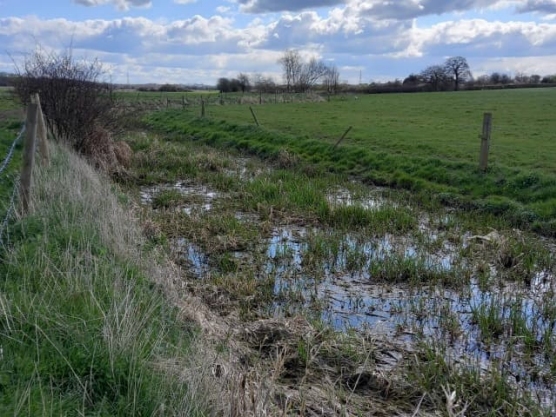
Water feature type: Main River
	Catchment area: 6.95km <sup>2</sup>
	Key hydraulic connections: Gowy Tributary 2 connects Stanney Mill Brook and Stanney Main Drain. Picton Brook flows into the Stanney Mill Brook. The Stanney Mill Brook drains into the Gowy downstream of the A5117.
	Surrounding land use: Farmland, agricultural buildings, roadways, Suburban (Picton, Mickle Trafford), Peat bogs.
<b>Catchment Characteristics</b>	River Condition Score: Moderate – Fairly Poor  Stanney Mill Brook drains agricultural and pastoral land. The channel flows through a culvert under the M56. The channel rises north of Mickle Trafford. It has a maximum catchment altitude of (45mAOD). There is a wastewater treatments works on the Stanney Mill Brook south of the A5117.
<b>Catchment Geology and Soils</b>	The bedrock geology of the Stanney Mill Brook catchment consists of sandstone; the Chester Formation (pebbly and gravelly). These

<b>Watercourse name</b>	<b>Stanney Mill Brook</b>
	<p>sediments are fluvial in origin. Further downstream, the channel is underlain by the Wilmslow Sandstone Formation consisting of sandstones, formed in environments previously dominated by hot deserts.</p> <p>The superficial deposits within the catchment include Devensian tills, glaciofluvial deposits (sand and gravel), and tidal flat deposits (clay, silt, and sand), Peat.</p> <p>Within the upstream reaches, the soils consist of slowly permeable seasonally wet slightly acid but base-rich loamy and clayey soils. Within the study area, the soils area comprised of Fen peats.</p>
<b>Catchment Hydrology</b>	The cut channel drains the surrounding arable and horticultural, and suburban land. The channel appears to have been artificially straightened. The watercourse is ungauged. Potential outfall from Wastewater Treatment Works. Single thread channel. This watercourse is ungauged.

<b>Oxygenation Conditions</b>	Water quality samples regularly collected by the EA from the Stanney Mill Brook (near Denison Bridge, approximately 1.3km downstream from the proposed Order Limits) between 2010 – 2013 demonstrate that the dissolved oxygen levels ranged from 1.8 -

<b>Watercourse name</b>	<b>Stanney Mill Brook</b>
	13.7mg/L (18 - 119% saturation), with a mean of 6.13mg/L (47.8% saturation).
<b>Salinity</b>	No data is available for this watercourse.
<b>Acidification Status</b>	Water quality samples regularly collected by the EA from the Stanney Mill Brook (near Denison Bridge, approximately 1.3km downstream from the proposed Order Limits) between 2010 – 2013 demonstrate that the pH ranged from 7.2 - 8.1, with a mean of 7.5.
<b>Nutrient Conditions</b>	Water quality samples regularly collected by the EA from the Stanney Mill Brook (near Denison Bridge, approximately 1.3km downstream from the proposed Order Limits) between 2010 – 2013 demonstrate that the nitrate levels ranged from 2.09 - 12.6mg/L, with a mean of 5.2mg/L.
<b>Priority Hazardous Substances</b>	Only one priority hazardous substance, chloride, was monitored in the water quality samples collected from the Stanney Mill Brook (near Denison Bridge, approximately 1.3km downstream from the proposed Order Limits) between 2010 – 2013. Levels ranged from 36.4 - 323.0mg/L, with a mean of 120.8mg/L.

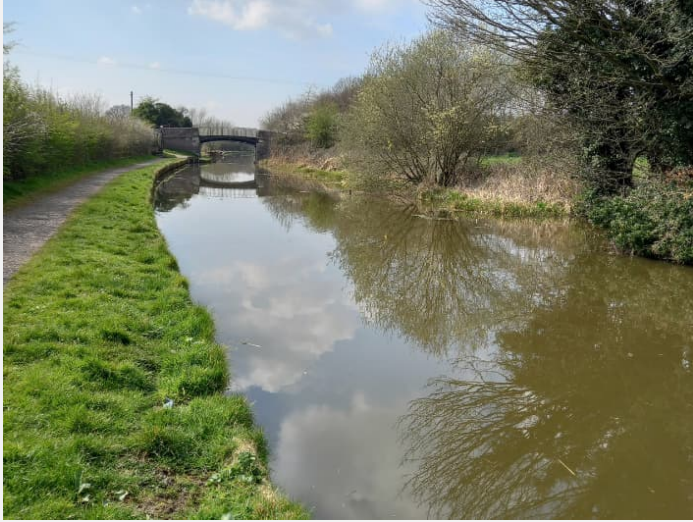
Watercourse name	Shropshire Union Canal

Water feature type: Canal
	Catchment area: n/a (artificial canal system)
	Key hydraulic connections: The canal joins the Manchester Ship Canal to the River Dee at Chester.
	Surrounding land use: Rural (farmland, arable and pastoral), woodland, urban, industrial, recreational (golf courses, etc)
	River Condition Score: Fairly poor
<b>Catchment Characteristics</b>	Artificial channel built in the late 18 <sup>th</sup> century for industry and trade. Ellesmere and Chester canal branches. 16 locks separate Manchester Ship Canal from River Dee.
<b>Catchment Geology and Soils</b>	n/a (artificial canal)
<b>Catchment Hydrology</b>	Series of weirs and locks controls water level throughout the canal system.

<b>Watercourse name</b>	<b>Shropshire Union Canal</b>
<b>Historical Channel Change</b>	Additional branches of canal added throughout the early 19 <sup>th</sup> century, completed in 1835.
<b><u>Biological</u></b>	
<b>Fish</b>	The e-DNA from 12 species of fish were detected in the sample that was collected from within the proposed Order Limits on 16 February 2022, including one SPI, European eel. No INNS were detected.
<b>Invertebrates</b>	Existing EA data collected in 2016 from invertebrate surveys conducted 5.4km downstream from the proposed Order Limits classified this site within the Shropshire Union Canal to be of moderate conservation value, with the predominant presence of scoring taxa primarily associated with a sedimented watercourse and slow/sluggish flow. Further invertebrate surveys were scoped out due to lack of suitable invertebrate habitat identified within the proposed Order Limits during the aquatic habitat walkover survey.

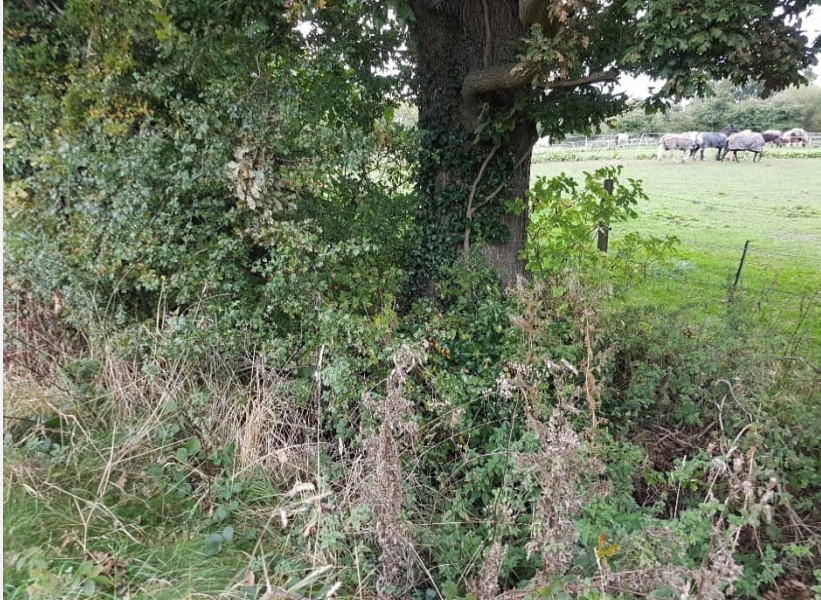
Water feature type: Ordinary Watercourse
	Catchment area: <1km <sup>2</sup>
	Key hydraulic connections: Onward connection to canal ditch and is likely culverted beneath Shropshire Union Canal to join Finchetts Gutter.
	Surrounding land use: Farm buildings and tracks, improved grassland, arable and horticultural land, some broadleaved, mixed and yew woodland
	River Condition Score: Not surveyed
<b>Catchment Characteristics</b>	Drains agricultural and pastoral land. It has a maximum catchment altitude of (~ 42mAOD - ~11mAOD).
<b>Catchment Geology and Soils</b>	Bedrock geology comprising the Chester Formation (sandstone, pebbly, gravelly). The superficial geology of the catchment consists

<b>Watercourse name</b>	<b>Collinge Wood Brook</b>
	of Devensian tills (diamicton) and Tidal Flat Deposits - Clay, Silt and Sand.
<b>Catchment Hydrology</b>	The cut channel drains the surrounding arable and horticultural land. The channel appears to have been artificially straightened. The watercourse is ungauged.
<b>Historical Channel Change</b>	The channel has retained the same planform since 1892
<b><u>Biological</u></b>	
<b>Fish</b>	Scoped out due to lack of suitable fish habitat identified during the aquatic habitat walkover survey.
<b>Invertebrates</b>	Scoped out due to lack of suitable invertebrate habitat identified during the aquatic habitat walkover survey.
<b>Macrophytes &amp; Phytoplankton</b>	Scoped out due to lack of suitable macrophyte and phytoplankton habitat identified during the aquatic habitat walkover survey.
<b><u>Physico-Chemical</u></b>	
<b>Thermal Conditions</b>	No data is available for this watercourse.

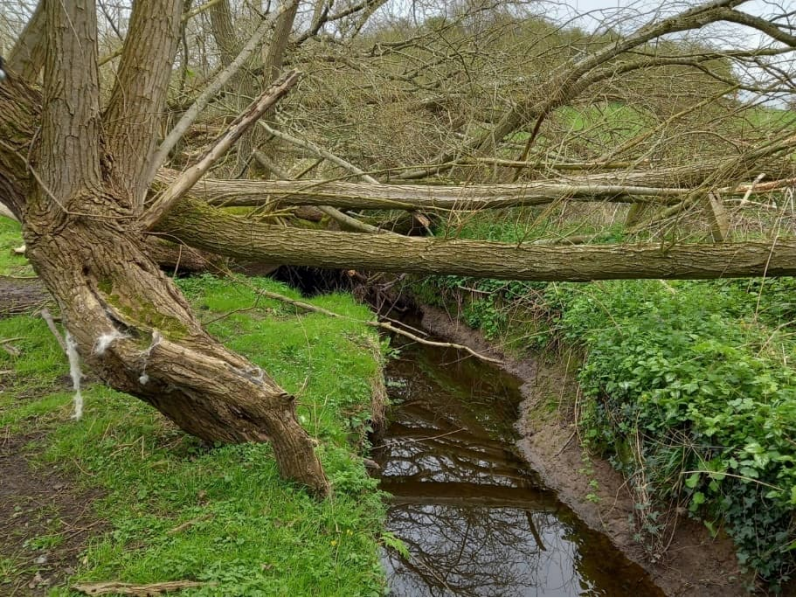
Water feature type: Main River
	Catchment area: 4.97km <sup>2</sup>
	Key hydraulic connections: There are three tributaries of Backford Brook which drain land south of Dunkirk and the M56. Backford Brook is culverted beneath the Shropshire Union Canal and then joins Finchetts Gutter.
	Surrounding land use: Pasture, grassland, and woodland.
	River Condition Score: Fairly Good upstream of field culvert. Fairly Poor downstream of field culvert.
<b>Catchment Characteristics</b>	Elevation varies from 38m, to 19mAOD. The catchment is predominantly rural.
<b>Catchment Geology and Soils</b>	Geology is dominated by sandstone and conglomerate. Soils in the catchment are slightly acid loamy and clayey soils with impeded drainage and loamy and sandy soils with naturally high groundwater and a peaty surface

<b>Watercourse name</b>	<b>Backford Brook</b>
<b>Catchment Hydrology</b>	No gauge records are available for this catchment.
<b>Historical Channel Change</b>	No change in planform can be seen from existing online maps (from 1982 onwards).
<b><u>Biological</u></b>	
<b>Fish</b>	One species was recorded during a single catch electric fishing survey undertaken on 21 September 2021, three-spined stickleback <i>Gasterosteus aculeatus</i> . Due to the dense silt bed impacting the efficacy of electric fishing methods, e-DNA sampling was also conducted on 01 June 2022. The e-DNA from two species of fish were detected in the composite water sample, including on SPI, European eel.
<b>Invertebrates</b>	Invertebrate sampling was undertaken within the proposed Order Limits on 08 April and 21 September 2021. Results indicated that the site had low conservation value, with the predominant presence of scoring taxa primarily associated with sedimented (spring sample)/heavily sedimented (autumn sample) and slow flowing/standing water. There was no strong dominance by pollution tolerant or intolerant taxa.

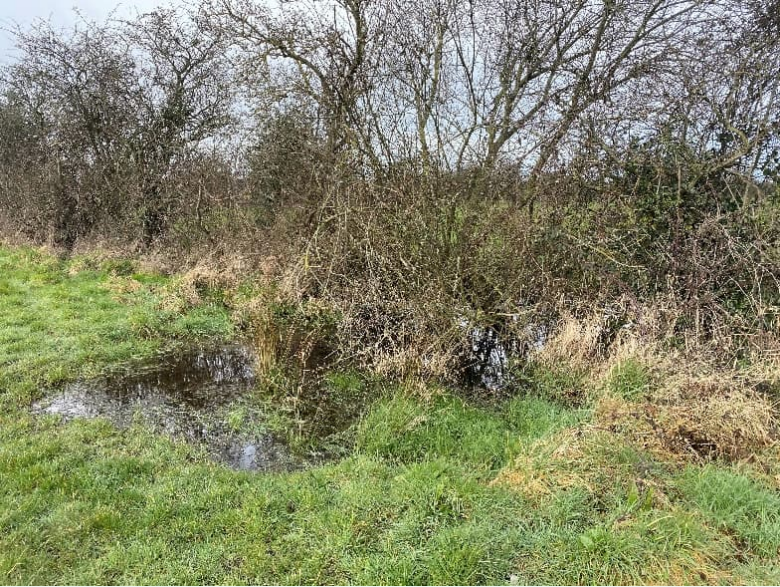
Water feature type: Ordinary Watercourse (Hedgerow Ditch)
	Catchment area: <math><1\text{km}^2</math>
	Key hydraulic connections: Overwood Ditch flows southwards towards Finchetts Gutter Tributary. There is a pond which flows into Overwood Ditch.
	Surrounding land use: The ditch flows through a field used for pastoral farming. The wider area is predominantly rural.
	River Condition Score: No survey completed
<b>Catchment Characteristics</b>	This is a small catchment which is dominated by agricultural land uses.
<b>Catchment Geology and Soils</b>	The bedrock geology of the catchment includes the Chester Formation, comprising sandstones, and pebbly/ gravelly sediments. Superficial deposits consist of diamicton formed under ice age conditions. The catchment comprises slowly permeable seasonally wet slightly acid but base-rich loamy and clayey soils.

<b>Watercourse name</b>	<b>Overwood Ditch</b>
<b>Catchment Hydrology</b>	This watercourse drains a small catchment which has predominantly rural and agricultural land use.
<b>Historical Channel Change</b>	The channel appears to have been artificially straightened as it follows the natural boundary of the arable fields. The channel has retained its planform since 1892.
<b><u>Biological</u></b>	
<b>Fish</b>	Scoped out due to lack of suitable fish habitat identified during the aquatic habitat walkover survey.
<b>Invertebrates</b>	Scoped out due to lack of suitable invertebrate habitat identified during the aquatic habitat walkover survey.
<b>Macrophytes &amp; Phytoplankton</b>	Scoped out due to lack of suitable macrophyte and phytoplankton habitat identified during the aquatic habitat walkover survey.
<b><u>Physico-Chemical</u></b>	
<b>Thermal Conditions</b>	No data is available for this watercourse.

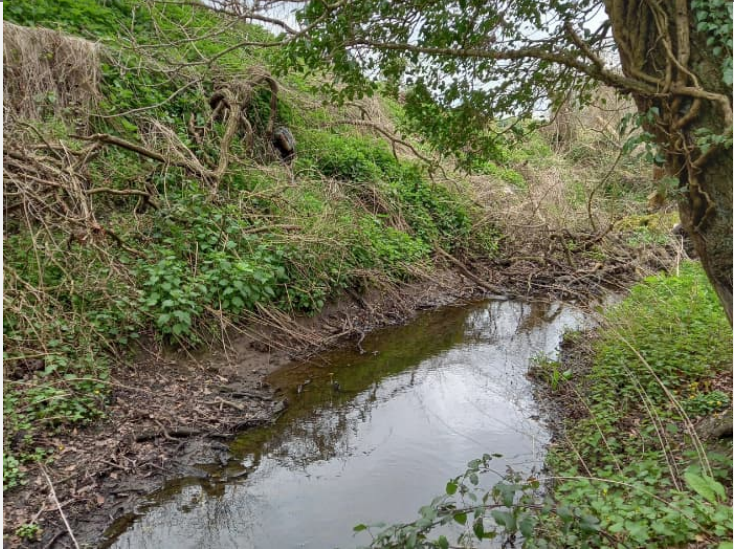
<p data-bbox="250 778 981 853"><b>Moderate section within Newbuild Infrastructure Boundary</b></p>	
<b>Catchment Characteristics</b>	<p data-bbox="1048 895 2056 1015">The watercourse is approximately 7km in length, with an elevation range between 10m and 46mAOD. The catchment drains local farmland and arable fields.</p> <p data-bbox="1048 1038 2056 1201">The catchment is rural in nature, with mainly open farmland and has some small areas of trees standing. Relatively shallow gradient and unconfined floodplain. Channel slightly sinuous, although realigned for agriculture in the past.</p>
<b>Catchment Geology and Soils</b>	<p data-bbox="1048 1241 2056 1321">Bedrock composed of the Kinnerton Sandstone formation. Superficial geology composed of Devensian till and diamicton.</p>

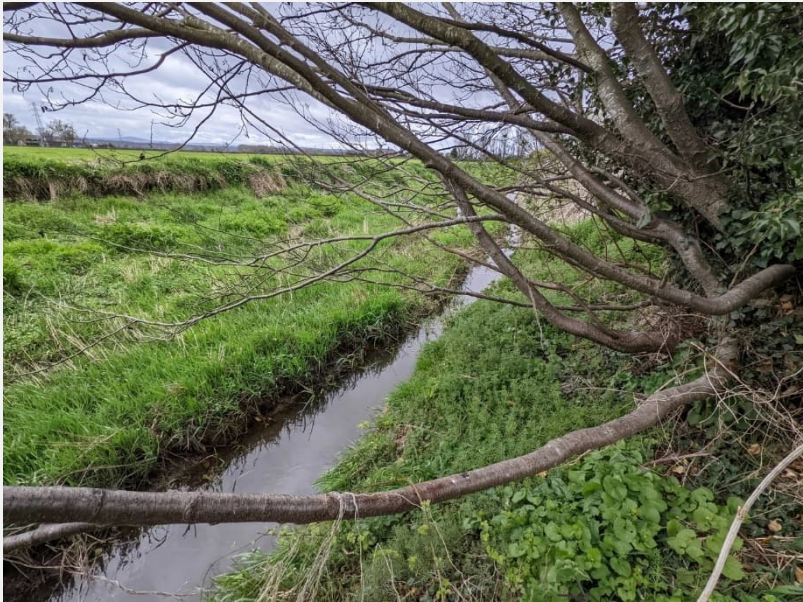
Water feature type: Main River
	Catchment area: 6.74km <sup>2</sup>
	Key hydraulic connections: The Sealand Main Drain receives water from the Seahill Drain and the Garden City Gutter before flowing to the River Dee.
	Surrounding land use: Tilled farm land, pasture, grassland, woodland and urban. There is a golf course on the right bank of the watercourse, close to the DCO Proposed Development.
	River Condition Score: Fairly poor
<b>Catchment Characteristics</b>	The catchment is marked by several artificial watercourses; therefore, it is unlikely to reflect the original geometry.
<b>Catchment Geology and Soils</b>	Catchment geology is sandstone and conglomerate. The catchment soil is loamy and clayey soils of coastal flats with naturally high groundwater.
<b>Catchment Hydrology</b>	No gauge records are available for this catchment.

<b>Watercourse name</b>	<b>Sealand Main Drain</b>
<b>Historical Channel Change</b>	No change in planform can be seen from existing online maps (from 1982 onwards).
<b><u>Biological</u></b>	
<b>Fish</b>	Natural Resource Wales (NRW) advised that one SPI, European eel, is present in this watercourse. The reach within the proposed Order Limits was however scoped out of further survey due to a lack of suitable fish habitat identified during the aquatic habitat walkover survey.
<b>Invertebrates</b>	Invertebrate sampling was undertaken within the proposed Order Limits on 09 April and 20 September 2021. Results indicated that the site had low conservation value, with the predominant presence of scoring taxa primarily associated with and heavily sedimented watercourse and flowing/standing water. There was a slight dominance by pollutant tolerant taxa.
<b>Macrophytes &amp; Phytoplankton</b>	Scoped out due to lack of suitable macrophyte and phytoplankton habitat identified during the aquatic habitat walkover survey.

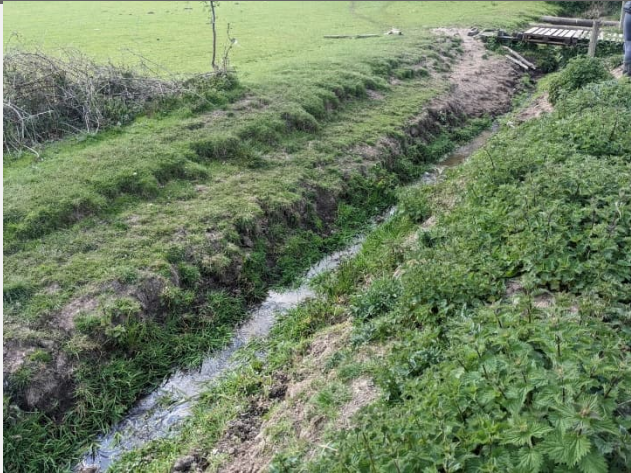
<b>Watercourse name</b>	<b>Mancot Brook</b>

<p data-bbox="203 699 434 735">Upstream reach</p>	
<b>Catchment Characteristics</b>	The catchment drains farmland and arable fields. Elevation varies from 80 - 8mAOD. Relatively flat catchment which is predominantly rural.
<b>Catchment Geology and Soils</b>	<p>The channel flows over a variety of bedrock geologies, including Kinnerton sandstone formation, Etruria Formation (Mudstone, sandstone and conglomerate) from riverine environments. The channel is also underlain by bedrock geologies of Pennine Middle and Lower Coal Measures Formation - Mudstone, Siltstone and Sandstone, from swamps, estuarine and delta environments, Bowland Shale Formation (Mudstone, formed in open seas with pelagite deposits), and Gwespyp Sandstone formed within swamps, estuaries, and deltas.</p> <p>Superficial deposits also include tidal flat deposits (clay, silt and sand), Devensian tills, and glaciofluvial deposits.</p>

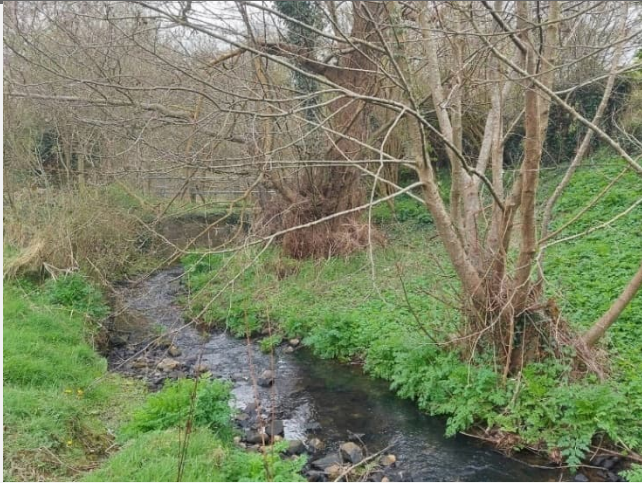
**Wepre Brook Brookside reach**

<b>Watercourse name</b>	<b>Wepre Brook</b>
<b>River Depth and Width Variation</b>	At the A55 reach the channel is narrow (approximately 1m width and 0.3m water depth). Through Brookside and Northop Hall reaches the watercourse is wider (width up to 2m and water depth 0.2m)
<b>Structure and Substrate of the River Bed</b>	Bed is well mixed generally, with areas of both gravel-pebble mix and cobbles. Some areas of sand are observed overlaying armoured substrate in the A55 reach.
<b>Structure of the Riparian Zone</b>	At the A55 reach the left bank is short grass pasture for grazing whilst the right bank is plantation woodland and scrub. Through Brookside and Northop Hall there are more mature trees on both banks. There are gabion baskets supporting the right bank through the Brookside reach. The riparian zone through the Northop Hall reach is more substantial than other reaches.

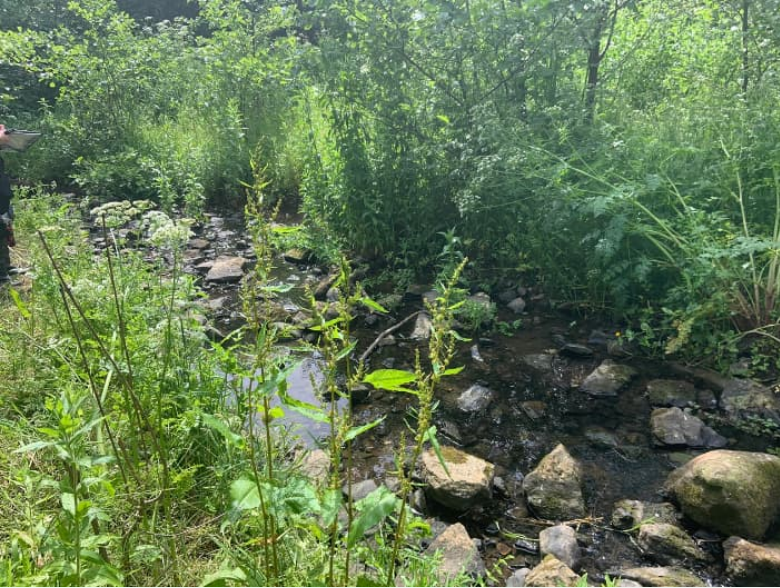
Watercourse name	Nant-y-Fflint

Water feature type: Ordinary watercourse
	Catchment area: 4.31km <sup>2</sup>
	Key hydraulic connections: The Nant-y-Fflint has several unnamed tributaries mostly from the south of the catchment which join the watercourse upstream of the DCO Proposed Development.
	Surrounding land use: Mainly rural farmland (arable and pastoral, forestry)
	River Condition Score: Fairly Good
<b>Catchment Characteristics</b>	The catchment is relatively steep, with a confined floodplain in a wooded valley. The catchment is predominantly rural with small settlements in Pentre Halkyn and Halkyn.
<b>Catchment Geology and Soils</b>	Somewhat complex bedrock geology, consisting of areas of mudstone and sandstone from different formations. Superficial deposits poorly recorded in this

<b>Watercourse name</b>	<b>Nant-y-Fflint</b>
<b>Thermal Conditions</b>	When sampled on 16 June 2022, the water temperature was recorded as 13.8°C. No long-term monitoring data is available for this watercourse.
<b>Oxygenation Conditions</b>	When sampled on 16 June 2022, the dissolved oxygen level was recorded as 4.21mg/L (40.9% saturation). No long-term monitoring data is available for this watercourse.
<b>Salinity</b>	No data available for this watercourse.
<b>Acidification Status</b>	When sampled on 16 June 2022, the pH was recorded as 7.68. No long-term monitoring data is available for this watercourse.
<b>Nutrient Conditions</b>	No data available for this watercourse.
<b>Priority Hazardous Substances</b>	No data available for this watercourse.
<b><u>Hydromorphological</u></b>	
<b>Quantity and Dynamics of Flow</b>	Primarily rippled flow, with some areas of smooth flow. Due to gradient of channel and typology there is potential for the channel to experience more turbulent flow types in periods of spate.

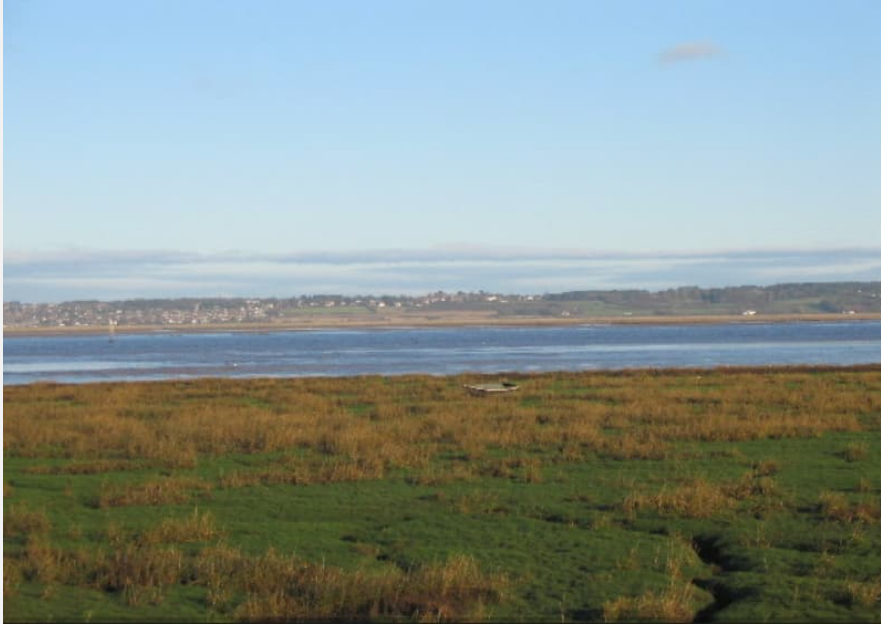
Water feature type: Transitional
	Catchment area: 136.7km <sup>2</sup>
	Key hydraulic connections:
	Surrounding land use: Rural, industrial, urban
	River Condition Score:
<b>Catchment Characteristics</b>	Major estuary with extensive mudflats and saltmarsh habitat, with entire estuary area designated as a SAC, SSSI and SPA. Land use is a mix of rural agriculture, industrial, urban areas (Flint, West Kirby, Neston, Heswall, Connah's Quay and the city of Chester at the historic head of the estuary).

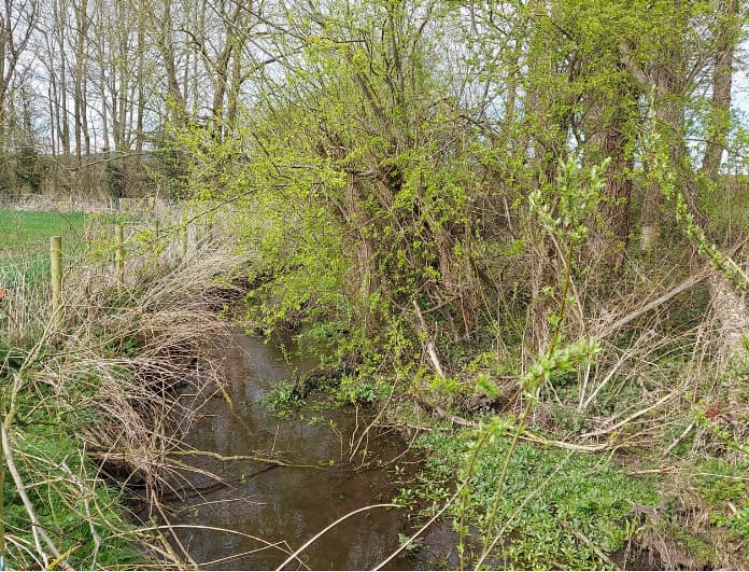
### Baseline data for Northop Brook

Water feature type: Ordinary Watercourse
	Catchment area: 0.98km <sup>2</sup>
	Key hydraulic connections: Northop Brook flows northwards and becomes the Lead Brook before joining the Dee.
	Surrounding land use: Mainly rural, with some settlement (village of Northrop)
	River Condition Score: Moderate
<b>Catchment Characteristics</b>	The catchment is predominantly rural with land used for pastoral and arable farming. The catchment is steep towards the Dee Estuary. The watercourse flows through agricultural land before entering a wooded gorge. There is an artificial lake/reservoir at the lower end of catchment.
<b>Catchment Geology and Soils</b>	Bedrock composed of the Pennine Lower Coal Measures Formation - Mudstone, Siltstone And Sandstone.

<b>Watercourse name</b>	<b>Northop Brook</b>
	Superficial geology composed of both Devensian till and diamicton.
<b>Catchment Hydrology</b>	There are no gauges present in catchment. The watercourse is impounded downstream by an artificial lake/reservoir, although appears to have a limited backwater effect.
<b>Historical Channel Change</b>	1 <sup>st</sup> edition OS map (1888) shows minimal channel changes. The reservoir was also in-situ at this time too.
<b><u>Biological</u></b>	
<b>Fish</b>	NRW advised that two SPIs, European eel and brown trout, are present within Northop Brook. e- NRW advised that two SPIs, European eel and brown trout, are present within Northop Brook. A composite water sample was collected within the proposed Order Limits on 31 May 2022 for e-DNA analysis, however, the sample failed to amplify. Therefore, no baseline data could be obtained.
<b>Invertebrates</b>	Scoped out due to lack of suitable invertebrate habitat identified during the aquatic habitat walkover survey.

<b>Watercourse name</b>	<b>Northop Brook</b>
<b>Oxygenation Conditions</b>	No data is available for this watercourse.
<b>Salinity</b>	No data is available for this watercourse.
<b>Acidification Status</b>	No data is available for this watercourse.
<b>Nutrient Conditions</b>	No data is available for this watercourse.
<b>Priority Hazardous Substances</b>	No data is available for this watercourse.
<b><u>Hydromorphological</u></b>	
<b>Quantity and Dynamics of Flow</b>	Flow is generally rippled, with some areas of smooth flow through the study reach.
<b>River Continuity</b>	No artificial impoundments or attenuating features are present in the surveyed reach (although there is an online reservoir approximately 2.5km downstream). There is a large tree in the channel which potentially causes continuity issues in peak flows. The watercourse flows through a steep valley and is therefore not connected to a floodplain.
