HyNet North West

ENVIRONMENTAL STATEMENT (VOLUME III)

Appendix 18.1 Baseline Information

HyNet North West Carbon Dioxide Pipeline DCO

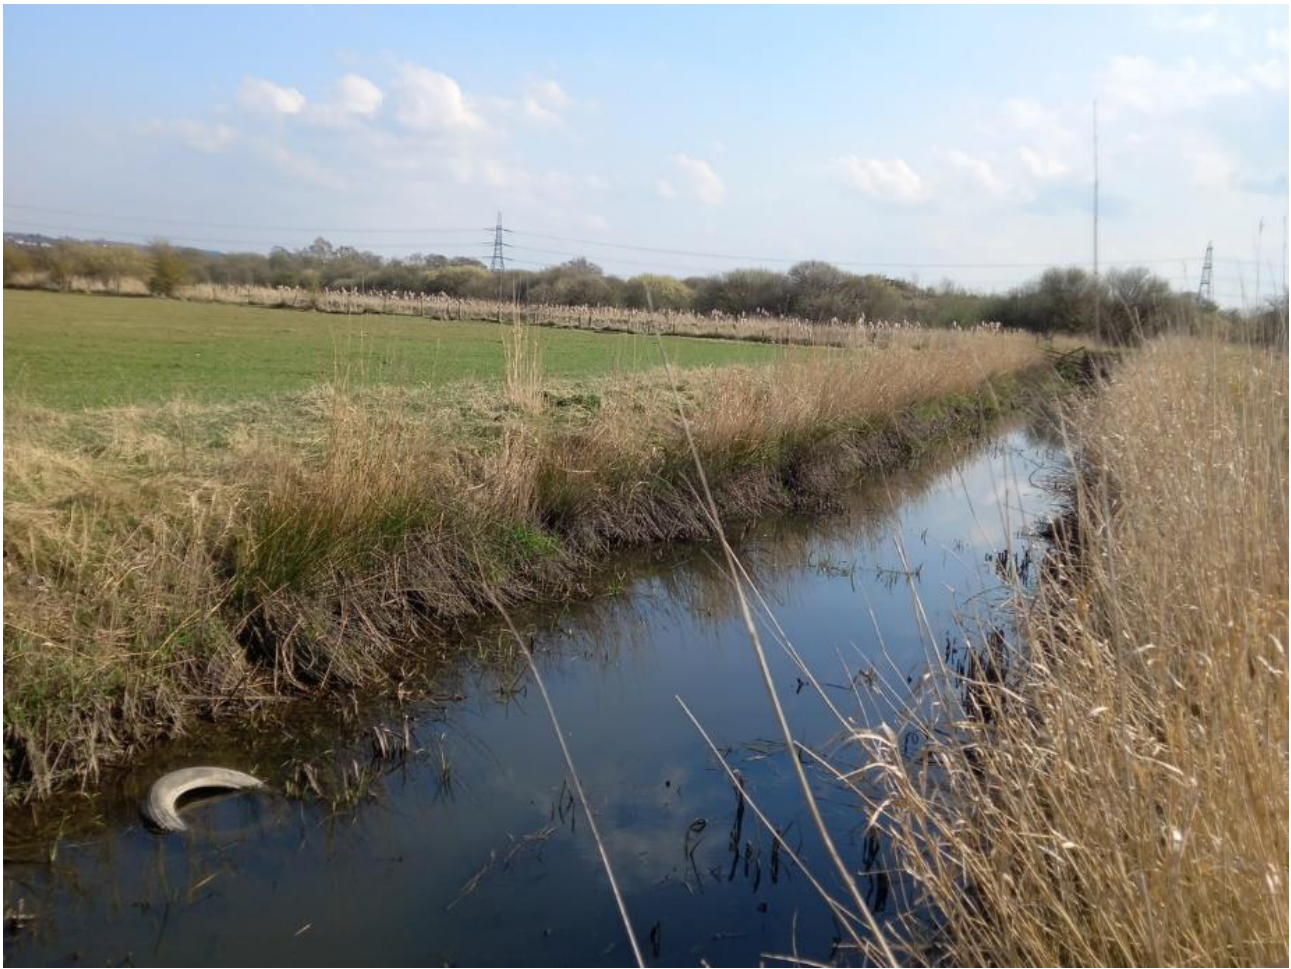
WEST CENTRAL DRAIN

Catchment area	0.55km ²
Key hydraulic connections	Drains the Elton Marsh Drains (1-13), joined by Hapsford Brook and East Central Drain at Ince Marshes. Flows northwards towards the Manchester Ship Canal where water is pumped into the canal at high flows. The watercourse discharges to Hoolpool Gutter.
River Condition Score	Fairly Poor
Catchment description	The West Central Drain forms the main stem off the Elton Marsh Drains (1 –13). The channel drains a small catchment of farm and agricultural land.

<p>Study reach description</p>	<p>The watercourse is a trapezoidal artificial channel with bankfull width varying between 5-6m and water depth approximately 0.8m. It has a mixture of steep and shallow banks through the Newbuild Infrastructure Boundary.</p> <p>Bed material is predominantly silt and organic matter. The riparian zone comprises grazed grassland which is frequently wet. There are tall grasses along both banks of the watercourses.</p> <p>The West Central Drain has provided drainage for the Ince Marshes since at least 1885. The Western Central Drain has maintained a similar form since 1914.</p>
<p>Interaction with the DCO Proposed Development</p>	<p>West Central Drain will be crossed by the Newbuild Carbon Dioxide Pipeline in one location via open cut. The watercourse would also be crossed by vehicles using existing access tracks over existing culverts in the Newbuild Infrastructure Boundary.</p>

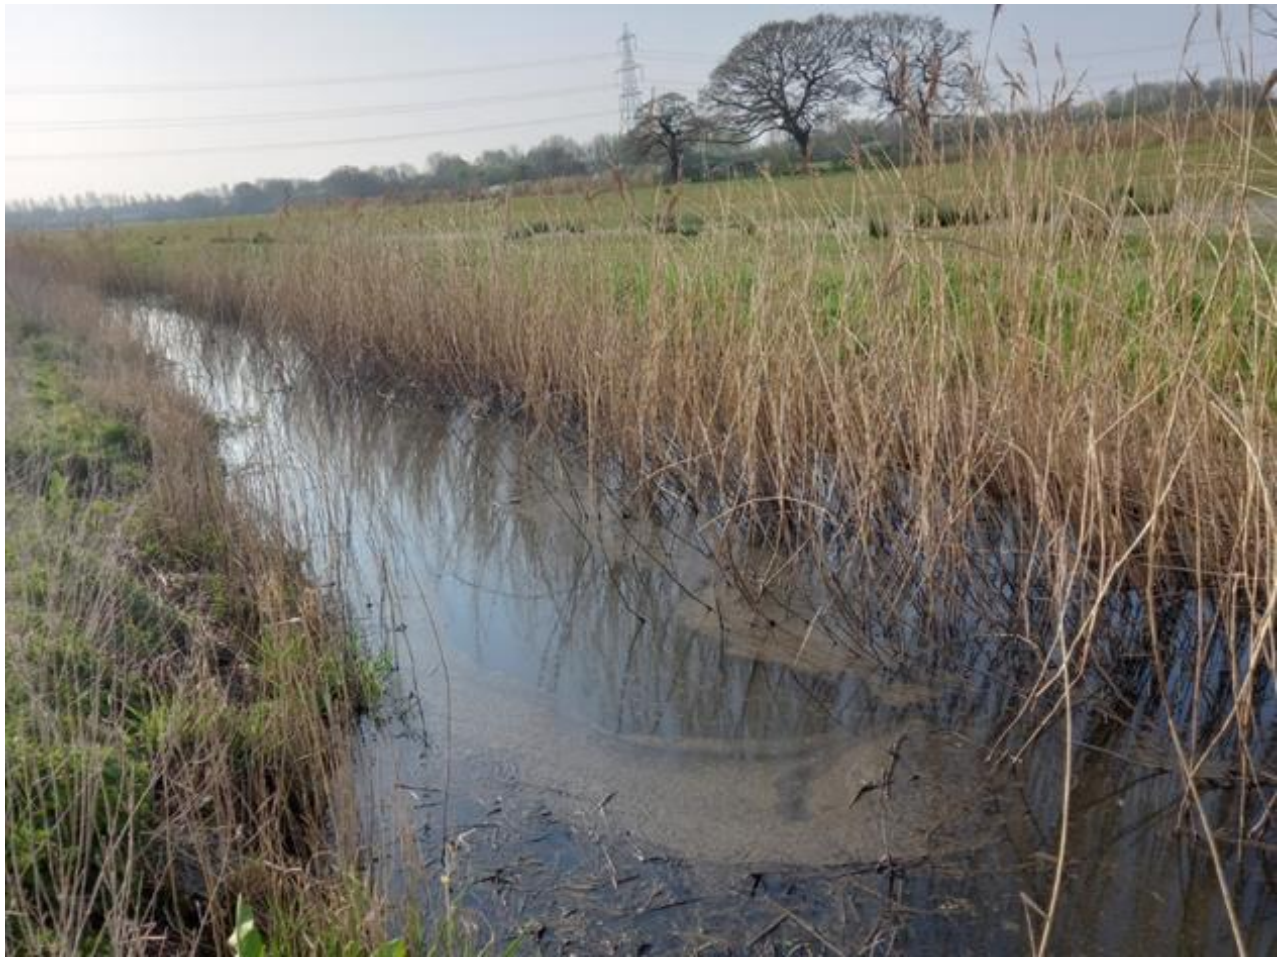
2.3. HAPSFORD BROOK

Catchment area	2.87km ²
Key hydraulic connections	The Hapsford Brook drains the Elton Marshes between Hapsford Lane and the M56, connecting to Elton Marsh Drains 9 to 13 in peak flow and discharging to West Central Drain.
River Condition Score	Moderate
Catchment description	The channel drains a catchment consisting of arable and horticultural grasslands, with some areas of development (Hapsford and Elton). The source of the Hapsford Brook rises from Dunham-on-the-Hill (40.1 -60 mAOD).

<p>Study reach description</p>	<p>The watercourse is a trapezoidal cut channel with a bankfull channel width of 5.5 m and depth of 0.4 m. The watercourse is ungauged.</p> <p>With regards to bed material, there is extensive silt cover with some accumulations of organic matter. There is some emergent reeds and linear leaved aquatic vegetation.</p> <p>There is a low diversity of riparian vegetation, with the banks being largely bare. The riparian zone is grazed pasture which is frequently wet.</p> <p>The planform morphology of the channel has been unchanged since 1903, though the watercourse was culverted following the construction of the M56 roadway (1968-1971).</p>
<p>Interaction with the DCO Proposed Development</p>	<p>The watercourse will be crossed by the Newbuild Carbon Dioxide Pipeline via open cut.</p>

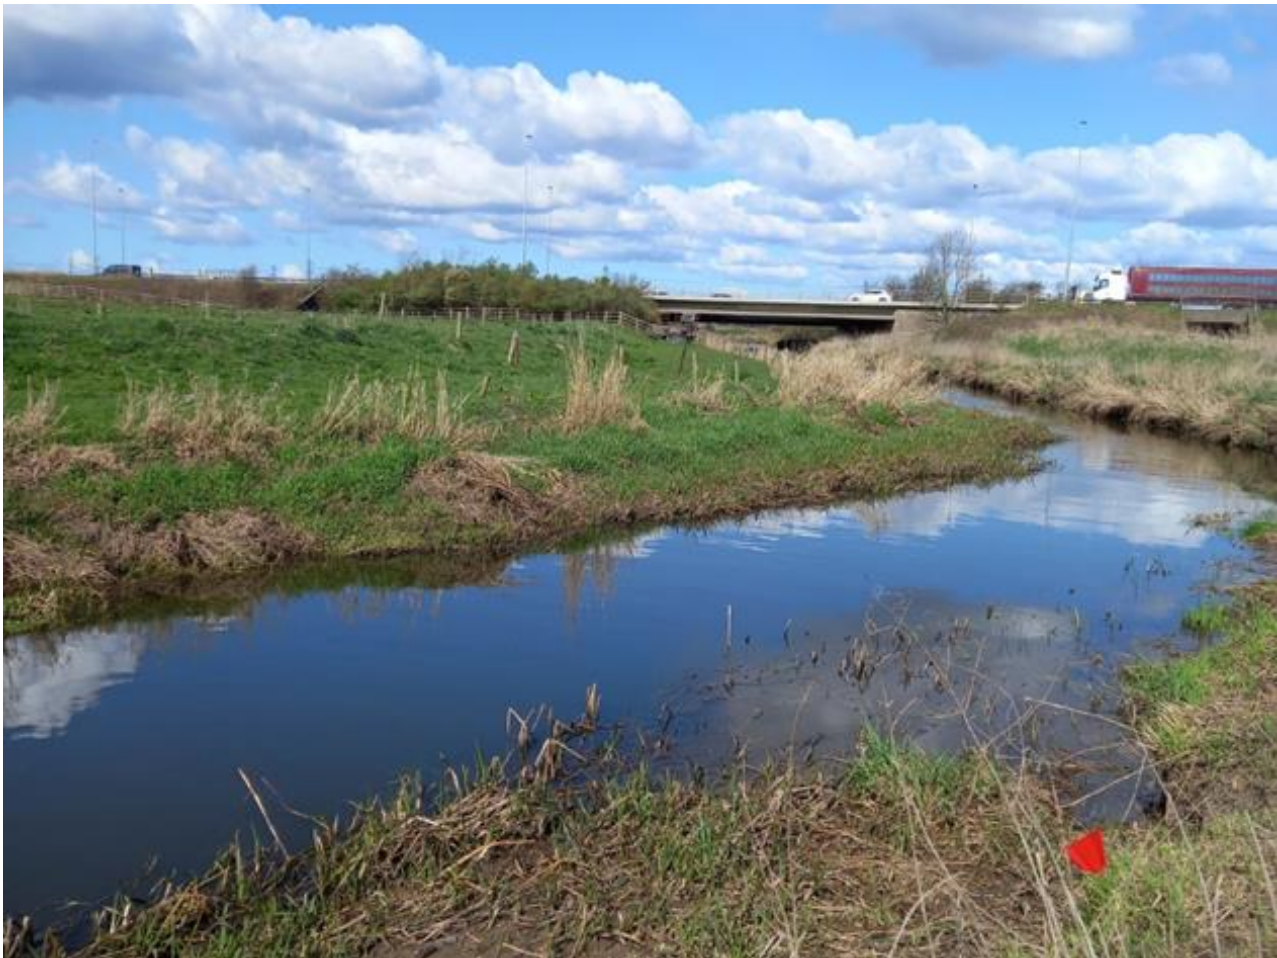
2.7. RIVER GOWY

Catchment area	150km ²
Key hydraulic connections	<p>The River Gowy is fed by the Barrow Brook, Back Brook, Milton Brook, Salters Brook and Ashton Brook upstream of the DCO Proposed Development. Downstream of the DCO Proposed Development, the River Gowy is joined by Thornton Main Drain, Thornton Uplands, Stanney Mill Brook and Gale Brook. The River Gowy flows into the River Mersey.</p> <p>The river is disconnected from its floodplain due to flood defences through most of its middle and lower course.</p>
River Condition Score	Moderate

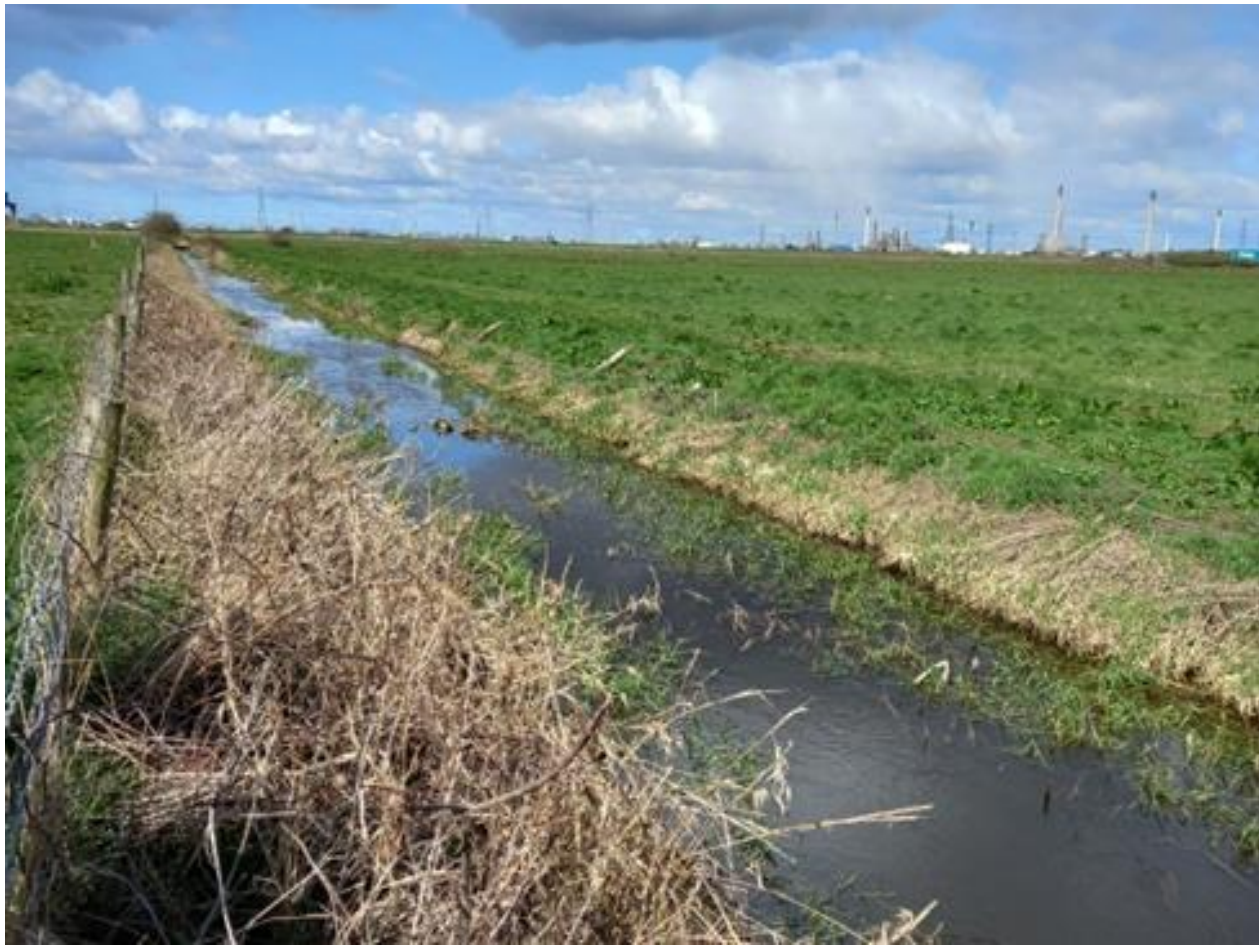
2.8. STANNEY MAIN DRAIN

Catchment area	<1km ²
Key hydraulic connections	This is an artificial drain within the River Gowy floodplain. It is connected to Thornton Ditch (1,2), Mill Brook, Mill Brook Tributary (1,2) and Gowy Tributary (1,2). It joins the River Gowy at the A5117.
River Condition Score	Fairly Poor
Catchment description	Stanney Main Drain drains agricultural and pastoral land in its headwaters, with the surrounding land use being farmland, agricultural buildings and roadways. The catchment is boggy in the headwaters. The channel rises from farm ditches, around 0.47 km west of Bridge Trafford. It has a maximum catchment altitude of 6 mAOD.

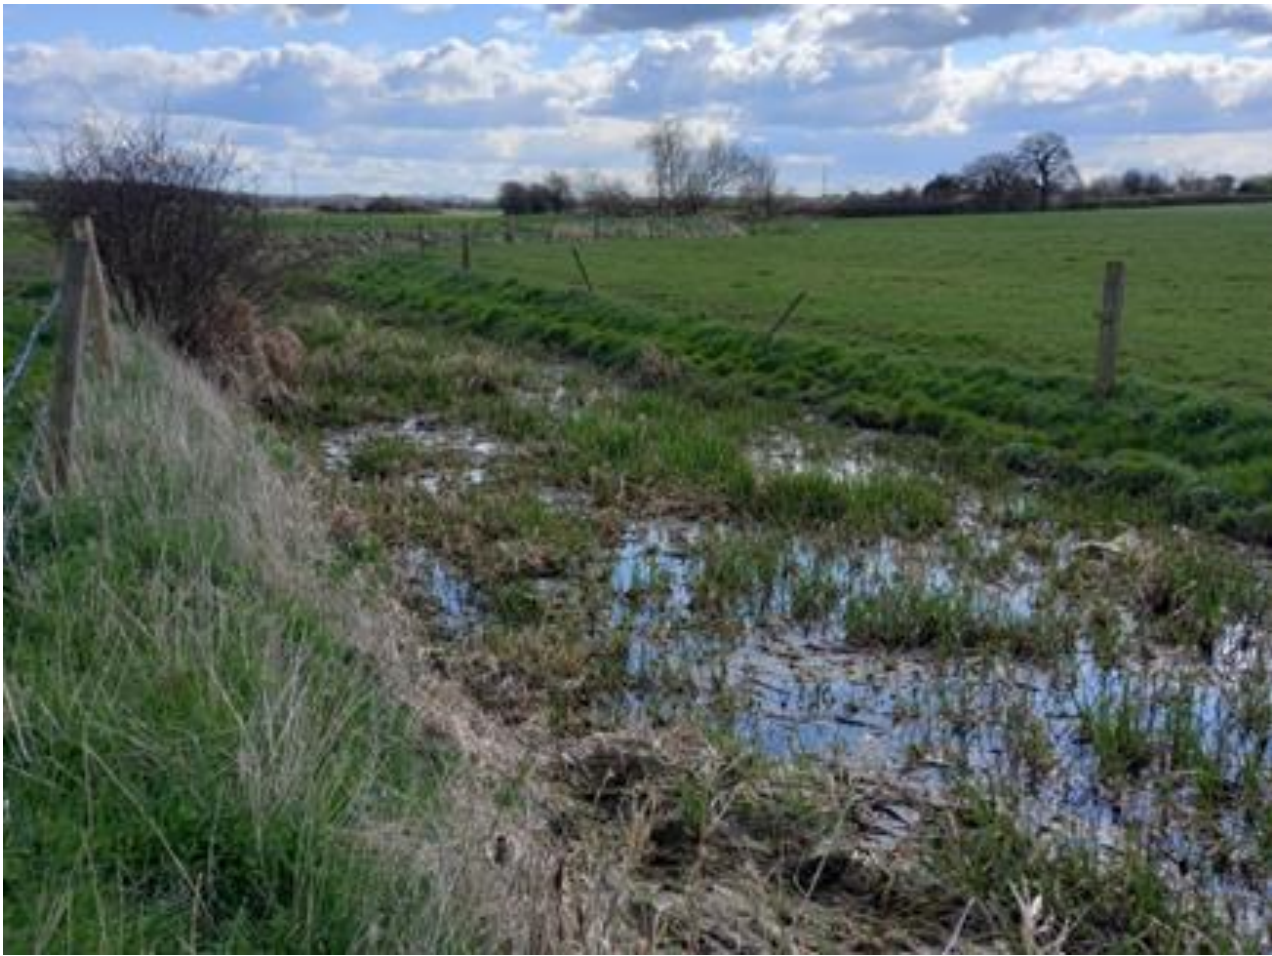
STANNEY MILL BROOK

Catchment area	6.95km ²
Key hydraulic connections	<p>Gowy Tributary 2 connects Stanney Mill Brook and Stanney Main Drain. Picton Brook flows into the Stanney Mill Brook. The Stanney Mill Brook drains into the Gowy downstream of the A5117.</p> <p>There is a wastewater treatments works on the Stanney Mill Brook south of the A5117 into which the watercourse may outfall, though this is unconfirmed.</p> <p>Within the Newbuild Infrastructure Boundary the watercourse is disconnected from its floodplain.</p>
River Condition Score	Moderate – Fairly Poor

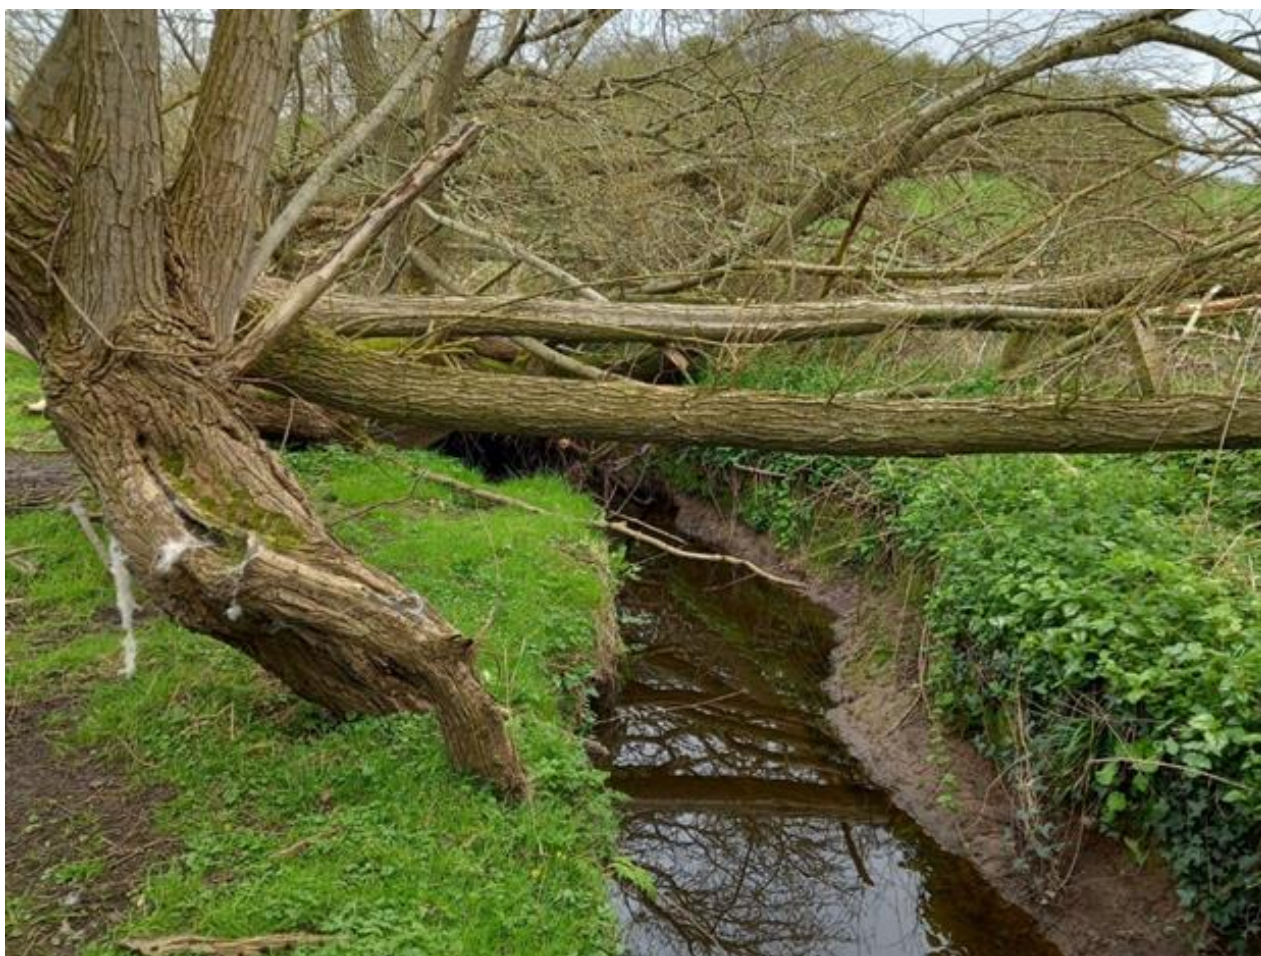
2.10. BACKFORD BROOK

Catchment area	4.97 km ²
Key hydraulic connections	There are three tributaries of Backford Brook which drain land south of Dunkirk and the M56. Backford Brook is culverted beneath the Shropshire Union Canal and then joins Finchetts Gutter.
River Condition Score	Fairly Good upstream of field culvert. Fairly Poor downstream of field culvert.
Catchment description	The catchment is predominantly rural, with the main land uses being pasture, grassland, and woodland. Elevation varies from 38m to 19mAOD.

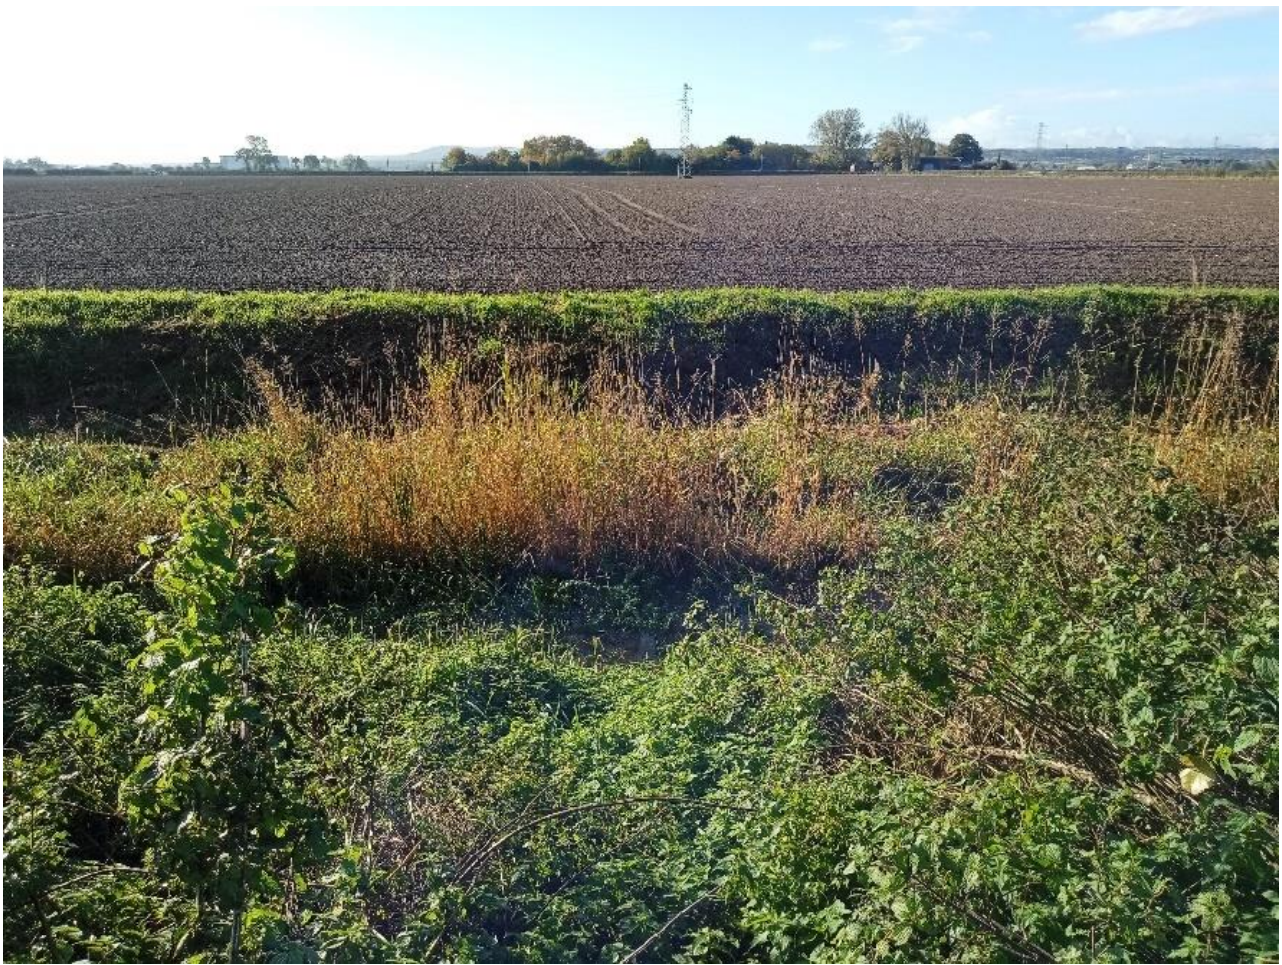
2.12. SEALAND MAIN DRAIN

Catchment area	6.74km ²
Key hydraulic connections	The Sealand Main Drain receives water from the Seahill Drain and the Garden City Gutter before flowing to the River Dee. The watercourse is disconnected from its floodplain.
River Condition Score	Fairly poor
Catchment description	The catchment is marked by several artificial watercourses; therefore, it is unlikely to reflect the original geometry. The current catchment drains tilled farm land, pasture, grassland, woodland, and urban areas.

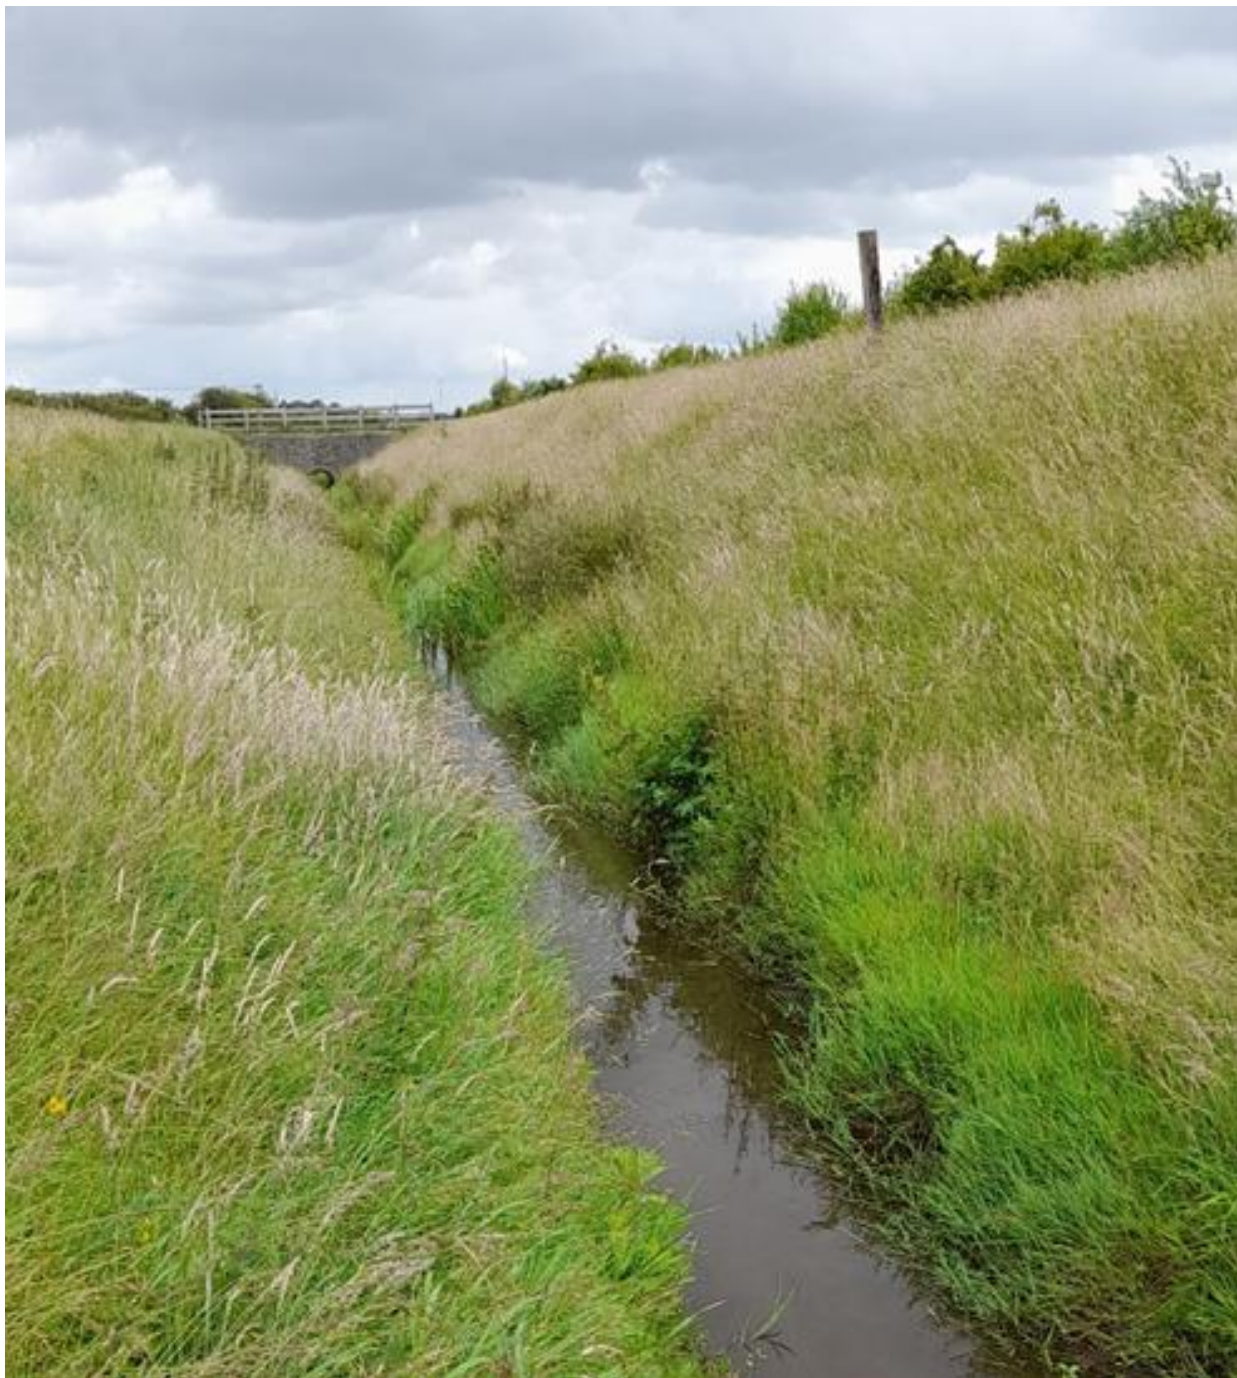
2.14. HAWARDEN BROOK

Catchment area	<1km ²
Key hydraulic connections	The Hawarden Brook discharges to the River Dee. There is a flow control structure on the confluence of the watercourse with the Dee to prevent tidal flows from entering Hawarden Brook.

River Condition Score	Not surveyed due to land access restrictions
Catchment description	This watercourse and its small low-lying catchment have been heavily modified by the constriction of the Dee and draining of the floodplain. The predominant land use is pastoral farming and the airfield.
Study reach description	Downstream of the B5129 the watercourse flows through an artificially incised, re-sectioned channel with a trapezoidal cross section. Whilst the channel is mostly unchanged since 1988, the catchment was heavily modified by the construction of the Airbus factory and runway.
Interaction with the DCO Proposed Development	The watercourse is not crossed by the Newbuild Carbon Dioxide Pipeline. It will be crossed via a new temporary crossing during the construction phase.

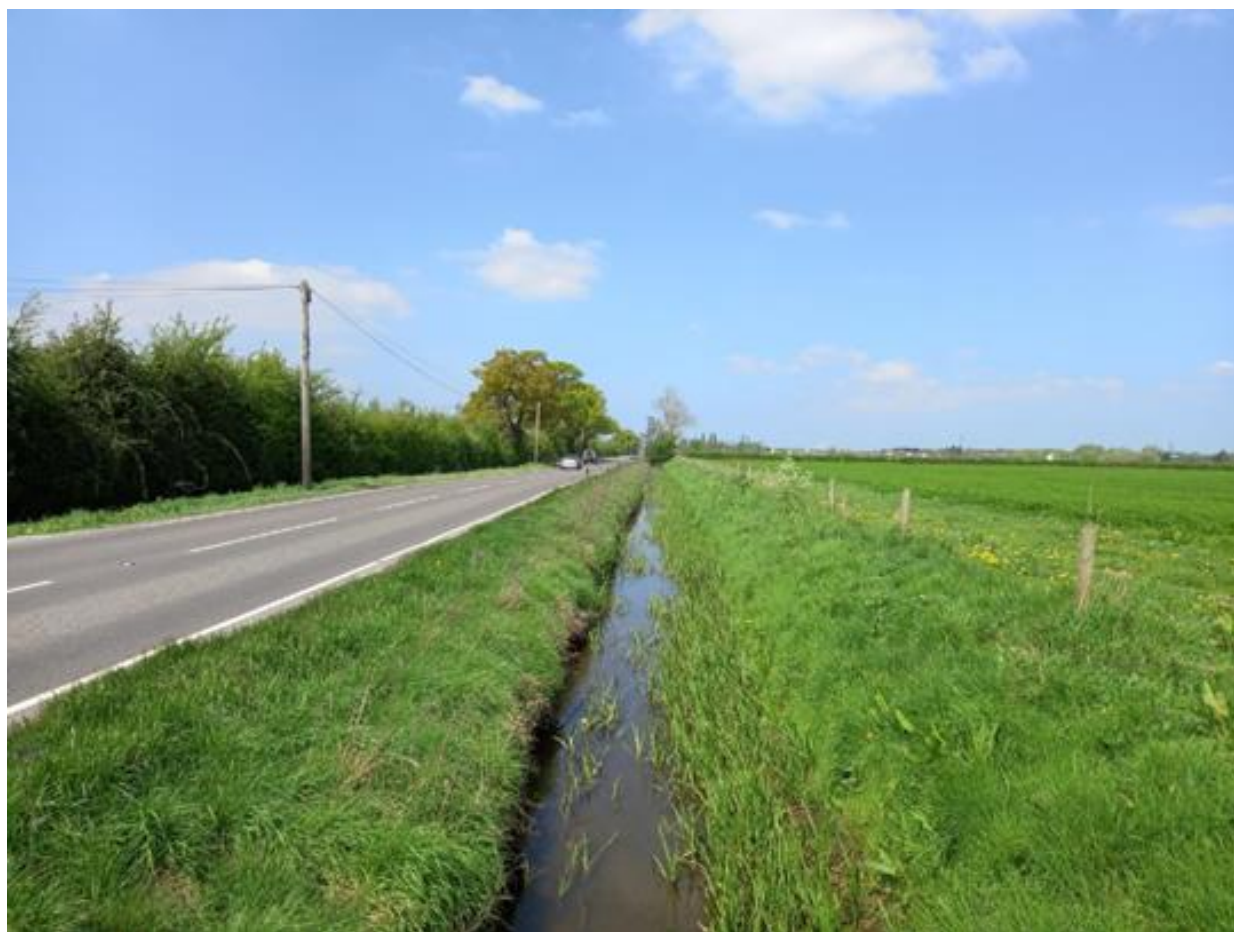
2.15. BROUGHTON BROOK

Catchment area	11.72km ²
Key hydraulic connections	<p>The Broughton Brook flows to the River Dee at Station Road. Along the B5129 it is joined by several tributaries flowing north-eastwards from Hawarden. There are drains along Chester Road which connect to the Broughton Brook prior to it joining the River Dee.</p> <p>The watercourse is disconnected from its floodplain as it is within an incised channel.</p>
River Condition Score	Fairly Poor
Catchment description	<p>The catchment has a high degree of human influence on watercourses and the landscape, with the surrounding land use predominantly arable farming, improved grassland and woodland. Elevation varies from ~ 157 mAOD to 8mAOD.</p>

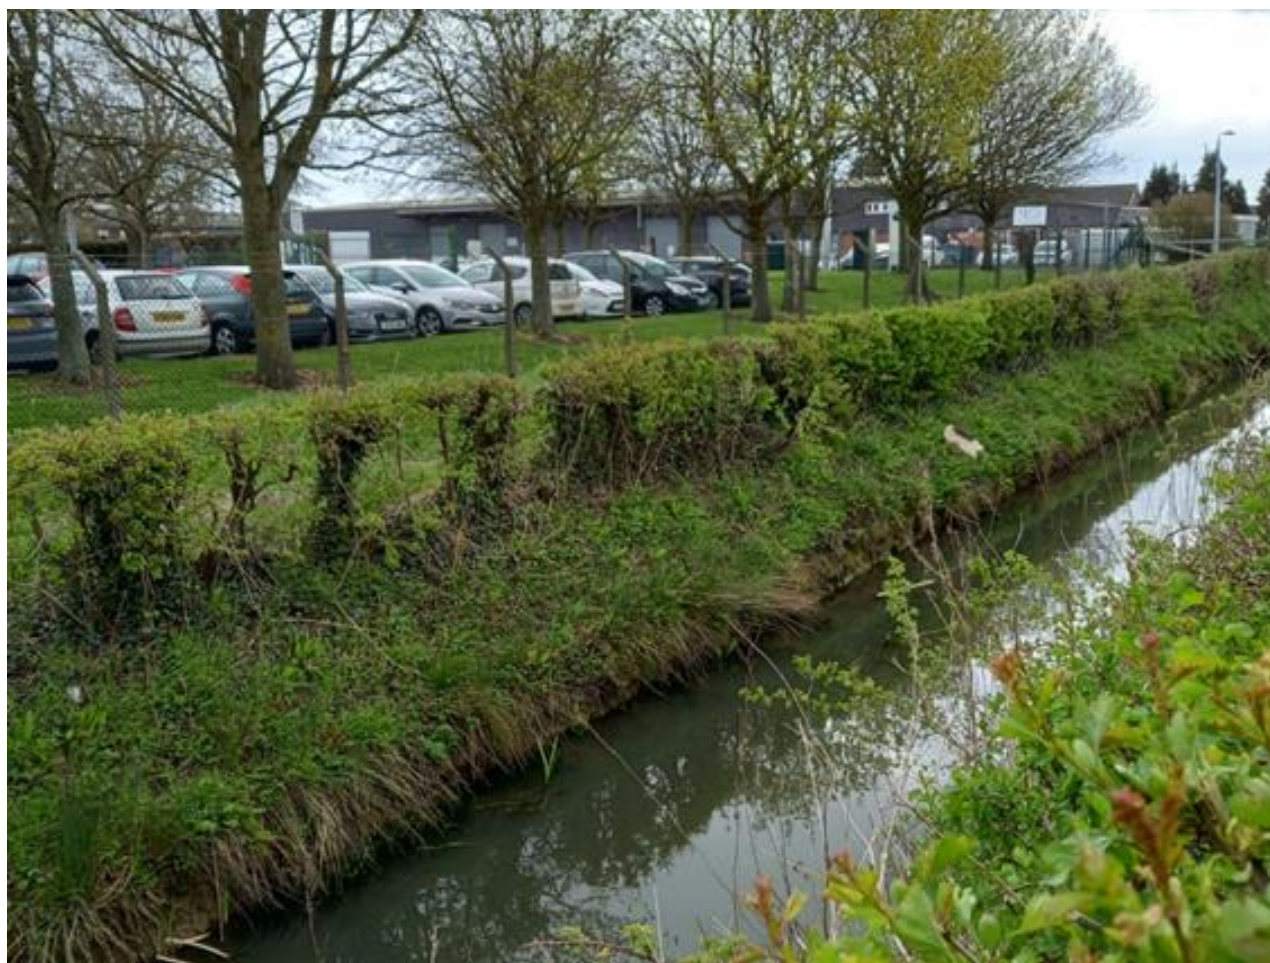
2.17. CHESTER ROAD DRAIN NORTH

Catchment area	1.67 km ²
Key hydraulic connections	This watercourse is hydraulically connected to both the Broughton Brook (southeast) and Aston Hall Brook (Northwest). The channel is not connected to the floodplain.
River Condition Score	Poor
Catchment description	The catchment drains farmland and arable fields, with extensive urbanisation north of the watercourse. The catchment is relatively flat catchment, with the elevation varying from 80 – 8 mAOD.

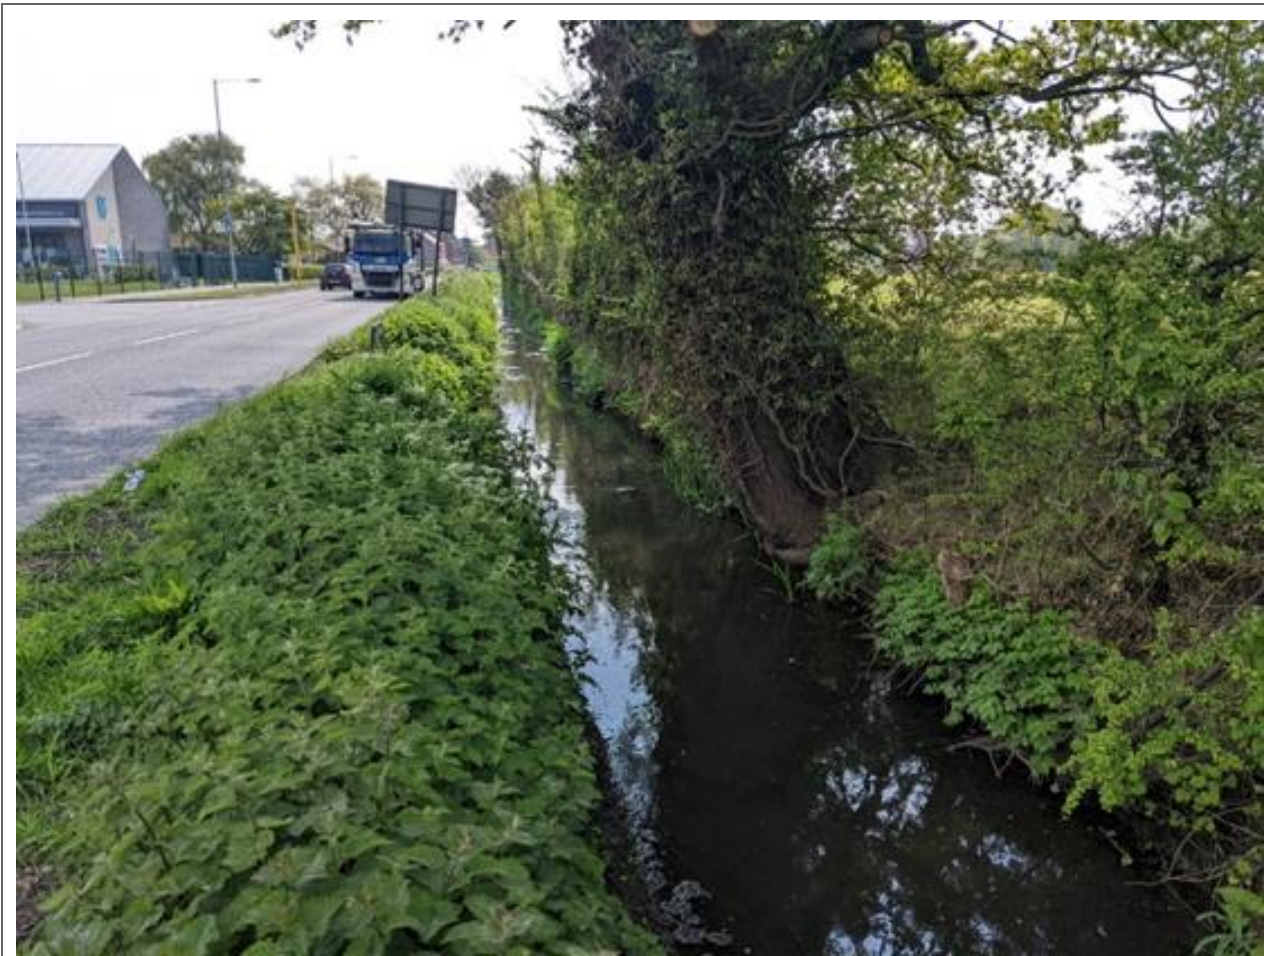
CHESTER ROAD DRAIN TRIBUTARY 1 AND 2

Catchment area	<1km ²
Key hydraulic connections	Onwards connection to Chester Road Drain North. The channel is not connected to the floodplain.
River Condition Score	Fairly Poor
Catchment description	The catchment drains farmland and arable fields with extensive urbanisation to the north of the watercourse. It has a relatively flat catchment, with elevation varying from 80 - 8 mAOD.

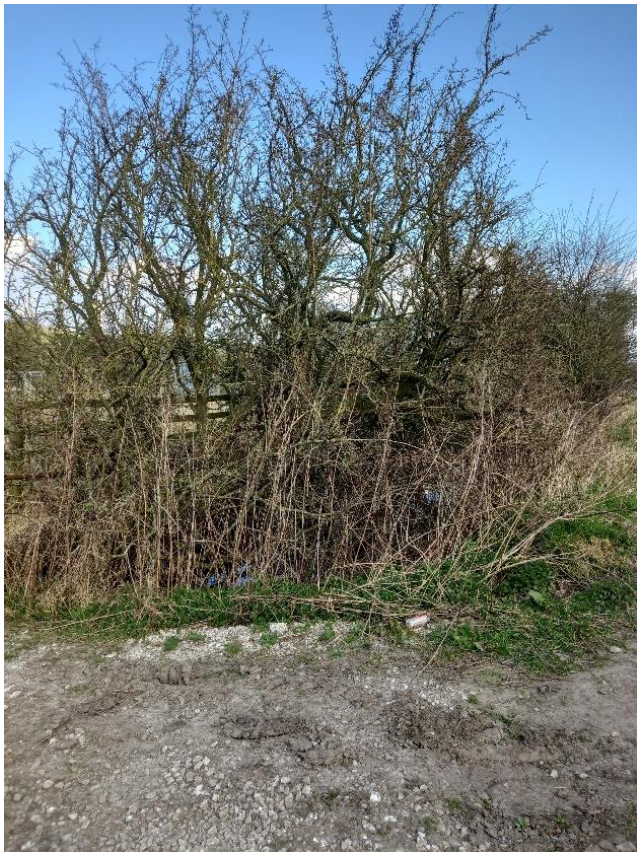
Catchment area	<1km ²
Key hydraulic connections	Ephemeral watercourses which connect to West Central Drain and East Central Drain
River Condition Score	Poor (Ditch survey) (Elton Lane Ditch 1, 2 and 6) Moderate (Ditch survey) (Elton Lane Ditch 4)
Catchment description	Grazed farmland which is historically coastal and fluvial marshland which has been drained via a series of ditches and pumping.
Study reach description	The ditches within the Newbuild Infrastructure Boundary are narrow channels artificially cut around field boundaries. These ditches are ephemeral and have simple vegetation structures.

Elton Lane Ditch 1 and 4 will be crossed by the Newbuild Carbon Dioxide Pipeline via open cut. Other ditches are located within the Newbuild Infrastructure Boundary. Elton Lane Ditch 1 is currently culverted beneath a field access. This culvert will be replaced with a longer culvert to provide permanent access to Ince AGI. Ince AGI is located within 10m of Elton Lane Ditch 1 and 2. The surface water drainage system from Ince AGI will discharge to Elton Lane Ditch 1.

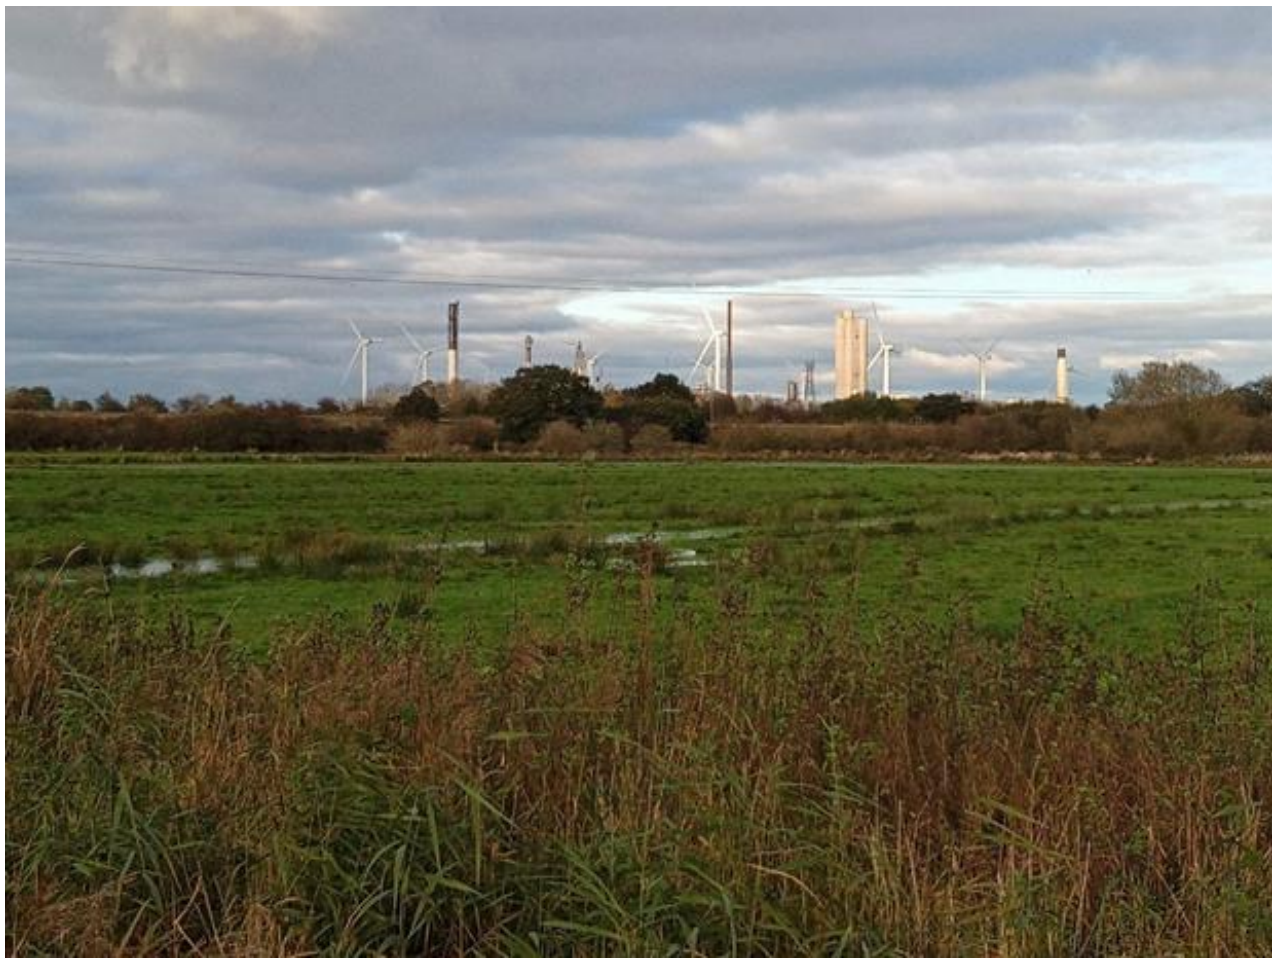
ELTON MARSH 1, 2, 3, 10, 11, 12, AND 13

Catchment area	<1km ²
Key hydraulic connections	Elton marsh ditches are all connected to the West Central Drain which is part of the wider Ince Marshes.
River Condition Score	Poor (Ditch survey)
Catchment description	Grazed farmland which is historically coastal and fluvial marshland which has been drained via a series of ditches and pumping.
Study reach description	The ditches are straight shallow ephemeral channels which have been artificially cut in order to drain the marshland. The floodplain is frequently flooded.
Interaction with the DCO Proposed Development	Elton Marsh 1, 2,3, 11, 12 and 13 could be crossed by the Newbuild Carbon Dioxide Pipeline via open cut. The exact route of the Newbuild Carbon Dioxide Pipeline is not determined at this stage.

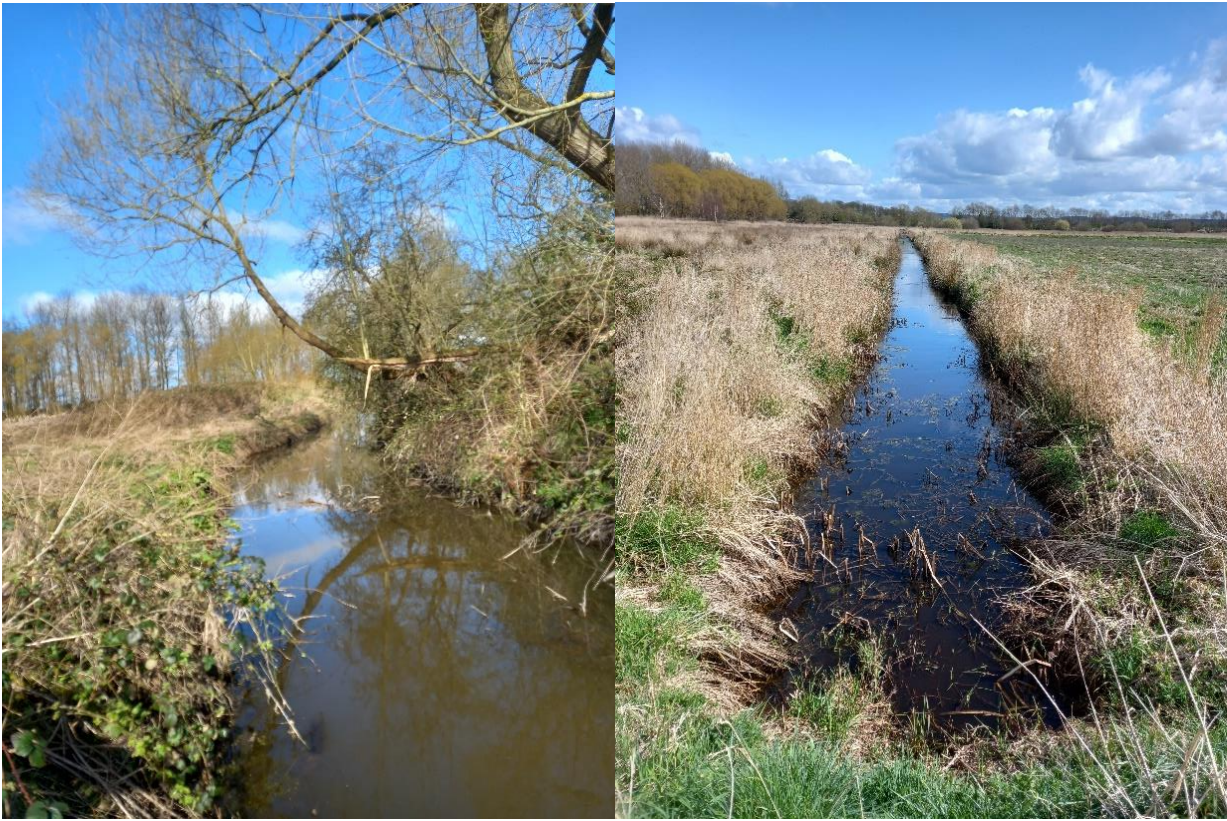
3.7. THORNTON DITCH 1, 2, 3, 4, 5 AND 6

Catchment area	<1km ²
Key hydraulic connections	Thornton Ditches 1 and 2 connect to Stanney Main Drain whilst Thornton Ditches 3, 4, 5 and 6 connect to Thornton Main Drain, both of which discharge to the River Gowy north of the DCO Proposed Development.
River Condition Score	Thornton Ditch 1: Moderate (Ditch survey) Thornton Ditch 2, 3, 4, 5 and 6: Poor (Ditch survey)
Catchment description	The catchment is predominantly grazed farmland or peat bog, most of which is within the fluvial floodplain of the River Gowy and is frequently wet.

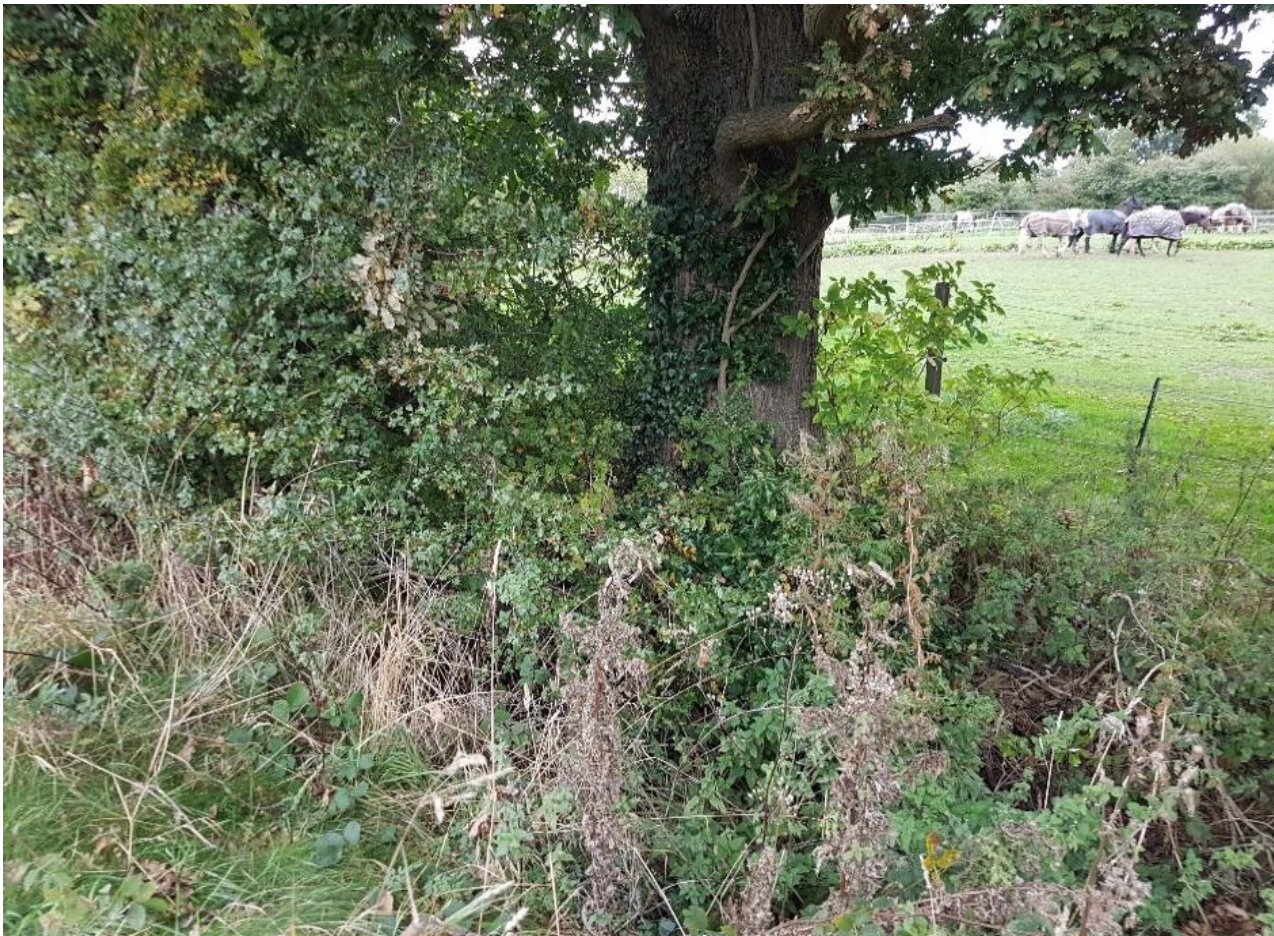
3.11. COLLINGE WOOD BROOK

Catchment area	<1km ²
Key hydraulic connections	Onward connection to canal ditch and is likely culverted beneath Shropshire Union Canal to join Finchetts Gutter.
River Condition Score	Not surveyed
Catchment description	Drains agricultural and pastoral land. The surrounding land use is farm buildings and tracks, improved grassland, arable and horticultural land, some broadleaved and mixed and yew woodland. Catchment altitude varies between ~ 42 mAOD - ~11mAOD.

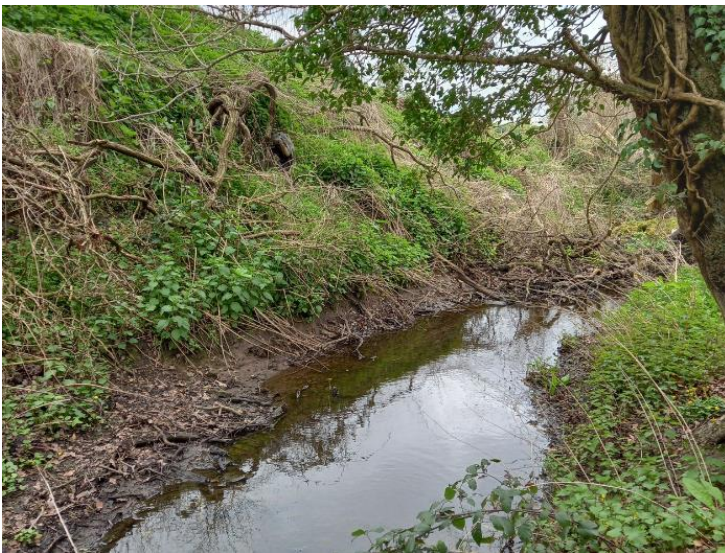
Moderate section within Newbuild Infrastructure Boundary

Key hydraulic connections	Finchetts Gutter Tributary flows southeast towards Blacon, under which it is culverted. It joins the Finchetts Gutter south of Saughall Road.
River Condition Score	Fairly good in the upper reach and moderate in the lower reach within the Newbuild Infrastructure Boundary.
Catchment description	<p>The catchment is rural in nature, with mainly open farmland and has some small areas of trees standing. Relatively shallow gradient and unconfined floodplain.</p> <p>The watercourse is approximately 7 km in length, with an elevation range between 10 and 46 mAOD. The catchment drains local farmland and arable fields</p>
Study reach description	<p>The channel is slightly sinuous, although it appears to have realigned for agriculture in the past. Bankfull width is up to 10m in some locations within the study reach. Water depths are shallow, at approximately 0.2m on average throughout surveyed reach.</p> <p>The bed material is primarily gravel and pebble, with areas of sand and silt present on channel bed. Within the riparian zone, the is channel lined with trees and scrub on both banks. Beyond the immediate treeline there is agricultural land on both banks.</p> <p>No significant changes in channel course since the 1st edition OS maps (1888)</p>

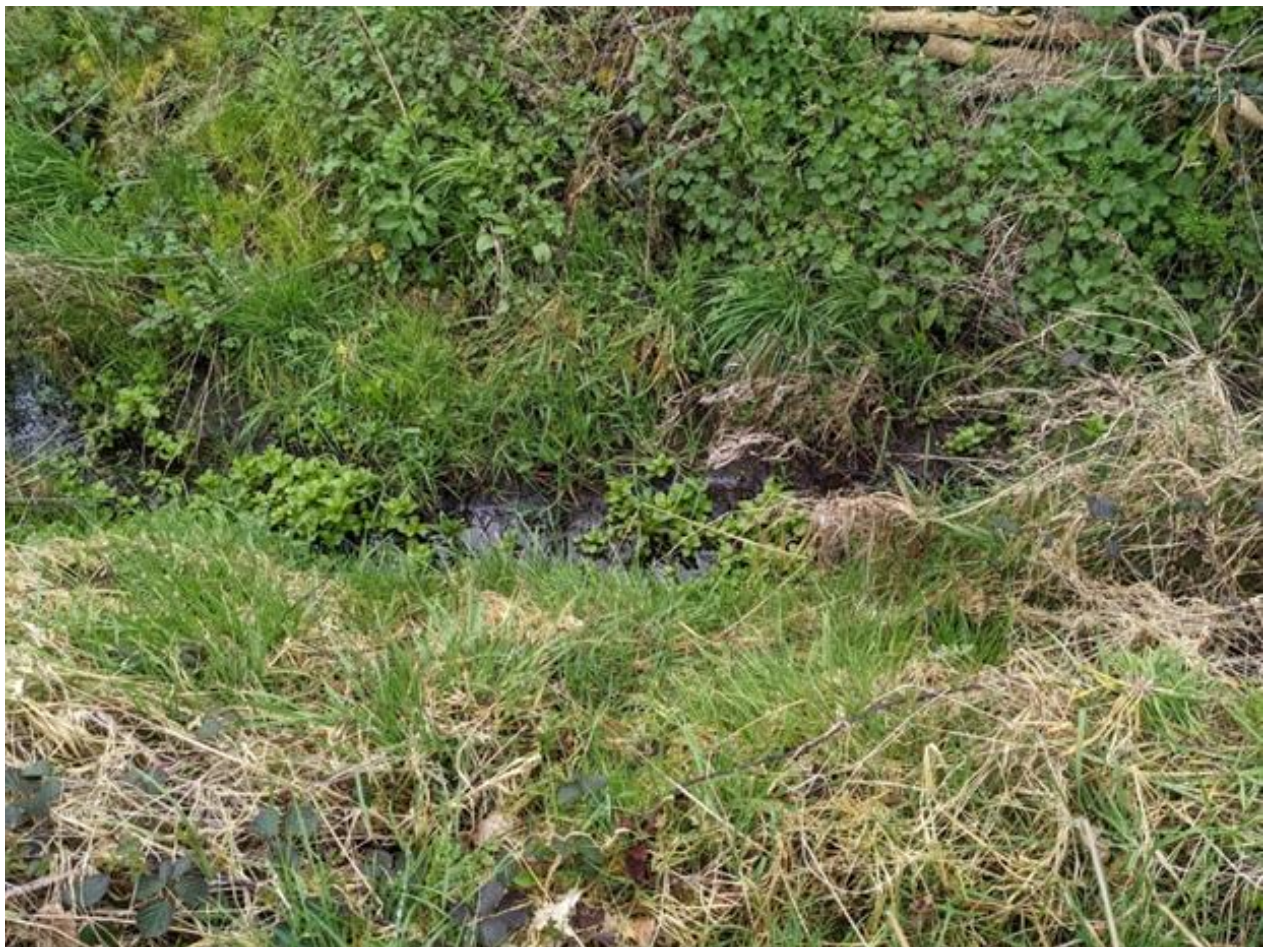
3.18. SEAHILL TRIBUTARY 2

Catchment area	0.270km ²
Key hydraulic connections	This watercourse has no tributaries. This watercourse joins the Seahill Drain at its downstream end.
River Condition Score	Fairly poor
Catchment description	Highly modified catchment, in which the land use is arable agriculture. The total watercourse length is 0.5km, and the elevation changes from 5mAOD to 20mAOD.
