HyNet North West

ENVIRONMENTAL STATEMENT (VOLUME III)

Appendix 18.1 Baseline Information

HyNet North West Carbon Dioxide Pipeline DCO

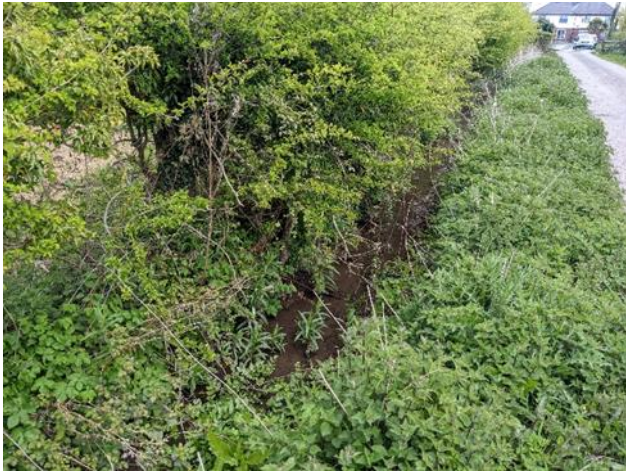
Mancot Brook - Downstream Reach

Key hydraulic connections	Onward connection into Chester Road Drain South, which flows beneath the B5129 to join the Broughton Brook.
River Condition Score	Moderate
Catchment description	<p>The catchment is predominantly rural, thus mostly draining farmland and arable fields. This comprises improved and neutral grassland, broadleaved, mixed and yew woodland.</p> <p>The catchment is relatively flat, with the elevation varying from 80 - 8 mAOD.</p>
Study reach description	<p>The channel is incised in places, with bankfull channel width varying between 1.5-3m, whilst water depth is between 0.05 – 0.07m.</p> <p>The channel has a silt substrate with extensive cover of bare earth. Some broad and linear leaved aquatic vegetation is present. At the location of the upstream proposed open cut crossing, the riparian zone is dominated by short grassland pasture. At the downstream proposed crossing location there is a hedge along the left bank and a private drive on the right bank within the riparian zone.</p> <p>Since 1913, the channel has retained its planform as a drainage channel to the surrounding arable land. The channel has been elongated to follow field boundaries, therefore resulting in a shallower gradient compared to its likely natural state.</p> <p>Mancot Brook Tributary is ephemeral and flows through a grazed pasture. It has extensive grass cover to bed and banks.</p>

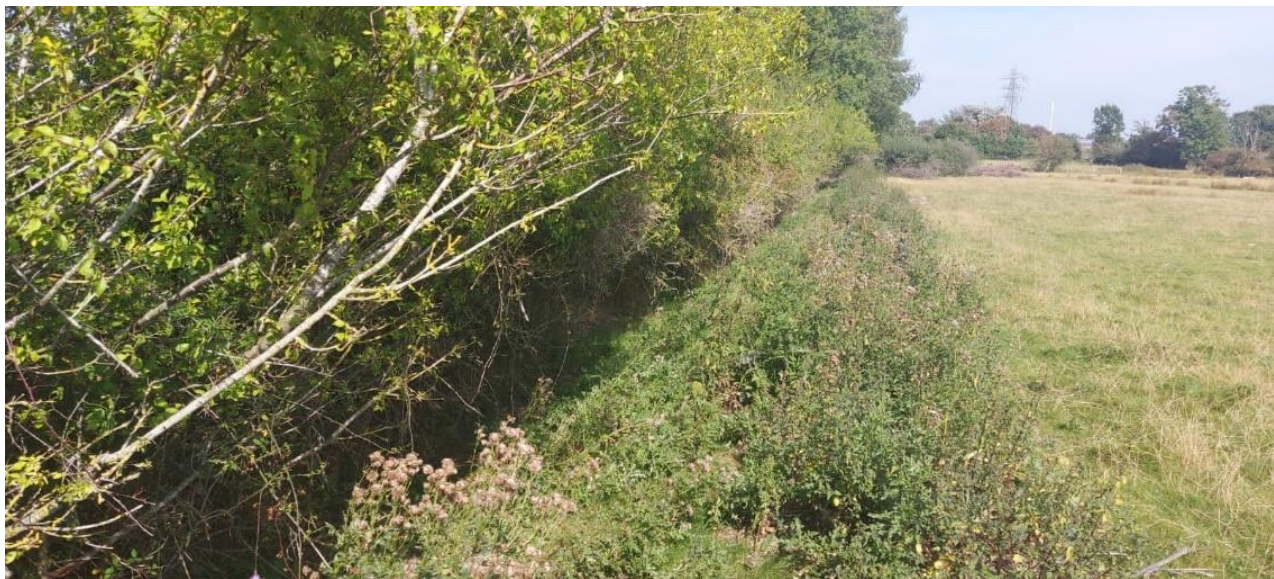
3.21. OAKFIELD DITCH 1 AND 3

Catchment area	<1km ²
Key hydraulic connections	The exact connections of these ditches are unknown however it is likely that water drains toward Chester Road Drain North, Broughton Brook and the Dee.
River Condition Score	Not surveyed
Catchment description	Small catchment of arable and grazed farmland.
Study reach description	The watercourse flows along a field boundary. It has a hedgerow along one bank.
Interaction with the DCO Proposed Development	Oakfield Ditch 3 will be crossed by the Newbuild Carbon Dioxide Pipeline via open cut. Oakfield Ditch 1 is located within the Newbuild Infrastructure Boundary and may be crossed via open cut.

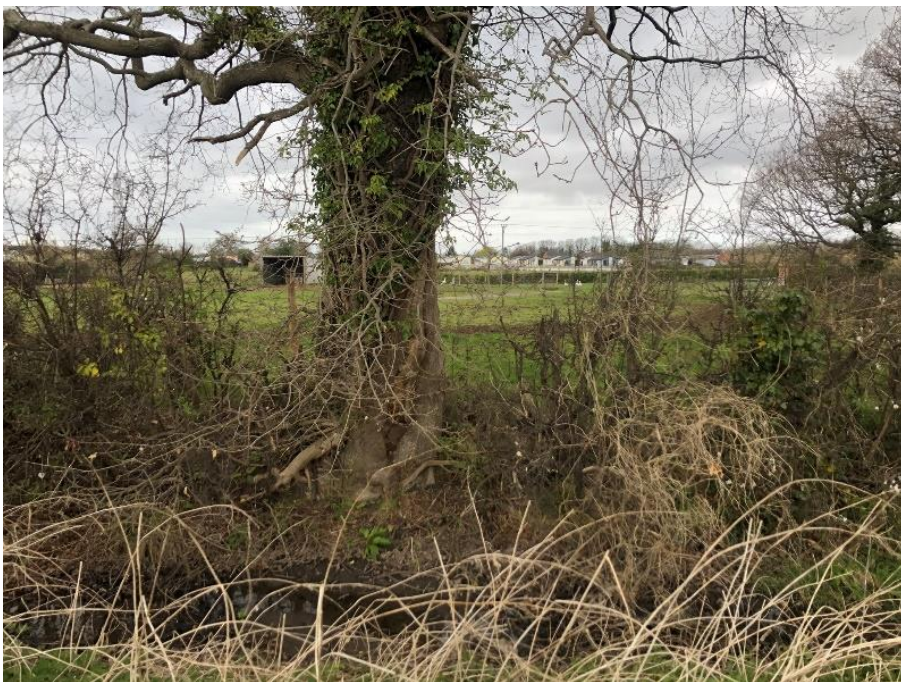
Downstream Moderate reach

River Condition Score	Upstream reach is Fairly Poor Downstream reach is Moderate
Catchment description	Relatively small catchment comprising agricultural fields and residential estates. There is a small on-line pond in the upper catchment.
Study reach description	Bankfull channel width varies between 1m and 2m. Depth varies between 0.3 and 1.5m. The substrate primarily comprises gravels and pebbles, with some silt and sand deposits, potentially introduced due to poaching activity. The channel is extensively poached, with hardcore/rubble used for partial bank protection on the right bank. Riparian vegetation is mostly short grasses and isolated trees on the right bank with hedgerow on the left bank. The bank top land use is pastoral farming.
Interaction with the DCO Proposed Development	The watercourse will be crossed by the Newbuild Carbon Dioxide Pipeline via open cut.

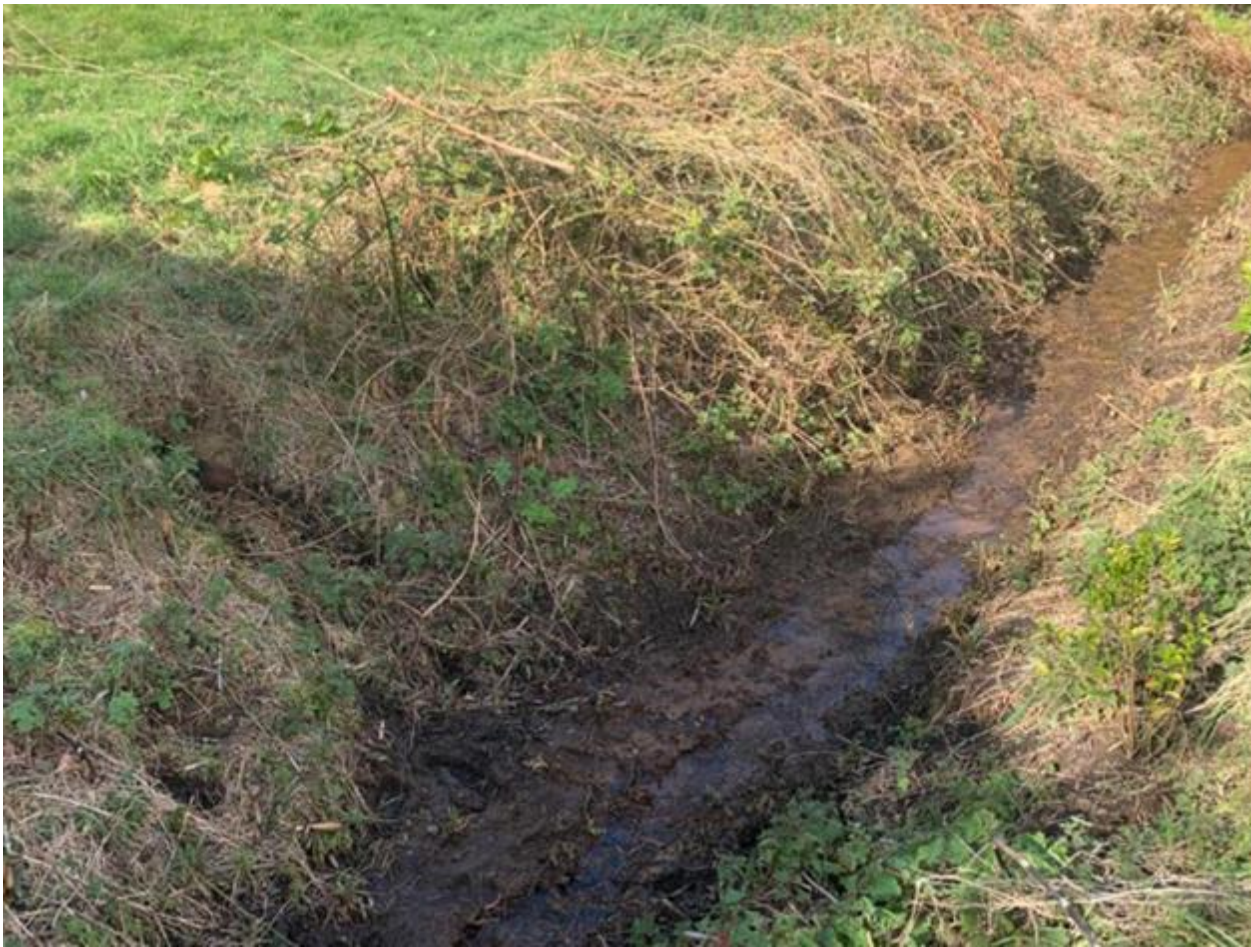
3.24. ASTON HALL BROOK

Catchment area	<0.5km ²
Key hydraulic connections	<p>This watercourse flows north-eastwards towards Deeside. It is joined by two tributaries before joining the Dee.</p> <p>The valley is steep, so the watercourses is not connected to a floodplain.</p>
River Condition Score	Fairly poor
Catchment description	The catchment is very small, with the surrounding land use predominantly rural farmland and suburban residential areas. The watercourse is potentially ephemeral.

<p>Study reach description</p>	<p>The channel has been over deepened and had shallow water depth of approximately 0.05m at the time of survey. Bankfull width was observed to be between 1.5m and 3m.</p> <p>The bed material is mainly composed of sand and silt, with some concrete reinforcement on bed through some private gardens. The riparian zone on the right bank is comprised of short grasses and pastoral farming, with a mixture of vegetation where it flows through private gardens.</p> <p>No changes recorded since 1st edition OS map.</p>
<p>Interaction with the DCO Proposed Development</p>	<p>This watercourse is within the Newbuild Infrastructure Boundary but is not crossed by the Newbuild Carbon Dioxide Pipeline.</p>

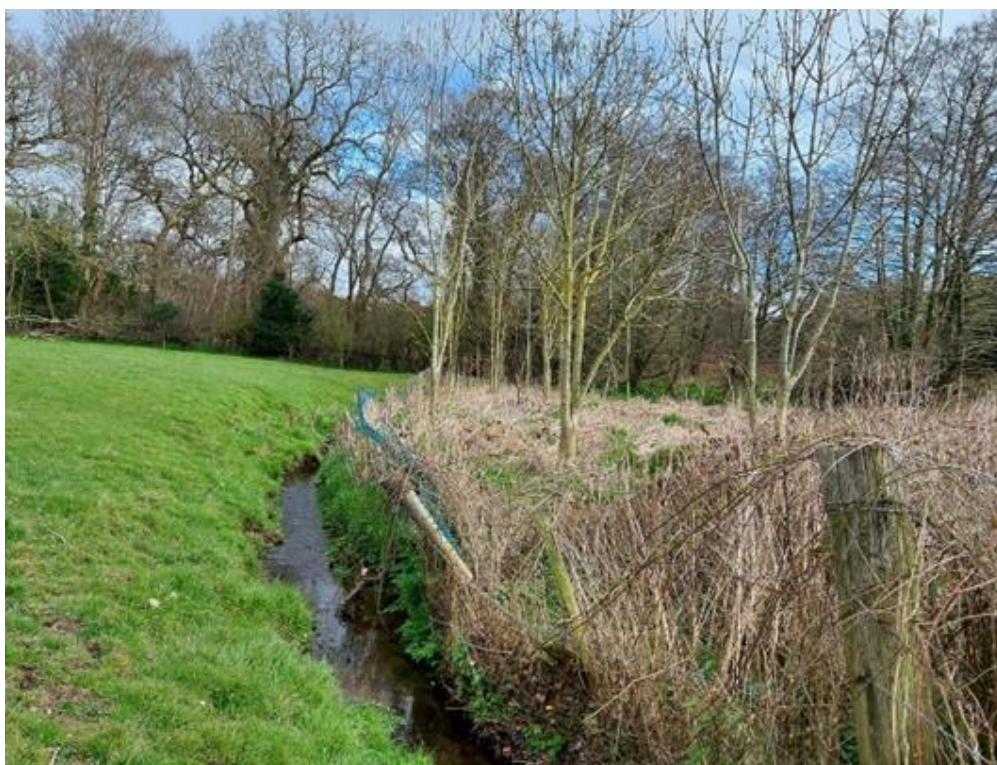
Wepre Brook A55 reach

Catchment area	9.57km ²
Key hydraulic connections	Wepre Brook has several tributaries, mostly from the south of the catchment. The Alltami Brook and New Inn Brook both connect to the Wepre Brook downstream of the study area.
River Condition Score	A55 reach: moderate; Brookside reach: fairly poor; Northrop Hall reach: fairly poor
Catchment description	The majority of the catchment is rural and agricultural. There are small settlements in the catchment (Northop, Northop Hall and Soughton). The A55 and Brookside run parallel to the Wepre Brook through the study reach.

<p>Study reach description</p>	<p>At the A55 reach the channel is narrow (approximately 1m width and 0.3m water depth). Through Brookside and Northop Hall reaches the watercourse is wider (width up to 2m and water depth 0.2m).</p> <p>The bed material is well mixed generally, with areas of both gravel-pebble mix and cobbles. Some areas of sand were observed overlaying armoured substrate in the A55 reach.</p> <p>At the A55 reach, the left bank is short grass pasture for grazing whilst the right bank is plantation woodland and scrub. Through Brookside and Northop Hall there are more mature trees on both banks. There are gabion baskets supporting the right bank through the Brookside reach. The riparian zone through the Northop Hall reach is more substantial than other reaches.</p> <p>Wepre Brook follows largely the same course as depicted on the 1st edition OS maps (1888).</p>
<p>Interaction with the DCO Proposed Development</p>	<p>There are four locations where this watercourse is within the Newbuild Infrastructure Boundary. At the Brookside reach the watercourse will be crossed by the Newbuild Carbon Dioxide Pipeline via open cut.</p> <p>The A55 reach of the Wepre Brook is no longer applicable to the assessment due to the relocation of Northop Hall AGI as part of Change Request 1, which includes the relocation of its outfall from this reach to Wepre Brook Tributary 1. The Northop Hall and Brookside reaches of Wepre Brook remains unchanged and valid.</p>

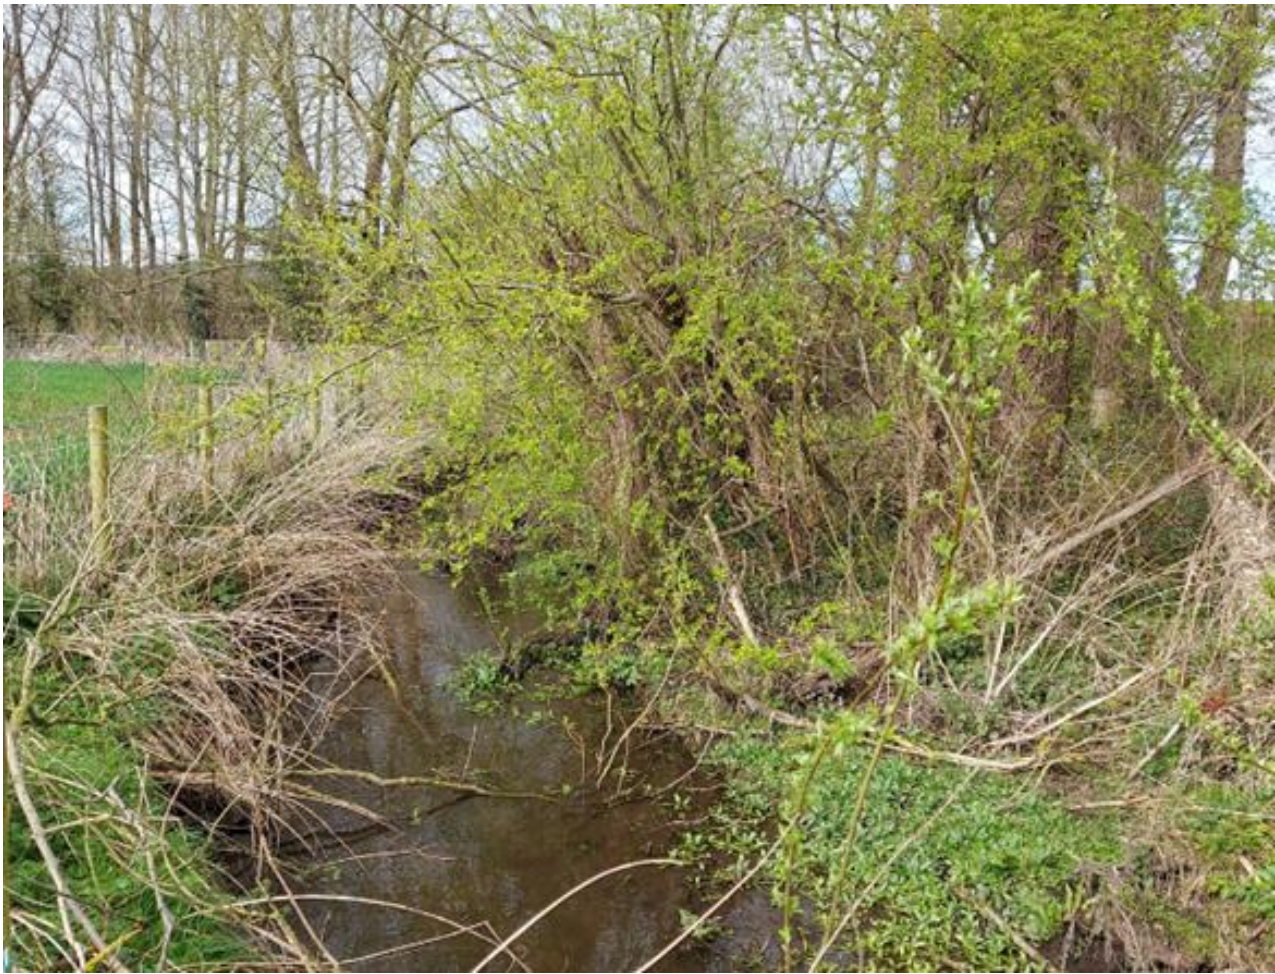
3.28. NORTHOP BROOK

Catchment area	0.98 km ²
Key hydraulic connections	Northop Brook flows northwards and becomes the Lead Brook before joining the Dee.
River Condition Score	Moderate
Catchment description	<p>The catchment is predominantly rural with land used for pastoral and arable farming. The catchment is steep towards the Dee Estuary. The watercourse flows through agricultural land before entering a wooded gorge.</p> <p>There is an artificial lake/reservoir at the lower end of catchment, downstream of the surveyed reach, although this appears to have a limited backwater effect.</p>

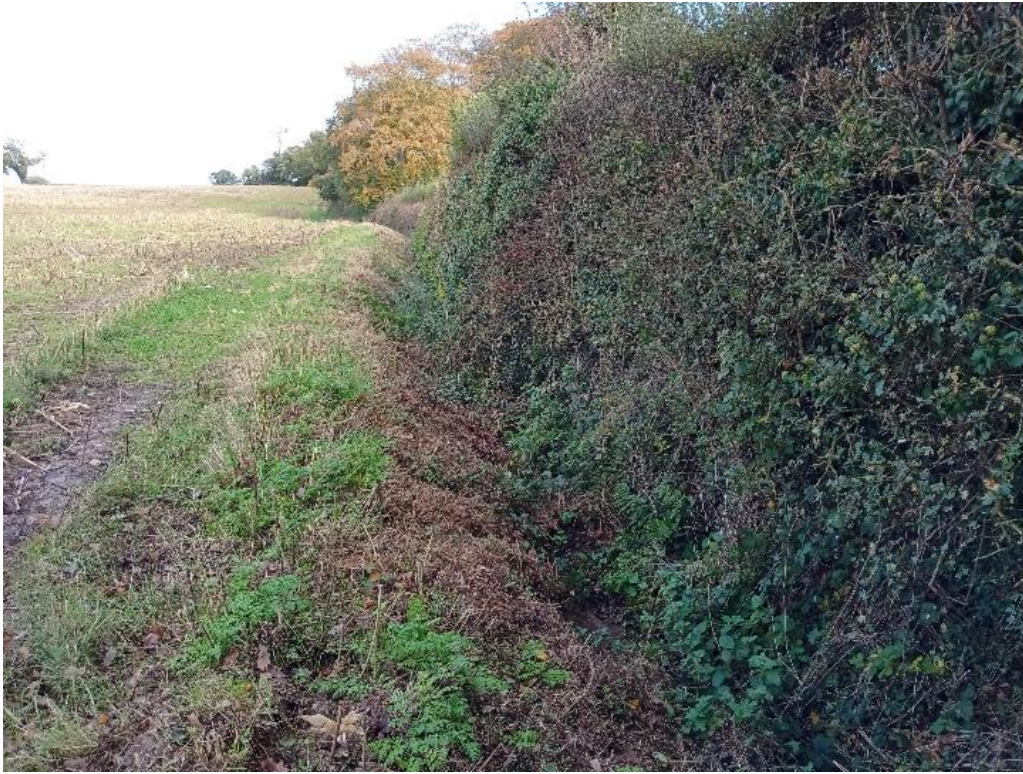
Northop Brook Tributary 1

Catchment area	Both <1km ²
Key hydraulic connections	Both tributaries join the Northop Brook which flows northwards and becomes the Lead Brook before joining the Dee.
River Condition Score	Not surveyed
Catchment description	The catchments of these tributaries are predominantly arable farmland.
Study reach description	Both watercourses flow along field boundaries. They both have a hedgerow on the right bank. The watercourses are likely ephemeral and their riparian zones are dominated by tilled land.
Interaction with the DCO Proposed Development	Both watercourses will be crossed by the Newbuild Carbon Dioxide Pipeline via open trench.

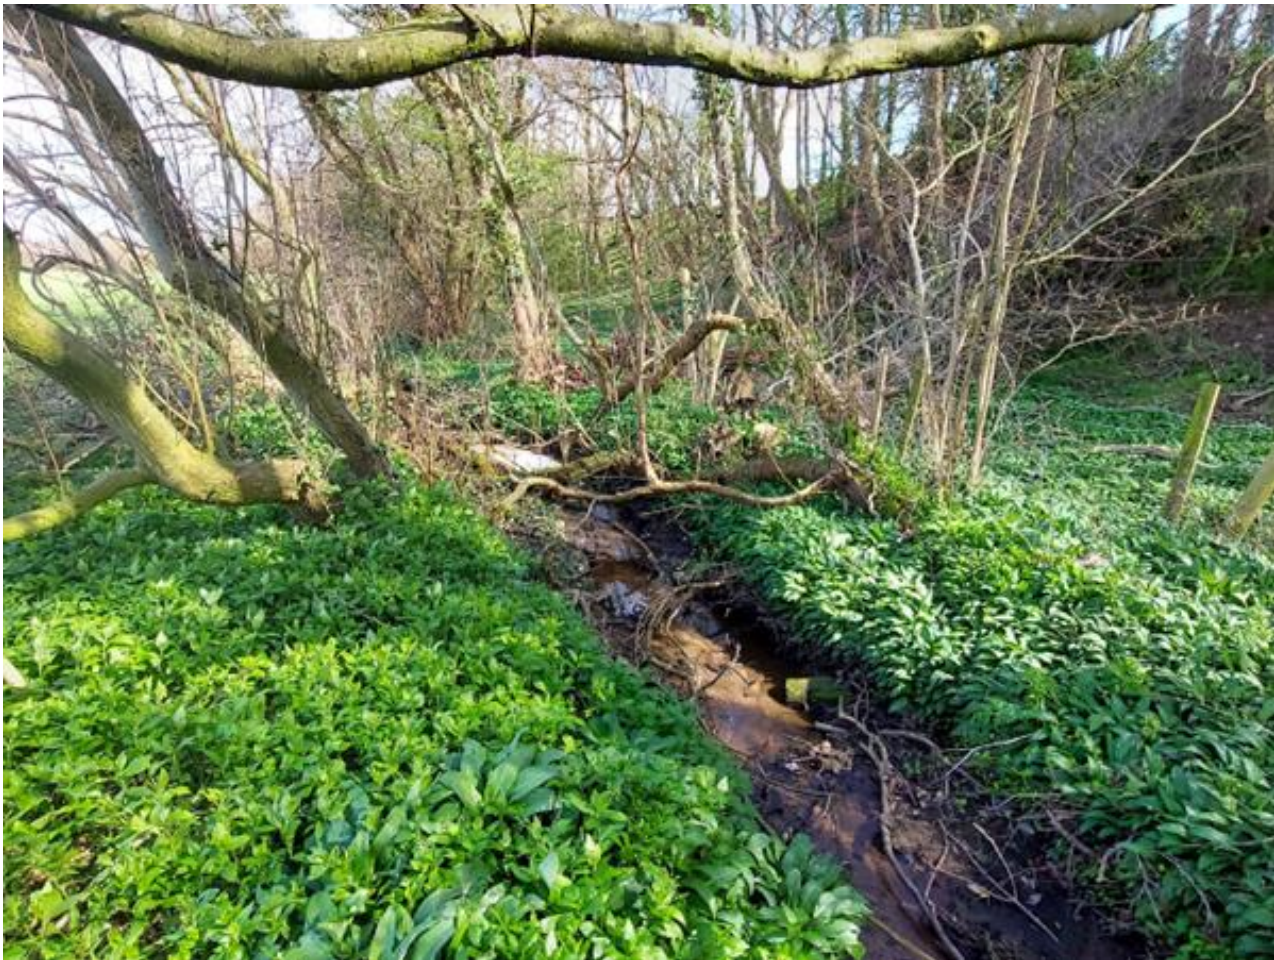
3.30. LITTLE LEAD BROOK

Catchment area	0.51 km ²
Key hydraulic connections	This watercourse flows northwards towards the Dee Estuary
River Condition Score	Moderate
Catchment description	A small catchment which is dominated by agriculture with no suburban areas. This is a steep catchment which slopes towards the Dee. There is a small on-line pond attenuating flow upstream of the study reach.

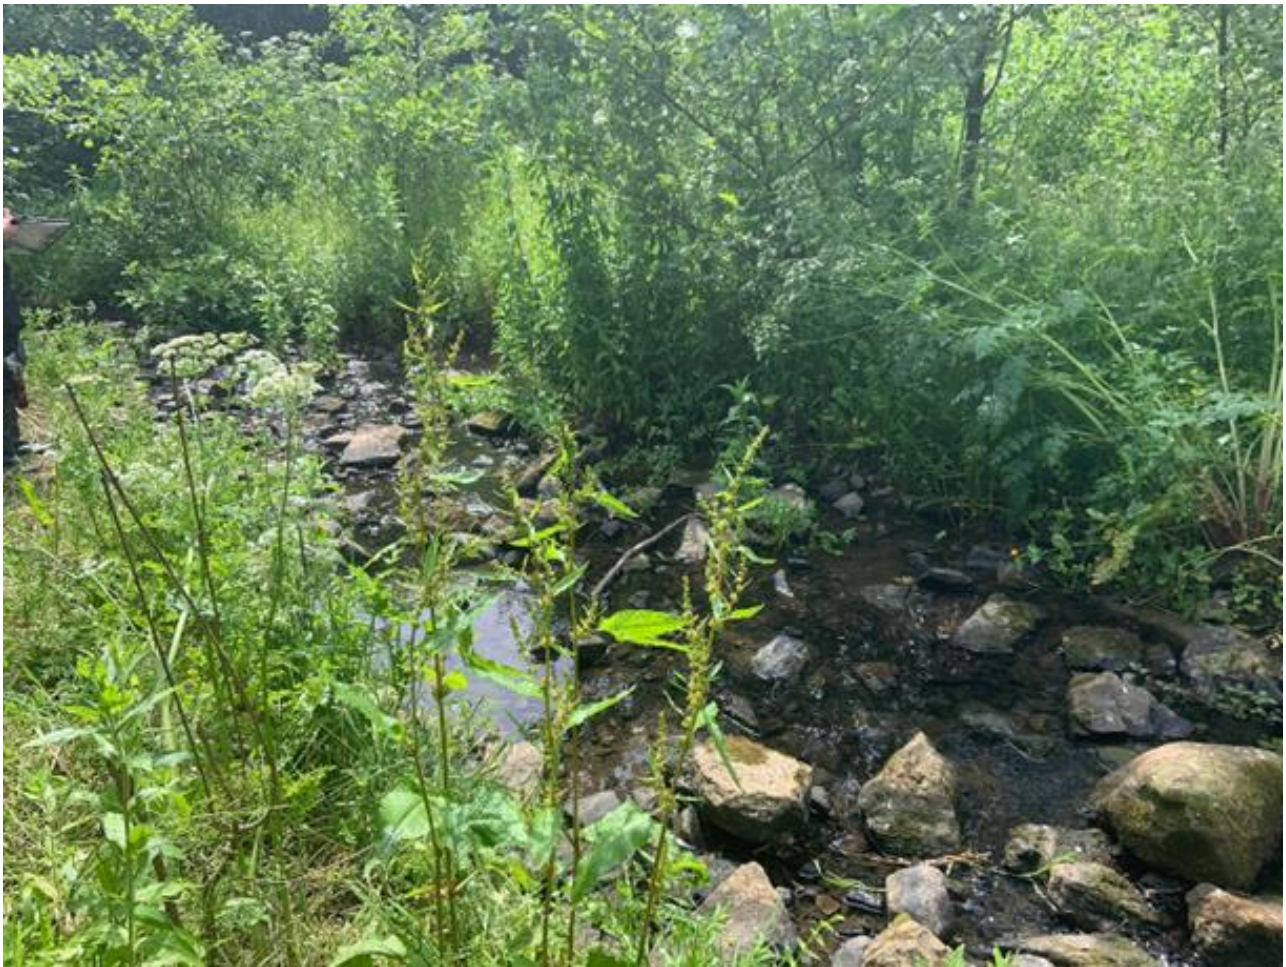
NANT-Y-FFLINT

Catchment area	4.31 km ²
Key hydraulic connections	The Nant-y-Fflint has several unnamed tributaries mostly from the south of the catchment which join the watercourse upstream of the DCO Proposed Development.
River Condition Score	Fairly Good
Catchment description	The catchment is relatively steep, with a confined floodplain in a wooded valley. The catchment is predominantly rural farmland (arable and pastoral, forestry) with small settlements in Pentre Halkyn and Halkyn.

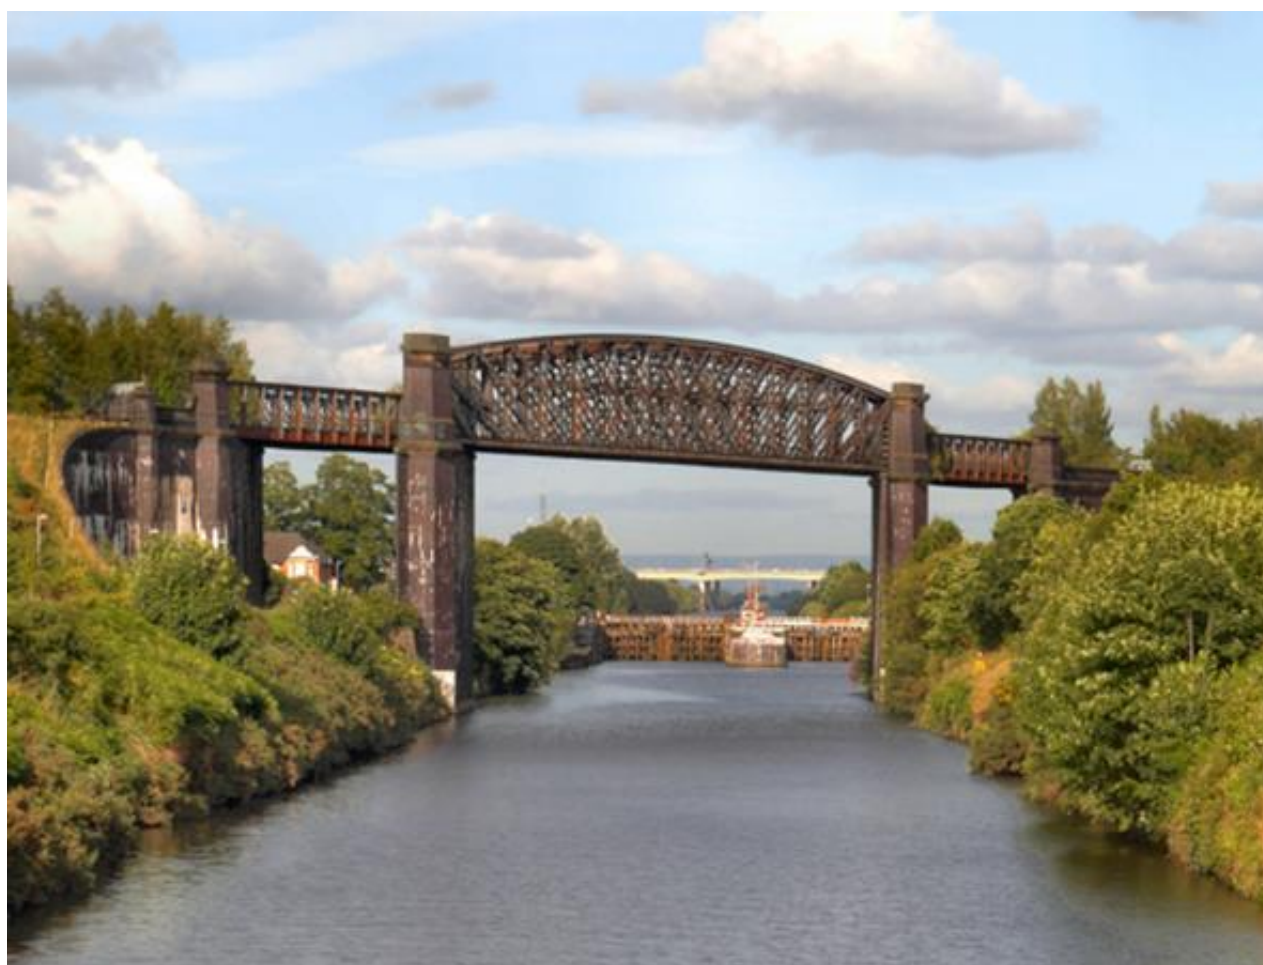
4.2. MANCHESTER SHIP CANAL

Catchment area	n/a (artificial canal)
Key hydraulic connections	River Irwell; River Irk; River Medlock
River Condition Score	Not surveyed
Catchment description	Major artificial canal, extensively used for shipping and trade. There are multiple locks and sluices to maintain water levels within the channel.
