HyNet North West

ENVIRONMENTAL STATEMENT (VOLUME III)

Appendix 18.1 Baseline Information

HyNet North West Carbon Dioxide Pipeline DCO

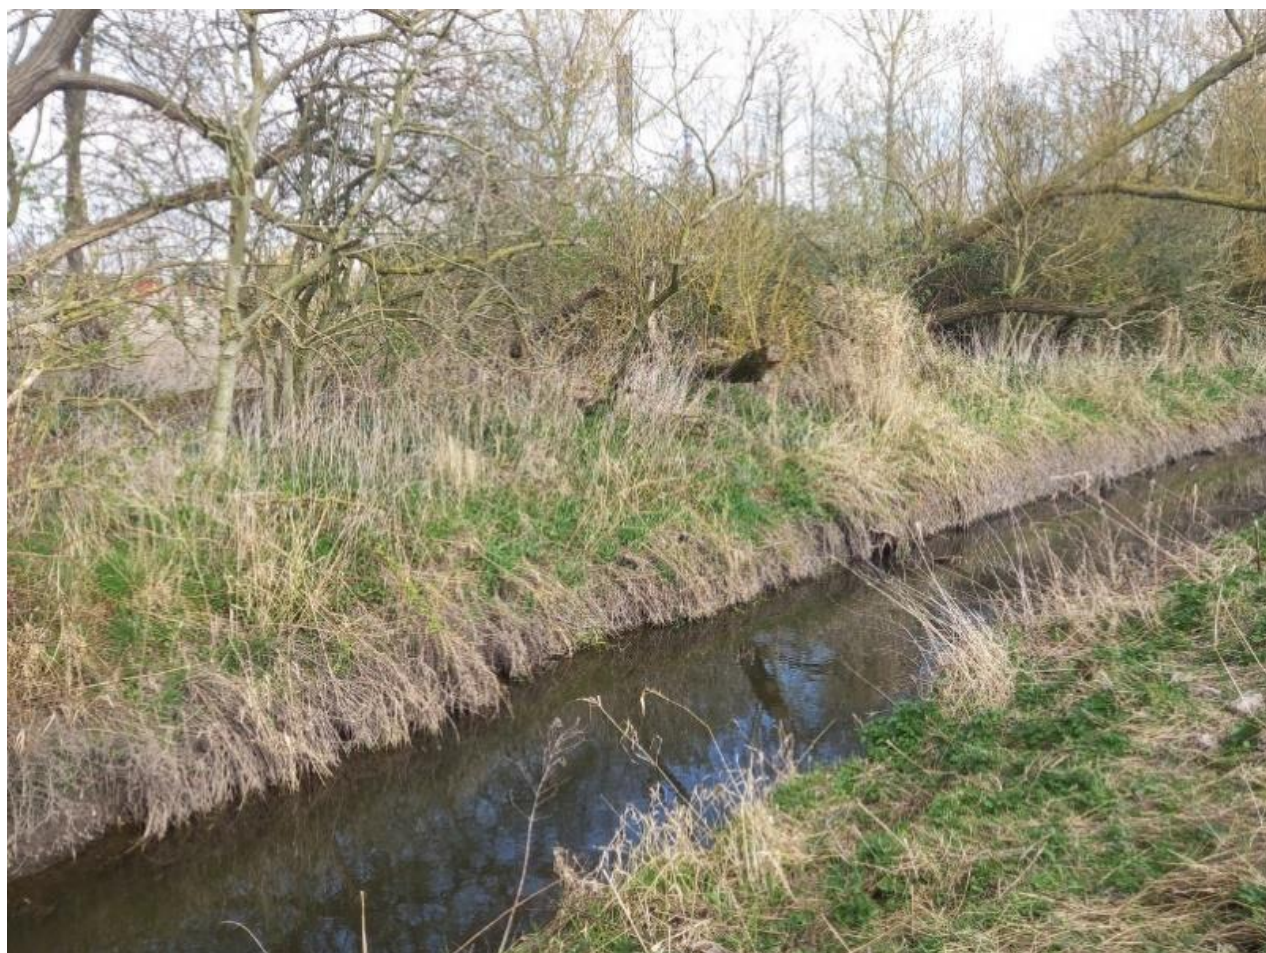
2.1. EAST CENTRAL DRAIN

<p>Study reach description</p>	<p>The watercourse is a trapezoidal artificial channel which is incised and not connected with the floodplain. Water depth is between 0.5 – 0.8m whilst bankfull width is 5- 6.5m.</p> <p>Bed material is silt and organic matter.</p> <p>The riparian zone on the left bank is grazed, whilst the right bank is woodland. In-channel vegetation is limited.</p> <p>The East Central Drain has provided drainage for the Ince Marshes since at least 1885. The East Central Drain has maintained a similar planform since 1885, to present day.</p>
<p>Interaction with the DCO Proposed Development</p>	<p>Ince AGI is located within 8m of this watercourse and the surface water drainage system from this AGI will connect to this watercourse.</p>

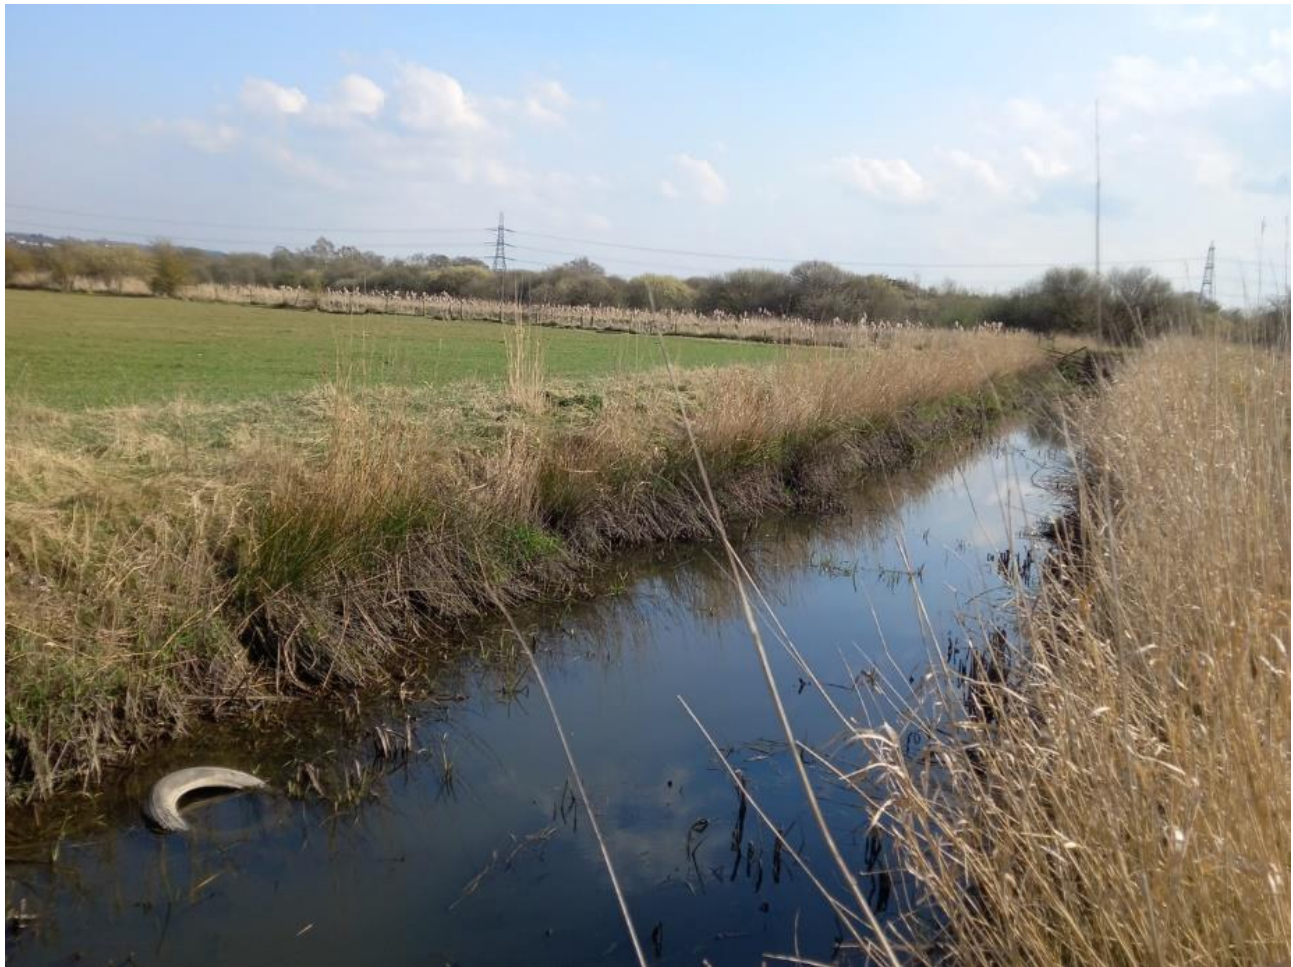
2.2. WEST CENTRAL DRAIN

<p>Study reach description</p>	<p>The watercourse is a trapezoidal artificial channel with bankfull width varying between 5-6m and water depth approximately 0.8m. It has a mixture of steep and shallow banks through the Newbuild Infrastructure Boundary.</p> <p>Bed material is predominantly silt and organic matter. The riparian zone comprises grazed grassland which is frequently wet. There are tall grasses along both banks of the watercourses.</p> <p>The West Central Drain has provided drainage for the Ince Marshes since at least 1885. The Western Central Drain has maintained a similar form since 1914.</p>
<p>Interaction with the DCO Proposed Development</p>	<p>West Central Drain will be crossed by the Newbuild Carbon Dioxide Pipeline in one location via open cut. The watercourse would also be crossed by vehicles using existing access tracks over existing culverts in the Newbuild Infrastructure Boundary.</p>

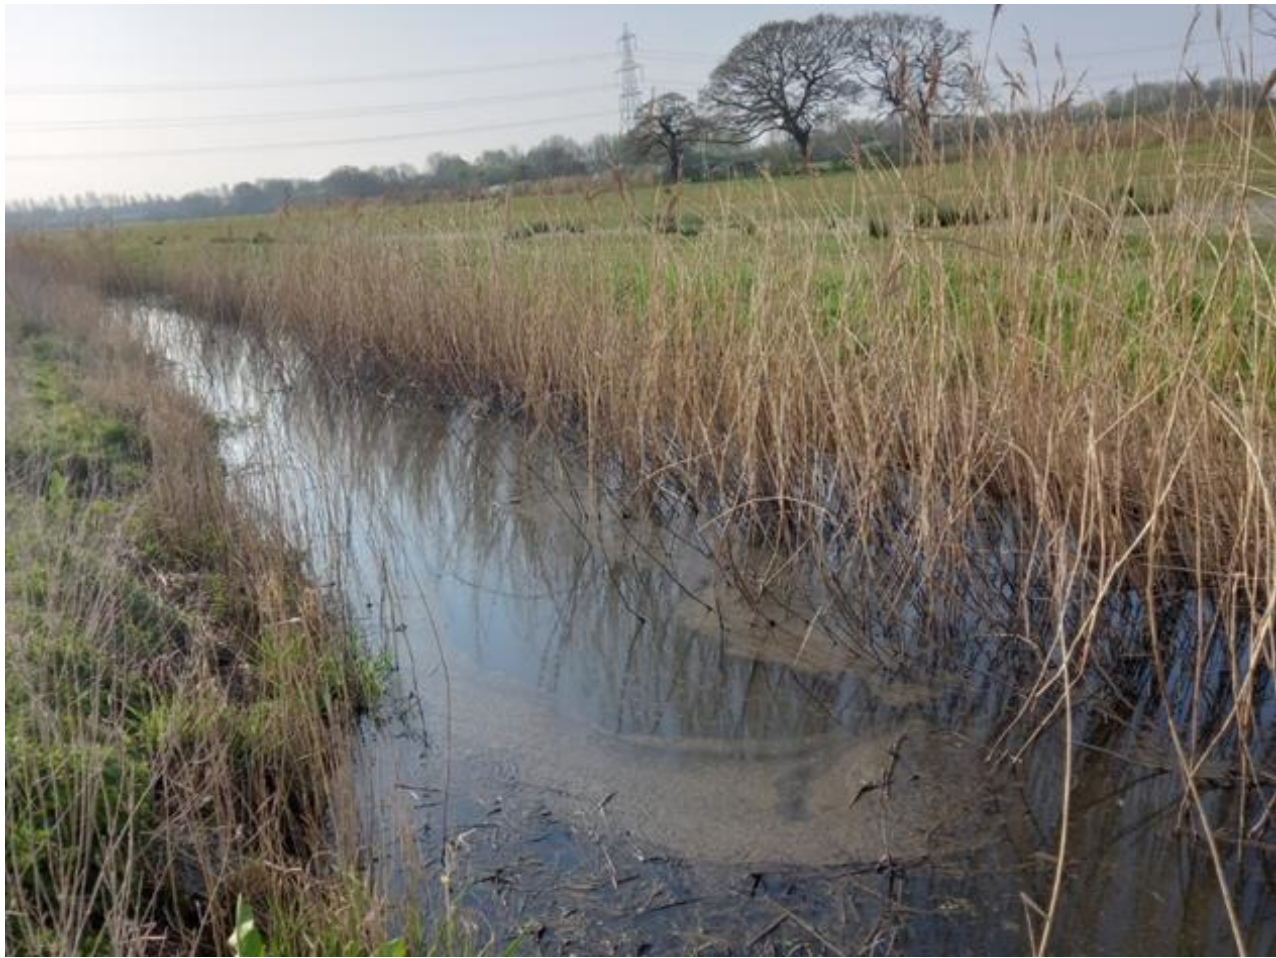
2.3. HAPSFORD BROOK

<p>Study reach description</p>	<p>The watercourse is a trapezoidal cut channel with a bankfull channel width of 5.5 m and depth of 0.4 m. The watercourse is ungauged.</p> <p>With regards to bed material, there is extensive silt cover with some accumulations of organic matter. There is some emergent reeds and linear leaved aquatic vegetation.</p> <p>There is a low diversity of riparian vegetation, with the banks being largely bare. The riparian zone is grazed pasture which is frequently wet.</p> <p>The planform morphology of the channel has been unchanged since 1903, though the watercourse was culverted following the construction of the M56 roadway (1968-1971).</p>
<p>Interaction with the DCO Proposed Development</p>	<p>The watercourse will be crossed by the Newbuild Carbon Dioxide Pipeline via open cut.</p>

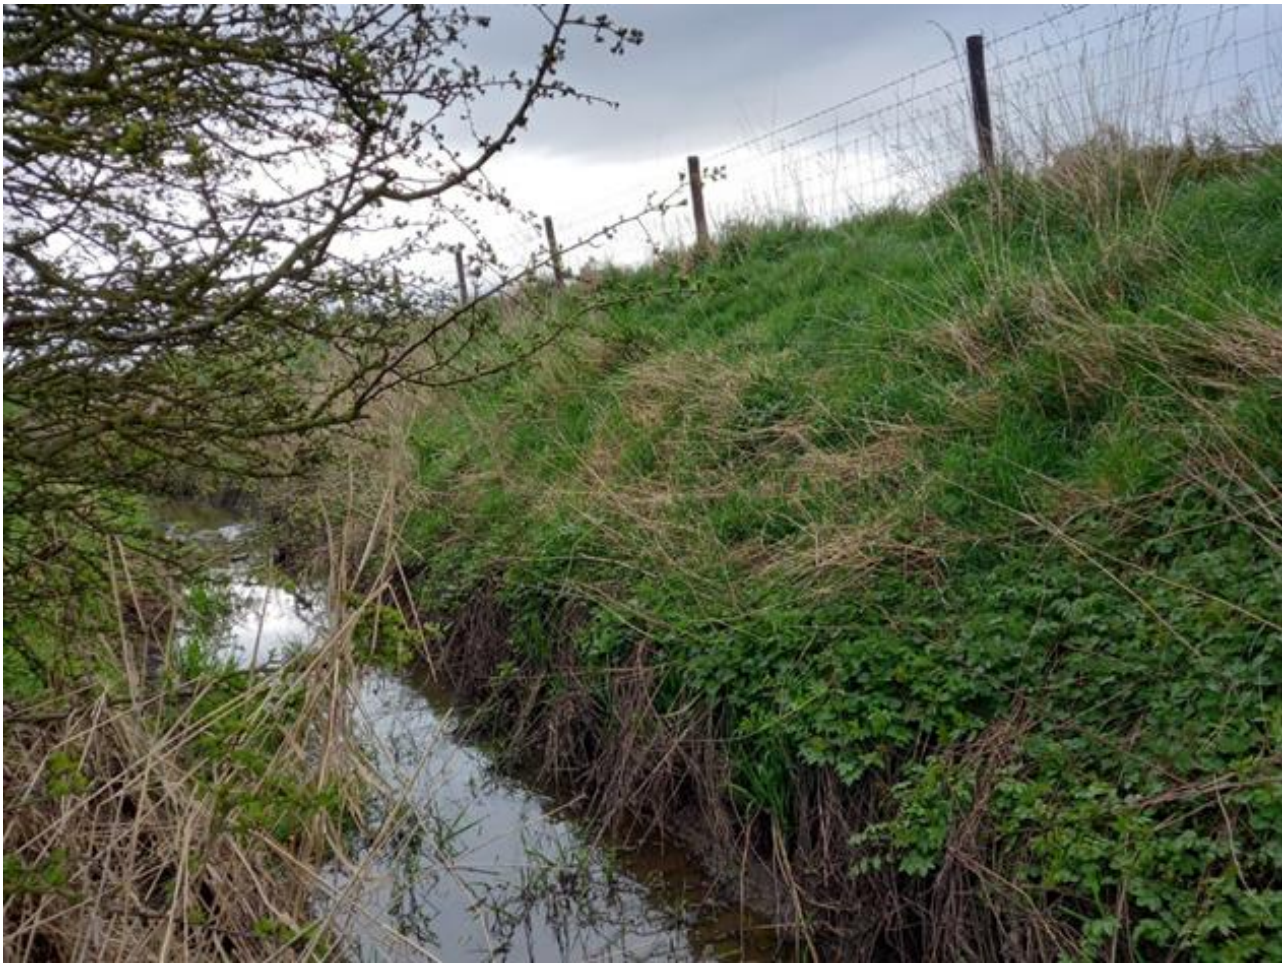
2.4. GALE BROOK

<p>Study reach description</p>	<p>The channel appears to have been artificially straightened and is a trapezoidal cut channel in the study area. Bankfull width varies between 2.5 and 6 m, with water depth approximately 0.2 - 0.3 m.</p> <p>The channel bed material is homogenously silty.</p> <p>The riparian zone is characterised by a lack of riparian habitat and vegetation complexity. It is comprised of mostly tilled arable land on both banks with a narrow buffer comprising short and tall herbs and grasses. There are some areas of scrub, shrub and trees.</p> <p>Downstream of the study reach, the Gale Brook was reconfigured to flow beneath the Essar Stanlow Refinery but has maintained its planform since 1945.</p>
<p>Interaction with the DCO Proposed Development</p>	<p>The Gale Brook is crossed by the Newbuild Carbon Dioxide Pipeline via open cut.</p>

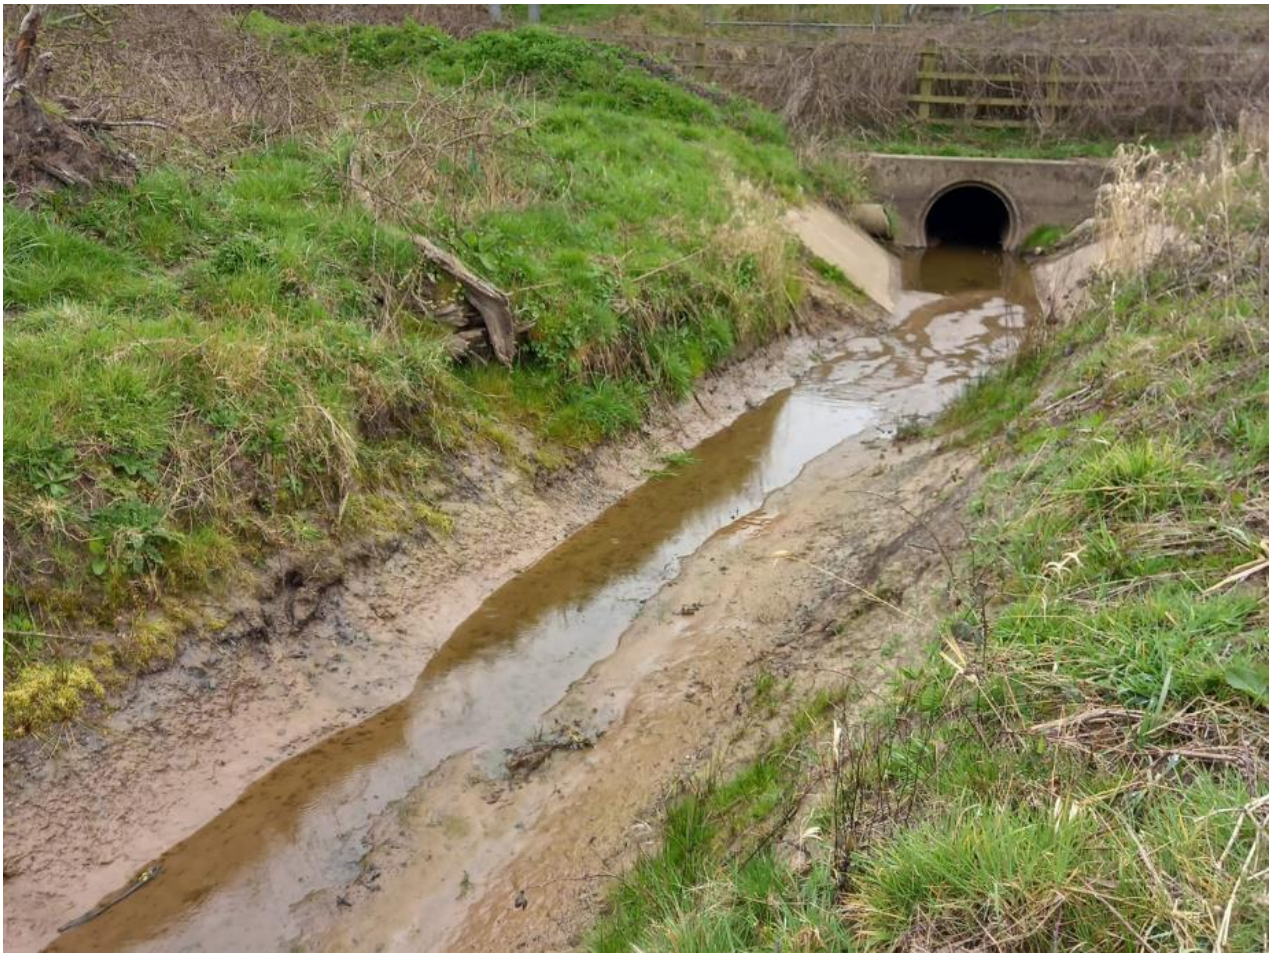
2.5. THORNTON UPLANDS

Catchment area	2.32km ²
Key hydraulic connections	Thornton Uplands flows northwards to River Gowy. It is joined by Halls Green Lane Brook and Thornton Marsh Central.
River Condition Score	Fairly Poor
Catchment description	Thornton Uplands drains agricultural and pastoral land in the headwaters and is culverted as it flows under Ince Lane and track lanes. The channel rises from farm ditches, around 1.4 km southwest of Dunham-on-the-Hill (10 mAOD).

<p>Study reach description</p>	<p>The watercourse is a trapezoidal cut channel, with obviously reshaped earth banks, with bankfull width between 3- 3.5 m and water depth approximately 0.03 m (within Newbuild Infrastructure Boundary).</p> <p>The bed material is a mixture of sediment, with the presence of gravel – pebble sized sediments. There is evidence of some sand, with extensive silt and clay components. No organic materials were present at the time of survey.</p> <p>The riparian zone is mostly farmland with some residential and farm building. The banks comprise extensive bare earth, with some short creeping herbs and grasses, tall herbs and grasses. Scrubs, shrubs and a few trees and saplings were also noted on the bank top.</p> <p>The channel has maintained a similar planform since 1884 – 1900.</p>
<p>Interaction with the DCO Proposed Development</p>	<p>Thornton Uplands will be crossed by the Newbuild Carbon Dioxide Pipeline via open trench.</p>

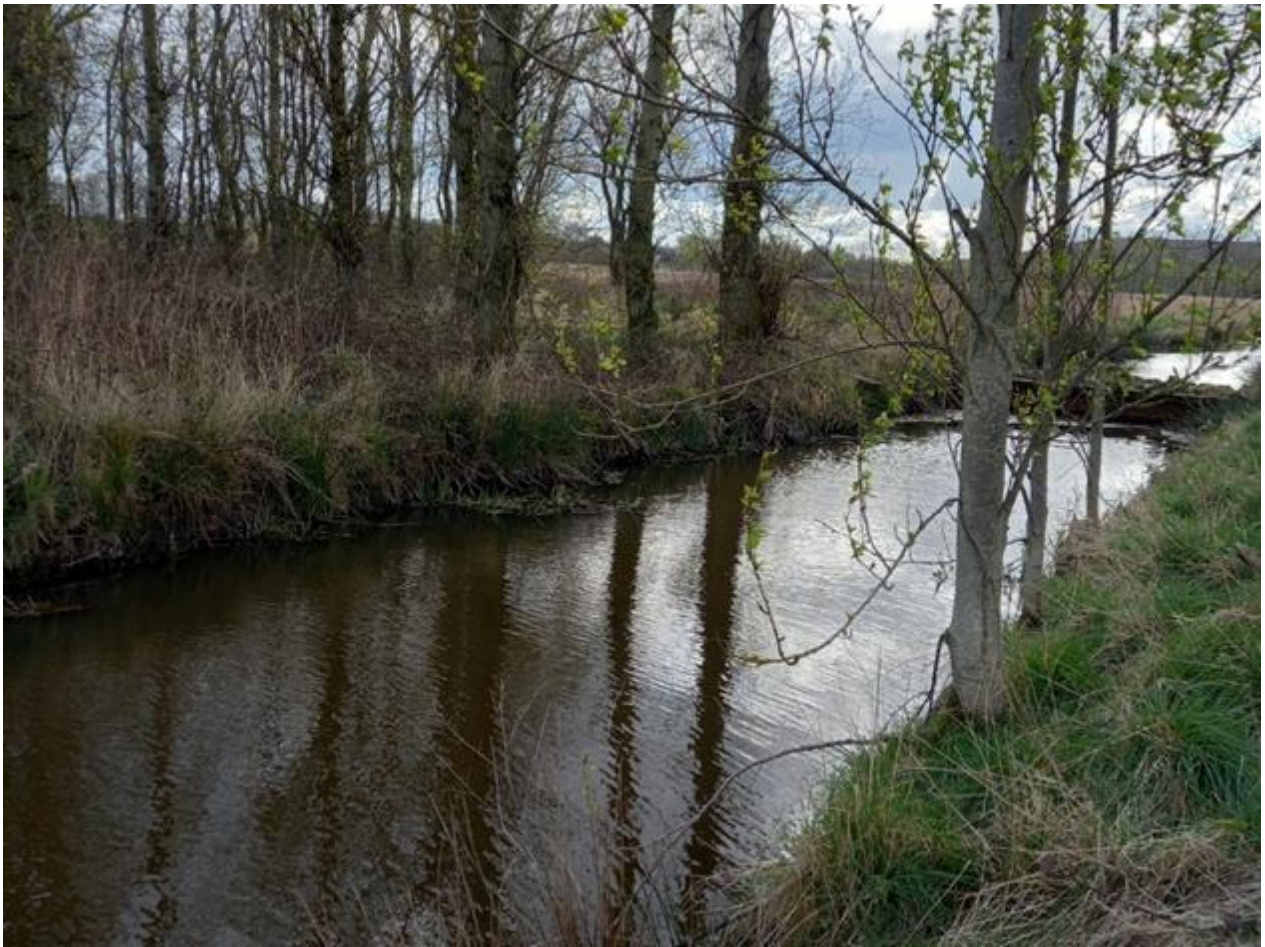
2.6. THORNTON MAIN DRAIN

Catchment area	3.00km ²
Key hydraulic connections	Thornton Ditches 5 – 12 drain into the Thornton Main Drain. The Thornton Main Drain joins the River Gowy at the A5117.
River Condition Score	Fairly Poor
Catchment description	Thornton Main Drain drains agricultural and pastoral land in its headwaters, with the surrounding land uses being farmland, agricultural buildings and settlement, a landfill site, and a peat bog. The channel rises from farm ditches, around 0.7 km northwest of Wimbolds (6 mAOD).

<p>Study reach description</p>	<p>The watercourse is an artificial cut channel, which has been artificially straightened and lacks geomorphic diversity. Bankfull width varies between 4.5 – 6m and depth between 0.8 - 1m.</p> <p>Bed material is mostly silt with extensive cover of unvegetated bare sediment, some emergent reeds and floating aquatic vegetation.</p> <p>The riparian zone is characterised by short herbs and grasses, extensive cover of tall herbs and grasses, emergent reeds and linear-leaved plants. Concrete bank protection and sheet piling forms the banks of the channel on the approach to the M56 culvert.</p> <p>The channel has maintained a similar planform since 1884 – 1900.</p>
<p>Interaction with the DCO Proposed Development</p>	<p>Thornton Main Drain is crossed by the Newbuild Carbon Dioxide Pipeline via open cut.</p>

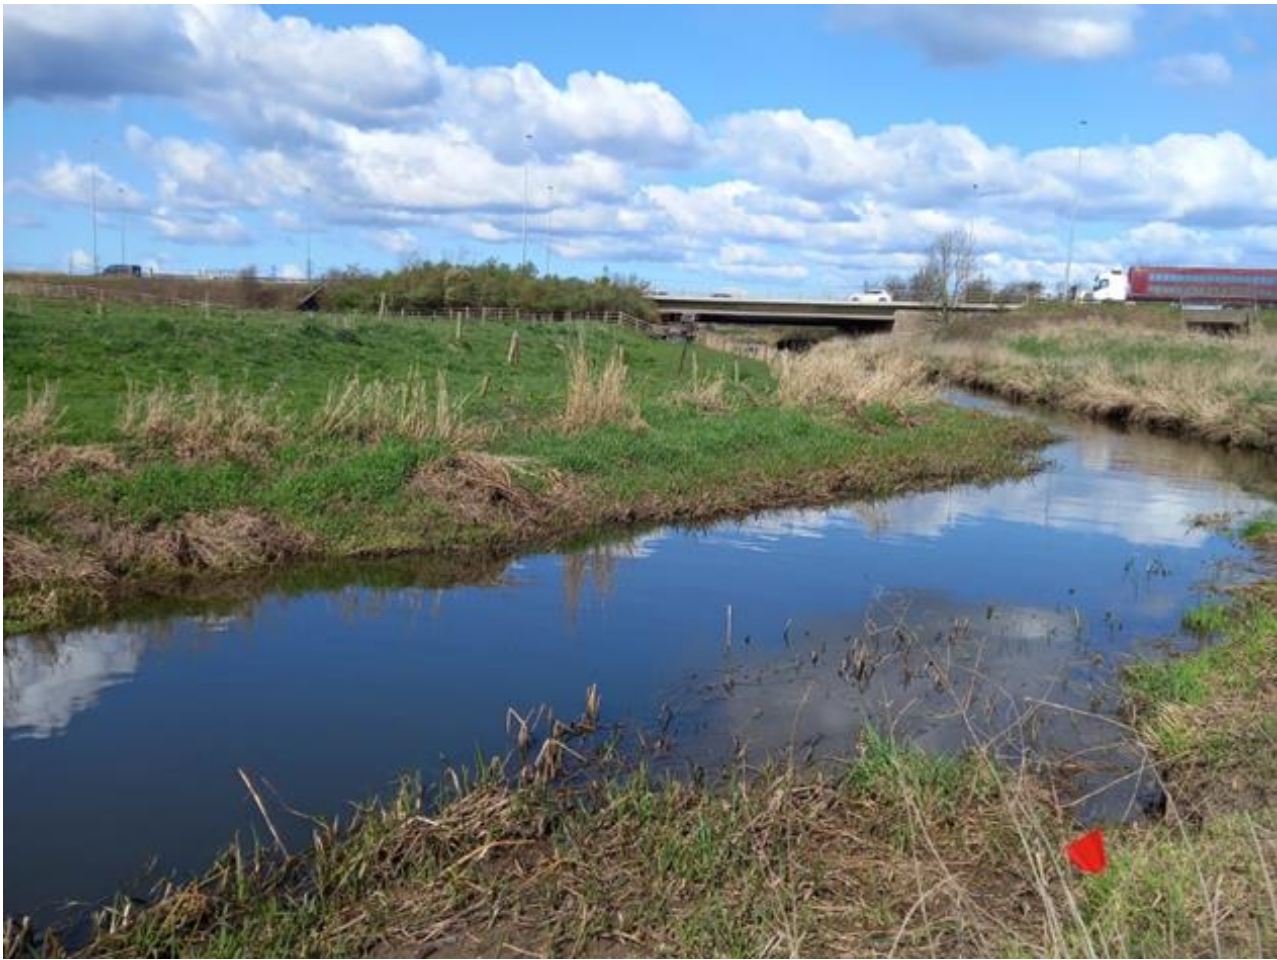
2.7. RIVER GOWY

Catchment area	150km ²
Key hydraulic connections	<p>The River Gowy is fed by the Barrow Brook, Back Brook, Milton Brook, Salters Brook and Ashton Brook upstream of the DCO Proposed Development. Downstream of the DCO Proposed Development, the River Gowy is joined by Thornton Main Drain, Thornton Uplands, Stanney Mill Brook and Gale Brook. The River Gowy flows into the River Mersey.</p> <p>The river is disconnected from its floodplain due to flood defences through most of its middle and lower course.</p>
River Condition Score	Moderate

<p>Catchment description</p>	<p>The River Gowy drains the surrounding arable and horticultural land, in addition to a landfill site, settlement and peat bog.</p> <p>There are a variety of geomorphic pressures (e.g. poor soil, nutrient, and livestock management, contaminated land, ecological discontinuity, ground water abstraction, pollution from wastewater industry and landfill). The catchment has a maximum elevation of 43 m ASL (Helsby Hill).</p>
<p>Study reach description</p>	<p>The channel is heavily modified, with generally shallow channel banks, obviously reshaped, and with set-back embankments. Bankfull width is 6.5 - 8 m and water depth is 0.8 - 1m. Some berms and eroding cliffs were noted within the Newbuild Infrastructure Boundary. Nest holes were observed in the channel banks.</p> <p>Bed material is silt with extensive cover of unvegetated bare sediment and some emergent and submerged aquatic vegetation. The riparian zone is mostly grazed pasture comprising predominantly grasses, creeping herbs and taller vegetation. The riparian zone is frequently wet.</p> <p>The confluence of the Gowy and Mersey has remained in the same place since at least 1892. However, the course of the Gowy upstream of this point has been heavily modified with evidence of straightening and realignment. The middle course of the channel has been canalised and flood embankments existing on both banks of the Gowy through the study reach.</p>

<p>Interaction with the DCO Proposed Development</p>	<p>The Gowy will be crossed by the Newbuild Carbon Dioxide Pipeline via trenchless methods (TRS-09).</p>

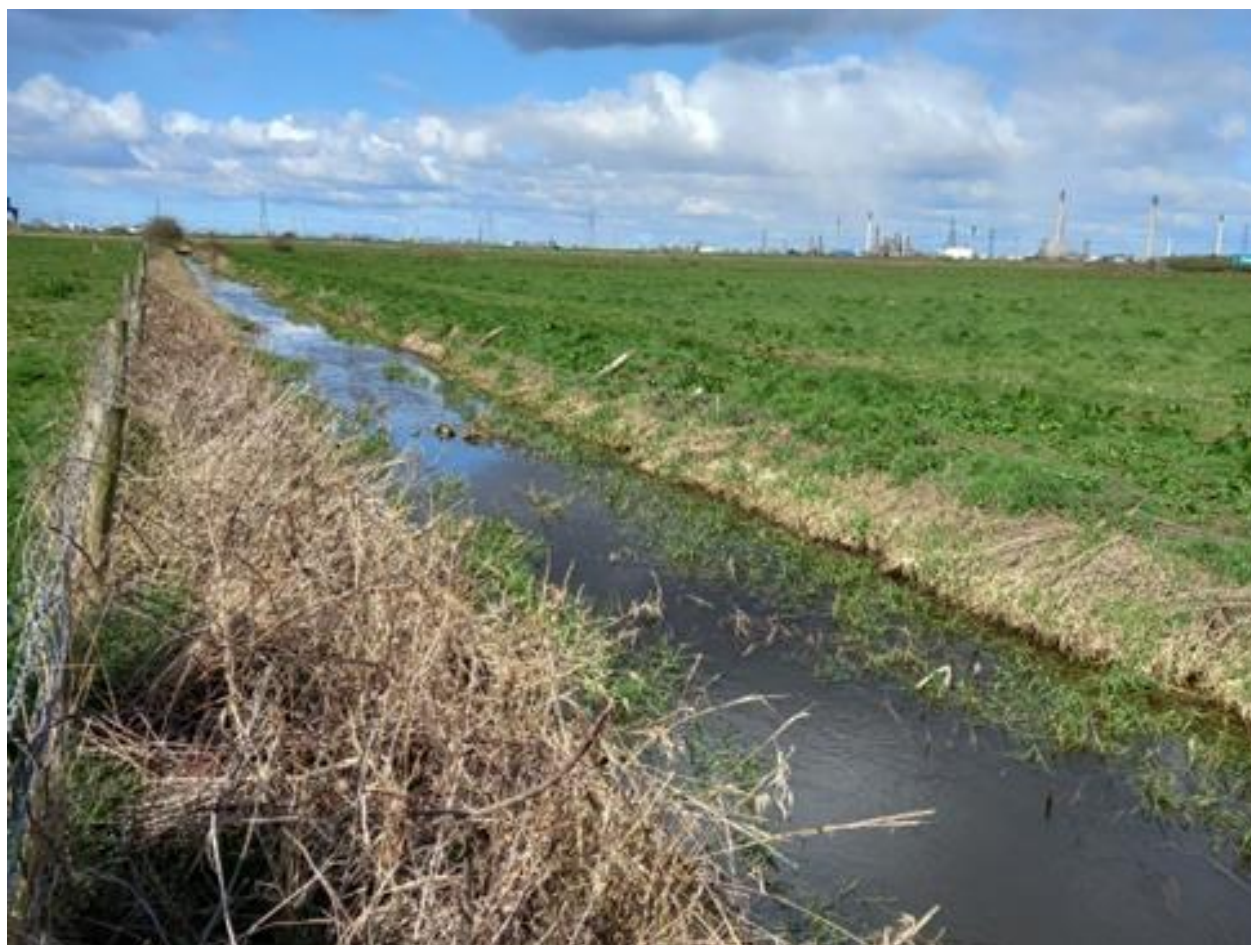
2.8. STANNEY MAIN DRAIN

Catchment area	<1km ²
Key hydraulic connections	This is an artificial drain within the River Gowy floodplain. It is connected to Thornton Ditch (1,2), Mill Brook, Mill Brook Tributary (1,2) and Gowy Tributary (1,2). It joins the River Gowy at the A5117.
River Condition Score	Fairly Poor
Catchment description	Stanney Main Drain drains agricultural and pastoral land in its headwaters, with the surrounding land use being farmland, agricultural buildings and roadways. The catchment is boggy in the headwaters. The channel rises from farm ditches, around 0.47 km west of Bridge Trafford. It has a maximum catchment altitude of 6 mAOD.

<p>Study reach description</p>	<p>Stanney Main Drain is a trapezoidal, cut and over deepened ditch that appears to have been artificially straightened. Bankfull width is approximately 5.5 m and water depth approximately 0.5 m, with benches present on the banks of the channel.</p> <p>Bed material is silt with extensive cover of bare sediment. The riparian zone is grazed farmland comprising short grasses with some tall herbs and grasses, shrubs and scrub and some emergent reeds/linear-leaved/horsetails on the banks.</p> <p>The channel has retained its planform, as a network of cut ditches, since 1885 though some sections have been realigned. Following construction of the Ellesmere Port Oil Refinery (post 1949 –1965), the confluence with the Gowy was moved further upstream to the south of the A5117 (approx., 420 m downstream from the contemporary position).</p>
<p>Interaction with the DCO Proposed Development</p>	<p>Stanney Main Drain will be crossed by the Newbuild Carbon Dioxide Pipeline via open cut.</p>

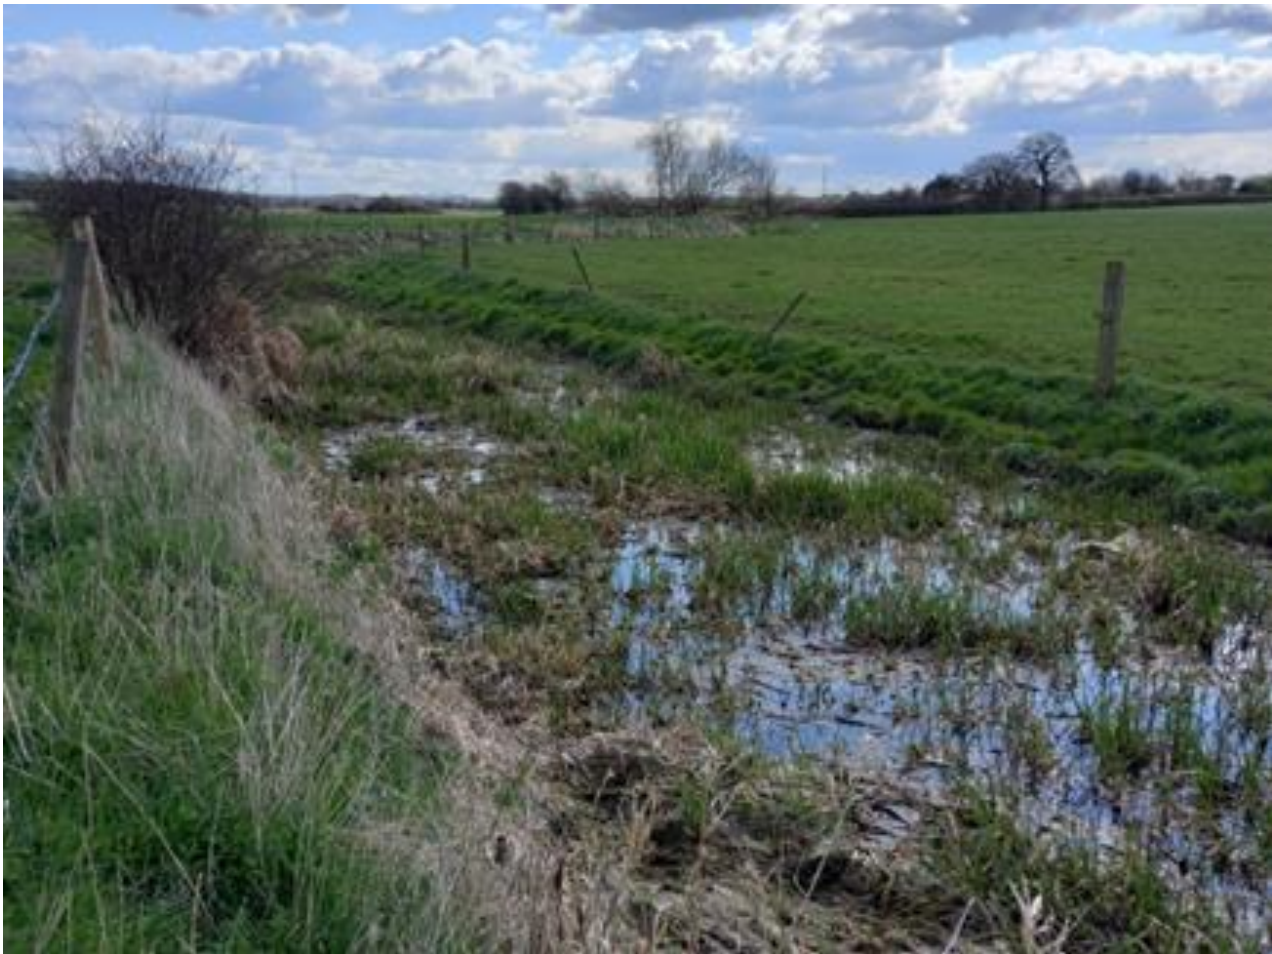
2.9. STANNEY MILL BROOK

Catchment area	6.95km ²
Key hydraulic connections	<p>Gowy Tributary 2 connects Stanney Mill Brook and Stanney Main Drain. Picton Brook flows into the Stanney Mill Brook. The Stanney Mill Brook drains into the Gowy downstream of the A5117.</p> <p>There is a wastewater treatments works on the Stanney Mill Brook south of the A5117 into which the watercourse may outfall, though this is unconfirmed.</p> <p>Within the Newbuild Infrastructure Boundary the watercourse is disconnected from its floodplain.</p>
River Condition Score	Moderate – Fairly Poor

<p>Catchment description</p>	<p>Stanney Mill Brook drains agricultural and pastoral land, with the surrounding land uses being farmland, agricultural buildings, roadways, suburban (Picton, Mickle Trafford) and peat bogs.</p> <p>It has a maximum catchment altitude of (45 mAOD).</p>
<p>Study reach description</p>	<p>The watercourse is a cut channel that has been artificially straightened and has a bankfull width of 4 - 7m and water depth of 0.05 – 0.5m.</p> <p>Bed material is mostly silt, with some bare unvegetated bed and berms present. The channel is choked with vegetation. The riparian zone is predominantly grazed farmland comprising short grasses, The banks have extensive cover of emergent reeds/linear-leaved/horsetails, along with some short and tall herbs and grasses.</p> <p>Stanney Mill Brook has retained the same form since 1913.</p>
<p>Interaction with the DCO Proposed Development</p>	<p>Stanney Mill Brook will be crossed by the Newbuild Carbon Dioxide Pipeline via open cut.</p>

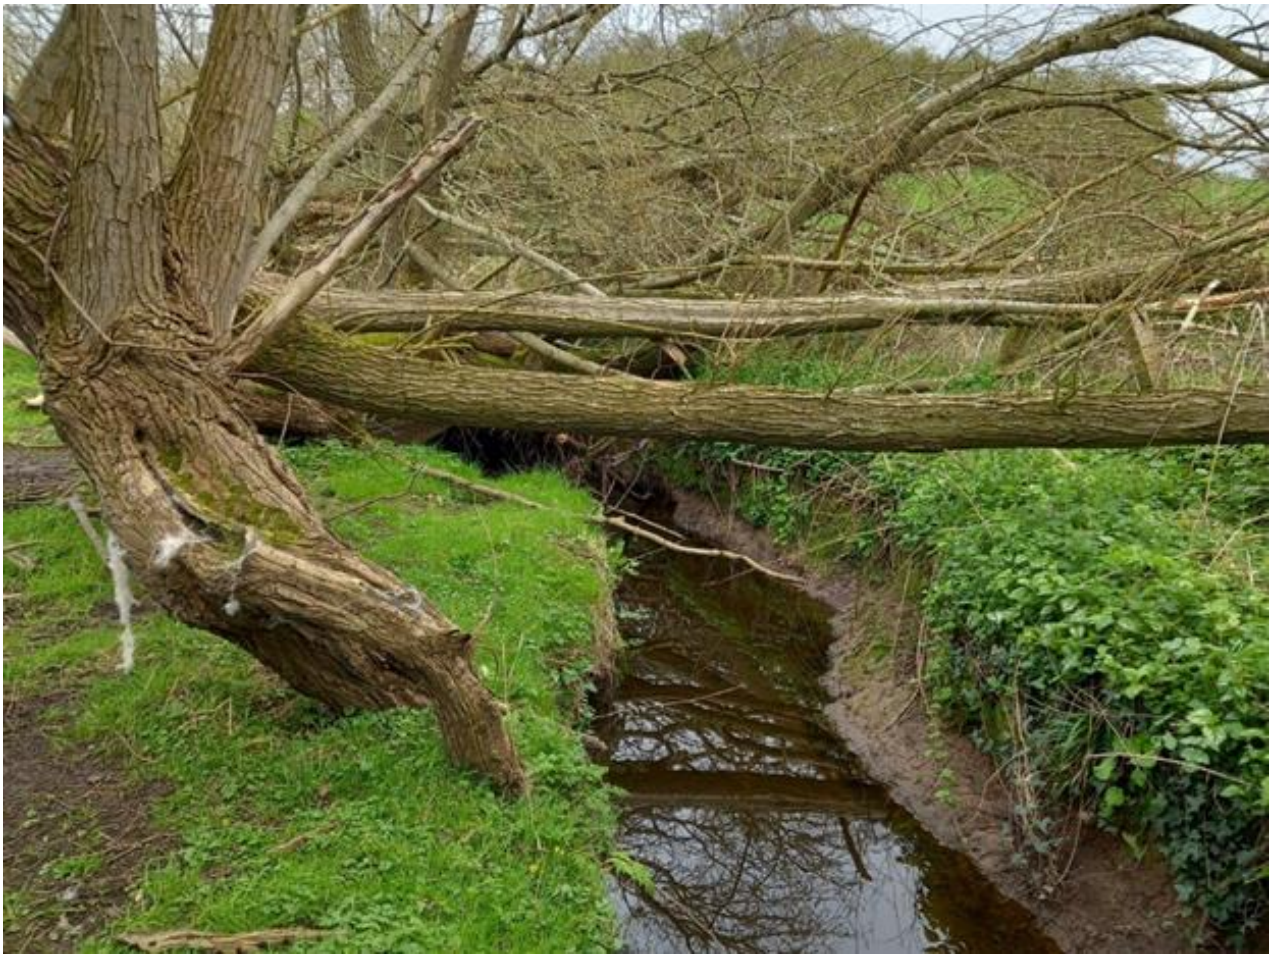
2.10. BACKFORD BROOK

Catchment area	4.97 km ²
Key hydraulic connections	There are three tributaries of Backford Brook which drain land south of Dunkirk and the M56. Backford Brook is culverted beneath the Shropshire Union Canal and then joins Finchetts Gutter.
River Condition Score	Fairly Good upstream of field culvert. Fairly Poor downstream of field culvert.
Catchment description	The catchment is predominantly rural, with the main land uses being pasture, grassland, and woodland. Elevation varies from 38m to 19mAOD.

<p>Study reach description</p>	<p>Upstream of the field culvert, the channel varies in width and depth, but it has approximately 0.5m and bankfull width is approximately 1.1m throughout the studied reach. The Backford Brook has a sinuous channel, with step-pools created by log jams, thus providing good in-channel habitat diversity. In addition, there are mature trees lining the channel with fallen trees and extensive large wood habitat along the reach upstream of the field boundary culvert.</p> <p>Downstream of the field culvert the watercourse flows through a modified reach featuring armoured banks and a trapezoidal cross section. The riparian zone in this reach has fewer trees and fallen trees and uninterrupted flow.</p> <p>The river bed substrate is made of sand and silt, with traces of organic matter. The riparian zone is mostly pasture, with a single line of mature trees along the bank top of the watercourses. The treeline is more mature in the reach upstream of the field culvert.</p> <p>No change in planform can be seen from existing online maps (from 1982 onwards).</p>

<p>Interaction with the DCO Proposed Development</p>	<p>Backford Brook will be crossed by the Newbuild Carbon Dioxide Pipeline via open cut.</p>

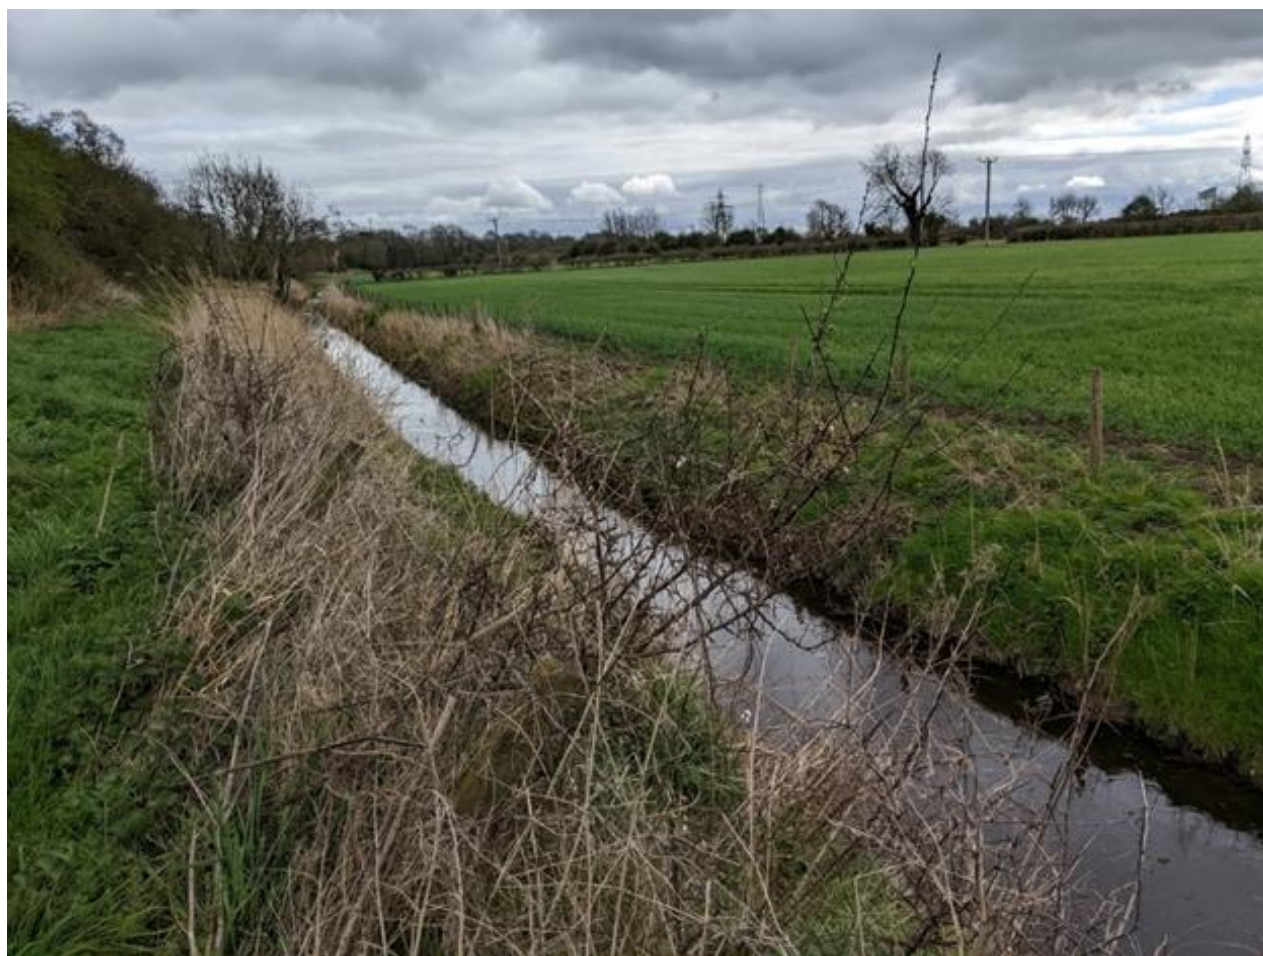
2.11. SEAHILL DRAIN

Catchment area	3.03 km ²
Key hydraulic connections	This watercourse has several tributaries and merges with the Garden City Gutter before reaching the River Dee.
River Condition Score	Fairly poor
Catchment description	The Seahill Drain catchment has a high degree of human influence on watercourses and landscape, with the land use being arable agriculture and permanently vegetated recreational. Elevation varies from ~ 25m to 5mAOD.

Study reach description	<p>Seahill Drain is a linear watercourse, with no significant variation in water depth and along the investigated reach. Mean water depth and width are 0.45m and 2.1m, respectively.</p> <p>The riverbed morphology is slow-glide with silt as the dominant particle size. The riparian zone is arable agriculture.</p>
Interaction with the DCO Proposed Development	<p>Seahill Drain will be crossed by the Newbuild Carbon Dioxide Pipeline via open cut.</p>

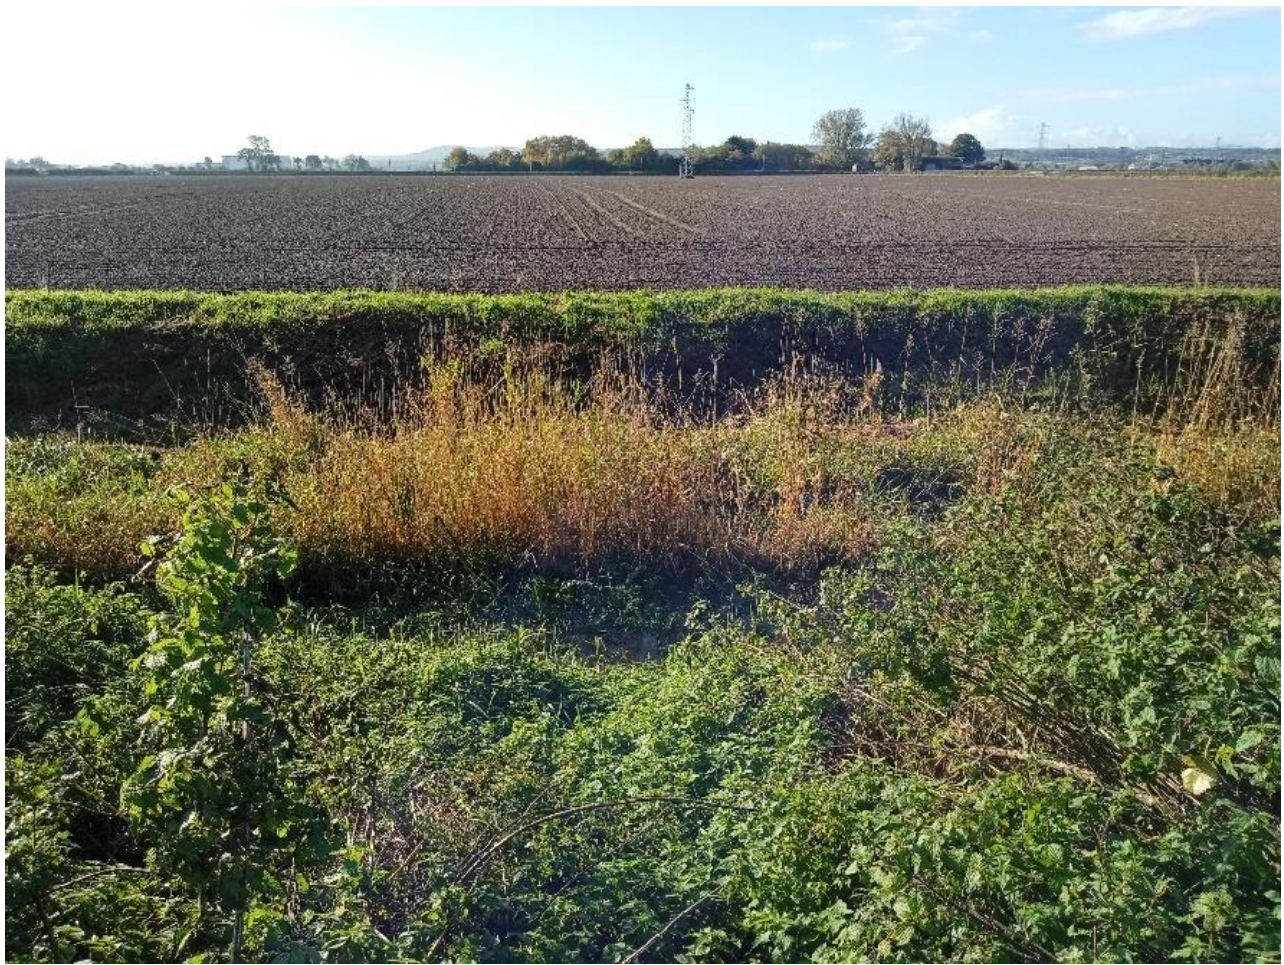
2.12. SEALAND MAIN DRAIN

Catchment area	6.74km ²
Key hydraulic connections	The Sealand Main Drain receives water from the Seahill Drain and the Garden City Gutter before flowing to the River Dee. The watercourse is disconnected from its floodplain.
River Condition Score	Fairly poor
Catchment description	The catchment is marked by several artificial watercourses; therefore, it is unlikely to reflect the original geometry. The current catchment drains tilled farm land, pasture, grassland, woodland, and urban areas.

<p>Study reach description</p>	<p>The channel is artificially incised in order to store and channel flood flows to the River Dee, with watercourse geometry minimal. Water width is ~ 1.1m, and water depth is ~ 0.15m.</p> <p>The bed material is largely dominated by silt particles and low morphological diversity. The riparian zone is primarily arable agriculture.</p> <p>No change in planform can be seen from existing online maps (from 1982 onwards).</p>
<p>Interaction with the DCO Proposed Development</p>	<p>Sealand Main Drain will be crossed by the Newbuild Carbon Dioxide Pipeline via open cut. The watercourse will also be crossed by construction vehicles in two other locations using existing access tracks via existing bridges / culverts.</p>

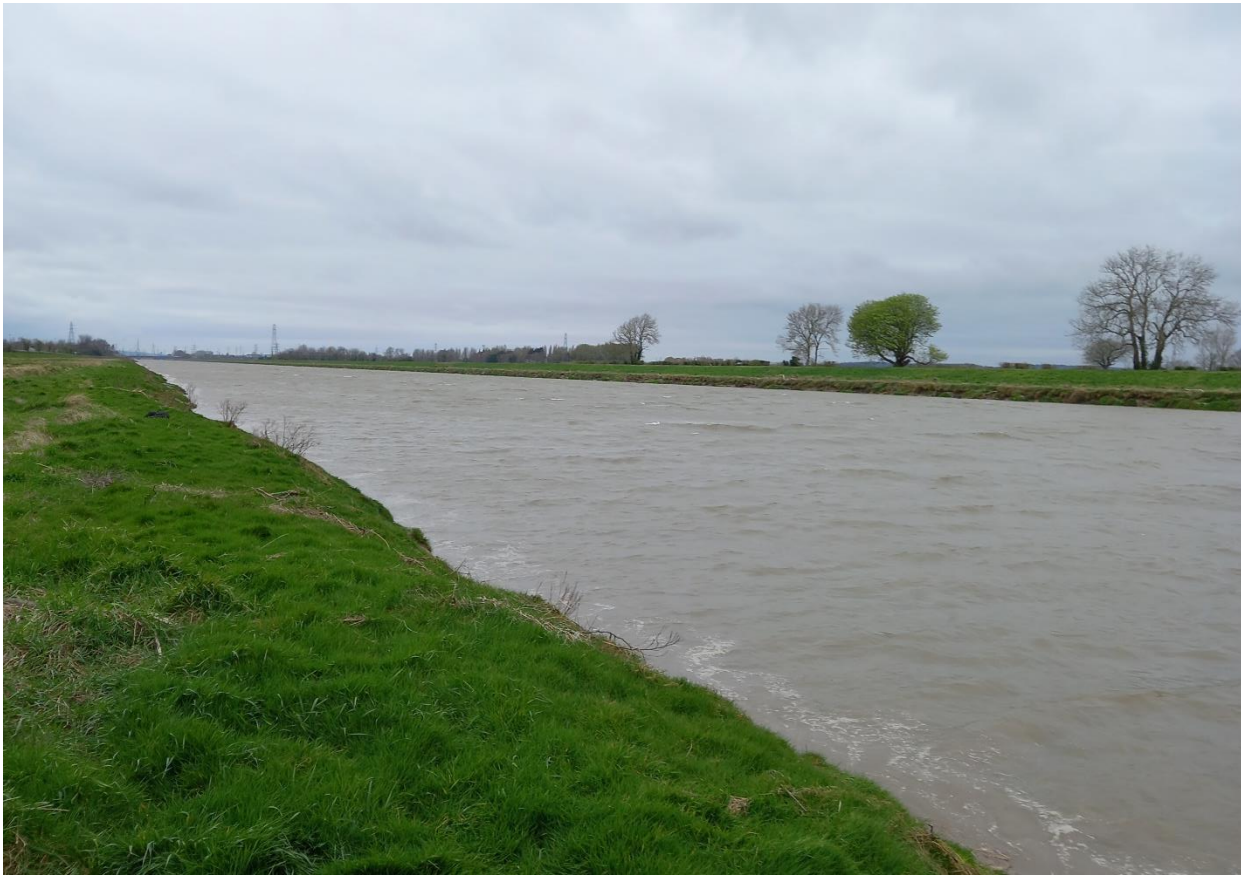
2.13. DEE ESTUARY

Catchment area	136.7 km ²
Key hydraulic connections	The Dee is the downstream receptors of many watercourses scoped into this assessment. The Dee is tidal up to Chester and flows out to the North Wales coastal water body.
River Condition Score	Moderate
Catchment description	<p>Major estuary with extensive mudflats and saltmarsh habitat, with entire estuary area designated as a SAC, SSSI and SPA. Land use is a mix of rural agriculture, industrial, urban areas (Flint, West Kirby, Neston, Heswall, Connah's Quay and the City of Chester at the historic head of the estuary).</p> <p>Estuary is macrotidal, with a 7.7mAOD tidal height on a spring tide and a 4.1mAOD tidal height on a neap tide. Approximately 90% of the estuary area is estimated to dry out in a large spring low tide.</p>

Study reach description	<p>The Dee through the Newbuild Infrastructure Boundary is homogenous with a channel width of approximately 90m. There are flood embankments on both banks with the left bank embankment set back approximately 30m from the channel. The channel bank showed signs of slumping due to repetitive wetting and drying due to the tidal flows in the channel.</p>
Interaction with the DCO Proposed Development	<p>The Dee will be crossed by the Newbuild Carbon Dioxide Pipeline via trenchless methods (TRS-28). It is also the downstream receptor of several watercourses which are crossed using open cut.</p>

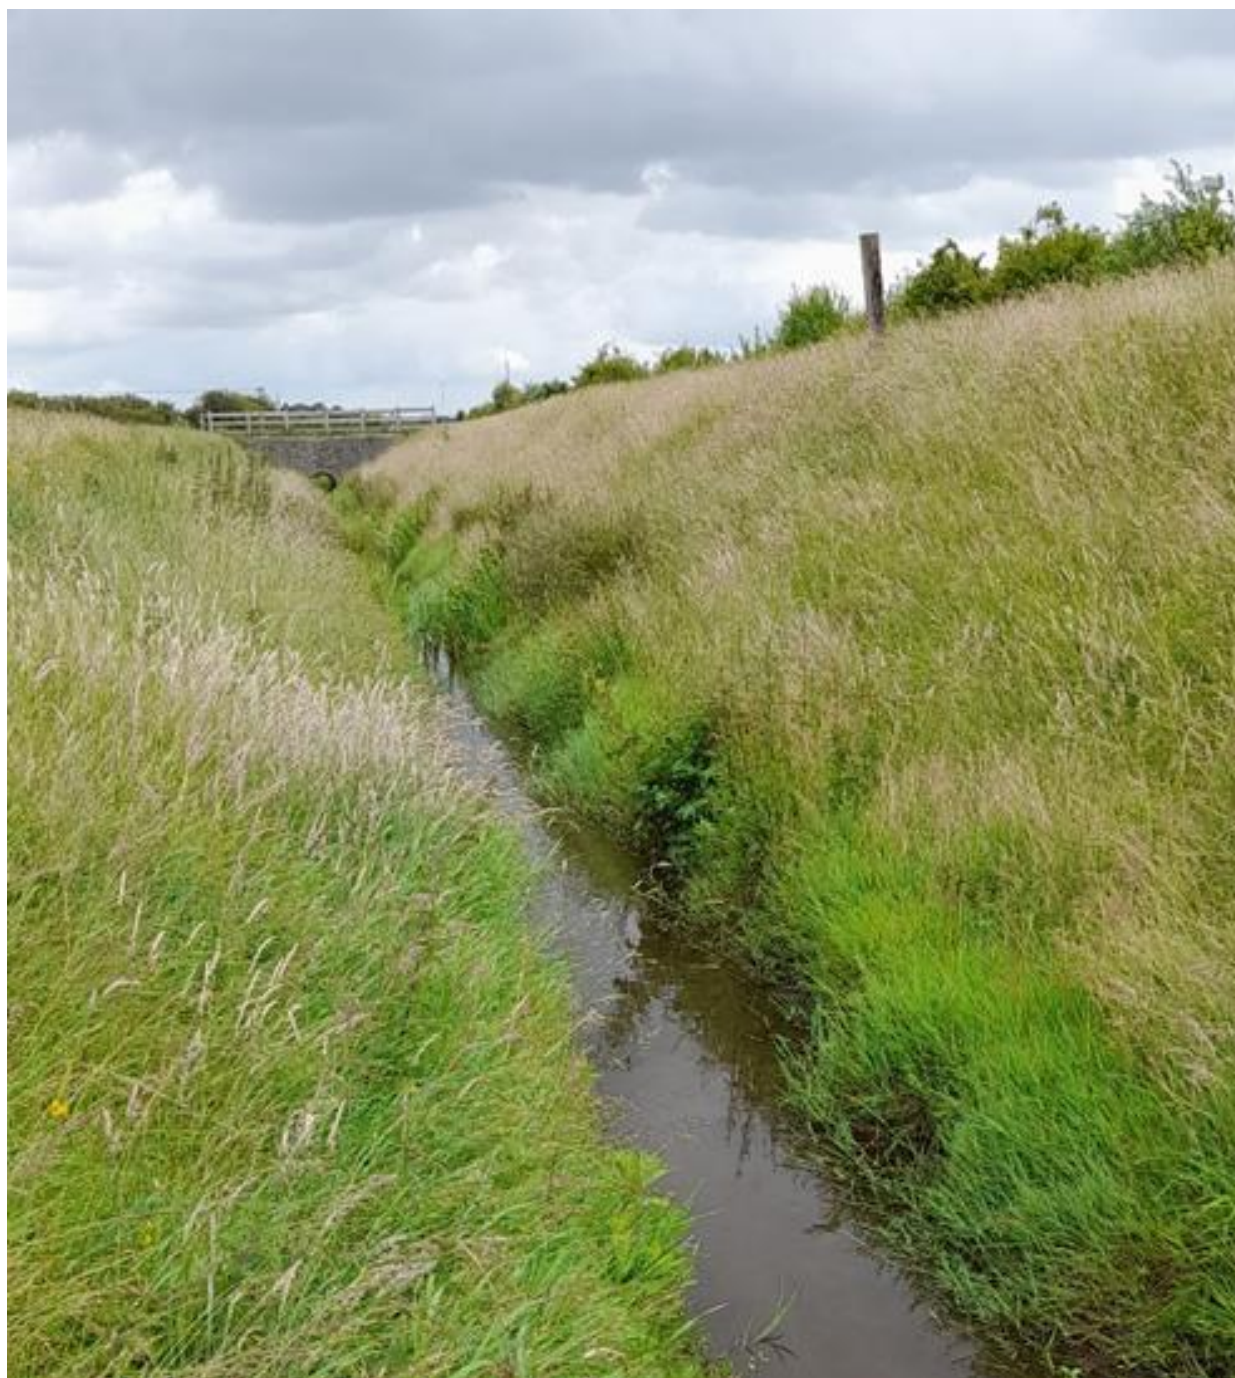
2.14. HAWARDEN BROOK

Catchment area	<1km ²
Key hydraulic connections	The Hawarden Brook discharges to the River Dee. There is a flow control structure on the confluence of the watercourse with the Dee to prevent tidal flows from entering Hawarden Brook.

River Condition Score	Not surveyed due to land access restrictions
Catchment description	This watercourse and its small low-lying catchment have been heavily modified by the constriction of the Dee and draining of the floodplain. The predominant land use is pastoral farming and the airfield.
Study reach description	Downstream of the B5129 the watercourse flows through an artificially incised, re-sectioned channel with a trapezoidal cross section. Whilst the channel is mostly unchanged since 1988, the catchment was heavily modified by the construction of the Airbus factory and runway.
Interaction with the DCO Proposed Development	The watercourse is not crossed by the Newbuild Carbon Dioxide Pipeline. It will be crossed via a new temporary crossing during the construction phase.
