HyNet North West

ENVIRONMENTAL STATEMENT (VOLUME III)

Appendix 18.1 Baseline Information

HyNet North West Carbon Dioxide Pipeline DCO

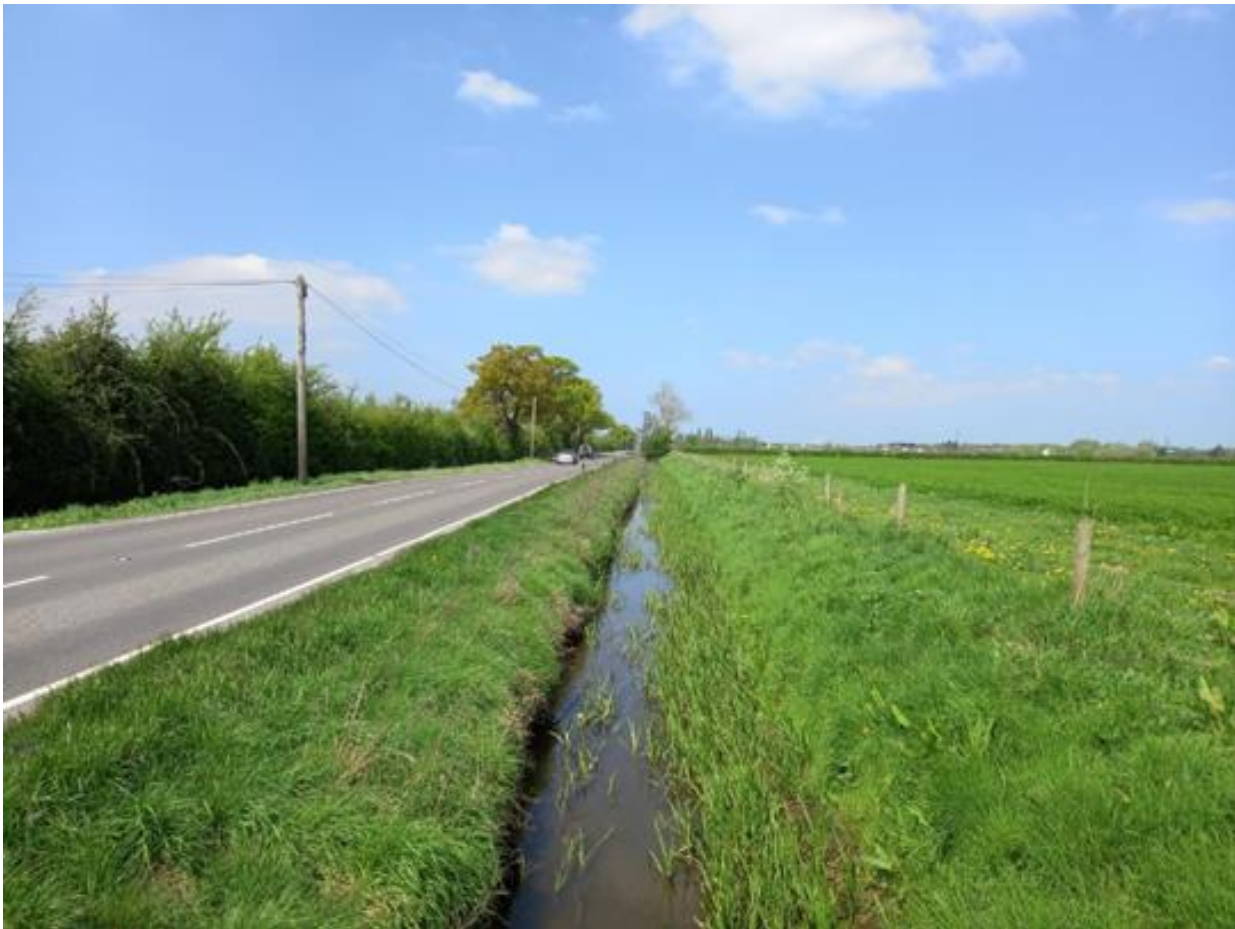
2.15. BROUGHTON BROOK

Catchment area	11.72km ²
Key hydraulic connections	<p>The Broughton Brook flows to the River Dee at Station Road. Along the B5129 it is joined by several tributaries flowing north-eastwards from Hawarden. There are drains along Chester Road which connect to the Broughton Brook prior to it joining the River Dee.</p> <p>The watercourse is disconnected from its floodplain as it is within an incised channel.</p>
River Condition Score	Fairly Poor
Catchment description	<p>The catchment has a high degree of human influence on watercourses and the landscape, with the surrounding land use predominantly arable farming, improved grassland and woodland. Elevation varies from ~ 157 mAOD to 8mAOD.</p>

<p>Study reach description</p>	<p>Broughton Brook channel is a cut trapezoidal drainage ditch, with consistent a bankfull width and water depth of 2m and 0.25m, respectively.</p> <p>The bed material is predominantly silt with some gravels and pebbles. Whilst the watercourse has a bare channel bed, there are some emergent reeds/ linear leaved or horsetails. The riparian zone is homogenous throughout the study area, with taller grasses on bank face and bank top, the B5129 on one bank and arable farming on the other.</p> <p>The planform of the channel has remained unchanged since 1913.</p>
<p>Interaction with the DCO Proposed Development</p>	<p>The Broughton Brook will be crossed by the Newbuild Carbon Dioxide Pipeline via trenchless methods (TRS-30).</p>

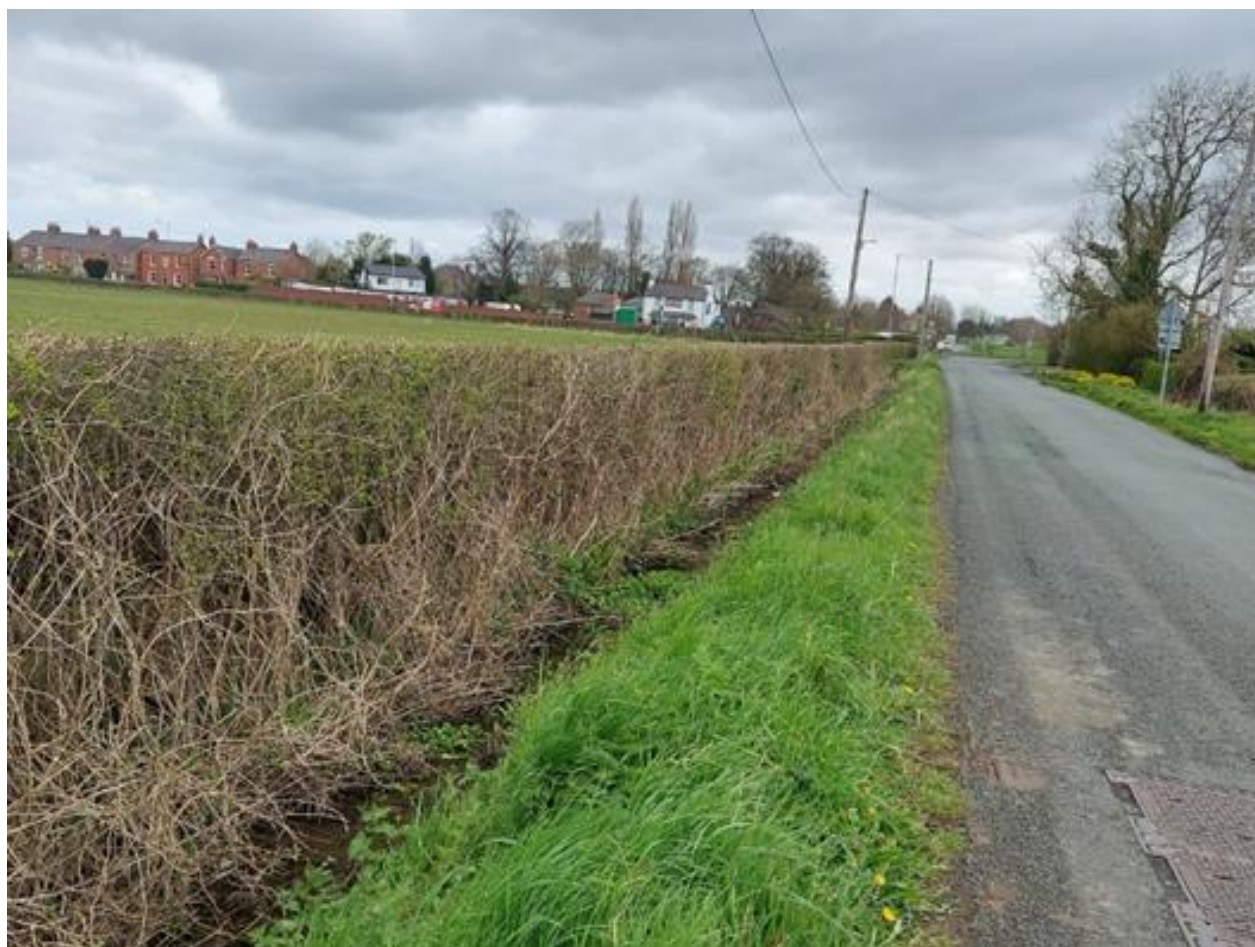
2.16. SANDYCROFT DRAIN

Catchment area	2.99km ²
Key hydraulic connections	Onward connection into Broughton Brook. It receives flows from roadside ditches of Moor Lane.
River Condition Score	Fairly Poor
Catchment description	The catchment drains the surrounding roads, urban areas, and arable fields and is relatively flat, with the elevation varying from 80 - 8 mAOD.

<p>Study reach description</p>	<p>The channel is a cut trapezoidal drainage ditch that appears to have been artificially straightened. The channel has a consistent bankfull width and water depth (1m and 0.05m, respectively).</p> <p>The bed material is predominantly silt with some sands. Whilst the channel bed sediment is bare, there are some emergent broadleaved and amphibious plants. The riparian zone is homogenous, with a hedgerow between the channel and the adjacent pastoral fields on one bank. The majority of the riparian zone is fields or road infrastructure.</p> <p>The planform of the channel has remained unchanged since 1913.</p>
<p>Interaction with the DCO Proposed Development</p>	<p>The Sandycroft Drain will be crossed by the Newbuild Carbon Dioxide Pipeline via trenchless methods (TRS-30) where it is parallel with Broughton Brook. At Moor Lane, the watercourse will be crossed by the Newbuild Carbon Dioxide Pipeline via open cut.</p>

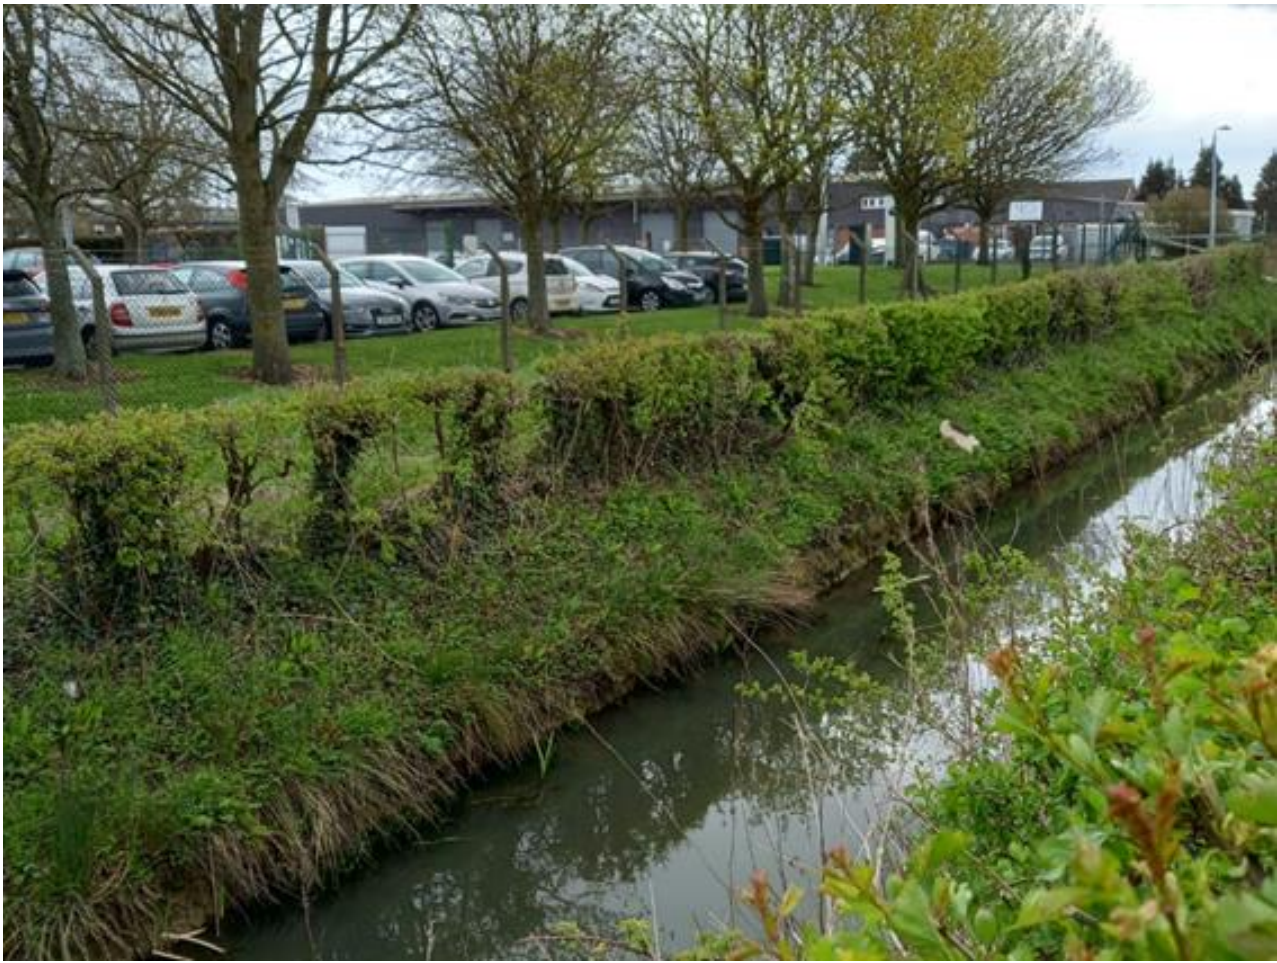
2.17. CHESTER ROAD DRAIN NORTH

Catchment area	1.67 km ²
Key hydraulic connections	This watercourse is hydraulically connected to both the Broughton Brook (southeast) and Aston Hall Brook (Northwest). The channel is not connected to the floodplain.
River Condition Score	Poor
Catchment description	The catchment drains farmland and arable fields, with extensive urbanisation north of the watercourse. The catchment is relatively flat catchment, with the elevation varying from 80 – 8 mAOD.

<p>Study reach description</p>	<p>Large sections of the watercourse are culverted or in an artificially incised channel with steep banks, with no variation in channel width (bankfull width 4 m) and depth (0.3 m) within the study area.</p> <p>The watercourse has a silt substrate, with a lack of geomorphic bed features. There is a lack of diversity in the riparian vegetation; however, in the open sections there is defunct hedgerow on the bank top with road and car parking within the riparian zone. There is bare earth on the bank faces, with some short creeping herbs and grasses</p> <p>Despite becoming progressively culverted, the channel has retained its contemporary planform since at least 1892.</p>
<p>Interaction with the DCO Proposed Development</p>	<p>This watercourse is within the Newbuild Infrastructure Boundary. The pit for the proposed trenchless crossings of Chester Road (TRS-31 and TRS-32) would be adjacent to this watercourse.</p>

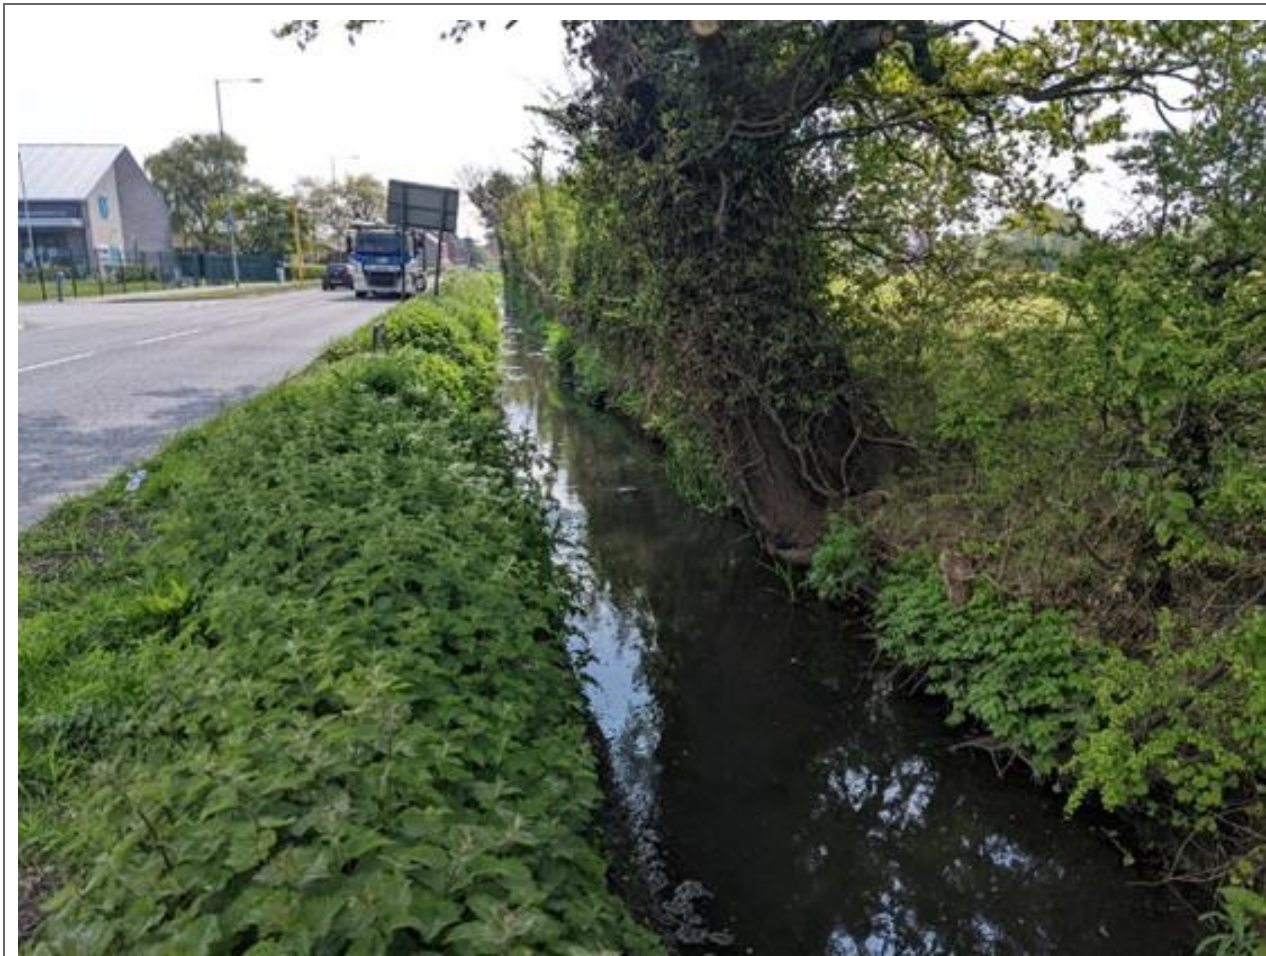
CHESTER ROAD DRAIN TRIBUTARY 1 AND 2

Catchment area	<1km ²
Key hydraulic connections	Onwards connection to Chester Road Drain North. The channel is not connected to the floodplain.
River Condition Score	Fairly Poor
Catchment description	The catchment drains farmland and arable fields with extensive urbanisation to the north of the watercourse. It has a relatively flat catchment, with elevation varying from 80 - 8 mAOD.

Study reach description	<p>The channel has a rectangular cross section with a consistent bankfull river width of 2.5m and water depth of 0.25m.</p> <p>The channel has a predominantly silt substrate with a lack of geomorphic diversity and bedforms. The riparian zone on the left bank is arable farmland, whilst on the right bank it is road infrastructure.</p> <p>Despite becoming progressively culverted, the channel has retained its contemporary planform since at least 1892.</p>
Interaction with the DCO Proposed Development	<p>This watercourse is within the Newbuild Infrastructure Boundary. The pit for the proposed trenchless crossing of Chester Road (TRS-31 and TRS-32) would be adjacent to this watercourse. The watercourse will be crossed by the Newbuild Carbon Dioxide Pipeline however the method is not yet determined.</p>

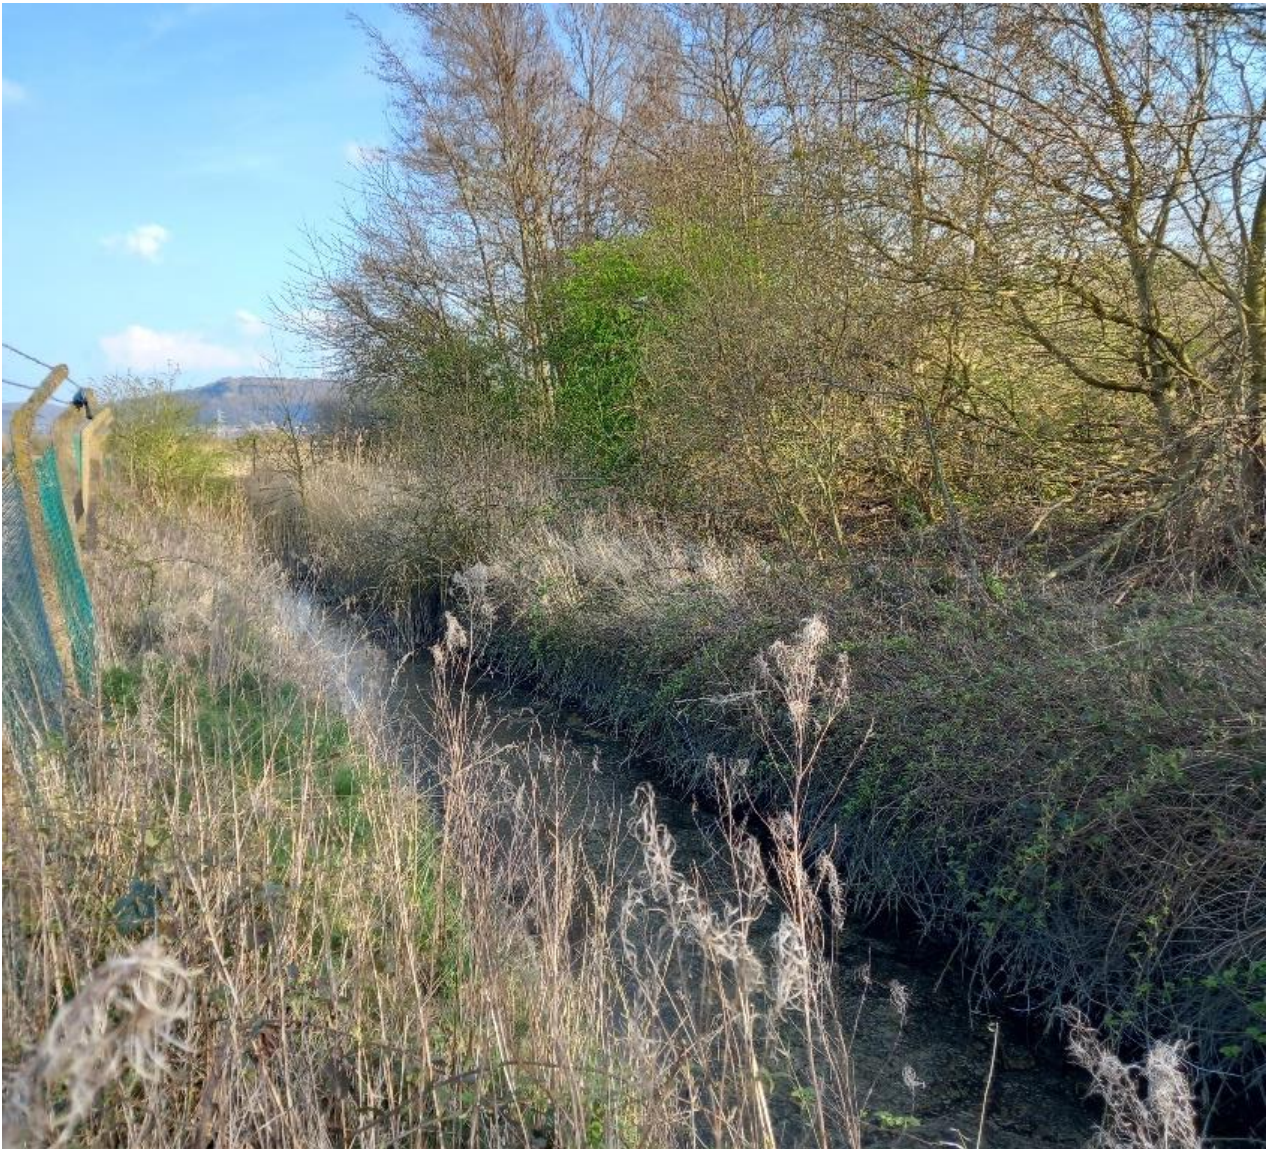
3.1. GLASS FACTORY DITCH

Catchment area	1.41km ²
Key hydraulic connections	Glass Factory Ditch connects to the West Central Drain and Ince Marshes.
River Condition Score	Fairly Poor
Catchment description	The majority of the catchment is used for industrial purposes.

Study reach description	<p>The watercourse flows through a straightened channel with re-sectioned banks. There are some concrete structures within the channel, likely used for sluices and penstocks historically. The watercourse is culverted beneath two access tracks before joining the West Central Drain.</p>
Interaction with the DCO Proposed Development	<p>The watercourse is not crossed by the Newbuild Carbon Dioxide Pipeline however it will be crossed by vehicles via existing access tracks via existing bridges / culverts.</p>

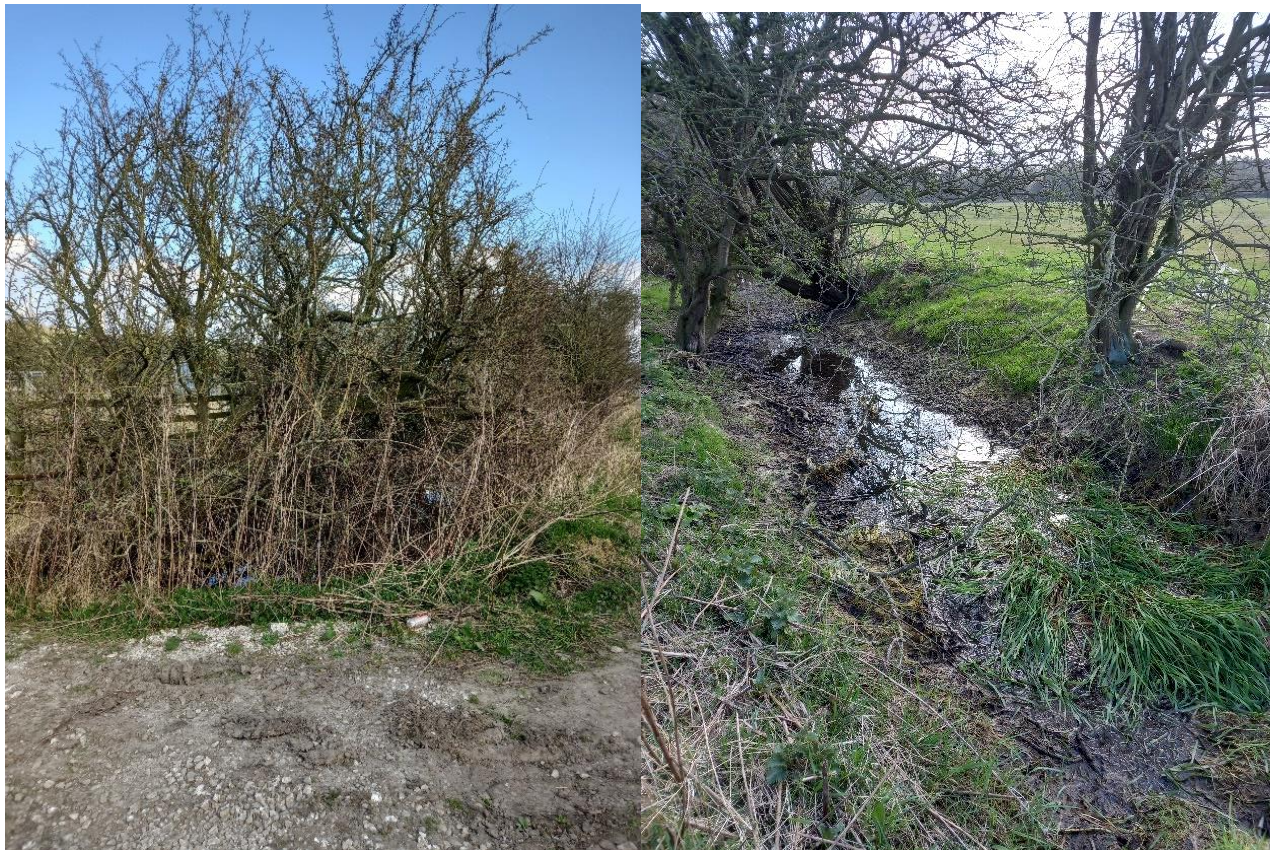
Elton Lane Ditch 1

Catchment area	<1km ²
Key hydraulic connections	Ephemeral watercourses which connect to West Central Drain and East Central Drain
River Condition Score	Poor (Ditch survey) (Elton Lane Ditch 1, 2 and 6) Moderate (Ditch survey) (Elton Lane Ditch 4)
Catchment description	Grazed farmland which is historically coastal and fluvial marshland which has been drained via a series of ditches and pumping.
Study reach description	The ditches within the Newbuild Infrastructure Boundary are narrow channels artificially cut around field boundaries. These ditches are ephemeral and have simple vegetation structures.

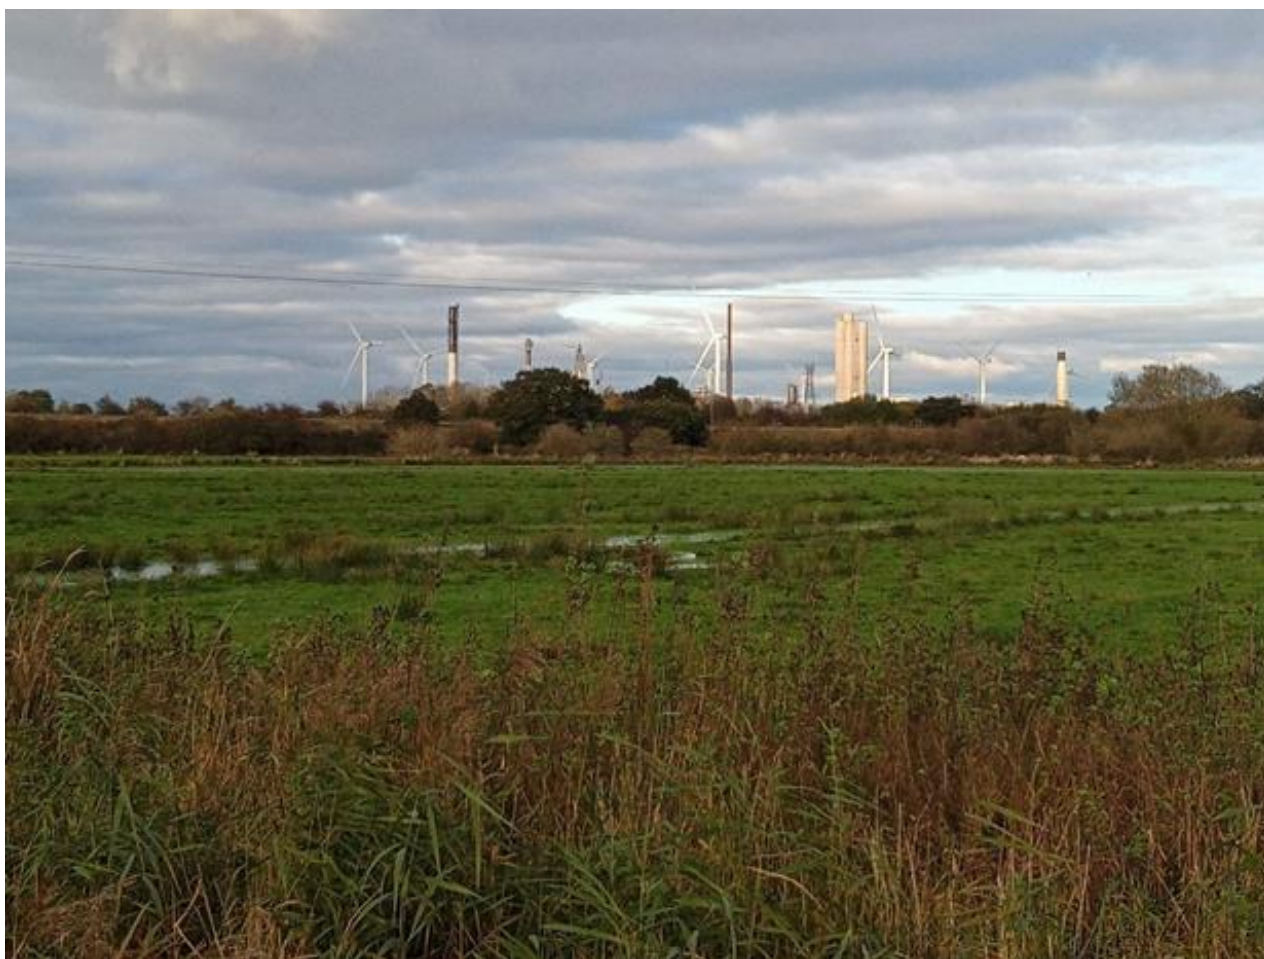
3.4. ELTON MARSH 1, 2, 3, 10, 11, 12, AND 13

Catchment area	<1km ²
Key hydraulic connections	Elton marsh ditches are all connected to the West Central Drain which is part of the wider Ince Marshes.
River Condition Score	Poor (Ditch survey)
Catchment description	Grazed farmland which is historically coastal and fluvial marshland which has been drained via a series of ditches and pumping.
Study reach description	The ditches are straight shallow ephemeral channels which have been artificially cut in order to drain the marshland. The floodplain is frequently flooded.
Interaction with the DCO Proposed Development	Elton Marsh 1, 2,3, 11, 12 and 13 could be crossed by the Newbuild Carbon Dioxide Pipeline via open cut. The exact route of the Newbuild Carbon Dioxide Pipeline is not determined at this stage.

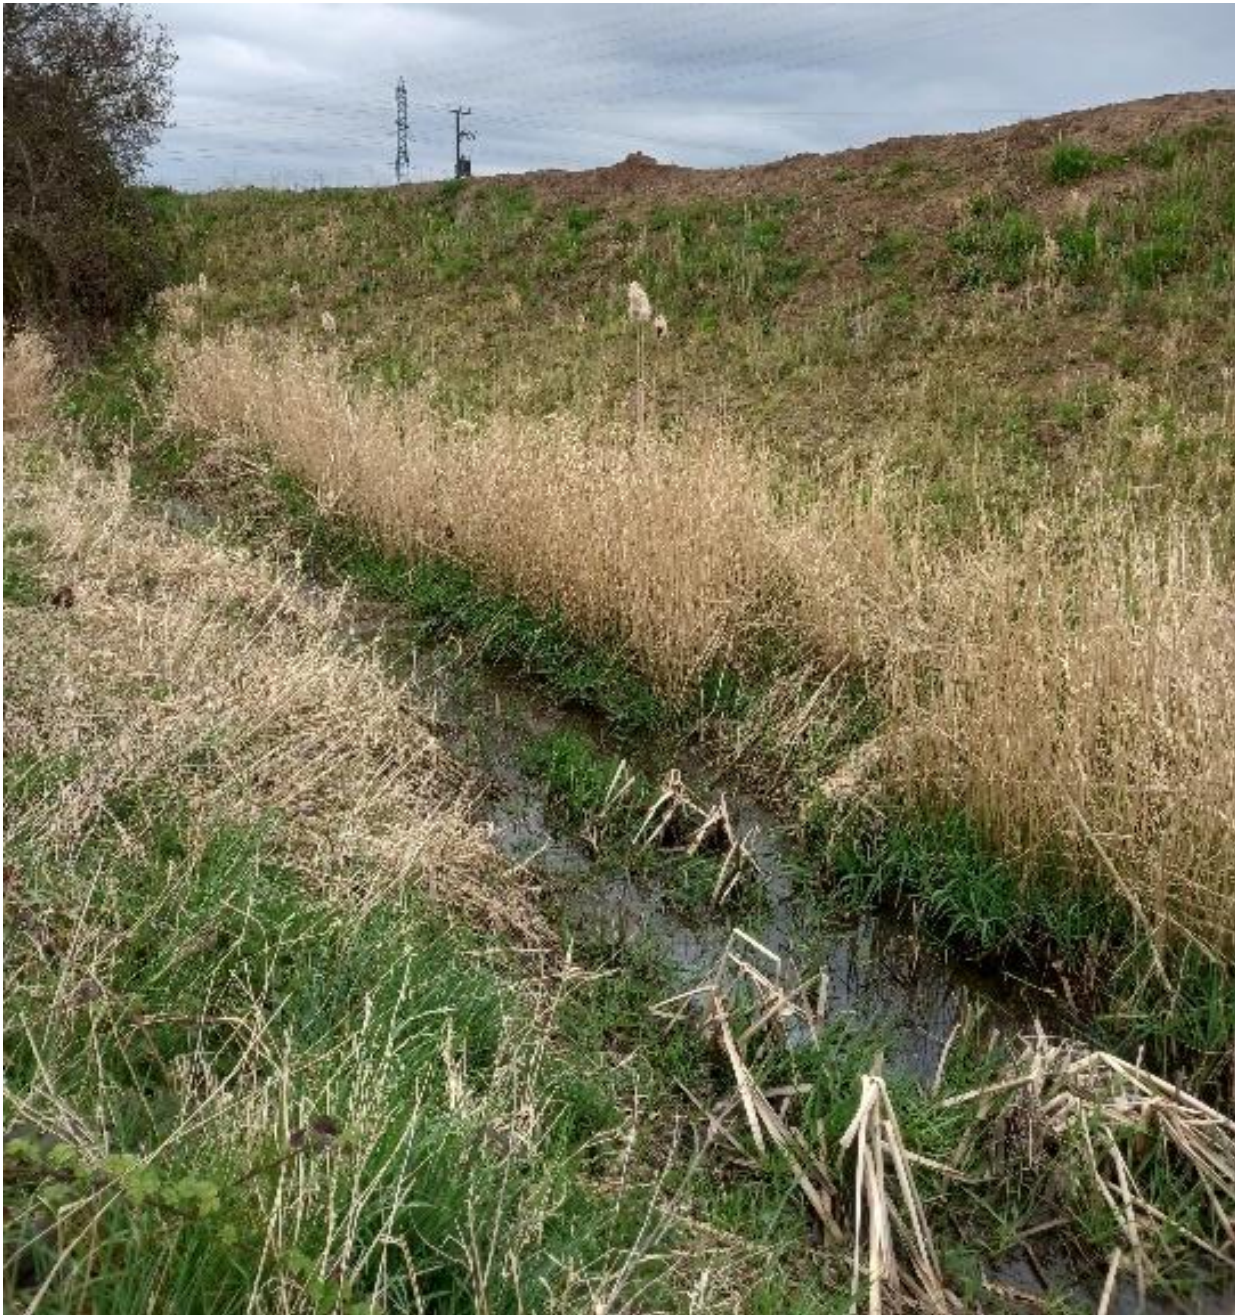
ELTON BROOK TRIBUTARY 1

Catchment area	<1km ²
Key hydraulic connections	Flows westwards into Gale Brook. The ditch is disconnected from its floodplain by incision and artificial bunding.
River Condition Score	Poor

Catchment description	Elton Brook Tributary 1 drains arable and horticultural land to the south of the A5117 and includes both the Essar Stanlow Refinery and the suburb of Elton.
Study reach description	<p>The channel is a cut trapezoidal, cut ditch with bunding along its south bank. There is potential evidence of physical damage along the ditch. It is unlikely that water levels are maintained throughout the summer (likely less than 50cm in depth).</p> <p>The bed material is comprised of silt and organic accumulation. The riparian zone is characterised by a lack of both marginal and aquatic vegetation.</p> <p>The Elton Brook Tributary 1 was formed between 1965 –1970 and the channel has maintained its contemporary position since its construction. However, a travellers' site was constructed in the location of the drain between 2009 –2010 creating bunding on the south bank.</p>
Interaction with the DCO Proposed Development	Elton Brook Tributary 1 will be crossed by the Newbuild Carbon Dioxide Pipeline via trenchless methods (TRS-05 and TRS-06).

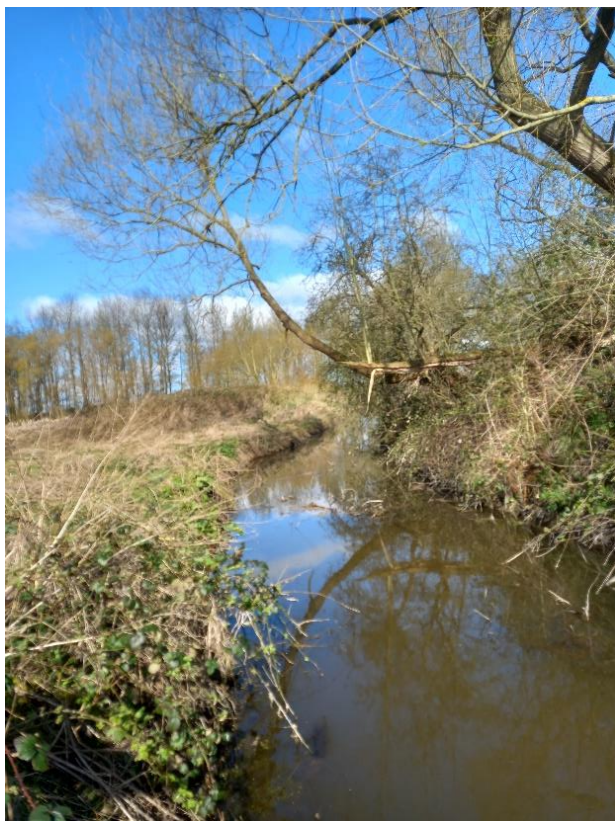
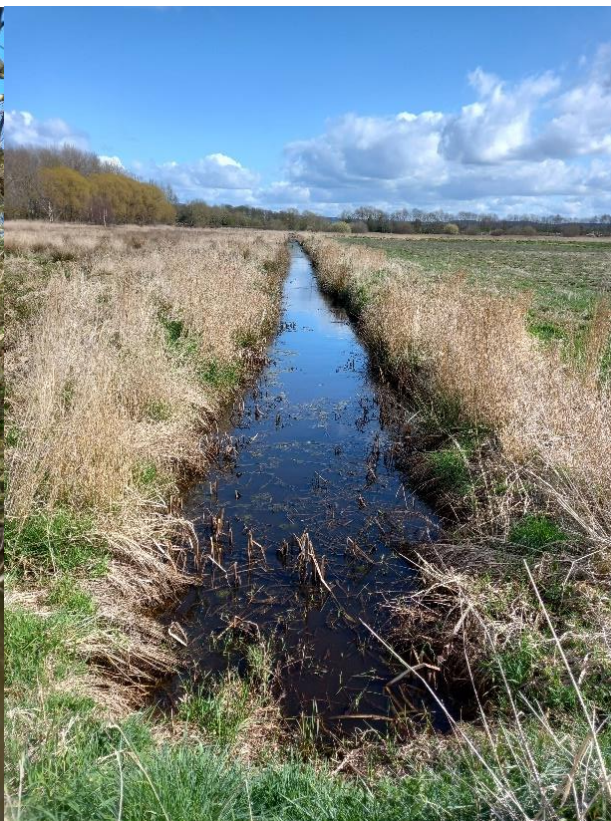
Thornton Ditch 4

Catchment area	<1km ²
Key hydraulic connections	Thornton Ditches 1 and 2 connect to Stanney Main Drain whilst Thornton Ditches 3, 4, 5 and 6 connect to Thornton Main Drain, both of which discharge to the River Gowy north of the DCO Proposed Development.
River Condition Score	Thornton Ditch 1: Moderate (Ditch survey) Thornton Ditch 2, 3, 4, 5 and 6: Poor (Ditch survey)
Catchment description	The catchment is predominantly grazed farmland or peat bog, most of which is within the fluvial floodplain of the River Gowy and is frequently wet.

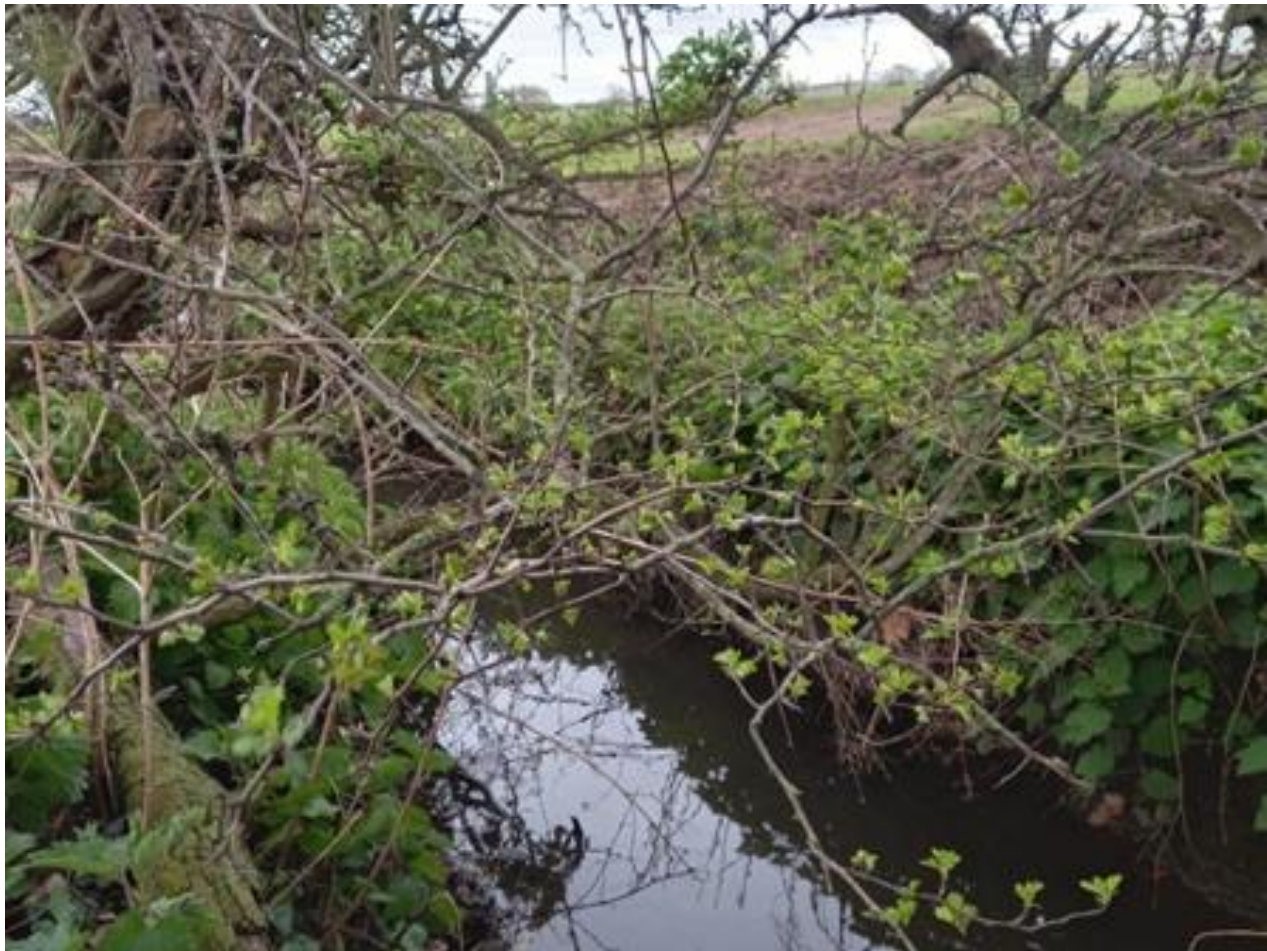
GOWY TRIBUTARY 2

Catchment area	1.1 km ²
Key hydraulic connections	Gowy Tributary 2 flows into Stanney Mill Brook and the River Gowy. At the proposed site access crossing, for where vehicles will be crossing to access the working corridor, the channel is connected to its floodplain. Nearer to the Gowy, the watercourse is in an incised ditch and disconnected from the floodplain.
River Condition Score	Access reach: Moderate Stoak reach: Fairly Poor.
Catchment description	Gowy Tributary 2 drains the surrounding arable, horticultural, and suburban land. The channel rises west of Upton Health. It has a maximum catchment altitude of 42 mAOD.

<p>Study reach description</p>	<p>The channel appears to have been artificially straightened and has reshaped banks at the three locations where surveys were carried out. Bankfull river width is 1.5 - 2.75m and water depth is 0.05 - 0.1m.</p> <p>The bed material is comprised of gravel and pebbles, but mostly silts and clays with extensive coverage of bare sediment. The riparian zone is largely extensive cover of bare earth, with some vegetation and evidence of bank erosion (j-shaped and leaning trees).</p> <p>Gowy Tributary 2 has retained the same form since 1913.</p>
<p>Interaction with the DCO Proposed Development</p>	<p>Three sections of Gowy Tributary 2 are within the Newbuild Infrastructure Boundary. It is anticipated that the watercourse would not be crossed by the Newbuild Carbon Dioxide Pipeline as the exact location is not yet determined. However, if crossed, it would be via open cut.</p> <p>The most upstream surveyed section will be crossed by a new temporary access track during the construction phase.</p>

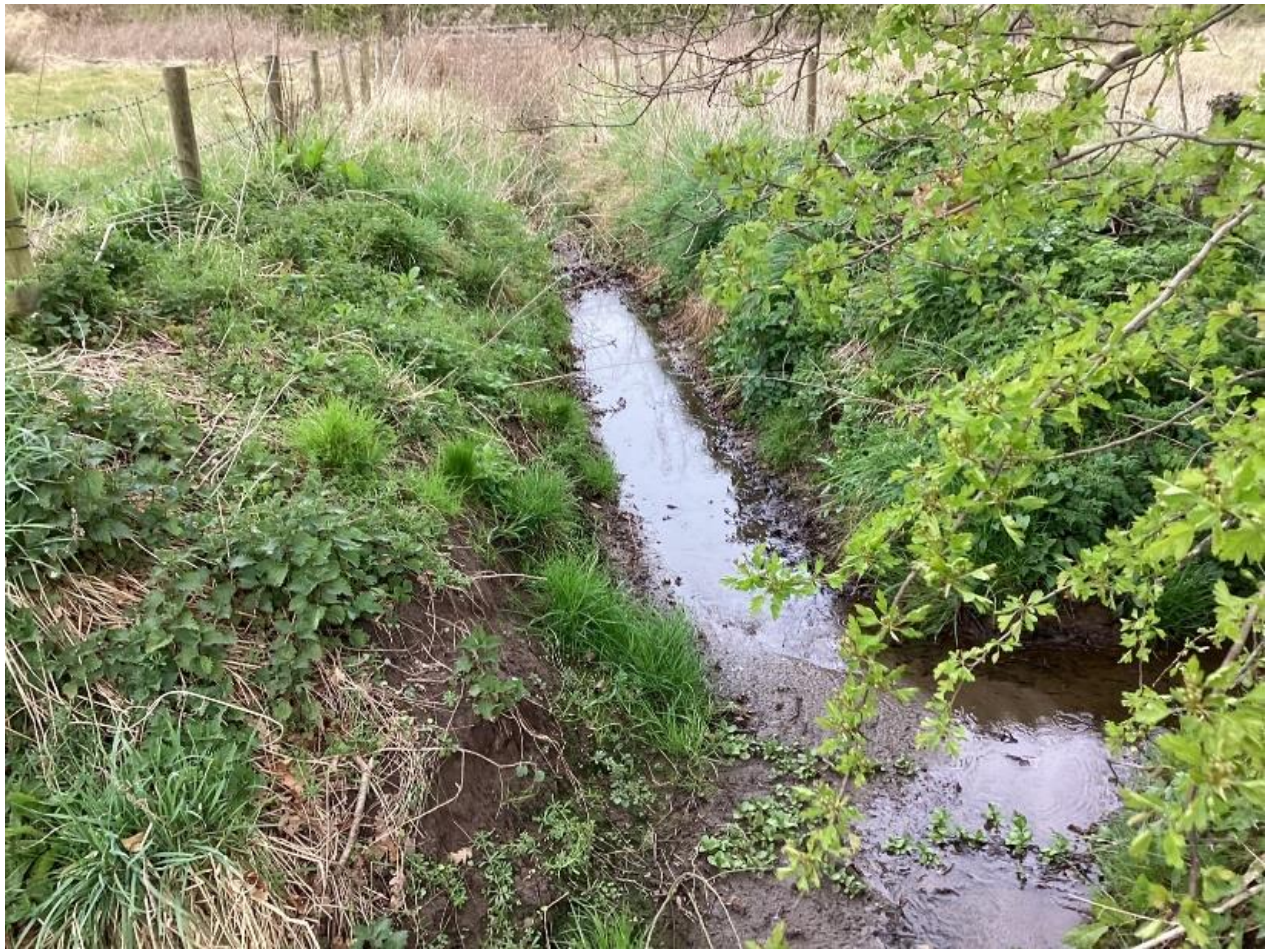
WERVIN HALL DITCH TRIBUTARY

Catchment area	<1km ²
Key hydraulic connections	Flows into Wervin Hall Ditch which flows under the Shropshire Union Canal and joins Canal Ditch; part of Finchetts Gutter water body.
River Condition Score	Poor
Catchment description	Wervin Hall Ditch Tributary drains agricultural and pastoral land. The channel rises east of Caughall road, with a maximum catchment altitude of circa 39 mAOD. The surrounding land use is farmland, agricultural buildings, roadways, Shropshire Union Canal and plantation woodland.

<p>Study reach description</p>	<p>The incised, cut channel appears to have been artificially straightened. The ditch is likely to be ephemeral.</p> <p>The bed material is sand, silt and gravel. The riparian zone has a lack of emergent, submerged, and floating leaved plants with some signs of potential eutrophication.</p> <p>The channel planform has remained consistent since 1892.</p>
<p>Interaction with the DCO Proposed Development</p>	<p>The ditch will be crossed by the Newbuild Carbon Dioxide Pipeline via trenchless methods (TRS-17).</p>

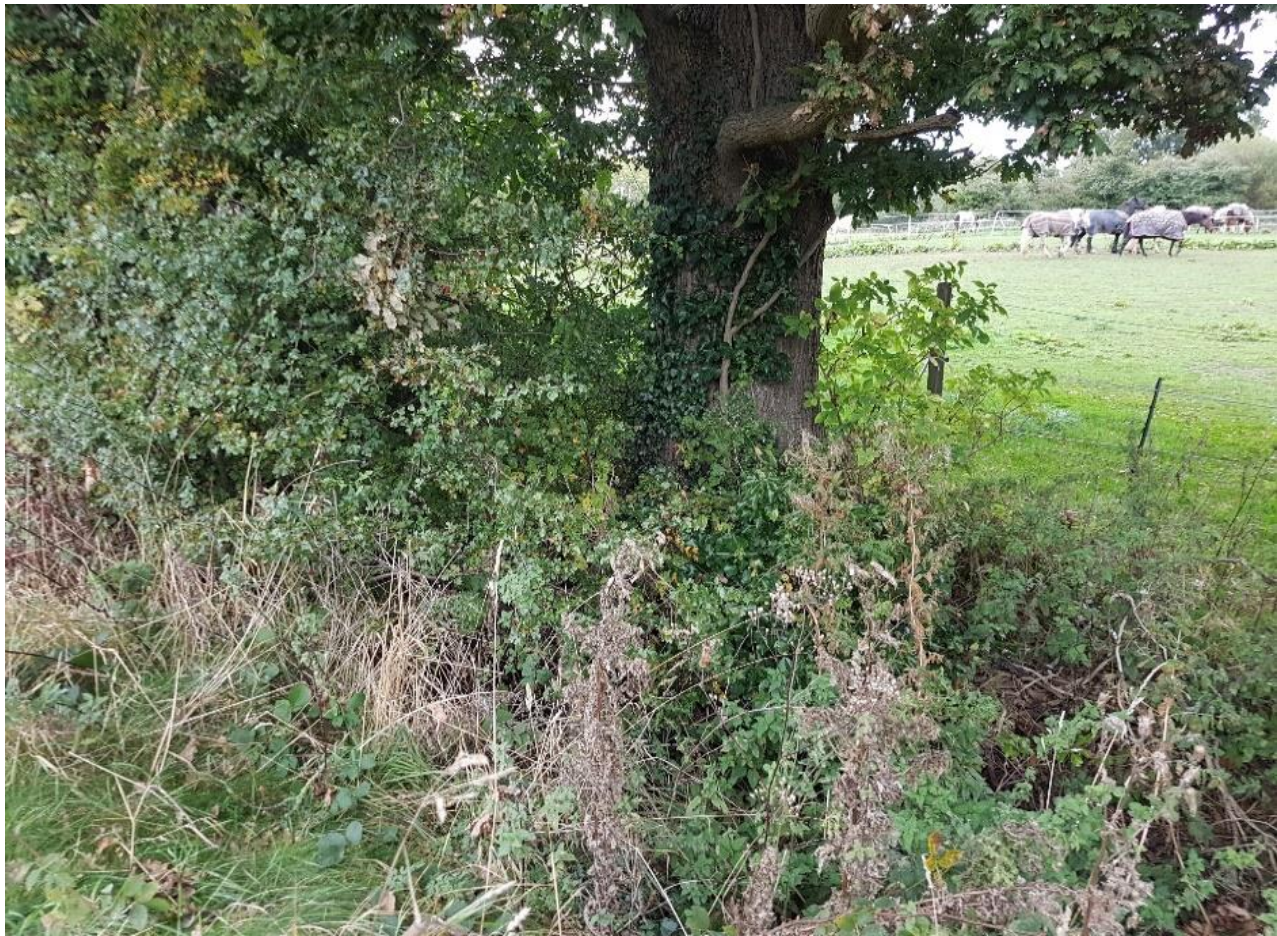
3.11. COLLINGE WOOD BROOK

Catchment area	<1km ²
Key hydraulic connections	Onward connection to canal ditch and is likely culverted beneath Shropshire Union Canal to join Finchetts Gutter.
River Condition Score	Not surveyed
Catchment description	Drains agricultural and pastoral land. The surrounding land use is farm buildings and tracks, improved grassland, arable and horticultural land, some broadleaved and mixed and yew woodland. Catchment altitude varies between ~ 42 mAOD - ~11mAOD.

<p>Study reach description</p>	<p>The cut channel has been re-sectioned, over deepened and artificially straightened. The channel has rectangular and trapezoidal sections with gently sloping banks and a bankfull width of ~1.5m,</p> <p>The bed material is fine, with no visible channel bed features. The bed of the channel is unconsolidated. There is a continuous riparian buffer along right bank, which has a uniform and simple riparian zone structure. The bank materials are composed of cohesive earth. There is simple bank face vegetation, with a semicontinuous tree line on the right bank.</p> <p>The channel has retained the same planform since 1892.</p>
<p>Interaction with the DCO Proposed Development</p>	<p>The watercourse will be crossed by the Newbuild Carbon Dioxide Pipeline via open cut.</p>

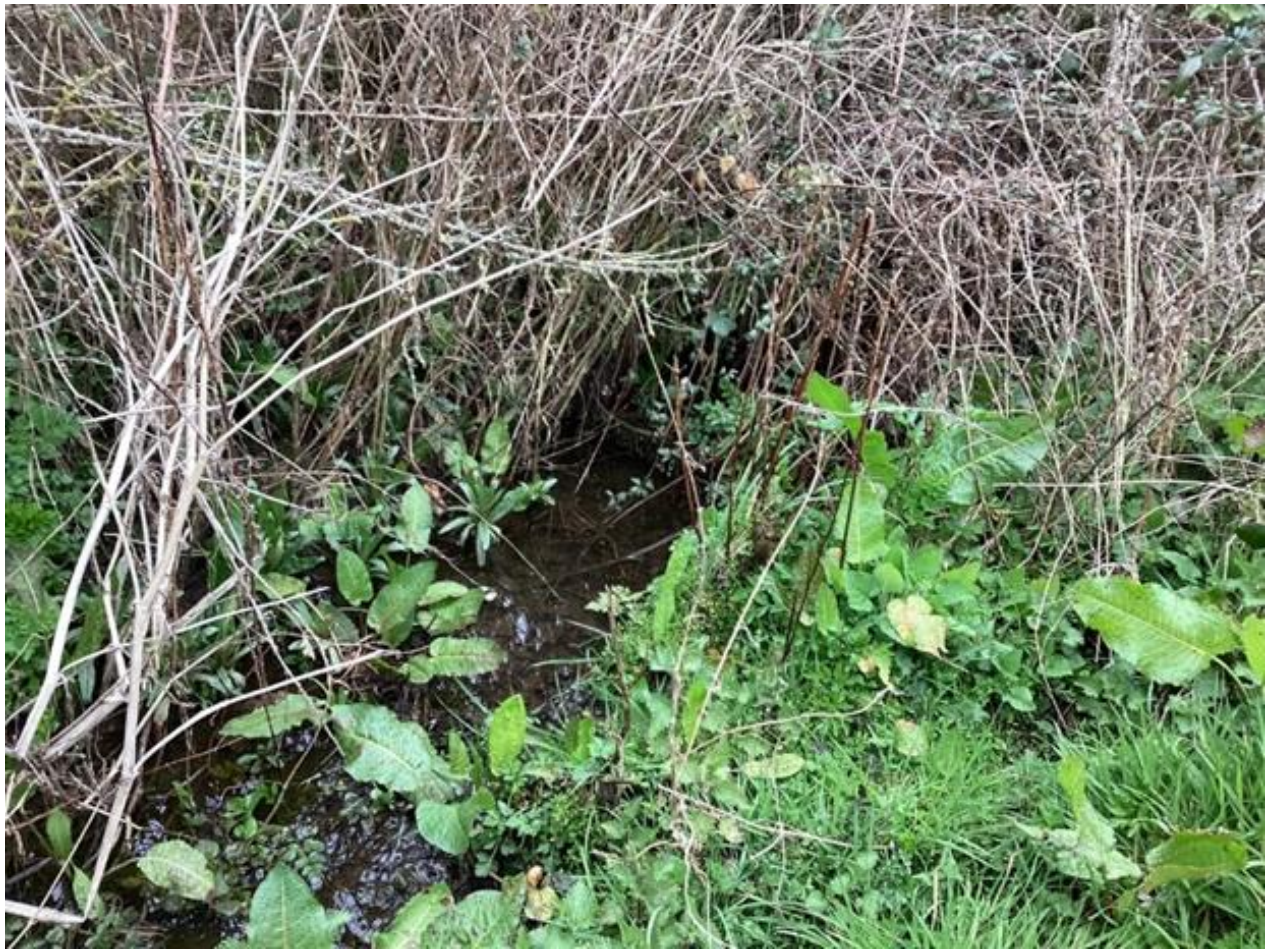
3.12. RAKE LANE BROOK

Catchment area	3.3km ²
Key hydraulic connections	This watercourse flows beneath the Shropshire Union Canal and joins Finchetts Gutter.
River Condition Score	Moderate
Catchment description	The watercourse is ~ 0.7km long, with the surrounding land use being pasture, grassland, and woodland. Elevation varies from 24m to 20mAOD.

<p>Study reach description</p>	<p>The watercourse has a shallow and narrow wetted channel. At the time of the survey, it had a water depth of 0.05m. Channel width varied between 0.5 and 0.8m.</p> <p>The riverbed substrate is rich in silt and organic particles. The riparian zone is primarily permanently vegetated agricultural land use. The fields on both banks are grazed and there is a hedgerow along the right bank.</p> <p>No change in planform can be seen from existing online maps (from 1982 onwards).</p>
<p>Interaction with the DCO Proposed Development</p>	<p>The watercourse will be crossed by the Newbuild Carbon Dioxide Pipeline via open cut.</p>

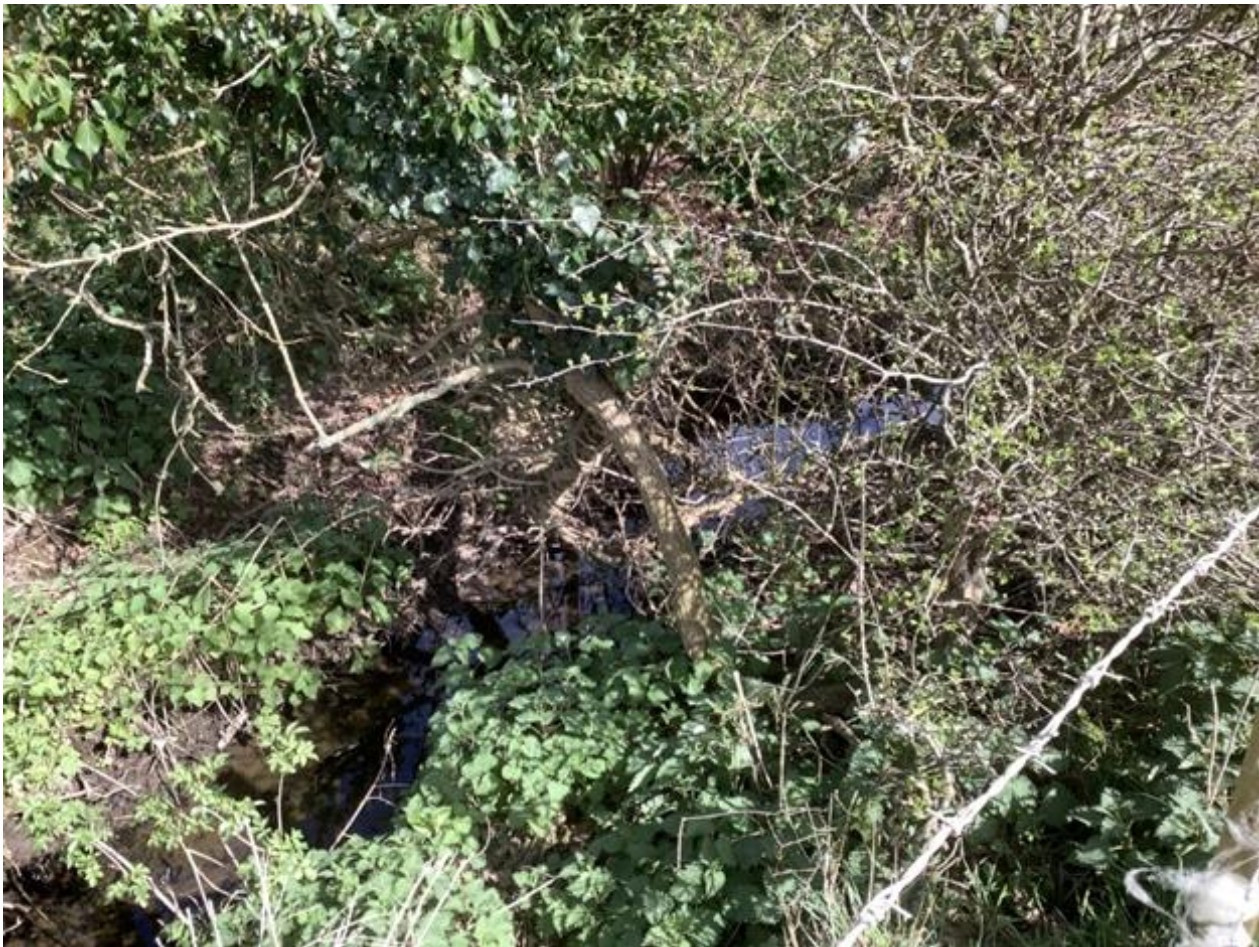
3.13. FRIARS PARK DITCH

Catchment area	0.135km ²
Key hydraulic connections	This watercourses flow southeast, under the Shropshire Union Canal and connects to Finchetts Gutter.
River Condition Score	Fairly Good
Catchment description	The watercourse drains a catchment south of Lea-by-Backford in which the land use is characterised as pasture, grassland, and woodland The elevation ranges from 12m to 25mAOD.

<p>Study reach description</p>	<p>The watercourse is in a deep channel much lower than the surrounding pasture, with water depth varying from 0.03m to 0.15m, and river width from 0.3m to 0.5m.</p> <p>The river bed substrate is dominated by silt with organic matter overlaying the silt. The riparian zone is primarily composed of permanently vegetated agriculture. There is a line of mature trees along the bank top of the watercourse, with more vegetation on the bank face.</p> <p>No change in planform can be seen from existing online maps (from 1982 onwards).</p>
<p>Interaction with the DCO Proposed Development</p>	<p>The watercourse will be crossed by the Newbuild Carbon Dioxide Pipeline via open cut. Construction vehicles will also cross this watercourse via the existing crossing to the south of the potential crossing location.</p>
