HyNet North West

ENVIRONMENTAL STATEMENT (VOLUME III)

Appendix 18.1 Baseline Information

HyNet North West Carbon Dioxide Pipeline DCO

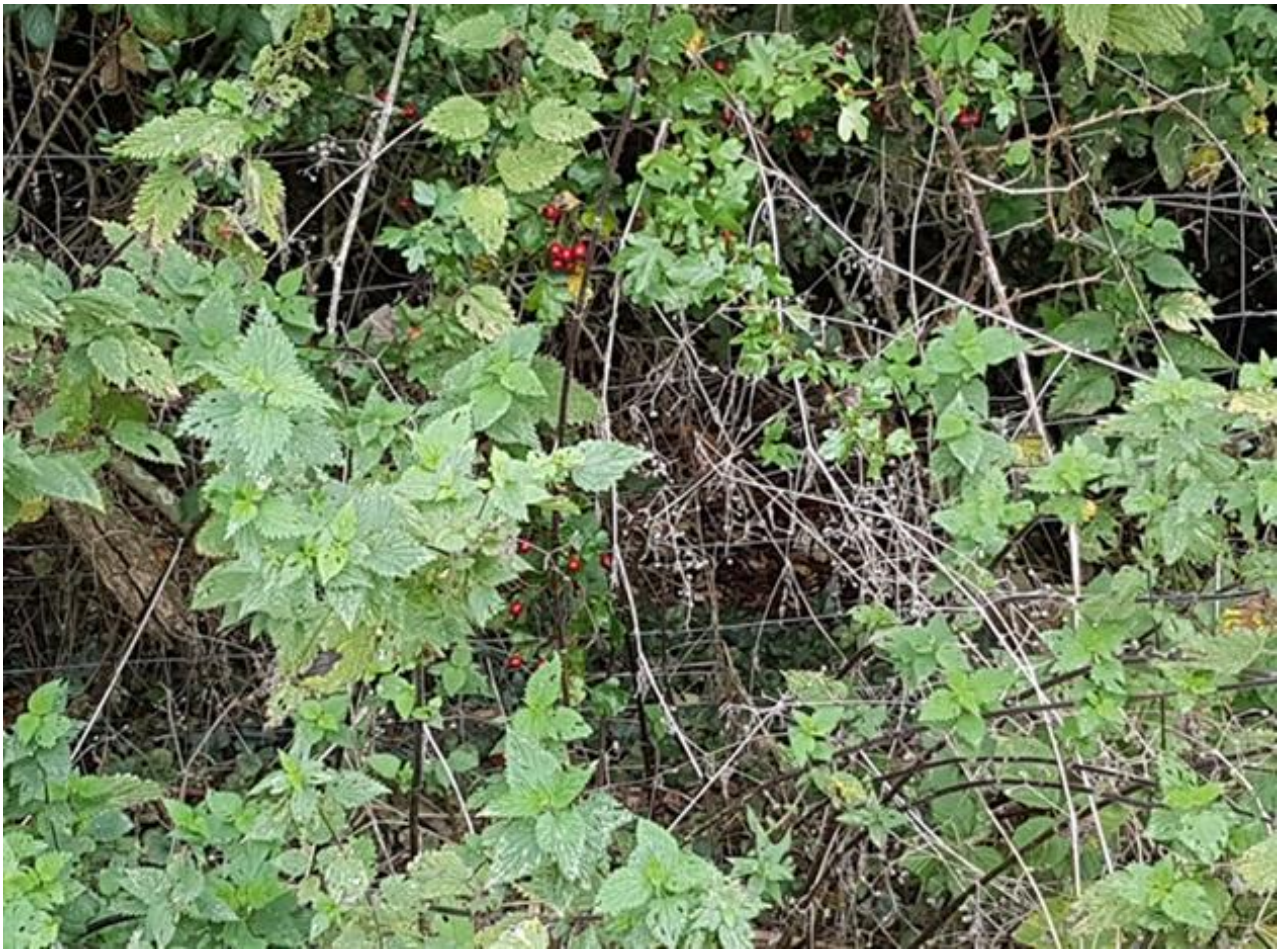
3.15. GYPSY LANE BROOK

Catchment area	1.51 km ²
Key hydraulic connections	Network of hedgerow ditches, which flows southeast, beneath the Shropshire Union Canal and then joins Finchetts Gutter. The watercourse is disconnected from the floodplain.
River Condition Score	No survey completed
Catchment description	The catchment includes local farmland and arable fields, along with the urban development Lea by Backford. It has an elevation range between 14 and 41 mAOD.

<p>Study reach description</p>	<p>The watercourse has a straight channel planform and rectangular and trapezoidal cross section. It has been resectioned, over-deepened and artificially straightened. Channel depth is around 1.5 m, and bankfull width is around 1.5m</p> <p>At time of survey there was an obscured view of the channel bed, precluding identification of the channel bed material. Within the Newbuild Infrastructure Boundary, the riparian zone includes a hedgerow along the right bank of the channel though predominant land use is arable and pastoral farming. There is simple bank top and bank face vegetation.</p> <p>The channel has retained its planform since 1892.</p>
<p>Interaction with the DCO Proposed Development</p>	<p>The watercourse will be crossed by the Newbuild Carbon Dioxide Pipeline via open cut.</p>

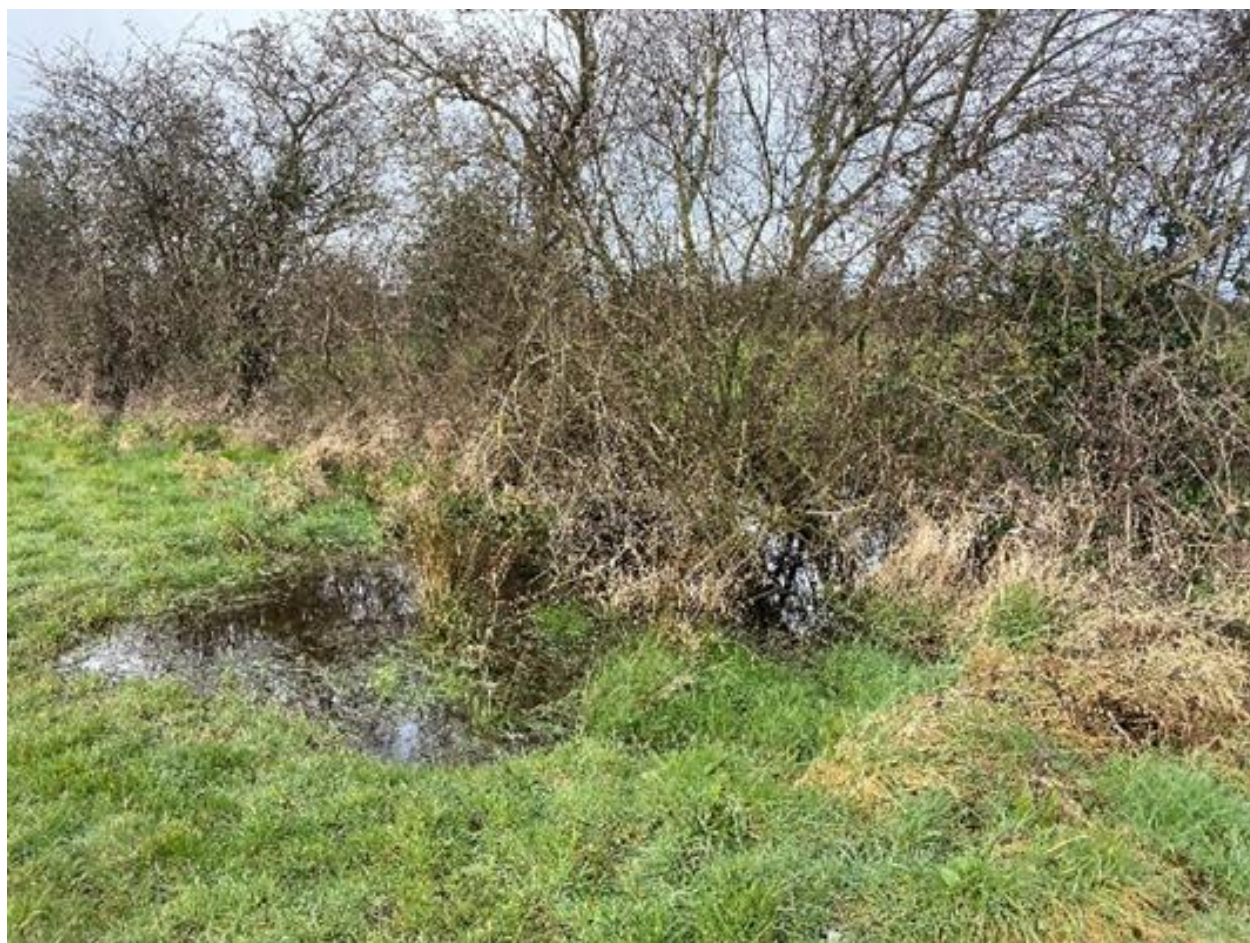
3.16. OVERWOOD DITCH

Catchment area	<1km ²
Key hydraulic connections	Overwood Ditch flows southwards towards Finchetts Gutter Tributary. There is a pond which flows into Overwood Ditch.
River Condition Score	No survey completed.
Catchment description	This is a small catchment which is dominated by agricultural land uses.

<p>Study reach description</p>	<p>The watercourse has a straight channel planform and rectangular and trapezoidal cross section. It has been resectioned, over-deepened and artificially straightened.</p> <p>At time of survey there was an obscured view of the channel bed, precluding identification of the channel bed material. Based on catchment land use and gradients, bed material is likely to be fine material such as silt. Within the Newbuild Infrastructure Boundary, there is a hedgerow along both banks of the channel, though the predominant land use within the riparian zone is pastoral farming. There is simple bank top and bank face vegetation.</p> <p>The channel has retained its planform since 1892.</p>
<p>Interaction with the DCO Proposed Development</p>	<p>The watercourse will receive runoff from Mollington BVS.</p> <p>It may be crossed by the Newbuild Carbon Dioxide Pipeline as the exact alignment has not yet been determined.</p>

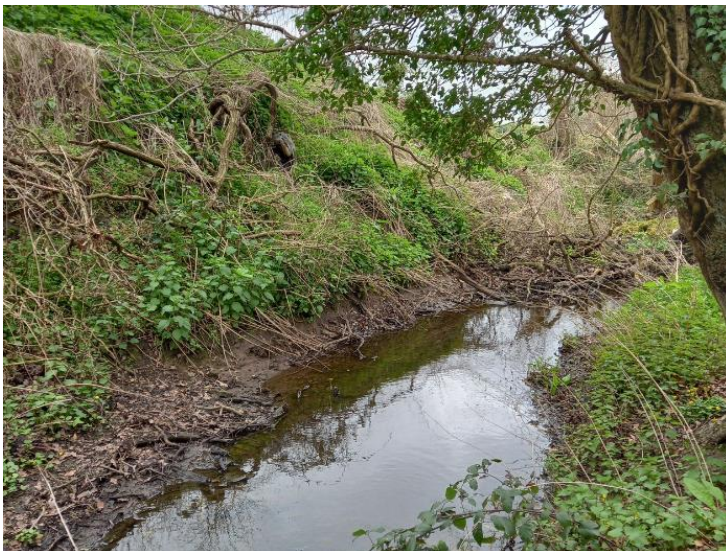
Moderate section within Newbuild Infrastructure Boundary

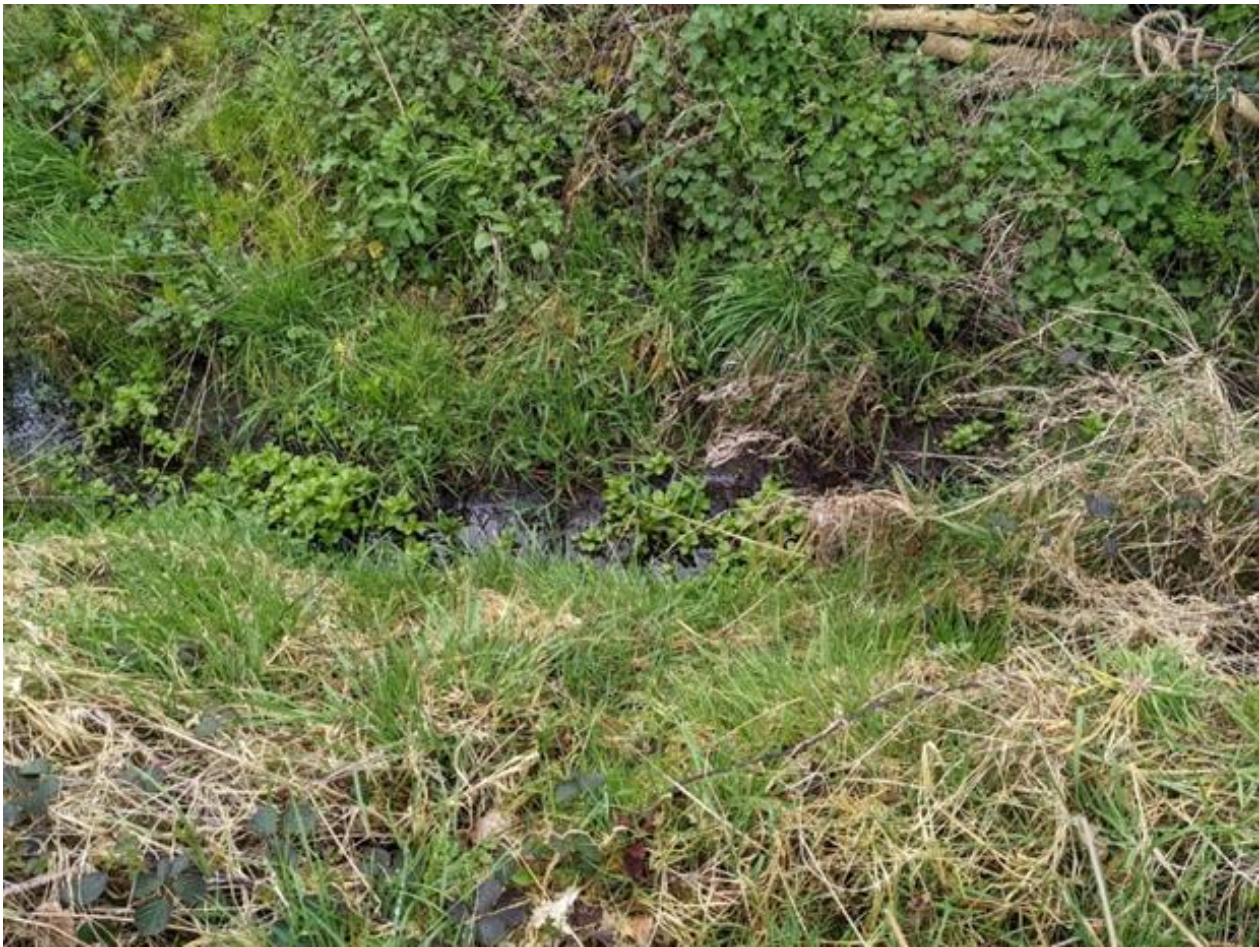
3.18. SEAHILL TRIBUTARY 2

Catchment area	0.270km ²
Key hydraulic connections	This watercourse has no tributaries. This watercourse joins the Seahill Drain at its downstream end.
River Condition Score	Fairly poor
Catchment description	Highly modified catchment, in which the land use is arable agriculture. The total watercourse length is 0.5km, and the elevation changes from 5mAOD to 20mAOD.

<p>Study reach description</p>	<p>Watercourse geometry is minimal throughout the study area. Water width is ~ 0.5m, and water depth is ~ 0.02m.</p> <p>The bed is dominated by silt particles and low morphological diversity. The riparian zone is primarily arable agriculture.</p> <p>No change in planform can be seen from existing online maps (from 1982 onwards).</p>
<p>Interaction with the DCO Proposed Development</p>	<p>The watercourse will be crossed by the Newbuild Carbon Dioxide Pipeline via open cut.</p>

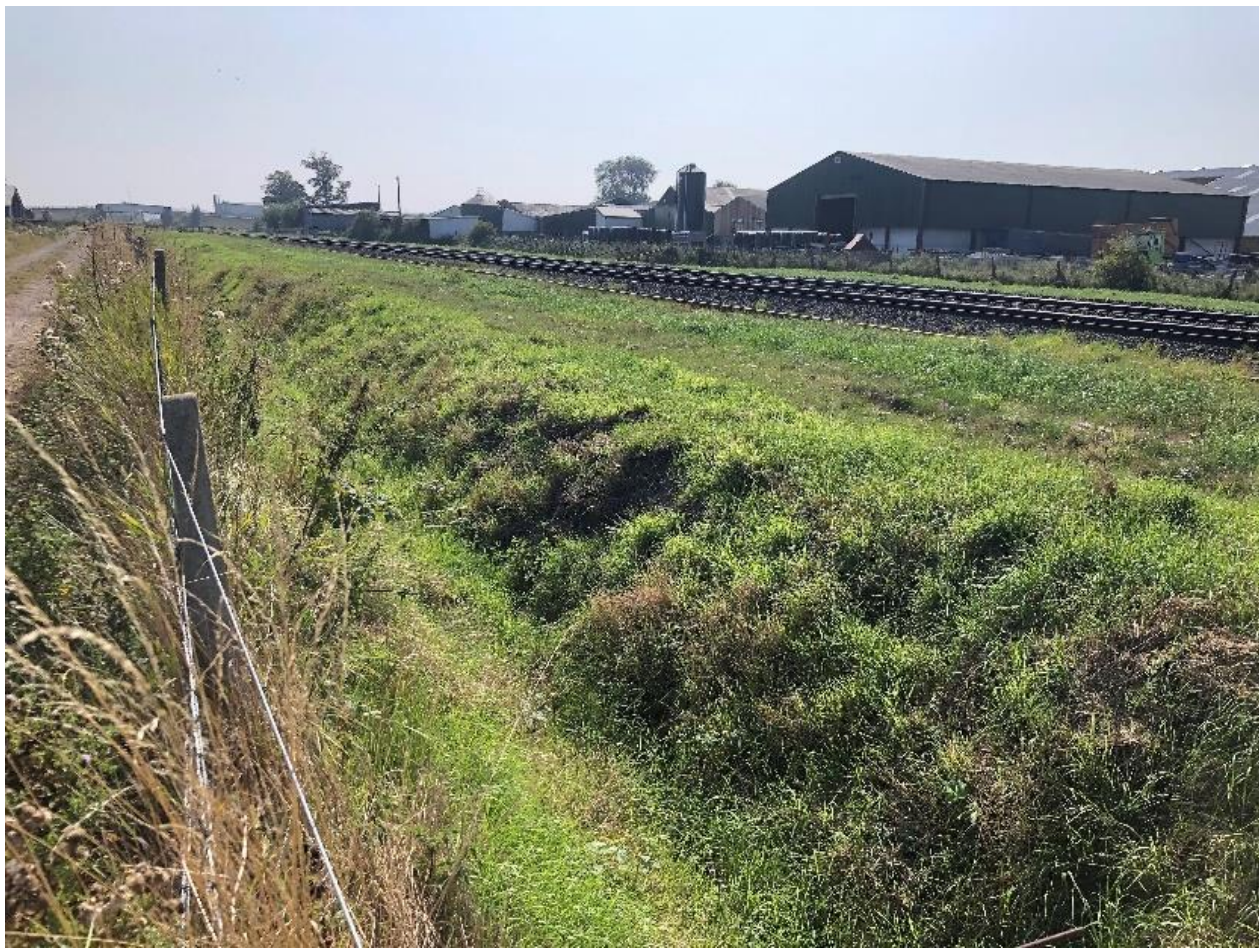
3.19. RAILWAY DITCHES 1 AND 2

Catchment area	<1km ²
Key hydraulic connections	The railway ditches are ephemeral. It is assumed that they connect to Hawarden Brook which flows northwards to the Dee Estuary.
River Condition Score	Poor
Catchment description	Small catchment modified by artificial drains and the railway. The surrounding land use is predominantly arable and horticultural, with some urban development.
Study reach description	These are small ditches, and the bed material is mostly silt and organic matter. The riparian zone is heavily modified, a railway embankment on one side of the ditch and farmland on the other side. There is an absence of marginal vegetation along most of the ditches. Since 1913, the channel has retained its planform.

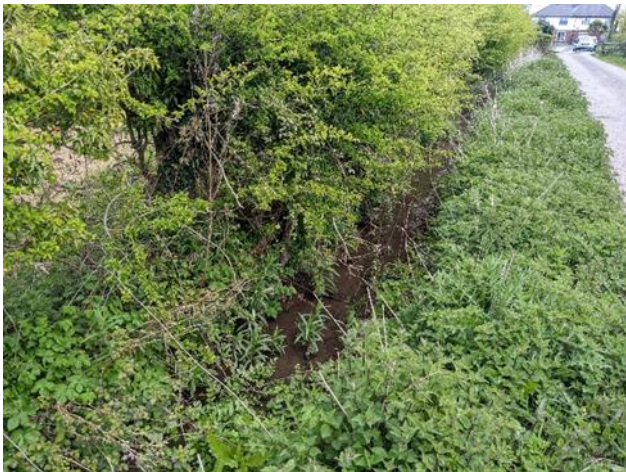
Mancot Brook - Downstream Reach

Key hydraulic connections	Onward connection into Chester Road Drain South, which flows beneath the B5129 to join the Broughton Brook.
River Condition Score	Moderate
Catchment description	<p>The catchment is predominantly rural, thus mostly draining farmland and arable fields. This comprises improved and neutral grassland, broadleaved, mixed and yew woodland.</p> <p>The catchment is relatively flat, with the elevation varying from 80 - 8 mAOD.</p>
Study reach description	<p>The channel is incised in places, with bankfull channel width varying between 1.5-3m, whilst water depth is between 0.05 – 0.07m.</p> <p>The channel has a silt substrate with extensive cover of bare earth. Some broad and linear leaved aquatic vegetation is present. At the location of the upstream proposed open cut crossing, the riparian zone is dominated by short grassland pasture. At the downstream proposed crossing location there is a hedge along the left bank and a private drive on the right bank within the riparian zone.</p> <p>Since 1913, the channel has retained its planform as a drainage channel to the surrounding arable land. The channel has been elongated to follow field boundaries, therefore resulting in a shallower gradient compared to its likely natural state.</p> <p>Mancot Brook Tributary is ephemeral and flows through a grazed pasture. It has extensive grass cover to bed and banks.</p>

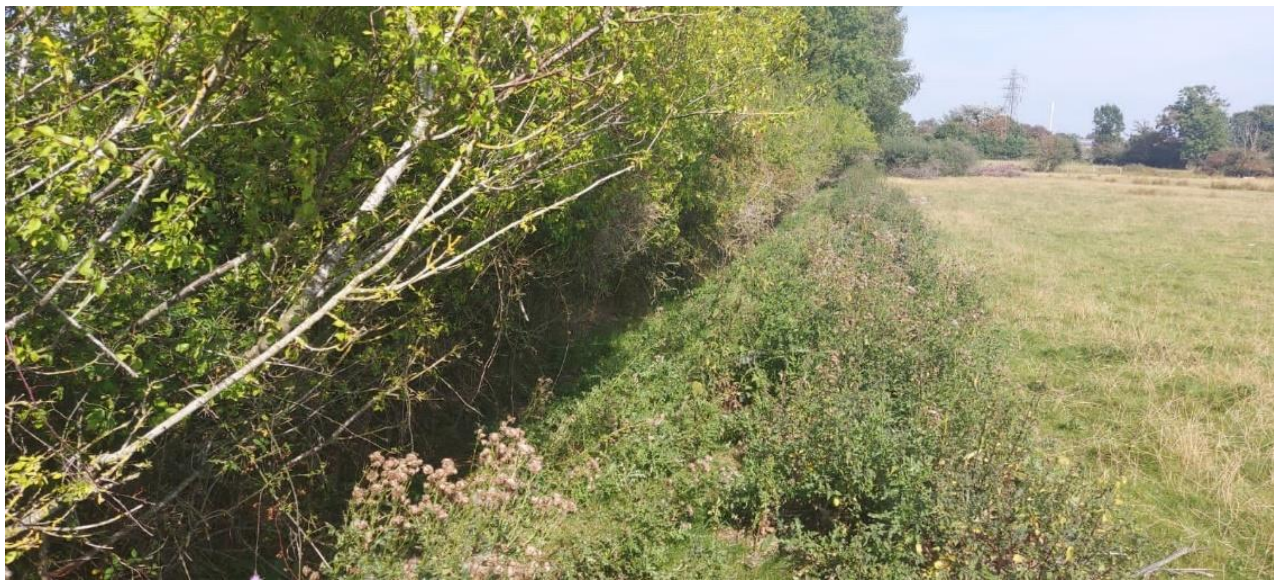
3.21. OAKFIELD DITCH 1 AND 3

Catchment area	<1km ²
Key hydraulic connections	The exact connections of these ditches are unknown however it is likely that water drains toward Chester Road Drain North, Broughton Brook and the Dee.
River Condition Score	Not surveyed
Catchment description	Small catchment of arable and grazed farmland.
Study reach description	The watercourse flows along a field boundary. It has a hedgerow along one bank.
Interaction with the DCO Proposed Development	Oakfield Ditch 3 will be crossed by the Newbuild Carbon Dioxide Pipeline via open cut. Oakfield Ditch 1 is located within the Newbuild Infrastructure Boundary and may be crossed via open cut.

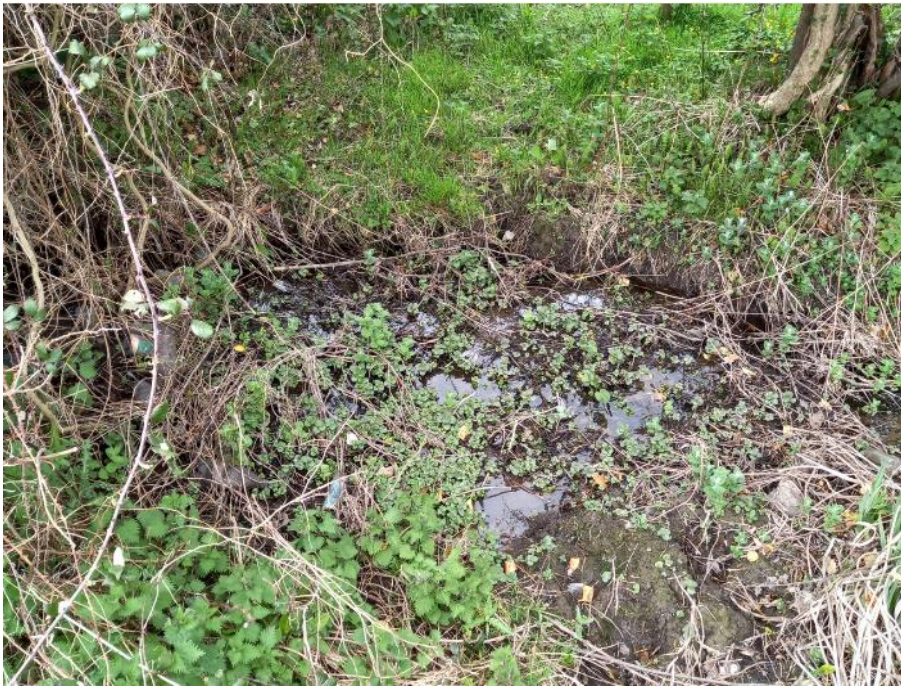
Upstream Fairly Poor reach

River Condition Score	Upstream reach is Fairly Poor Downstream reach is Moderate
Catchment description	Relatively small catchment comprising agricultural fields and residential estates. There is a small on-line pond in the upper catchment.
Study reach description	Bankfull channel width varies between 1m and 2m. Depth varies between 0.3 and 1.5m. The substrate primarily comprises gravels and pebbles, with some silt and sand deposits, potentially introduced due to poaching activity. The channel is extensively poached, with hardcore/rubble used for partial bank protection on the right bank. Riparian vegetation is mostly short grasses and isolated trees on the right bank with hedgerow on the left bank. The bank top land use is pastoral farming.
Interaction with the DCO Proposed Development	The watercourse will be crossed by the Newbuild Carbon Dioxide Pipeline via open cut.

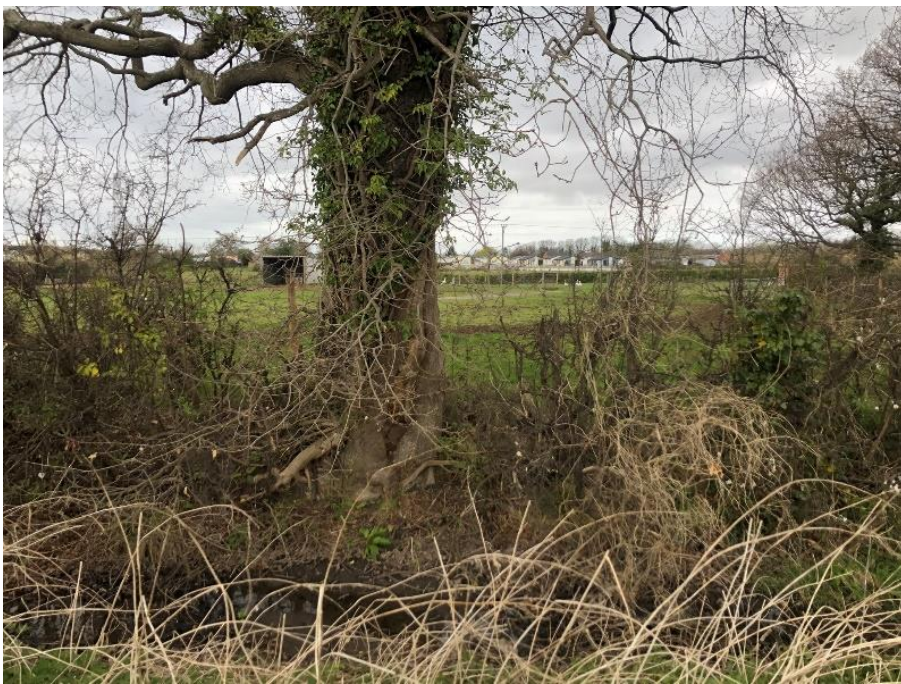
Downstream Moderate reach

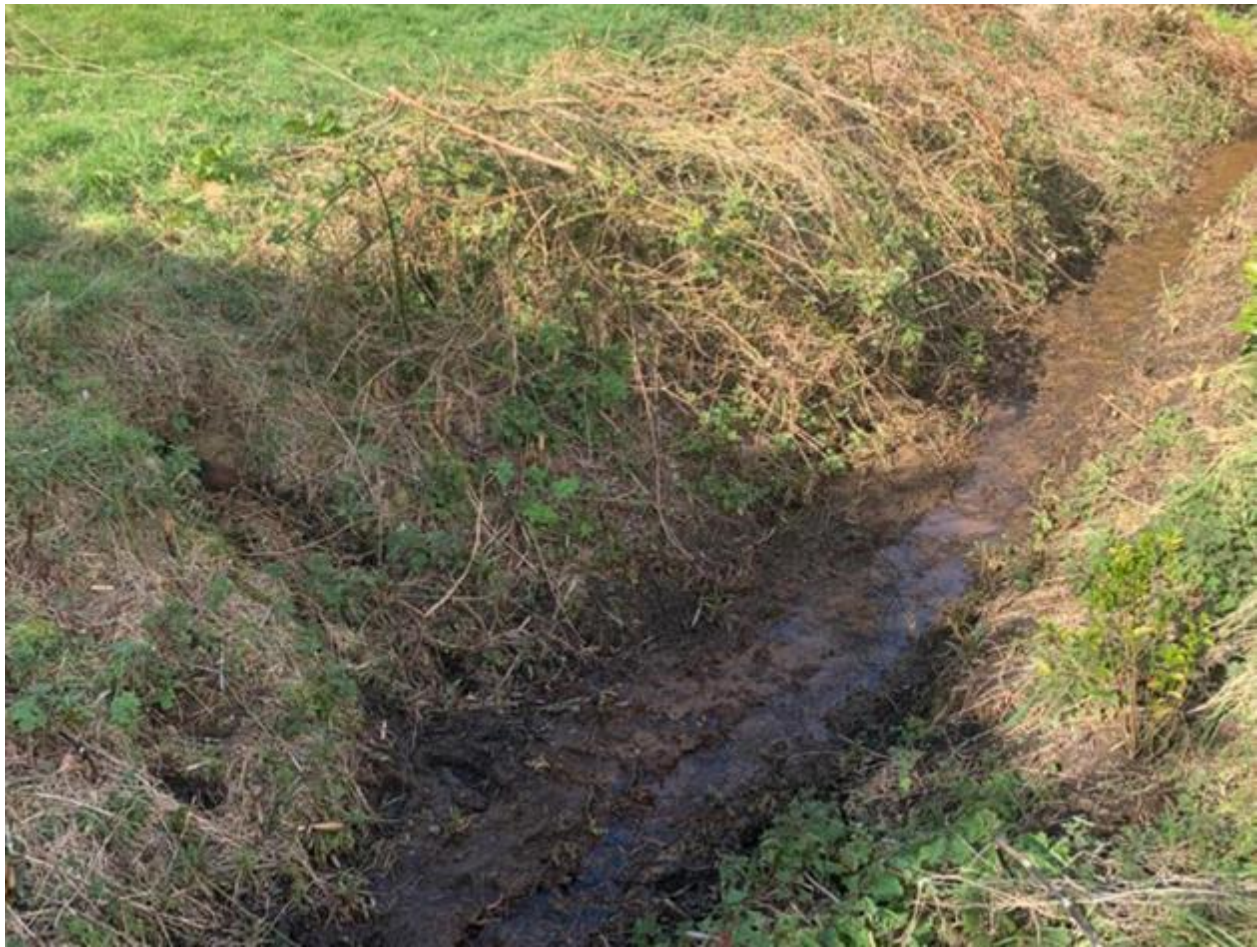
3.24. ASTON HALL BROOK

<p>Study reach description</p>	<p>The channel has been over deepened and had shallow water depth of approximately 0.05m at the time of survey. Bankfull width was observed to be between 1.5m and 3m.</p> <p>The bed material is mainly composed of sand and silt, with some concrete reinforcement on bed through some private gardens. The riparian zone on the right bank is comprised of short grasses and pastoral farming, with a mixture of vegetation where it flows through private gardens.</p> <p>No changes recorded since 1st edition OS map.</p>
<p>Interaction with the DCO Proposed Development</p>	<p>This watercourse is within the Newbuild Infrastructure Boundary but is not crossed by the Newbuild Carbon Dioxide Pipeline.</p>

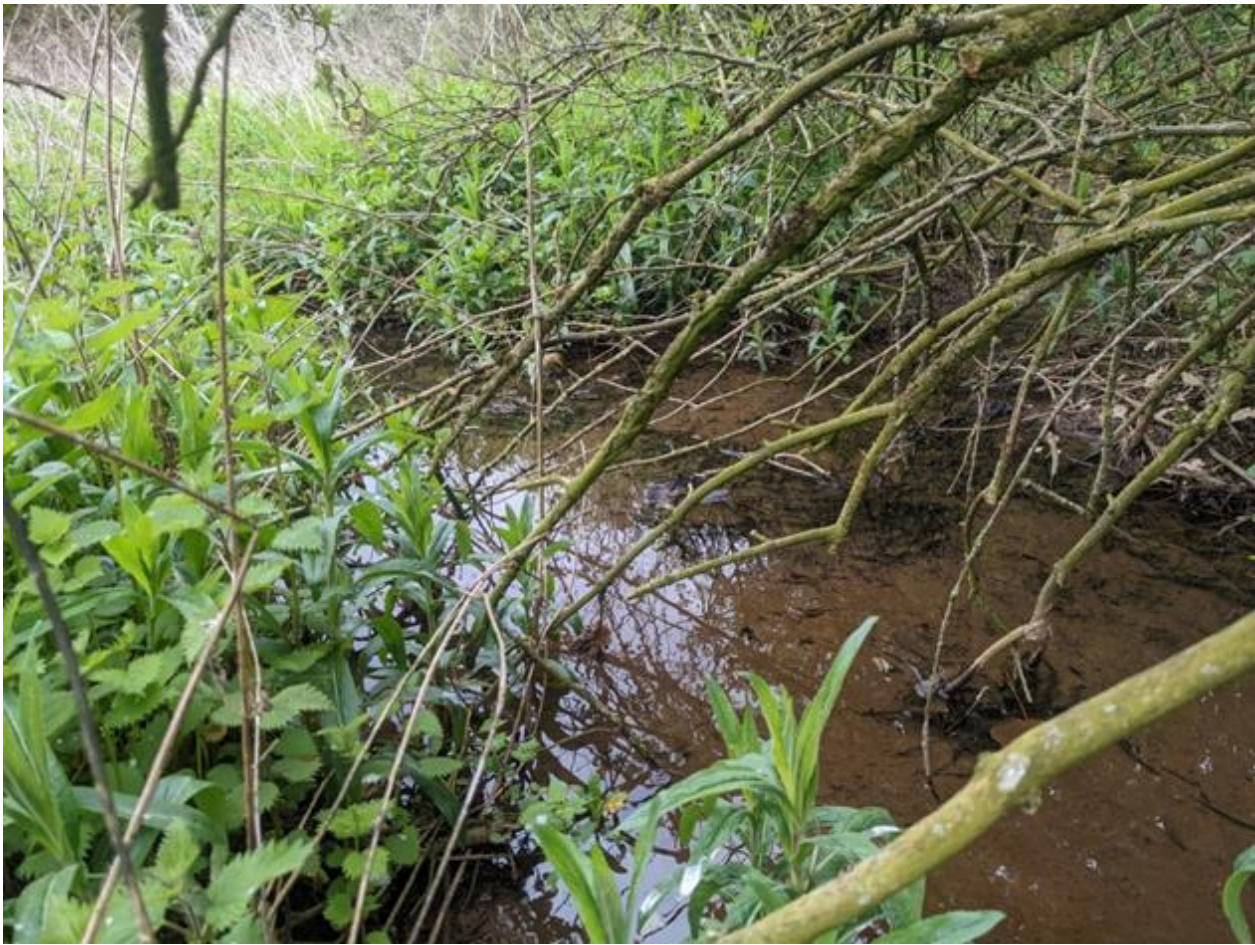
3.25. NEW INN BROOK

Catchment area	2.68km ²
Key hydraulic connections	Downstream connectivity to Wepre Brook
River Condition Score	Fairly Good
Catchment description	<p>The catchment drains farmland and arable fields. The catchment is predominantly rural though there is extensive urbanisation in the upper catchment (Buckley).</p> <p>Elevation varies from 166 - 62 mAOD.</p>

<p>Study reach description</p>	<p>The watercourse has shallow channel banks, a bankfull width around 0.7m and channel depth around 0.2m. At the downstream end of the reach within the Newbuild Infrastructure Boundary the watercourse becomes multi-thread.</p> <p>The bed material is predominantly a silt substrate with some clays and sands. The channel bed has some linear leaved vegetation growing at the margins and the channel bed is covered in fine layer of debris.</p> <p>The riparian zone on the left bank is historically pasture which has been left unused and has therefore grown more mature vegetation which is dominated by long grassy vegetation, shrubs and scrub. On the right bank the riparian zone includes mixed hedgerow and arable fields.</p> <p>The channel has retained a similar planform since 1898 but has been culverted where developments have been implemented (post 1949).</p>
<p>Interaction with the DCO Proposed Development</p>	<p>This watercourse will be crossed by the Newbuild Carbon Dioxide Pipeline via open cut.</p>

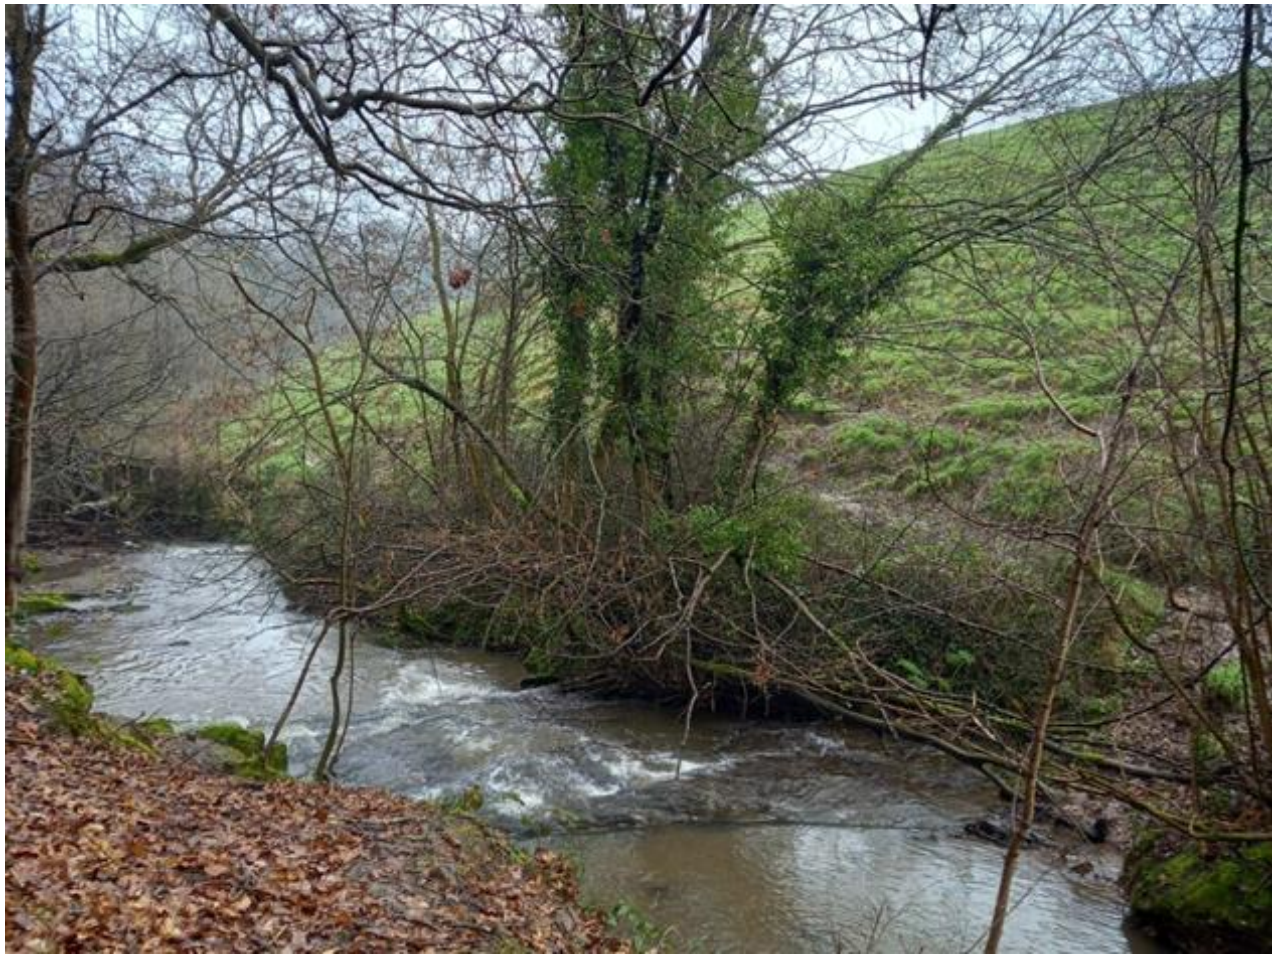
3.26. ALLTAMI BROOK

Catchment area	6.52 km ²
Key hydraulic connections	The Alltami Brook joins Wepre Brook downstream of the Newbuild Infrastructure Boundary and has approximately 10 tributaries upstream of the study area.
River Condition Score	Fairly Good
Catchment description	The catchment drains farmland and arable fields. There is extensive urbanisation in the upper catchment (Buckley, New Brighton). Downstream the watercourse flows through a narrow gorge to Wepre Brook. There is a clay quarry within the catchment. Elevation varies from 170 - 76 mAOD.

<p>Study reach description</p>	<p>The watercourse flows through a naturally deep valley, with bankfull width varying between 6 – 7 m and water depth between 0.2 – 0.3 m. There is varied roughness through the reach which has pools, riffles, steps and glides. There is some active bank erosion with undercut banks within the study reach.</p> <p>The predominant structure of the river bed is bedrock which is overlain with some boulders, cobble, gravel and silts, with some bedrock outcrops throughout the reach. The Alltami Brook has an unvegetated channel bed. Within the riparian zone, the bank top comprises mature woodland on the left bank and pasture on the right bank.</p> <p>The watercourse has retained a similar plan form since 1892, though there has been some localised straightening and culverting of the watercourse (namely following the construction of the A55).</p>
<p>Interaction with the DCO Proposed Development</p>	<p>The watercourse will be crossed by the Newbuild Carbon Dioxide Pipeline via open cut.</p>

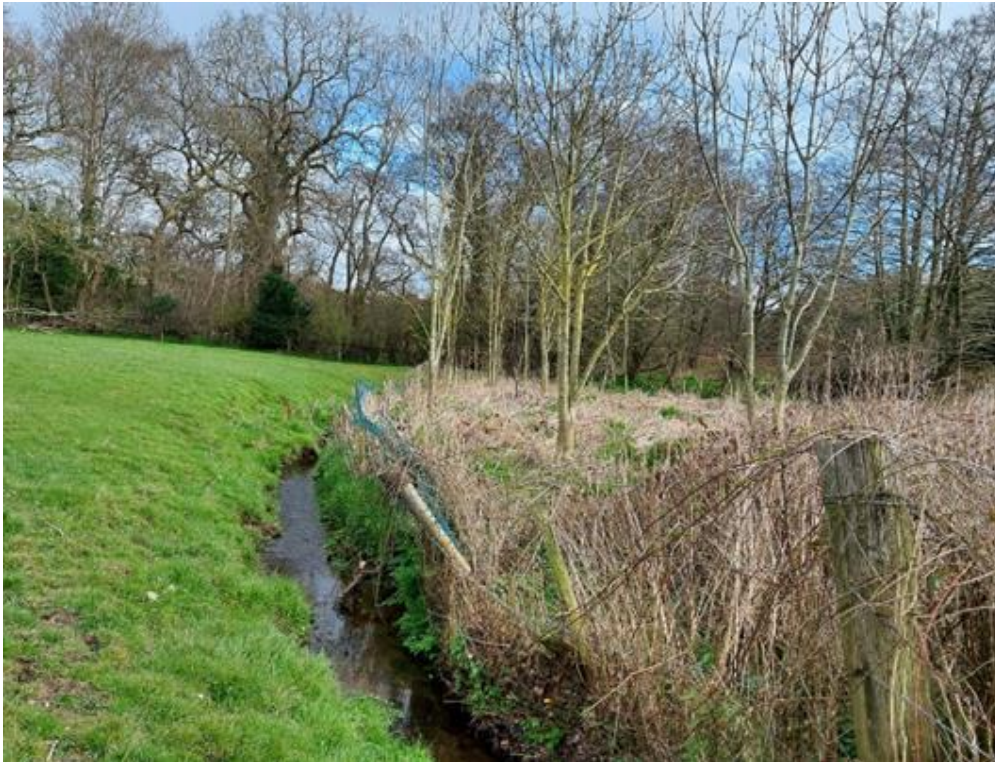
Wepre Brook A55 reach

<p>Study reach description</p>	<p>At the A55 reach the channel is narrow (approximately 1m width and 0.3m water depth). Through Brookside and Northop Hall reaches the watercourse is wider (width up to 2m and water depth 0.2m).</p> <p>The bed material is well mixed generally, with areas of both gravel-pebble mix and cobbles. Some areas of sand were observed overlaying armoured substrate in the A55 reach.</p> <p>At the A55 reach, the left bank is short grass pasture for grazing whilst the right bank is plantation woodland and scrub. Through Brookside and Northop Hall there are more mature trees on both banks. There are gabion baskets supporting the right bank through the Brookside reach. The riparian zone through the Northop Hall reach is more substantial than other reaches.</p> <p>Wepre Brook follows largely the same course as depicted on the 1st edition OS maps (1888).</p>
<p>Interaction with the DCO Proposed Development</p>	<p>There are four locations where this watercourse is within the Newbuild Infrastructure Boundary. At the Brookside reach the watercourse will be crossed by the Newbuild Carbon Dioxide Pipeline via open cut.</p> <p>The A55 reach of the Wepre Brook is no longer applicable to the assessment due to the relocation of Northop Hall AGI as part of Change Request 1, which includes the relocation of its outfall from this reach to Wepre Brook Tributary 1. The Northop Hall and Brookside reaches of Wepre Brook remains unchanged and valid.</p>

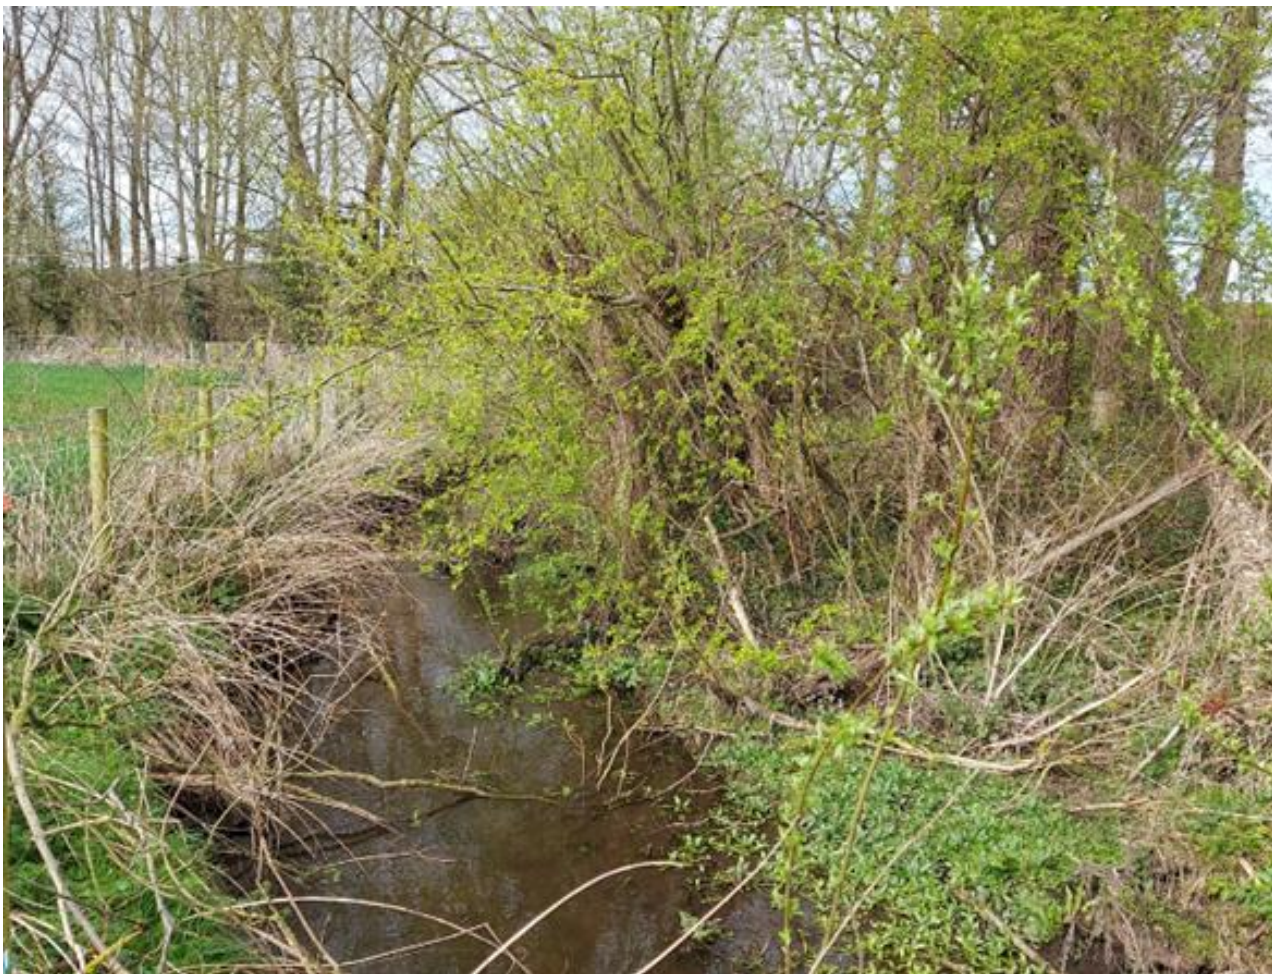
3.28. NORTHOP BROOK

Catchment area	0.98 km ²
Key hydraulic connections	Northop Brook flows northwards and becomes the Lead Brook before joining the Dee.
River Condition Score	Moderate
Catchment description	<p>The catchment is predominantly rural with land used for pastoral and arable farming. The catchment is steep towards the Dee Estuary. The watercourse flows through agricultural land before entering a wooded gorge.</p> <p>There is an artificial lake/reservoir at the lower end of catchment, downstream of the surveyed reach, although this appears to have a limited backwater effect.</p>

<p>Study reach description</p>	<p>Channel width varies between 2m and 3m. Water depth is approximately 0.5m.</p> <p>Bed material composed primarily of sands and silt throughout surveyed reach. The riparian buffer zone is composed of scrub and shrubs with some mature trees and fallen trees.</p> <p>1st edition OS map (1888) shows minimal channel changes. The reservoir was also in-situ at this time too.</p>
<p>Interaction with the DCO Proposed Development</p>	<p>The watercourse will be crossed by the Newbuild Carbon Dioxide Pipeline via trenchless (TRS-43) methods.</p>

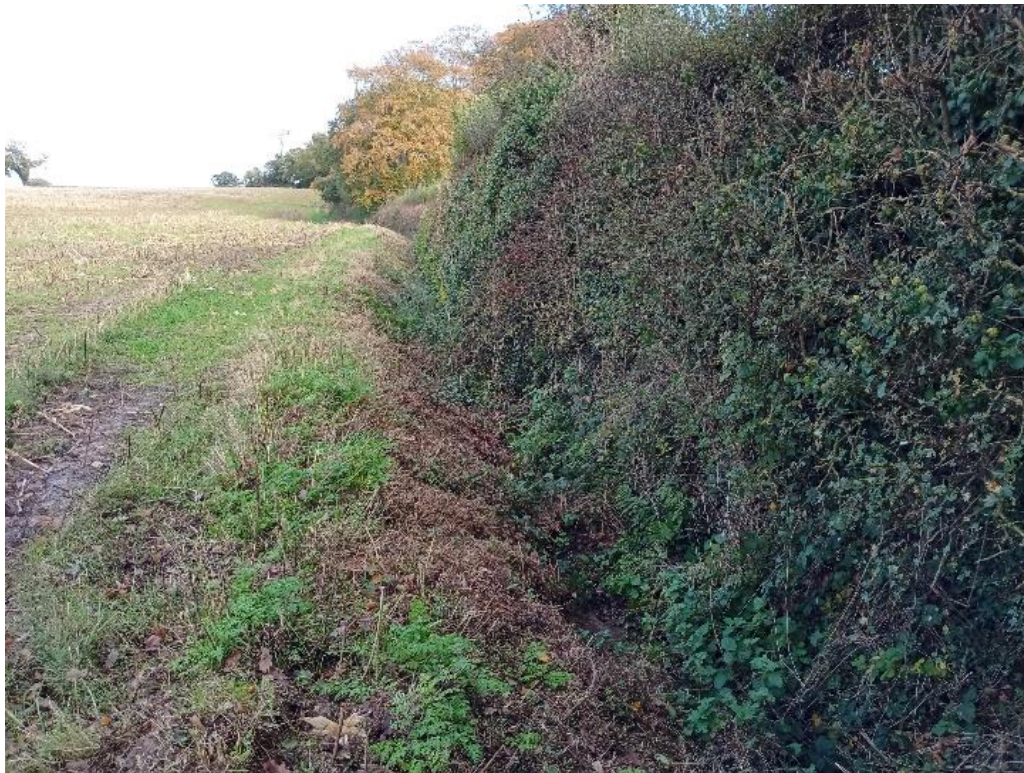
Northop Brook Tributary 1

Catchment area	Both <1km ²
Key hydraulic connections	Both tributaries join the Northop Brook which flows northwards and becomes the Lead Brook before joining the Dee.
River Condition Score	Not surveyed
Catchment description	The catchments of these tributaries are predominantly arable farmland.
Study reach description	Both watercourses flow along field boundaries. They both have a hedgerow on the right bank. The watercourses are likely ephemeral and their riparian zones are dominated by tilled land.
Interaction with the DCO Proposed Development	Both watercourses will be crossed by the Newbuild Carbon Dioxide Pipeline via open trench.

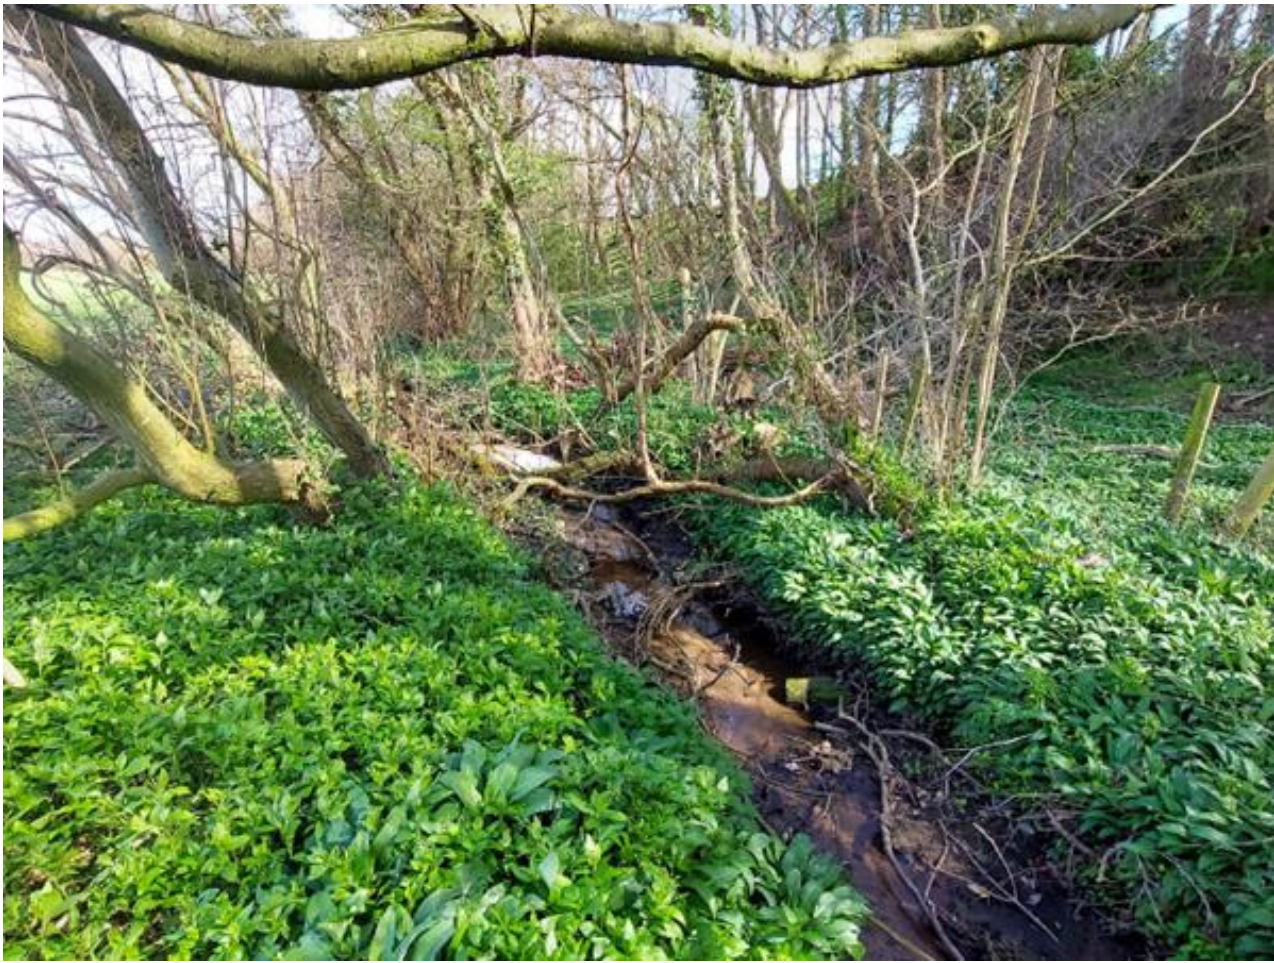
3.30. LITTLE LEAD BROOK

Catchment area	0.51 km ²
Key hydraulic connections	This watercourse flows northwards towards the Dee Estuary
River Condition Score	Moderate
Catchment description	A small catchment which is dominated by agriculture with no suburban areas. This is a steep catchment which slopes towards the Dee. There is a small on-line pond attenuating flow upstream of the study reach.

<p>Study reach description</p>	<p>Channel bankfull width is approximately 1m throughout the survey reach. Water depth is very shallow (0.05m).</p> <p>Channel bed composed of gravels and pebbles, with significant areas of sands and silts present. The riparian zone on the right bank is an ancient woodland comprising of mature trees and fallen trees. On the left bank the riparian zone is tilled land behind occasional trees on the bank top.</p> <p>Channel course unchanged since 1st edition OS maps, although online pond is relatively recent (post 1971).</p>
<p>Interaction with the DCO Proposed Development</p>	<p>The watercourse will receive runoff from the Flint AGI. The waercourse will not be crossed by the Newbuild Carbon Dioxide Pipeline.</p>

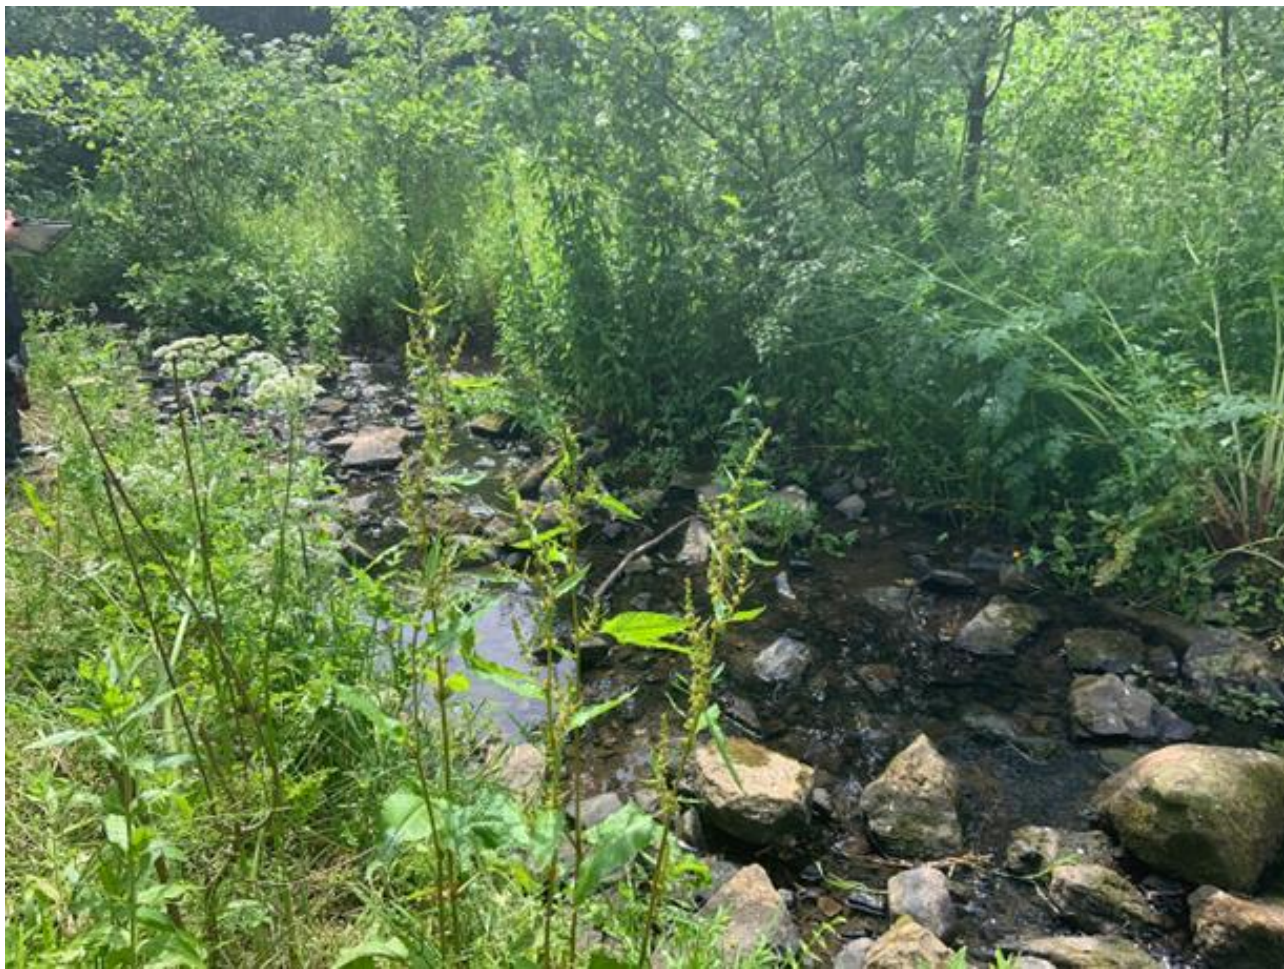
3.31. NANT-Y-FFLINT

Catchment area	4.31 km ²
Key hydraulic connections	The Nant-y-Fflint has several unnamed tributaries mostly from the south of the catchment which join the watercourse upstream of the DCO Proposed Development.
River Condition Score	Fairly Good
Catchment description	The catchment is relatively steep, with a confined floodplain in a wooded valley. The catchment is predominantly rural farmland (arable and pastoral, forestry) with small settlements in Pentre Halkyn and Halkyn.

Study reach description	<p>Bankfull width varies between 10 and 15m, with the surveyed wetted channel approximately 5m in width. Water depth is relatively shallow, between 0.1 and 0.2m in the surveyed reach.</p> <p>The channel river bed is characteristic of steeper typologies, with step pool systems composed of cobbles and boulders, mixed with gravel and pebbles throughout surveyed reach. At the time of the survey, the riparian zone was comprised of wooded valley and was heavily vegetated.</p> <p>No significant areas of channel change recorded since 1st edition OS maps (1888)</p>
Interaction with the DCO Proposed Development	The watercourse will receive runoff from Cornist Lane BVS.

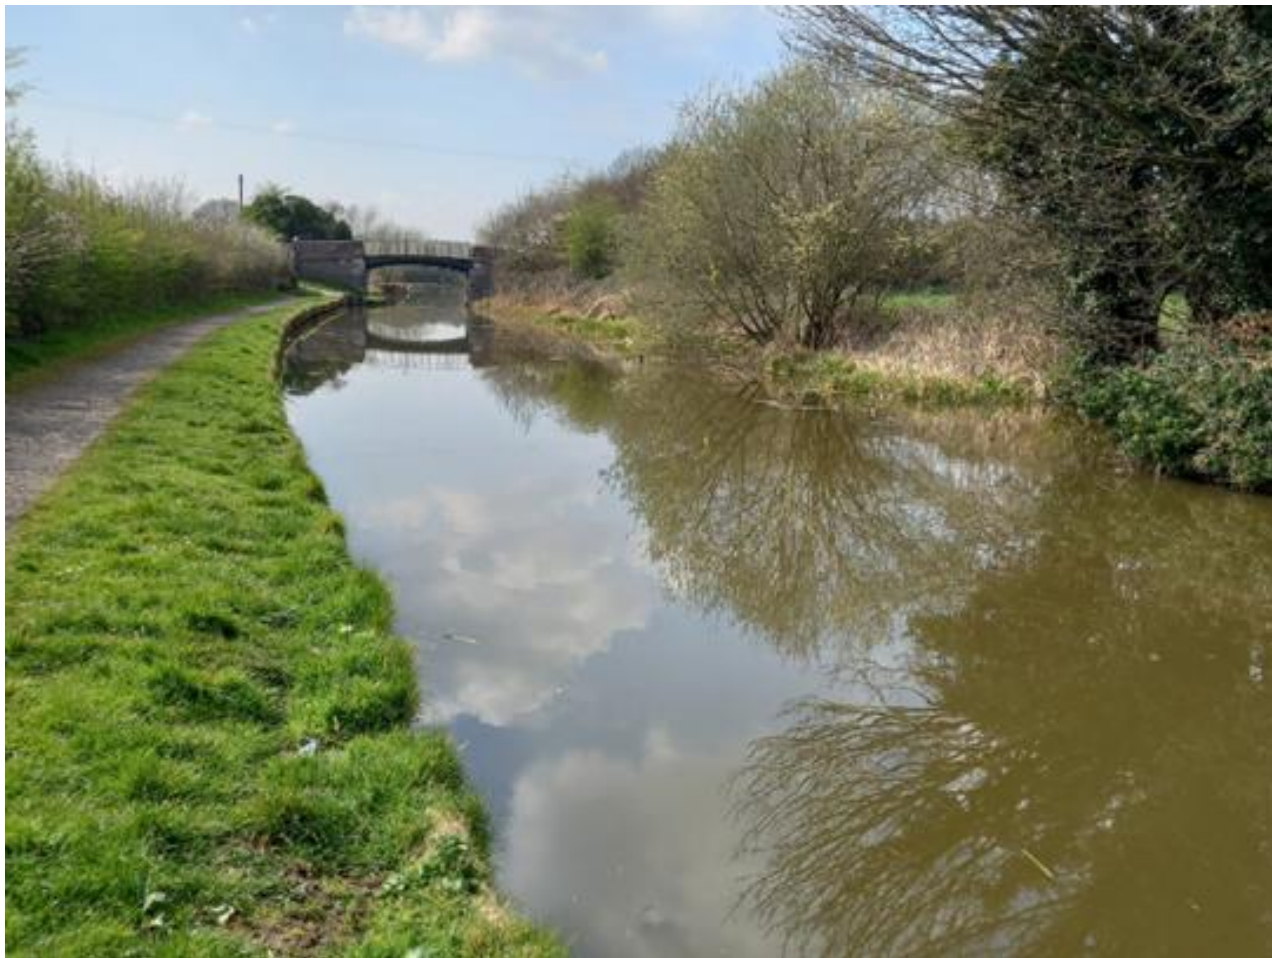
4.1. SHROPSHIRE UNION CANAL

Catchment area	n/a (artificial canal system)
Key hydraulic connections	The canal joins the Manchester Ship Canal to the River Dee at Chester.
River Condition Score	Fairly poor
Catchment description	<p>Artificial channel built in the late 18th century for industry and trade. Ellesmere and Chester canal branches. 16 locks separate Manchester Ship Canal from River Dee, whilst a series of locks and weirs control water level throughout the canal system.</p> <p>The surrounding land use is rural (farmland, arable and pastoral), woodland, urban, industrial and recreational (golf courses, etc).</p>

<p>Study reach description</p>	<p>Width uniformly 10m across, depth approximately 1.5m, with the canal level being higher than adjacent ground level.</p> <p>Canal bed is composed of silts. Within the riparian zone, there is sheet piling on both banks, with a towpath on the right bank.</p> <p>Additional branches of canal added throughout the early 19th century, completed in 1835.</p>
<p>Interaction with the DCO Proposed Development</p>	<p>The canal will be crossed by the Newbuild Carbon Dioxide Pipeline via trenchless (TRS-17) methods.</p>
