HyNet North West

ENVIRONMENTAL STATEMENT (VOLUME III)

Appendix 18.1 Baseline Information

HyNet North West Carbon Dioxide Pipeline DCO

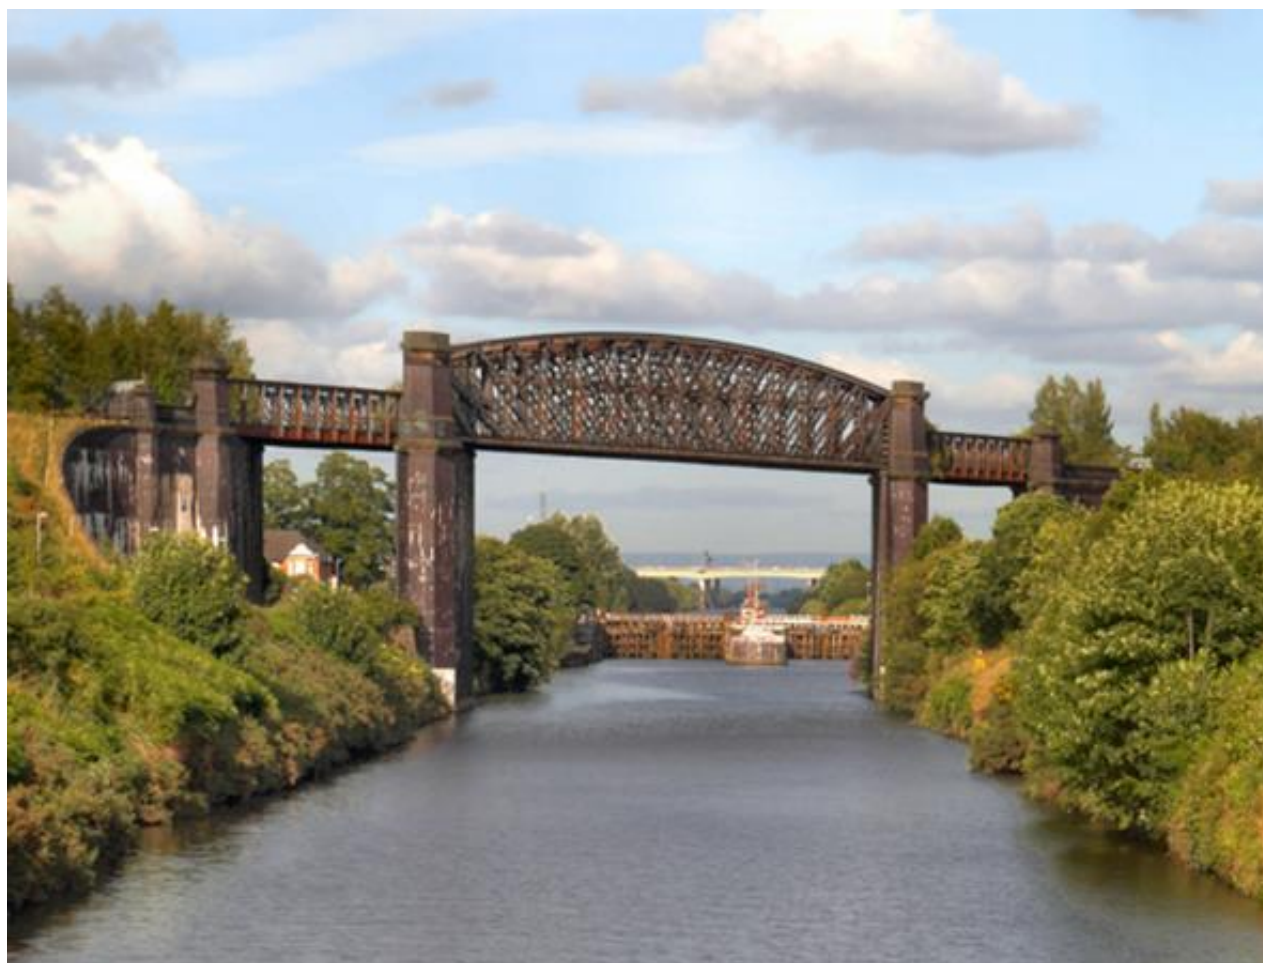
4.2. MANCHESTER SHIP CANAL

Catchment area	n/a (artificial canal)
Key hydraulic connections	River Irwell; River Irk; River Medlock
River Condition Score	Not surveyed
Catchment description	Major artificial canal, extensively used for shipping and trade. There are multiple locks and sluices to maintain water levels within the channel.

<p>Study reach description</p>	<p>The canal varies between 14 – 24m in width, and up to 9m in depth. The bed of the canal is likely to be silt and mud substrate.</p> <p>The riparian zone includes a tow path and other urban infrastructure, as well as recreational rural areas (fields, trees in country parks, golf courses etc).</p> <p>Channel construction in the late 19th century, no changes to course in intervening years.</p>
<p>Interaction with the DCO Proposed Development</p>	<p>The Manchester Ship Canal is not within the Newbuild Infrastructure Boundary. Water from Ince Marshes is pumped into the canal during peak flows and therefore is a downstream receptor of activities within Ince Marshes.</p>
