ENVIRONMENTAL STATEMENT (VOLUME III)

Appendix 18.3 Water Framework Directive Assessment (Tracked)

HyNet Carbon Dioxide Pipeline DCO

Document Reference Number D.6.3.18.3

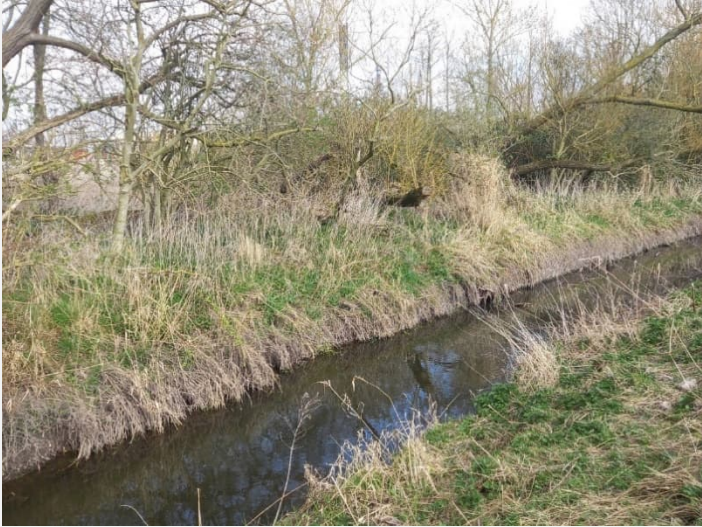
Watercourse name	East Central Drain

Water feature type: Main River
	Catchment area: 1.02km ²
	Key hydraulic connections: Flows into West Central Drain
	Surrounding land use: Mostly pastoral fields with stands of plantation woodland and an industrial estate. Access tracks and paved roads are present.
	River Condition Score: Moderate
Catchment Characteristics	The catchment mostly comprises grassland with some arable and horticultural land uses. A smaller proportion of the catchment has built-up land use and woodland. The catchment has an elevation between 4.9 - 40mAOD).
Catchment Geology and Soils	The bedrock geology comprises Kinnerton sandstone formation (sandstone). The East Central Drain is underlain by superficial

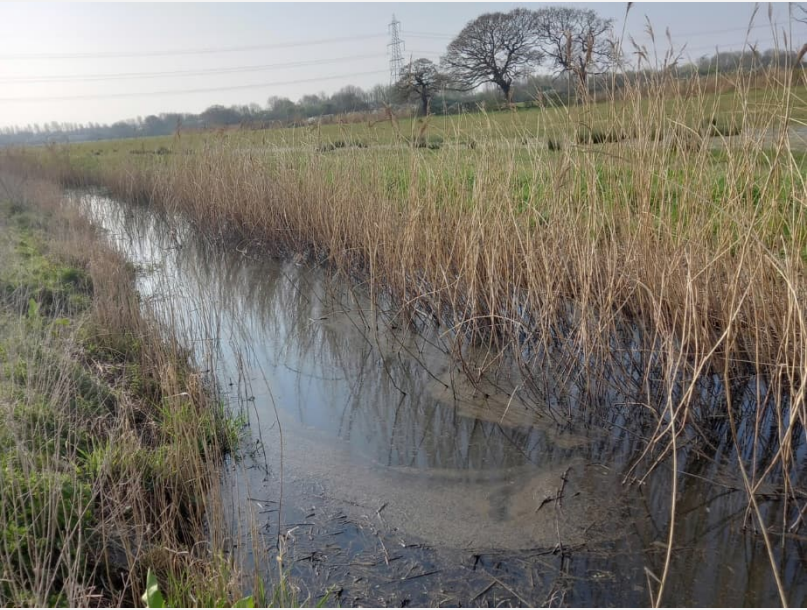
Water feature type: Main River
	Catchment area: 2.87km ²
	Key hydraulic connections: Connects to Elton Marsh Drains 9 to 13 in peak flow and discharges to West Central Drain.
	Surrounding land use: Farming and agricultural, M56 to the south, paved road network, suburban.
	River Condition Score: Moderate
Catchment Characteristics	The Hapsford Brook drains the Elton Marshes between Hapsford Lane and the M56. The channel drains a catchment consisting of the suburban area of Elton, rural village of Hapsford and a lorry service station. The Hapsford Brook flows under the Great Northern and London and North Western Joint Railway line. The catchment consists mostly of arable and horticultural grasslands, with some areas of development (Hapsford and Elton). The M56 (junction 14) and A5117 roads dissect the channel south of Elton.

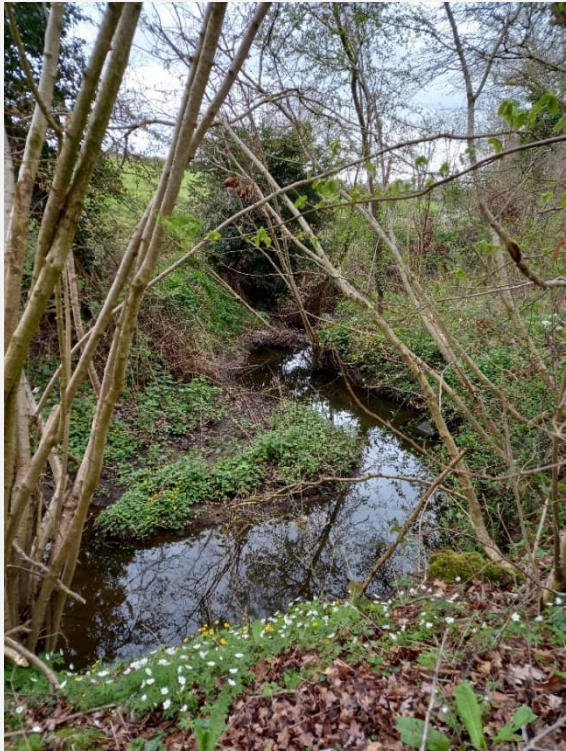
<p data-bbox="230 1114 1001 1190">Fairly Good section within Newbuild Infrastructure Boundary</p>	Water feature type: Ordinary Watercourse
	Catchment area: 3.21km ²
	Key hydraulic connections: Finchetts Gutter Tributary flows southeast towards Blacon, under which it is culverted. It joins the Finchetts Gutter south of Saughall Road.
	Surrounding land use: Within the Newbuild Infrastructure Boundary, the land use is predominantly arable and horticultural land, improved grassland, neutral grassland, some broadleaved mixed and yew woodland. There is urban development in Mollington and along Parkgate Road.
	River Condition Score: Fairly good in the upper reach and moderate in the lower reach within the Newbuild Infrastructure Boundary.

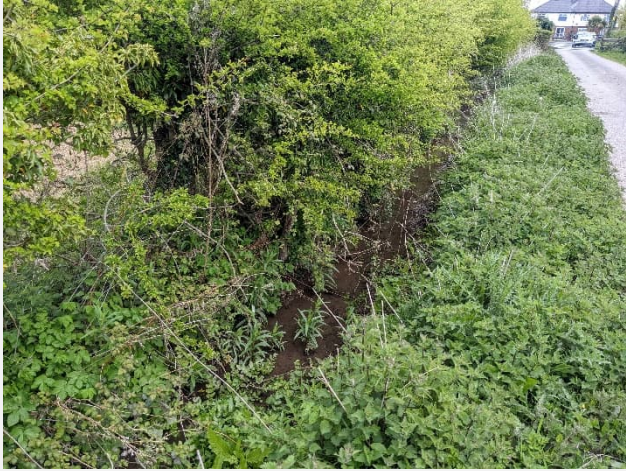
<p>Downstream reach</p>	Water feature type: Ordinary Watercourse
	Catchment area: 1.66km ²
	Key hydraulic connections: Onward connection into Chester Road Drain South, which flows beneath the B5129 to join the Broughton Brook.
	Surrounding land use: The watercourse primarily flows through pasture. This comprises improved and neutral grassland, broadleaved, mixed and yew woodland.
	River Condition Score: Moderate
