Appendix 8.4 Geophysical Survey Report

HyNet Carbon Dioxide Pipeline DCO

Document Reference Number D.6.3.8.4

Geophysical Survey Report
HyNet CO2 Pipeline

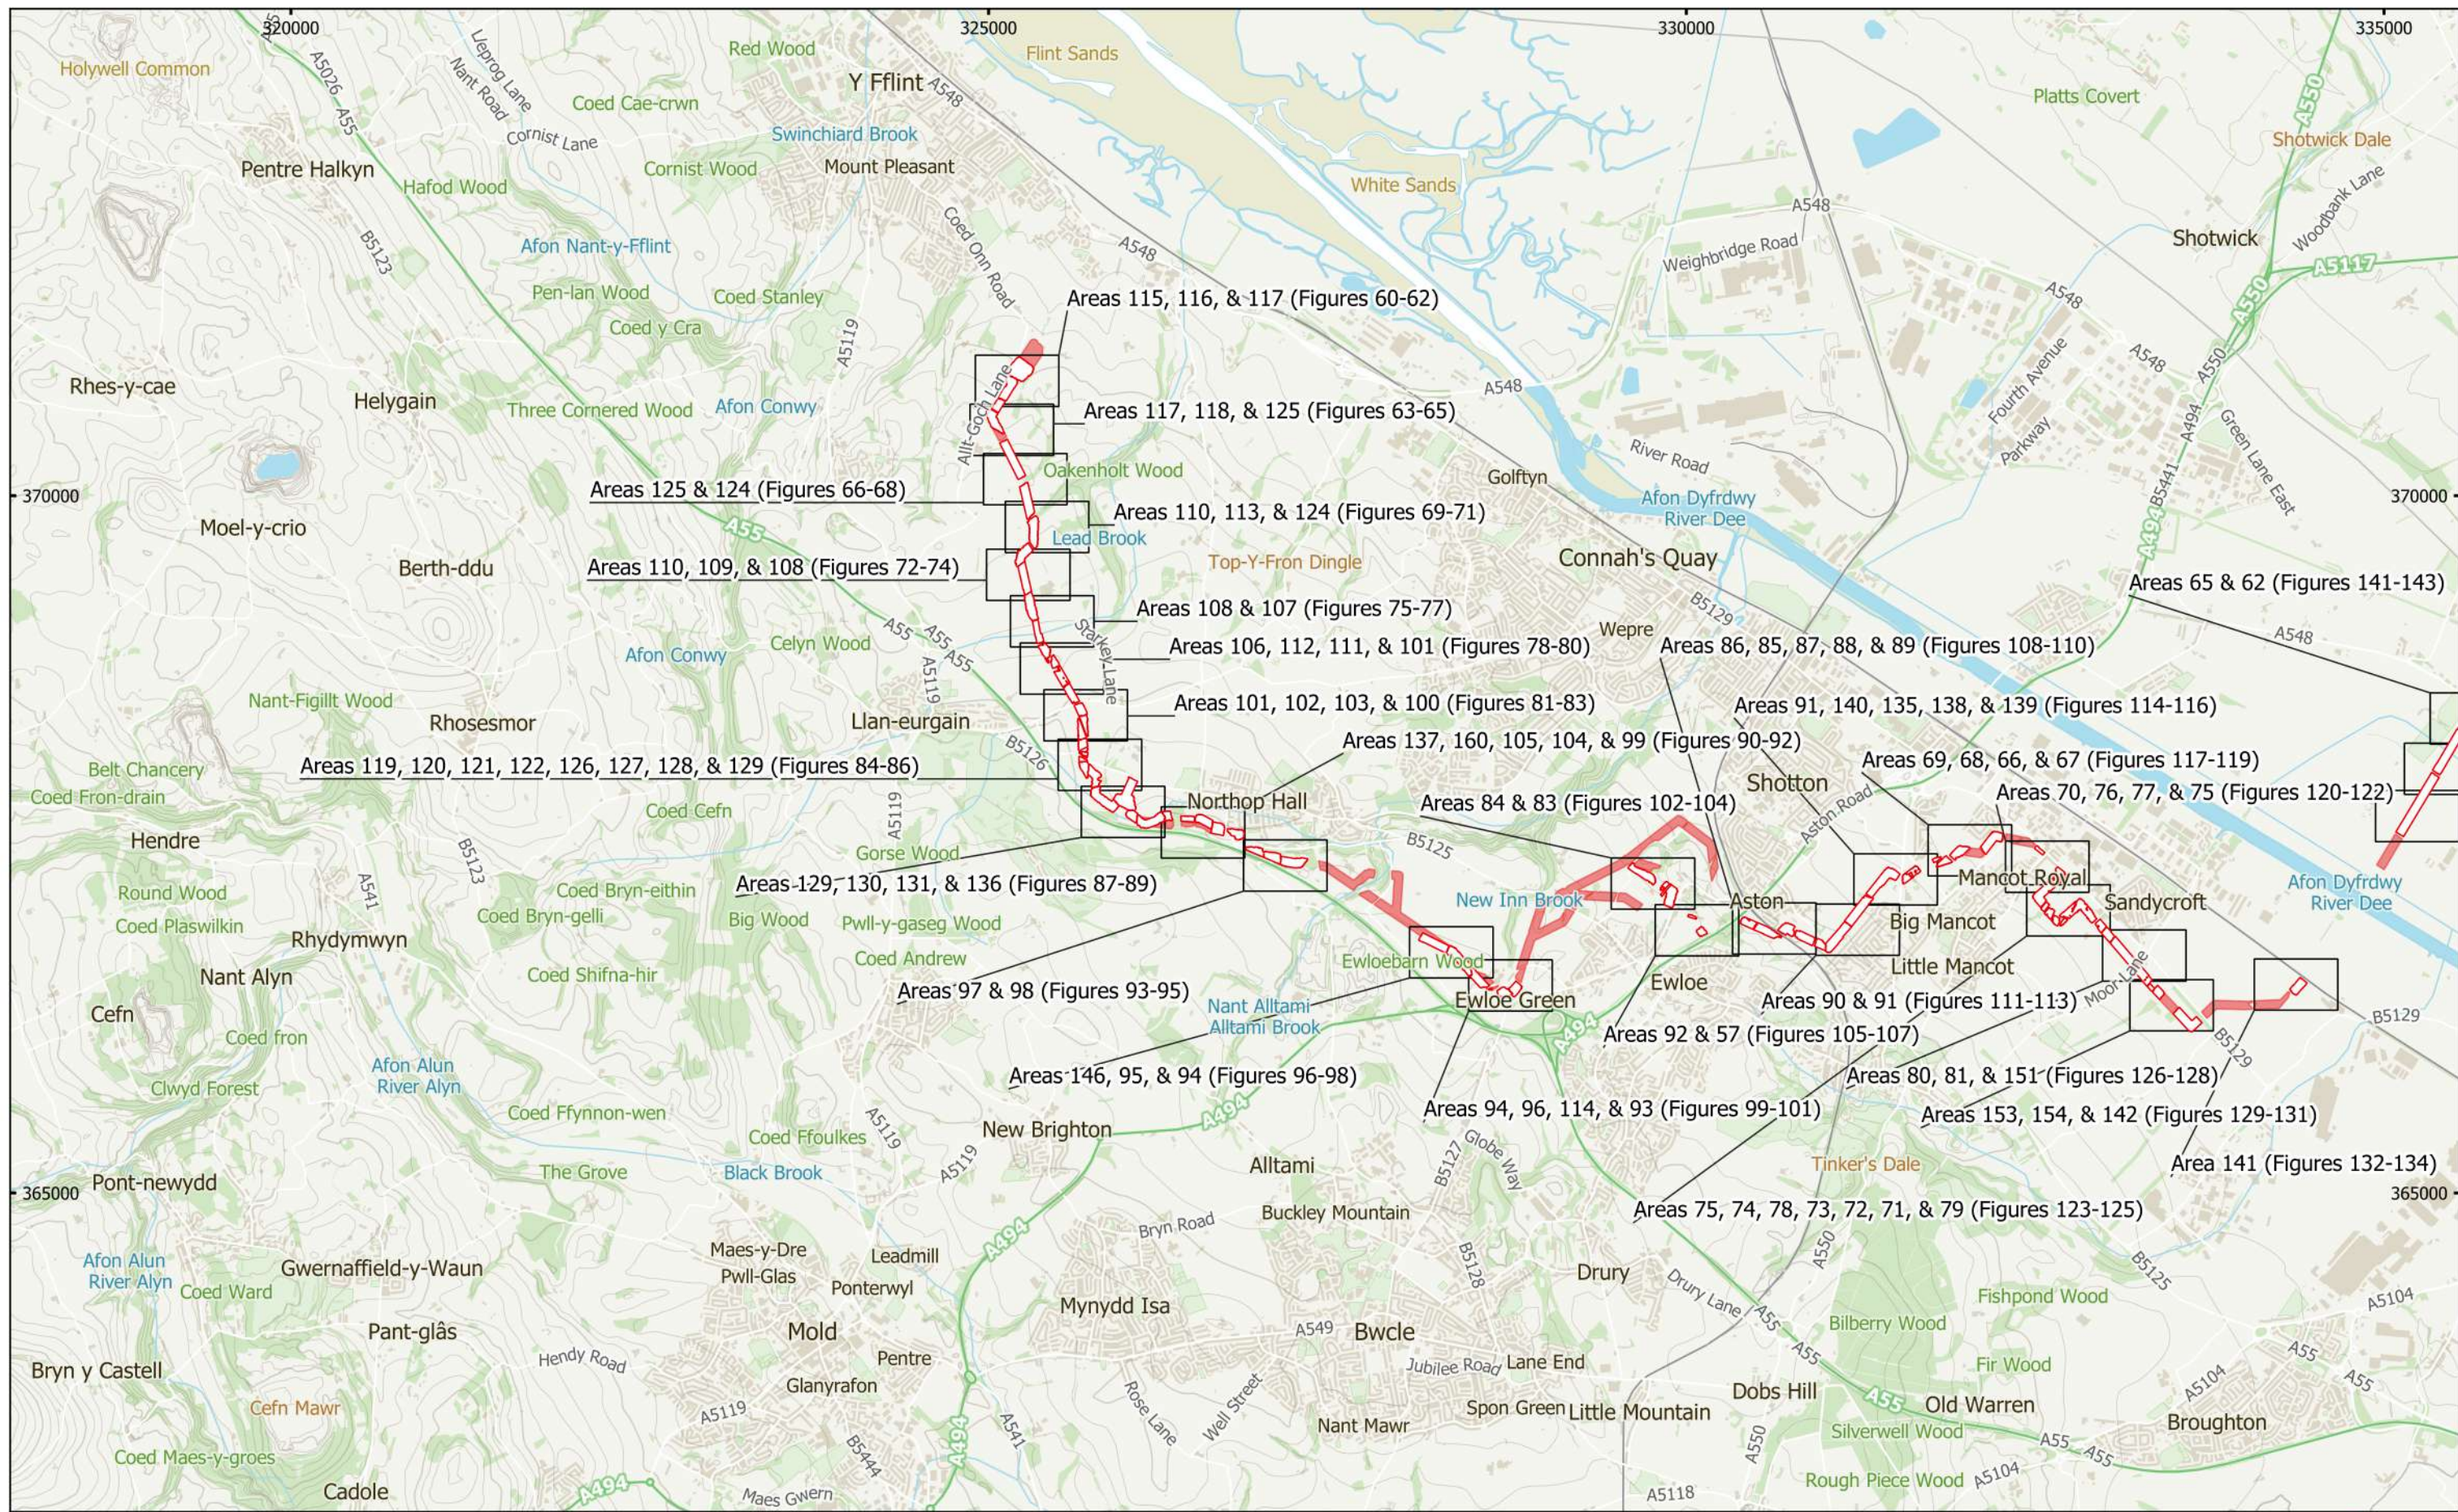
MSSJ1172 - HyNet CO2 Pipeline
 Figure 2 - Location of Survey Areas (West)
 1:40,000 @ A3
 Copyright Magnitude Surveys Ltd 2022
 Contains Ordnance Survey data © Crown Copyright and database right 2022

4.1. The survey area was a route between a point south-east of Flint, Wales, (SJ 2532 7114), north of Chester, to another point east of Ellesmere Port, Cheshire (SJ 4689 7610) (Figure 1). Gradiometer survey was undertaken across c. 147.7ha covering 156 fields (Figure 2 & 3), with the remaining areas deemed not to be surveyable due to access constraints or unsuitable ground conditions. The survey areas were numbered according to the order they were surveyed in.

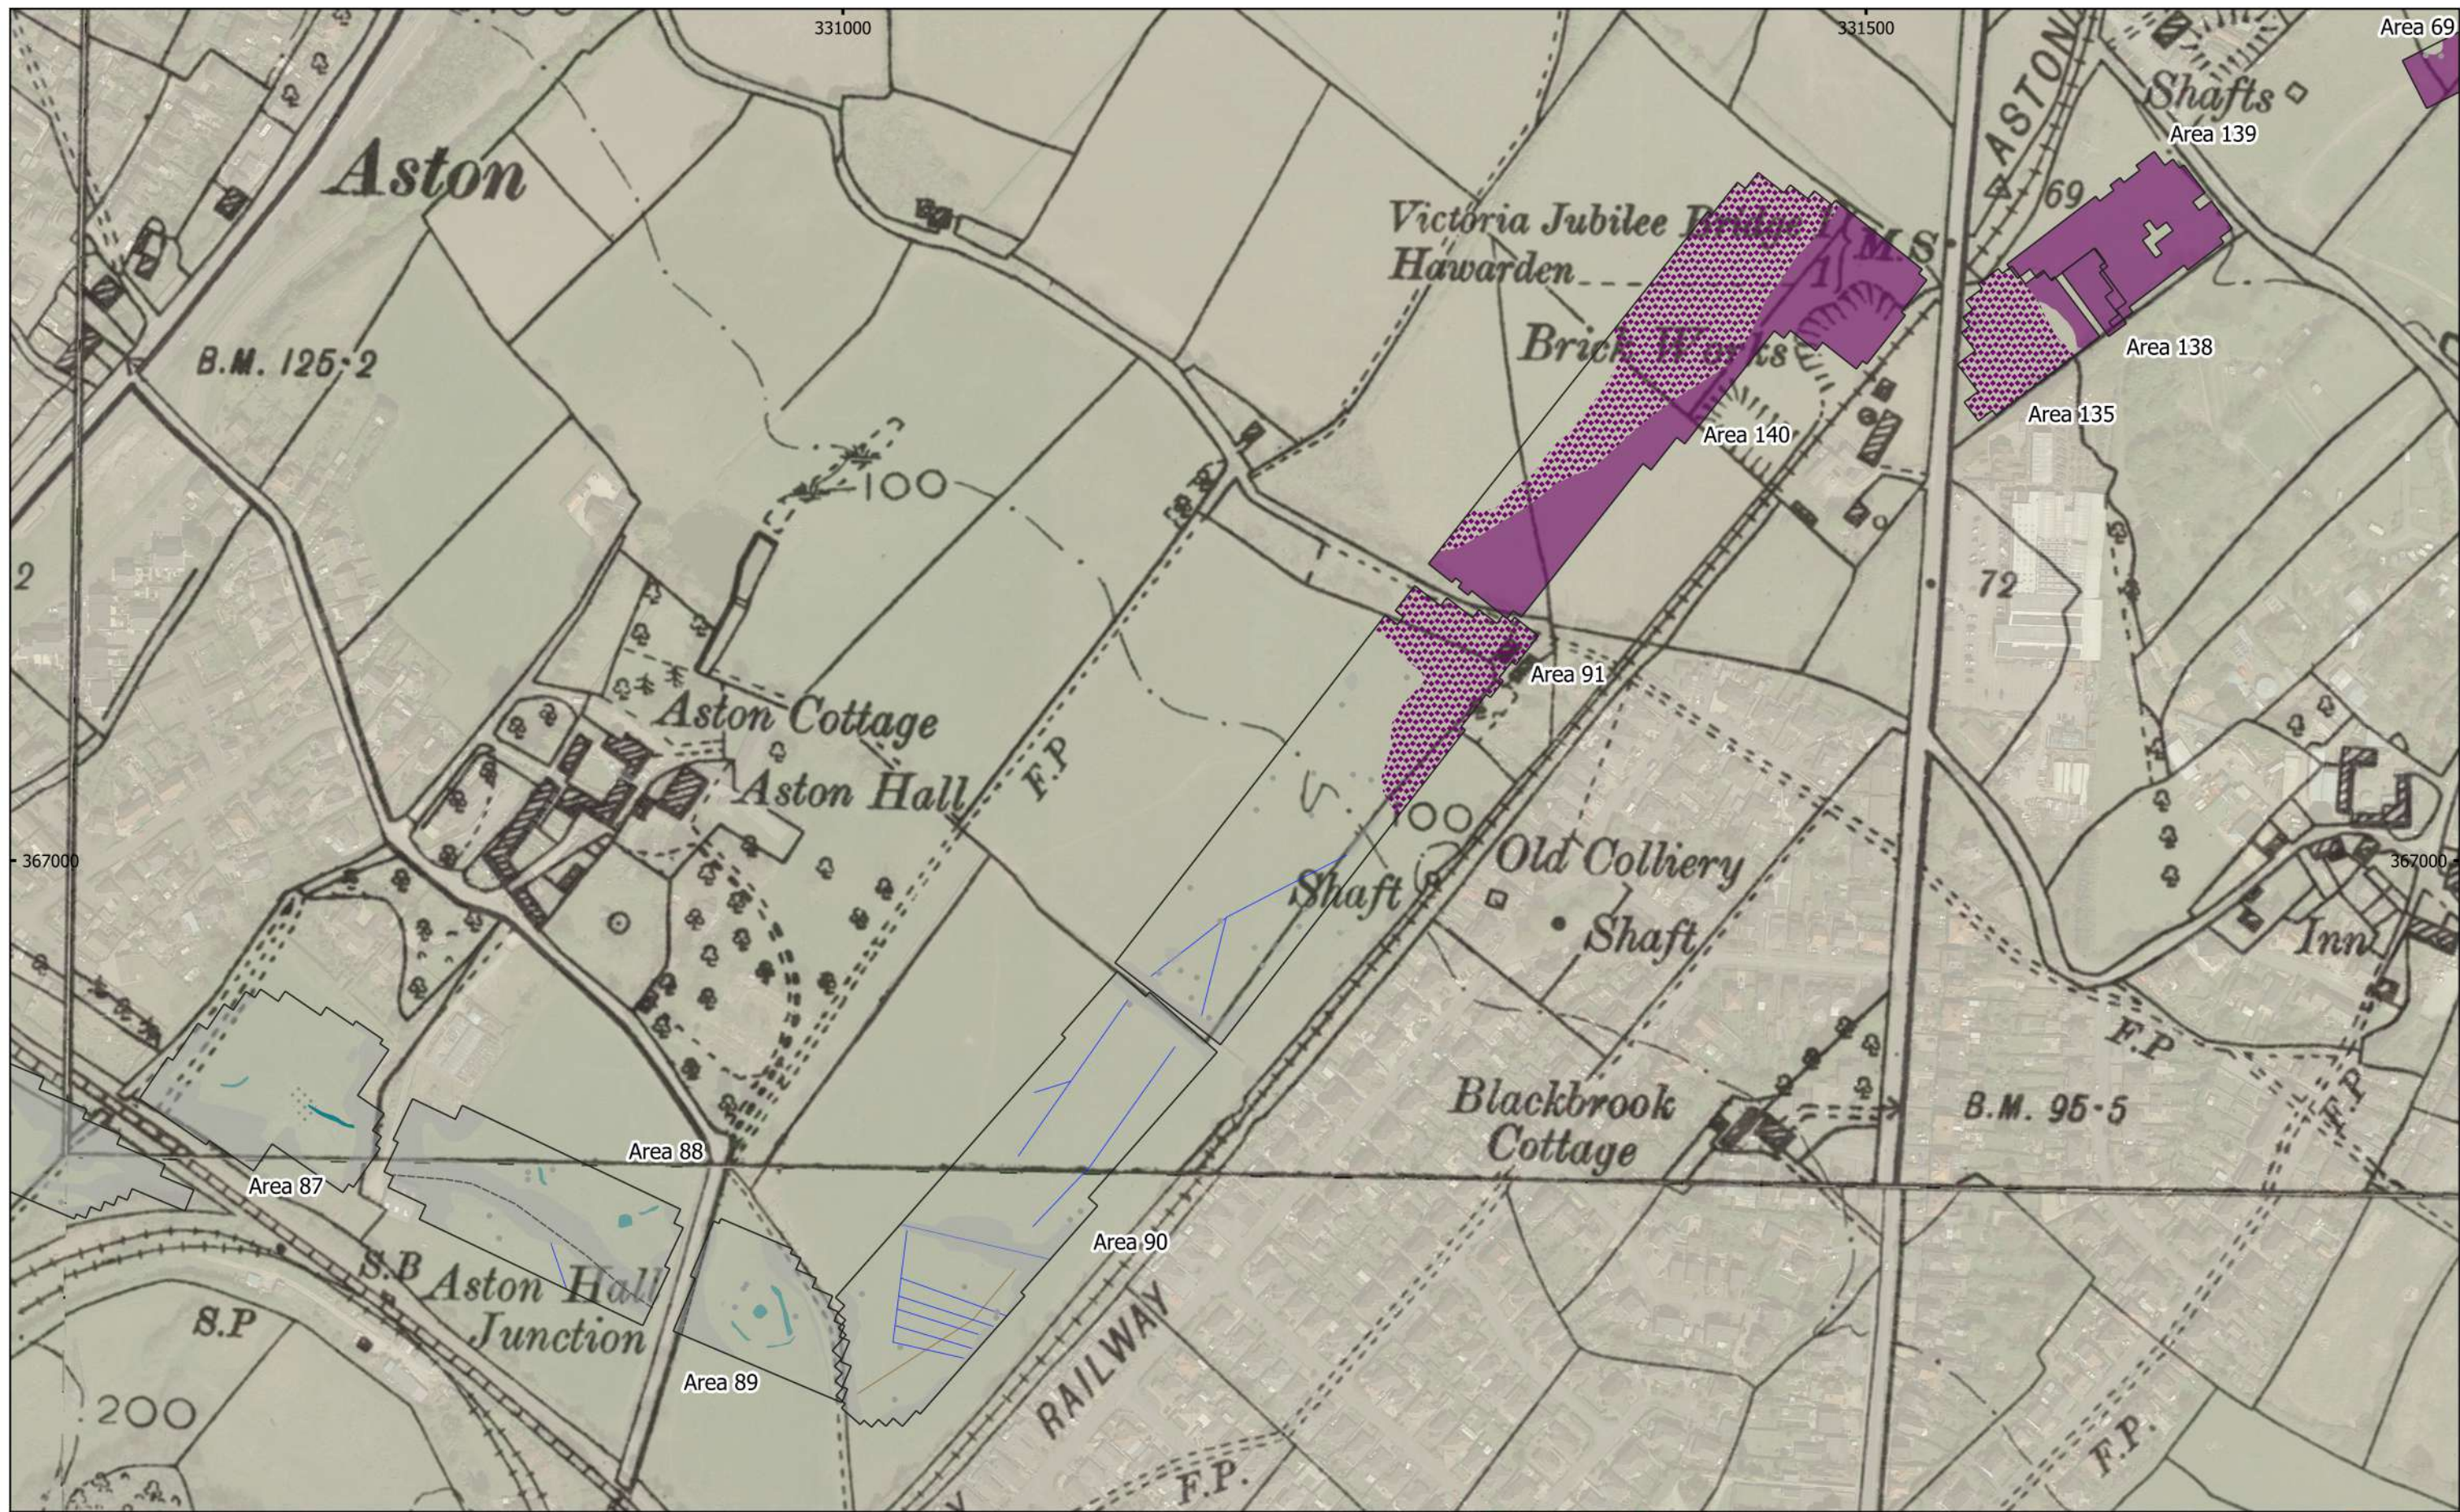
MSSJ1172 - HyNet CO2 Pipeline
 Figure 21 - Magnetic Interpretation Over Historical Maps (Overview) (Areas 85, 87, 88, 89, 90, 91, 140, 135, 138, & 139)
 1:3,000 @ A3
 Copyright Magnitude Surveys Ltd 2022
 Contains historical mapping © CLS Data 2022: Ordnance Survey, 6" 2nd edition c. 1882-1913

Based on evidence from historical mapping, within Areas 15, 16, 45, 50, 68, 69 & 108 discrete zones of strong positive and dipolar enhancement have been identified and interpreted as being due to extraction activity or other similar utilisation of the landscape. These anomalies collocate with, or are in the vicinity of, areas of extraction or infilled ponds identified in 2nd edition OS Maps (Figures 5, 17, 21, 33, 35, 37, 53, & 55). Within Areas 68, 69, 135, 138, 139, 91 & 140, the magnetic data is dominated by strong dipolar anomalies likely caused by material from a brick works, pits and mineshafts recorded on historical OS Maps (Figures 21 & 23) and described in the archaeological background (see Section 5).

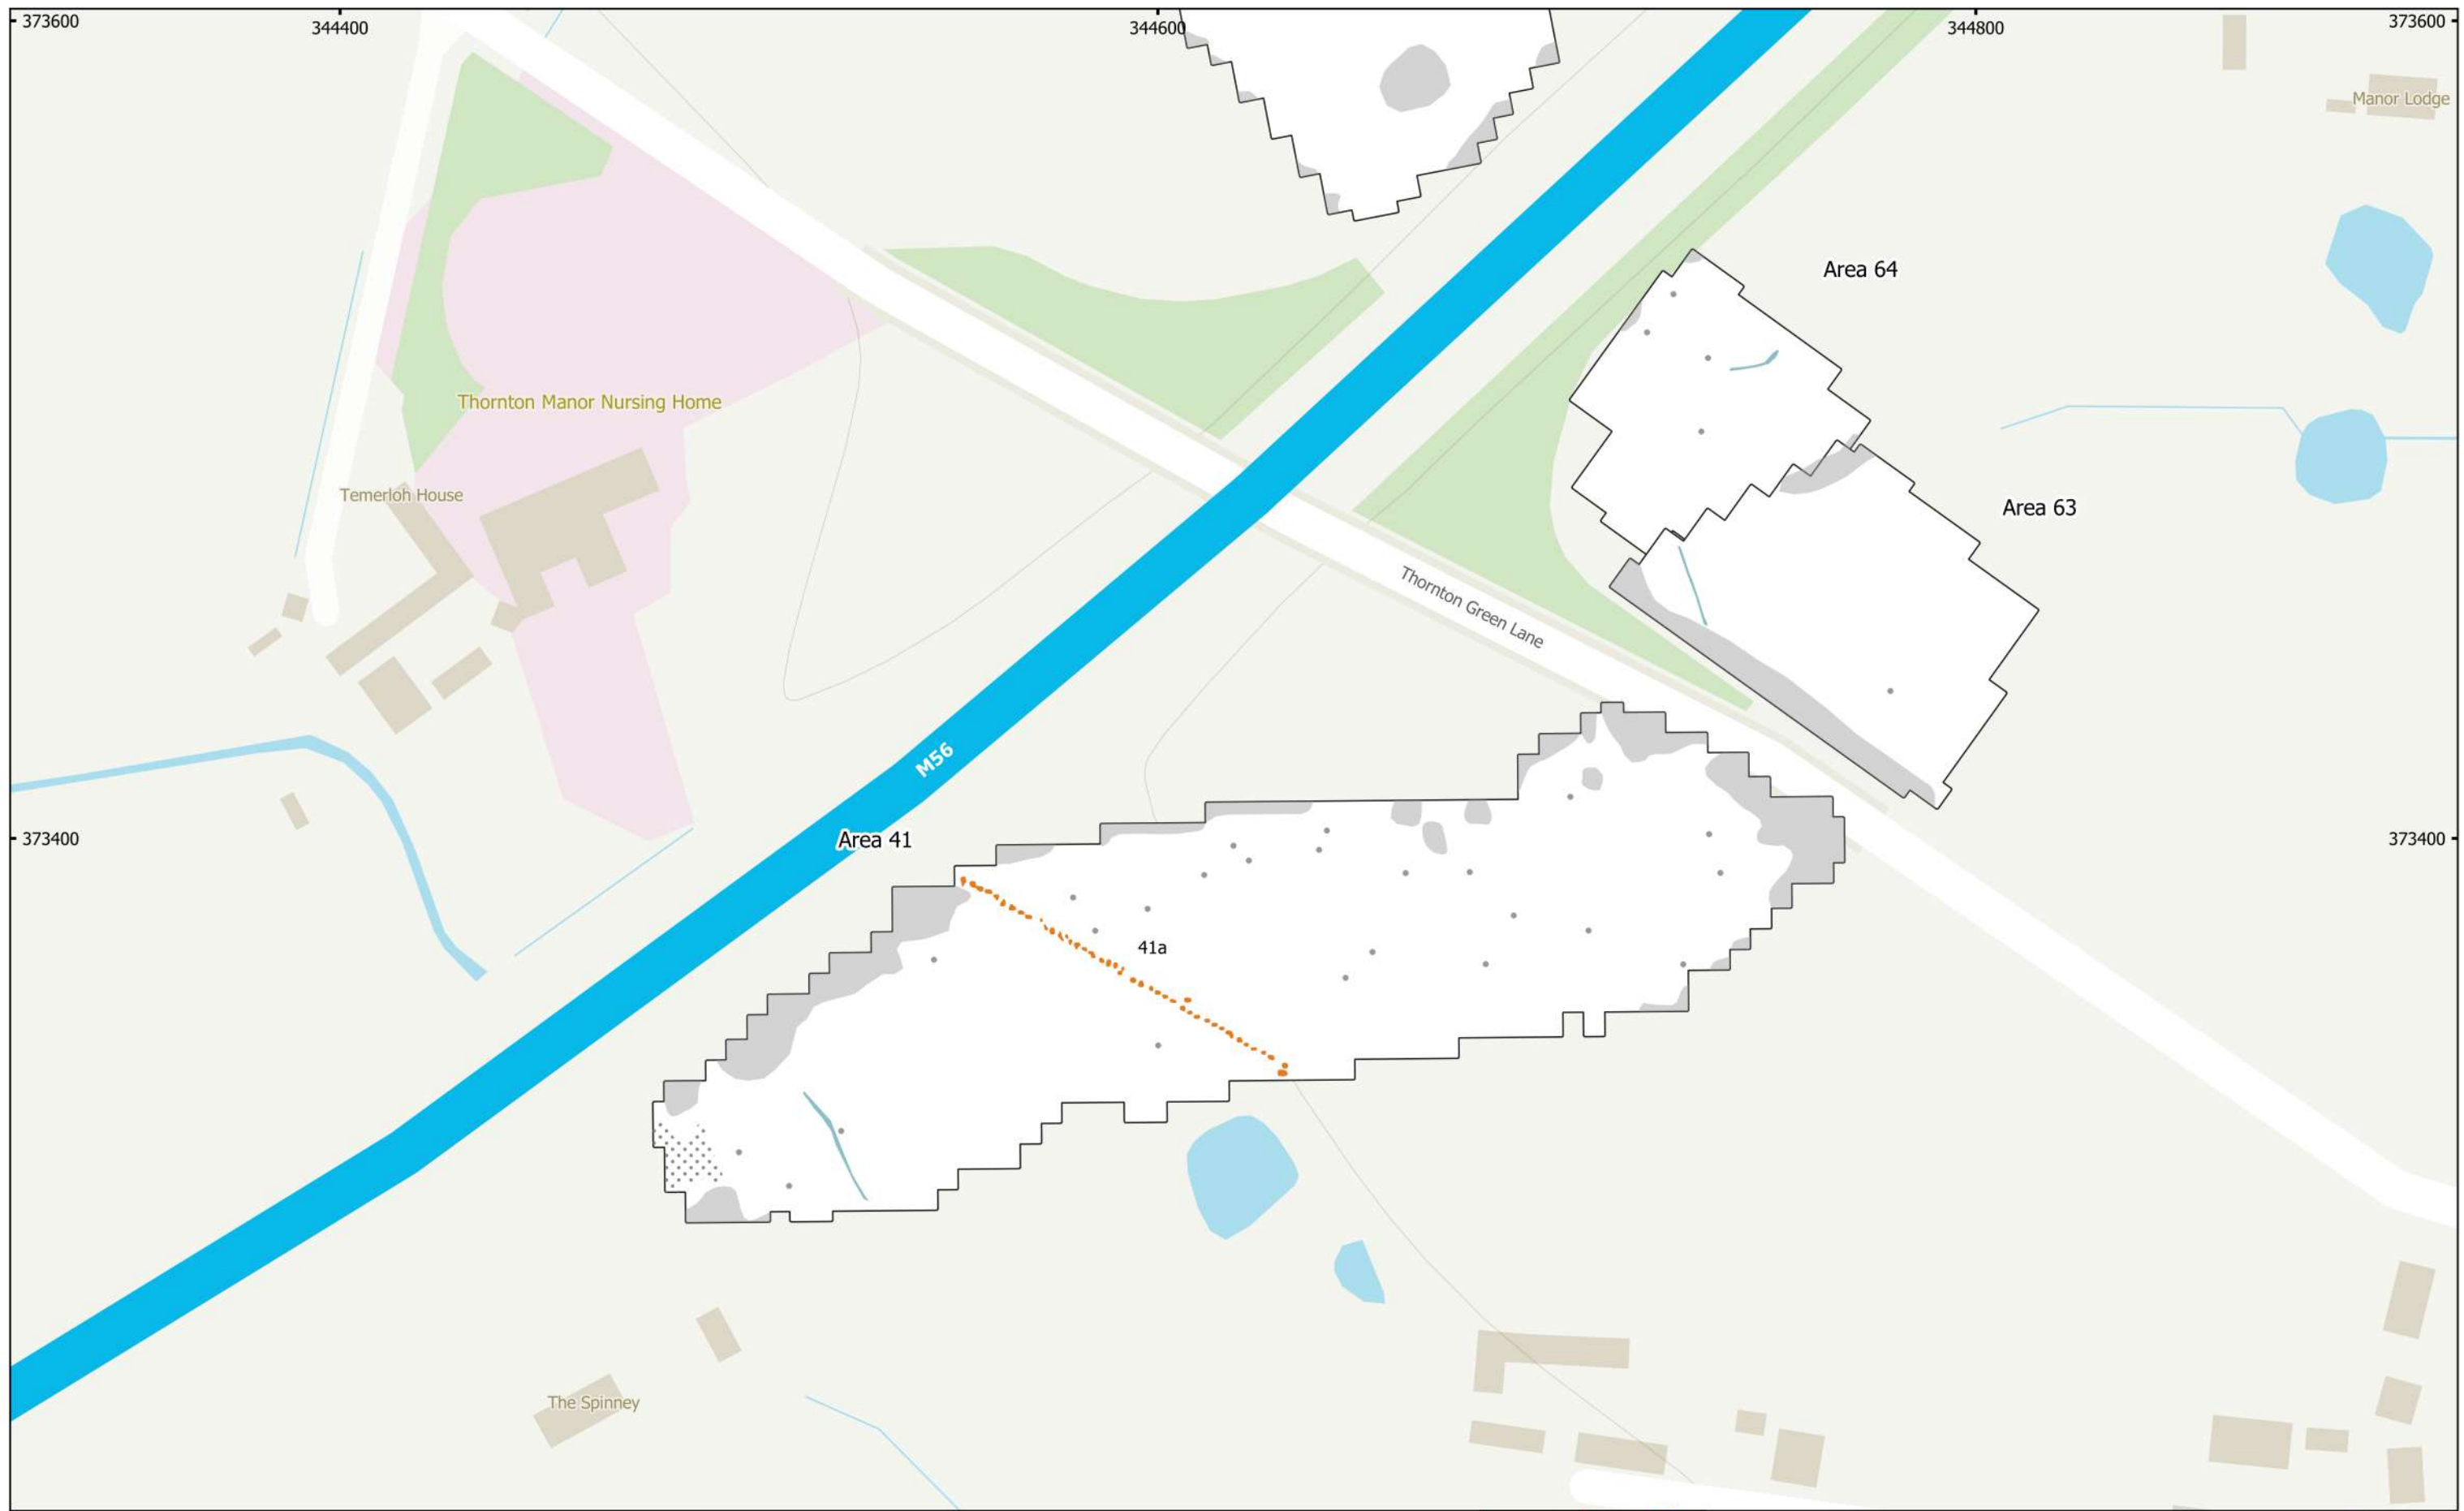
MSSJ1172 - HyNet CO2 Pipeline
 Figure 211 - Magnetic Interpretation (Areas 41, 63, & 64)
 1:1,500 @ A3
 Copyright Magnitude Surveys Ltd 2022
 Contains Ordnance Survey data © Crown Copyright and database right 2022

7.2.5. In the east of the survey corridor, south of Elton, evidence of possible archaeological activity has been identified in the form of possible pit alignment (Figure 211), which could date from prehistory to the medieval period. However, due to the limited context provided by the survey corridor it is not possible to provide a more definitive interpretation. While this anomaly has a magnetic signal typical of infilled pits, it could be caused by modern agricultural activity such as a drain.
