Appendix 18.3 Water Framework Directive Assessment (Tracked)

HyNet Carbon Dioxide Pipeline DCO

Document Reference Number D.6.3.18.3

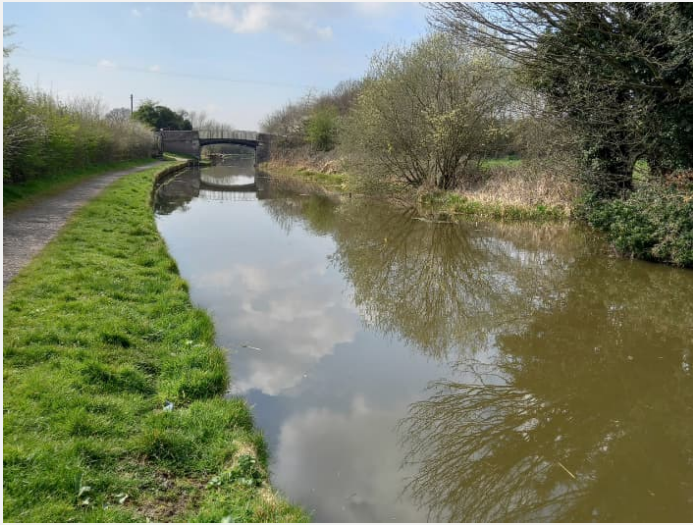
Water feature type: Canal
	Catchment area: n/a (artificial canal system)
	Key hydraulic connections: The canal joins the Manchester Ship Canal to the River Dee at Chester.
	Surrounding land use: Rural (farmland, arable and pastoral), woodland, urban, industrial, recreational (golf courses, etc)
	River Condition Score: Fairly poor
Catchment Characteristics	Artificial channel built in the late 18 th century for industry and trade. Ellesmere and Chester canal branches. 16 locks separate Manchester Ship Canal from River Dee.
Catchment Geology and Soils	n/a (artificial canal)
Catchment Hydrology	Series of weirs and locks controls water level throughout the canal system.

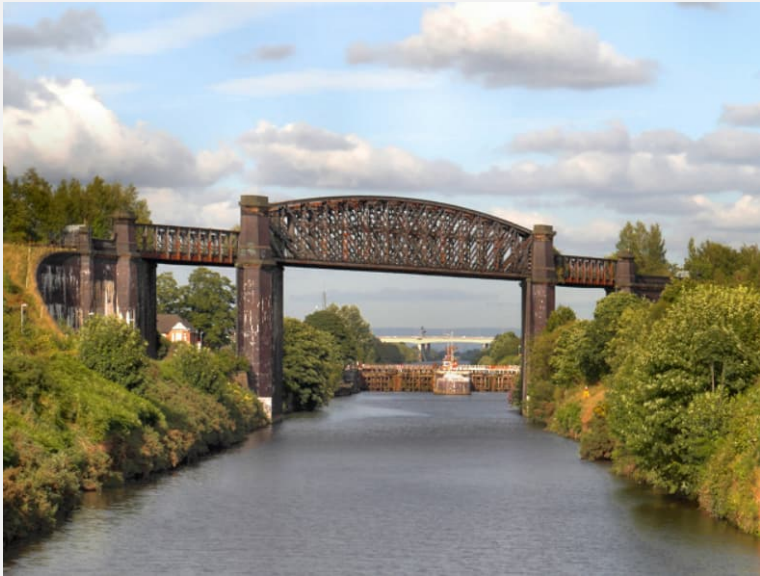
Water feature type: Canal
	Catchment area: n/a (artificial canal)
	Key hydraulic connections: River Irwell; River Irk; River Medlock
	Surrounding land use: Major industrial and urban centres in canal catchment. Large areas of farmland.
	River Condition Score: Not surveyed
Catchment Characteristics	Major artificial canal, extensively used for shipping and trade.
Catchment Geology and Soils	n/a (artificial canal)
Catchment Hydrology	Multiple locks and sluices maintain water levels within the channel.
Historical Channel Change	Channel construction in the late 19 th century, no changes to course in intervening years.

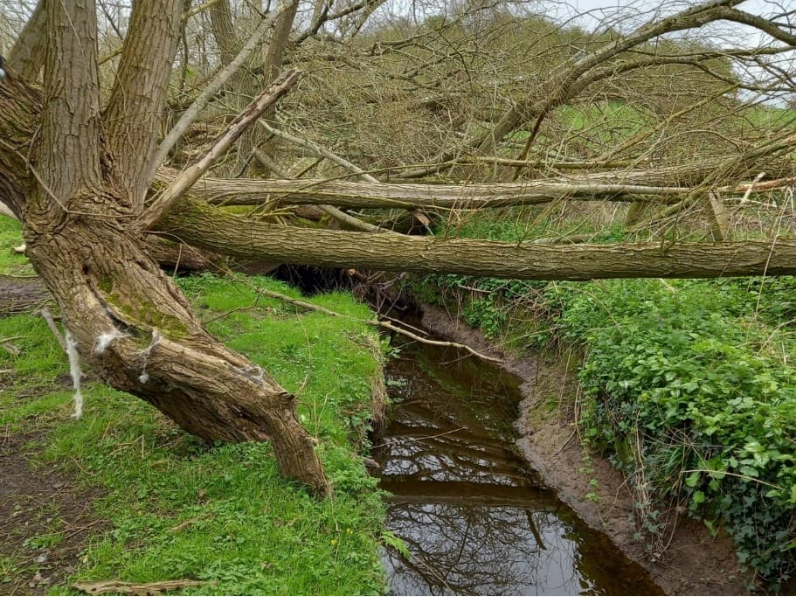
Water feature type: Main River
	Catchment area: 4.97km ²
	Key hydraulic connections: There are three tributaries of Backford Brook which drain land south of Dunkirk and the M56. Backford Brook is culverted beneath the Shropshire Union Canal and then joins Finchetts Gutter.
	Surrounding land use: Pasture, grassland, and woodland.
	River Condition Score: Fairly Good upstream of field culvert. Fairly Poor downstream of field culvert.
Catchment Characteristics	Elevation varies from 38m, to 19mAOD. The catchment is predominantly rural.
Catchment Geology and Soils	Geology is dominated by sandstone and conglomerate. Soils in the catchment are slightly acid loamy and clayey soils with impeded drainage and loamy and sandy soils with naturally high groundwater and a peaty surface

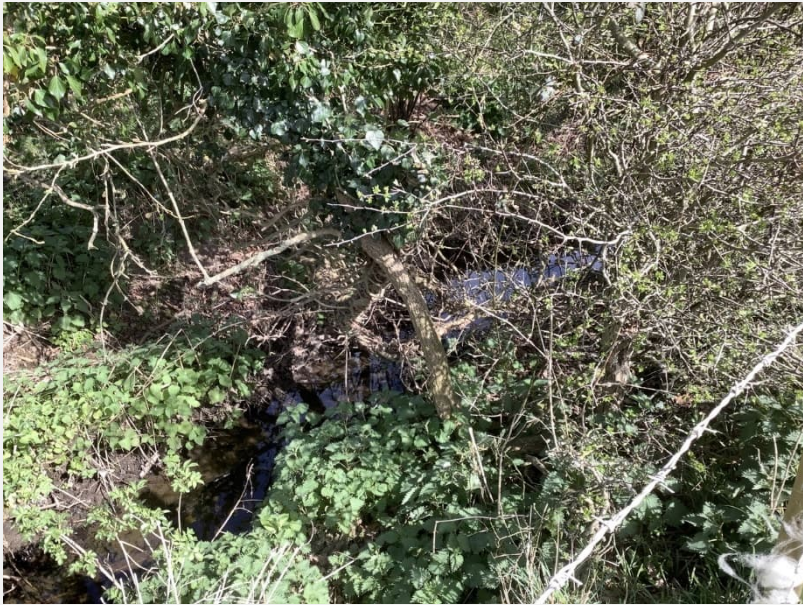
Water feature type: Ordinary Watercourse
	Catchment area: 0.135km ²
	Key hydraulic connections: This watercourses flow southeast, under the Shropshire Union Canal and connects to Finchetts Gutter.
	Surrounding land use: Pasture, grassland, and woodland.
	River Condition Score: Fairly Good
Catchment Characteristics	The watercourse drains a catchment south of Lea-by-Backford. The elevation ranges from 12m to 25mAOD.
Catchment Geology and Soils	Geology is dominated by sandstone and conglomerate. Soil in the catchment is slightly acid loamy and clayey soils with impeded drainage.
Catchment Hydrology	No gauge records are available for this catchment.

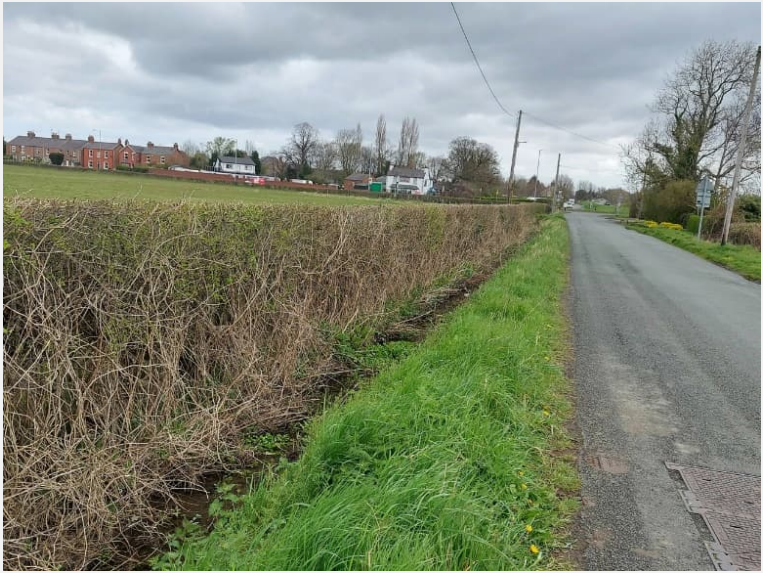
Water feature type: Main River and ordinary watercourse
	Catchment area: 2.99km ²
	Key hydraulic connections: Onward connection into Broughton Brook. It receives flows from roadside ditches of Moor Lane.
	Surrounding land use: arable and horticultural
	River Condition Score: Fairly Poor
Catchment Characteristics	Catchment with high degree of human influence on watercourses and landscape. Elevation varies from 80 - 8 mAOD. Relatively flat catchment.
Catchment Geology and Soils	The channel flows over a variety of bedrock geologies, including Kinnerton sandstone formation, Etruria Formation (Mudstone, sandstone and conglomerate) from riverine environments. The channel is also underlain by bedrock geologies of Pennine Middle Coal

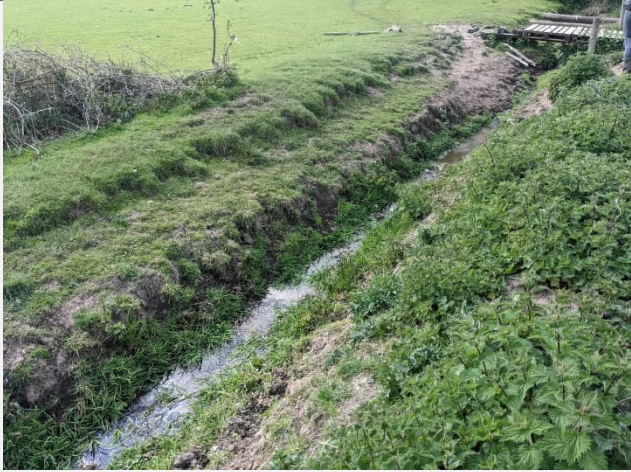
<p data-bbox="203 699 434 735">Upstream reach</p>	
Catchment Characteristics	The catchment drains farmland and arable fields. Elevation varies from 80 - 8mAOD. Relatively flat catchment which is predominantly rural.
Catchment Geology and Soils	<p>The channel flows over a variety of bedrock geologies, including Kinnerton sandstone formation, Etruria Formation (Mudstone, sandstone and conglomerate) from riverine environments. The channel is also underlain by bedrock geologies of Pennine Middle and Lower Coal Measures Formation - Mudstone, Siltstone and Sandstone, from swamps, estuarine and delta environments, Bowland Shale Formation (Mudstone, formed in open seas with pelagite deposits), and Gwespyp Sandstone formed within swamps, estuaries, and deltas.</p> <p>Superficial deposits also include tidal flat deposits (clay, silt and sand), Devensian tills, and glaciofluvial deposits.</p>

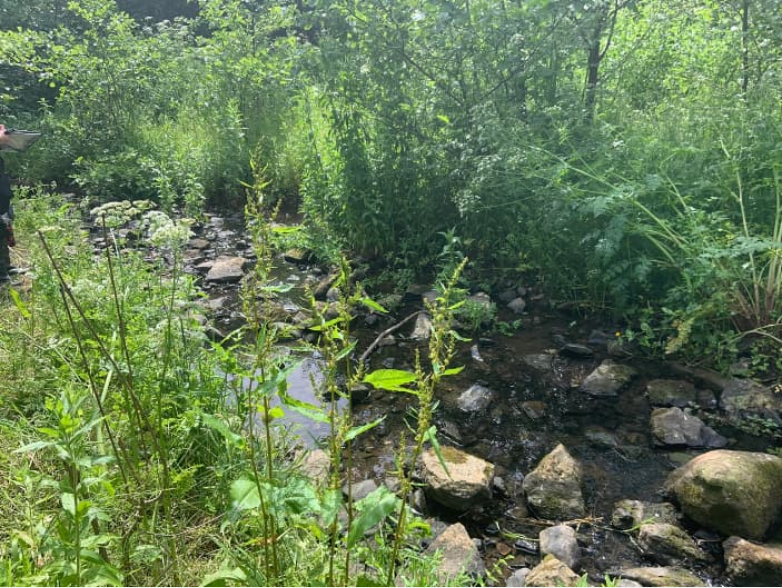
Water feature type: Ordinary watercourse
	Catchment area: 4.31km ²
	Key hydraulic connections: The Nant-y-Fflint has several unnamed tributaries mostly from the south of the catchment which join the watercourse upstream of the DCO Proposed Development.
	Surrounding land use: Mainly rural farmland (arable and pastoral, forestry)
	River Condition Score: Fairly Good
Catchment Characteristics	The catchment is relatively steep, with a confined floodplain in a wooded valley. The catchment is predominantly rural with small settlements in Pentre Halkyn and Halkyn.
Catchment Geology and Soils	Somewhat complex bedrock geology, consisting of areas of mudstone and sandstone from different formations. Superficial deposits poorly recorded in this
