Viking CCS Pipeline

**Environmental
Statement Volume IV –
Appendix 6-3: Otter and
Water Vole Survey
Report**

Document Reference: EN070008/APP/6.4.6.3

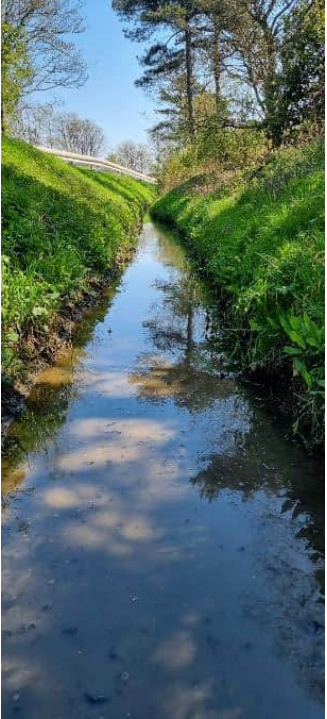
Crossing Point	Survey Dates	Watercourse description	Water vole field signs	Otter field Signs	Photograph
DX004P	18/04/2023	Ditch associated with hedgerow with earth banks. Bankside vegetation includes tall grasses and ruderals.	None	None

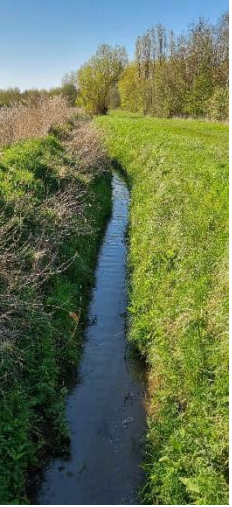
DX007P	09/06/2022	Steep banks on both sides of the ditch, vegetation includes tall ruderals and common reed.	None	None

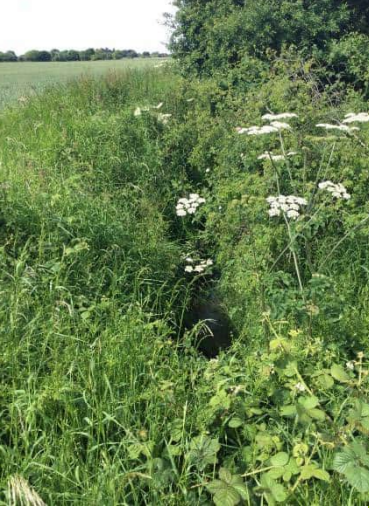
DX011P	18/04/2023	3m wide 20cm deep ditch. Bankside vegetation consists of tall ruderals	None	None	No photograph taken

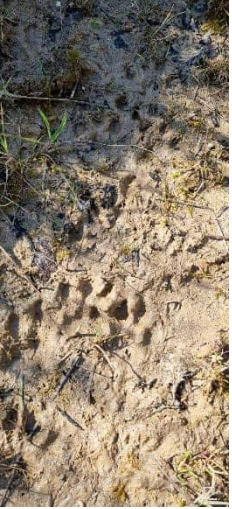
Crossing Point	Survey Dates	Watercourse description	Water vole field signs	Otter field Signs	Photograph
DX012P	18/04/2023	Dry ditch	None	Otter footprints recorded

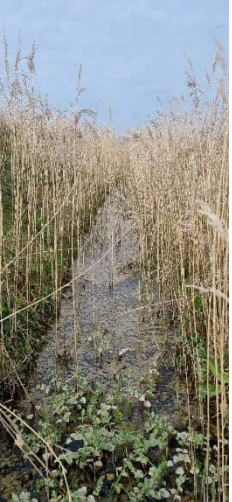
DX013P	19/04/2023	1m wide and 25cm deep ditch. Earth banks and slow flow with emergent vegetation present	None	None

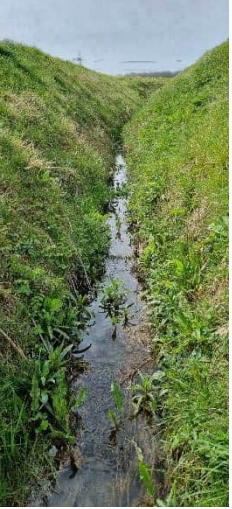
Crossing Point	Survey Dates	Watercourse description	Water vole field signs	Otter field Signs	Photograph
DX017P	19/04/2023	1m wide and 20cm deep ditch with steep earth banks with vegetation of tall grasses and tall ruderals	None	None

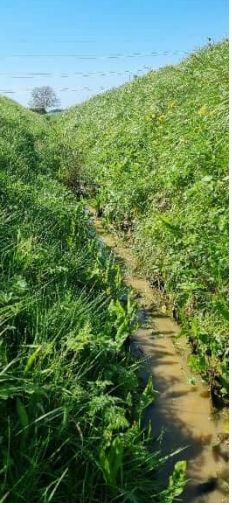
DX018P	19/04/2023	50cm wide 30cm deep ditch with steep earth banks and bankside vegetation of tall grasses and tall ruderals.	None	None

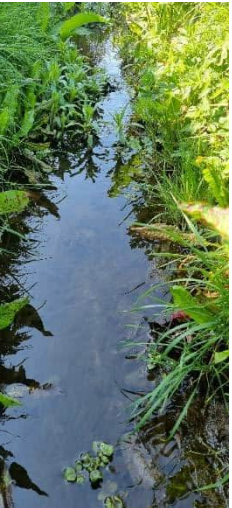
Crossing Point	Survey Dates	Watercourse description	Water vole field signs	Otter field Signs	Photograph
DX019P	19/04/20 23	1m wide 30cm deep ditch with earth banks and emergent vegetation present.	None	None

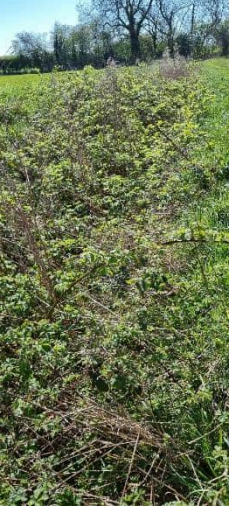
Crossing Point	Survey Dates	Watercourse description	Water vole field signs	Otter field Signs	Photograph
DX029P	19/04/2023	Heavily vegetated ditch with bramble.	None	None

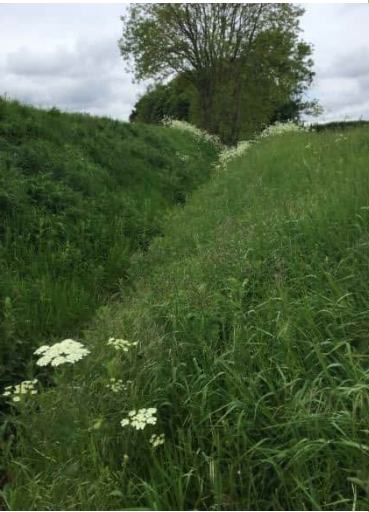
DX040P	20/04/2023	75cm wide 30cm ditch with steep earth banks vegetated by tall grasses and ruderals, emergent plants present within the channel.	None	None

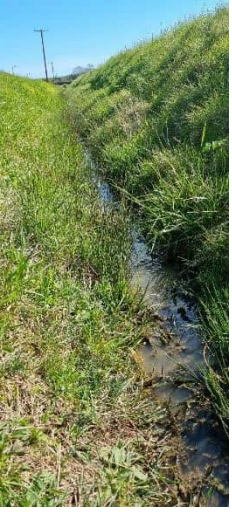
Crossing Point	Survey Dates	Watercourse description	Water vole field signs	Otter field Signs	Photograph
DX047P	20/04/2023	50cm wide 25cm deep ditch with earth banks vegetated by grasses and ruderals.	None	None	No photograph available
DX048P	20/04/2023	Small ditch with steep banks which likely dries in the summer. Depth is approximately 10cm	None	None

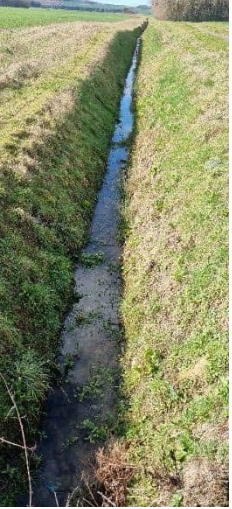
Crossing Point	Survey Dates	Watercourse description	Water vole field signs	Otter field Signs	Photograph
DX049P	20/04/2023	50cm wide 25cm deep ditch with some aquatic macrophytes present including marginals and emergent species. No shading.	None	None

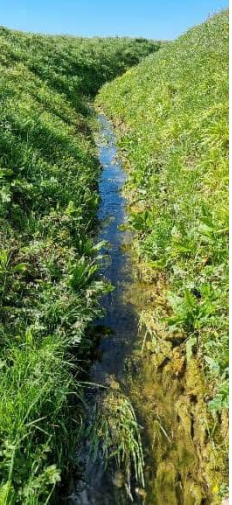
DX050P	20/04/2023	50cm wide 10cm deep ditch with moderately sloped earth banks vegetated by grasses and tall ruderals. No shading.	None	None

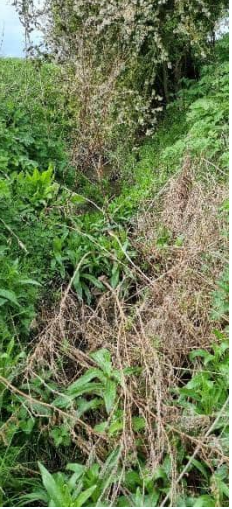
Crossing Point	Survey Dates	Watercourse description	Water vole field signs	Otter field Signs	Photograph
DX054P	20/04/2023	50cm wide 30cm deep ditch with moderately sloped earth banks vegetated by grasses and tall ruderals	None	None

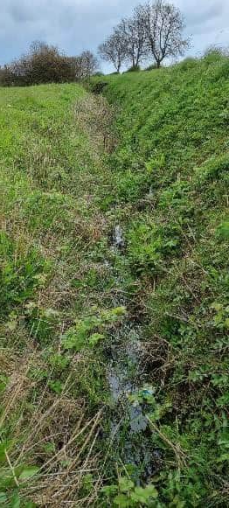
DX055P	24/04/2023	20cm wide 10cm deep ditch with moderately sloped banks vegetated by grasses and tall ruderals	None	None

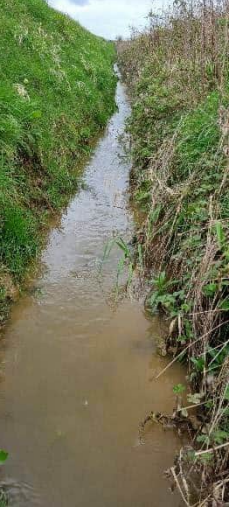
Crossing Point	Survey Dates	Watercourse description	Water vole field signs	Otter field Signs	Photograph
DX059P	24/04/2023	1m wide 50cm deep ditch with steep earth banks vegetated by dense scrub on one bank and tall grasses on the other. No shading, and some emergent plant species present	None	None

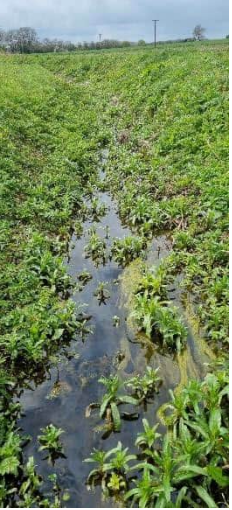
DX061P	24/04/2023	1m wide 25cm deep ditch with shallow earth banks vegetated by grasses and tall ruderals. The channel had emergent aquatic vegetation present.	None	None

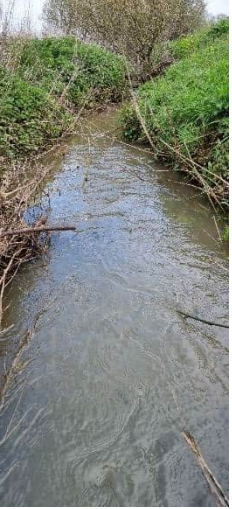
Crossing Point	Survey Dates	Watercourse description	Water vole field signs	Otter field Signs	Photograph
RVX001EP	24/04/2023	5m wide 60cm deep river with earth banks and moderate water flow. Banks vegetated by tall grasses and ruderal.	None	None

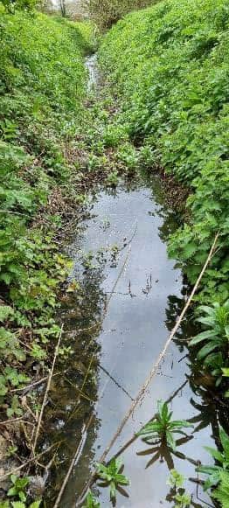
DX064P	24/04/2023	1m wide 30cm deep ditch with moderately sloped earth banks with tall grasses and tall ruderals.	None	None

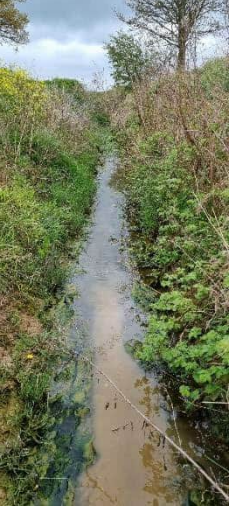
Crossing Point	Survey Dates	Watercourse description	Water vole field signs	Otter field Signs	Photograph
DX066P	24/04/2023	1m wide 30cm deep ditch with steep earth banks vegetated by tall ruderals and occasional trees. Limited shading.	None	None

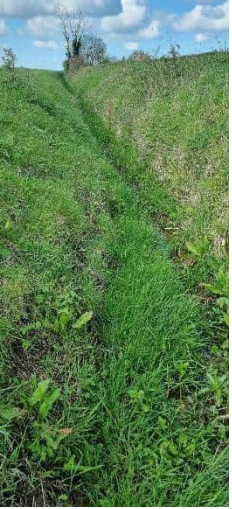
Crossing Point	Survey Dates	Watercourse description	Water vole field signs	Otter field Signs	Photograph
DX071P	25/04/2023	20cm x 20xm ditch with moderately sloped earth banks which are vegetated by grasses and tall ruderals.	None	None

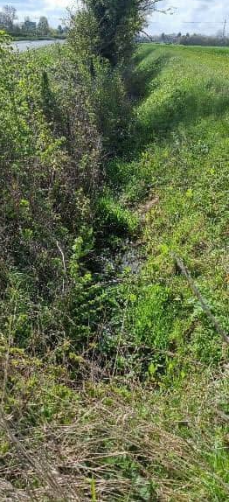
DX072P	25/04/2023	30cm wide 30cm deep ditch with moderately sloped earth banks vegetated by tall grasses and associated with a hedgerow. Some shading.	None	None

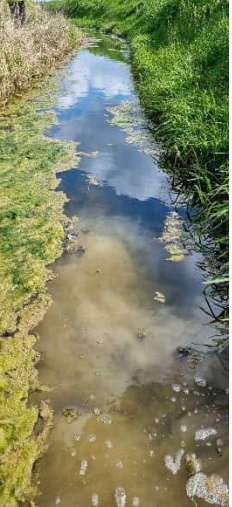
Crossing Point	Survey Dates	Watercourse description	Water vole field signs	Otter field Signs	Photograph
<p>RVX003A P</p>	<p>25/04/2023</p>	<p>3m wide 50cm deep river with earth banks which are vegetated by tall grasses. Emergent plant species present in the channel. Mink footprints also observed.</p>	<p>Two burrows and one latrine</p>	<p>Footprints</p>

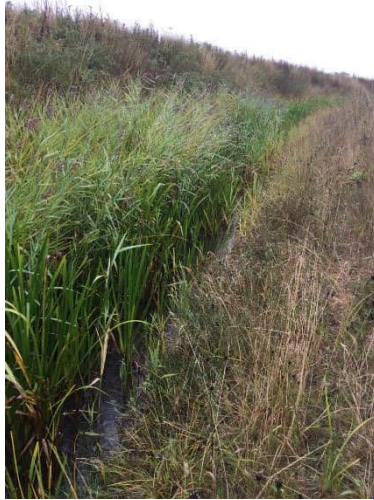
DX084P	25/04/2023	30cm wide 20cm deep ditch associated with a hedgerow. South bank vegetated by grasses and moderately sloped.	None	None

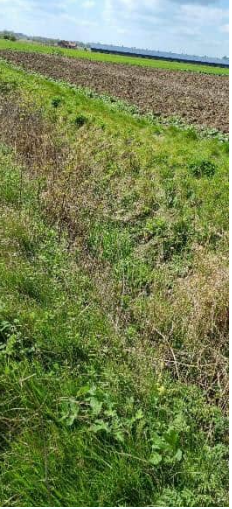
Crossing Point	Survey Dates	Watercourse description	Water vole field signs	Otter field Signs	Photograph
DX085P	25/04/2023	30cm wide 10cm ditch with moderately sloped earth banks.	None	None

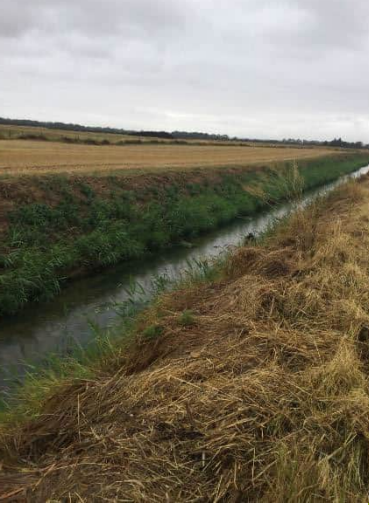
Crossing Point	Survey Dates	Watercourse description	Water vole field signs	Otter field Signs	Photograph
DX089AP	25/08/2022 25/04/2023	3m wide 70cm deep drain with tall grasses and emergent vegetation.	None	Feeding remains.

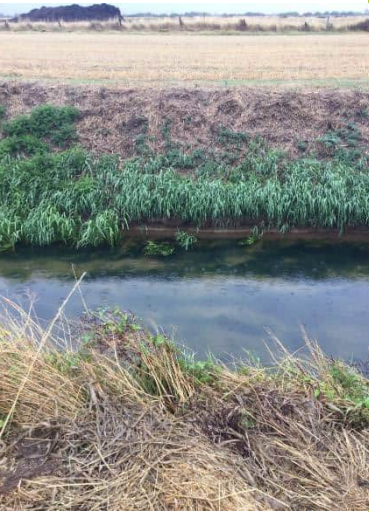
DX090BP	25/08/2022 25/04/2023	7m wide 75cm deep ditch with earth banks vegetated by grasses. Submerged and emergent vegetation present	None	Footprints and feeding remains

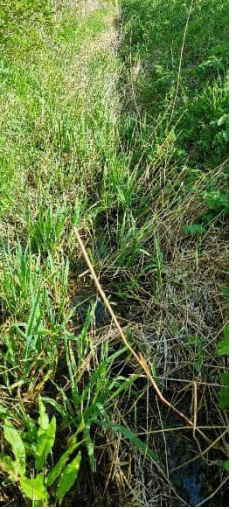
Crossing Point	Survey Dates	Watercourse description	Water vole field signs	Otter field Signs	Photograph
DX092P	25/04/2023	30cm wide 20cm deep ditch with emergent vegetation and earth banks vegetated by grassed	None	None

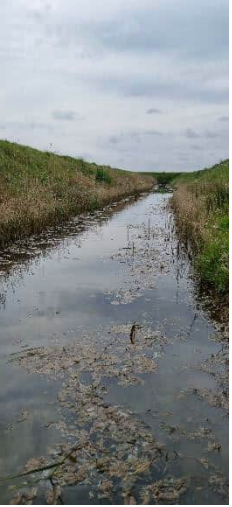
DX095AP	26/04/2023	7m wide 1m deep drain with moderately sloped earth banks vegetated by grasses. Marginals are present within the channel	None	Footprints

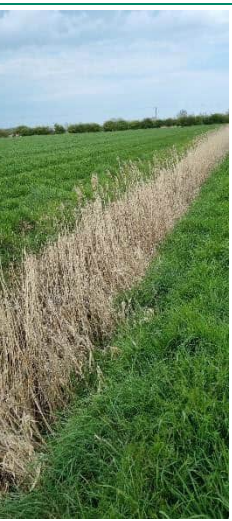
DX108P	26/04/2023	50cm wide 40cm deep ditch with steep earth banks vegetated by grasses. Common reed dominates the channel	None	None

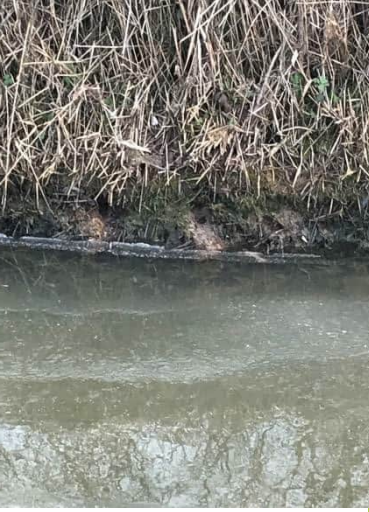
Crossing Point	Survey Dates	Watercourse description	Water vole field signs	Otter field Signs	Photograph
RVX002P	25/08/2022	5m wide 1.5m deep river. Moderately sloped earth banks vegetated by grasses.	None	Live otter seen swimming in river

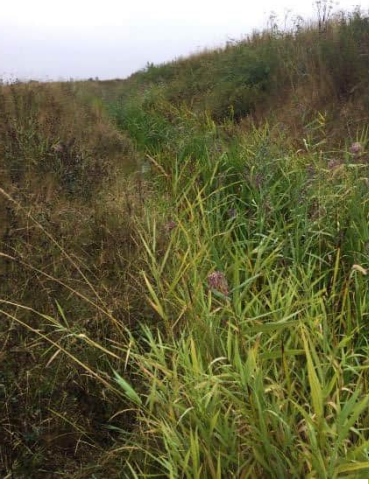
RVX007P	25/08/2022	7m wide 1m deep river. Moderately sloped earth banks vegetated by grasses.	None	Live otter observed swimming in the river further upstream

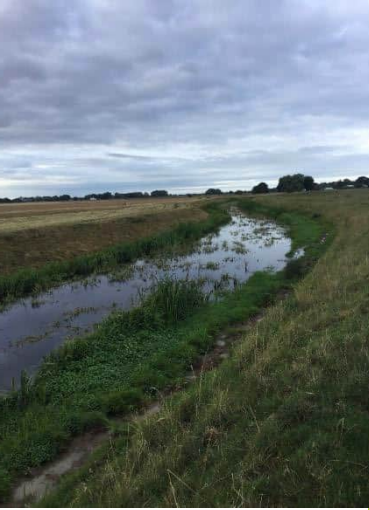
- 4.4.13 Crossing points DX111AP and DX111Apa both occur on The Cut. The Cut is approximately 5m wide and approximately 1m deep. The banks are earth, and suitable for water vole burrowing. The drain and its banks supports stands of suitable foodplants. Bankside trees are absent and there is no shading of the channel.
- 4.4.14 The drain is connected to a network of drains in the wider landscape and provides potential movement corridors for water vole between other areas of suitable habitat.
- 4.4.15 Evidence of water vole was observed within the drain and consisted of a total of two burrows and one potential latrine across 250m of survey. The small number of signs suggests The Cut supports a minimum of one territory.

Crossing Point	Survey Dates	Watercourse description	Water vole field signs	Otter field Signs	Photograph
DX111APa & DX11AP	25/04/2023	5m wide and 1m deep drain. Moderately sloped earth banks	Burrow and latrine	None

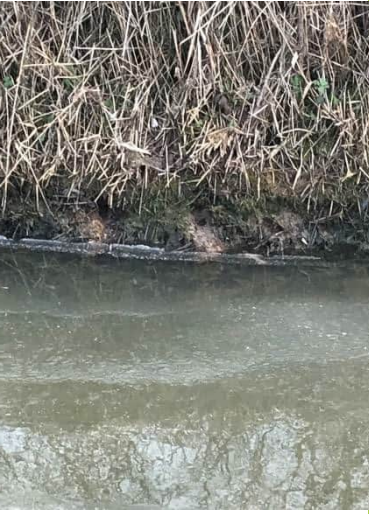
Crossing Point	Survey Dates	Watercourse description	Water vole field signs	Otter field Signs	Photograph
RVX002P	25/08/2022	5m wide 1.5m deep river. Moderately sloped earth banks vegetated by grasses.	None	Live otter seen swimming in river

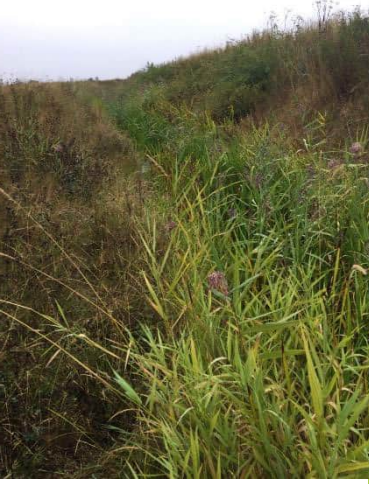
RVX007P	25/08/2022	7m wide 1m deep river. Moderately sloped earth banks vegetated by grasses.	None	Live otter observed swimming in the river further upstream
