Viking CCS Pipeline

**Environmental
Statement Volume IV –
Appendix 8-2: Aerial
Review and LiDAR**

Document Reference: EN070008/APP/6.4.8.2

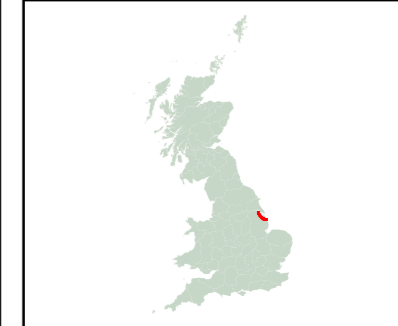
FIGURE TITLE
Figure 2
Historic England Aerial Photographs

- 1.4.1 Paper based copies of all vertical, military oblique and specialist oblique aerial photos held at the HE Archive were examined in detail in the HE Public Search Room, by Air Photo Services Ltd in March and April 2023. The locations of these photos are shown on **Figure 2**. HE coversearch enquiry number 138509 which was undertaken in March 2023 provided access to:

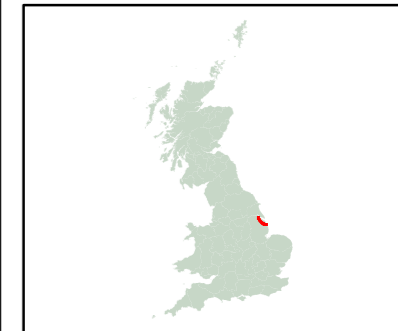
FIGURE TITLE
Figure 3
Cambridge University Collection of Aerial Photography Aerial Photographs

- 1.4.3 The CUCAP collection continues to be closed for digitisation, but a coversearch was obtained online at: [REDACTED]. The location of the CUCAP photos within the DCO Site Boundary and environs are shown on **Figure 3**. Some of these photos are available as copies in the HE Archive, and all were used as appropriate by the Lincolnshire National Mapping Programme (LNMP).

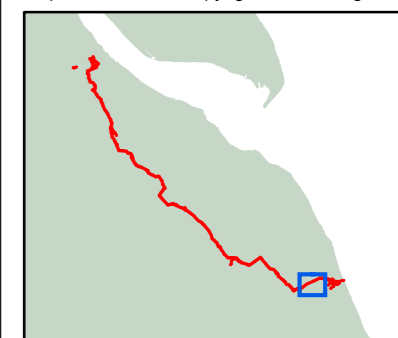
FIGURE TITLE
Figure 6
Geology
Page 02 of 18

- 1.7.4 The geological substrates and soils, (Cranfield University 2023, British Geological Survey (BGS) 2023), which are shown on **Figure 6** and **7**. These geologies comprise a mixture of well drained substrates and some more waterlogged areas. Most of the route however is conducive to the formation of crop marks, visibility of earthworks and foundations and marks in soils over buried features.

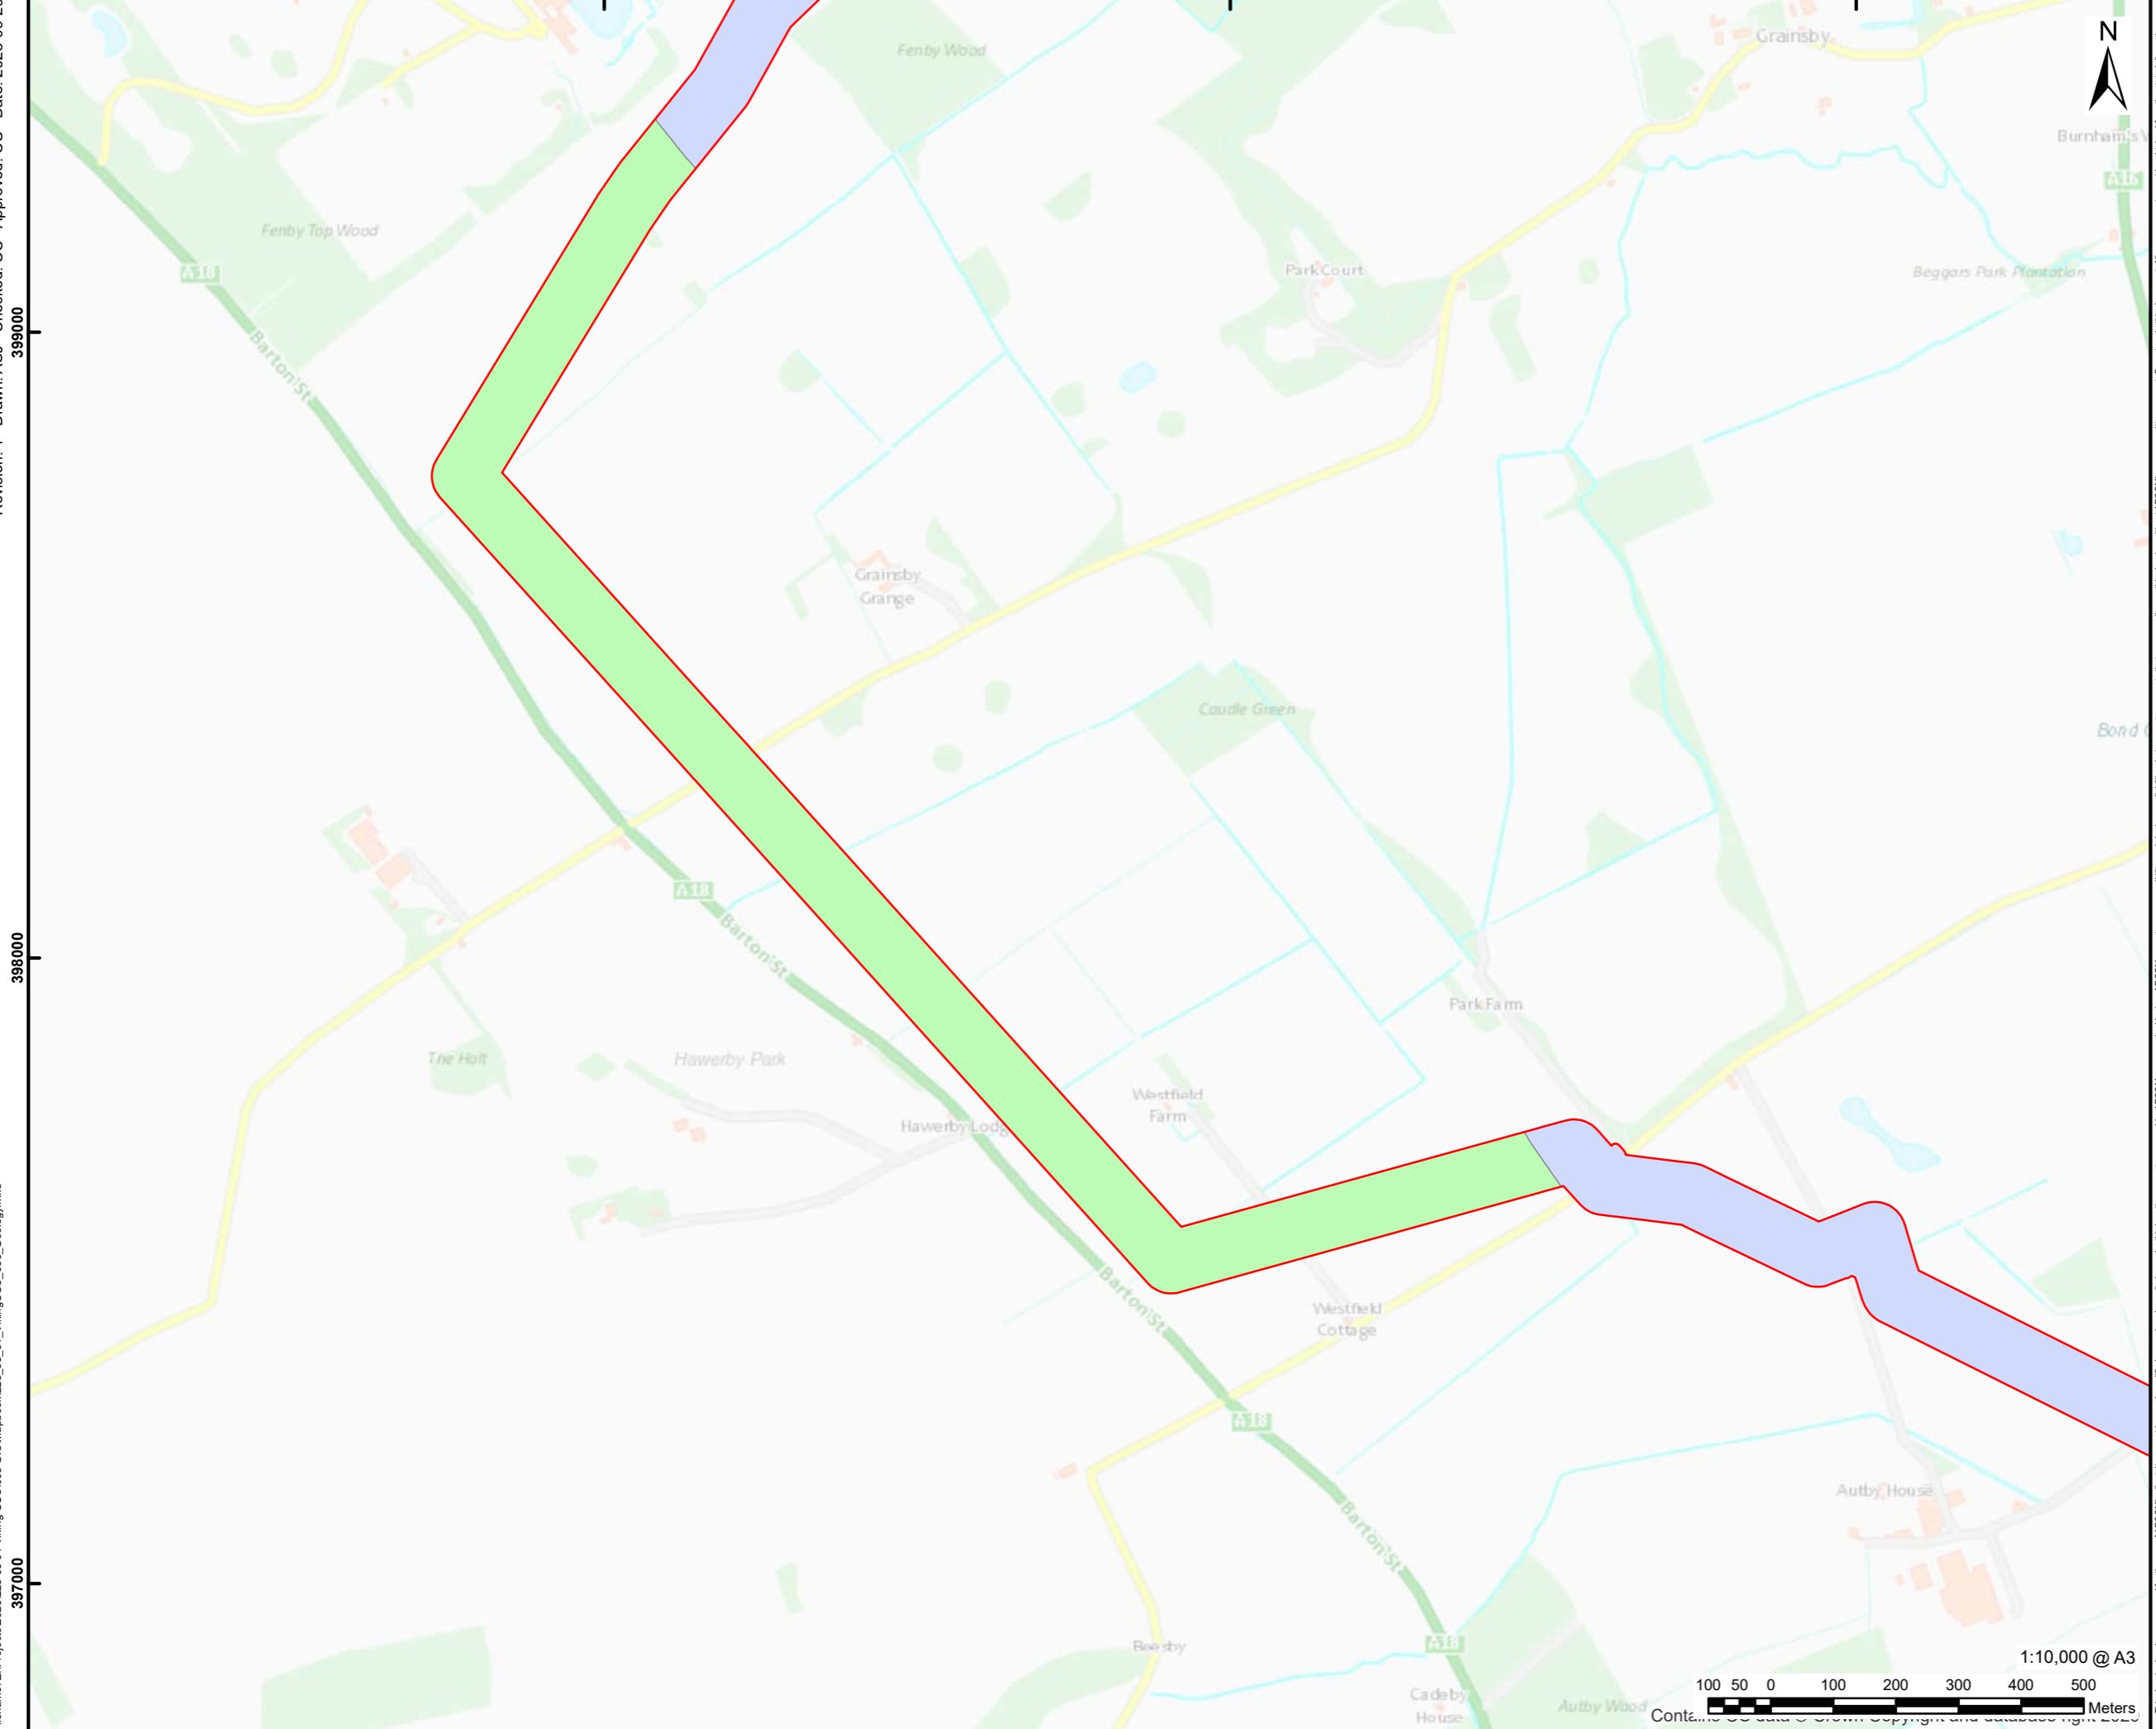
FIGURE TITLE
Figure 6
Geology
Page 10 of 18

DCO Site Boundary
	Chalk and chalky drift
	Chalky drift and chalk
	Chalky till
	Dune sand and marine shingle
	Glaciofluvial drift
	Glaciofluvial sand and gravel
	Marine alluvium
	Reddish till

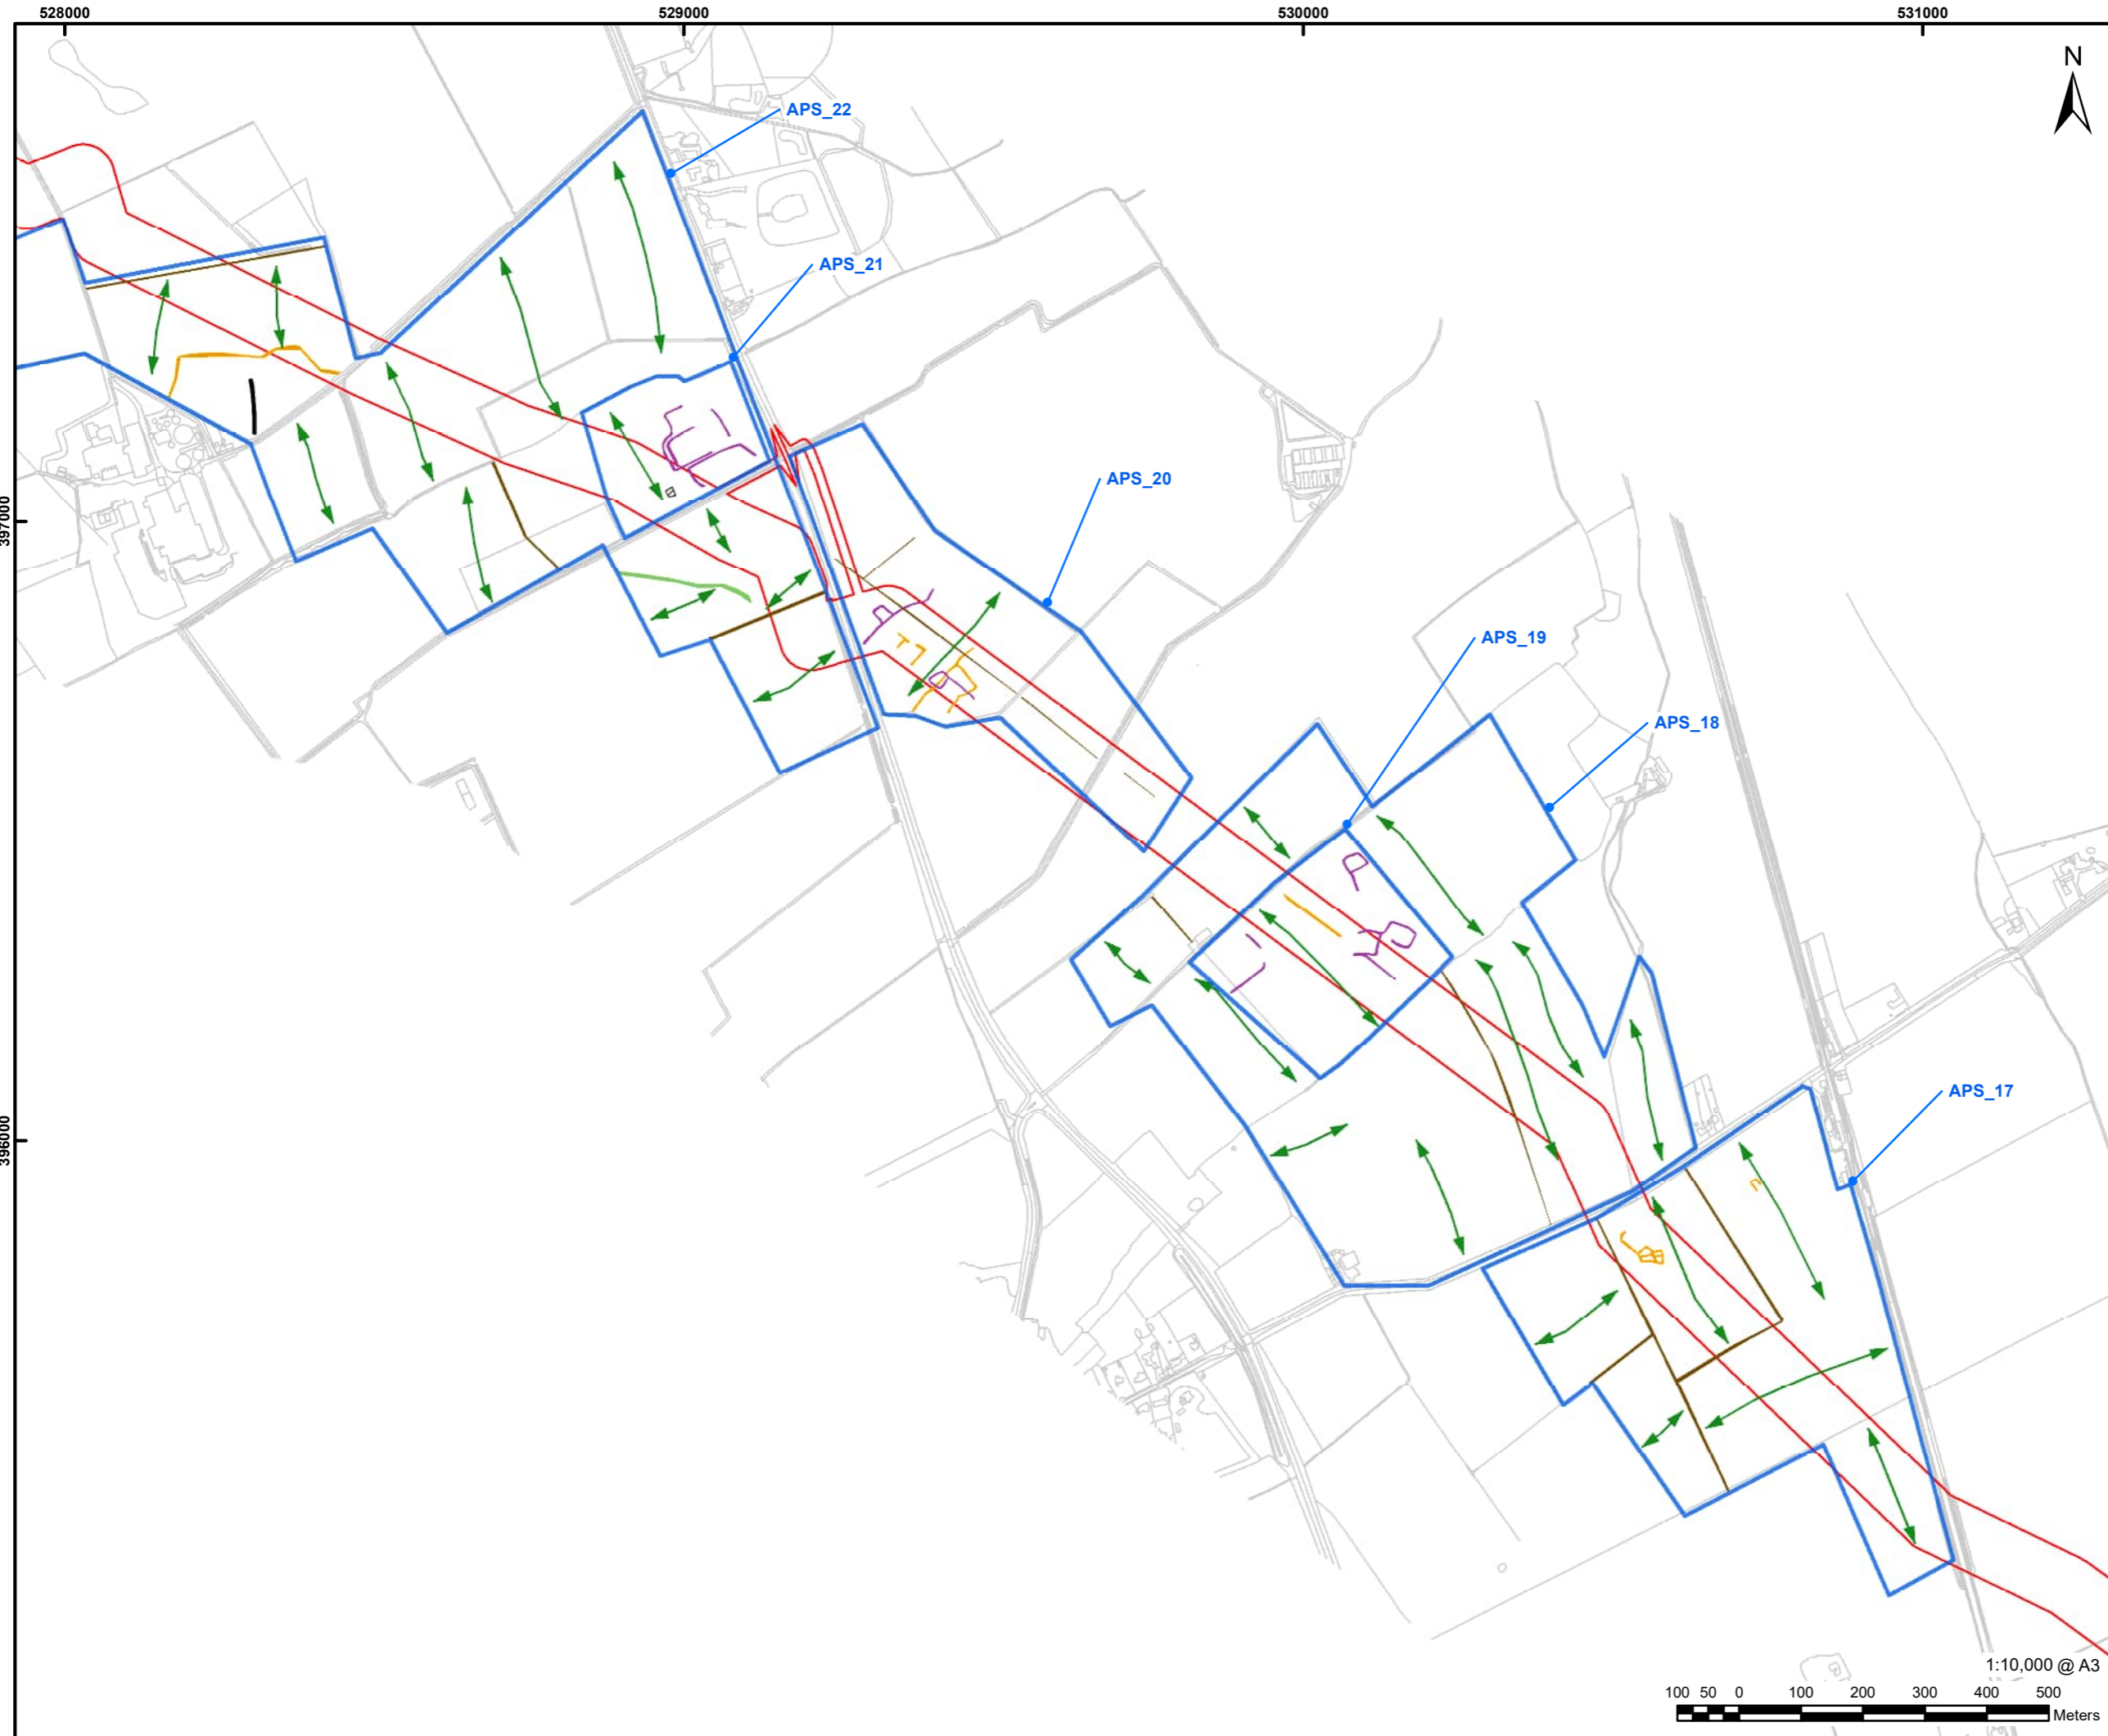
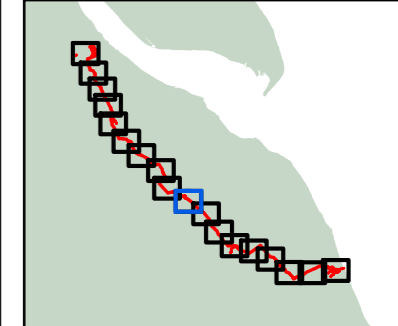
FIGURE TITLE
Figure 9
Detailed Map Book
Page 09 of 18

- LEGEND**
- DCO Site Boundary
 - Site Extents
 - Asset_Type**
 - Eroded Ridge and Furrow
 - Ditch
 - Enclosure
 - Field Boundary
 - Headland
 - Mining
 - Lincolnshire NMP

- 1.8.5 All recorded features are illustrated in a heritage mapbook on **Figure 8** and **Figure 9**.
- 1.8.6 **Table 1** details all the heritage assets which were recorded for this assessment.
