H2Teesside Project

Environmental Statement

Appendix 10A: Geology, Hydrogeology and Contaminated Land Desk Based Summary Report

Document Reference: 6.4.11

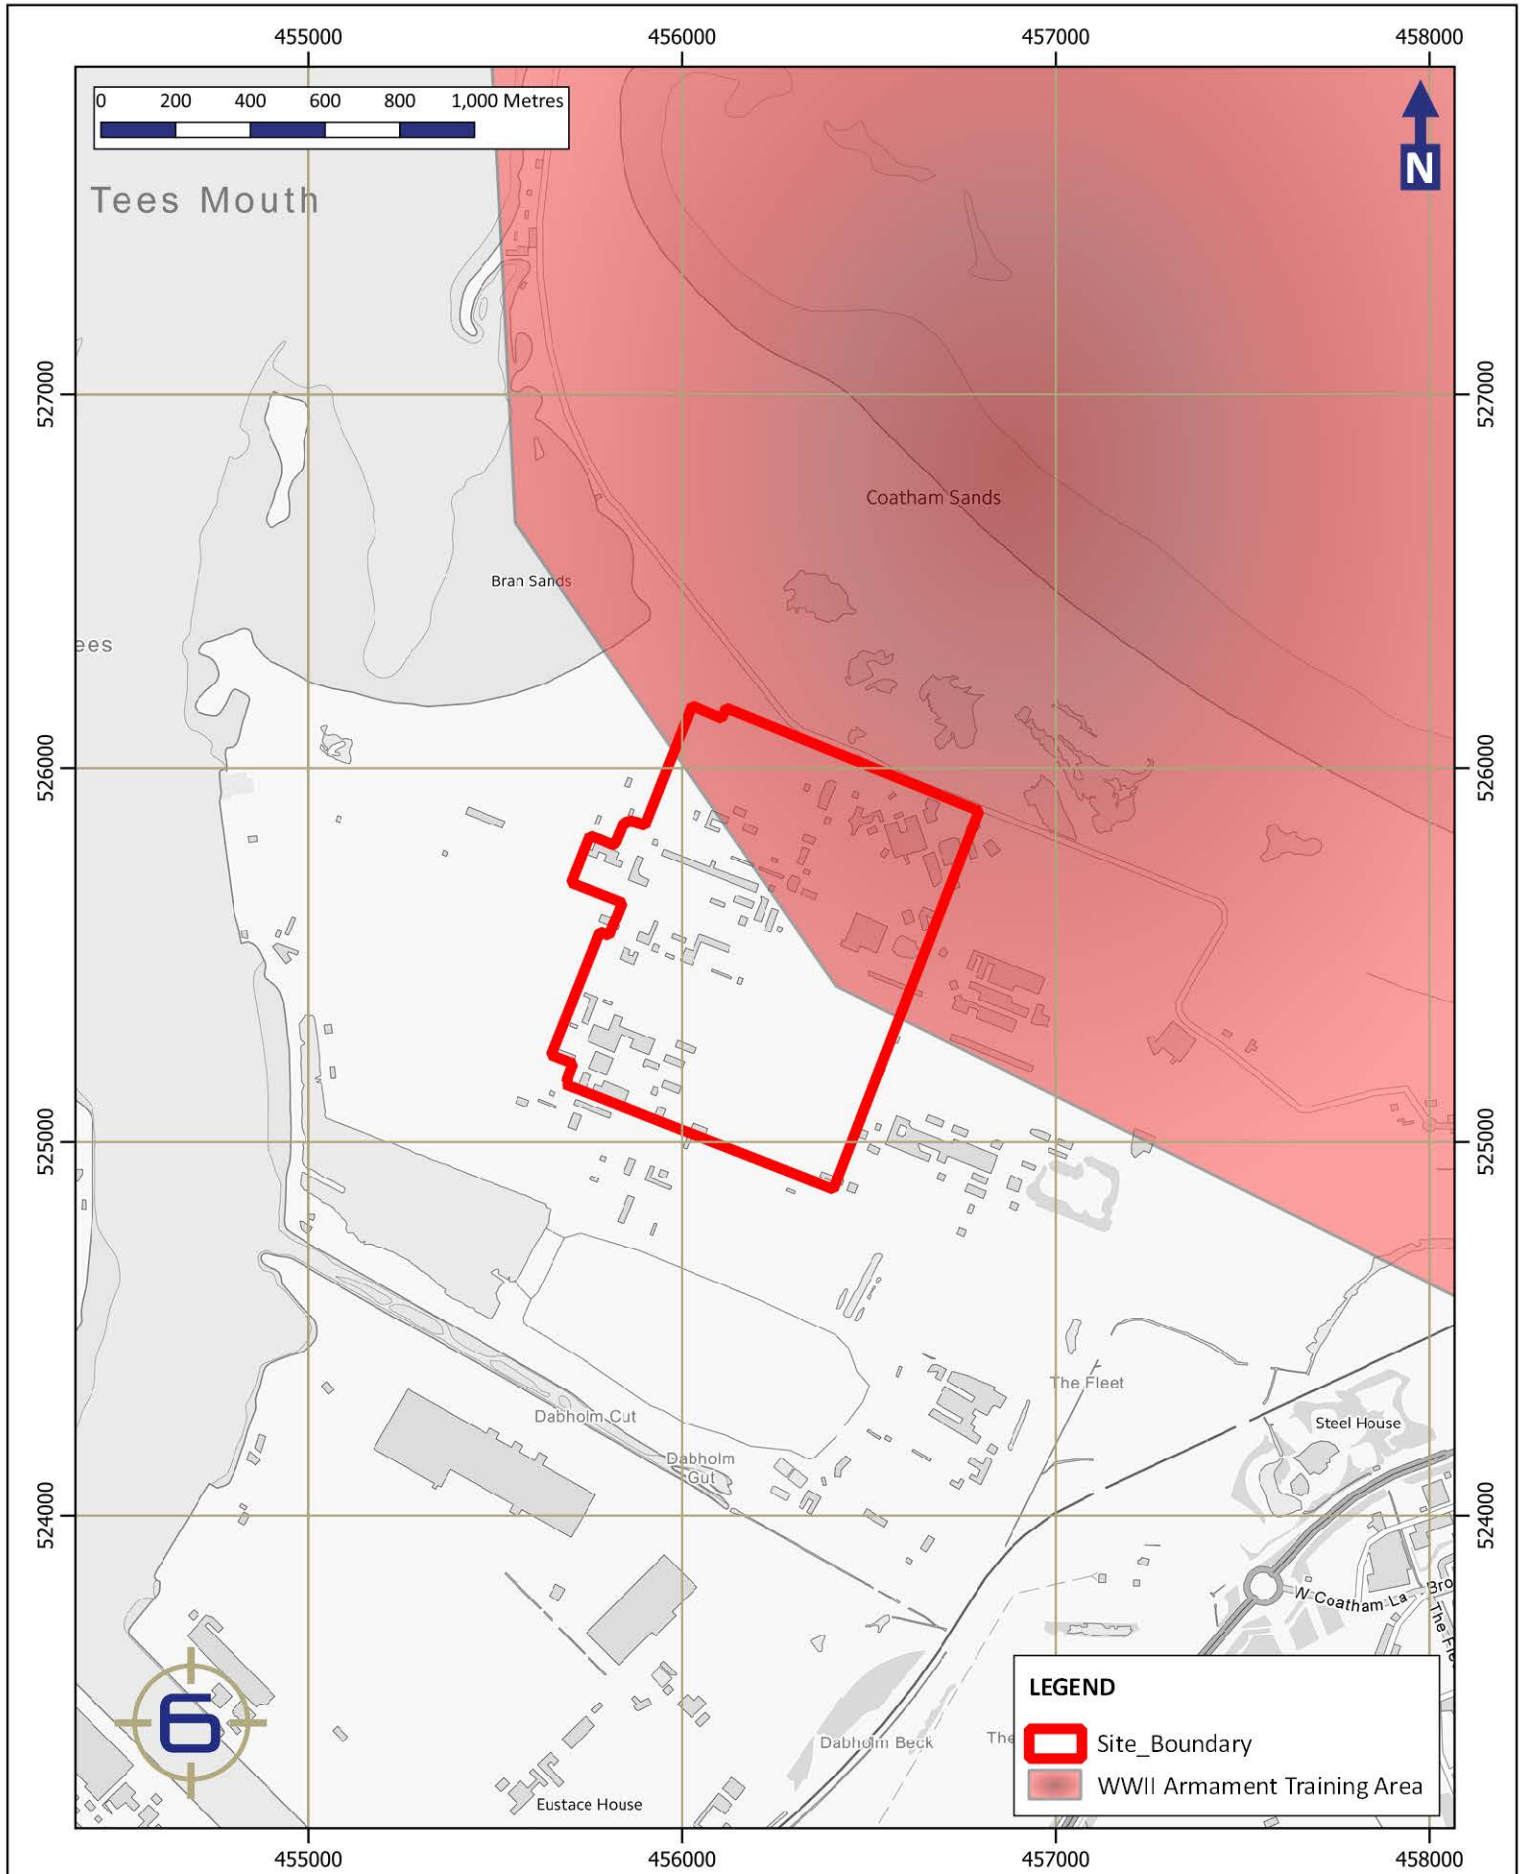
Figure Seven - WWII Armament Training Area

Extent of WWII Armament Training Areas
