M20 Junction 10a

TR010006

Appendix 8.8 Protected Species Report - Riparian Mammals

Volume 6.3
July 2016

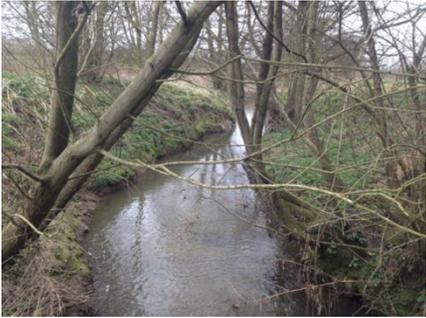
Description	Photo
Aylesford Stream (April 2015)

- 2.2.1 A walk over survey was undertaken on 19 November 2014 by two Mott MacDonald ecologists. The channel has natural earth banks, comprising sandy vertical banks at a gradient of >45°. The bank profile was approximately 1.5m high and were lined with frequent stands of alder *Alnus glutinosa*, although other occasional / rare stands of other species are present¹². There was no vegetation within the channel of the stream, as shown in Table 2.2. Although at the time of the initial walk over the flow rate was rapid, subsequent visits found that the flow was highly changeable and that the majority of the time the rate of water flow was moderate to low. The water was turbid, with the majority of the Stream bed substrate comprised of sand with silt, although a few areas of rubble were evident.

- 2.2.3 Both banks provided well developed riparian cover, including a variety of herbaceous plants. Erosion of the banks was evident in localised areas along the stream, but comprised a very small proportion of the stream habitat within the section surveyed. These attributes lead to an overall assessment that the stream was highly suitable for water vole^{13,14}.

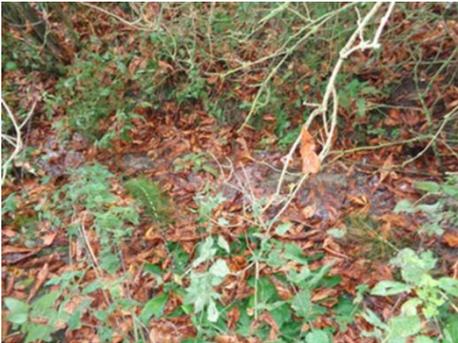
Ditch adjacent to the M20 balancing pond and perpendicular to Aylesford Stream (November 2015)

- 2.2.5 A ditch approximately 35m long lay perpendicular to the Aylesford Stream, and adjacent to the M20 balancing pond. The ditch was dry at the time of the River Habitat Survey³⁴, although a trickle of water was seen in November 2015. There is potential for water vole to use this on an adhoc basis, as part of the Aylesford Stream corridor.

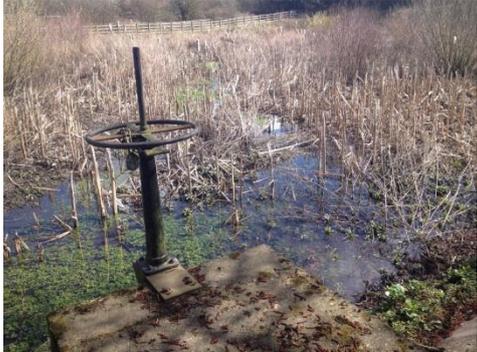
M20 balancing pond (April 2015)

- 2.2.4 The M20 balancing pond reed swamp was dominated by common reedmace *Typha latifolia* and common reed *Phragmites australis* common reed, with willow coppice growing through. The pond bed had silted over and was solid enough to walk on carefully in some parts. The aquatic habitat declined to a small channel of water through the middle of the reed bed approximately 50cm wide, although water mint *Mentha aquatica* clogged the channel as the year progressed. The pond has potential to provide foraging opportunities for water vole, but is not considered suitable nesting habitat as the reed was not sufficiently dense to provide cover from predators. The edges of the pond were concrete lined and not suitable for burrows.

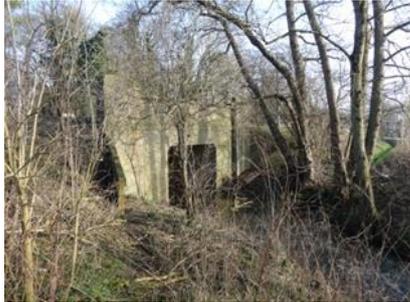
Description	Photo
Section of Stream between the M20 and A20 carriageways (April 2015)

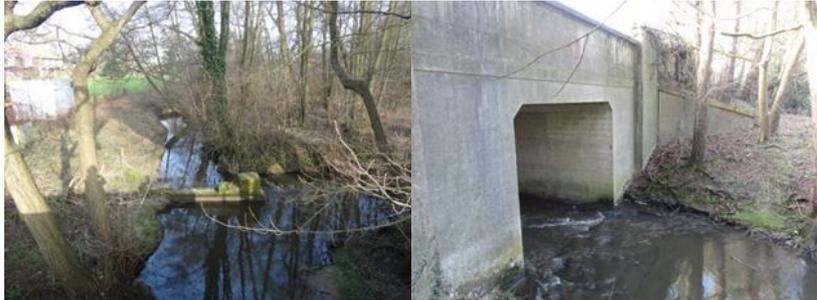
Stream to the north of the A20 Culvert (April 2015)

- 2.2.2 The depth of water is variable along the River corridor; with shallow and deep water in parts but averaging approximately 30cm deep. However, the water appeared deeper towards the Lacton Farm Culvert, with steeper bank profiles approximately 2m high.

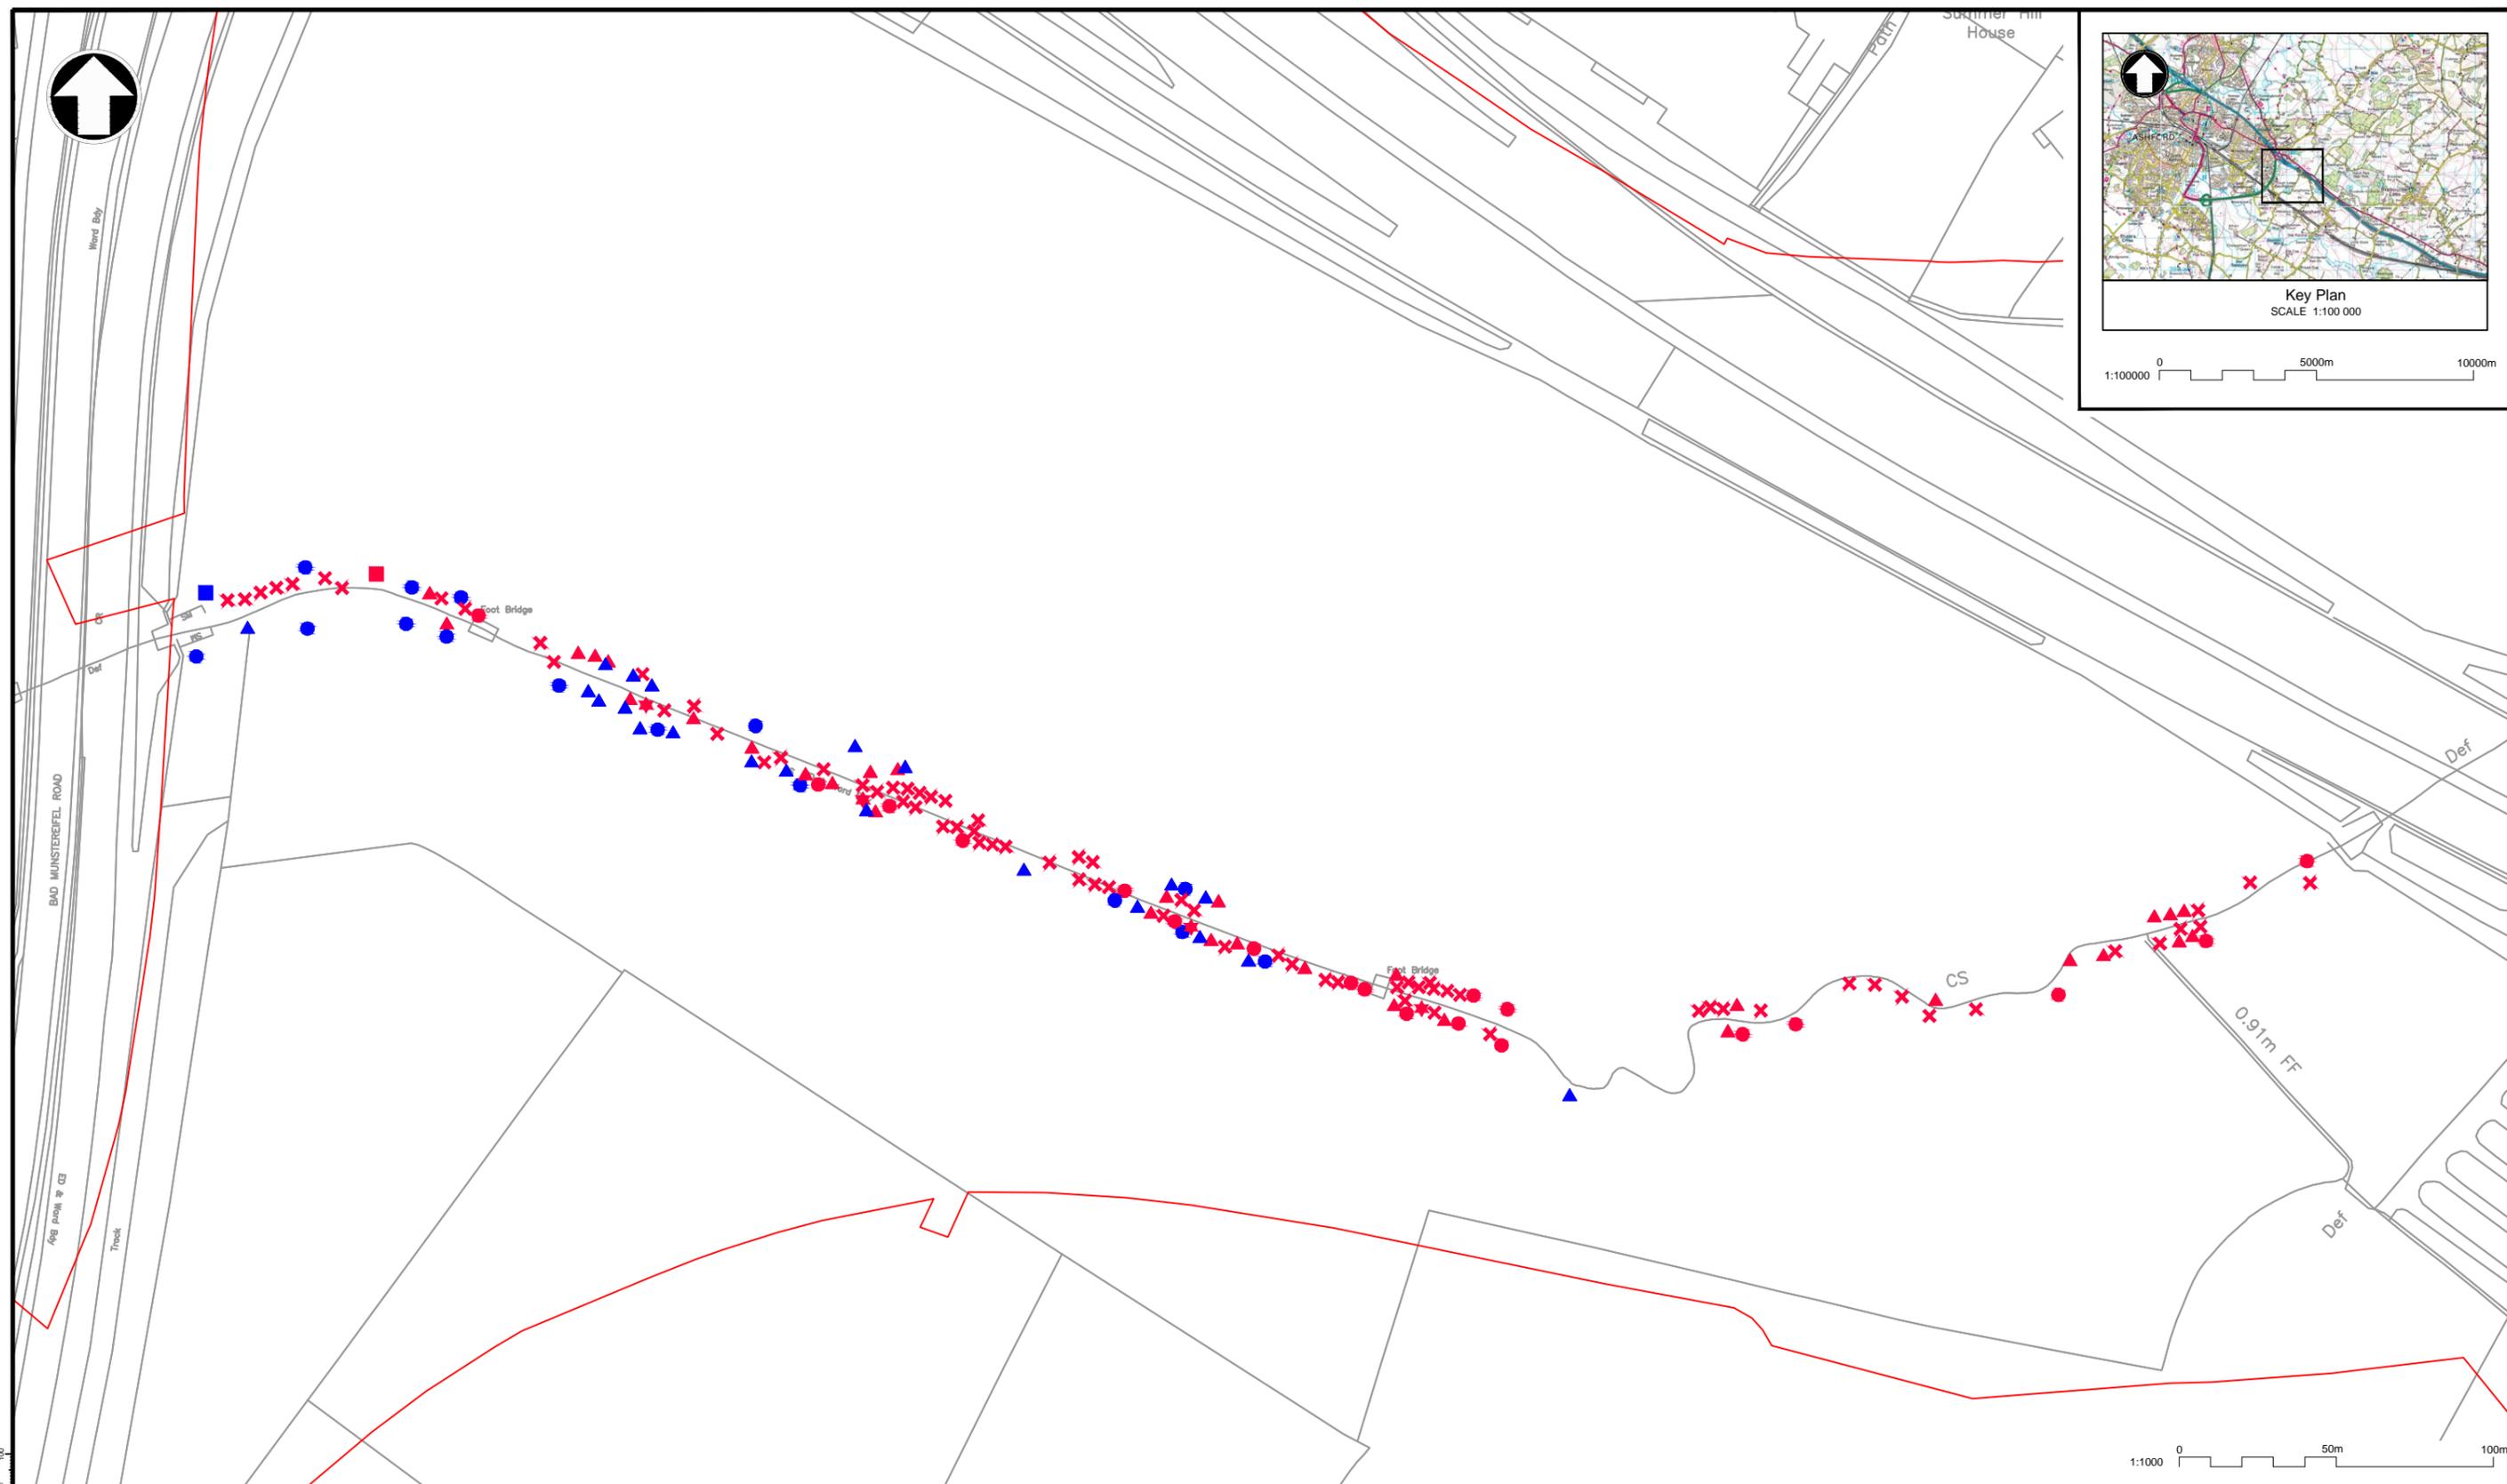
Appendix A. Survey Results

KEY:
WATER VOLE EVIDENCE IDENTIFIED

SEPTEMBER:	MAY:
▲ LATRINE	▲ LATRINE
★ FEEDING REMAINS	★ FEEDING REMAINS
● FOOTPRINTS	● FOOTPRINTS
× BURROWS	× BURROWS
■ RUN	■ RUN

- 3.1.1 During the first survey in May 2015, numerous burrows (85), latrines (28), footprints, feeding stations and runs through vegetation were recorded, both old and new, indicating water vole were active at the time of survey (see 0). Based on current guidelines as described in Table 2.3, the 28 latrines found along the 600m stretch between the M20 and A2070 give an average of 6 latrines per 100m, indicating a medium population density. No signs of water vole were observed along the stretch of the stream between the M20 and A20 Culverts. During a bat survey on the 1 July 2015, two water voles were observed foraging along the eastern end of the stream section.

- 3.1.2 The second survey, undertaken in September 2015, identified 21 latrines and 5 burrows along a stretch of the stream from the A2070 Culvert to approximately half way along the Stream within the study area. The remaining half to the east could not be surveyed as the overhanging tree branches and deep water areas prevented safe access. These results also suggest a medium population.
