A63 Castle Street Improvements, Hull Environmental Statement

CULTURAL HERITAGE – BASELINE REPORT

**TR010016/APP/6.3
HE514508-MMSJV-HER-S0-RP-LH-000010
4 September 2018**

Appendix 8.1 Baseline report

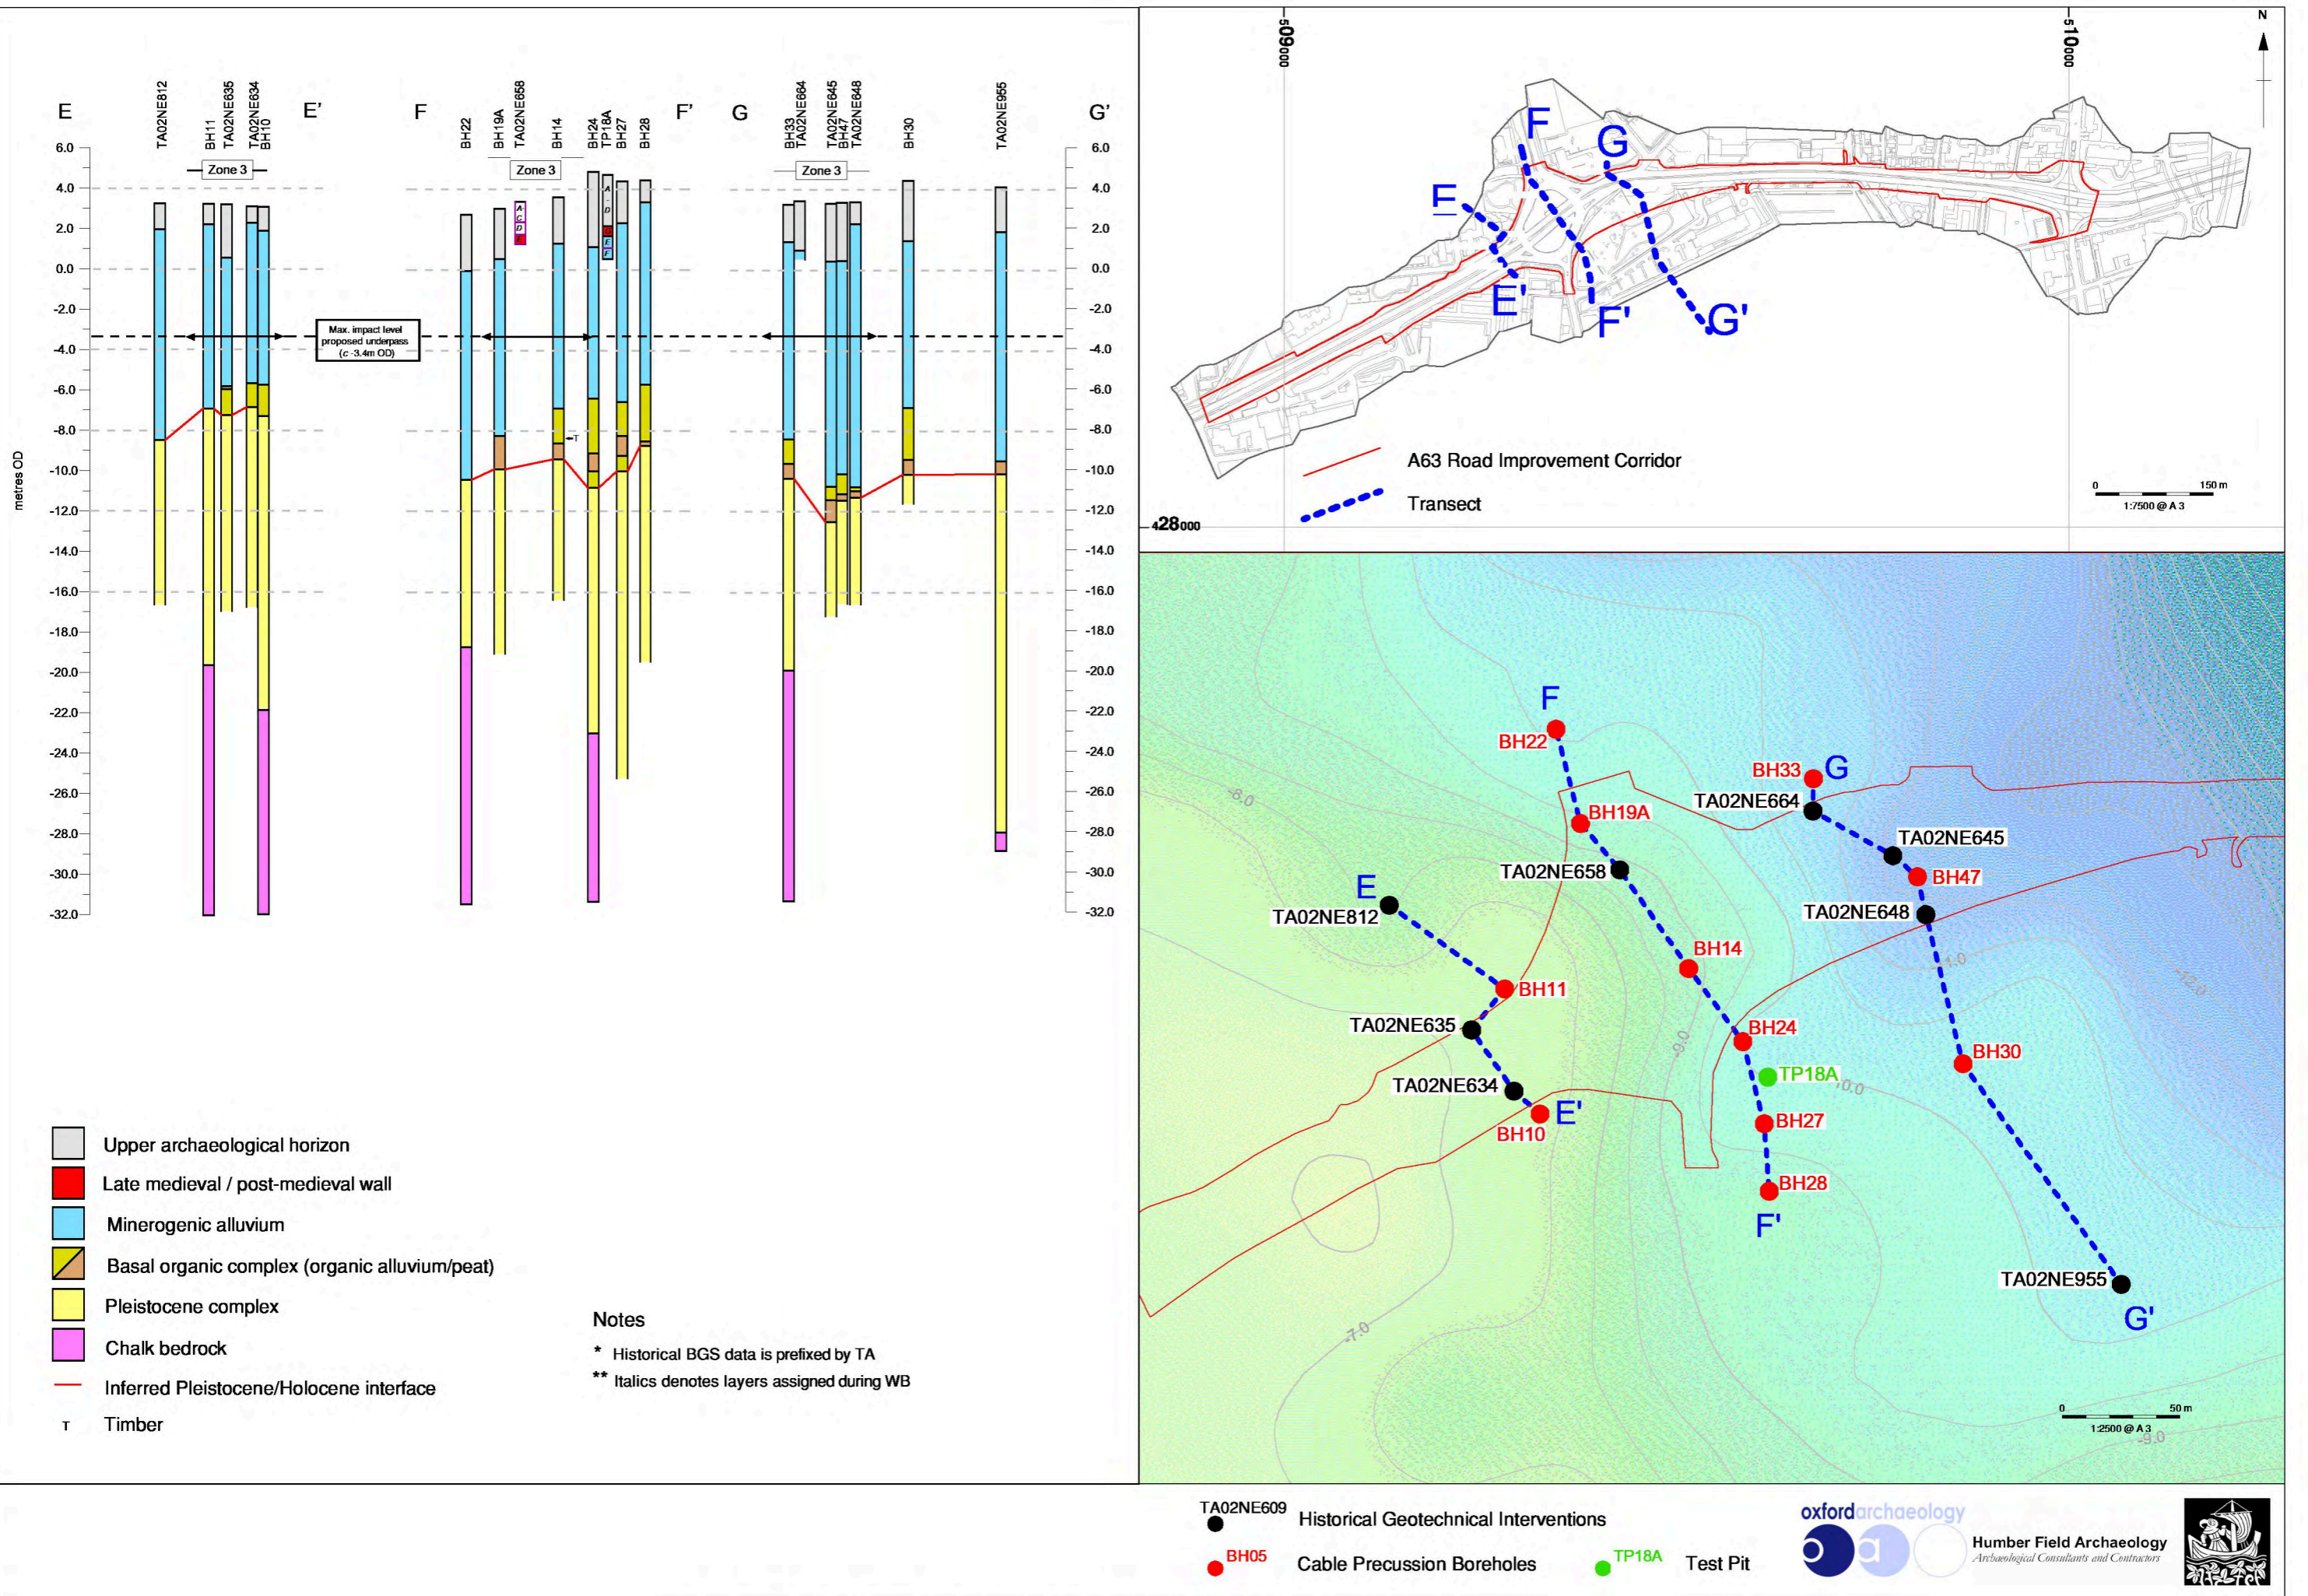
Figure 30: West/east borehole transect B-B', western part of the route

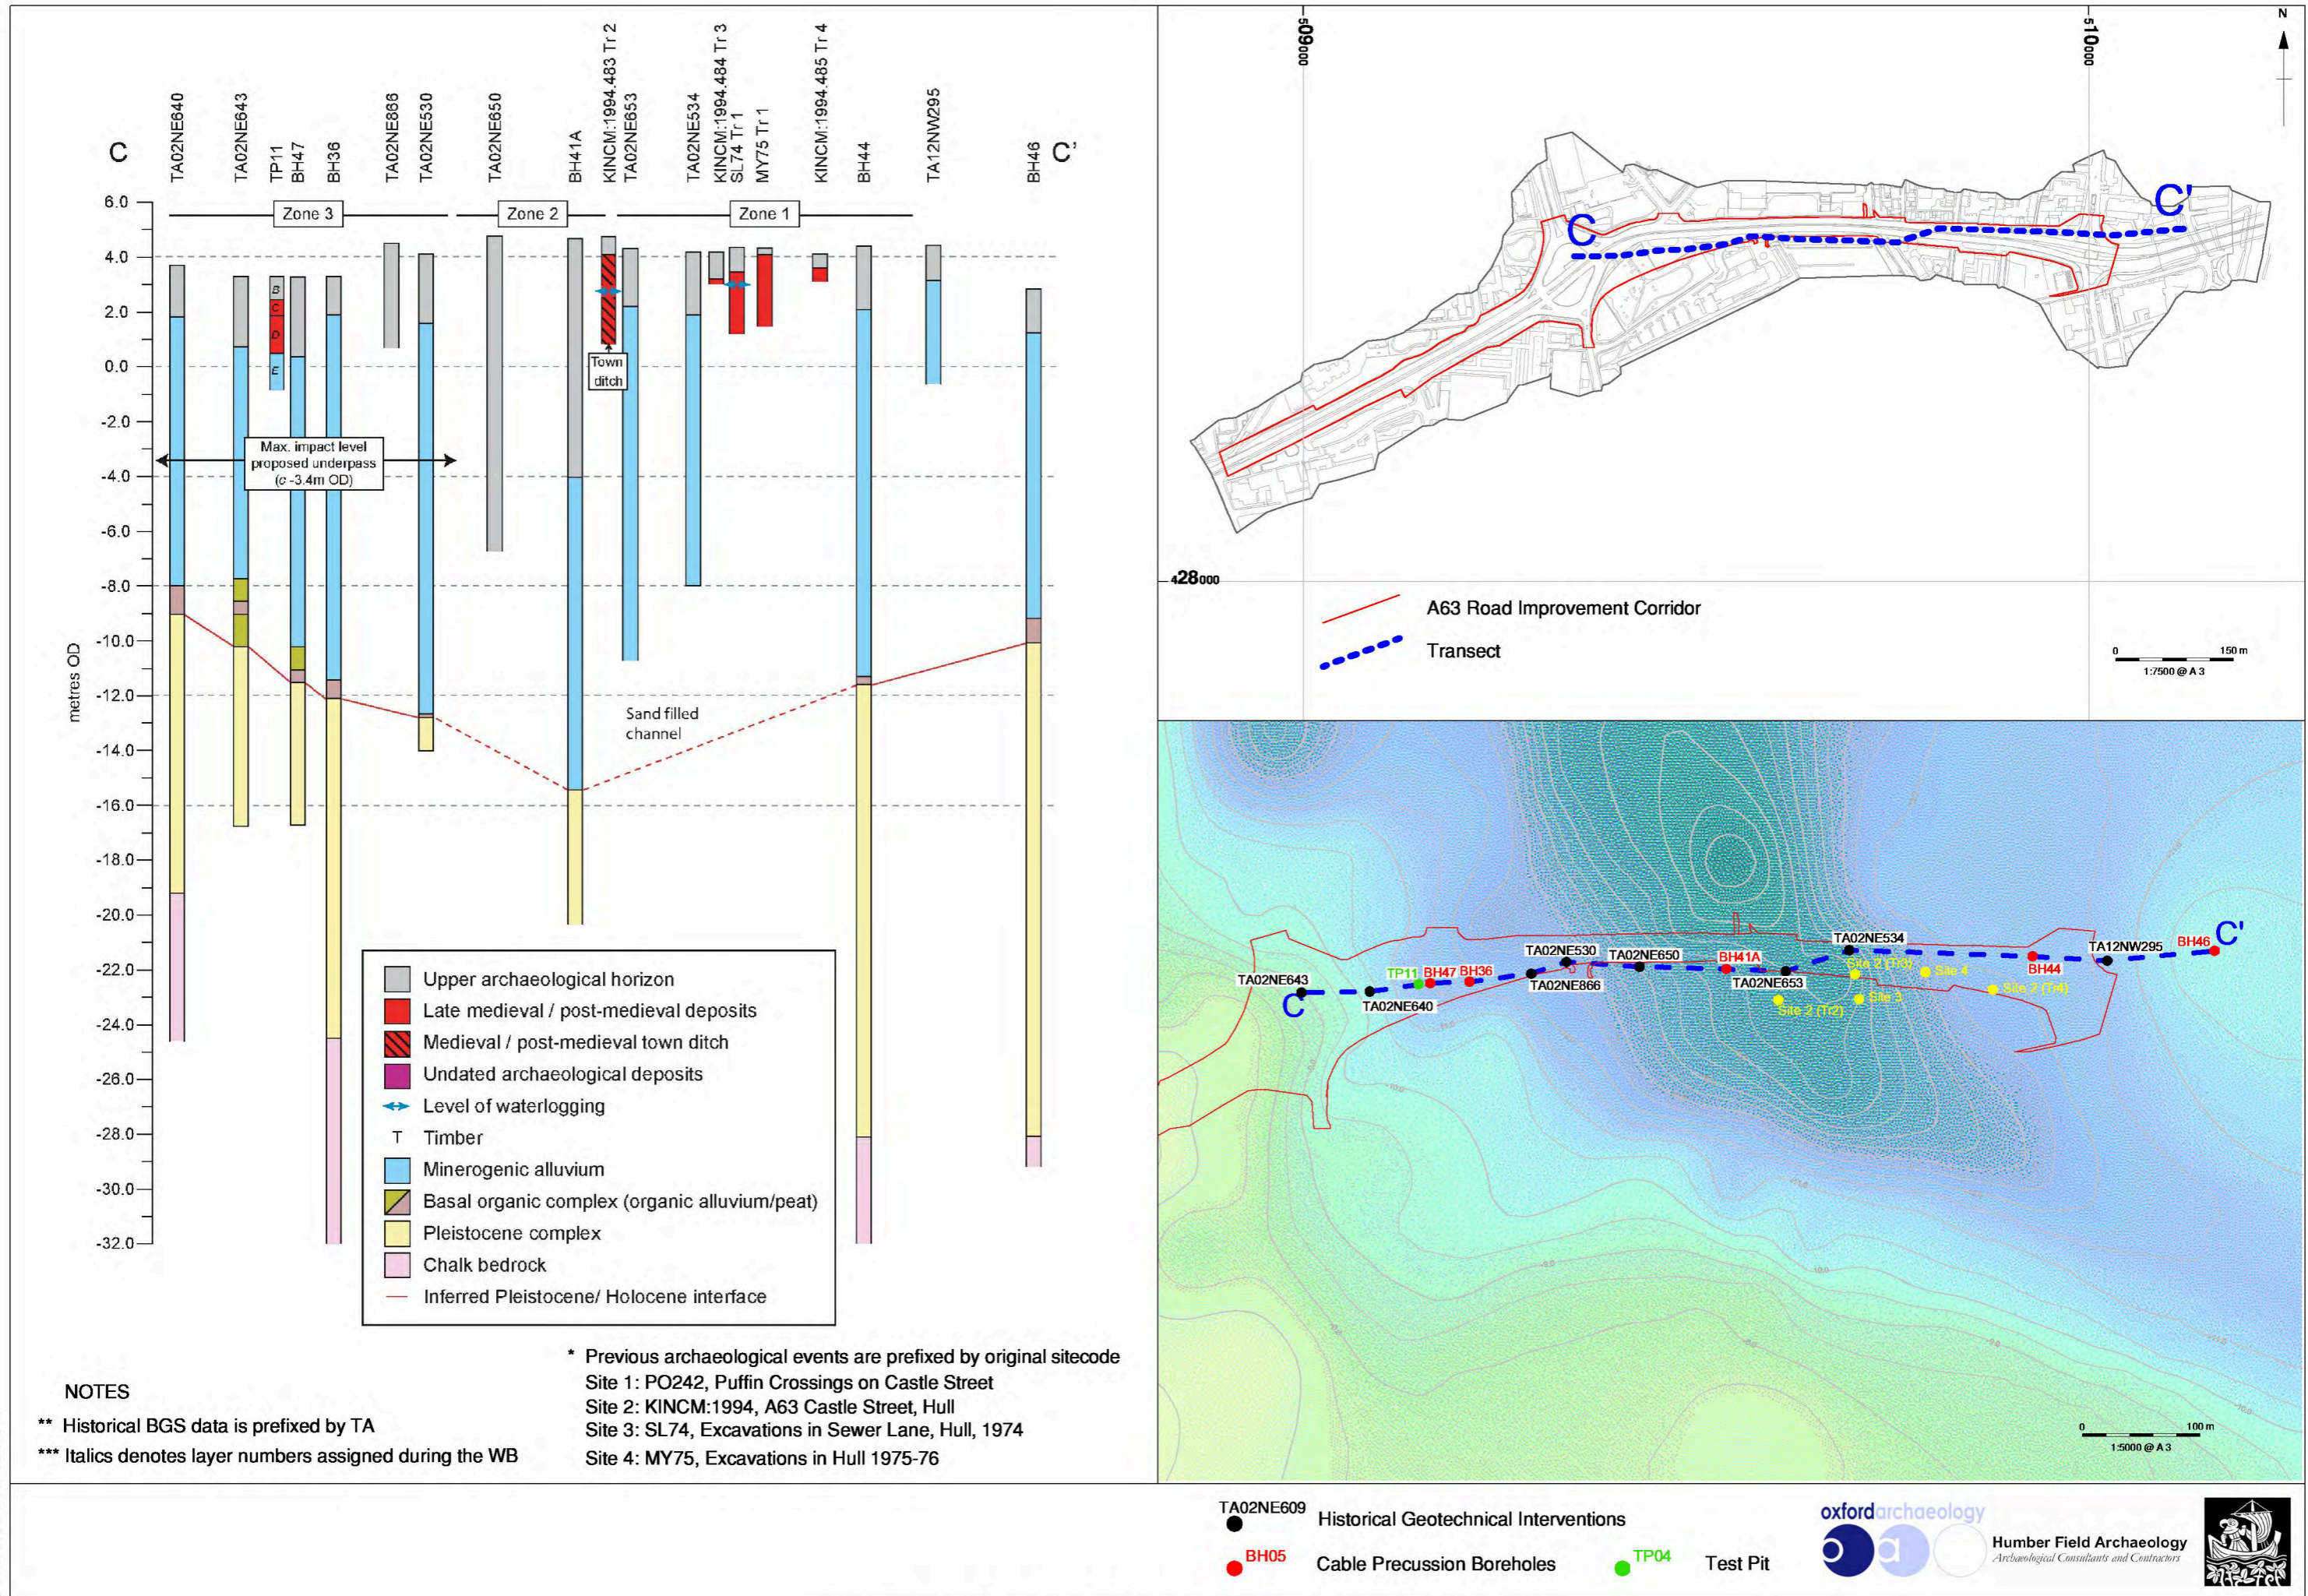
Figure 31: North-south borehole transects E-E', F-F' and G-G', central part of route

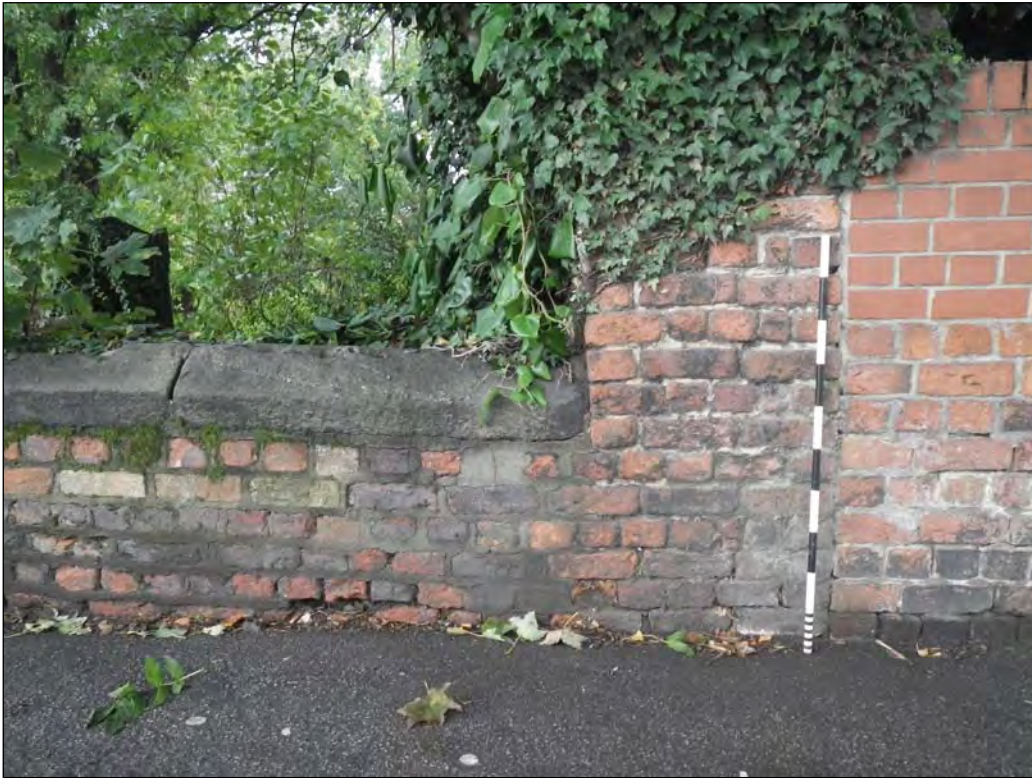
Plate 12: Detail shot of the west-wall buttress; note disturbed coping bricks on ground

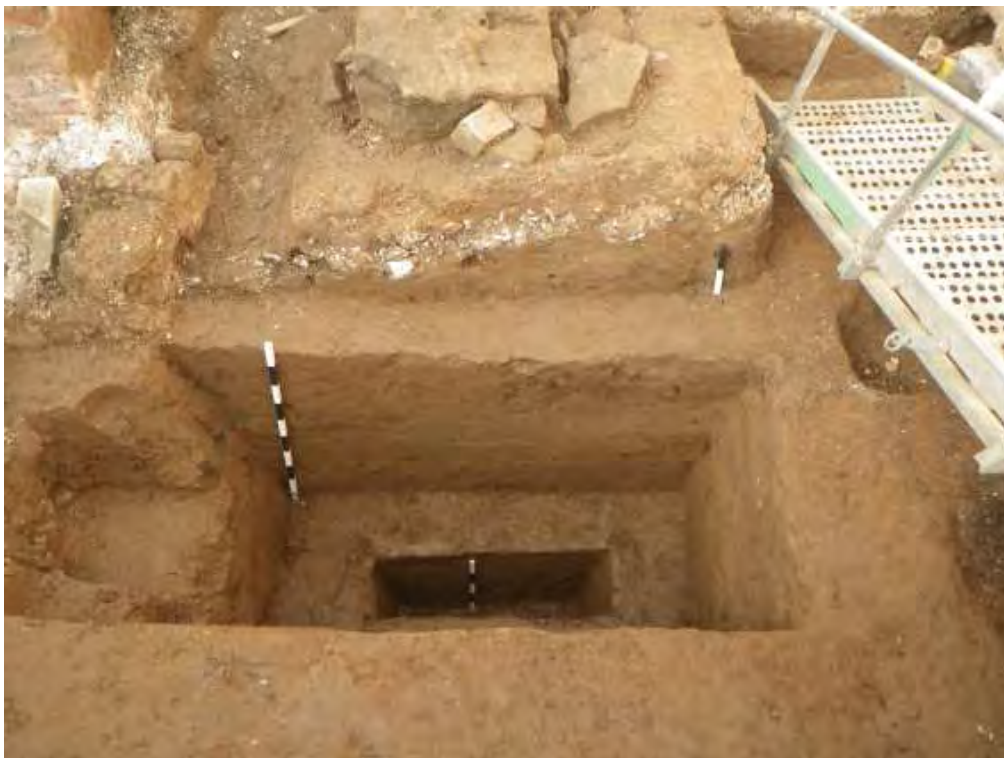
- 3.2.5 The wider sondage in the southerly trench extension saw an increase in the presence and visibility of deposits associated with the upper fills of the Town Ditch. Overlying the laminated silt sequence was **308/337**, a hardened deposit of heavily compacted silts with small pebble inclusions, up to 0.2m thick, found at 3.59m OD in the northern sondage and at 3.83m OD in the southern sondage, dropping to the south-east at 3.50m OD. This deposit may represent a deliberately laid surface capping the ditch fills at a point in time where the feature had silted up to such a degree that it was no longer reached by tidal inundation. A thin layer of sand (**307**), only 0.05m thick (at 3.53m OD), was found lying above **309** in the northern sondage.

Plate 3: Hand-dug sondages through the upper parts of the Town Ditch, looking north-west. The sequence of layers, from top to bottom, represents a post-medieval upper chalk consolidation layer, clay that possibly derives from the slighted rampart, below which is the darker line of an indurated surface laid on the upper medieval ditch fills, which themselves appear as fine, clean silt laminations. At the top (left) of the photo are the partial remains of a post-medieval brick wall which cuts into the upper chalk consolidation layer

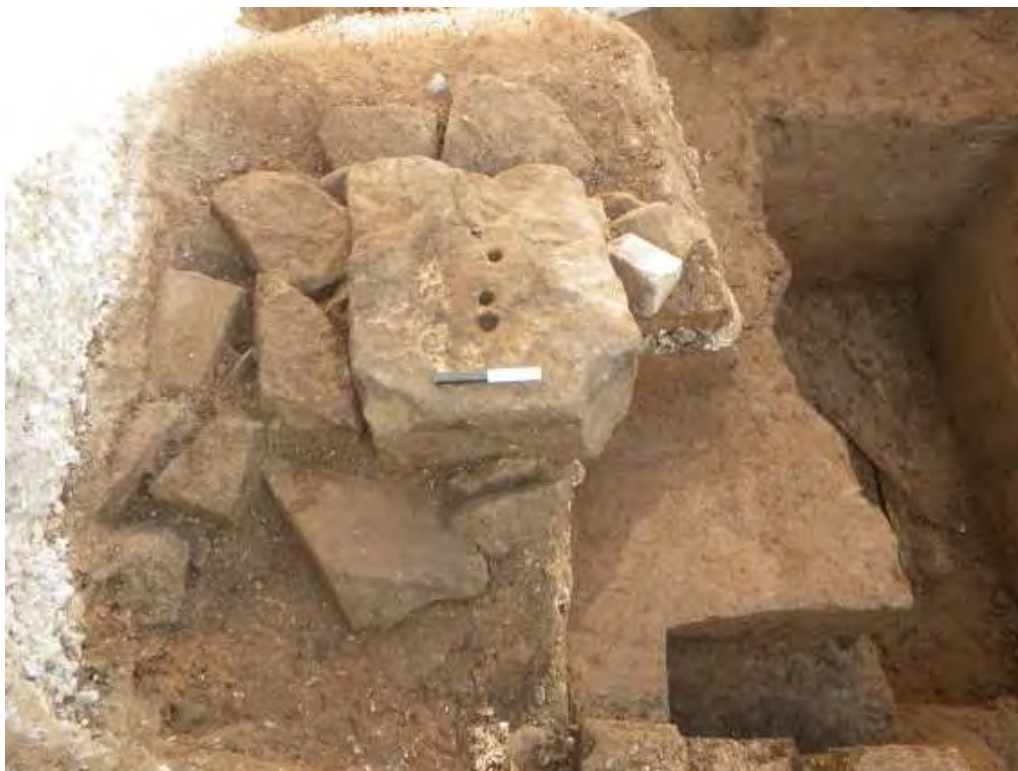
cut was a rough-hewn block of limestone or sandstone (**320**). The block measured 640mm x 620mm x 280mm, roughly squared with a series of four, off-centre, 25mm-diameter and 35mm-deep drilled holes set across the top, in a line; the top of the stone foundation was at 4.52m OD. The north-eastern hole had what appeared to be the remains of a sheared-off bolt or similar left *in-situ*. The backfill of the foundation, **319**, consisted of broken fragments of limestone, some partially faced, mixed within a dark grey/brown clay silt matrix.

Plate 4: The nineteenth-century derrick base, looking north-east

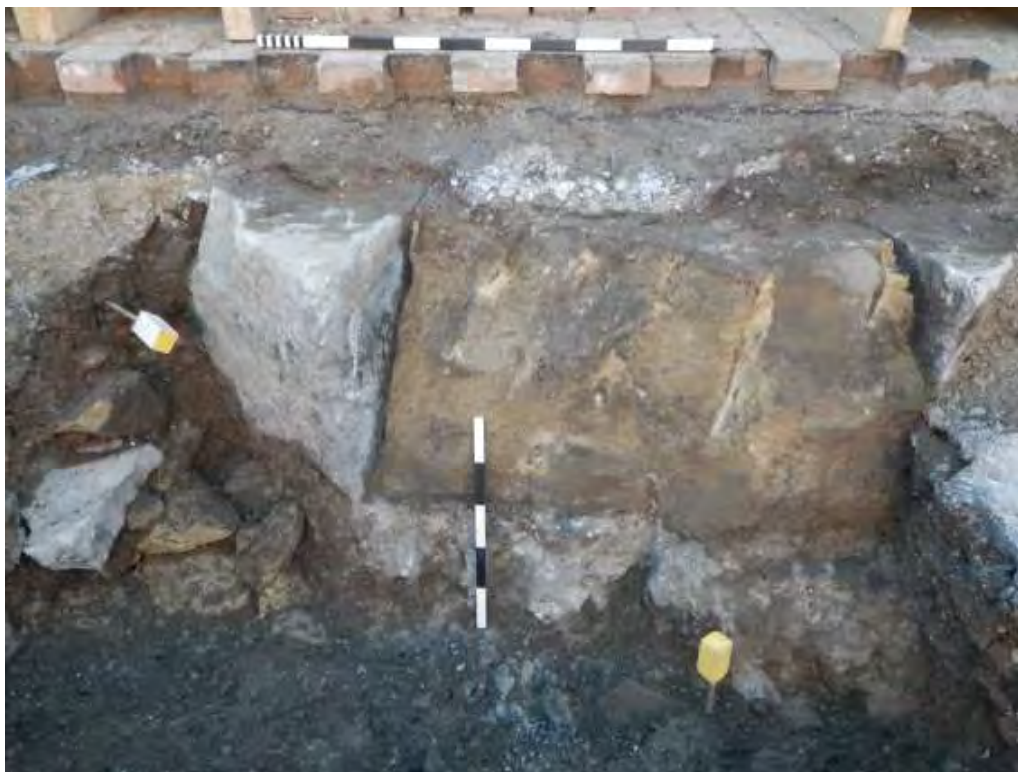
blocks. It is likely that these broken stone fragments originate from the original masonry upper levels of the dock, and were demolished as part of the re-build.

Plate 5: Late nineteenth-century reconstruction of the dock upper stonework sat on concrete; looking south-west

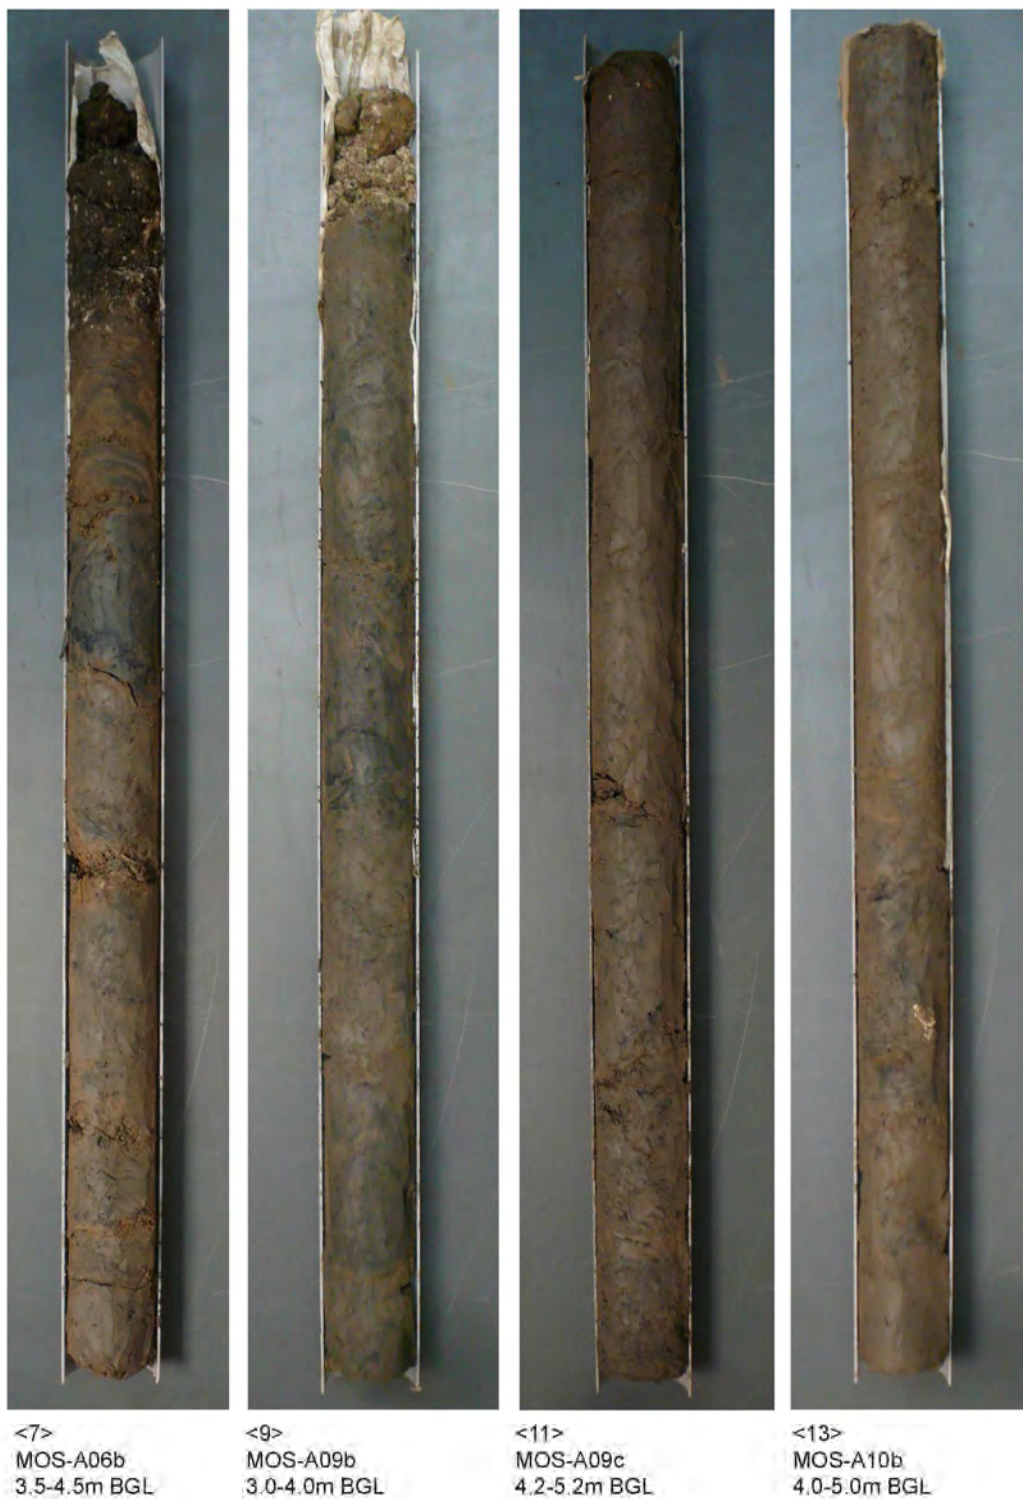
Plate 7: Representative deposits within MOSTAP samples

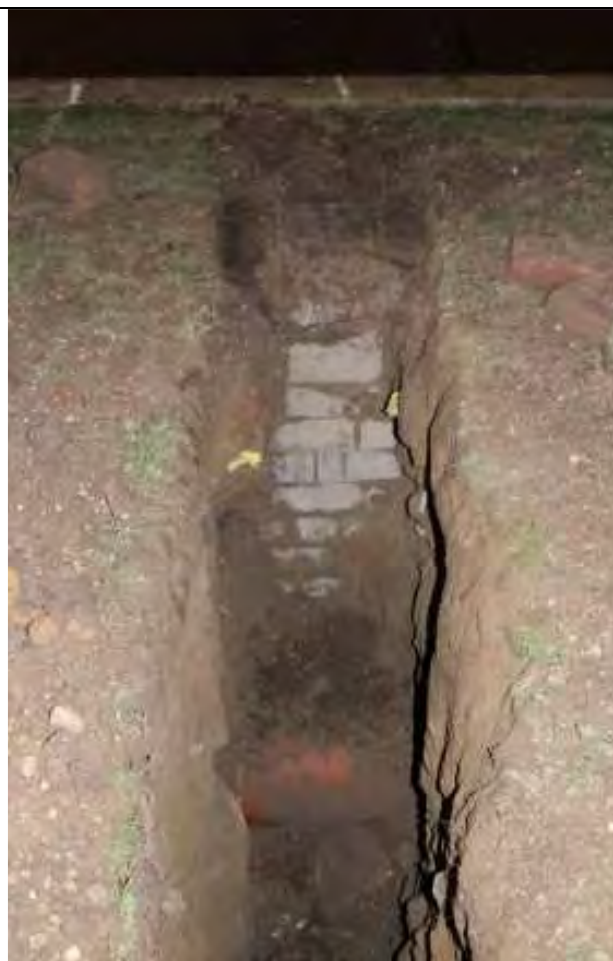
Photo: Wall in the northern end of trial pit 12

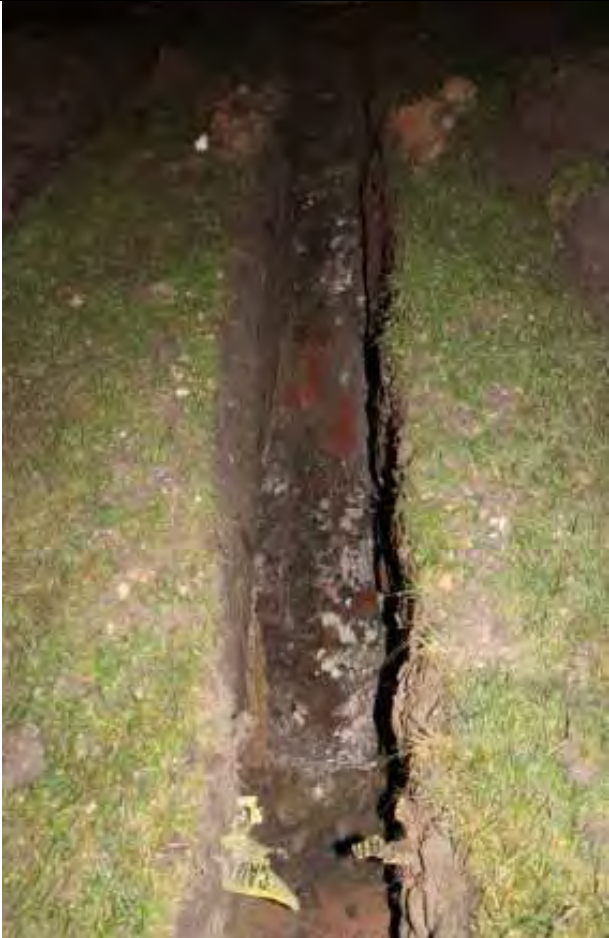
S6: southern part (OA-HFA Trial Pit 13)	Time and Date: 9/12/2015 11:30pm – 11:59pm 10/12/2015 00:00am – 1:30am
Location: within landscaped area to north of Humber Dock	Observed: A Batey Dimensions: 6m long, 0.4m wide, and 1.2m deep
Depth:	Sediments:
0 – 0.2m	Friable, greyish-brown sandy-silty-clay topsoil. The same wall as in trial Trench 12 (S4) is visible in the north end of this trench
0.2 – 0.5m	Firm, greyish-brown, slightly silty-clay subsoil
0.5 – 1.2m	Made ground and rubble. The wall was still visible in the north end of the trench, although it was in poor condition. A brick surface was visible in the south end of the trench, and it extended for about 2m from the south end of the trench
End of trial pit at 1.2m	
Images: Plate 0: Damaged brick surface at base of Trench 13

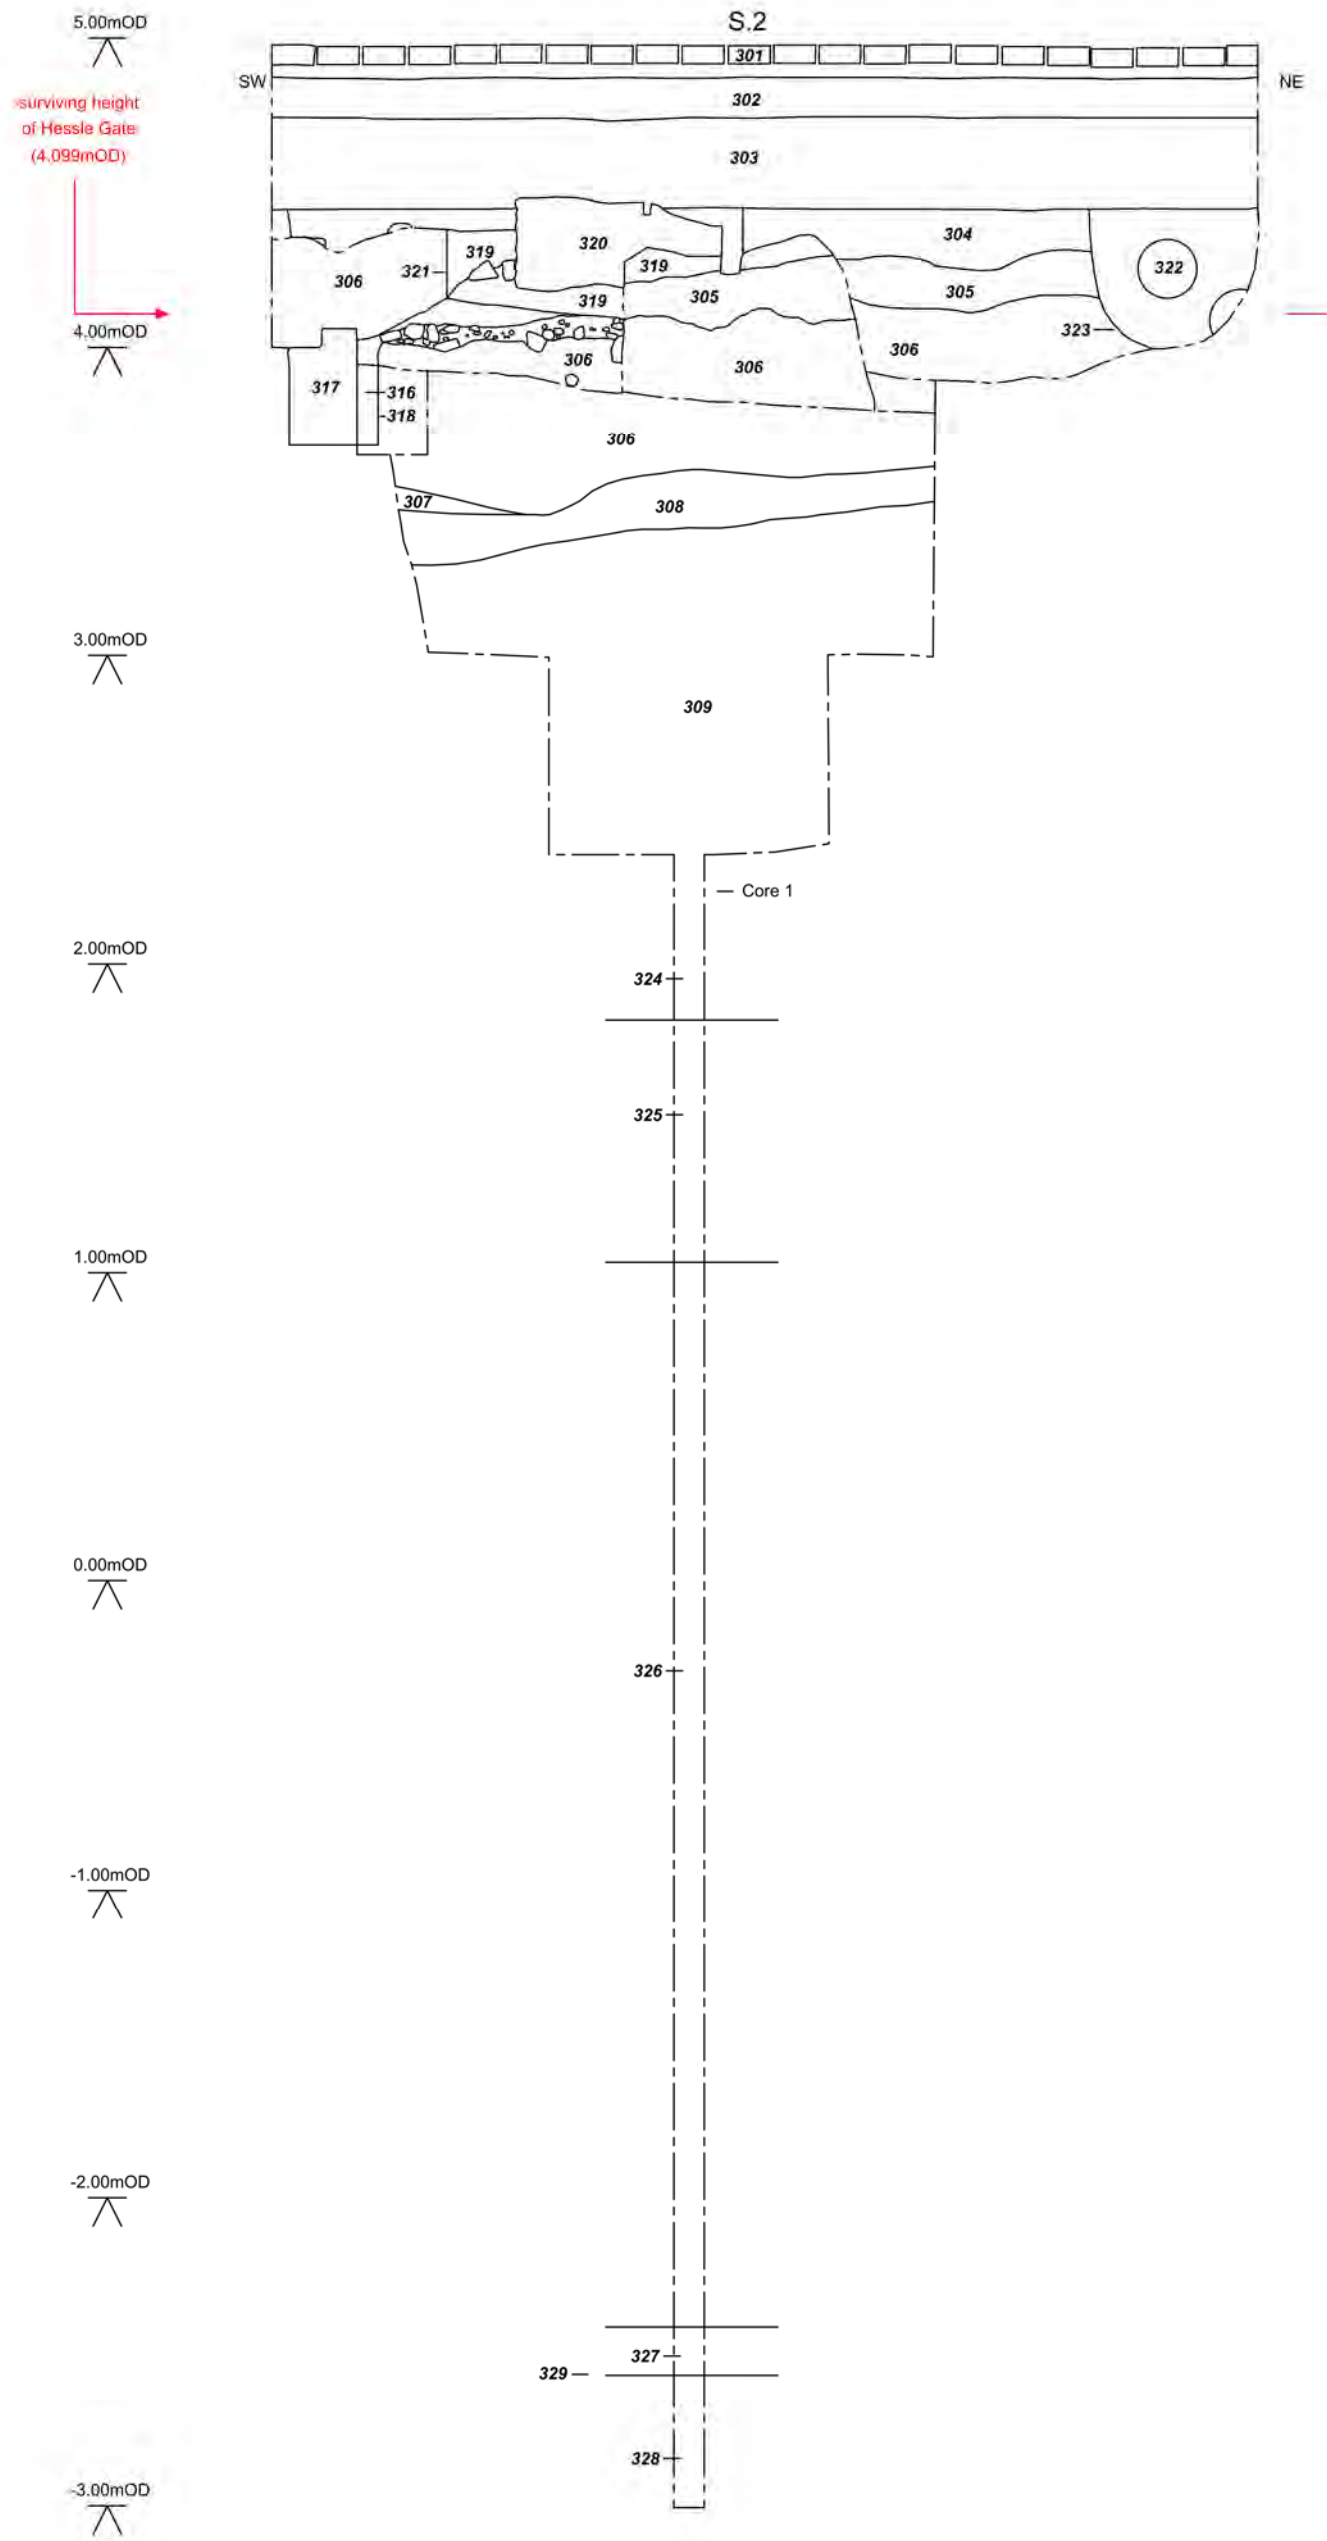
Figure 4: Composite profile of Trench 3 (southern trench) showing dock reconstruction cut, slighted rampart deposits and town ditch sequence

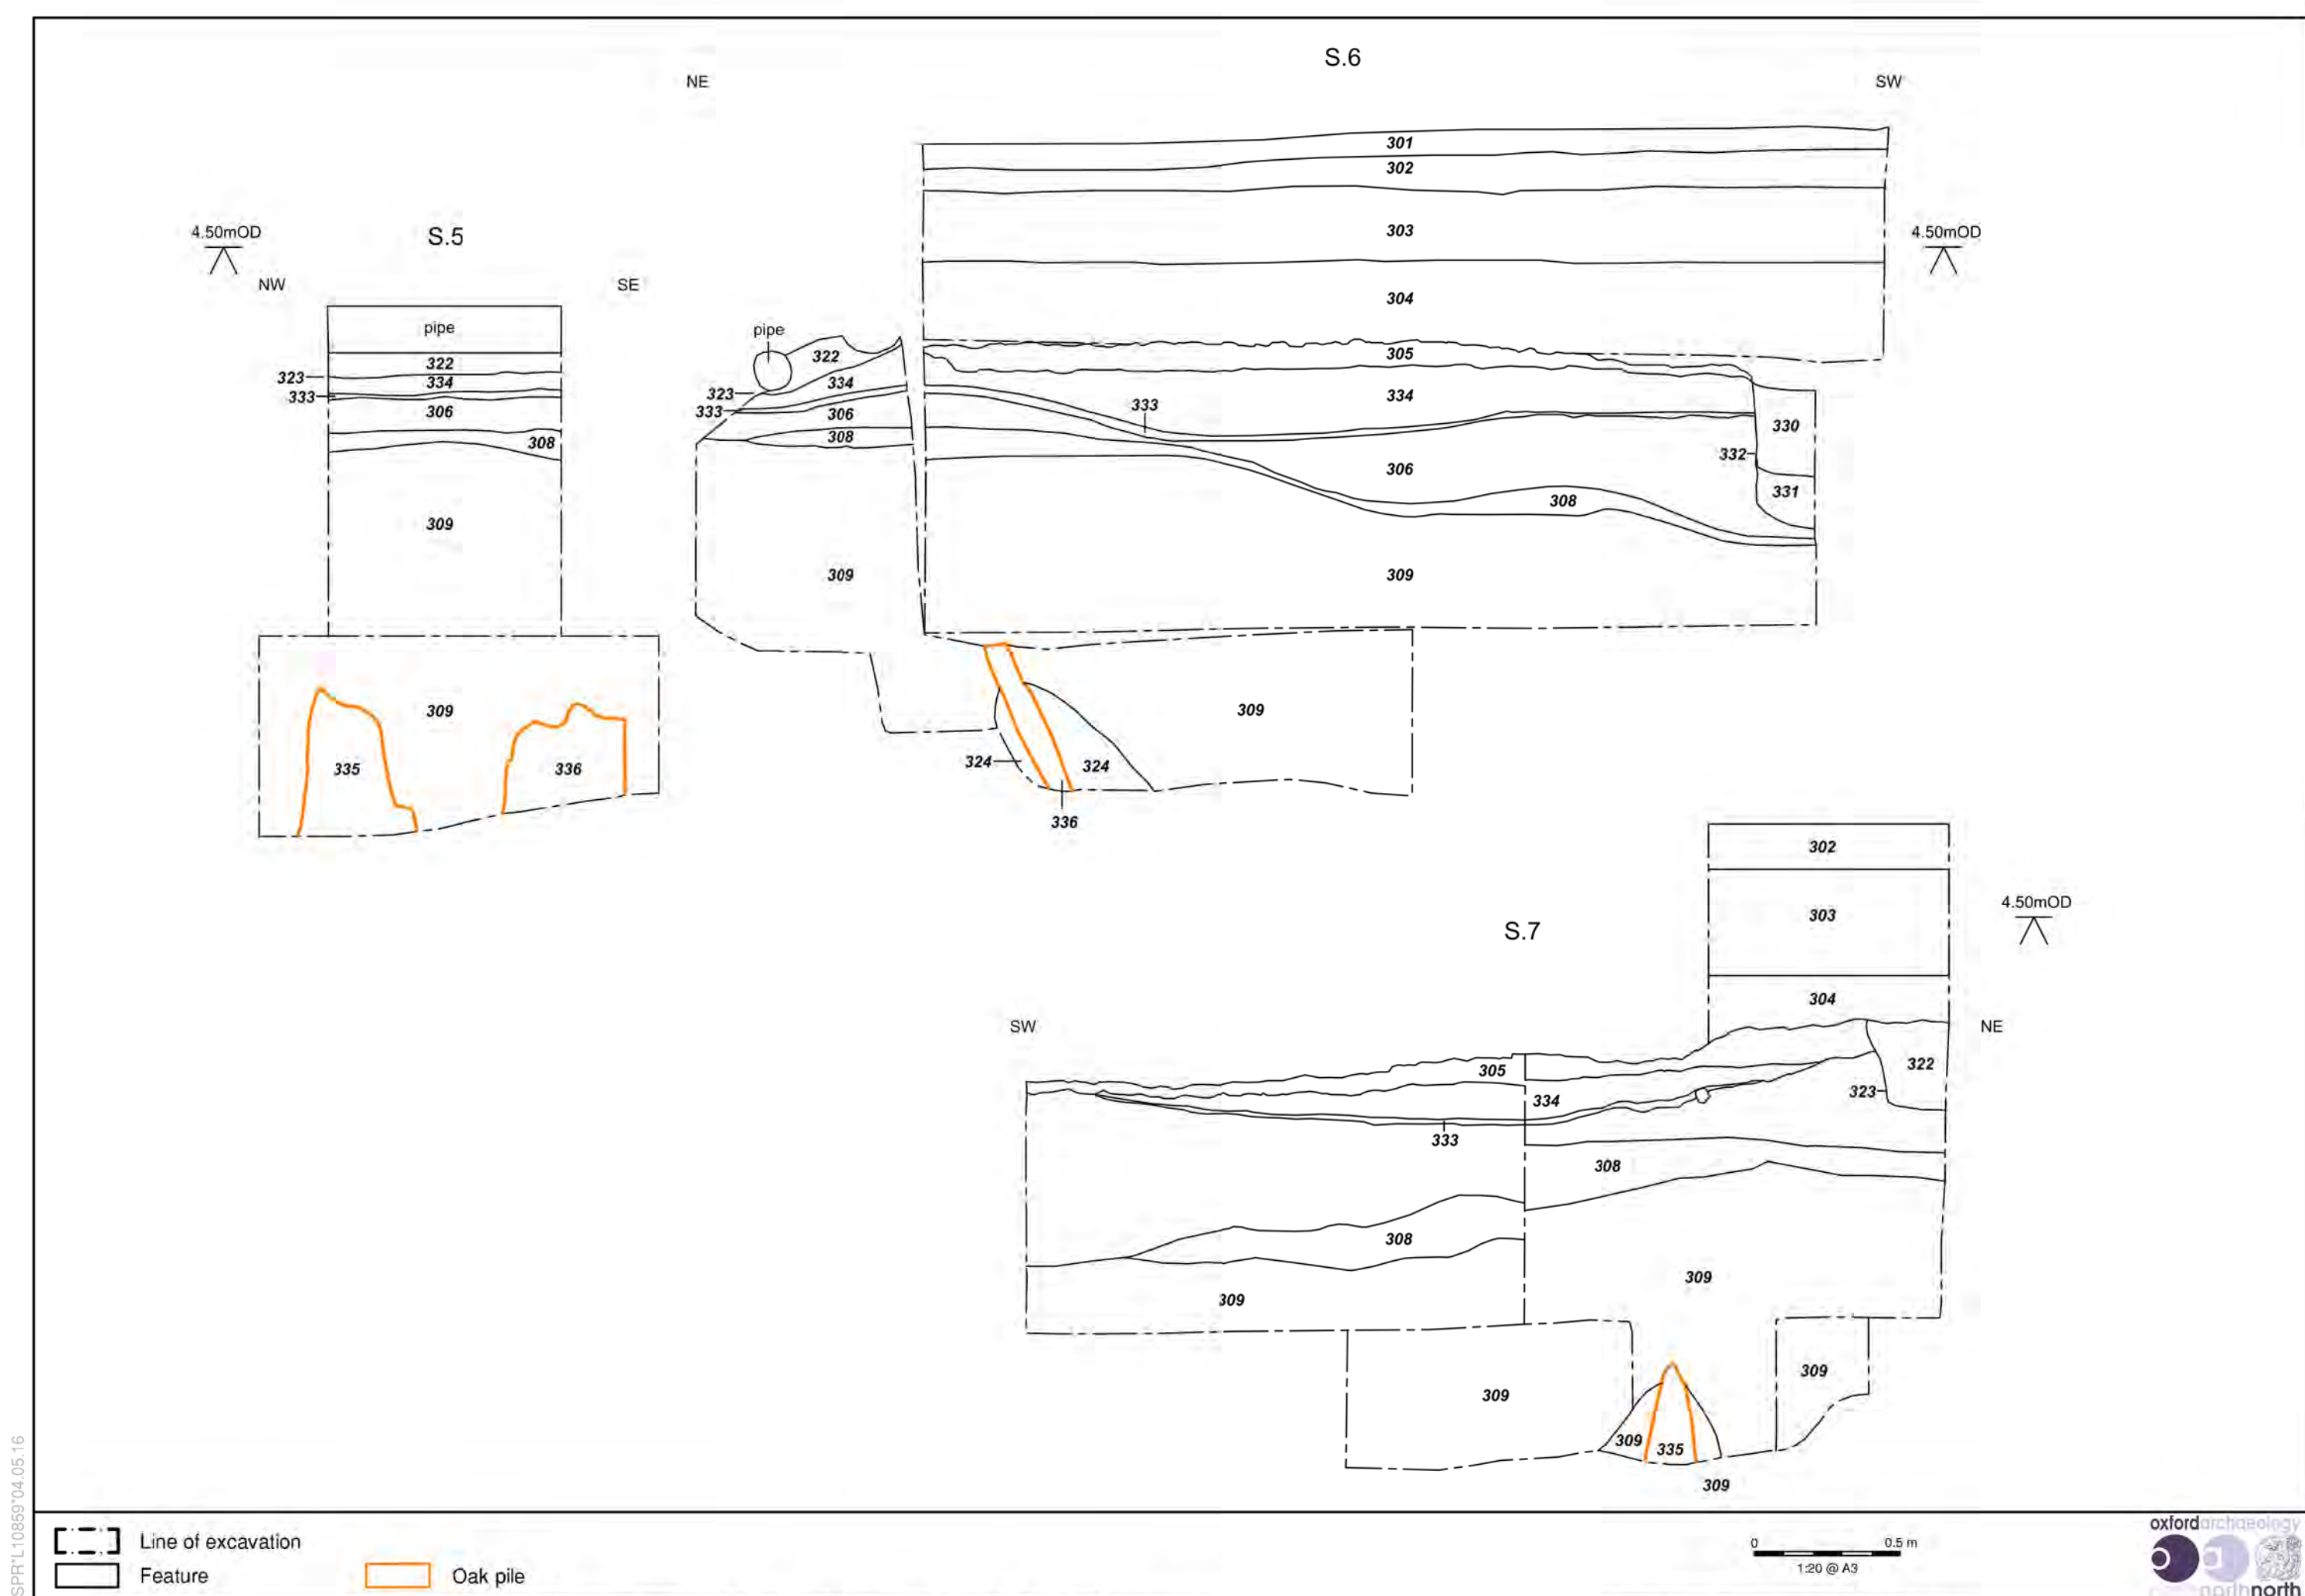
Figure 5: Composite profile of Trench 2 (southern trench) showing post-medieval and nineteenth-century features above slighted rampart deposits and town ditch sequence
