A63 Castle Street Improvements, Hull Environmental Statement

CULTURAL HERITAGE – BASELINE REPORT

**TR010016/APP/6.3
HE514508-MMSJV-HER-S0-RP-LH-000010
4 September 2018**

Appendix 8.1 Baseline report

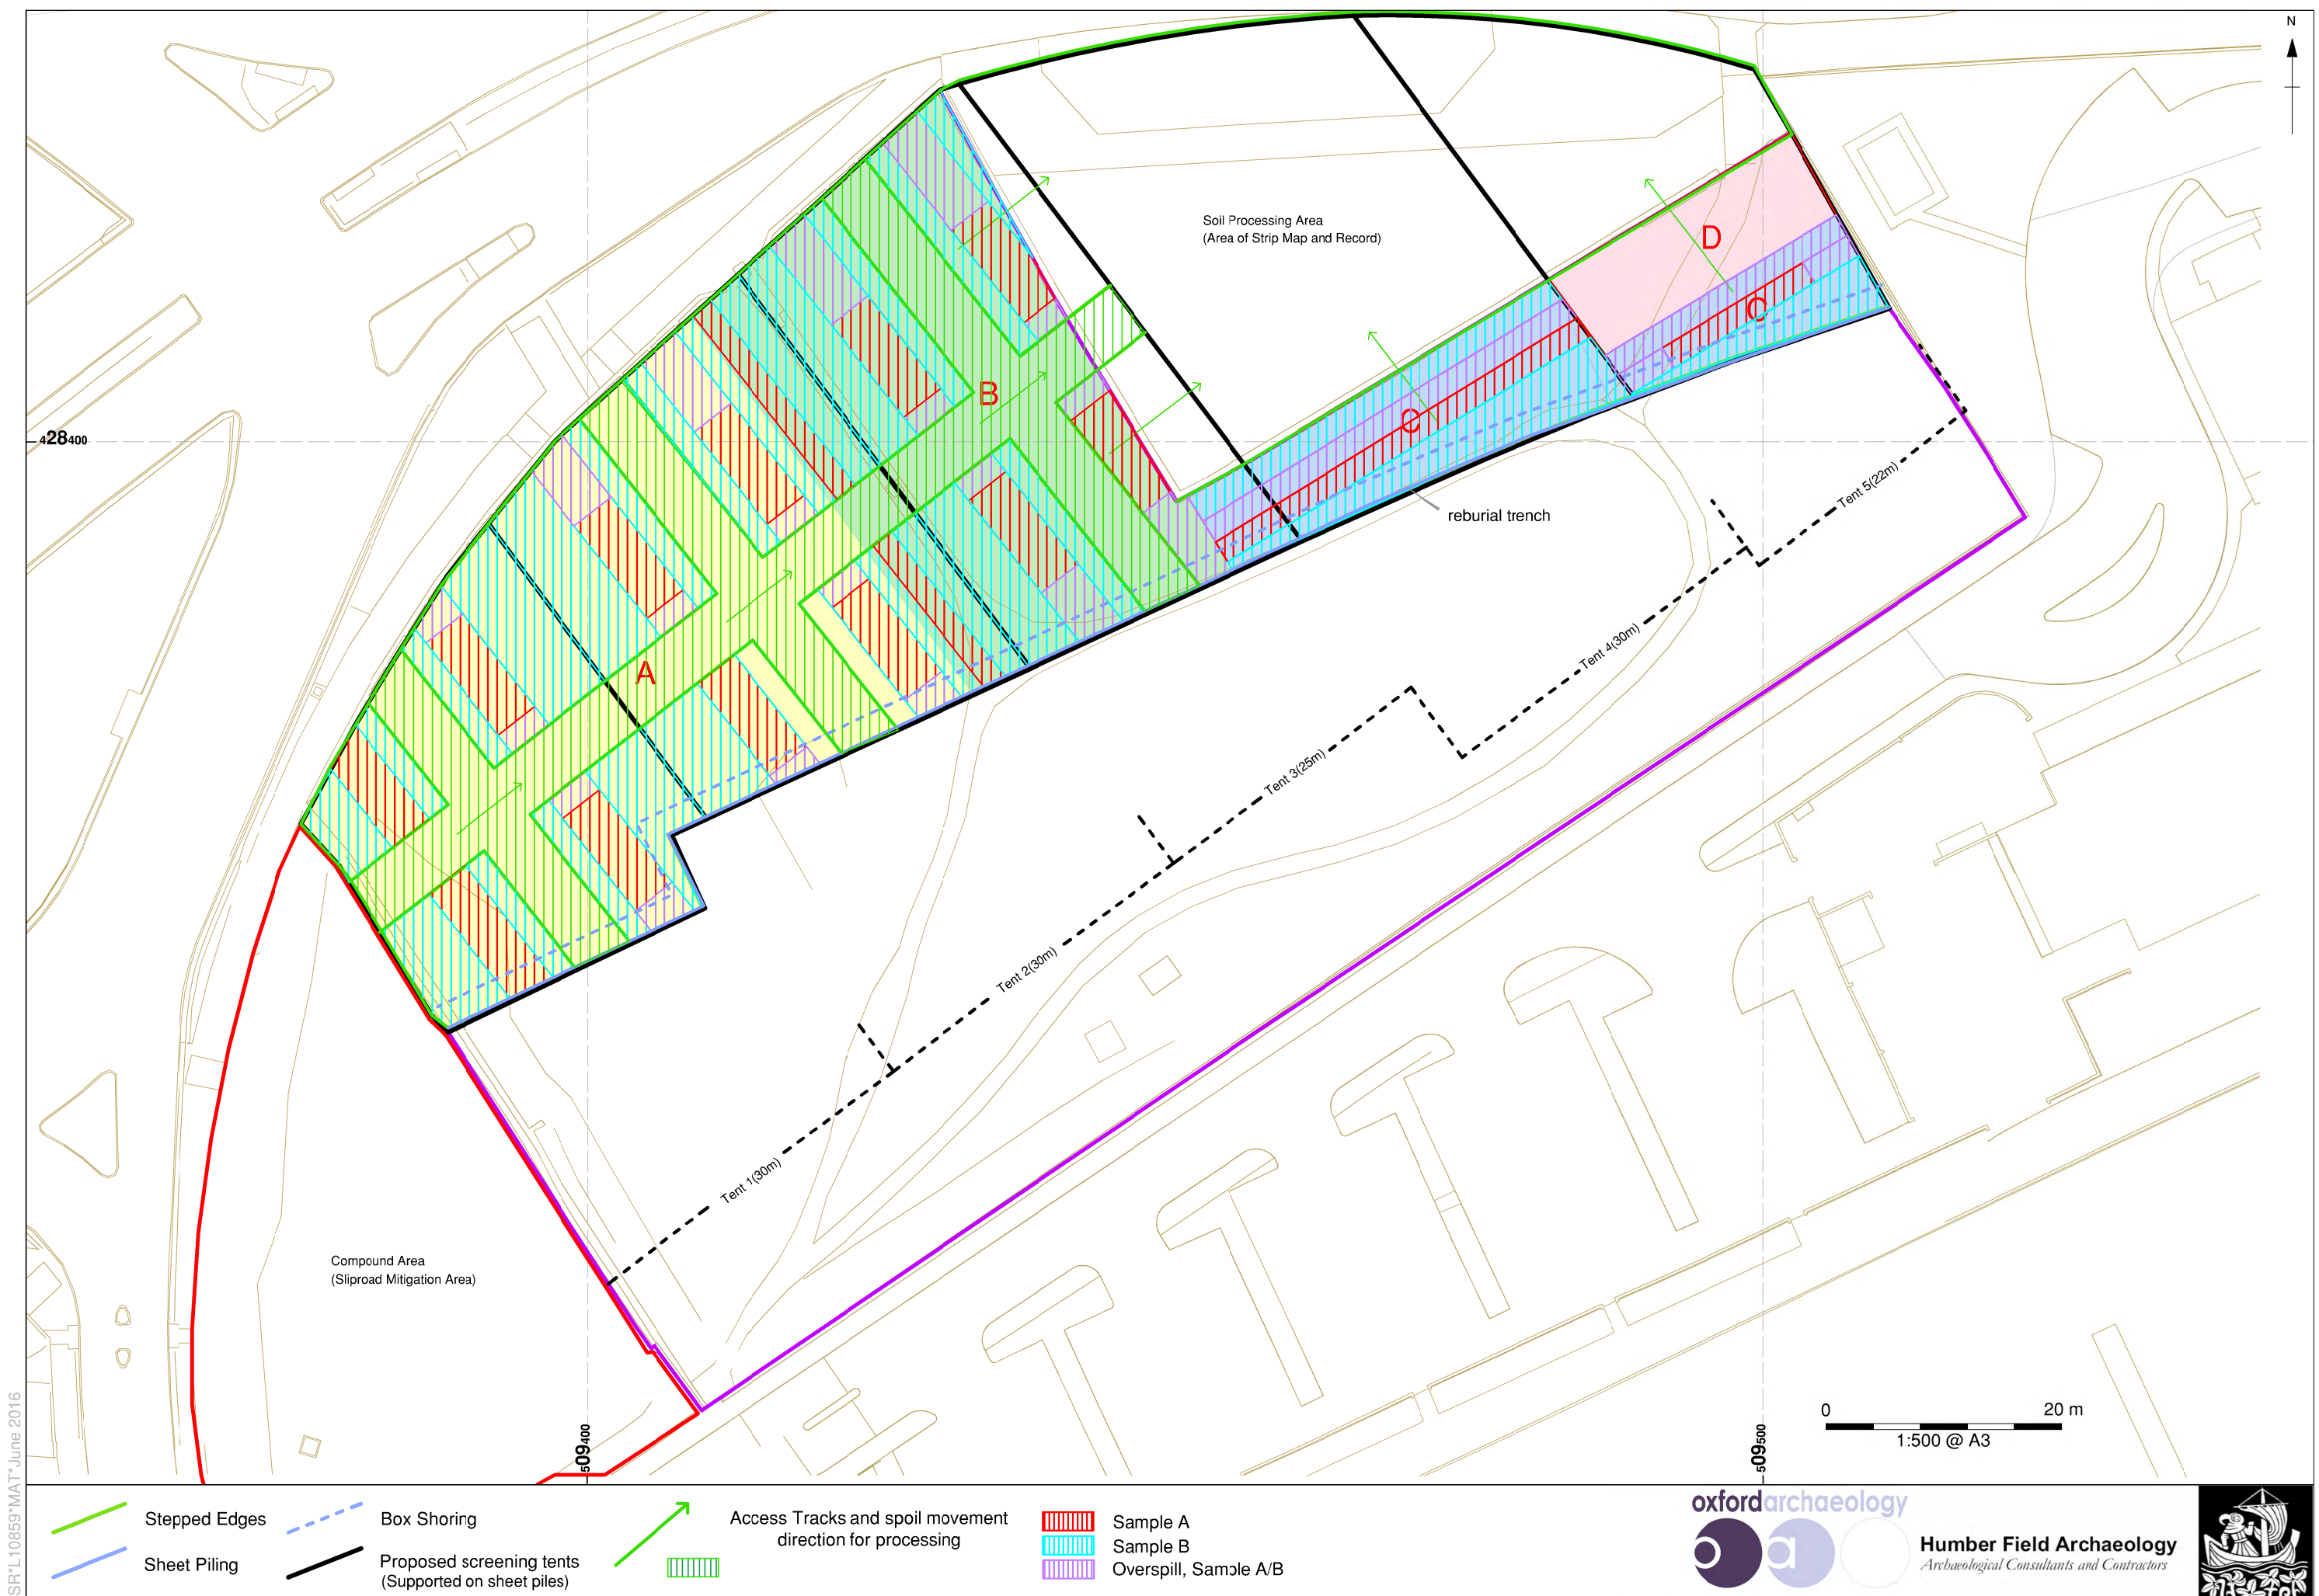
Figure 3: Plan showing proposed screening tent layout

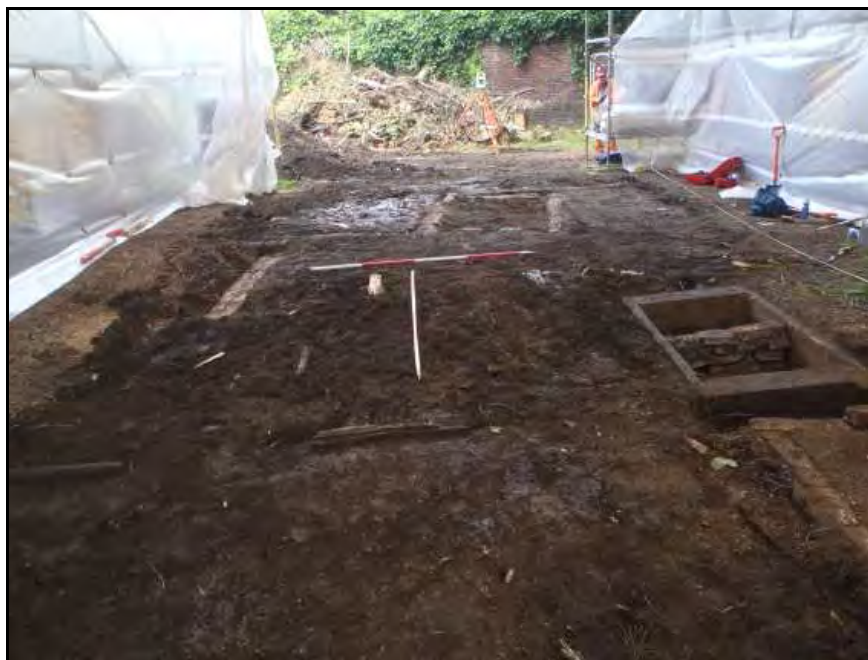
- 5.3.3 During the course of removing the topsoil, two further brick-built vaults were revealed; tomb **3007**, within the south-eastern half of the trench and at a slight angle to its neighbours and tomb **3006**, partially revealed extending from the northern limit of excavation (Plate 12). In addition, an array of memorial furniture, including kerb stones (**3005**, **3013**, and **3011**) and the substantial footing of a headstone (**3012**), were revealed within the north-western corner of the trench, while several basal fragments of headstones were recorded towards the centre (**3004**), and protruding from the southern limit of excavation (**3009** and **3010**). Collectively, these burial monuments displayed evidence of the rows that had been set out within this part of the burial ground. Gravestone stubs **3004** and **3009** were in the same row, and aligned with the western (head) end of the Holme family ledger, but also with the eastern (probable foot) end of kerbstone **3005**. Headstone **3012** shared the alignment of the western end of vault **3006**.

Plate 12: Trench B with the various red brick-built tombs exposed at or just below ground level, and the sandstone box support for ledger 1179 visible to the centre right. Viewed facing east

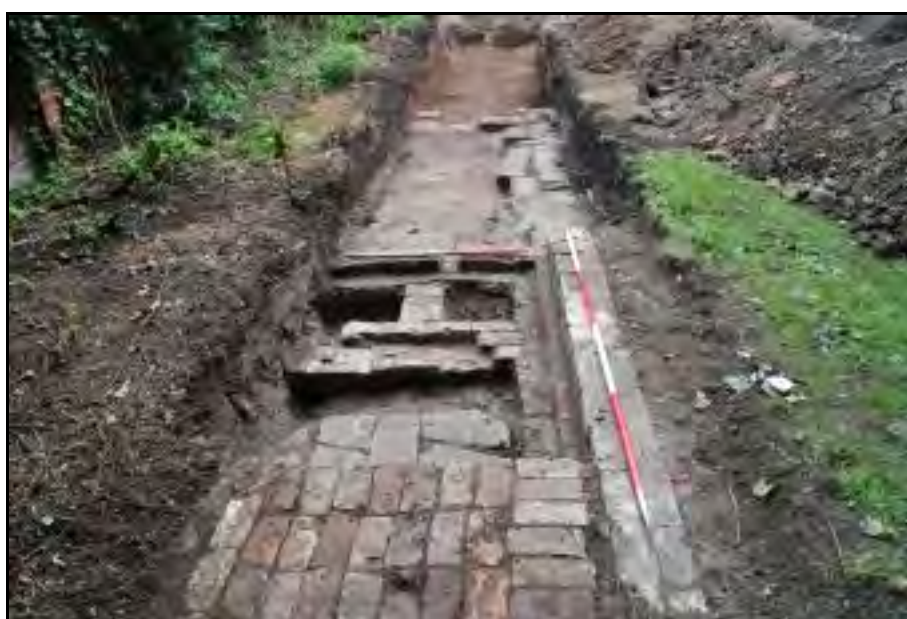
5.5.1 Trench D was excavated in the north-eastern corner of the burial ground, immediately west of the main entrance. It measured 13m east/west by 2m north/south and was excavated to a maximum depth of 1m. Overburden deposits comprised a variable, but relatively thick topsoil, between 0.1m and 0.6m deep, directly overlying structural features or demolition and backfill deposits within the western end of the trench (Fig 13; Plate 18). In the eastern half of the trench the topsoil overlay levelling and consolidation deposits associated with the modern path, giving access to the burial ground from the main entrance, but otherwise directly overlay a clean medium brown sandy clay natural layer (5028). Within this area there were no signs of burial activity and the only human skeletal remains to be recovered from the trench amounted to a single finger bone incorporated within demolition layer 5009.

Plate 18: General view of Trench D. Viewed facing east with floor 5001 in the foreground

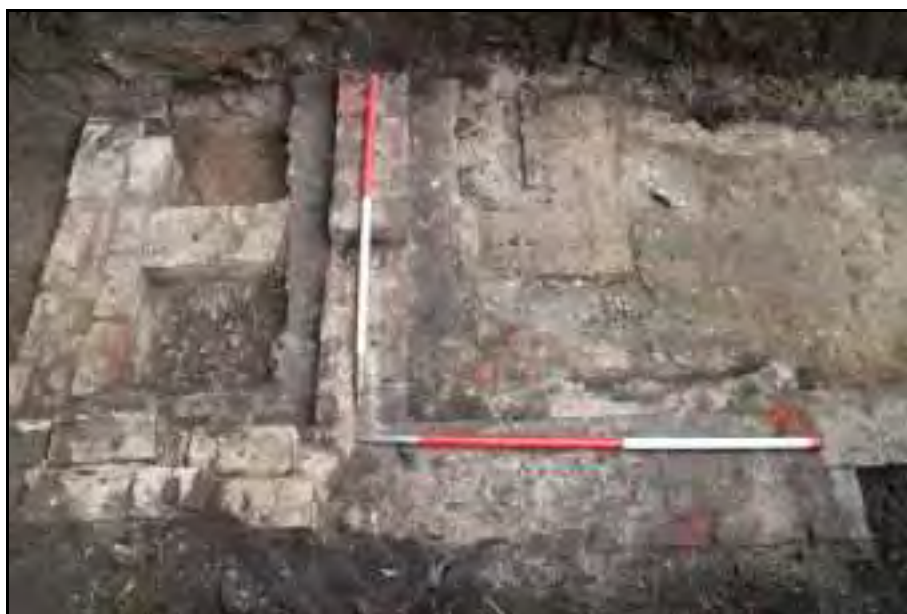
- 5.5.4 To the east of the sandstone flag surface, a series of internal red-brick walls (**5007**, **5011** and a differently aligned section of wall **5005**), extended north at right-angles to the southern boundary wall (Plate 19). Wall **5007** contained several well-dressed sandstone blocks towards its northern extremity, one of which contained a single square-shaped cut recess in its upper surface, presumably to hold a metal or wooden upright. The walls all appeared to be supported by, or else keyed into, a foundation deposit comprising a very rough concrete mix (**5006**), and collectively defined a series of rectangular recesses. Each recess was filled, below the level of the walls, by a distinct mortar-rich deposit (**5009**, **5010**, and **5012**) up to 0.2m thick. Below these deposits there was a layer of apparent made ground, although investigation did not progress below this depth.

*Plate 19: The internal wall, **5007** (left), the north/south-aligned aspect of **5005** (centre), and **5011** (centre right) forming the recesses infilled by mortar-rich deposits. Also featuring the southern external wall **5004/5005** (foreground) and mortared floor **5013** (right). Viewed facing north*

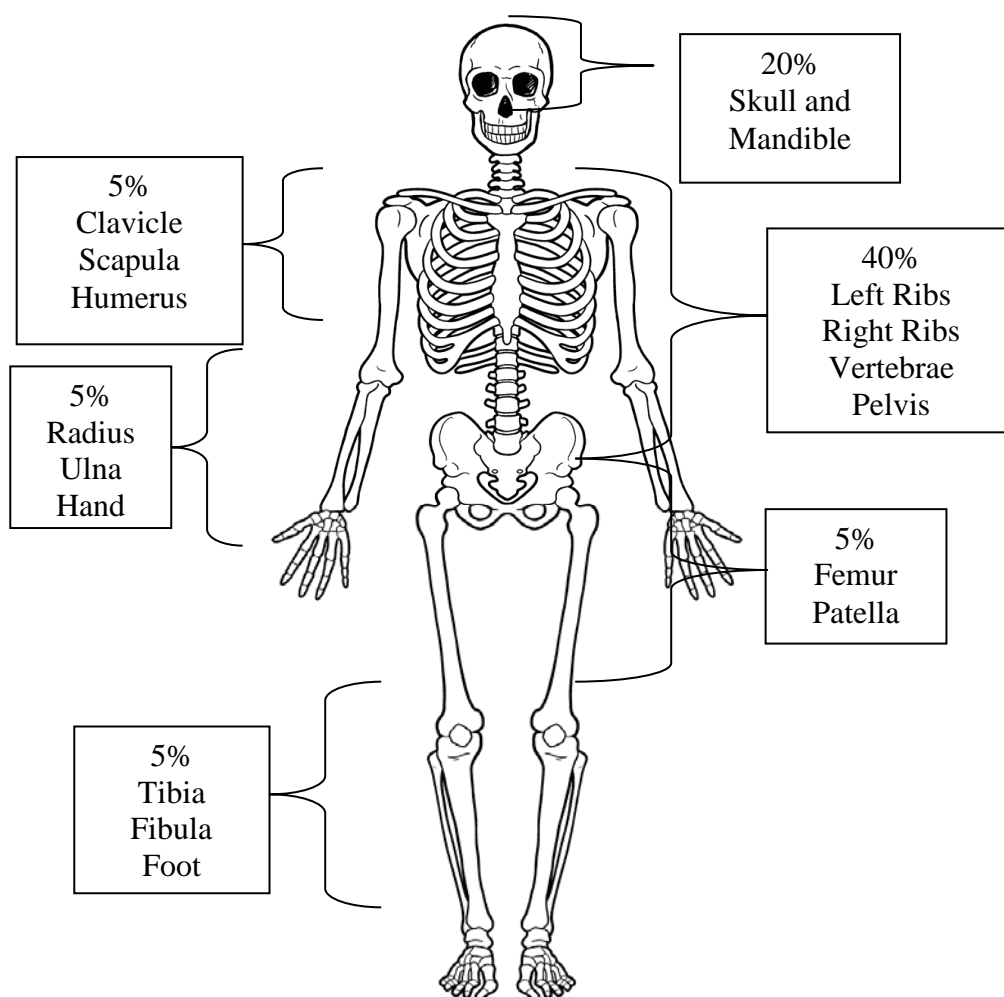
5.6.1 **Preservation and Completeness:** the condition and completeness of bone has considerable influence on the amount of information that can be retrieved from skeletons. Completeness was calculated depending on the presence of various elements as outlined on Figure 14. The vast majority of the TBG skeletons exhibited varying degrees of completeness, whilst the nature of the evaluation meant that it was often necessary to leave parts of skeletons unexcavated where they continued beyond the limits of excavation. When such partial skeletons are removed from consideration, over three-quarters of the articulated skeletons that lay within the detailed investigation areas were over 25% complete (Table 4). The whole assemblage was assessed for fragmentation, with generally low to moderate levels predominating (Table 5).

Figure 14: Scheme for calculating the completeness of articulated skeletons

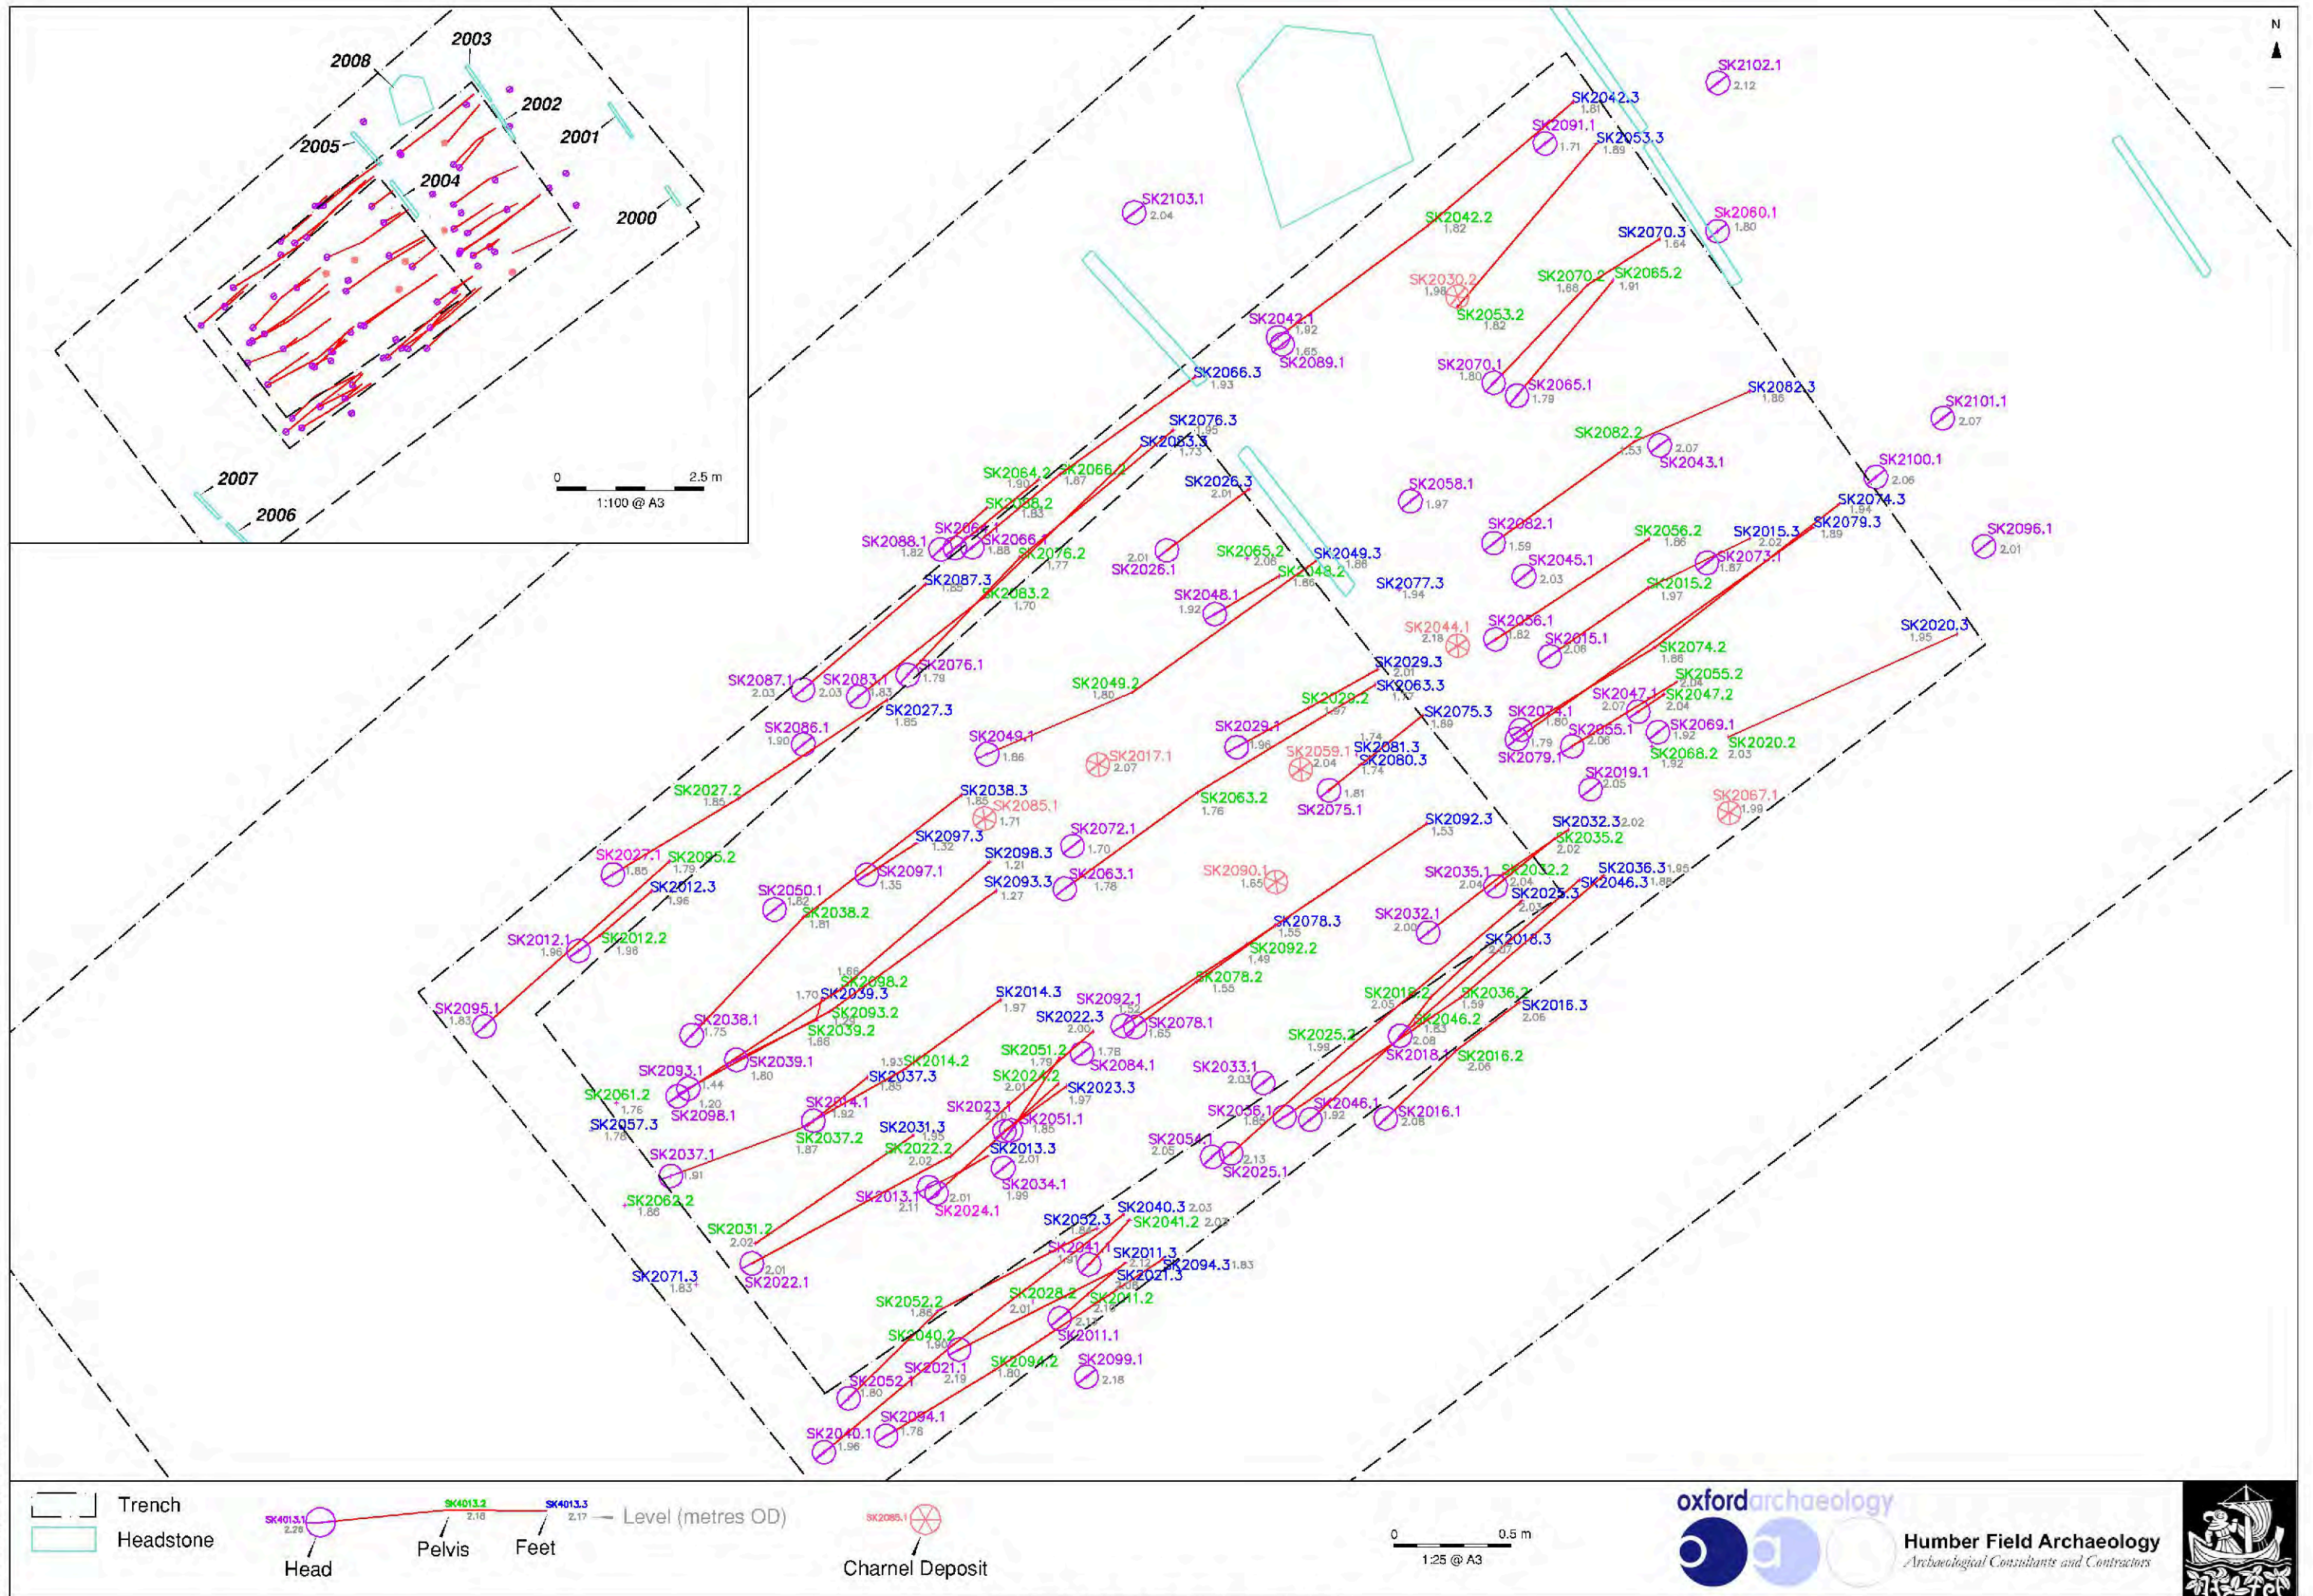
Figure 5: Plan of evaluation trench A

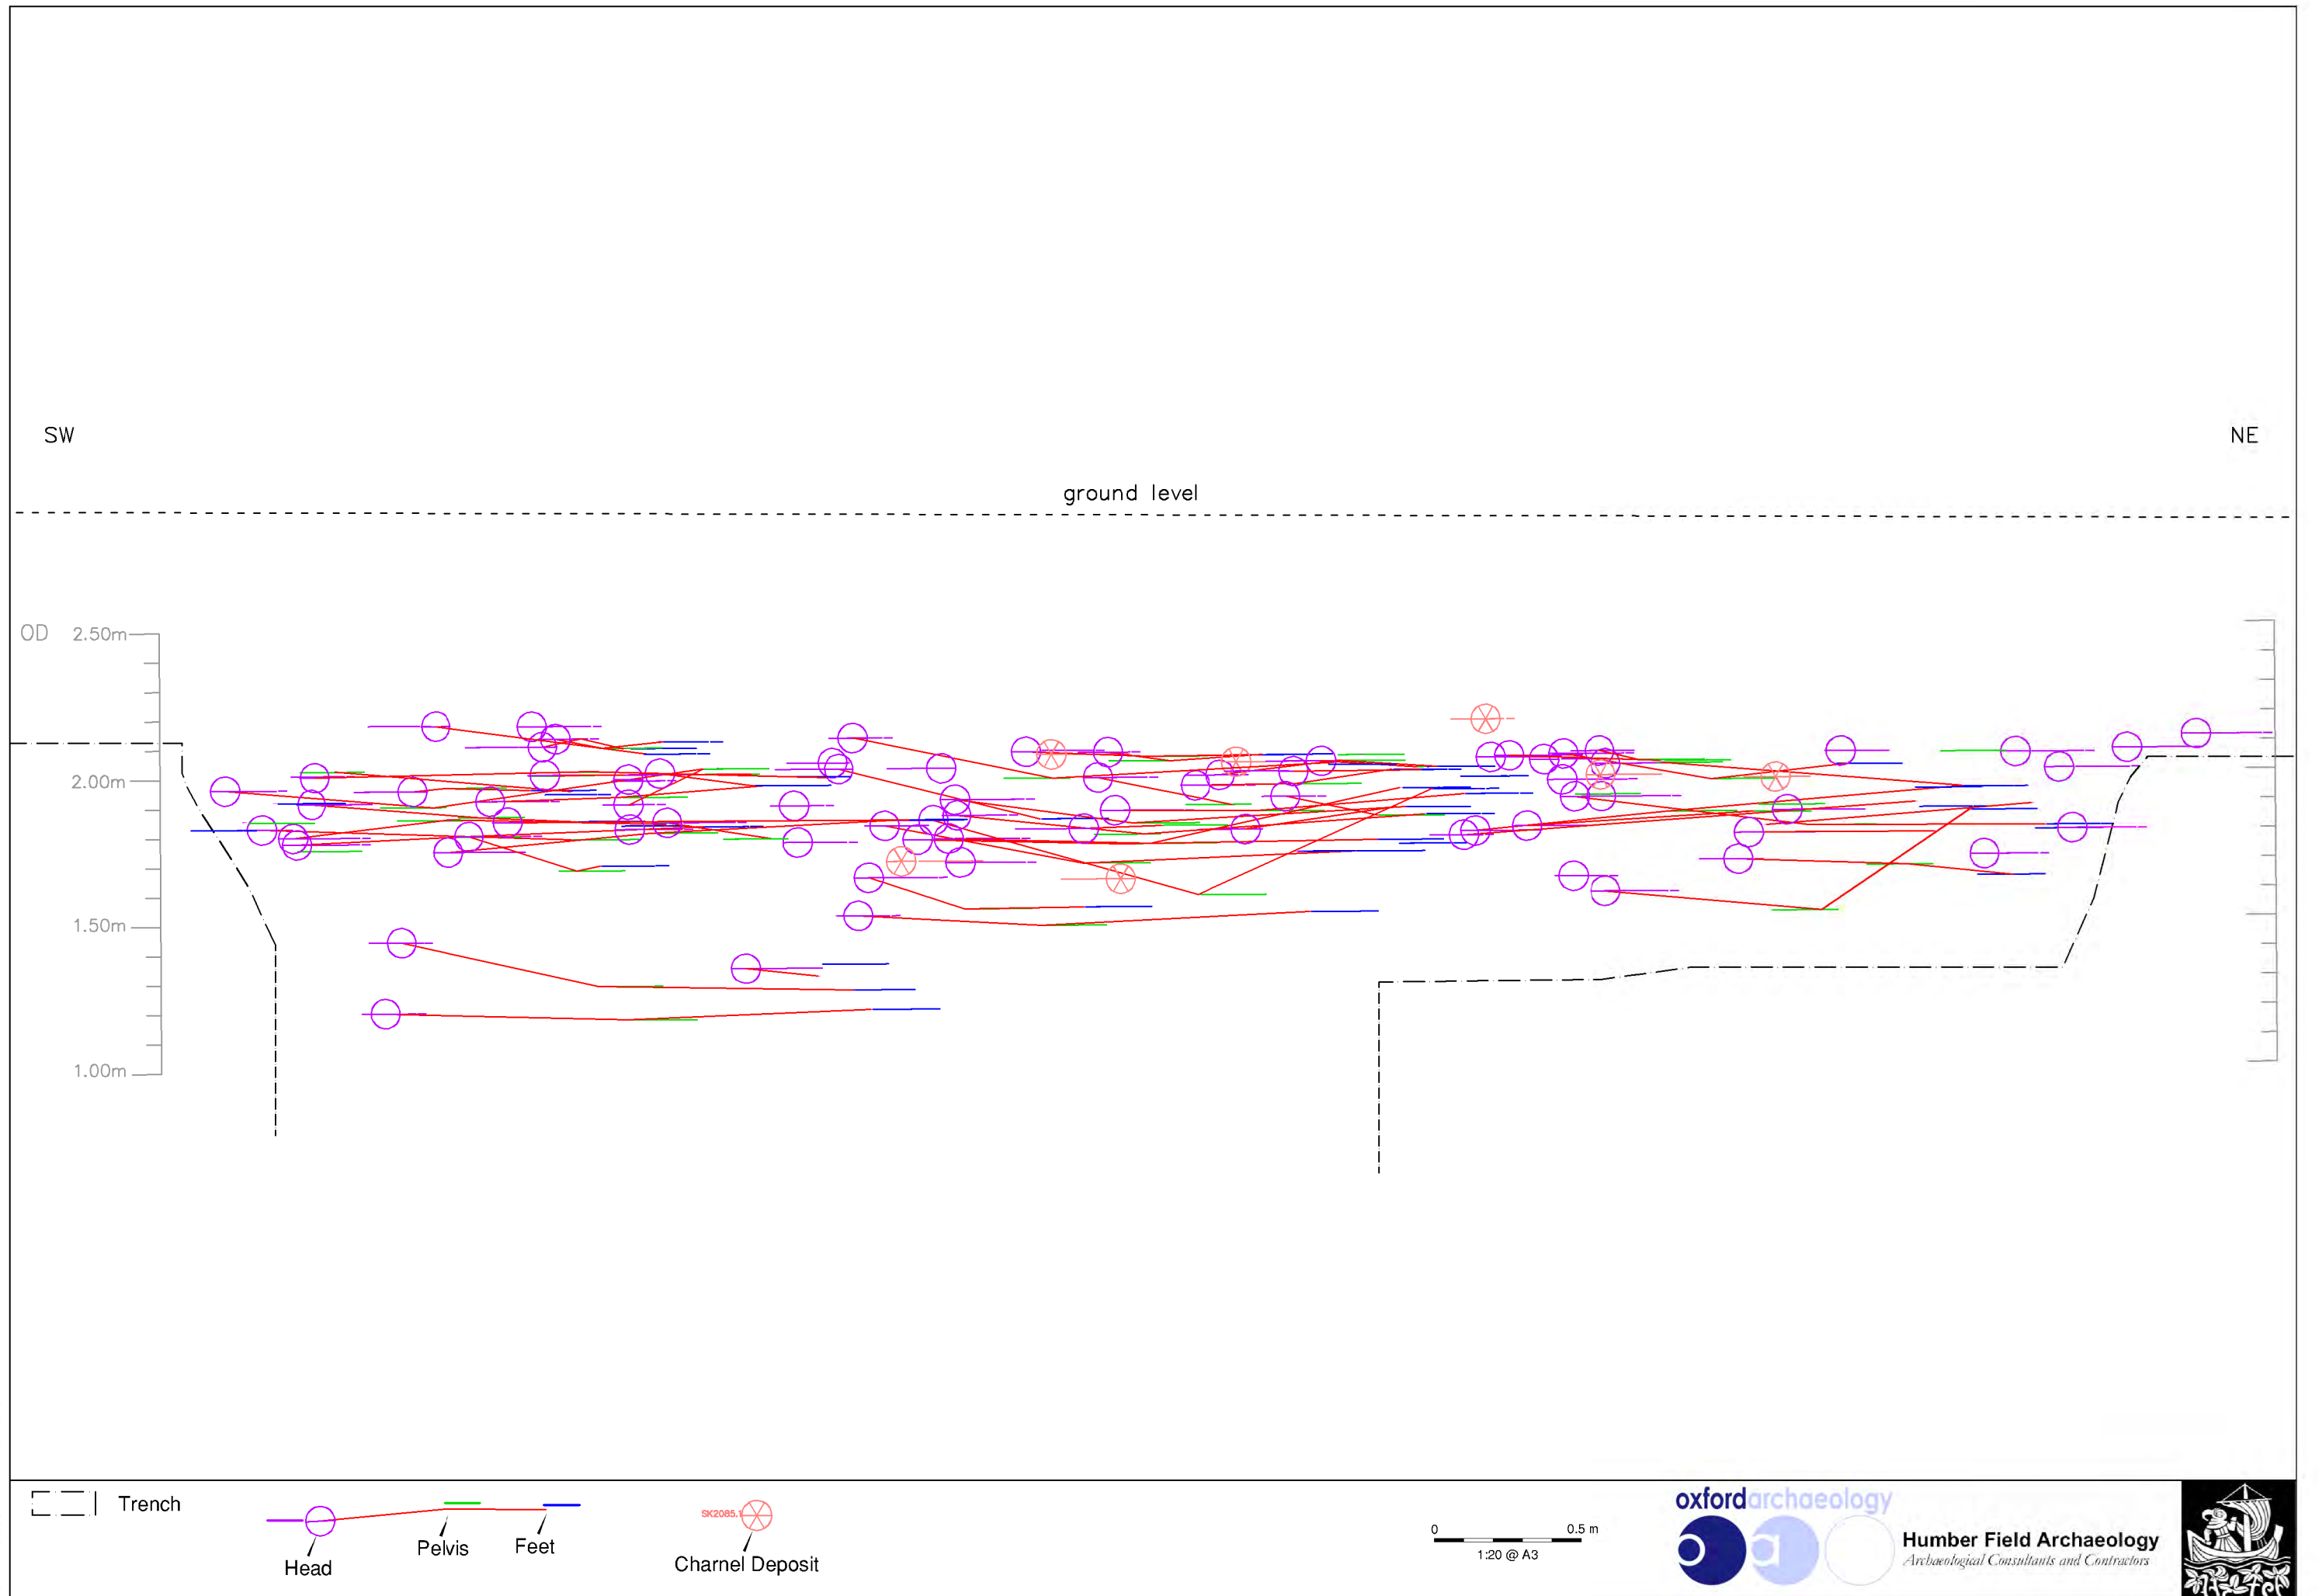
Figure 6: Sectional view of burials, evaluation trench A

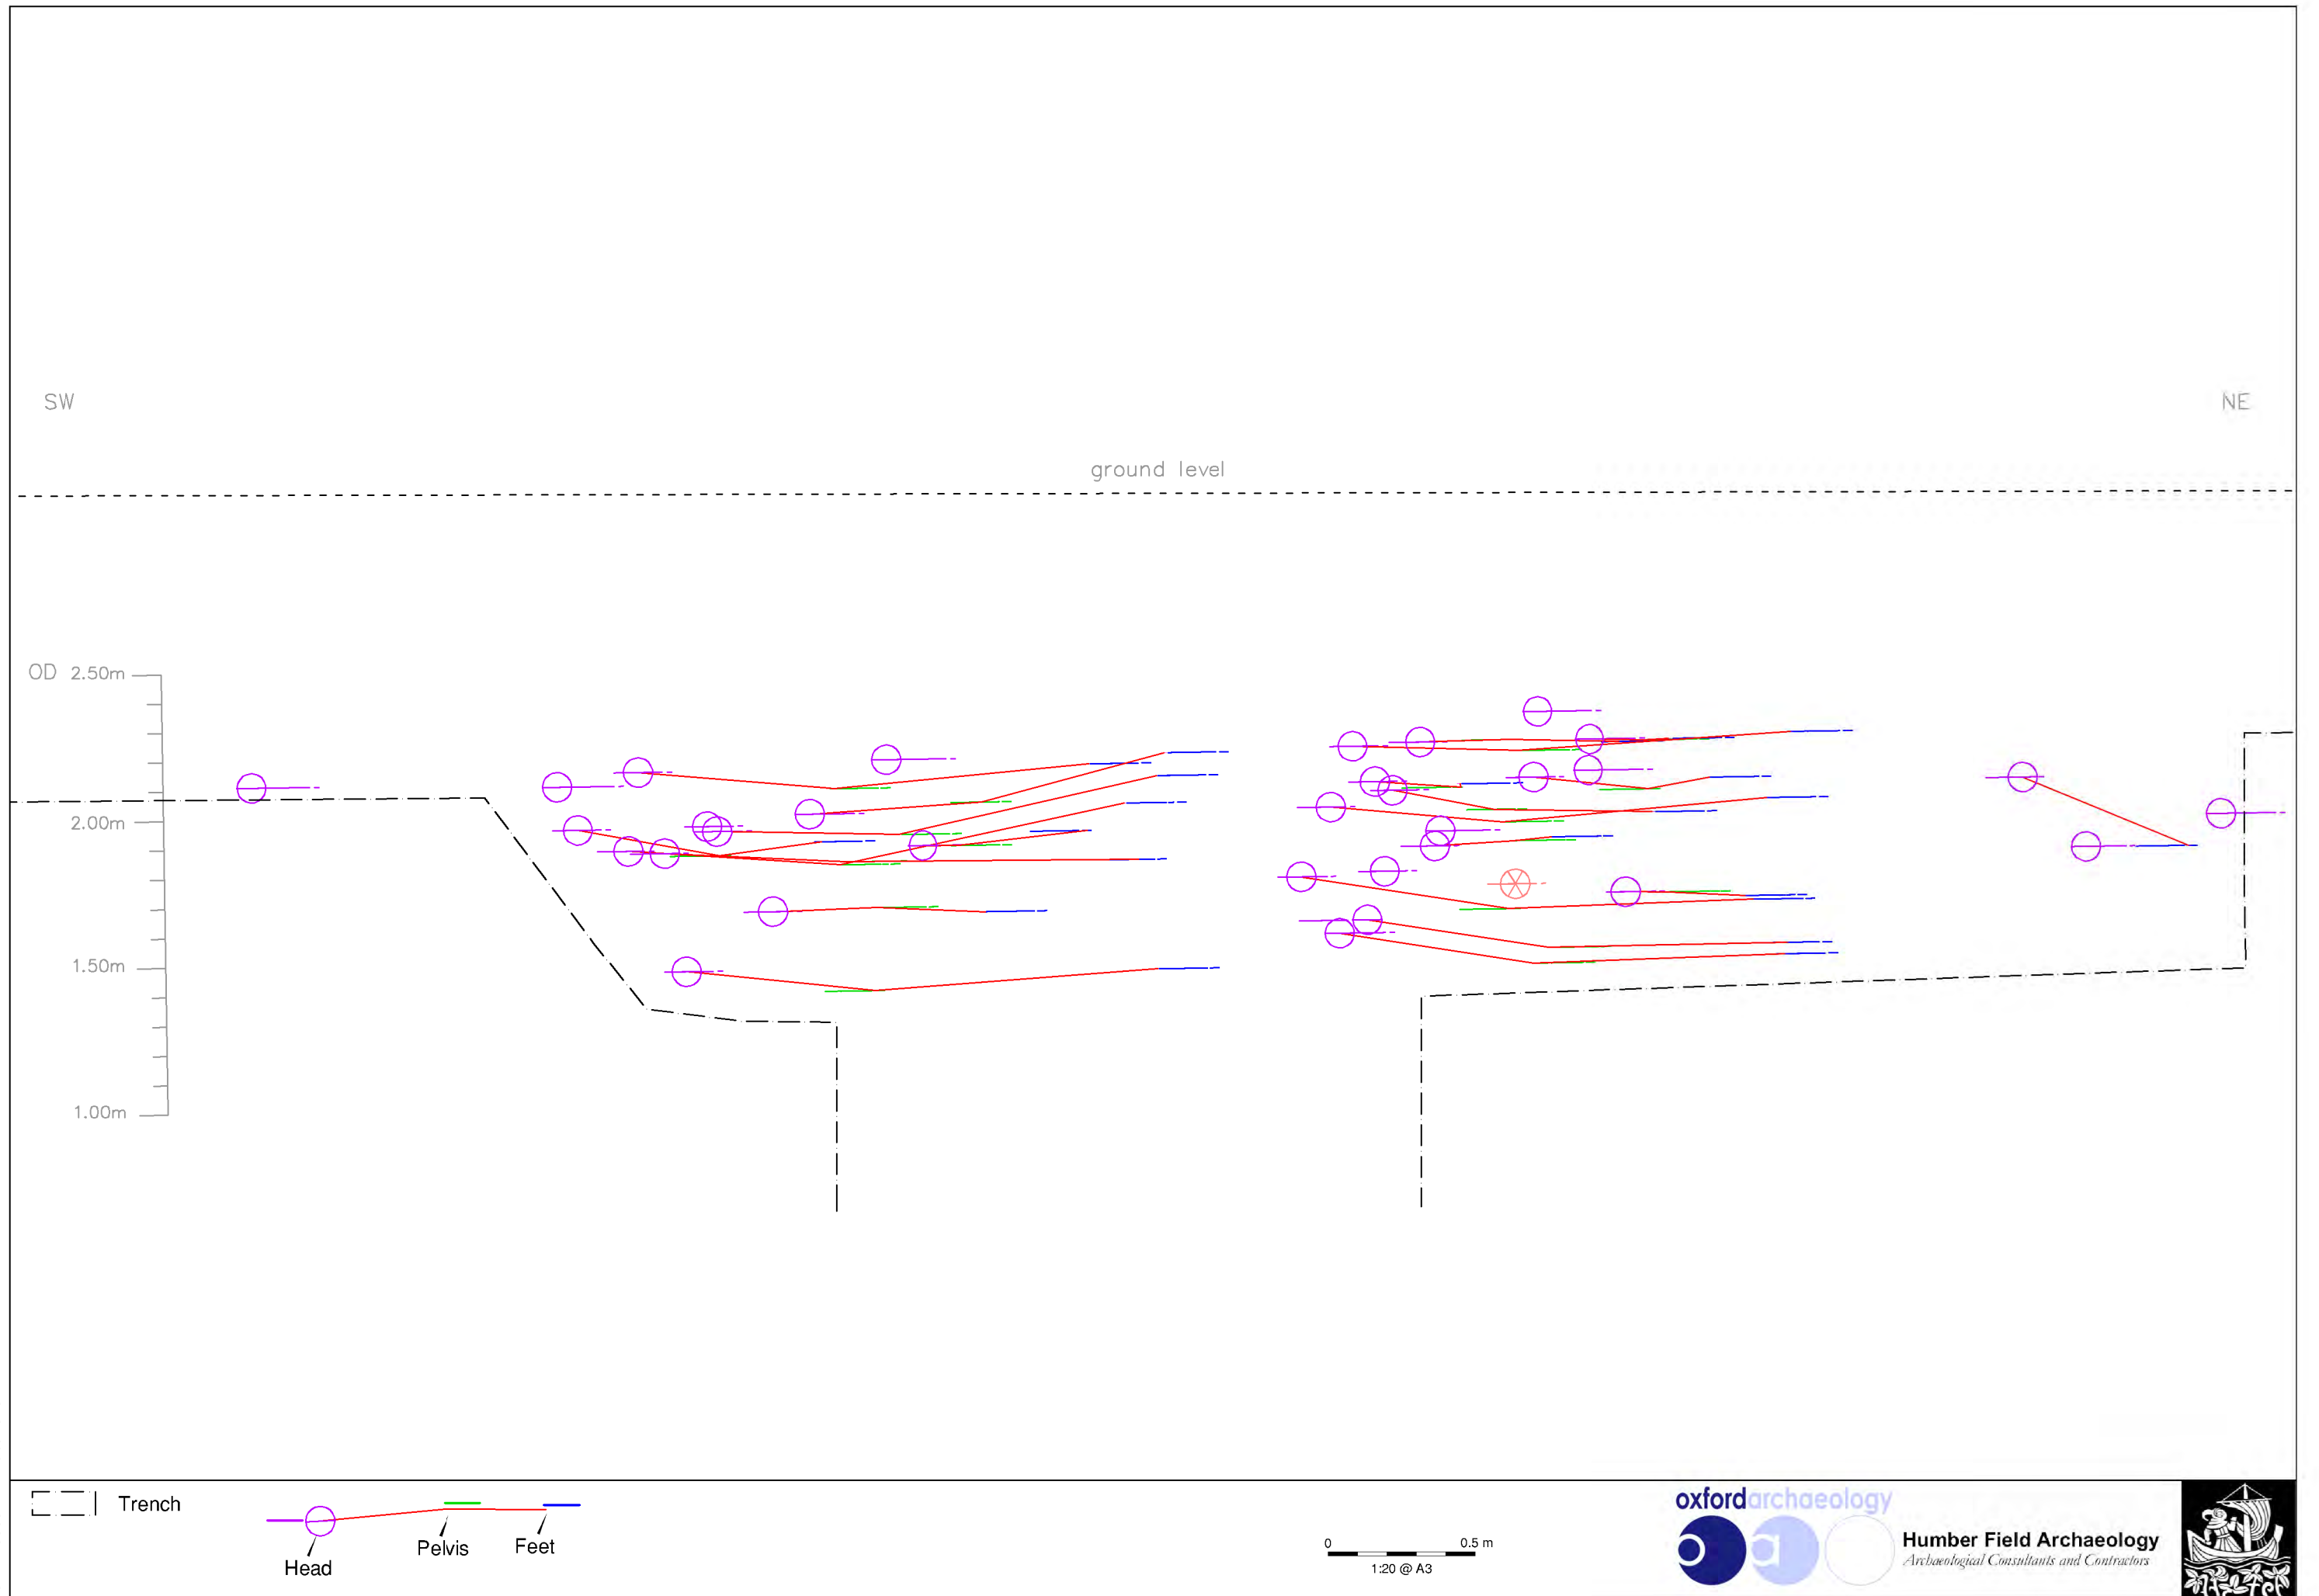
Figure 9: Sectional view of burials, evaluation trench B

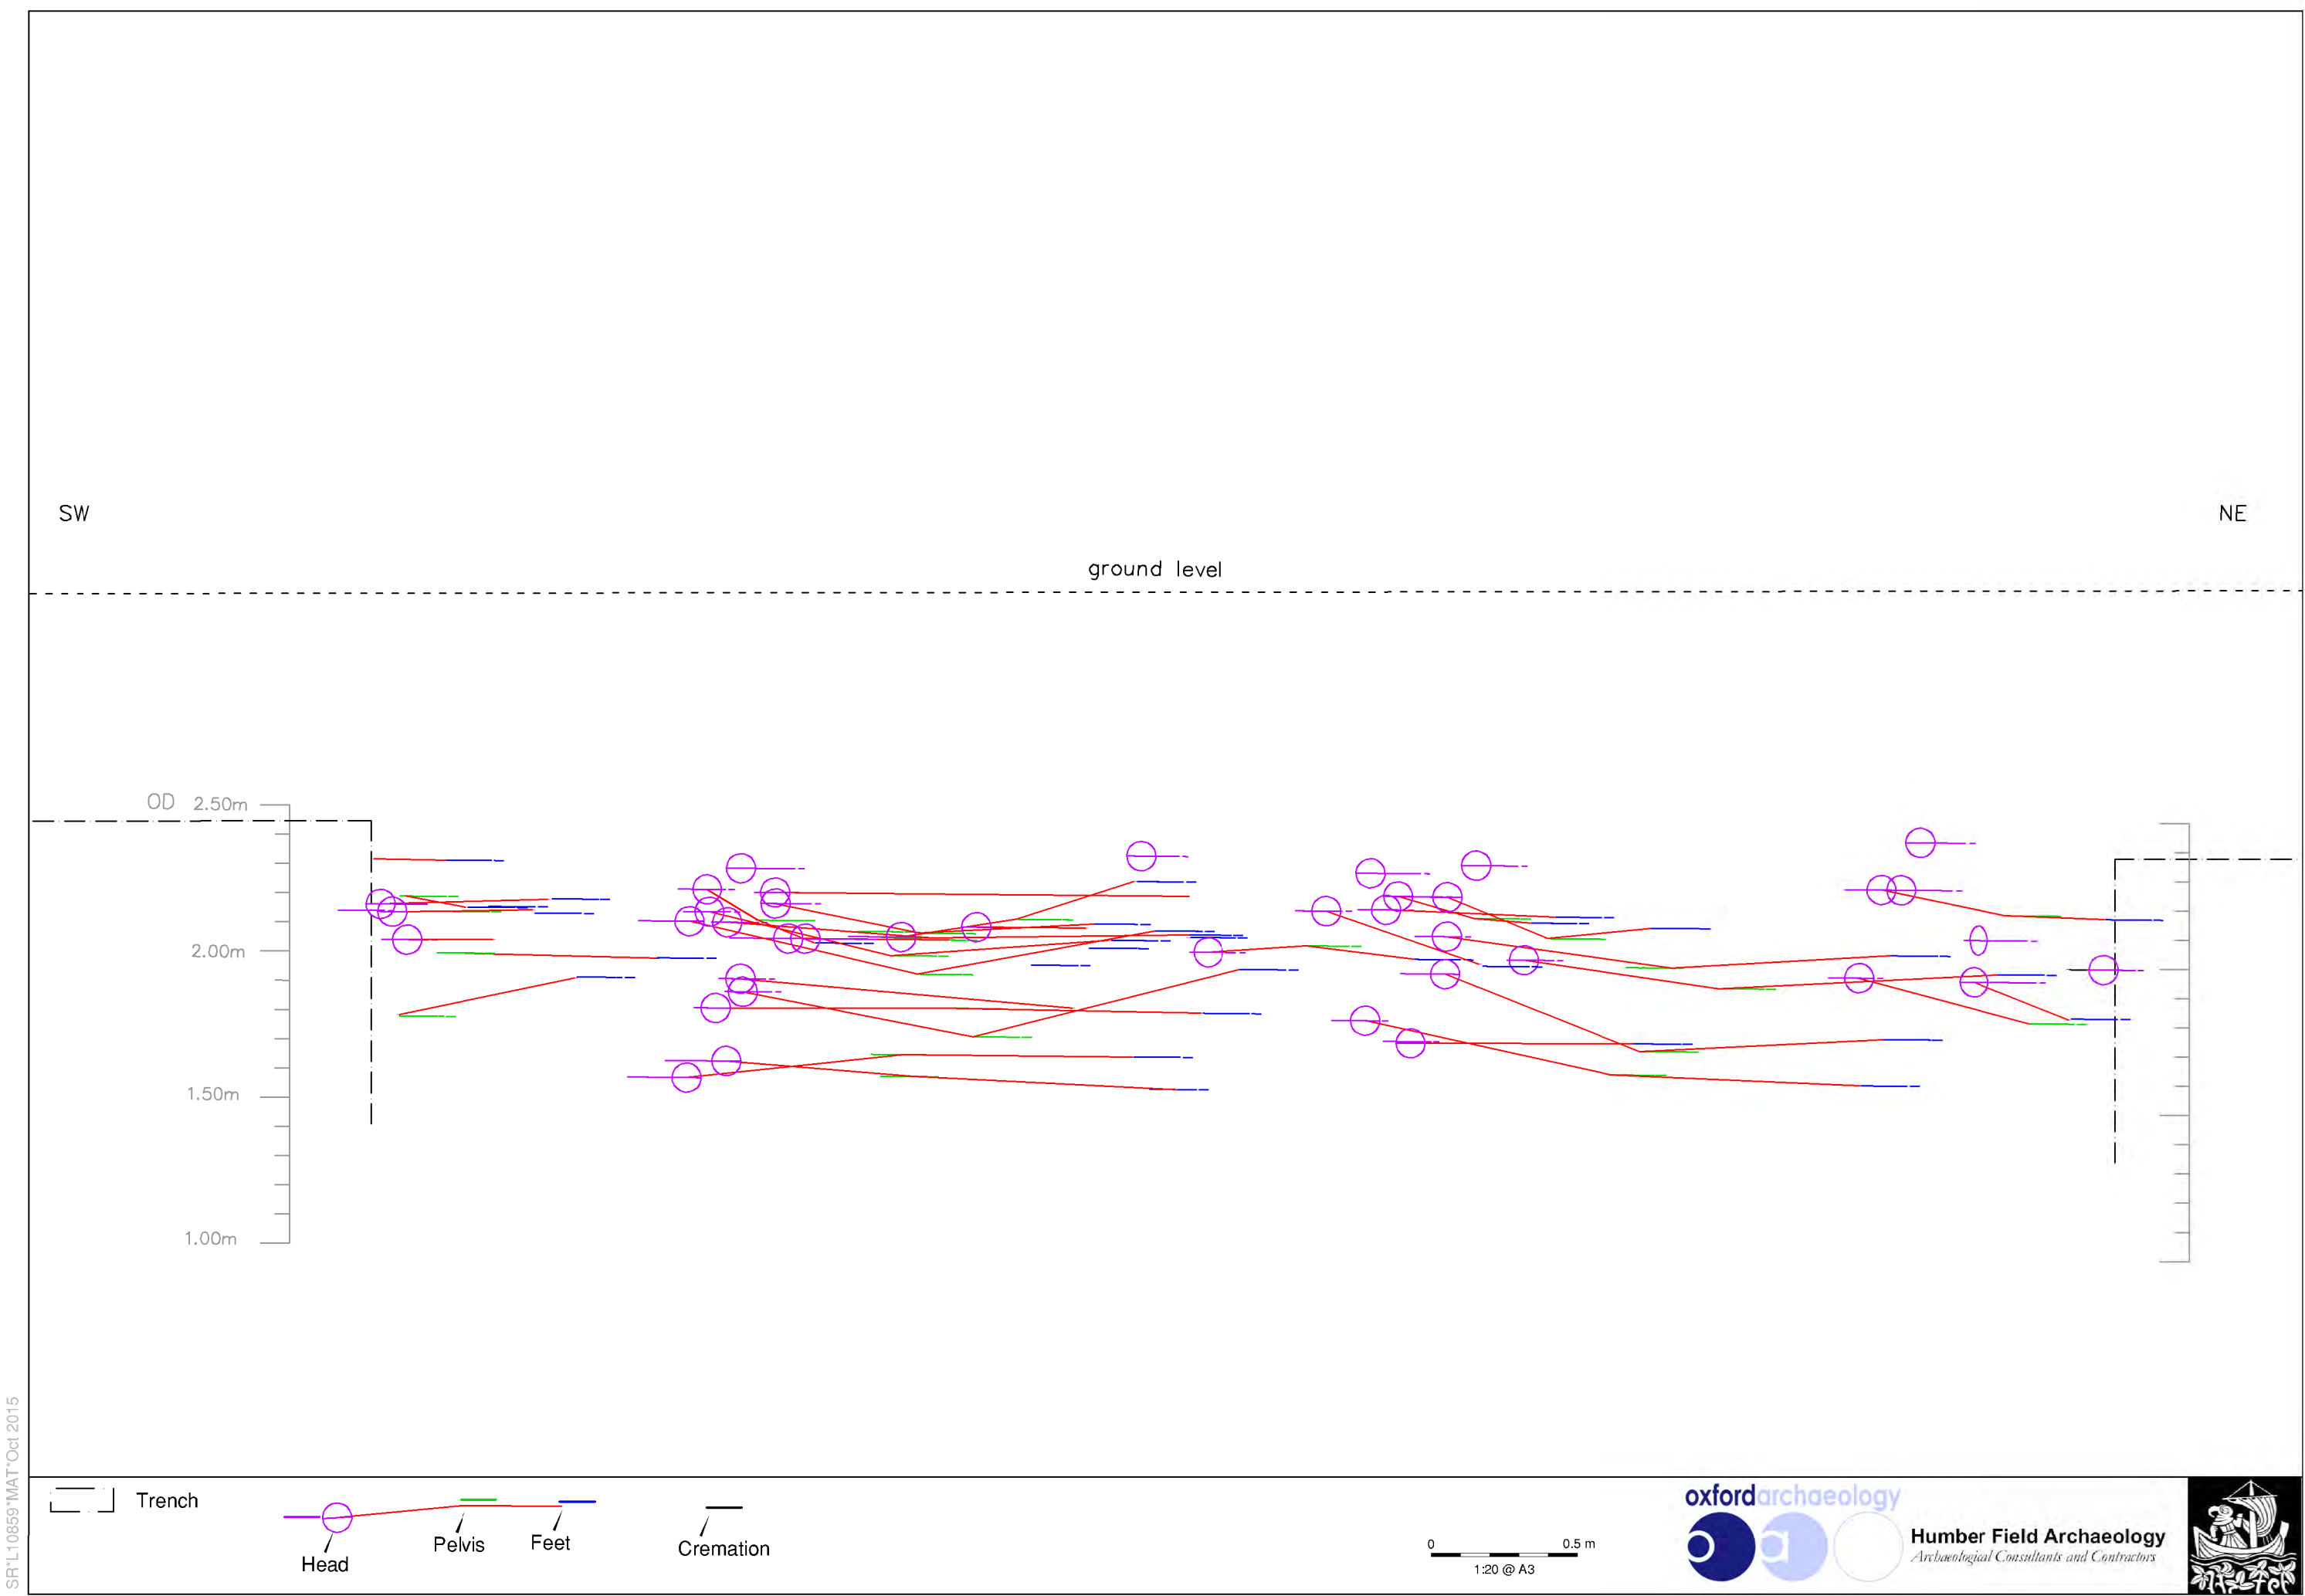
Figure 12: Sectional view of burials, evaluation trench C
